Characterization of Flaws in U.S. Reactor Pressure Vessels

Validation of Flaw Density and Distribution
in the Weld Metal of the PVRUF Vessel

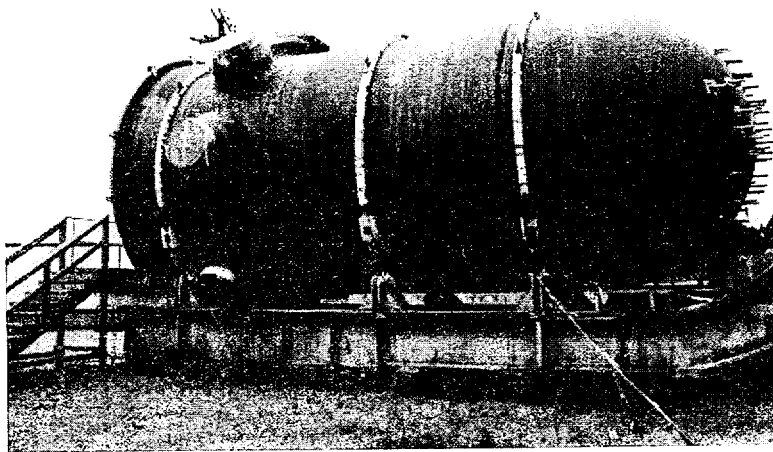
Figure 1.1 Photograph of the PVRUF Vessel at Oak Ridge National Laboratory

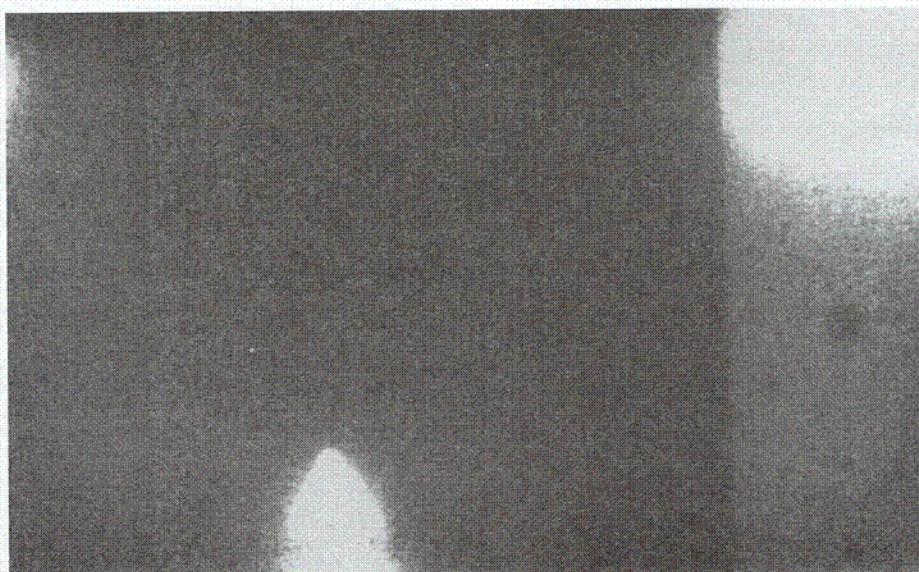
Figure 3.18 Digitized Image Radiograph of 25-mm Plate 5-1ab-9 Location 2. No RT indication was found at this location.

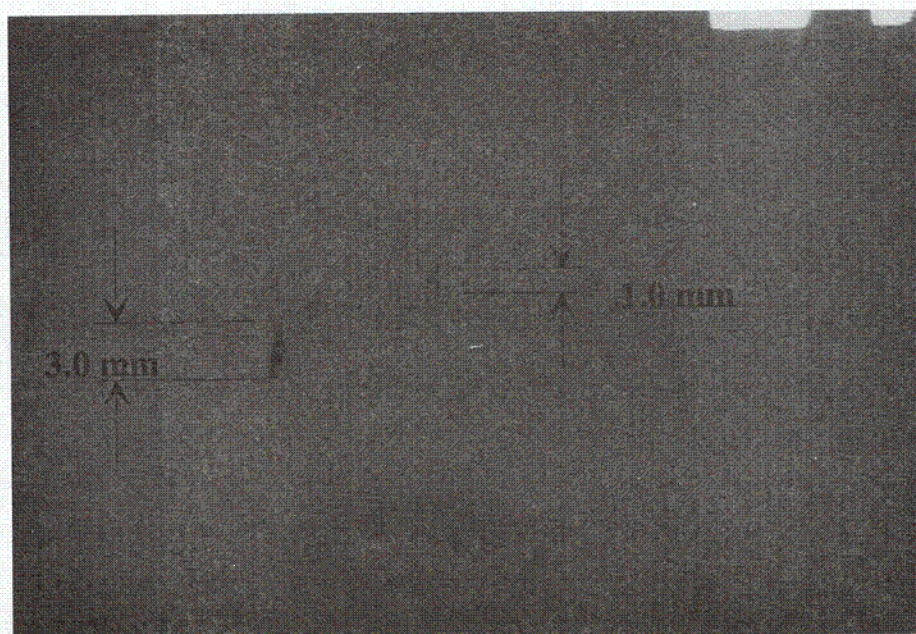
Figure 3.19 Digitized image of Radiograph of 25-mm Plate 5-1AB-11

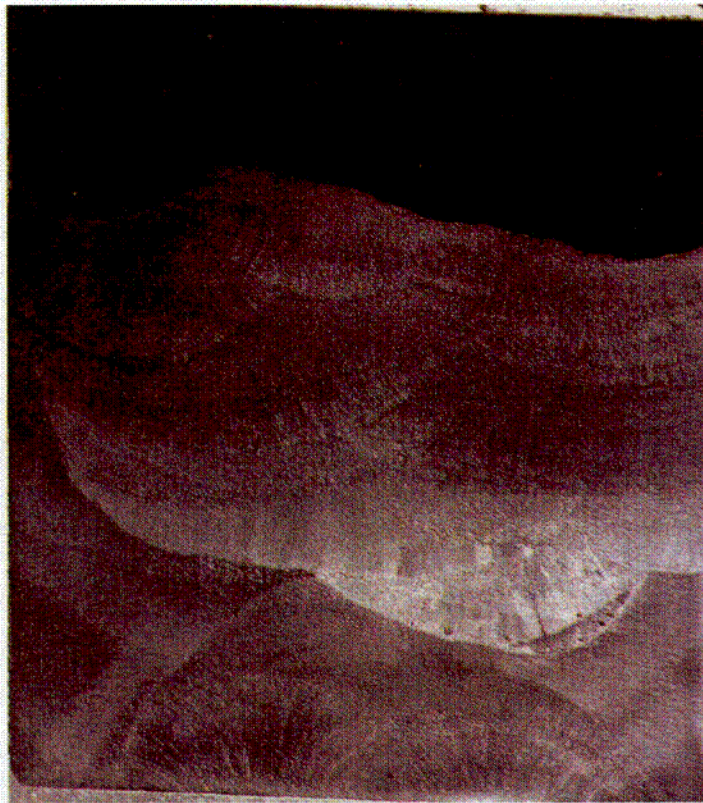
Figure 3.65 Micrograph of Cube Showing Failed Weld Bead

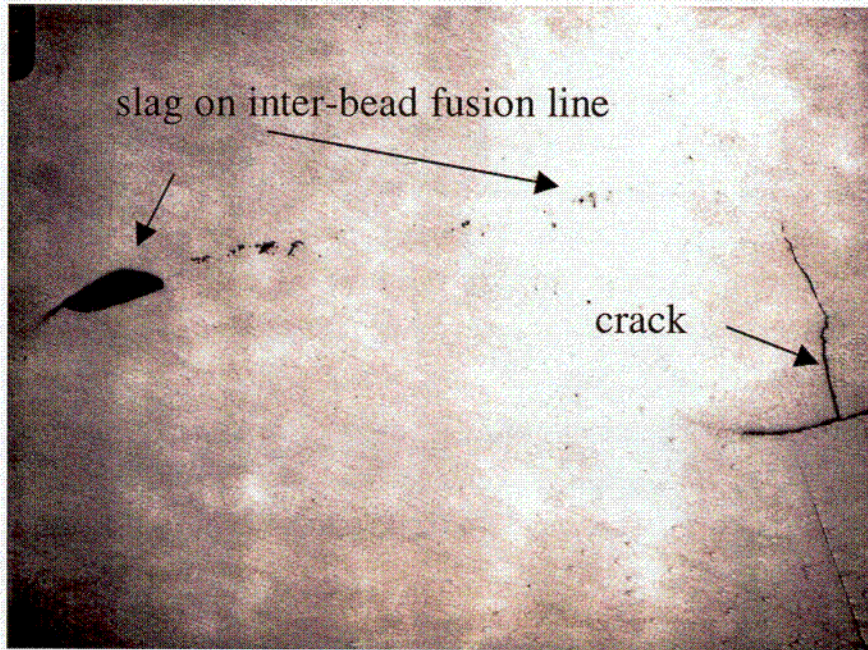
Figure 3.66 Micrograph of Cube 5-10EB1-IIbIIc Showing Flaws in the First Weld Pass of the Back-Fill

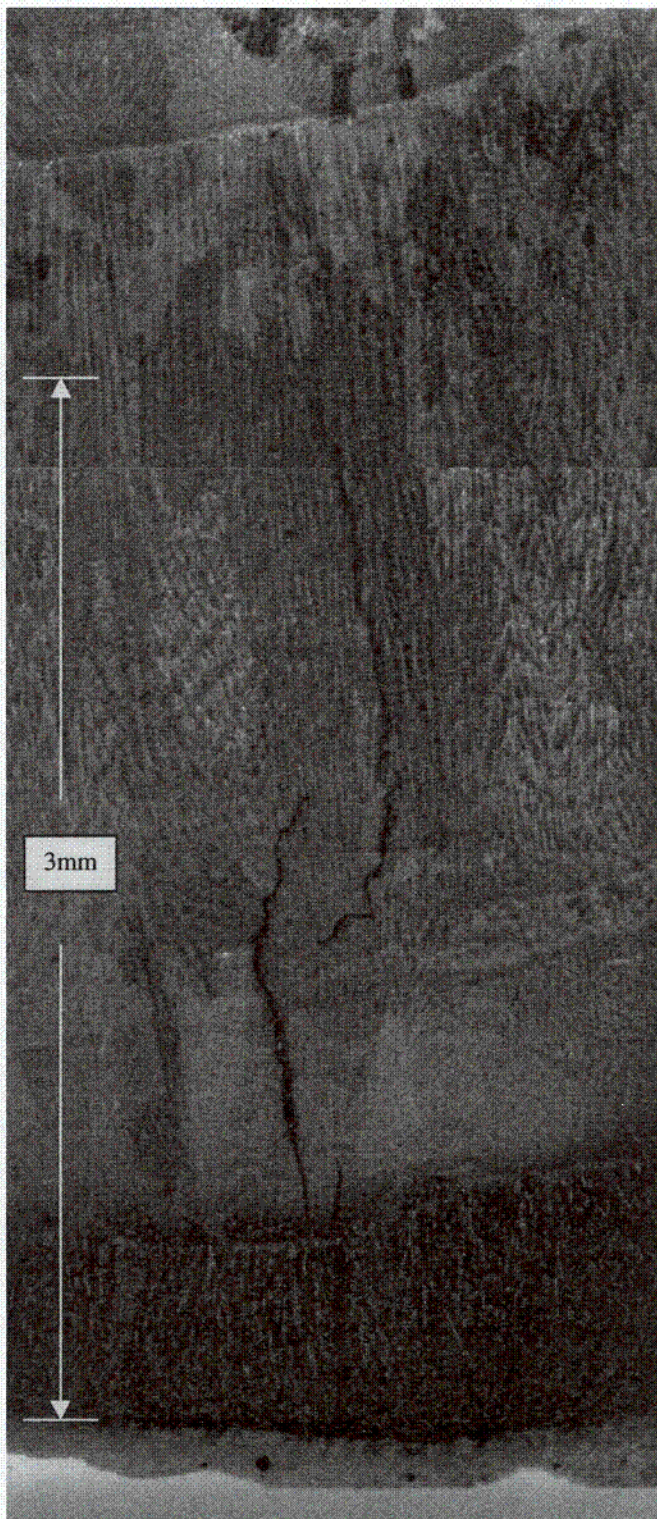
Figure 3.68 Micrograph of Crack in Flawed Weld Bead, Near Surface Zone of PVRUF

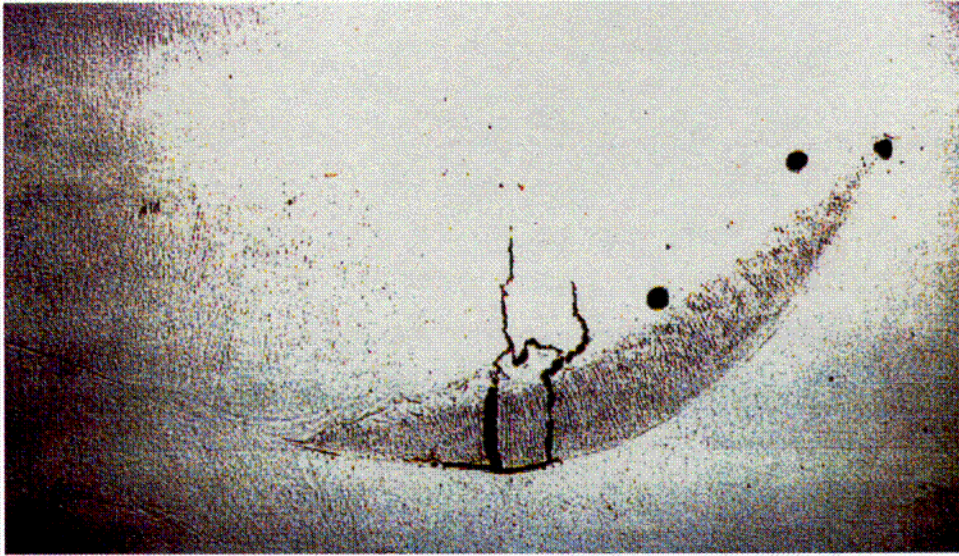
Figure 3.69 Micrograph of Cracked Weld Bead

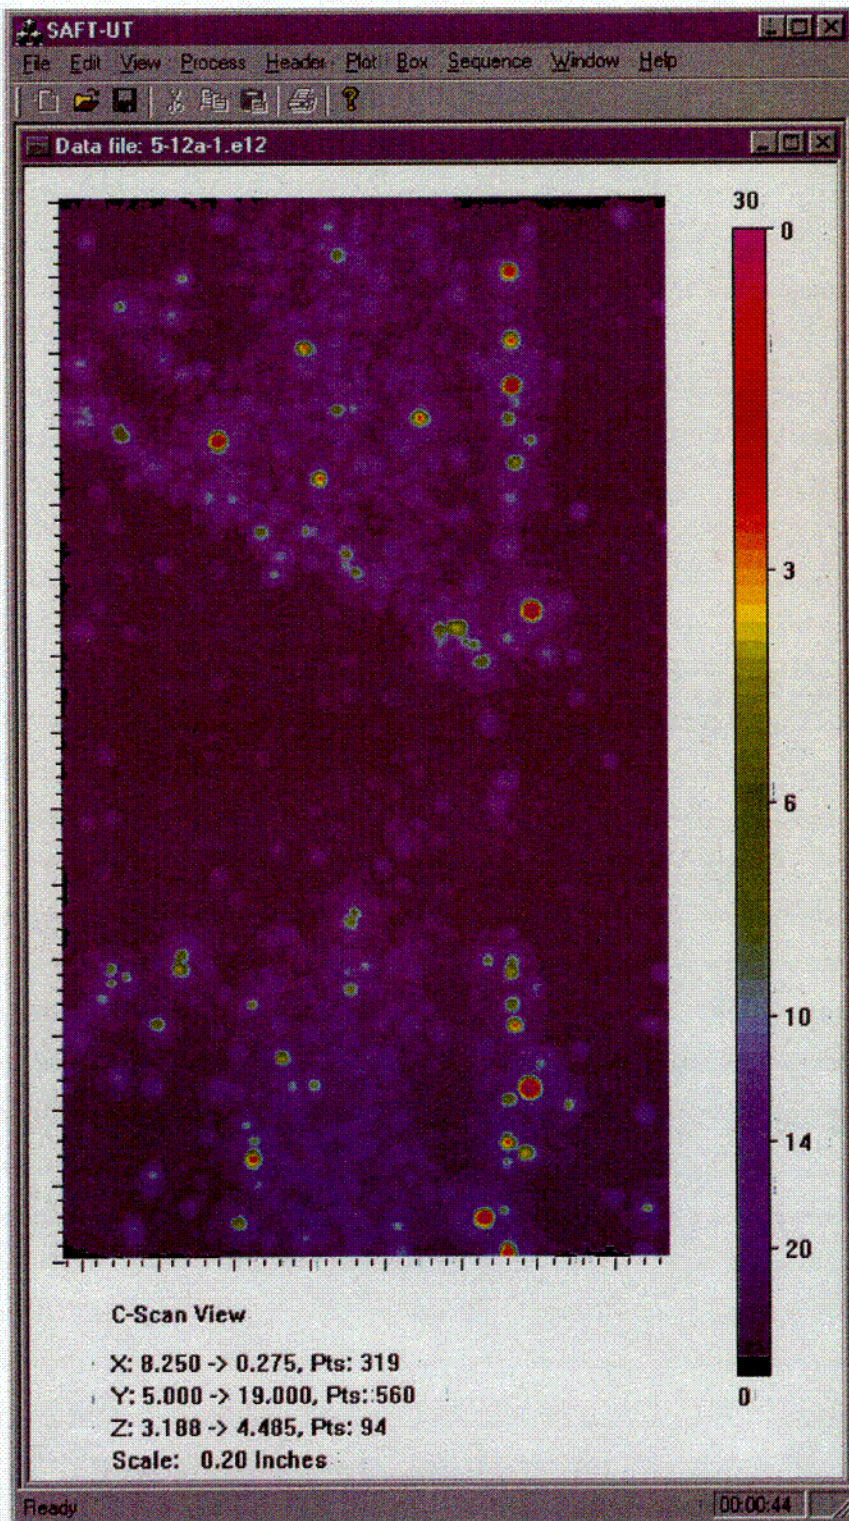
Figure 3.70 Weld-Normal UT C-scan Image of Weld Fusion Surface Showing Profile of Weld Repair's Low Acoustic Energy Signature

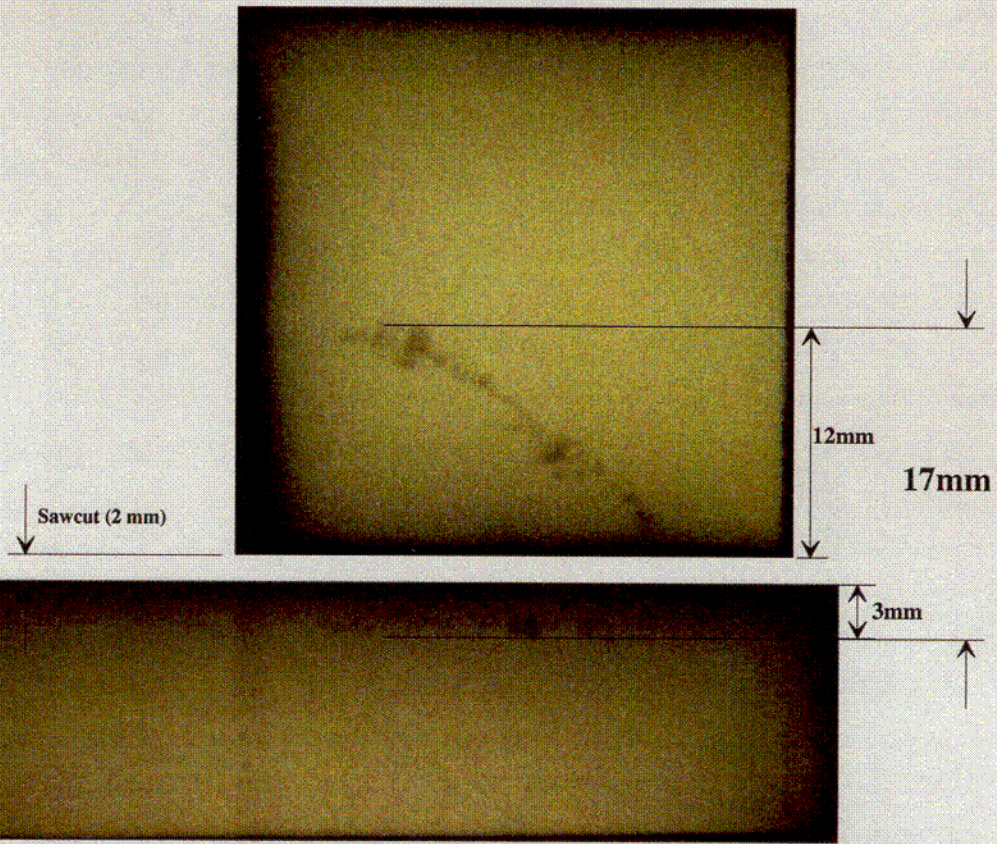
Block 5-12 AC5
Radiography View C
Block Dimensions are (13mm x 42mm)

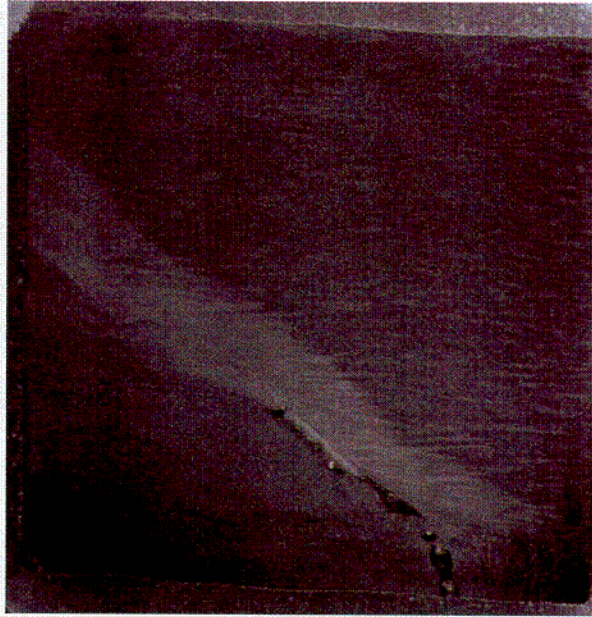
Figure 3.72 Micrograph of a Portion of the 17-mm Flaw. The composition of the flaw is taken to be slag, porosity, and contamination.

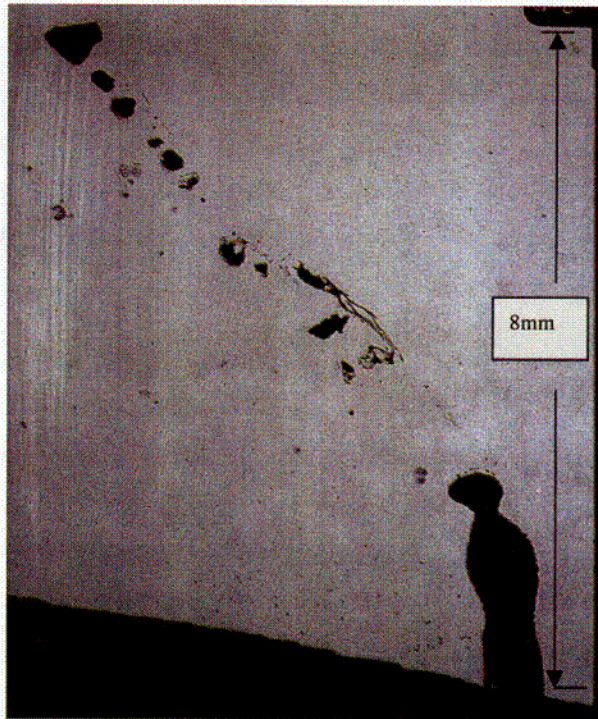
Figure 3.73 Micrograph Showing a Magnified View of a Portion of the 17-mm Flaw. A crack-like portion of the flaw is visible in this figure.

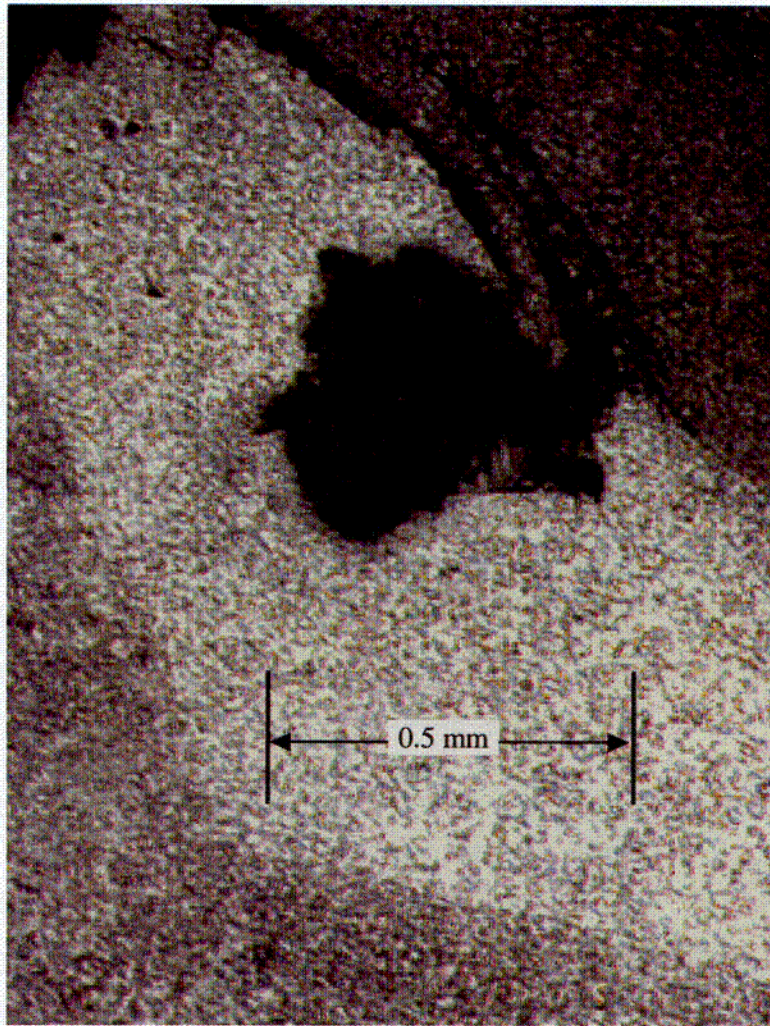
Figure 3.74 Micrograph Showing a Magnified View of the Crack-like Portion of the 17-mm Flaw. The crack originates from a small region between weld beads.

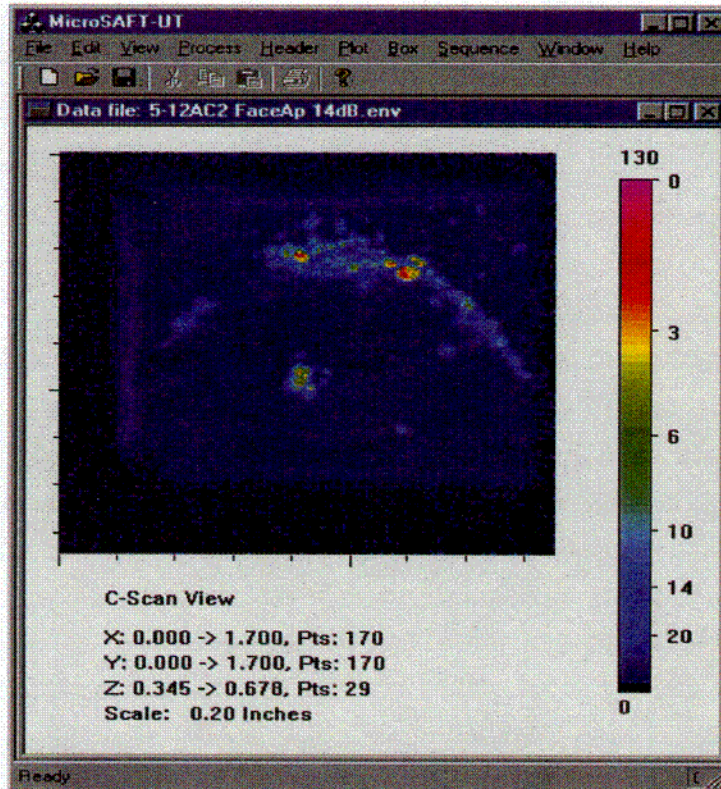
Figure 3.75 Focused Ultrasound (10-MHz Probe) Result Showing Top View of Flaw in 5-12AC2. This is a repair flaw located on the end of the repair. Vessel through-wall direction is into the page. Distance from weld center is on the abscissa. Distance along the beltline weld is on the ordinate. This image shows that the flaw is oriented principally in the axial direction.

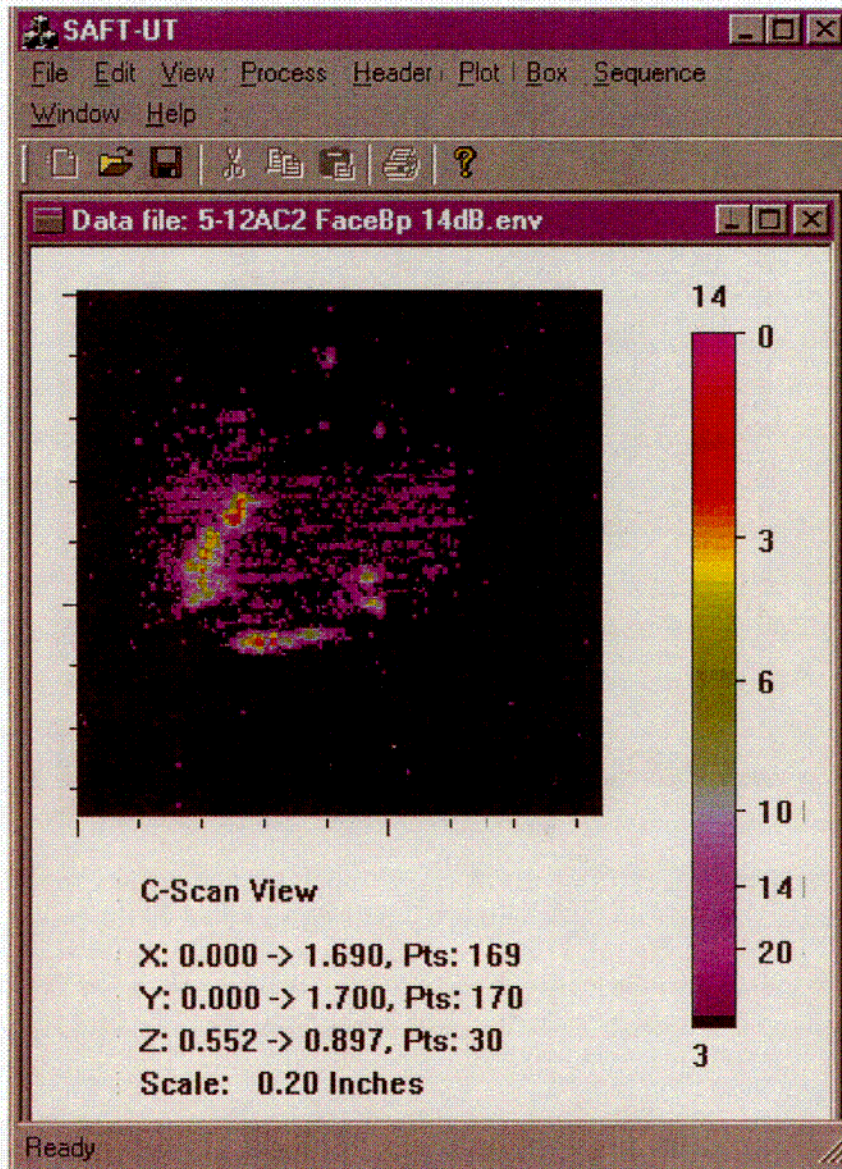
Figure 3.76 Focused Ultrasound (10-MHz probe) Result Showing Side View of Flaw in 5-12AC2. This is a repair flaw located on the end of the repair. Vessel through-wall direction is on the ordinate. Distance from weld center is into the page. Distance along the beltline weld is on the abscissa.

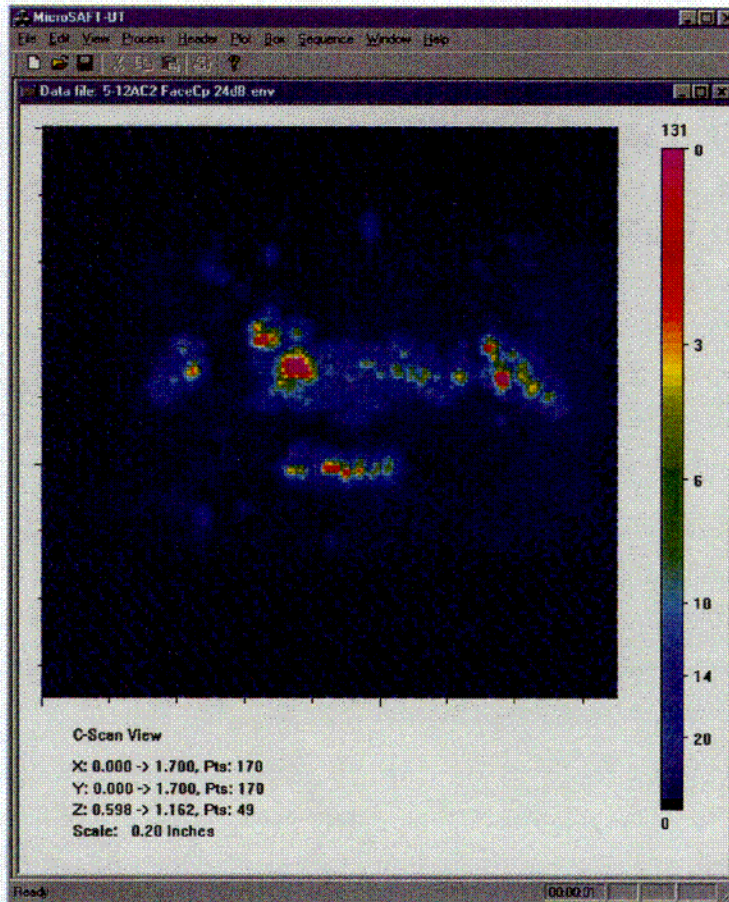
Figure 3.77 Focused Ultrasound (10-MHz probe) Result Showing End View of Flaw in 5-12AC2. This is a repair flaw located on the end of the repair. Vessel through-wall direction is on the ordinate. Distance from weld center is on the abscissa. Distance along the beltline weld is into the page.

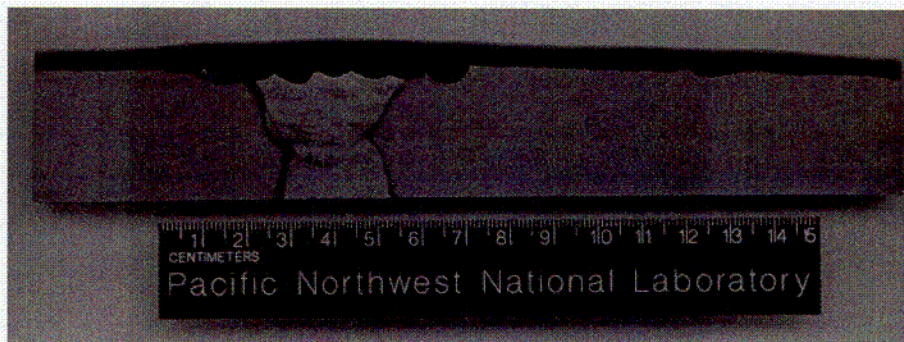
Figure 3.78 Micrograph of Upper Portion of Weld in PVRUF Specimen 5-6Eca. A weld repair, made from inside the vessel, was reported at this location. The repair was not detected.

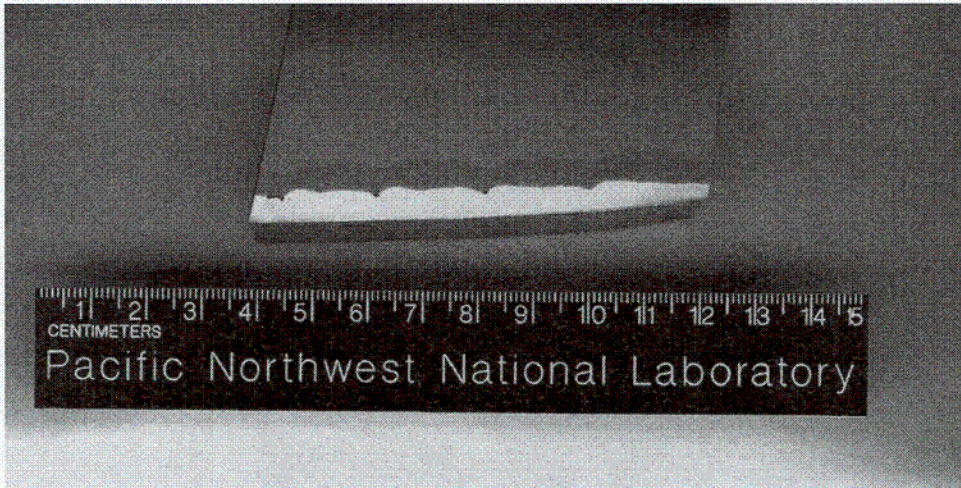
Figure 3.79 Photograph of PVRUF Specimen Showing Small Slag Inclusions at the Clad-to-Base Metal Interface.

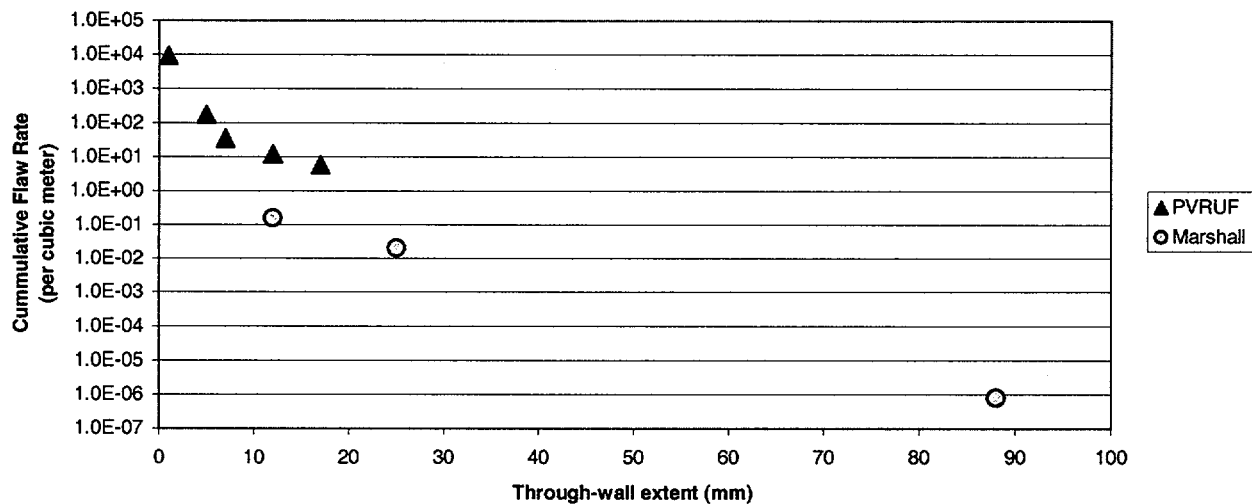
Figure 4.1. Comparison of Validated PVRUF and Marshall Cumulative Flow Rates. This semi-log plot shows the individual data points from the PVRUF validation Tables 4.1, 4.4, and 4.6 and the Marshall data (Marshall 1976).

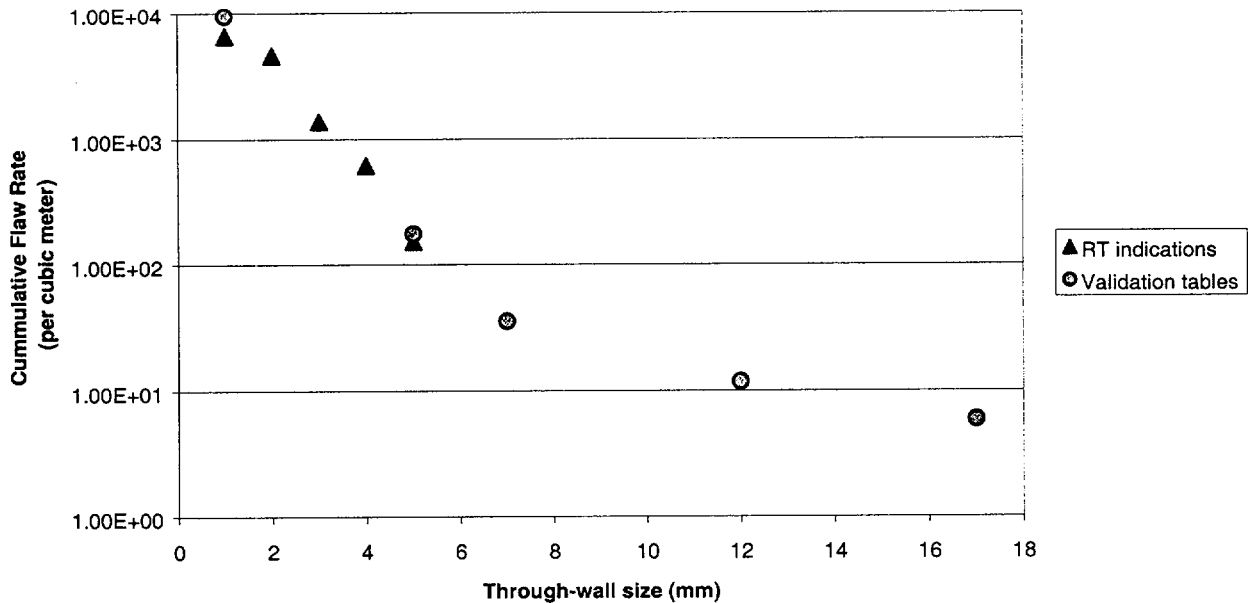
Figure 4.2. Size Distribution of Small Flaws in PVRUF Vessel as Measured by Radiographic Testing of 25-mm Thick Plate
