# Dry Cask Storage Characterization Project—Phase 1: CASTOR V/21 Cask Opening and Examination

Idaho National Engineering and Environmental Laboratory

U.S. Nuclear Regulatory Commission  
Office of Nuclear Regulatory Research  
Washington, DC 20555-0001

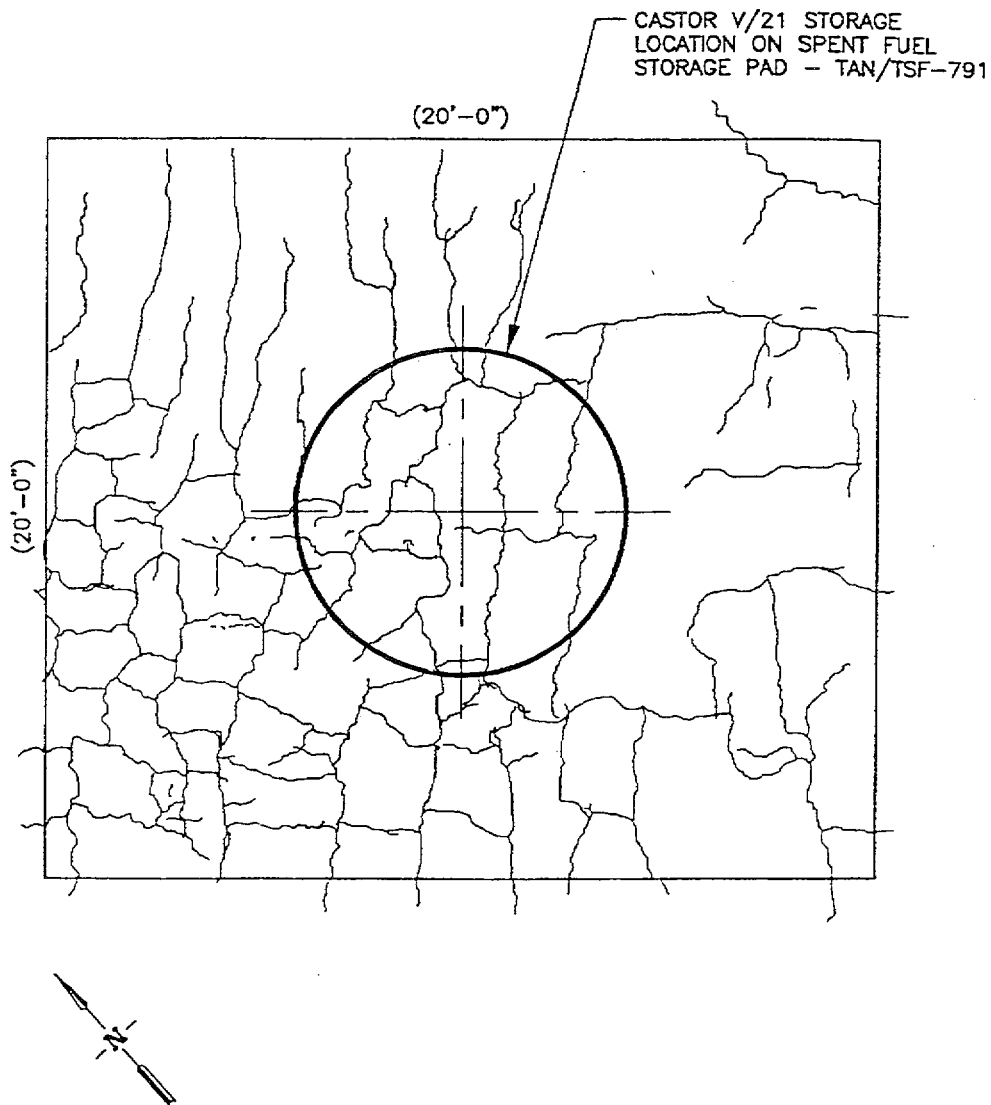
The pad was also visually inspected for evidence of degradation and structural failure. The surface of the whole pad did not exhibit any evidence of structural failure of the concrete, such as open cracks or cracks with displacements in elevation of the surface. The surface of the concrete did not exhibit any evidence of spallation of the surface, exposed aggregate, or aggregate pop-out from the surface. The surface was solid and exhibited only minor wear and environmental weathering, well within the extent of weathering expected for the cold and windy climate of Idaho. The broom-finished unpainted surface exhibited only a network of faint, fine surface shrinkage cracks (Figure 2-3), less than 0.8 mm (1/32 in.) wide and of superficial depth, and a few rust stains under the cask from lightly rusted bolts on the cask. Similar cracks were prevalent across the entire surface of the pad, and were not associated with the cask locations. Tests with a straight taught line across the 6.1 m  $\times$  6.1 m (20  $\times$  20 ft) grid indicated that there was no sag or vertical displacement in the concrete associated with the crack network; measurements with a straight edge and the taught line indicated only localized variations in the elevation of the concrete that were less than 3.2 mm (1/8 in.). The localized variations in elevation were not associated with the location of the cask and were most likely an artifact of the screeding and finishing when the concrete was originally poured.

Figure 2-3. Shrink crack indication of CASTOR V/21 concrete pad storage area.

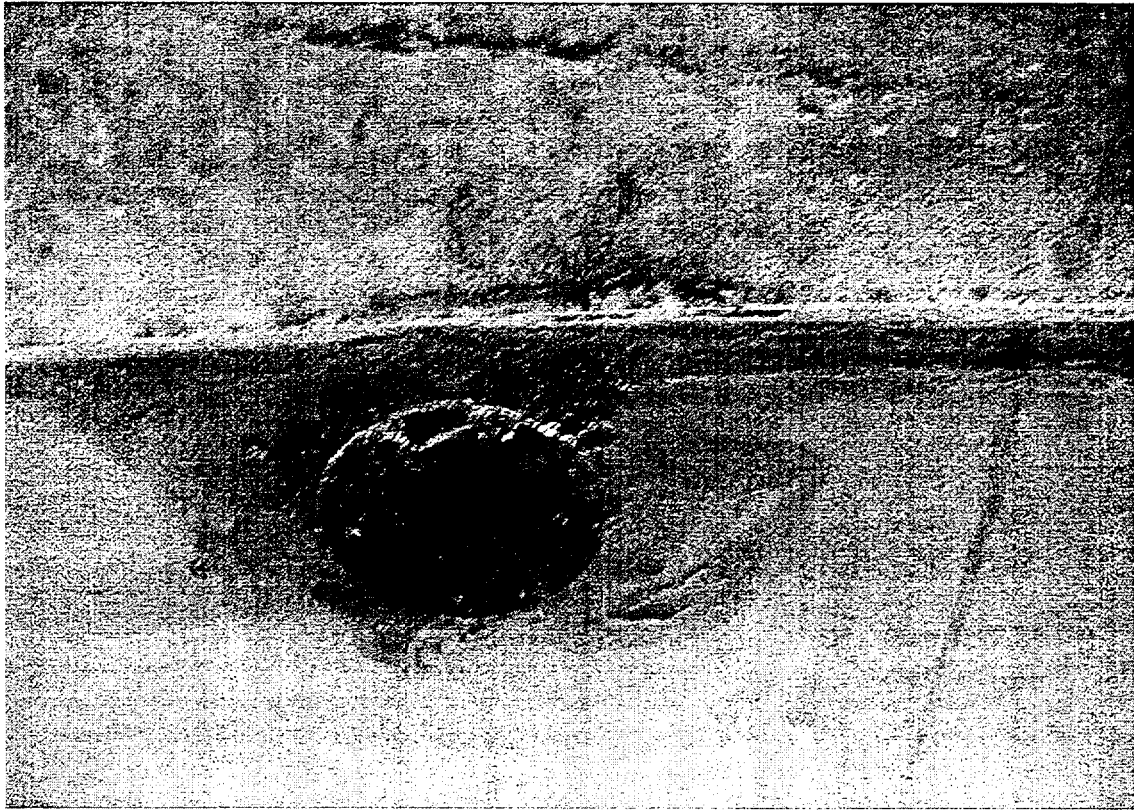
Figure 2-4. Cask bottom cover plate bolt corrosion.

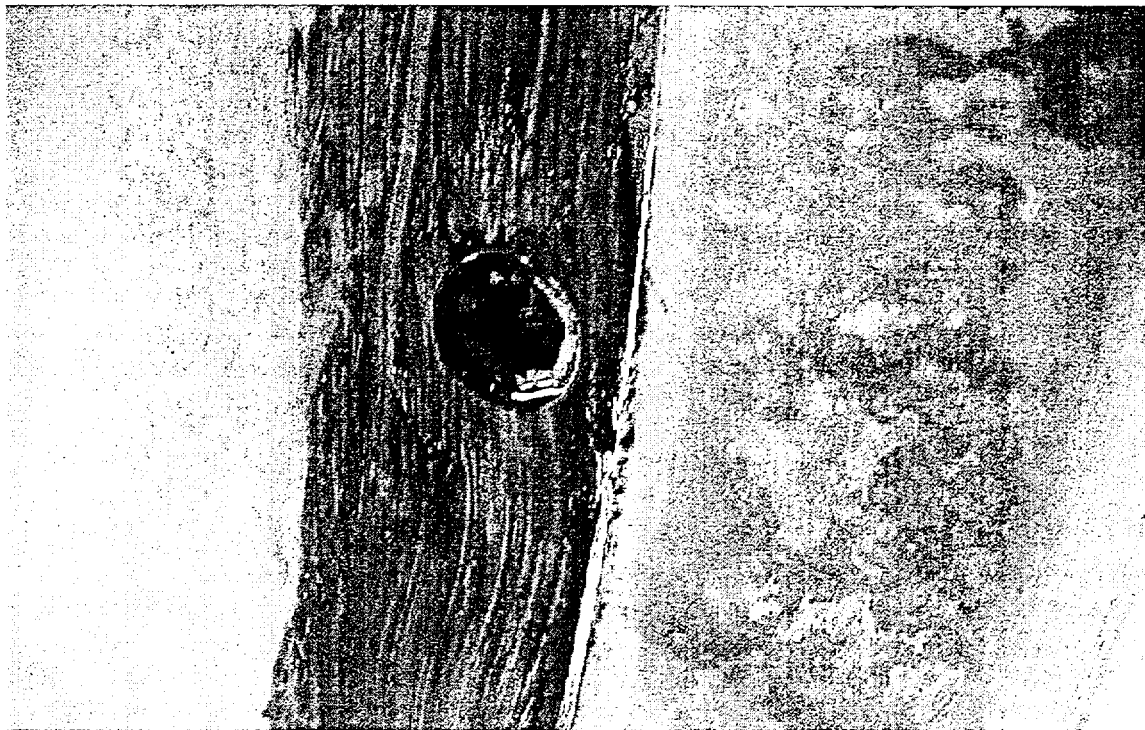
Figure 2-5. Cask bottom cover plate bolt after corrosion removal.

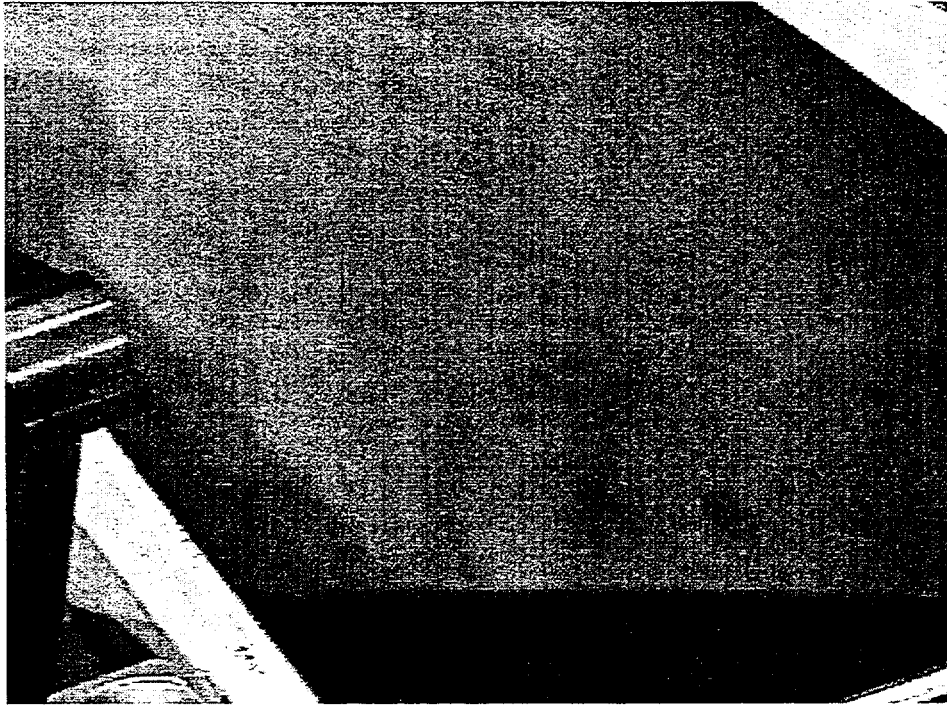
Figure 2-13. Cask wall at top—typical surface condition.

Considering the tight fit of the basket within the cask body, the nickel coating on the upper sidewall shows little evidence of damage due to insertion of the basket. The only discernible feature that might constitute significant coating damage was a black mark on the sidewall at the level of and coincident with the corner of fuel tube D3. However, the black surface mark appeared to be superficial, and did not have any burrs or dimensional relief indicative of substantial abrasion damage, corrosion product formation, or cracks. While the feature is coincident in location with the corner of fuel tube D3, it cannot be the result of abrasion by the corner of the fuel tube (by vibration from cask handling), for the fuel tube is separated from the wall by the thickness of the steel barrel plate comprising the outer rim of the basket. Instead, this feature may be the result of abrasion during insertion of the tightly fitting basket into the cask or from vertical thermal expansion of the tightly fitting basket barrel wall during the 1985 thermal tests. The upper sidewall has several similar, less distinct blemishes that could be construed as light scuffing or abrasion of the nickel coating from contact during the insertion of the basket into the cask body. These features consist of black 'scuffs' and spots on the nickel surface, as if the nickel plating was lightly abraded from the high points of the rough as-machined surface of the cask body. These features have no discernible relief, implying negligible superficial damage at worst, and have no evidence of more than possibly superficial surface corrosion as might have occurred prior to sealing the cask in 1985. Furthermore, there was no evidence of delamination and peeling of the nickel layer around these features or of subsurface corrosion or blistering in the areas surrounding the features, which could be the expected effect from a corrosive, oxidizing environment.

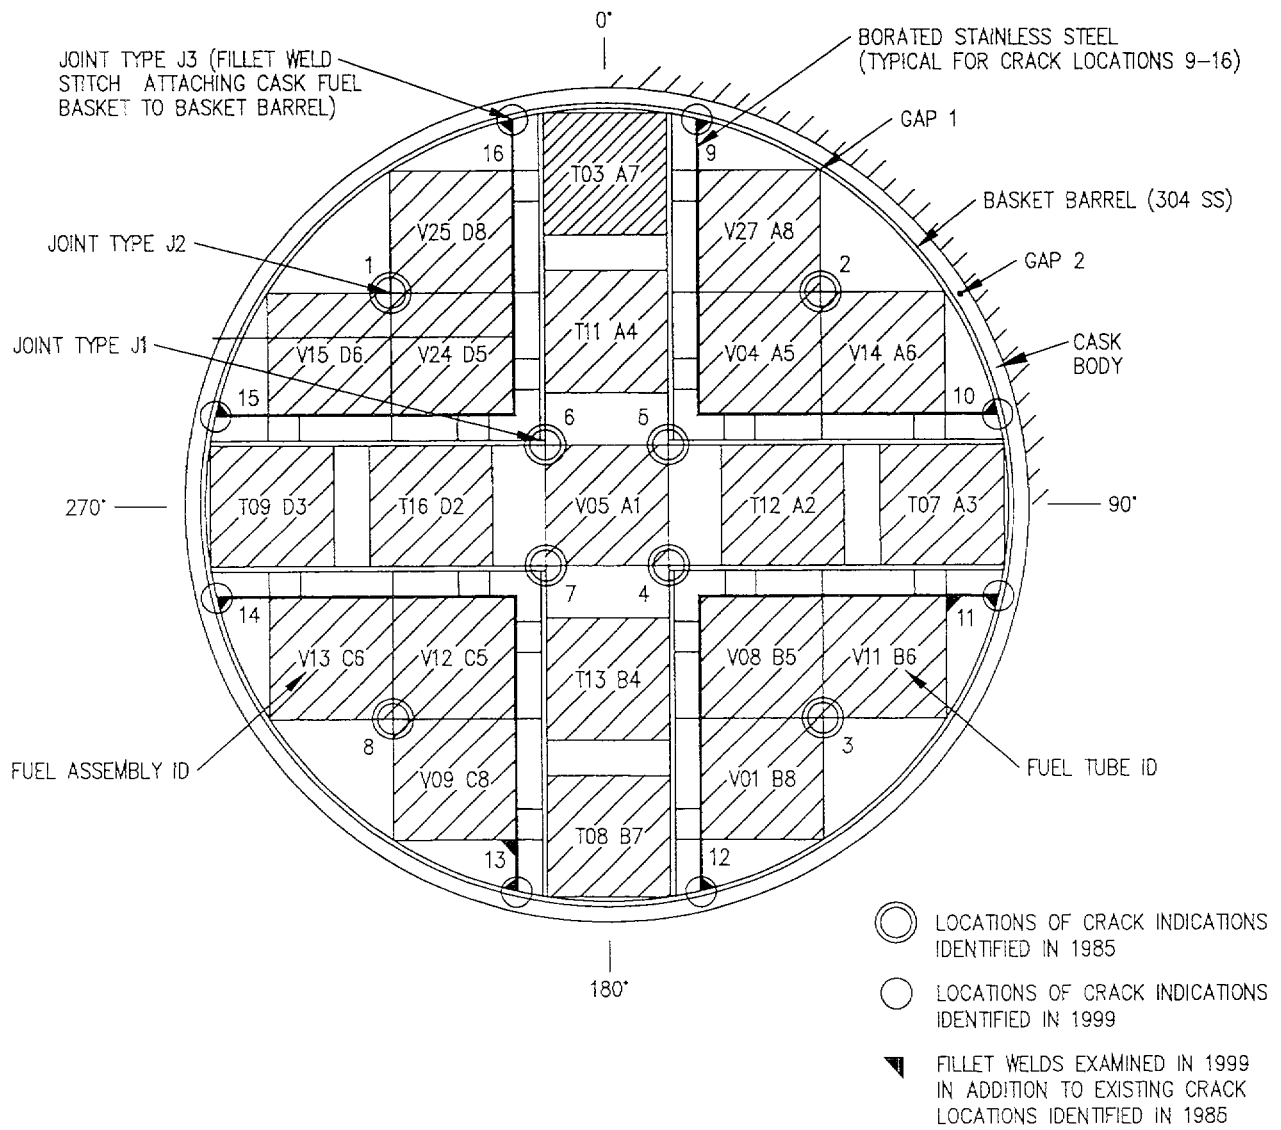
Additional cracks in basket welds (as shown in Figure 2-19.) were associated with stainless/borated steel junctions welds in fuel tubes.

Figure 2-16. CASTOR-V/21 basket crack indication locations and fuel tube arrangement.

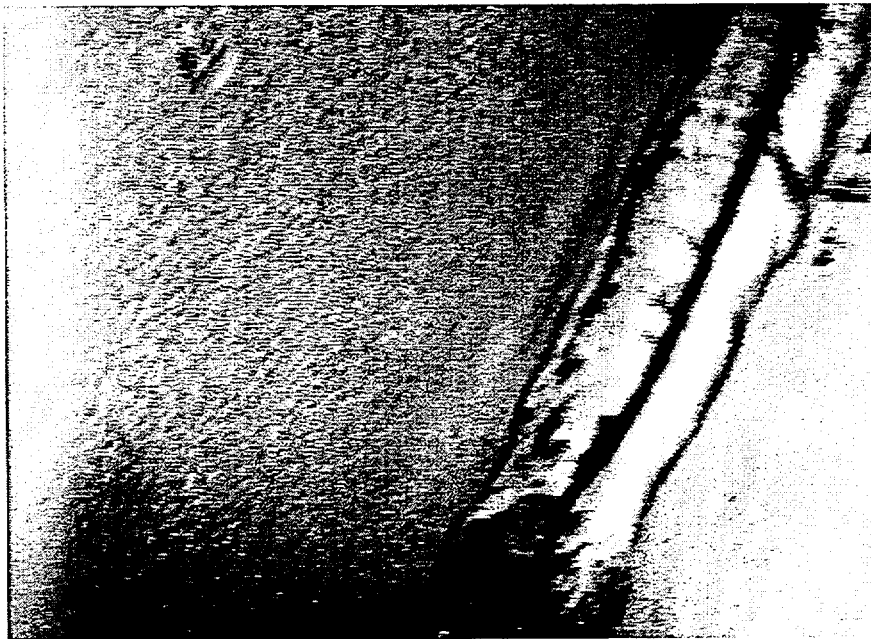
Figure B-6. Bottom weld crack at location 11 identified in Figure B-19.  
(Triangular air channel between fuel tube A3 & B6)

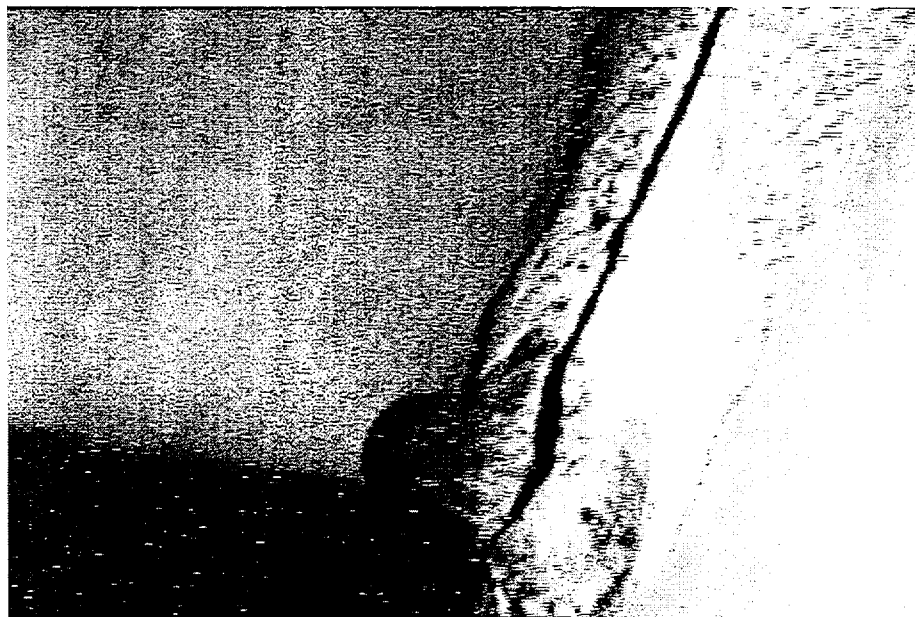
Figure B-8. Bottom weld crack at location 12 identified in Figure B-19.  
(Triangular air channel between fuel tube B7 & B8)

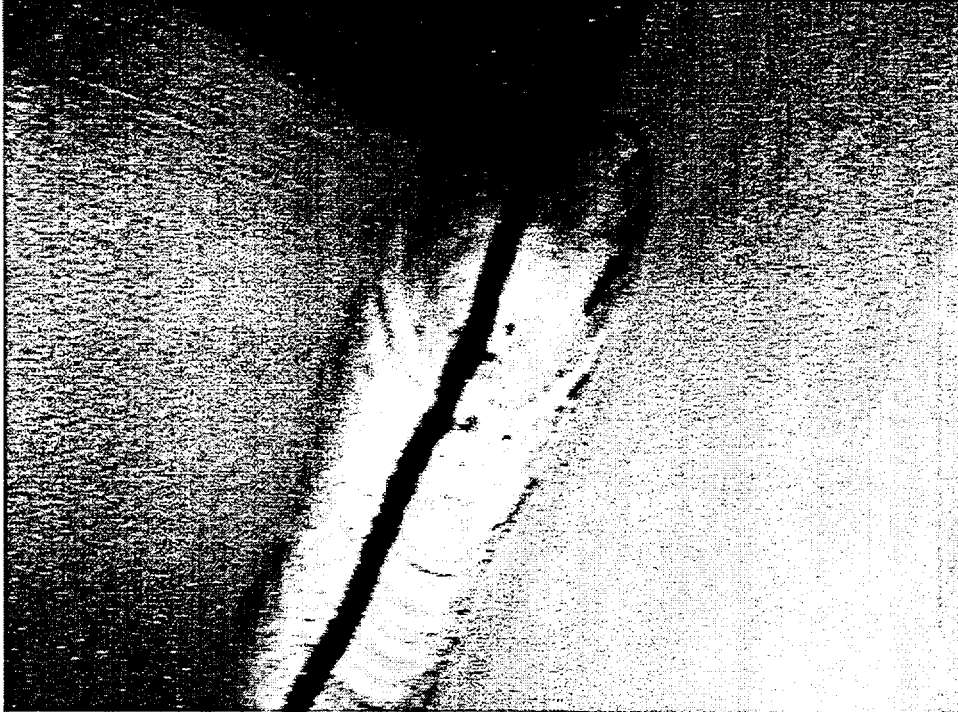
Figure B-11. Top weld crack at location 14 identified in Figure B-19.  
(Triangular air channel between fuel tube C6 & D3)

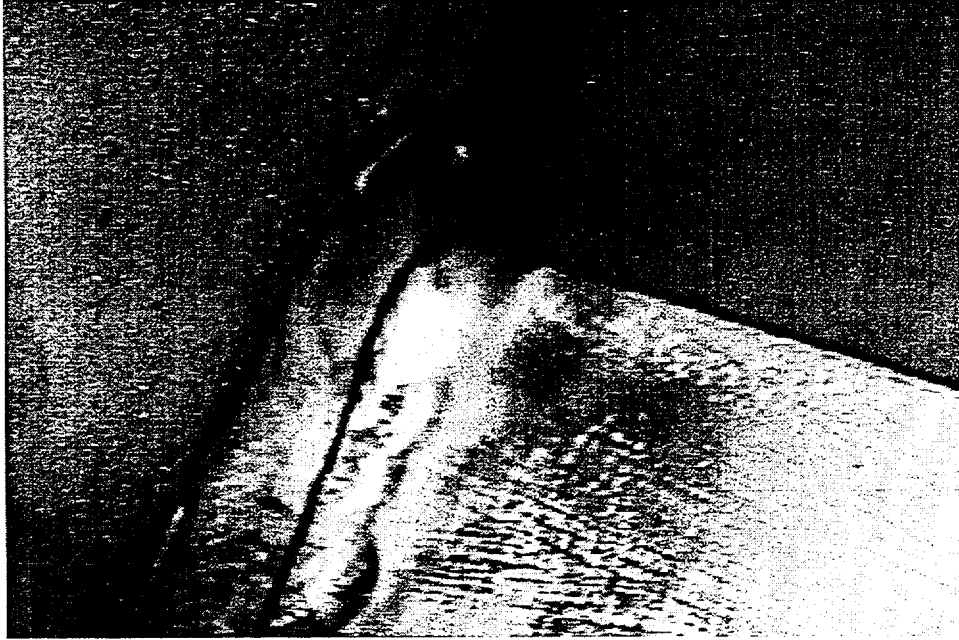
Figure B-13. Top weld crack at location 15 identified in Figure B-1.  
(Triangular air channel between fuel tube D3 & D6)

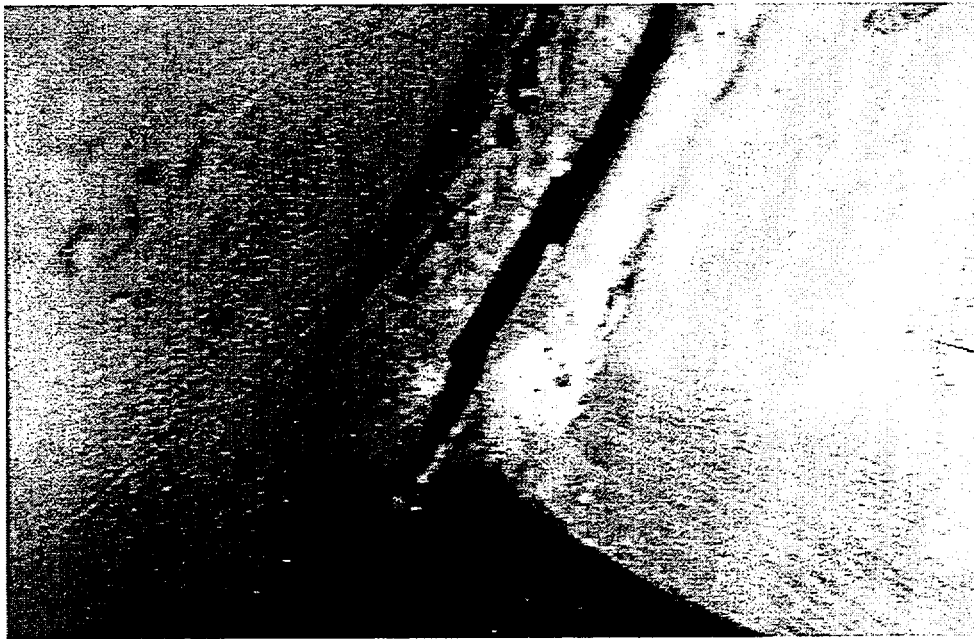
Figure B-14. Bottom weld crack at location 15 identified in Figure B-19.  
(Triangular air channel between fuel tube D3 & D6)

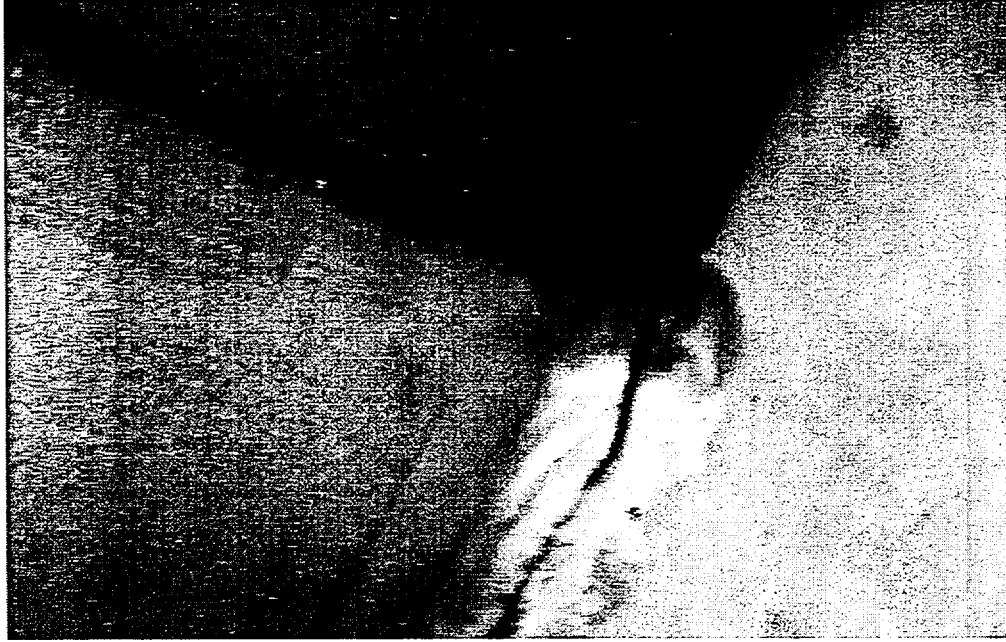
Figure B-15. Top weld crack at location 16 identified in Figure B-19.  
(Triangular air channel between fuel tube A7 & D8)

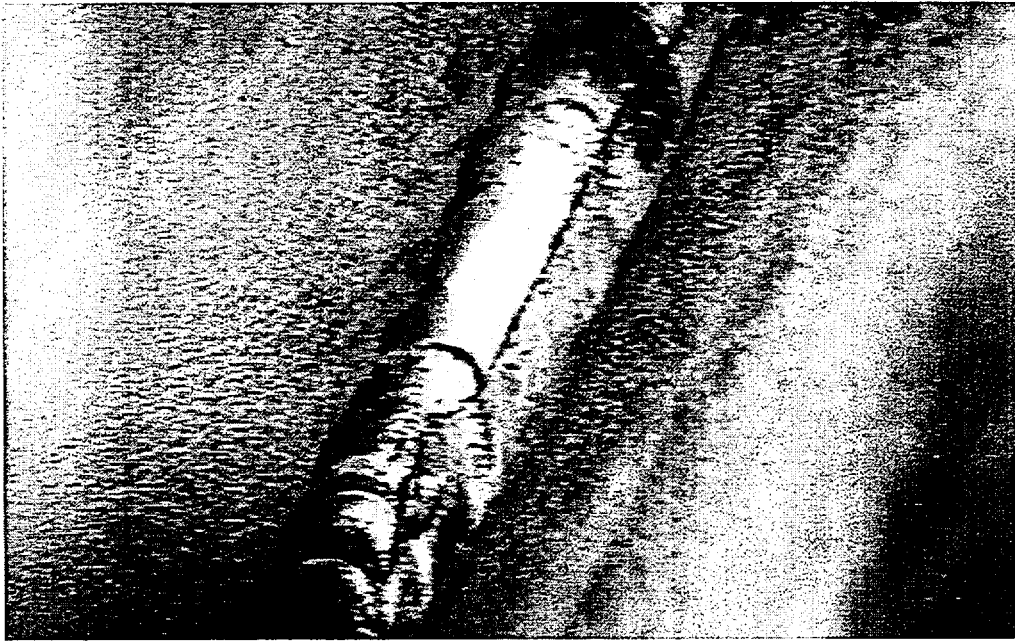
Figure B-16. Bottom weld crack at location 16 identified in Figure B-19.  
(Triangular air channel between fuel tube A7 & D8)

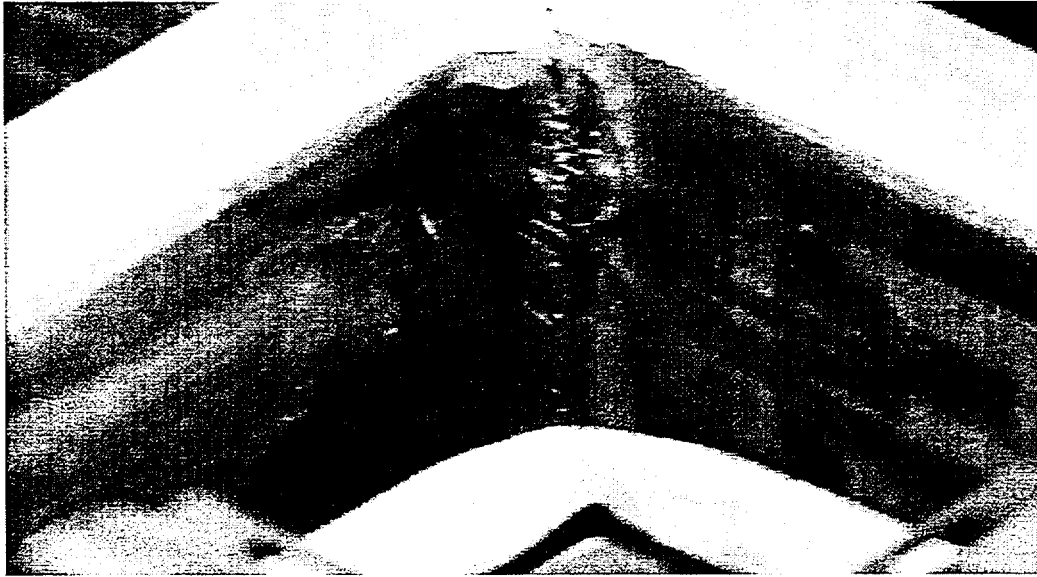
Figure B-17. Crack in basket weld below weld crack 4 ( $120^\circ$ ) identified in Figure B-19.

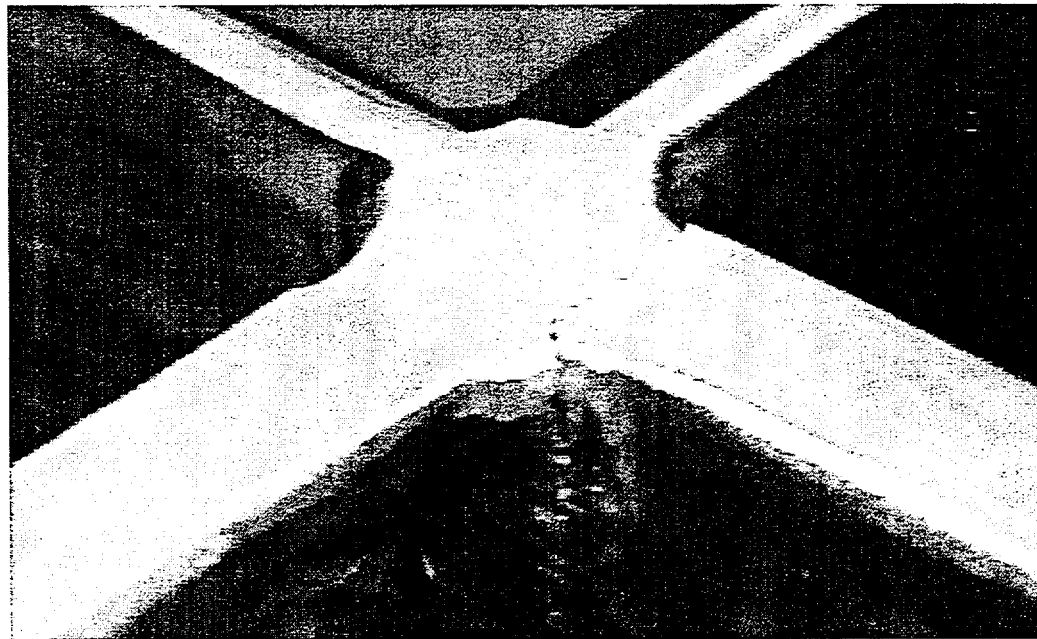
Figure B-18. Same as Figure B-17 with complete view of existing weld crack 4 identified in Figure B-19.

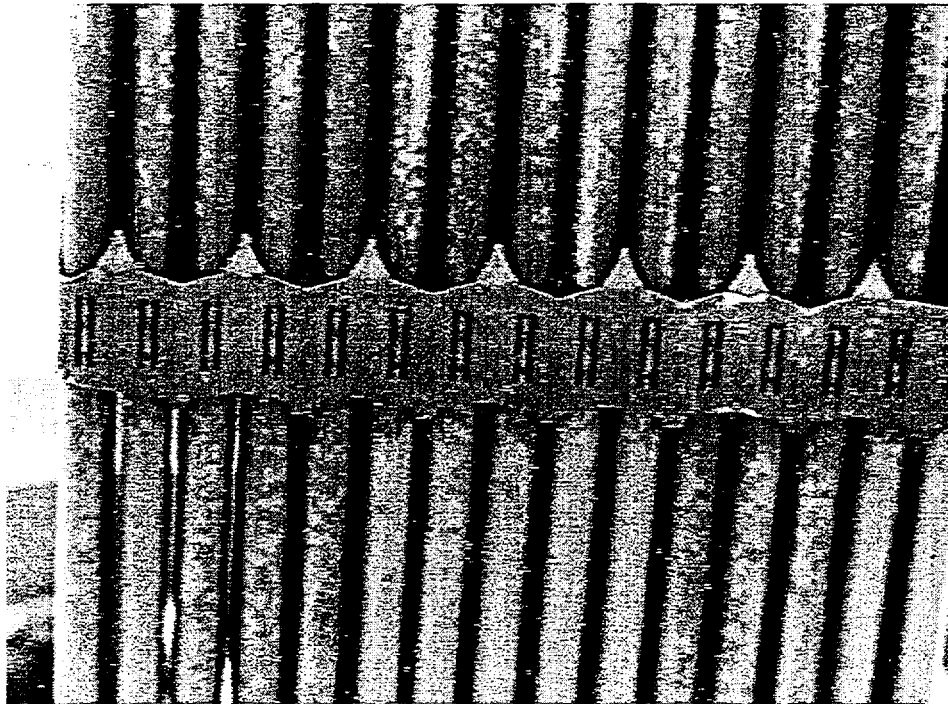
Figure C-3. Oxide mottling noted around spacer #5 on fuel assembly V-05.

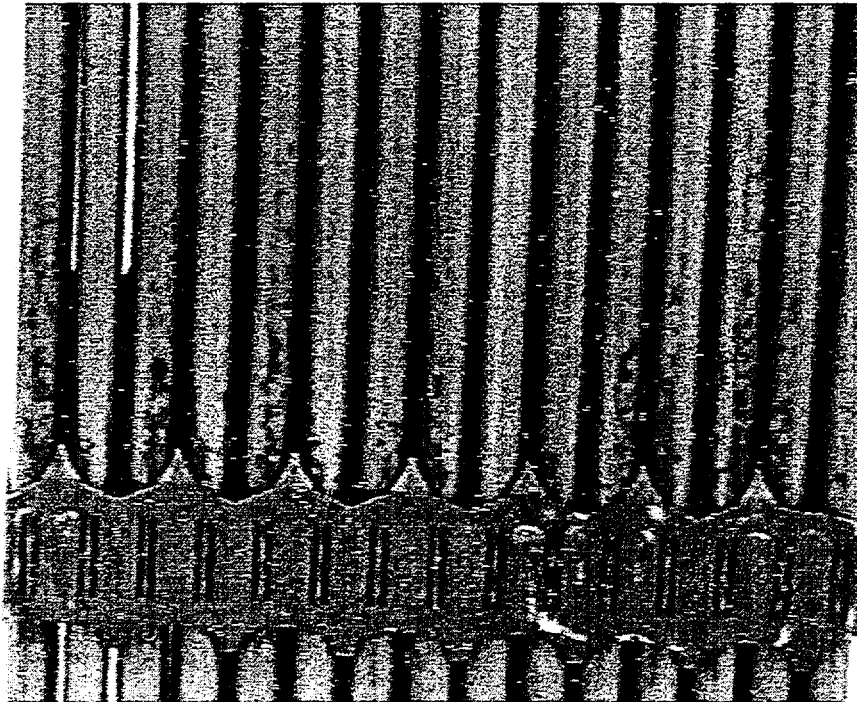
Figure C-4. Oxide mottling noted around grid spacer #6 on V-05.

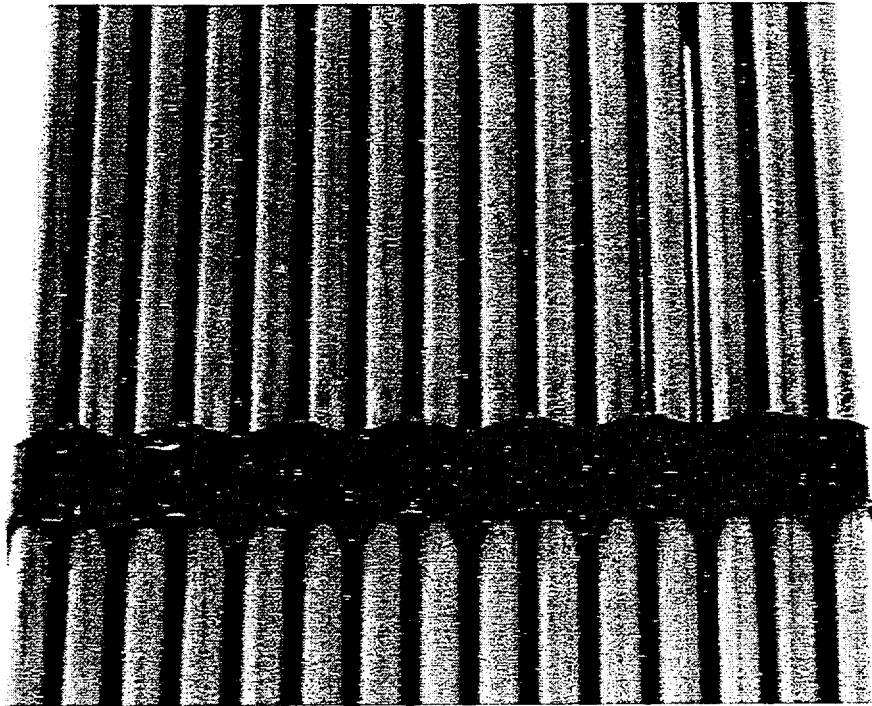
Figure C-5. Fuel assembly V-05—area around upper grid spacer—rods clean and minimal bowing noted.

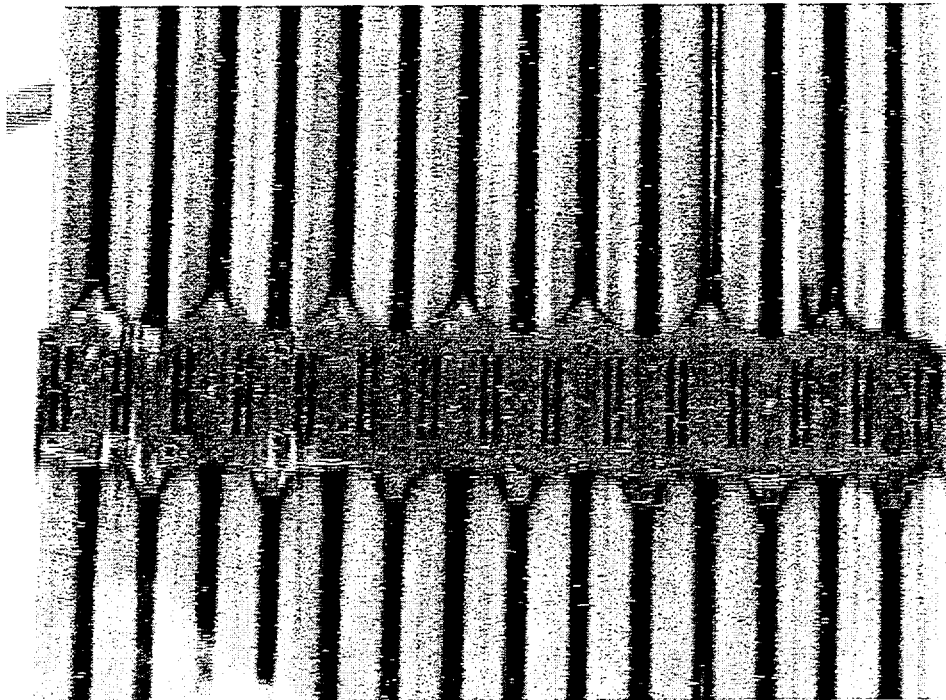
Figure C-6. Fuel assembly V-05 area around third grid spacer—noted light abrasion marking on spacer.

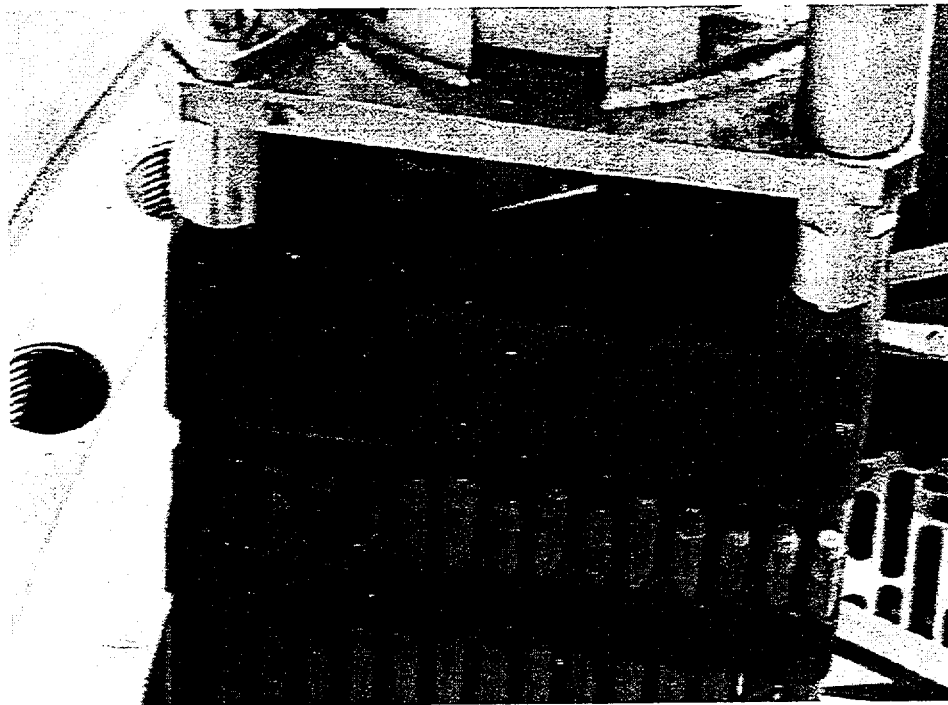
Figure C-14. Element T-03 being withdrawn—note fuel rod growth.

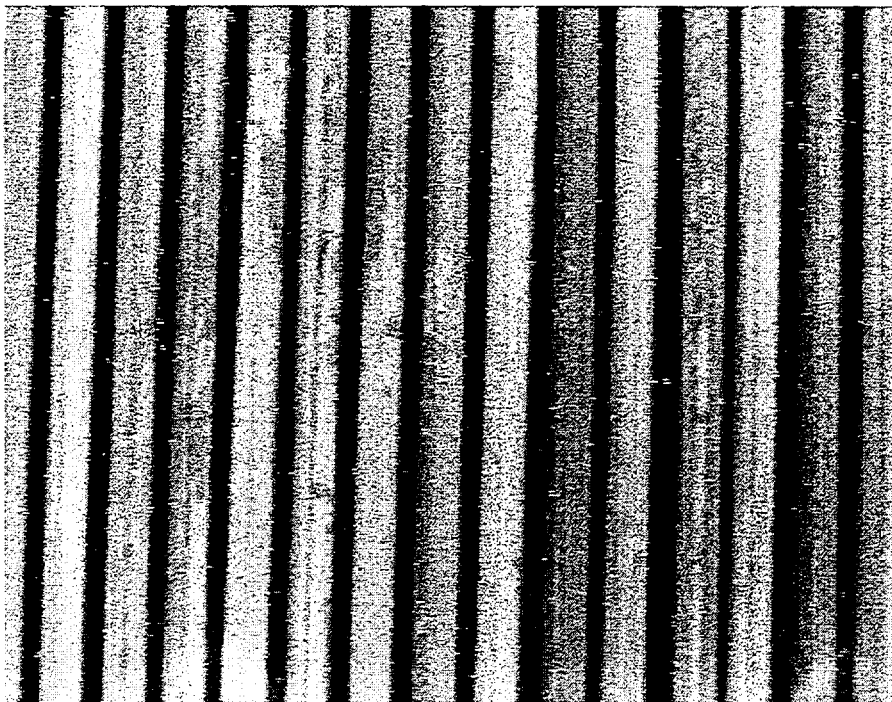
Figure C-16. Element T-03 midpoint of assembly noted oxide density increases as we go lower on the element.

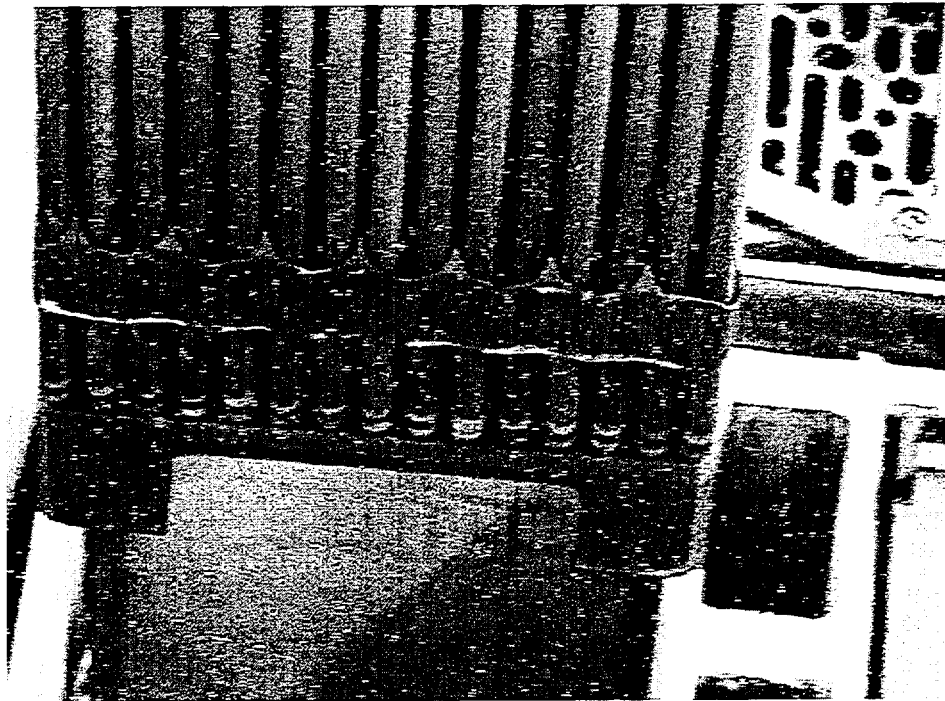
Figure C-18. Element T-03 bottom of fuel element—light oxide—no loose material obvious on surfaces.

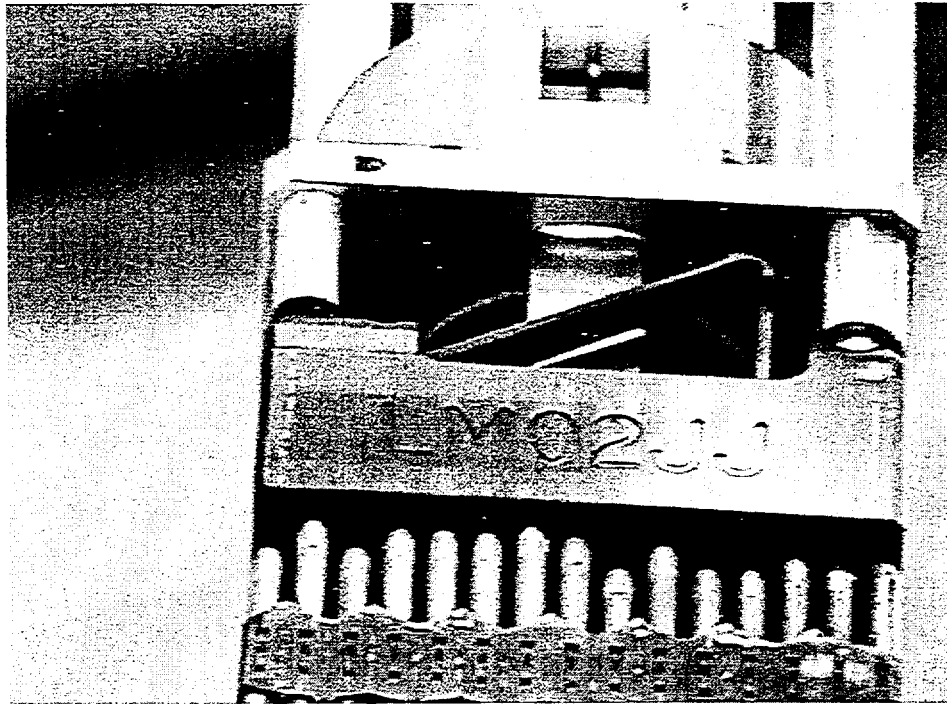
Figure C-19. Fuel element T-03—notes serial number—fuel rod growth evident.

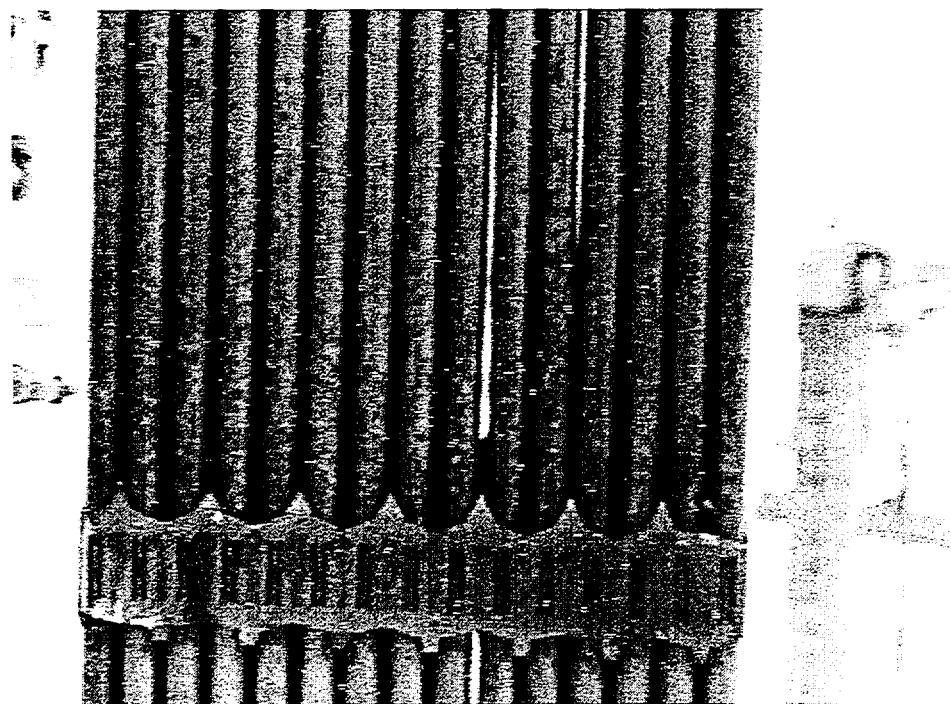
Figure C-22. Fuel assembly V-27 oxide mottling noted.

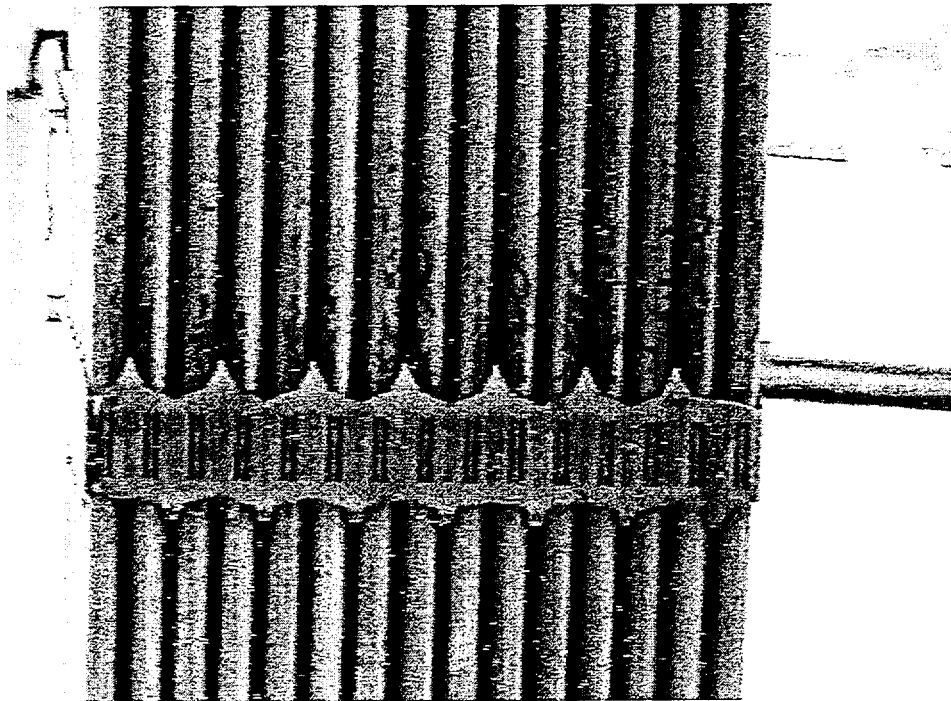
Figure C-66. Fuel assembly V-04 mottling at fifth grid spacer.

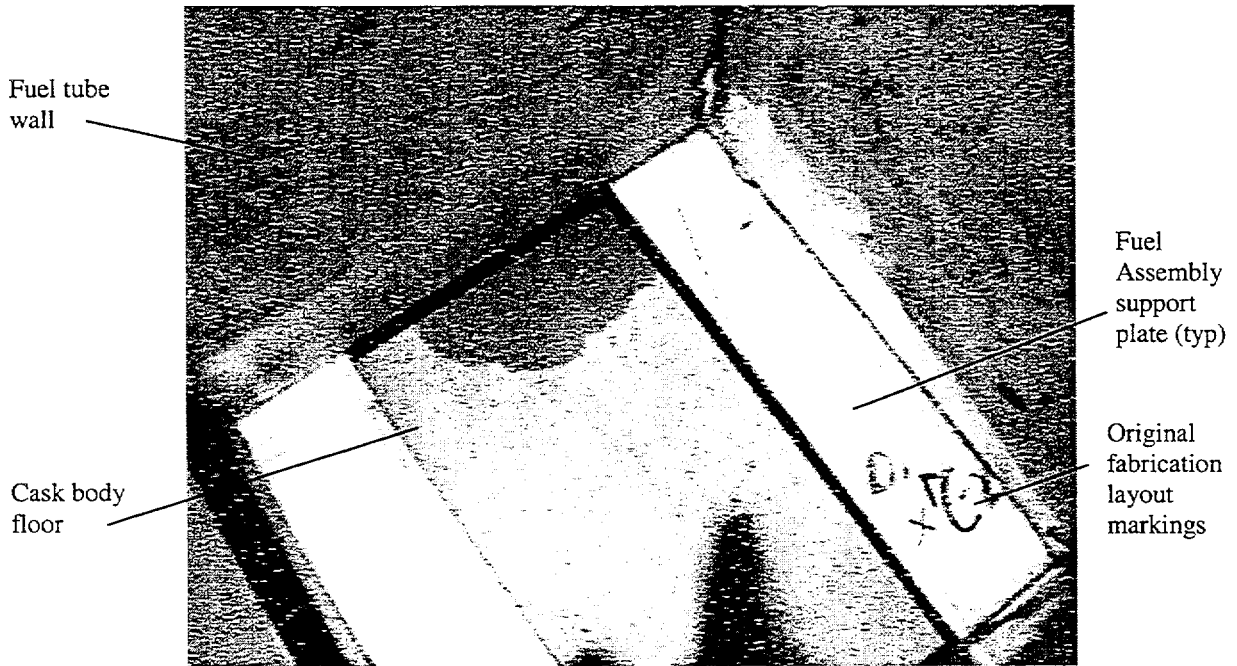
Figure D-3. Fuel tube A-7 – closeup of bottom – noted stain – no conclusion – surfaces are clean and bright. This view approximates condition viewed at the bottom of all fuel tubes.

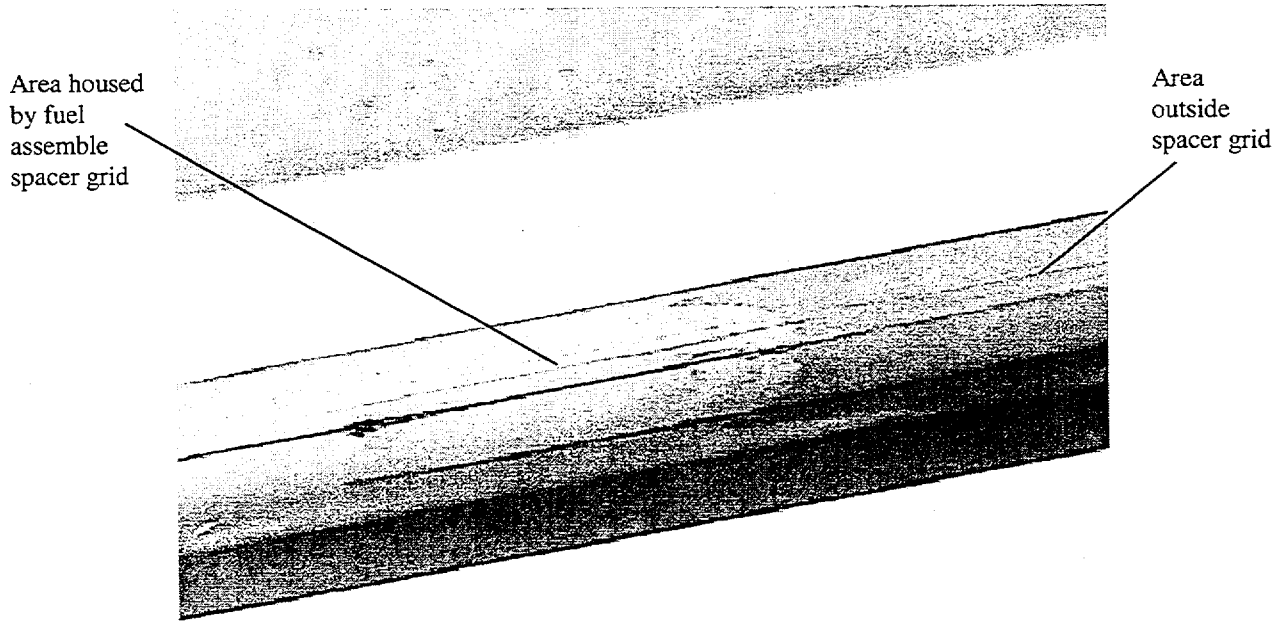
Figure E-7. Condition of fuel rod—light oxide coating minor—scratches believed from moving rod through spacer grids.

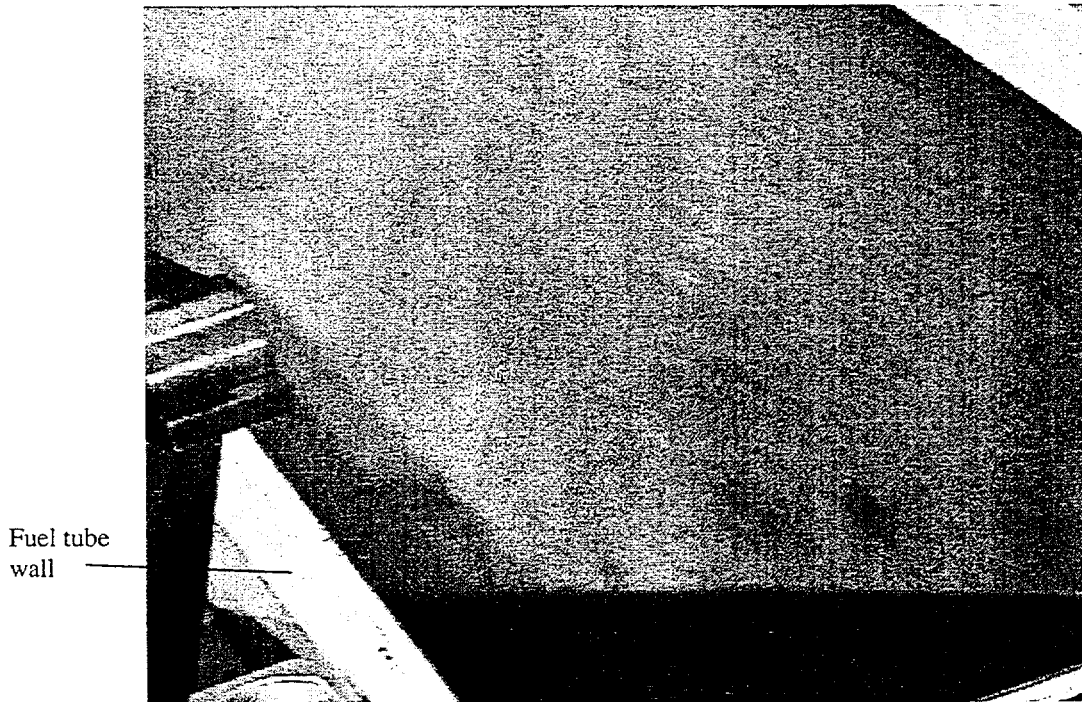
Figure F-2. Cask inner wall at top—typical surface condition.

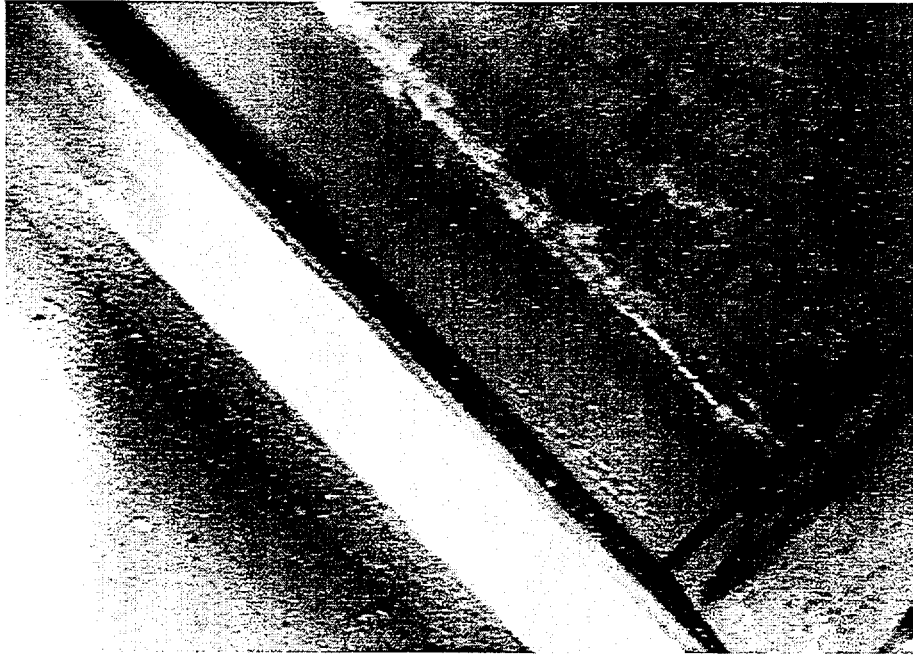
Figure F-7. Cask floor and wall below fuel tube A7—reflective surfaces free of corrosion—minor granular debris on floor.

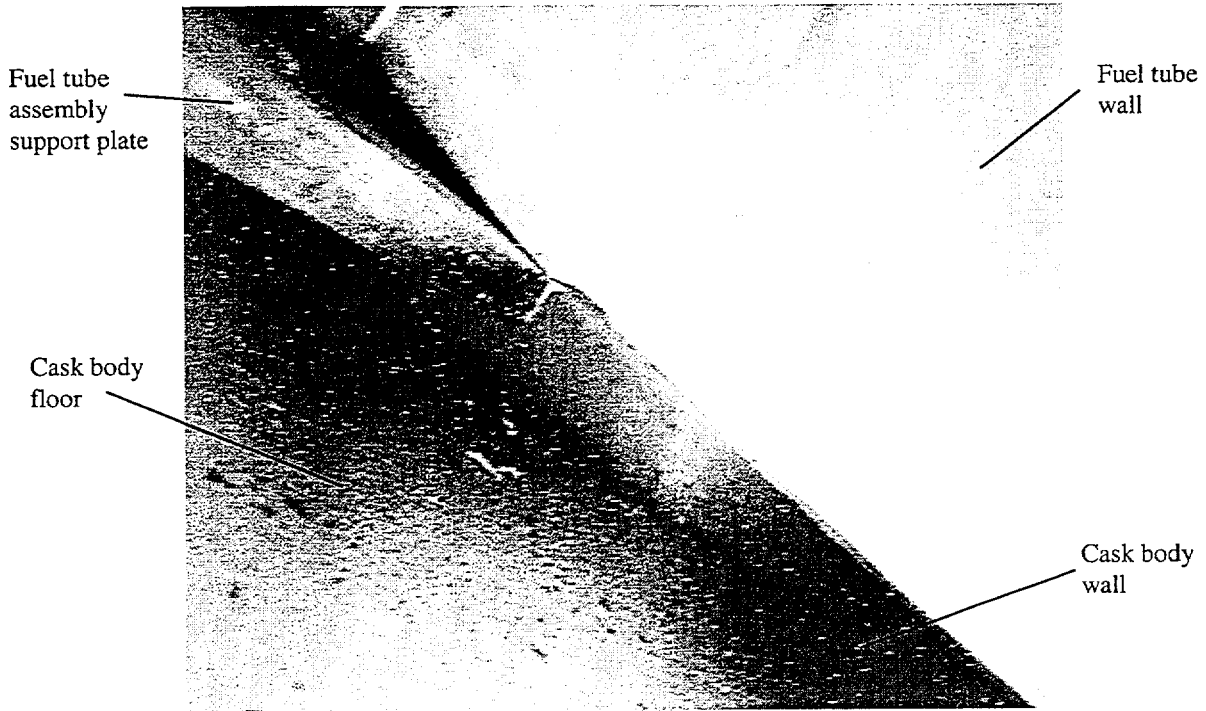
Figure F-9. Cask floor below fuel tube B6—reflective surfaces free of corrosion—minor granular debris on floor.
