# Dry Cask Storage Characterization Project—Phase 1: CASTOR V/21 Cask Opening and Examination

Idaho National Engineering and Environmental Laboratory

U.S. Nuclear Regulatory Commission  
Office of Nuclear Regulatory Research  
Washington, DC 20555-0001

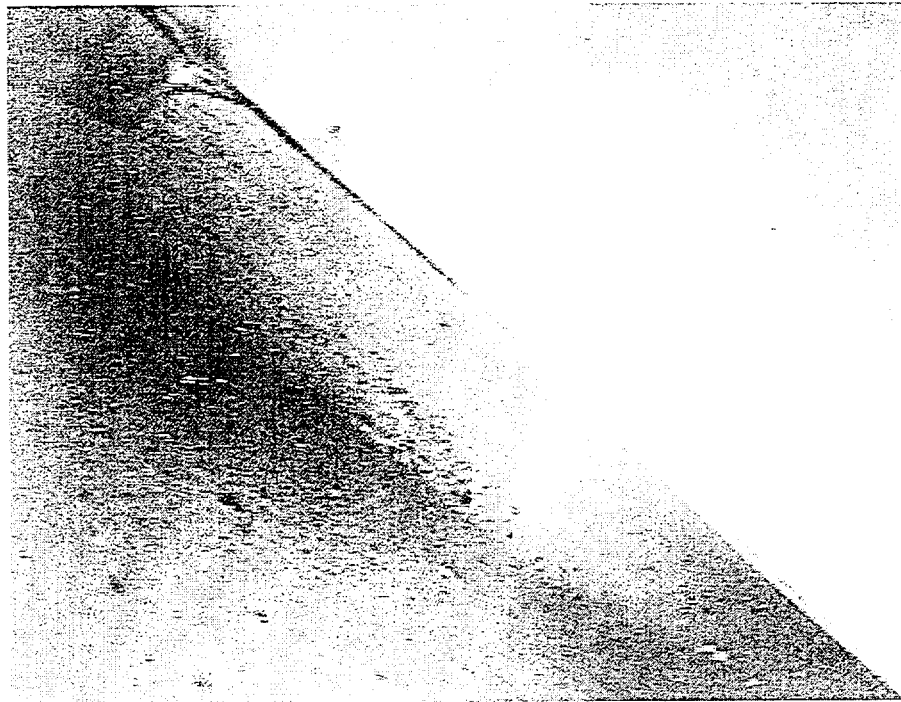
Figure F-10. Cask floor below fuel tube B8—reflective surfaces free of corrosion—minor granular debris on floor.

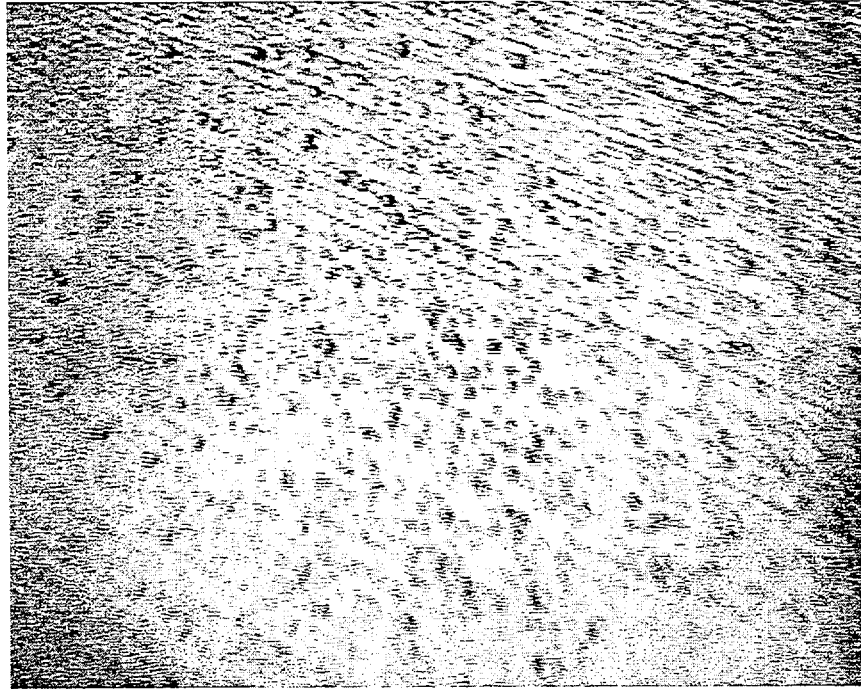
Figure F-11. Cask wall below and between fuel tube A7 and A8—reflective surface free of corrosion—typical of cask wall condition without mineral stains—nodular ductile cast iron nickel plated.
