# **U.S. Plant Experience With Alloy 600 Cracking and Boric Acid Corrosion of Light-Water Reactor Pressure Vessel Materials**

**U.S. Nuclear Regulatory Commission  
Office of Nuclear Regulatory Research  
Washington, DC 20555-0001**

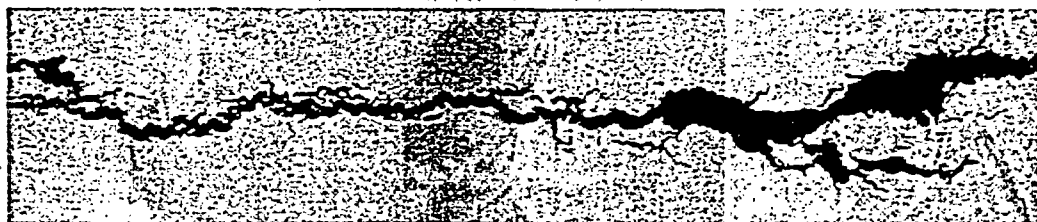
On March 5, 2002, during a shutdown for inspection and refueling of the Davis-Besse Nuclear Power Station, the plant's licensee, FirstEnergy Nuclear Operating Company, discovered severe boric acid corrosion wastage of the reactor pressure vessel (RPV) head. A triangular cavity approximately 5 inches wide, 7 inches long, and completely through the low-alloy steel RPV head thickness was located downhill of vessel head penetration (VHP) Nozzle #3 approaching Nozzle #11. The wastage consumed between 40 and 60 cubic inches of vessel head. This significantly compromised the integrity of the reactor coolant pressure boundary by reducing it in the vicinity of the boric acid corrosion attack to a section of stainless steel cladding ranging in thickness from 0.199 inch to 0.314 inch. The cladding had an exposed surface area of about 16.5 square inches and had deflected outward under system pressure. Additional boric acid wastage was discovered near VHP Nozzle #2.

Figure 2. A metallograph showing the profile of a crack in the attachment weld of Nozzle #3 in the (now discarded) Davis-Besse reactor head (Ref. 1).

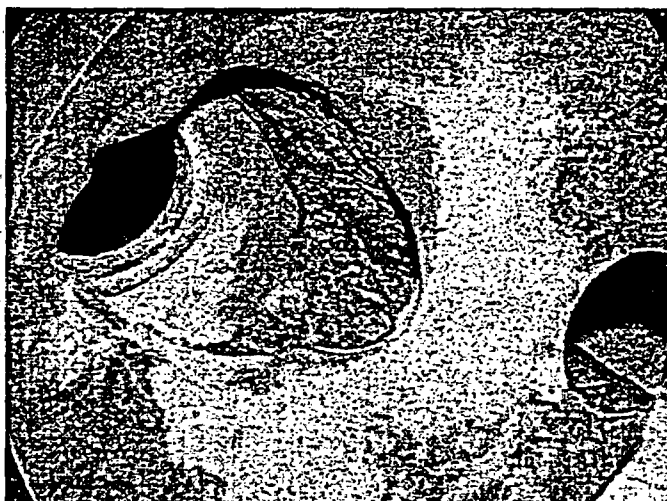
Degradation of the RPV head at Davis-Besse was discovered in March 2002. The integrity of the reactor coolant boundary was significantly compromised. A triangular cavity approximately 5 inches wide, 7 inches long, and completely through the low-alloy steel RPV head thickness was located downhill of VHP Nozzle #3 approaching Nozzle #11. The wastage consumed between 40 and 60 cubic inches of the vessel head. This reduced the reactor pressure boundary in the vicinity of the boric acid corrosion attack to a section of stainless steel cladding ranging in thickness from 0.199 inch to 0.314 inch. The cladding had an exposed surface area of 16.5 square inches and had deflected outward under system pressure. Additional boric acid wastage was also observed near VHP Nozzle #2. Figure 4 is a photograph of the extensive corrosion loss experienced on the head at the Davis-Besse plant.

Figure 4. A photograph of the 18-inch diameter section of the discarded Davis-Besse head, containing the corrosion cavity created by leakage from the included nozzle (#3). The hole at the right is from nozzle #11.
