Press Release Information	Nuclear and Industrial Safety Agency (NISA), Ministry of Economy, Trade and Industry (METI)
Consequences of "the Niigataken Chuetsu-oki Earthquake in 2007" at Kashiwazaki-Kariwa Nuclear Power Station, Tokyo Electric Power Company (the 5th report)

July 23, 2007

NISA/METI

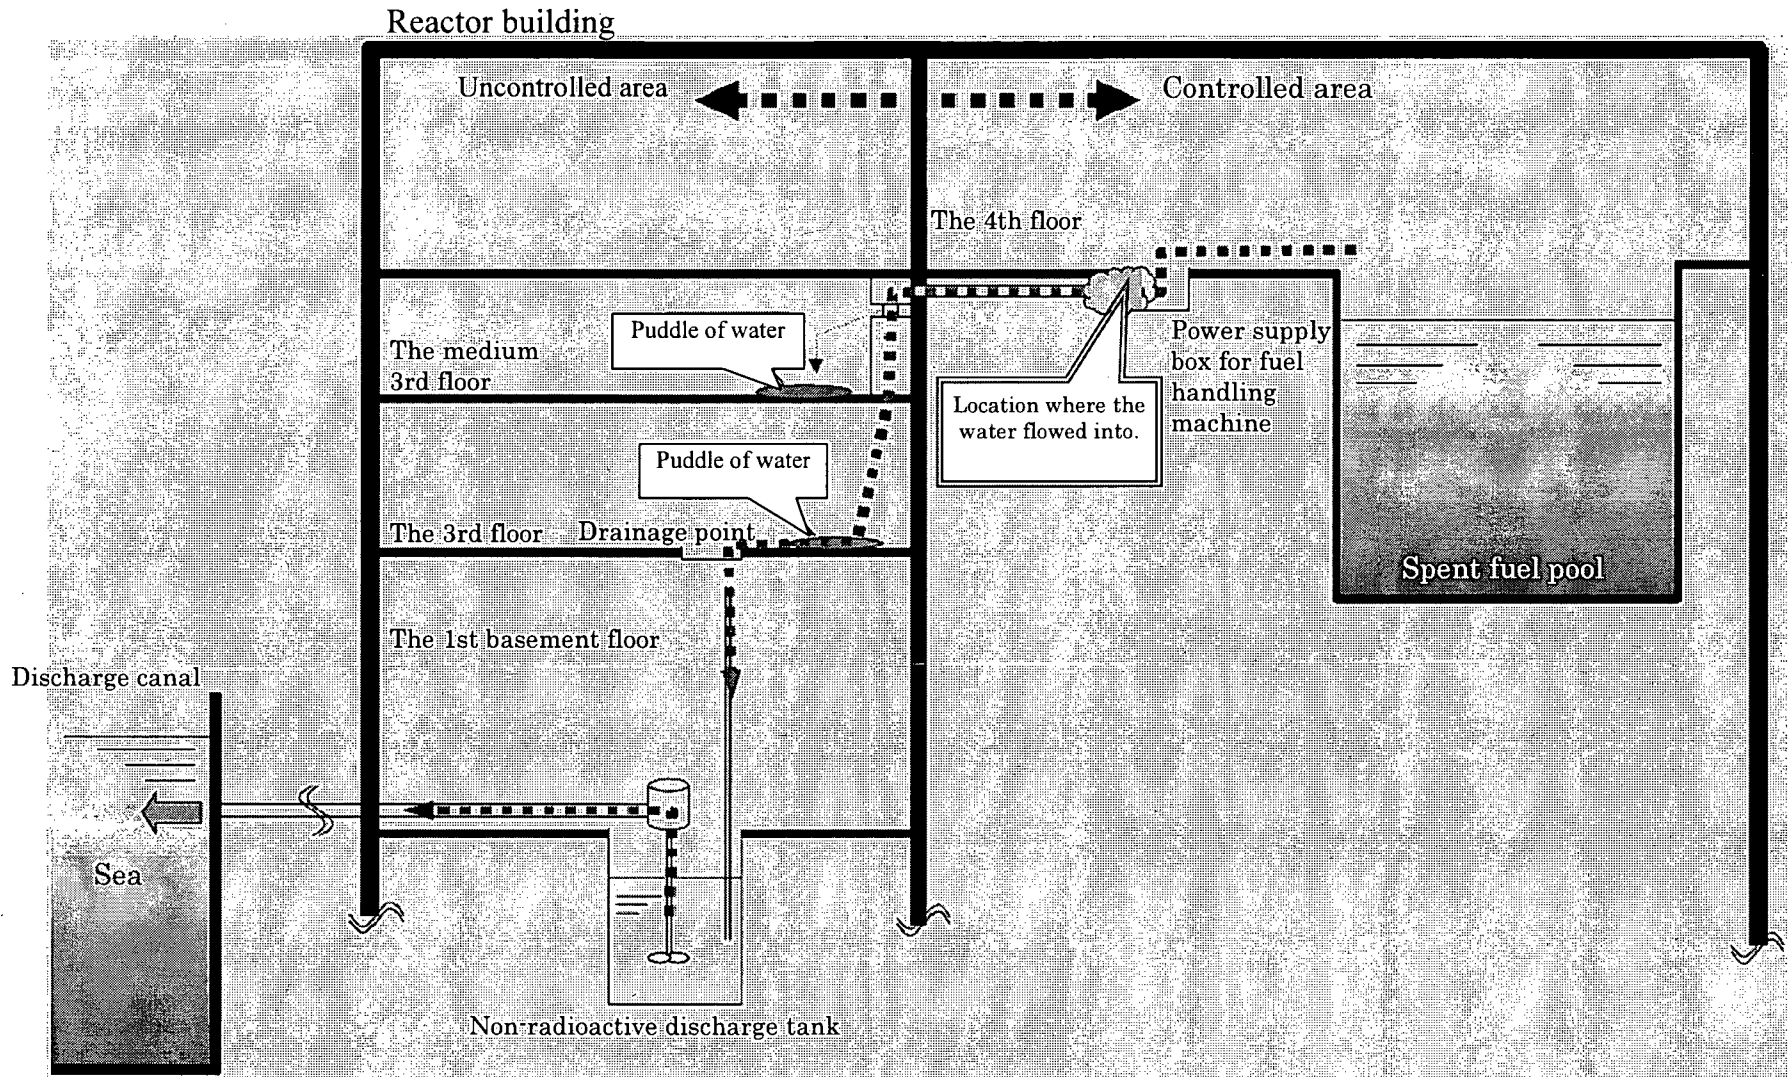
- 1) As for the water leakage in the uncontrolled area of Unit 6 (as announced on July 16), the water had splashed out of the spent fuel pool and flowed into the electric cable conduit and had dripped onto the medium 3rd floor from the area around the upper air conditioning system duct and the water had formed a puddle. Meanwhile, the water had dripped through the opening of the medium 3rd floor and had formed another puddle. It is estimated that the puddle water on the surface of the 3rd floor had flowed into the drain and had been discharged to the sea from the discharge canal. The work will be soon conducted to verify the validity of the estimated leak path (see the attached figure).

Schematic diagram of the water flow into the non-radioactive discharge tank and the water discharge to the sea at Unit 6
