Davis-Besse Reactor Pressure Vessel Head Degradation

Overview, Lessons Learned, and
NRC Actions Based on Lessons
Learned

NUREG/BR-0353, Rev. 1
August 2008

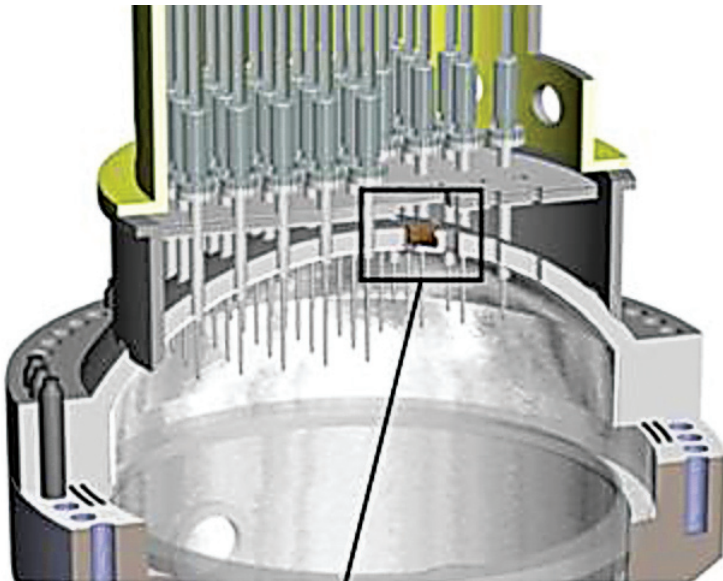
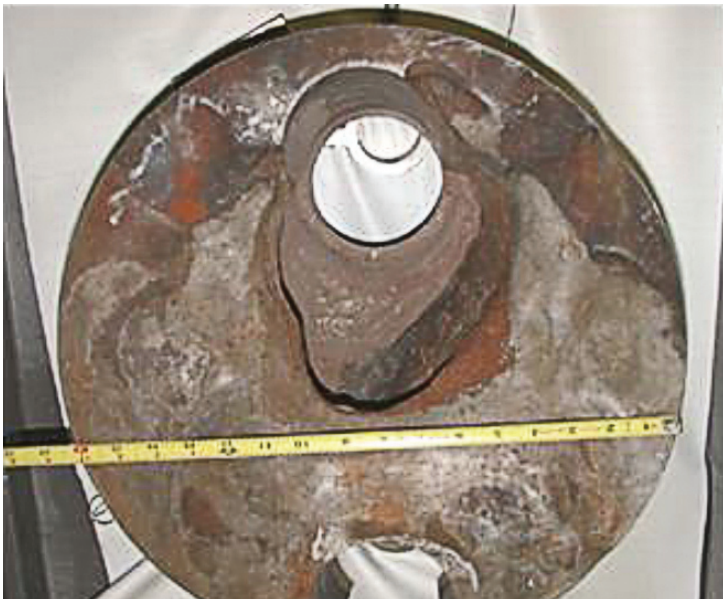
The licensee investigated the condition of the RPV head surrounding CRDM nozzle 3. The investigation included removing the CRDM nozzle and removing boric acid deposits from the top of the RPV head. Upon completing the boric acid removal on March 7, 2002, the licensee conducted a visual examination of the area and identified a large cavity in the RPV head on the downhill side of CRDM nozzle 3 (**Figure 2**). The corrosion was caused by borated water that leaked from the reactor coolant system onto the vessel head (**Figures 3 and 4**) through cracks in the nozzle and the weld that attached nozzle 3 to the RPV head (**Figures 5 and 6**). The remaining thickness of the RPV head in the wastage area was found to be approximately 3/8 inch. This thickness consisted of the thickness of the stainless steel cladding on the inside surface of the RPV head, which is nominally 3/8 inch thick. The stainless steel cladding is resistant to corrosion by boric acid, but it is not intended to provide structural integrity to the vessel. Failure of the stainless steel cladding would have resulted in a loss-of-coolant accident (LOCA). The LOCA would have resulted in actuation of the plant's emergency systems.

Figure 2. Region of the vessel head depicted by the model and photo of the cavity after it was removed from the vessel head

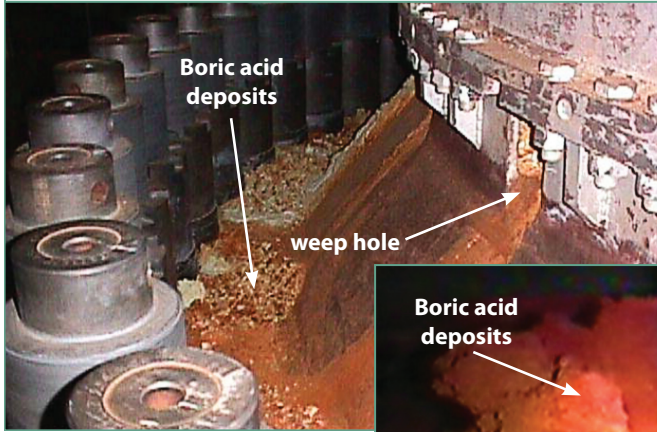
Figure 3a. RPV head flange area showing significant amounts of boric acid deposits (photo taken during the 2000 refueling outage at DBNPS)

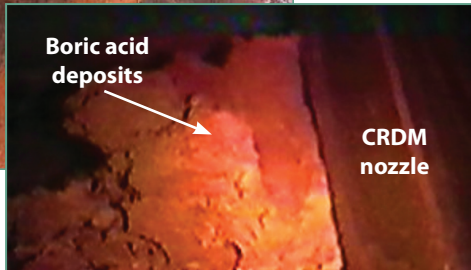
Figure 3b. Boric acid deposits accumulating near a CRDM nozzle (still photo of video taken during the 2000 refueling outage at DBNPS)

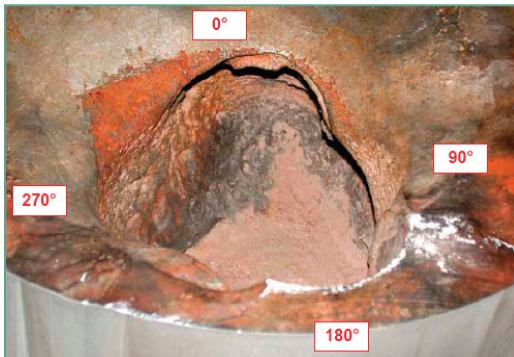
Figure 4a. Close-up view of the cavity

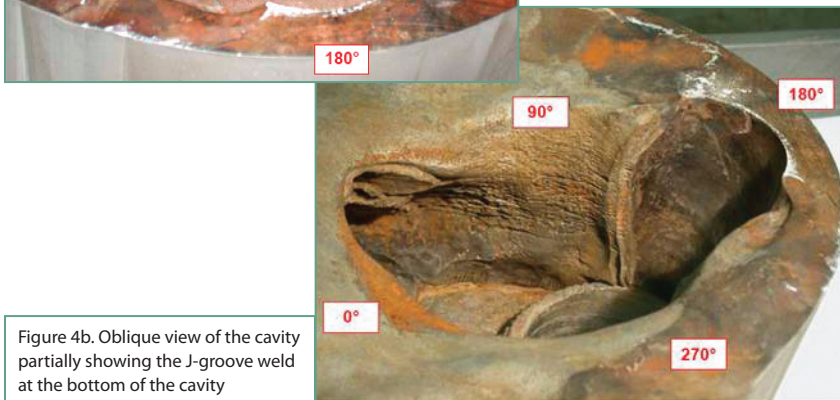
Figure 4b. Oblique view of the cavity partially showing the J-groove weld at the bottom of the cavity

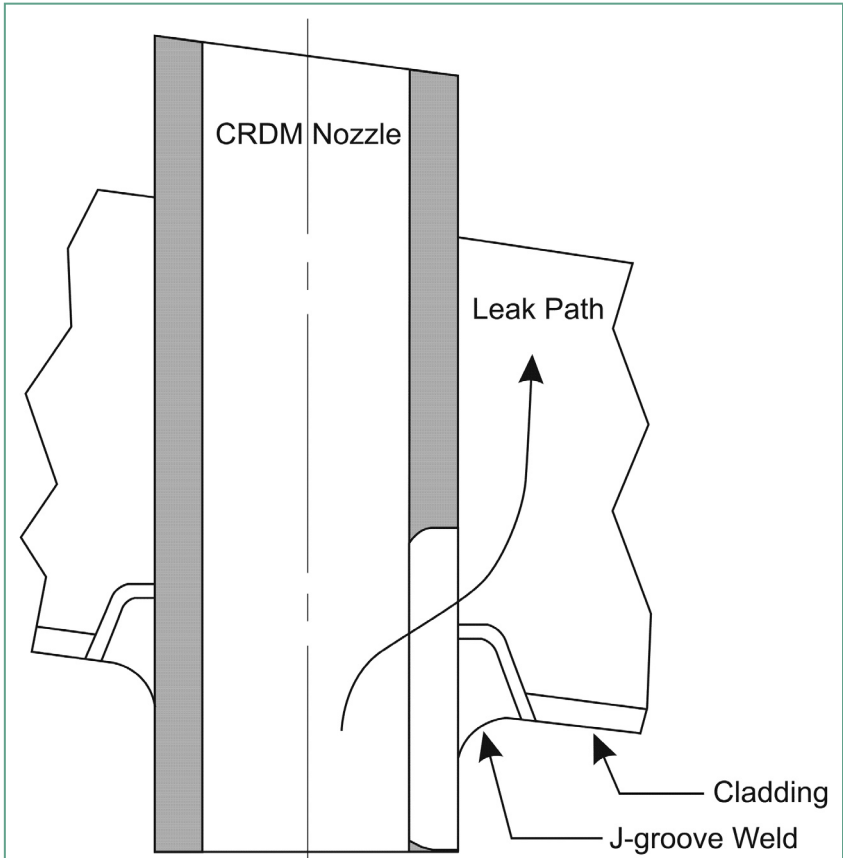
Figure 5. Schematic of the nozzle penetration cross section showing the leak path of the reactor coolant

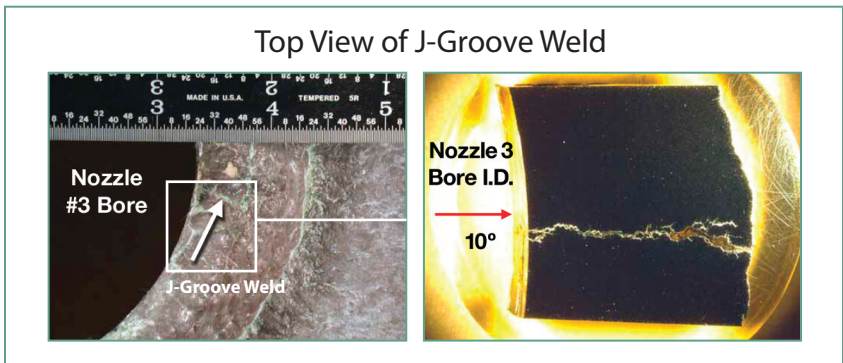
Figure 6. Top photo: Top view of the J-groove weld with an arrow pointing to a crack
 Top-right photo: Polished cross section of the area shown in the top photo showing the through-wall crack in the J-groove weld
