NUREG/CR-7101

Structural Materials Analyses of the Newhall Pass Tunnel Fire, 2007

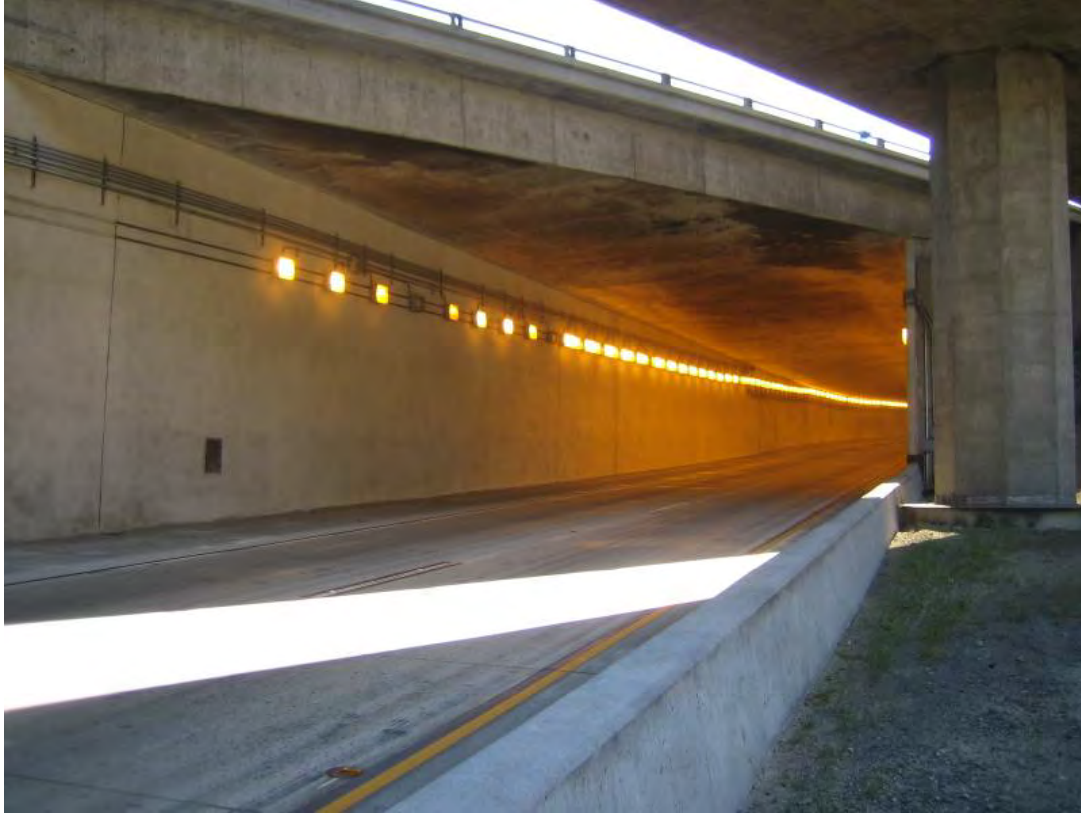
Figure 1-3. Newhall Pass Tunnel Exit After Repair

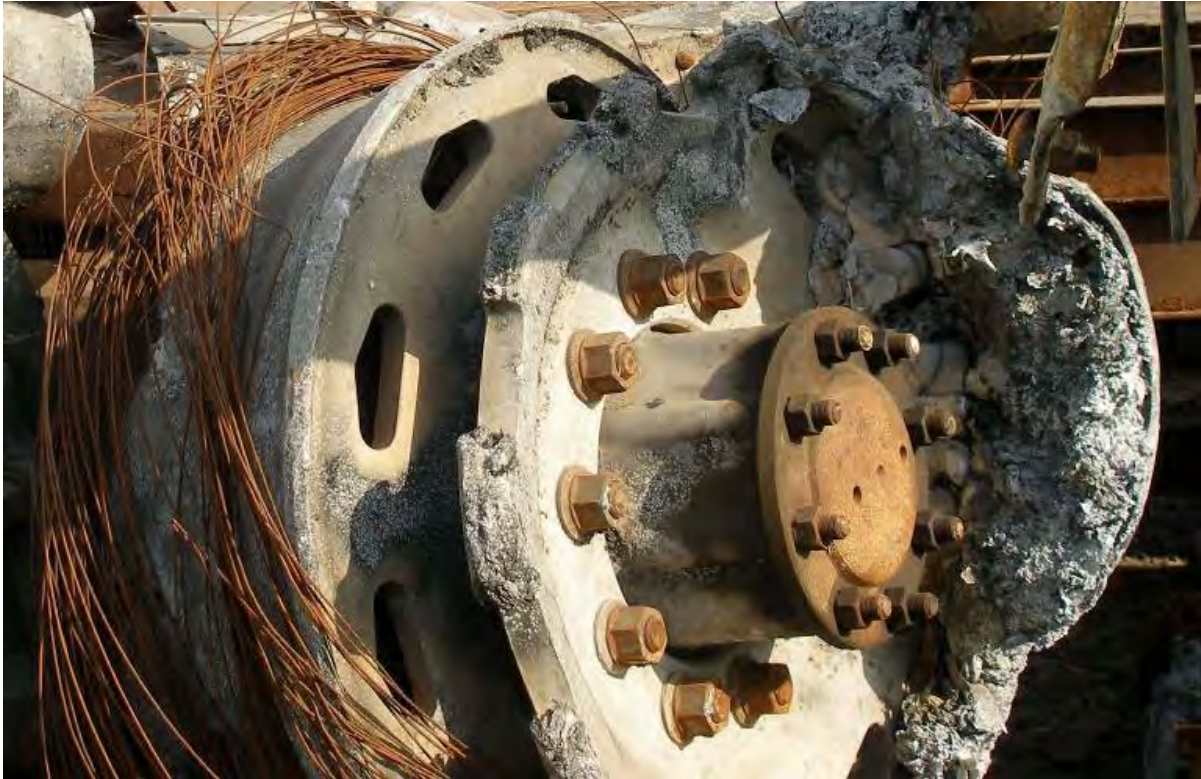
Figure 2-4. The Incinerated Wheel Vestige Shown Here Includes Multiple Metallic Components, Which Were Used To Assess the Fire Severity. This melted aluminum wheel was on vehicle 14.

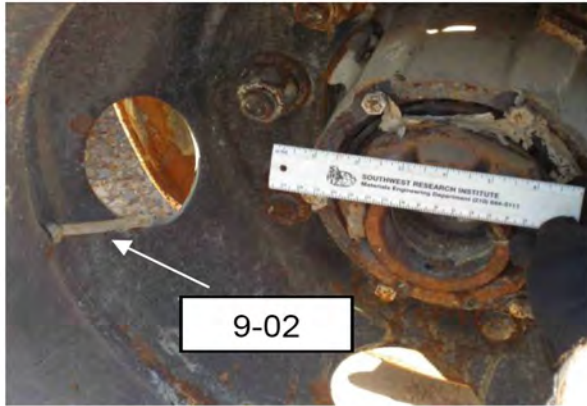
For brass, there is a wide range of compositions with corresponding variations in solidus temperatures. Figures 2-9 through 2-13 show the copper and brass alloys collected from the

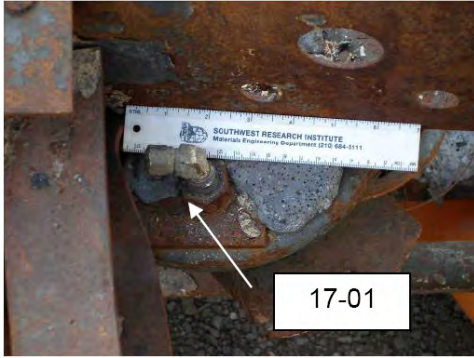
Figure 2-10. Incipient Melting Was Not Observed on Brass Samples From Truck 14

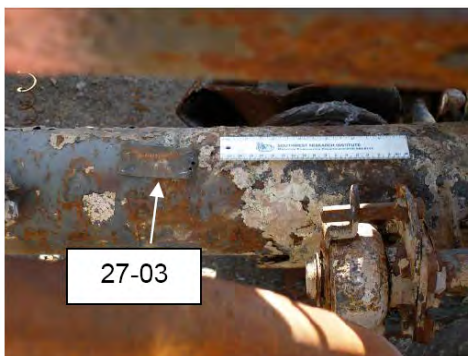
Figure 2-12. Incipient Melting Was Not Observed on Copper/Brass Samples From Truck 18

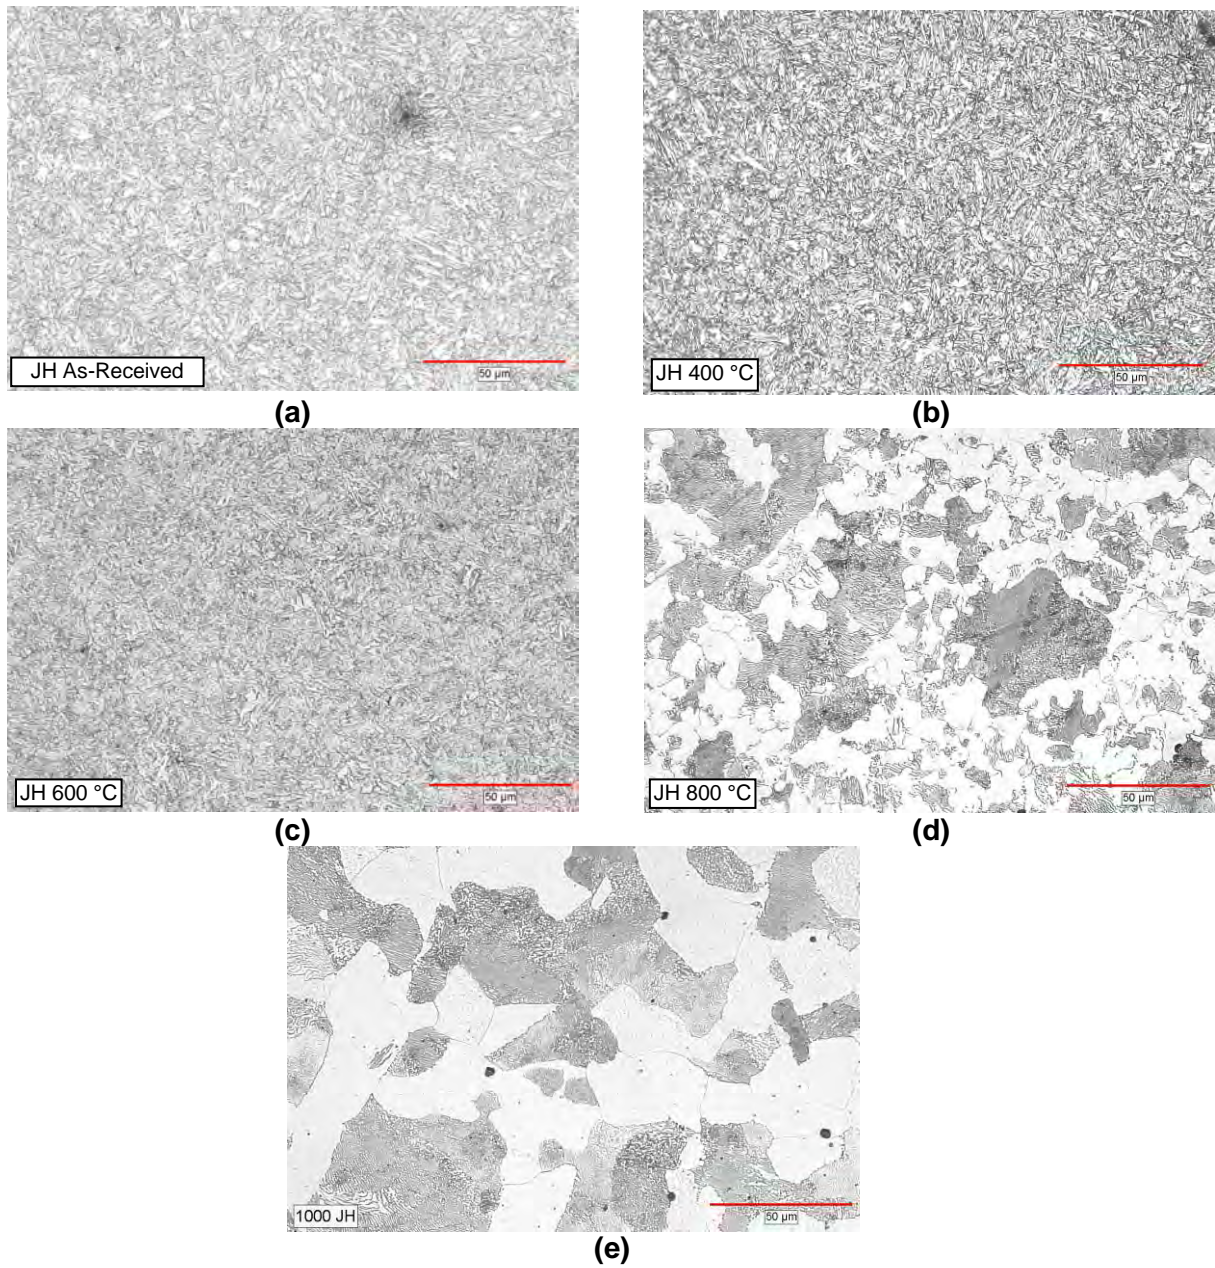
Figure 2-17. Microstructure of (a) As-Received Sample of Bolt JH Showing only Tempered Martensite, (b) Bolt JH After Thermal Exposure at 400°C [752°F] Showing Only Tempered Martensite, (c) Bolt JH After Thermal Exposure at 600°C [1,112°F] Showing only Tempered Martensite, (d) Bolt JH After Thermal Exposure at 800°C [1,472°F] Showing Pearlite, and (e) Bolt JH After Thermal Exposure to 1,000°C [752°F] Showing Pearlite

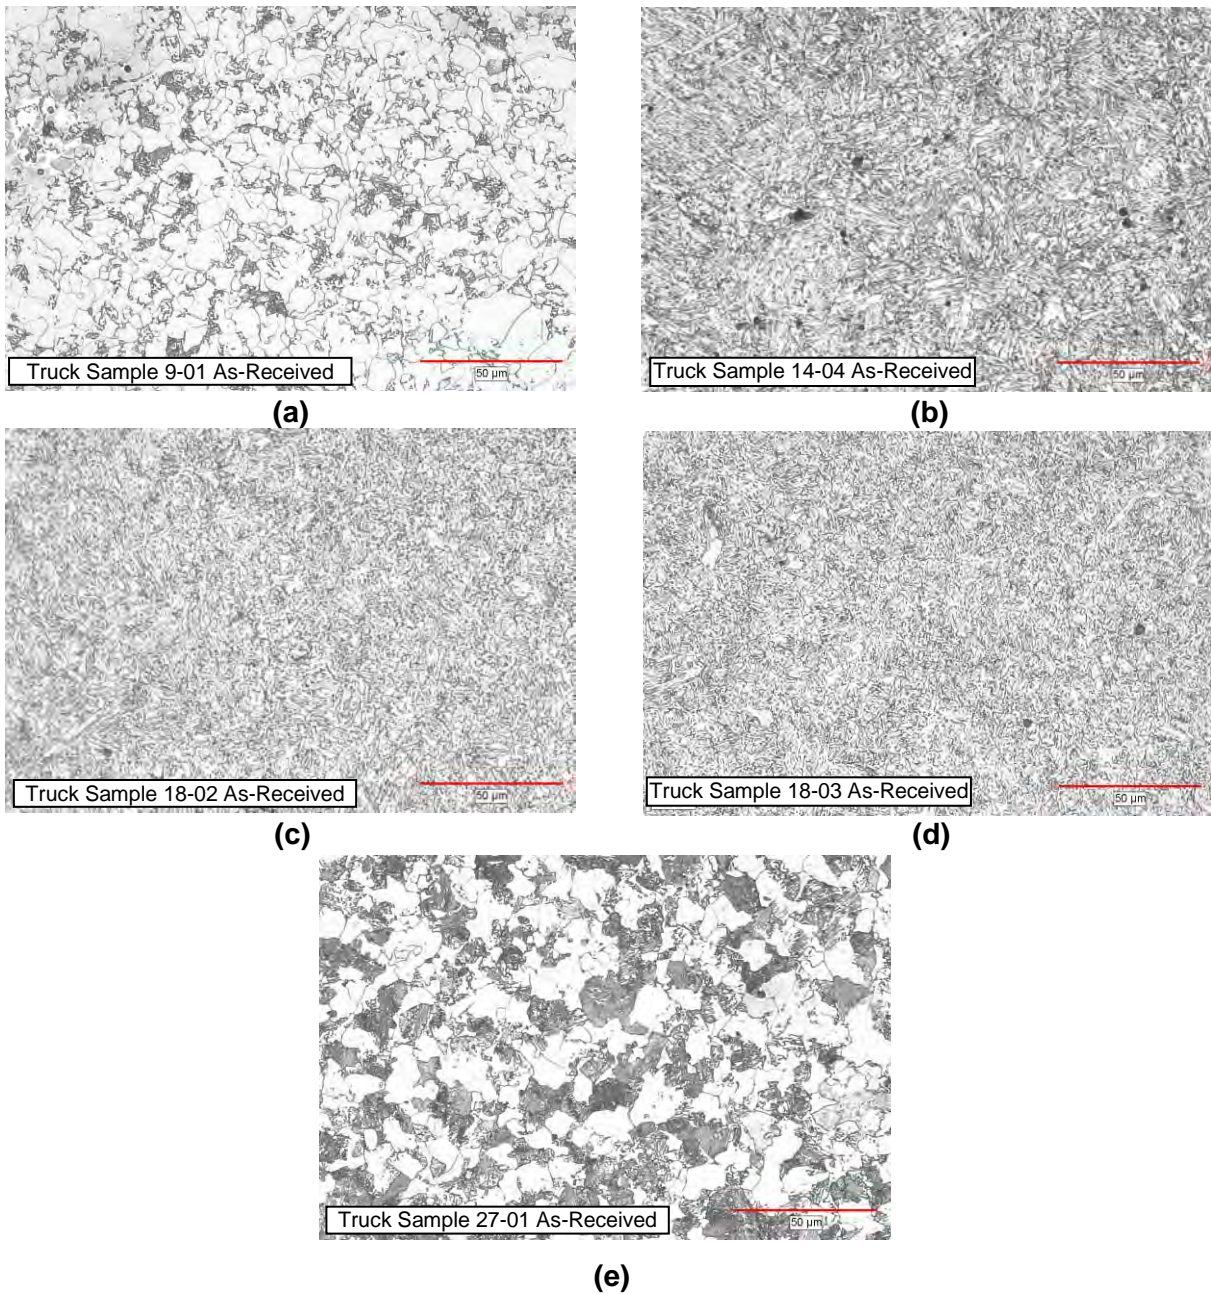
Figure 2-18. Microstructure of (a) Truck Sample 9-01 Showing Pearlite, (b) Truck Sample 14-04 Showing Only Tempered Martensite, (c) Truck Sample 18-02 Showing Only Tempered Martensite, (d) Truck Sample 18-03 Showing Only Tempered Martensite, and (e) Truck Sample 27-01 Showing Pearlite
