**UNITED STATES  
NUCLEAR REGULATORY COMMISSION**

**SUBJECT: DAVIS-BESSE NUCLEAR POWER STATION - INSPECTION TO EVALUATE THE ROOT CAUSE EVALUATION AND CORRECTIVE ACTIONS FOR CRACKING IN THE REINFORCED CONCRETE SHIELD BUILDING OF THE CONTAINMENT SYSTEM 05000346/2012009(DRS)**

IR 05000346/2012-009(DRS); 12/01/2011 - 5/09/2012, Davis-Besse Nuclear Power Station; Inspection to Evaluate the Root Cause and Corrective Actions for Cracking in the Reinforced Concrete Shield Building of the Containment System.

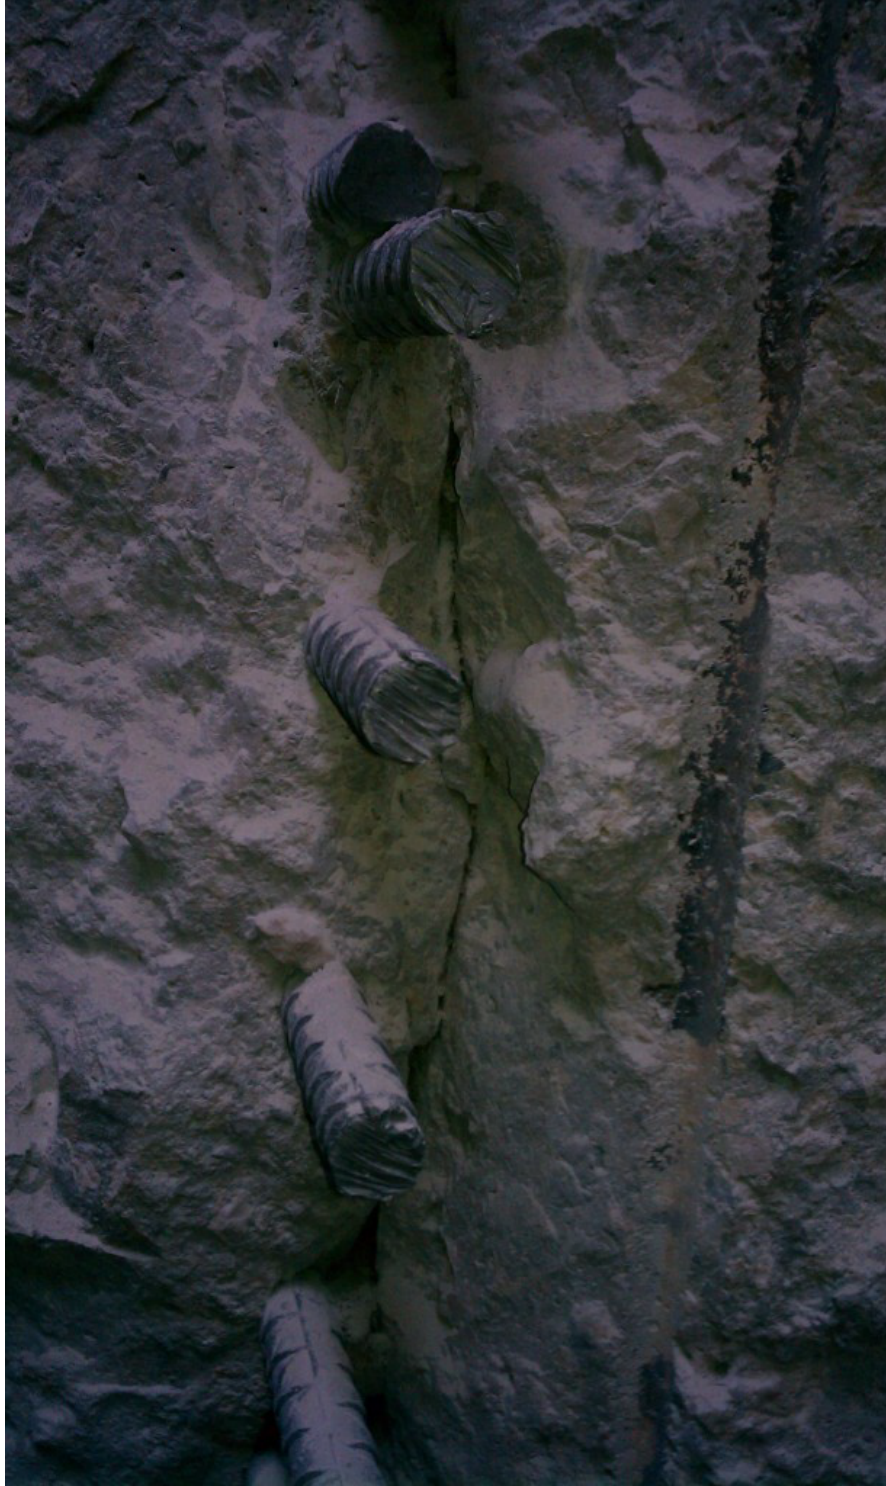
### Picture No. 3 - Davis-Besse Shield Building Laminar Subsurface Cracking

During construction of the SB access opening in the 17-mid-cycle outage, the licensee discovered subsurface cracking located near the outer rebar mat, which extended into areas of the SB that not been modified since original construction. The licensee attempted to remove the cracks discovered during the hydrodemolition process (Attachment 2, Picture 3) using a manual chipping process. Using this method, the crack indications along the left and bottom edges essentially disappeared, but the crack at the top of the opening did not disappear. The licensee investigated and confirmed the extent of subsurface laminar cracking through the use of impulse response (IR) testing and core boring samples (CBS) taken from the SB. Specifically, laminar subsurface concrete cracks were identified along the outer rebar mat in the SB flute shoulders, at the top of SB near the junction with the roof, and at the SB penetration openings. The licensee was able to demonstrate that the SB remained structurally adequate for the controlling load cases and remained capable of performing its safety functions. However,

(Note- initial condition after hydrodemolition to create an opening in the shield building and is included to show the relative location of subsurface laminar cracking. Based upon core bore samples, the crack condition (e.g., crack width) shown does not represent the laminar crack conditions in the sections of the shield building unaffected by the hydrodemolition process.)

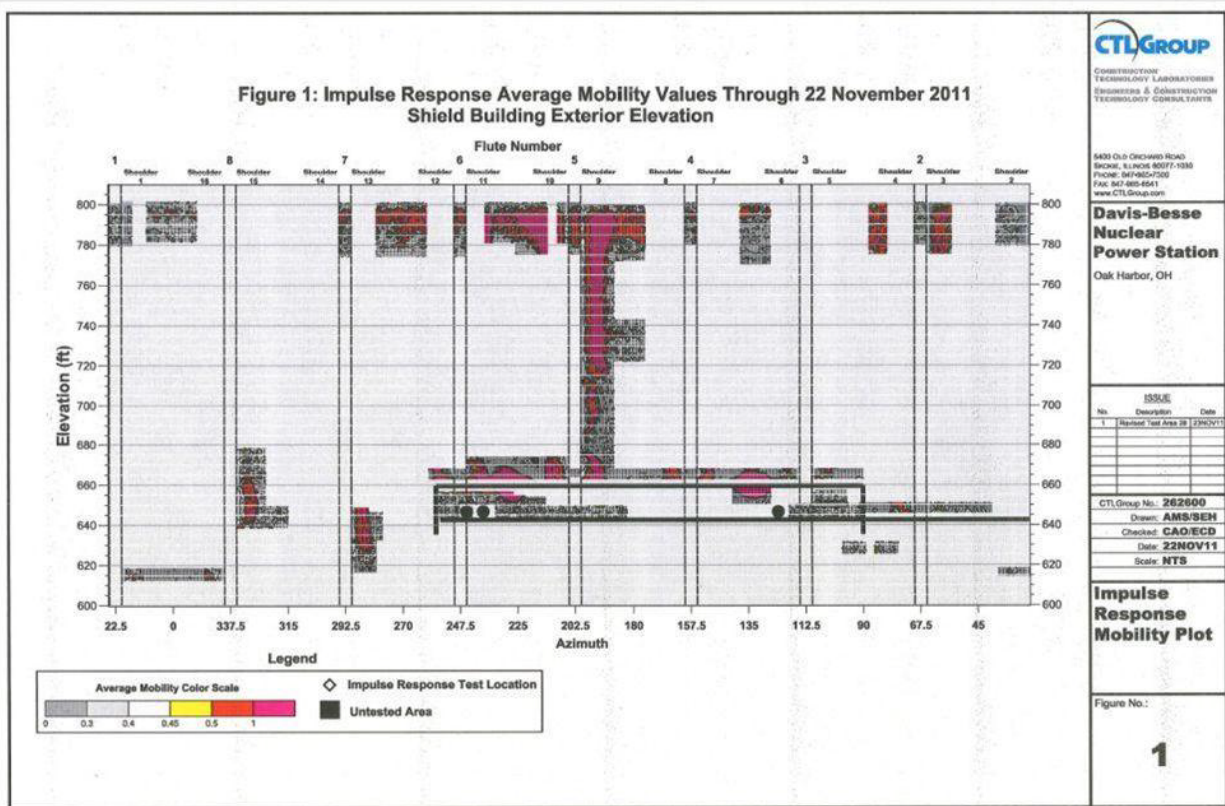
Picture No. 4 – Davis-Besse Shield Building Impulse Response Testing Mobility Plot

- The NRC team reviewed the IR mapping results (Attachment 2, Pictures 4 and 5) and SB drawings identifying the location and configuration of structural reinforcement (e.g., rebar) to determine if the extent of laminar cracking identified was consistent with the RCT conclusions that SB reinforcement design features contributed to the extent of cracking observed. The NRC team confirmed that the extent of cracking identified by IR testing results was consistent with the RCT identified Contributing Causes. However, the NRC team identified areas of laminar crack indications between SB shoulders 6 and 7 and above the mainstem line penetrations which did not include sufficient IR test locations to link this area directly with cracked areas in the adjacent SB shoulder regions. The NRC team's observation related to a lack of IR coverage did not invalidate the theory for the Direct Cause of the cracking or the Contributing Causes because the extensive computer modeling and vendor CBS testing provided a sufficient basis to validate these causes. Specifically, five analyses were completed in support of the SB laminar cracking causes Freezing Failure and Rebar Spacing Sensitivity Study, Structural and Thermal Analysis Investigation, Stress State During 1978 and 1977 Blizzards, Stress Analysis Due to 105 mph Wind Load, and Laminar Cracking Due to 1978 Blizzard. Therefore, the NRC team concluded that the RCT had developed a sufficient basis for the Contributing Causes.

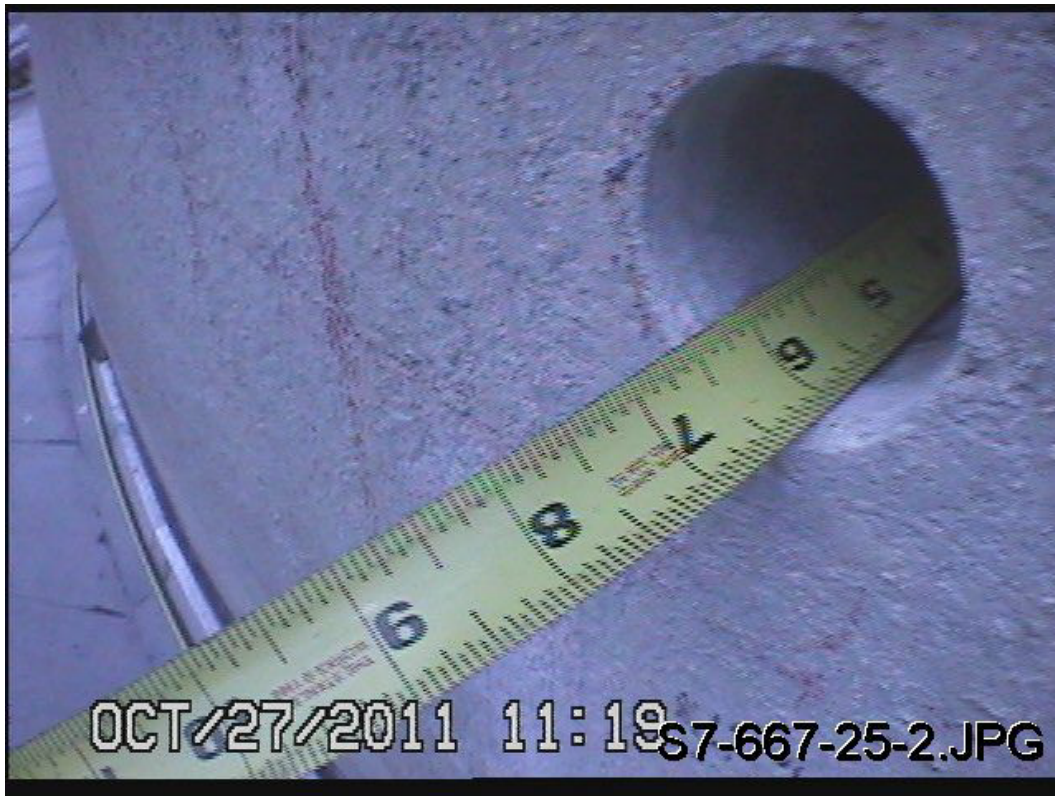
**Picture No. 6 – Davis-Besse Shield Building Core Bore Location S7-667-25-2**

The NRC team identified a brown deposit located near the bottom of a core bore at location S7-667.0-25, which had not been recorded on a licensee CR. The licensee staff believed this deposit was rust related stain and documented this condition in CR-2012-03889. The NRC team reviewed photographs from other SB core bore locations and noted a similar condition in the first core bore location (S15-645.5-3). The licensee staff believed this stain/deposit could be the results of minor rebar corrosion caused by water introduced during the core bore drilling operation. The licensee's corrective action associated with the identified corrosion is subject to future NRC inspection.

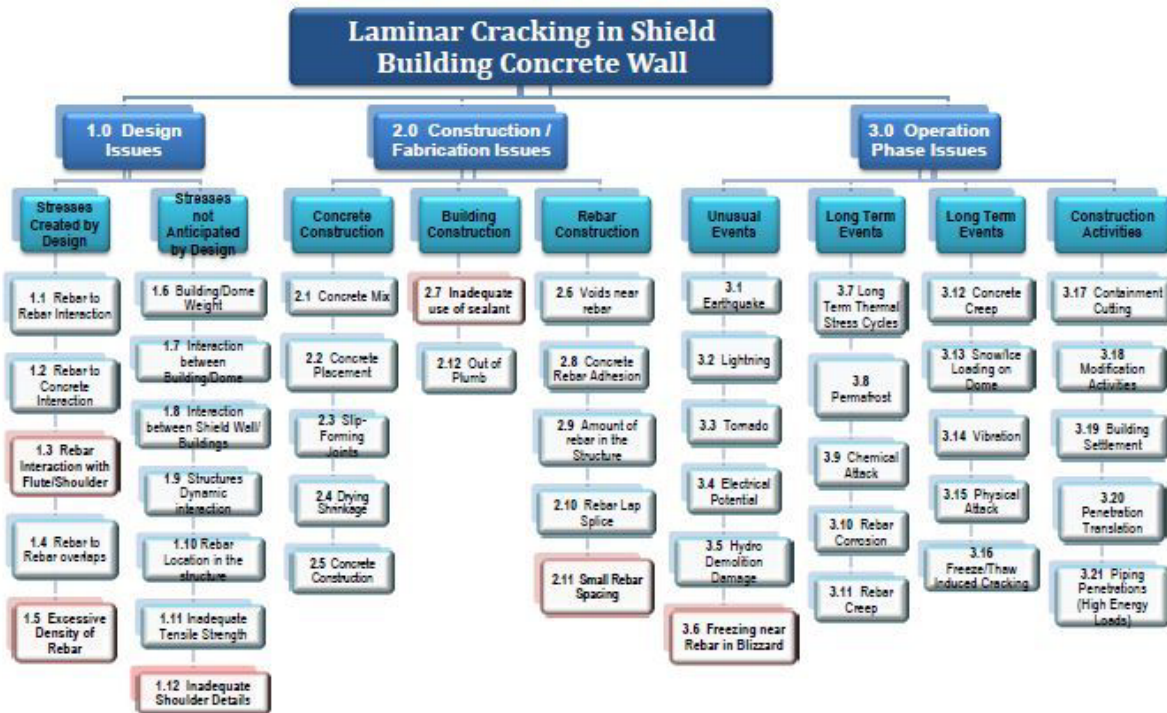
Picture No. 9 – Davis-Besse Shield Building Root Cause Analysis Report – Fault Tree

The RCT developed a fault tree of 45 possible failure modes that could potentially contribute to the laminar cracking, either individually or in concert based upon characteristics of the SB laminar cracking and other OEs with concrete issues. The 45 failure modes were grouped into three major categories consisting of Design, Construction and Fabrication, and Operational (Attachment 2, Picture 9) and each of these failure modes was evaluated during the root cause investigation. In general, each failure mode was either refuted or supported by laboratory tests and examinations or analysis. Some failure modes were refuted by deductive reasoning based on existing evidence to either support or refute their mode of failure. Potential failure modes were not eliminated without evidence to refute the postulated failure mode.

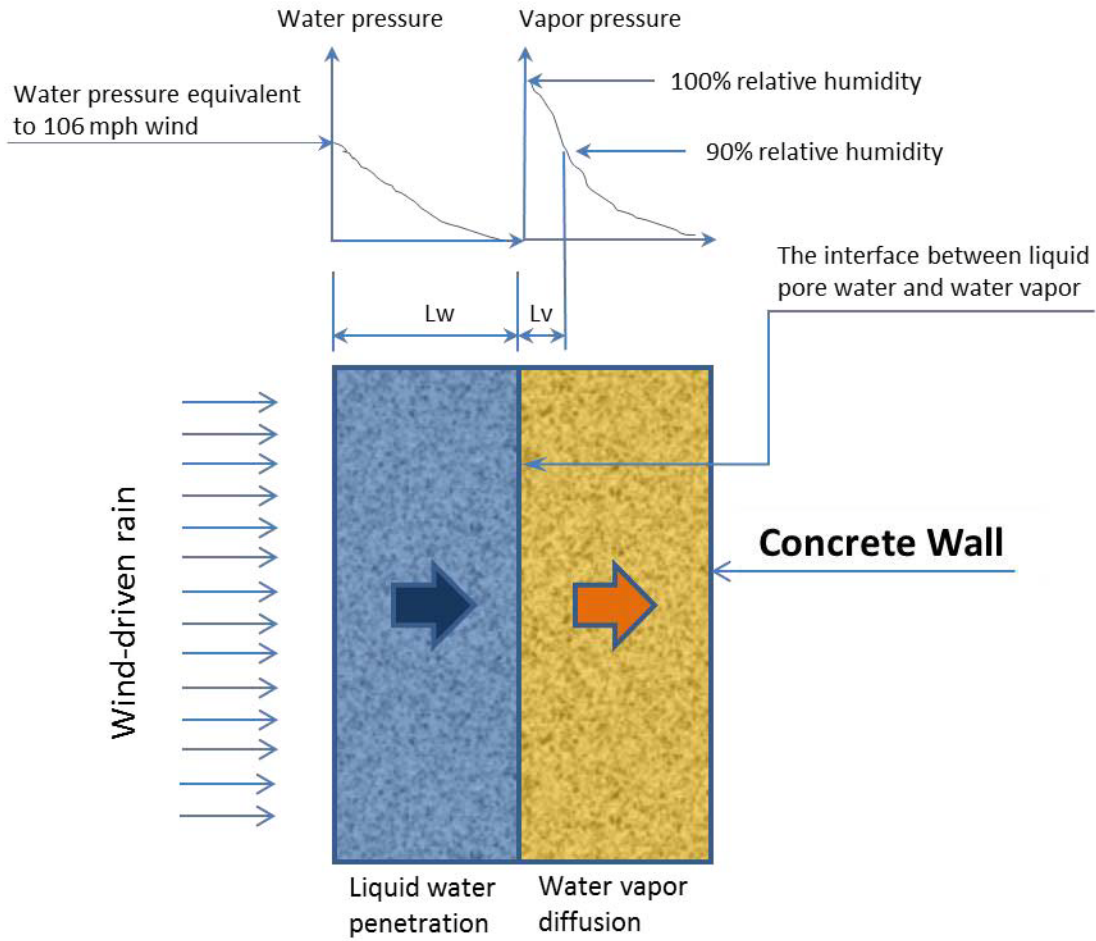
Picture No. 10 – Davis-Besse Shield Building – Water Migration

- The NRC team confirmed that weather records existed which supported the Direct Cause related to the extreme environmental conditions associated with the blizzard of 1978. This blizzard occurred from January 25 – 27, 1978, and produced rain with sustained winds, followed by rapid temperature drop and significant snowfall. Specifically, snowfall amounts ranging from 12 inches in Toledo to 22 inches at Saginaw, Michigan were recorded with wind speeds of 45 miles per hour (mph) and gusts to 105 mph west of Toledo, Ohio. This blizzard was preceded by a rapid drop in temperature beginning at 12 noon on January 25, 1978, and ending at midnight January 27, 1978. The vendor report included temperature maps that record a temperature drop from 40 degrees Fahrenheit (°F) at about 6:00 pm on January 25, 1978, to about -5° F by midnight. Daily temperatures were below 20° F by noon on January 26, 1978, and surface temperature continued to drop to near 0° F by midnight on January 27, 1978. These environmental conditions enabled moisture to penetrate the SB concrete, freeze and expand, which created a radial stress that exceeded the tensile strength of the concrete triggering the subsurface laminar cracking (Attachment 2, Pictures 10, 11 and 12).

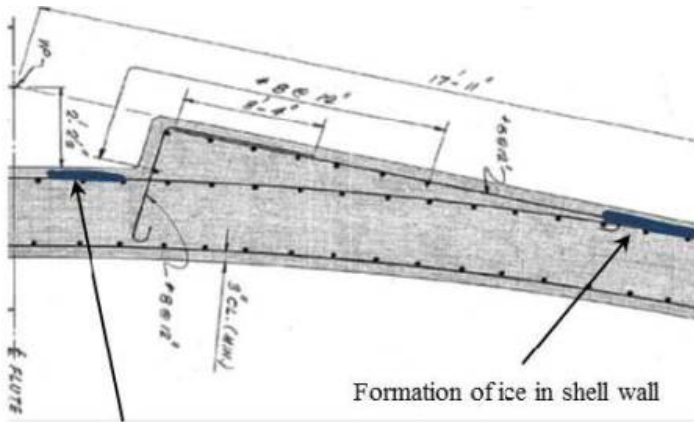
Picture No. 11 – Davis-Besse Shield Building – Location/Progression of Ice Formation

The RCT concluded that the Direct Cause for the SB concrete laminar cracking was the integrated affect of moisture content, wind speed, temperature, and the duration of these conditions created during the blizzard of 1978. The environmental conditions created by the blizzard of 1978 enabled moisture to penetrate the SB concrete, freeze and expand, which created radial stresses that exceeded the tensile strength of the concrete and initiated the subsurface laminar cracking (Attachment 2, Picture 11).

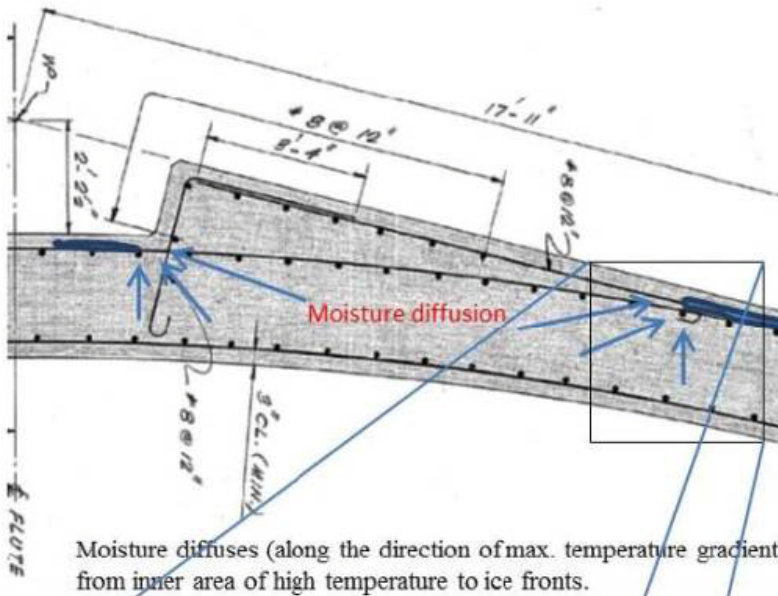
Formation of ice in flute

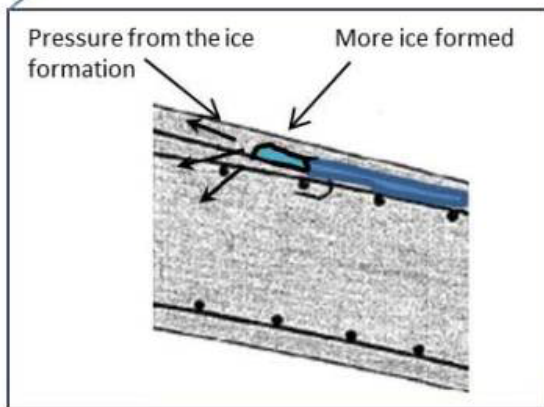
Moisture diffuses (along the direction of max. temperature gradient) from inner area of high temperature to ice fronts.

Progressive delamination of concrete cover near outer rebar mat due to ice formation
