Seismic Walkdown Checklist (SWC)

Diablo Canyon Power Plant, Unit 1

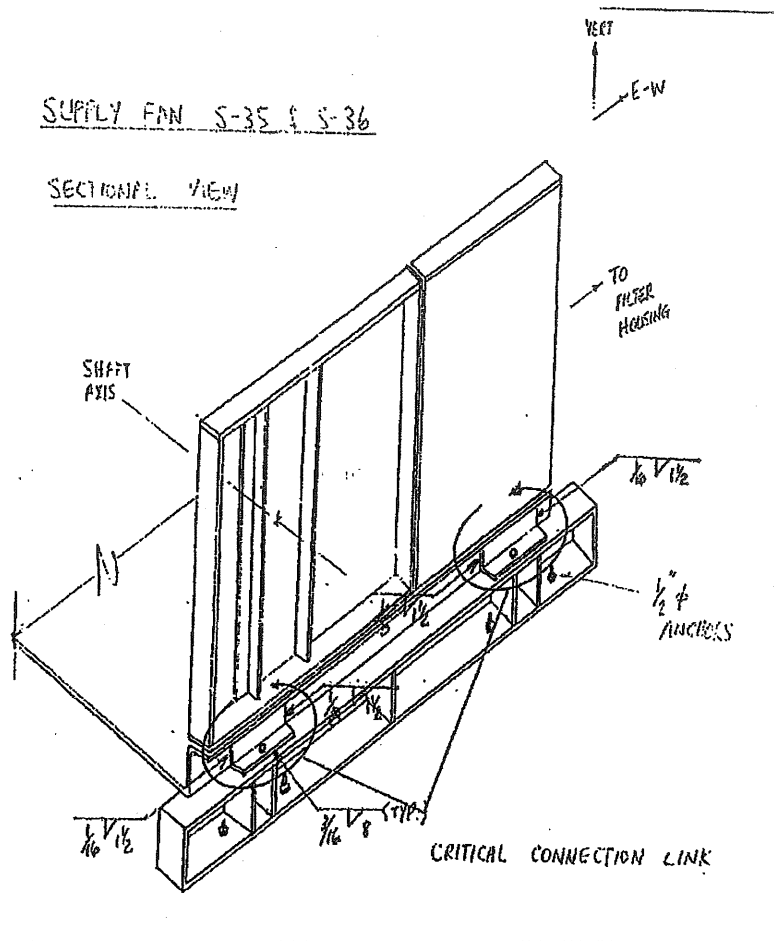
Attachment 1, Page 2 of 3

The supply fan S-35 is safety related. The seismic evaluation of the connecting angle is documented in seismic legacy calc # DHV-1.3, Pages 54 thru 61. The connecting angle is L1-1/2x2x3/16, which connects the supply fan and base skid. The skid is anchored to the concrete floor. Based on the original field walk down, the weld size between the supply fan and connecting angle is fillet weld 3/16", 1-1/2" long on both sides. The connection between the angle and base skid are 1/2" \varnothing bolt and a 3/16" fillet weld with 8" long. However, the field walk down has found that the weld size between the supply fan and connecting angle is smaller than that shown in seismic calculation. The weld sizes are fillet welds 1/8" on the left side and 1/16" on the right side (see sketch on Page 2).

The as-found condition is evaluated as shown on Page 3. The results show that the as-found condition has significant margin. Therefore, the as-found condition has no adverse effects on the seismic qualification of supply fan S-35.

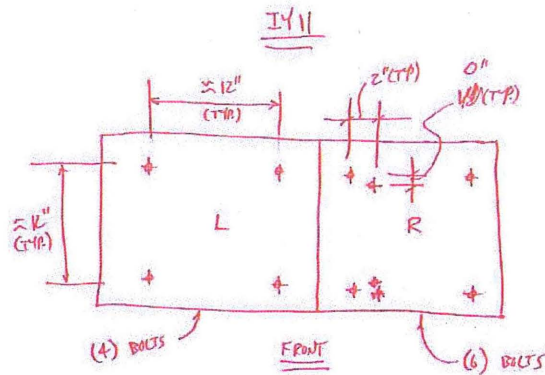
Unit 1 Field Walk Down Sketches:

The transformer on the left side is 80-314009-90 (See picture in page 2).
