**Seismic Walkdown Checklist (SWC)**

Equipment ID No.: 2SX169A

Equipment Description: DG 2A SX VLV ASMBLY

Project: Braidwood 2 SWEL

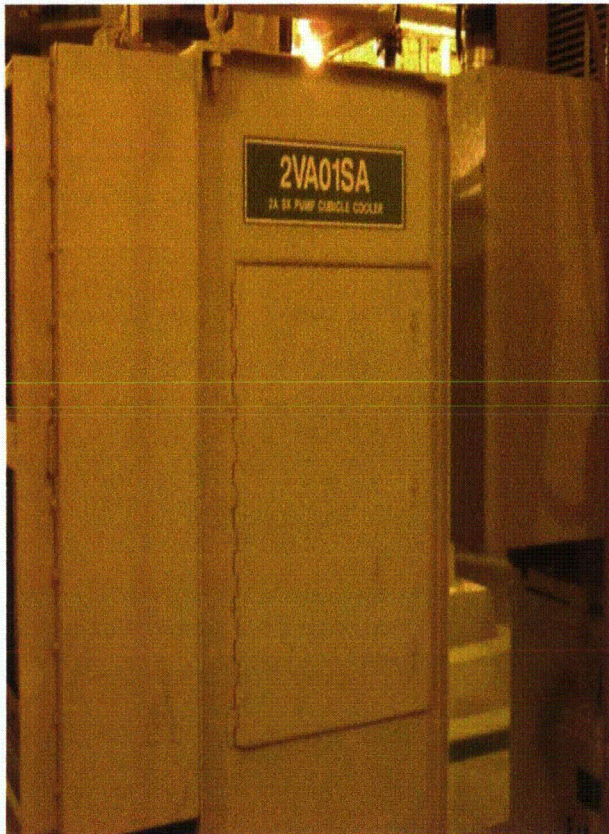
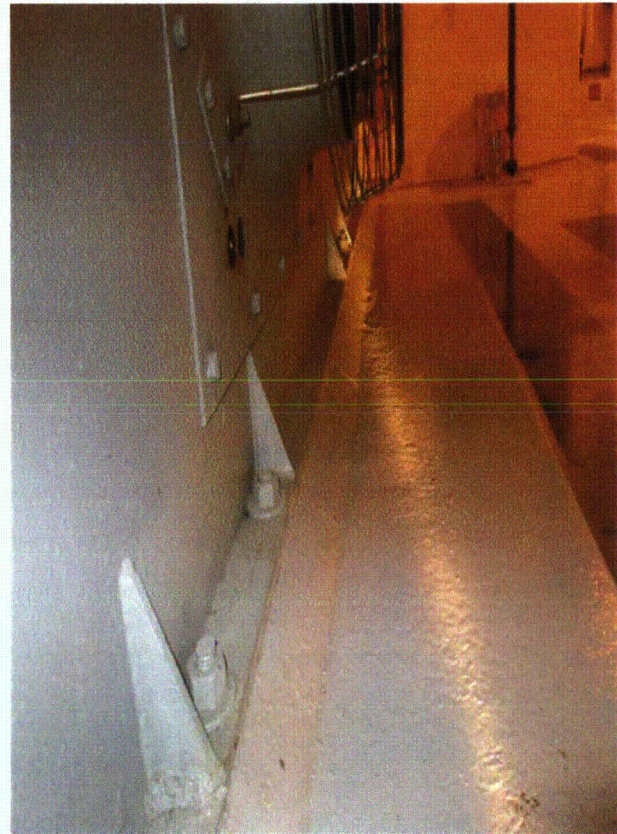
2. Is the anchorage free of bent, broken, missing or loose hardware? Yes  
*Broken bolt as per Drawing M-1219 Sheet 3 Revision AE*

6. Based on the above anchorage evaluations, is the anchorage free of potentially adverse seismic conditions? Yes  
*Drawing M-1219 Sheet 3 Revision AE*
