Seismic Walkdown Checklist (SWC)

Equipment ID No.: 1SX01PB

Equipment Description: PUMP,1B ESSENTIAL SER WTR ASMBLY

Project: Braidwood 1 SWEL

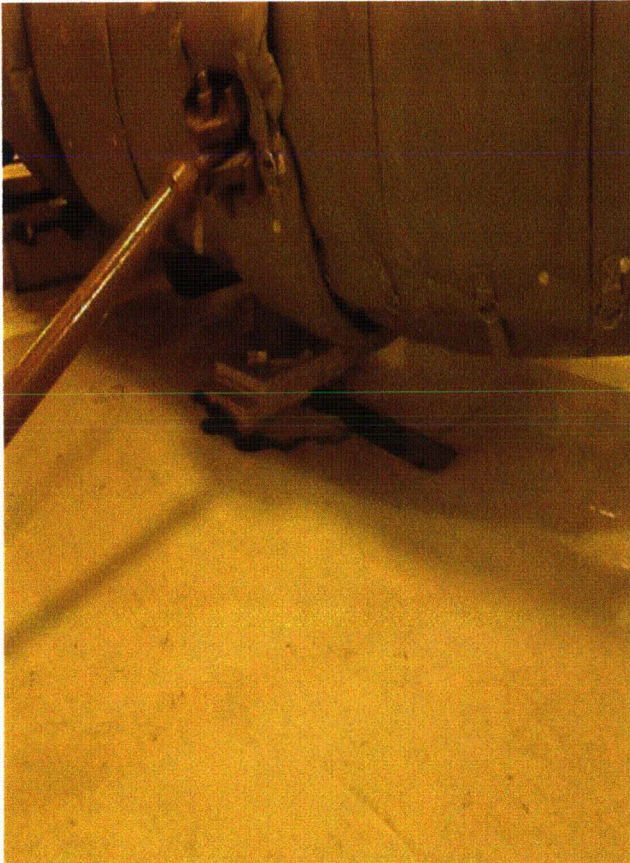
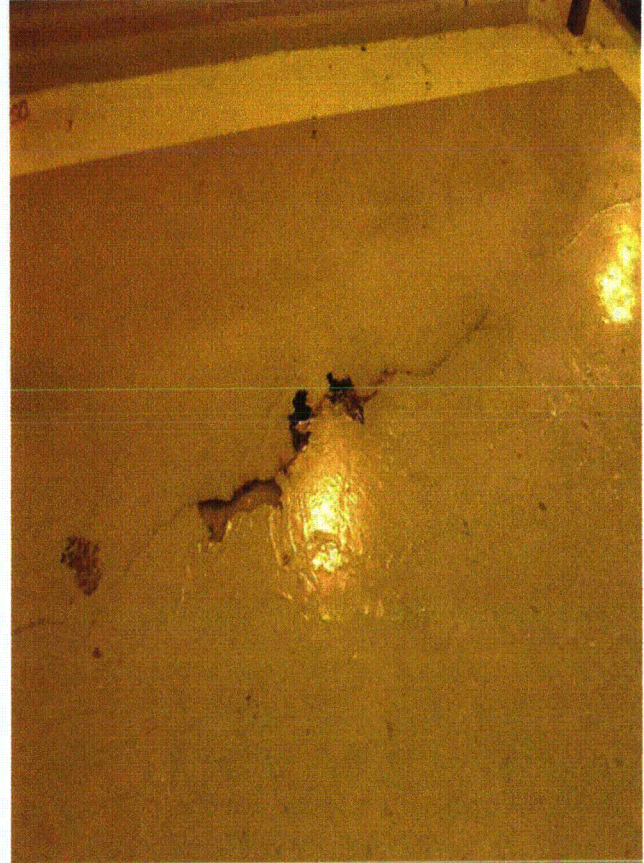
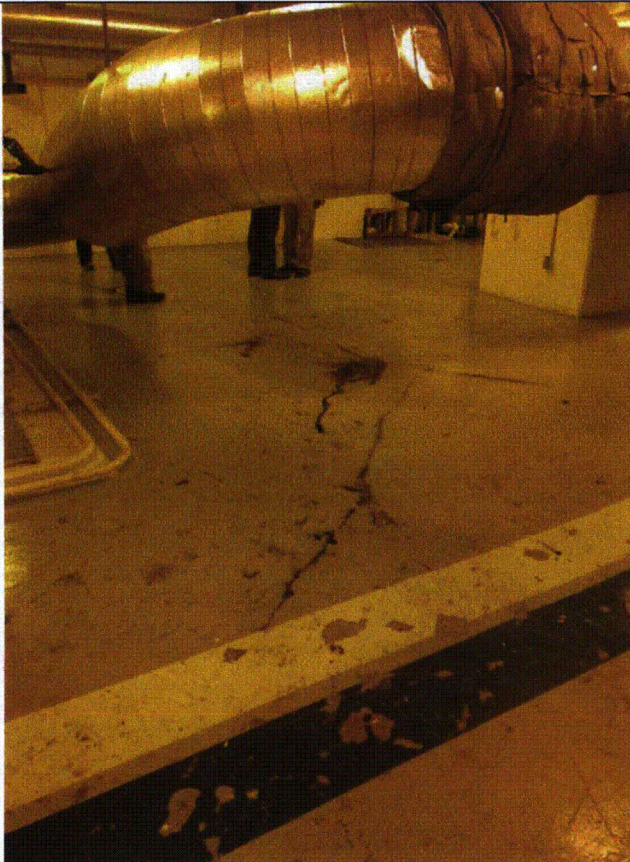
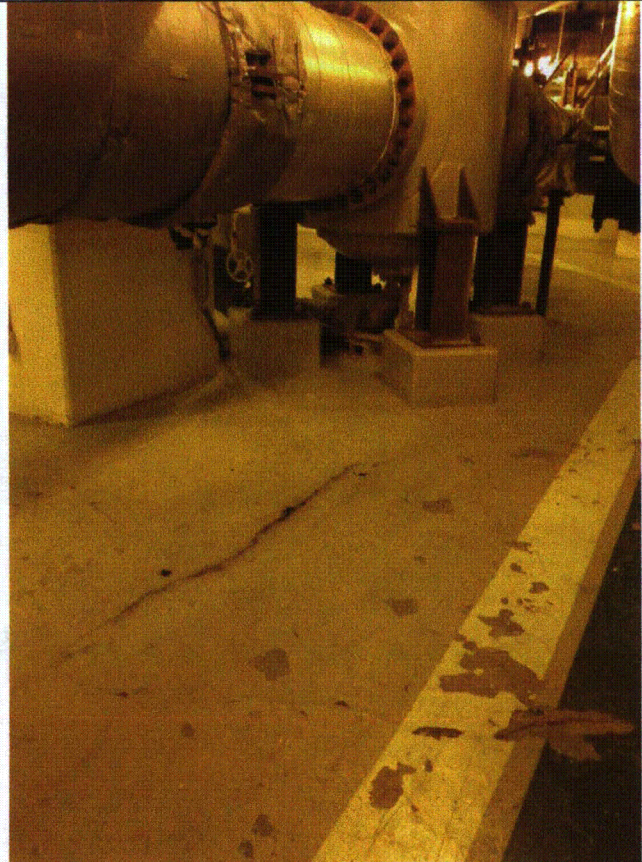
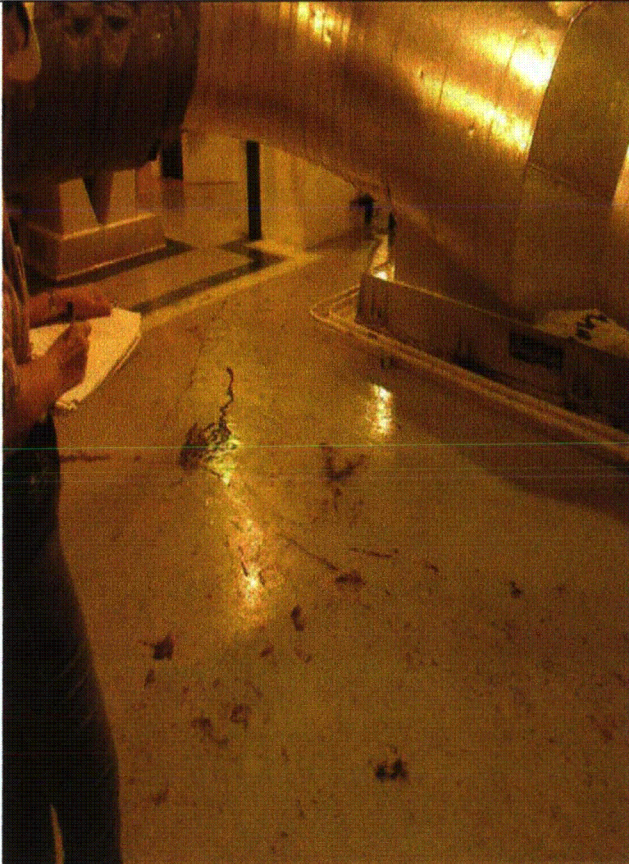
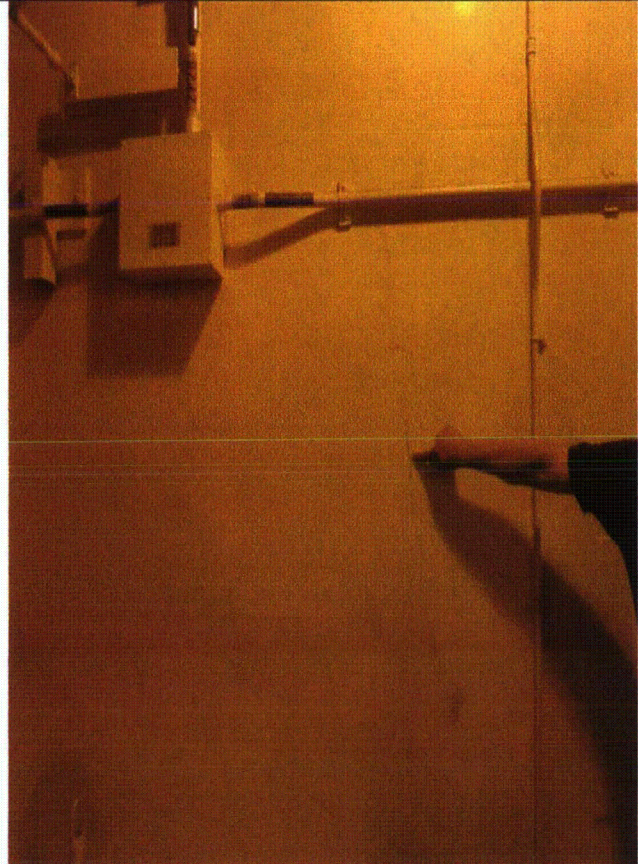
11. Have you looked for and found no adverse seismic conditions that could adversely affect the safety functions of the equipment? Yes
See AWC 28 for discussion on hairline concrete cracks.

1SX01PB (6695 - concrete cracks) 7-18-12 043

1SX01PB (6695 - concrete cracks) 7-18-12 044

1SX01PB (6695 - concrete cracks) 7-18-12 045

1SX01PB (6695 - concrete cracks) 7-18-12 046

1SX01PB (6695 - concrete cracks) 7-18-12 047

1SX01PB (6695 - concrete cracks) 7-18-12 048

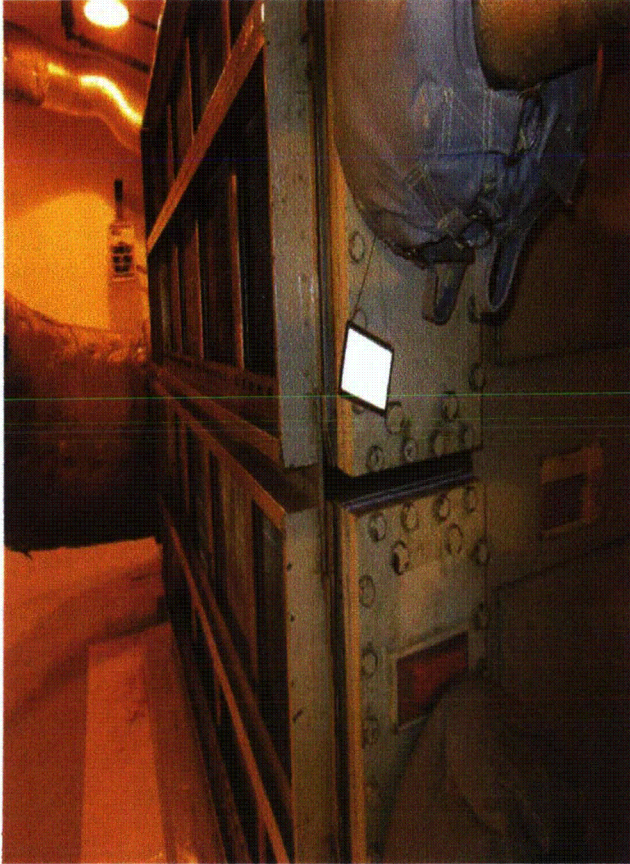
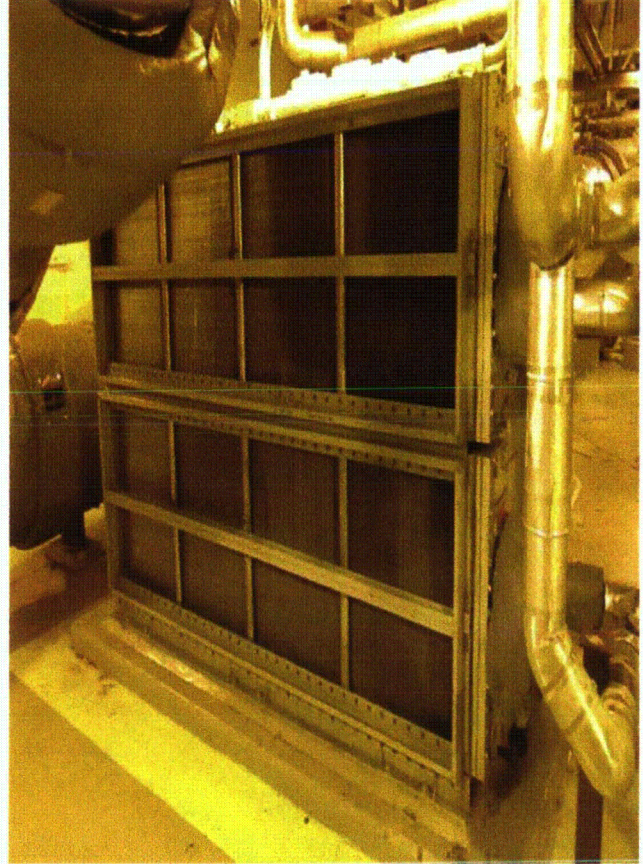
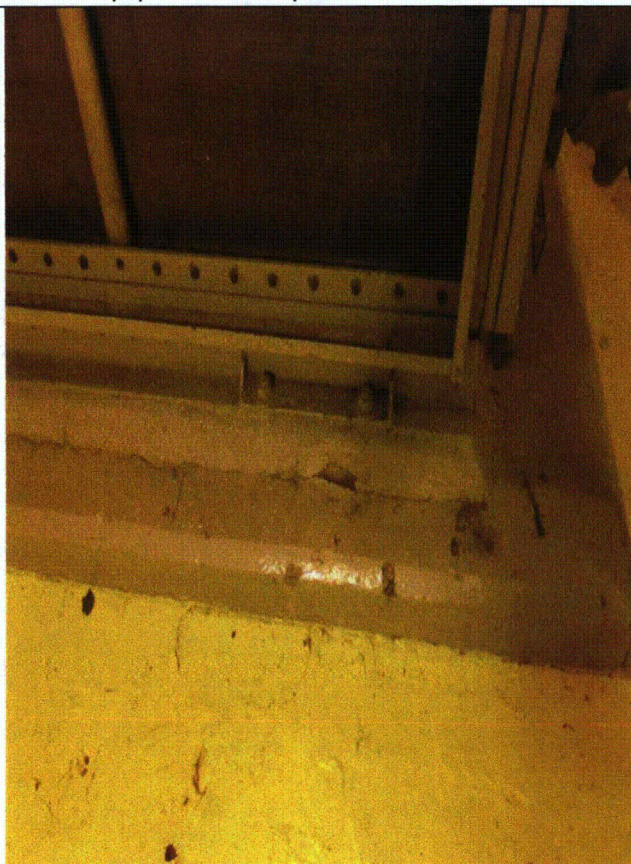
1VA01SB 7-18-12 036

5. Is the anchorage configuration consistent with plant documentation? (Note: This question only applies if the item is one of the 50% for which an anchorage configuration verification is required.) Yes
Drawing M-1219 Sheet 3 Revision AE
Confirmed missing washer, broken bolt
