ATTACHMENT 4

AREA WALK-BY CHECKLIST

Area Walk-By Checklist (AWC)

Location (Bldg, Elev, Room/Area): Area : AUX, 45, CAL-AB-440

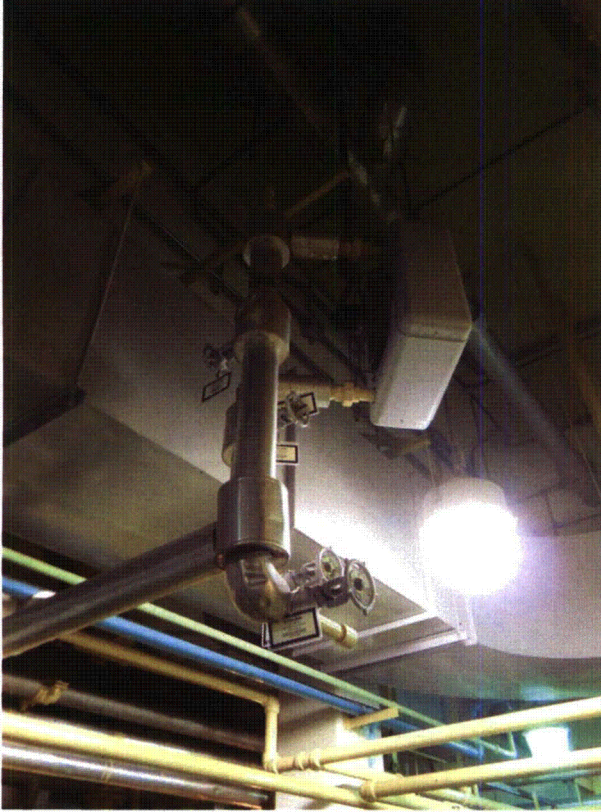
Area # AUX, 70, CAL-AB-527 8-9-12 152

1. Does anchorage of equipment in the area appear to be free of potentially adverse seismic conditions (if visible without necessarily opening cabinets)? Yes
Unable to verify rear anchorage of MCC 202F, but according to CCNPP, MCC is not safety related, therefore it is judged not to be a seismic hazard.
