Seismic Walkdown Checklist Form
Sheet 1 of 5
Status: YX N U
Seismic Walkdown Checklist (SWC) <u>SWC- 57</u>
Equipment ID No. <u>PI-2855-1</u> Equip. Class ¹ <u>18</u> , INSTRUMENT RACKS
Equipment Description RAW WATER PUMP AC-10B DISCHARGE PRESSURE INDICATOR
Location: Bldg. INTAKE Floor El. 998' Room, Area INTAKE, 16W'BB-10N'103
Manufacturer, Model, Etc. (optional but recommended)
Instructions for Completing Checklist
This checklist may be used to document the results of the Seismic Walkdown of an item of equipment on the SWEL. The space below each of the following questions may be used to record the results of judgments and findings. Additional space is provided at the end of this checklist for documenting other comments.
Anchorage
 Is the anchorage configuration verification required (i.e., is the item one Y⊠ N□ of the 50% of SWEL items requiring such verification)?

EA12-021, Rev. 0 ATTACHMENT 11.2 PAGE 238 OF 404

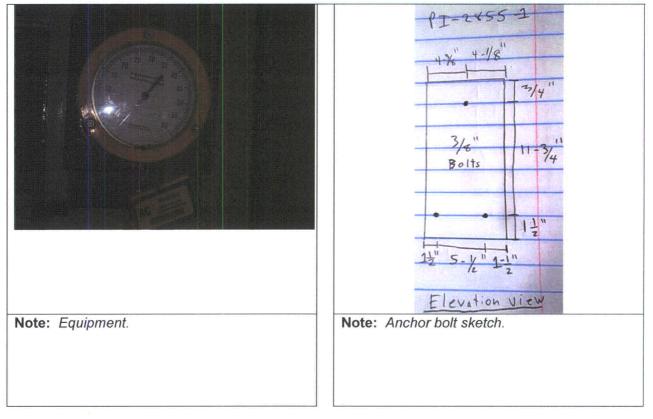
SE	ISMIC WALKDOWN CHECKLIST FORM
Sheet 2 of 5	
Seismic Walkdown Checklist (SWC) <u>SWC- 57</u>	Status: Y⊠ N⊡ U⊡
Equipment ID No. <u>PI-2855-1</u> Equip. Class2 <u>18, INSTRUMEN1</u>	RACKS
Equipment Description <u>RAW WATER PUMP AC-10B DISCHARGE PRESS</u>	URE INDICATOR
 Is the anchorage configuration consistent with plant documentation? (Note: This question only applies if the item is one of the 50% for which an anchorage configuration verification is required.) 	Y
Needs plant documentation. See sketch in photo section below. Licensing Basis Evaluation is required.

8. Are overhead equipment, distribution systems, ceiling tiles and lighting	, Y□ N⊠ U□ N/A□
and masonry block walls not likely to collapse onto the equipment?	
Light bulbs that could break and fall could have impact on indicator gauge. CR 2012-10629 has been initiated.

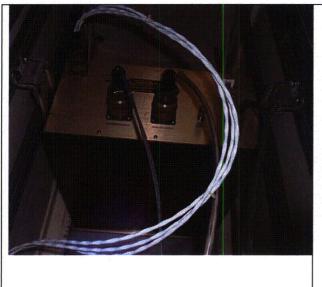
Note: Bottom view of Equipment

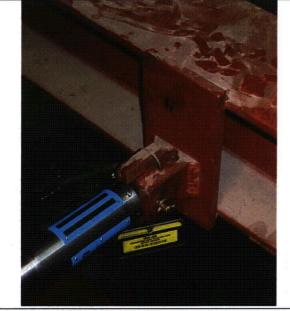
Note: Equipment strut support anchorage. (Welded to I-Beam)
