**Seismic Walkdown Checklist (SWC)**

Equipment ID No. C4104F004A Equip. Class<sup>1</sup> 8-Motor Operated and Solenoid Operated Valves

Equipment Description SLC Explosive (SQUIB) Valve

Location: Bldg. RB Floor El. 613'-6" Room, Area A-17, Col C-11

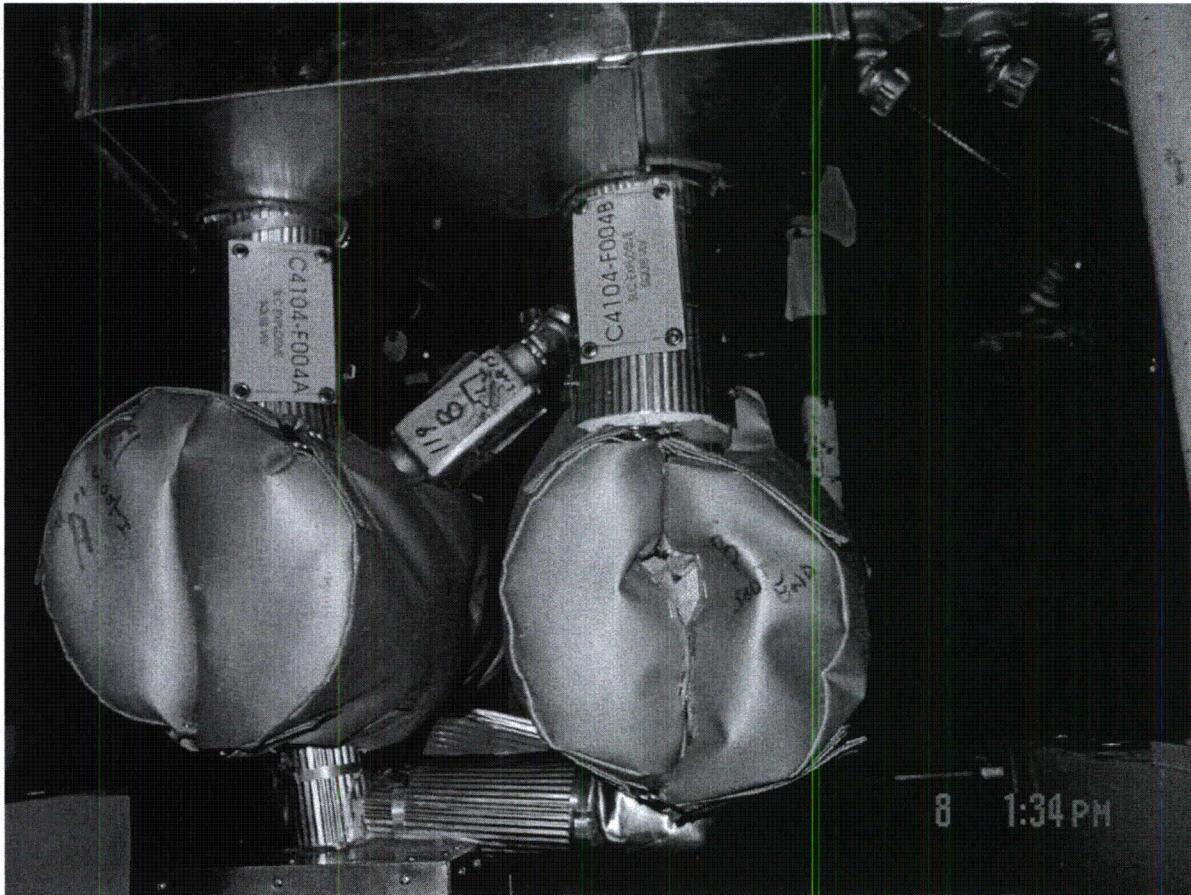
(Picture 1)

2. Is the anchorage free of bent, broken, missing or loose hardware?  Y  N  U  N/A  
*All visible anchorage associated with this asset is in good condition and intact, see picture 1.*

3. Is the anchorage free of corrosion that is more than mild surface oxidation?  Y  N  U  N/A  
*There is no anchorage with corrosion or surface oxidation. (See picture 1.)*

7. Are soft targets free from impact by nearby equipment or structures?  Y  N  U  N/A  
*The asset does not have any soft targets. (See picture 1.)*
8. Are overhead equipment, distribution systems, ceiling tiles and lighting, and masonry block walls not likely to collapse onto the equipment?  Y  N  U  N/A  
*The asset is protected overhead by the concrete slab. (See picture 2.)*
9. Do attached lines have adequate flexibility to avoid damage?  Y  N  U  N/A  
*The attached lines have adequate flexibility. (See picture 3.)*
10. Based on the above seismic interaction evaluations, is equipment free of potentially adverse seismic interaction effects?  Y  N  U
-

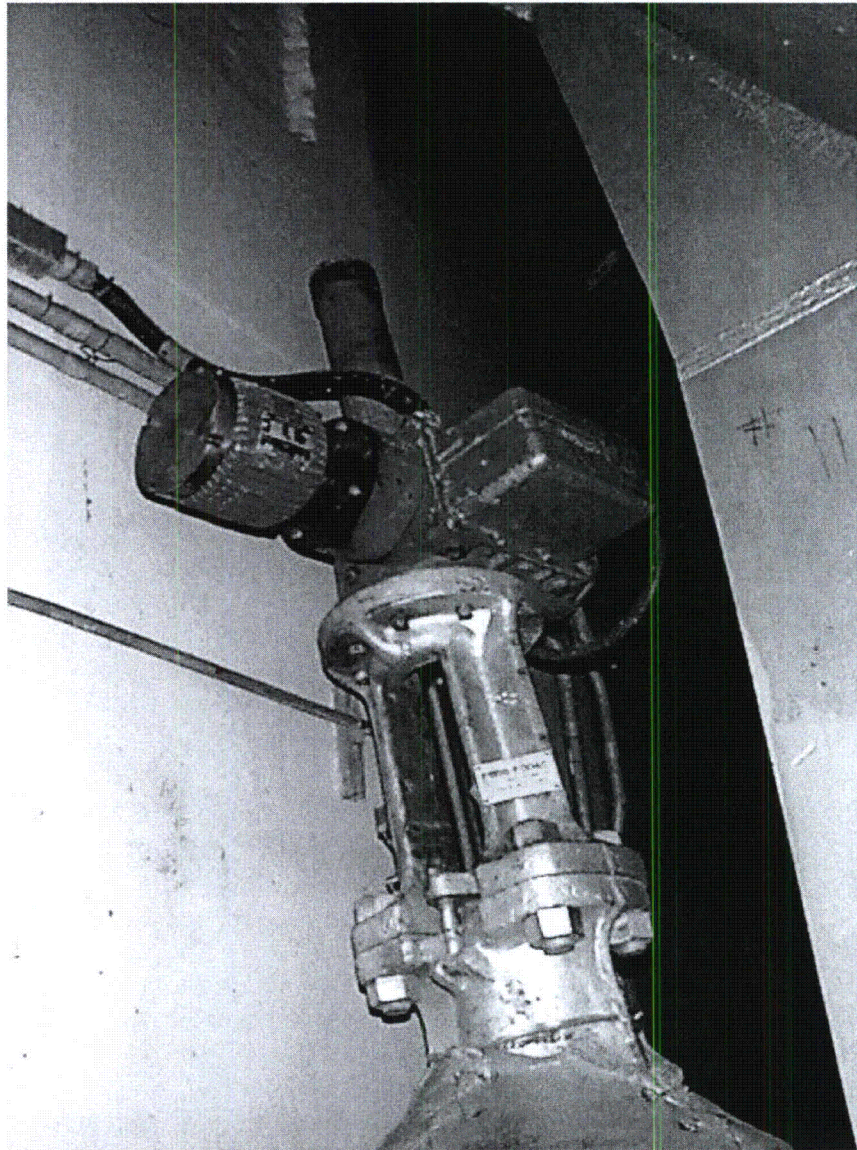
(Picture 1)

2. Is the anchorage free of bent, broken, missing or loose hardware?  Y  N  U  N/A  
*The assets anchorage connections are not attached to a civil structure. The asset is a valve attached to its own piping system with hardware that is in good condition. (See Picture 1.)*

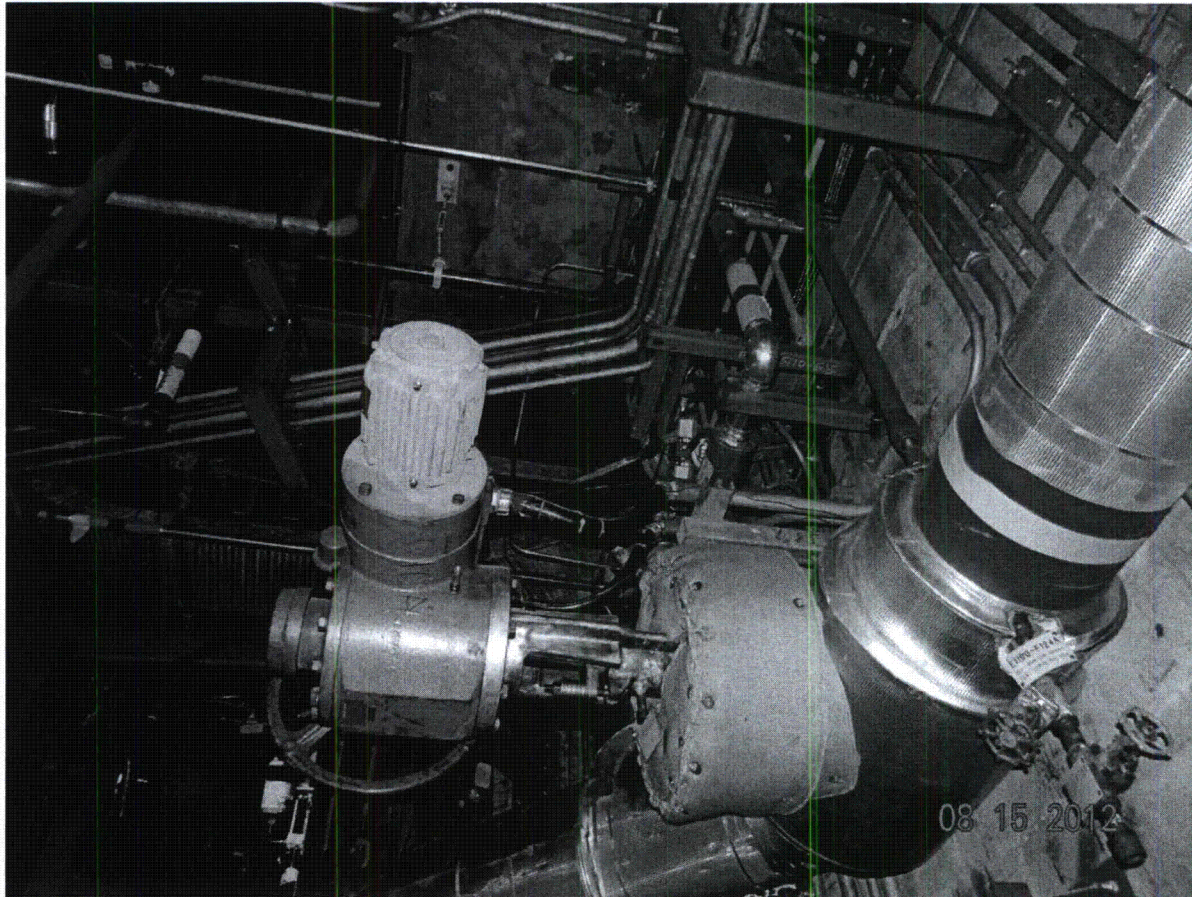
(Picture 4)

9. Do attached lines have adequate flexibility to avoid damage?  
*Attached lines are made of flexible material. (See picture 4.)*      Y N U N/A

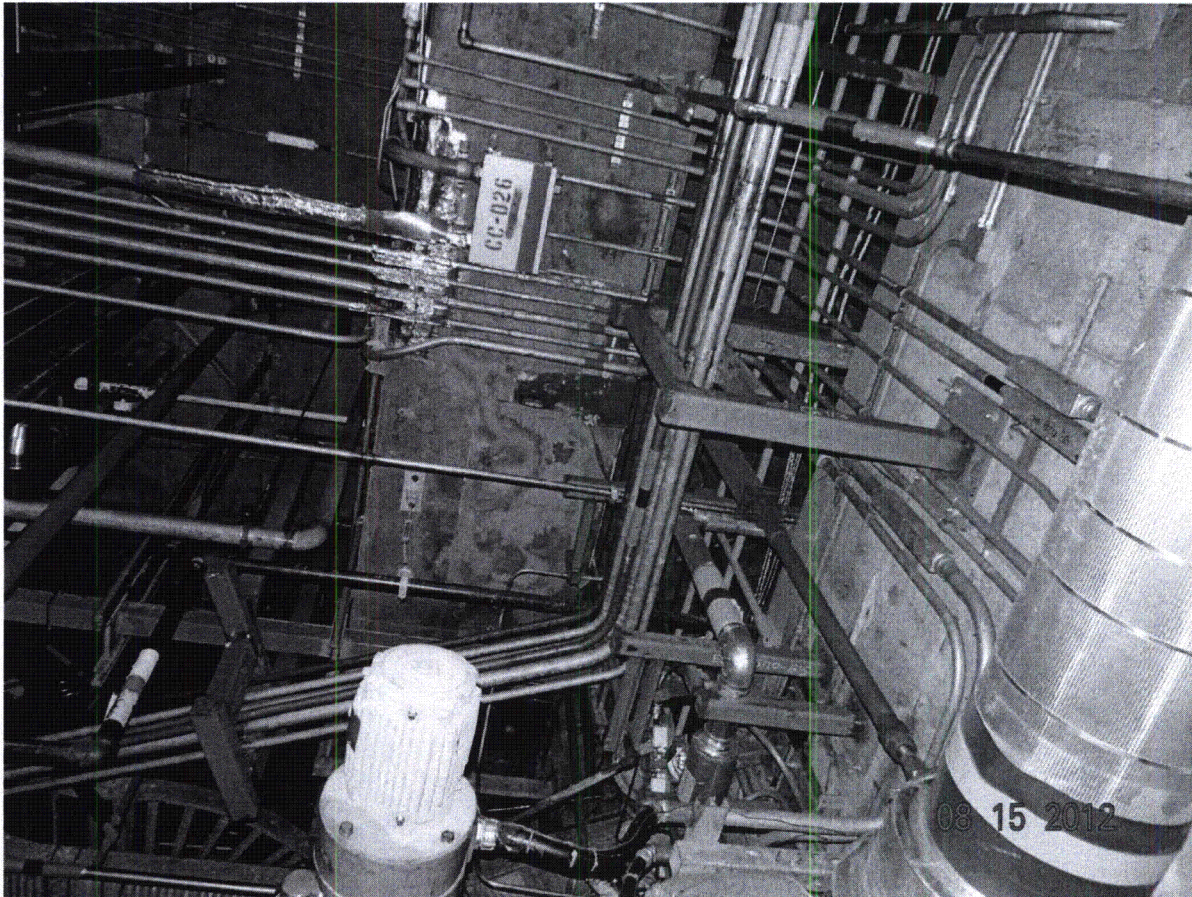
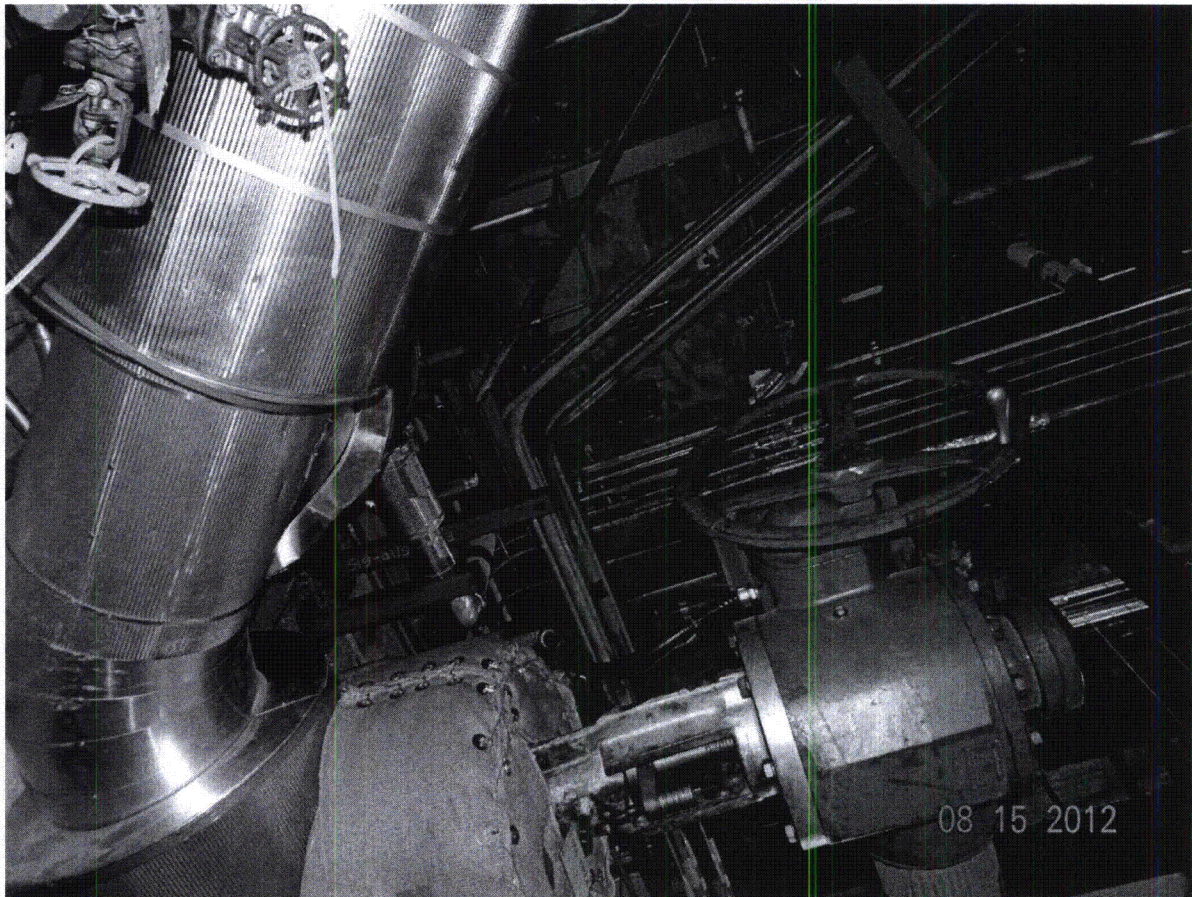
8. Are overhead equipment, distribution systems, ceiling tiles and lighting,  
and masonry block walls not likely to collapse onto the equipment?  
*There are no observed overhead hazards. (See picture 5 and 6.)*      Y N U N/A

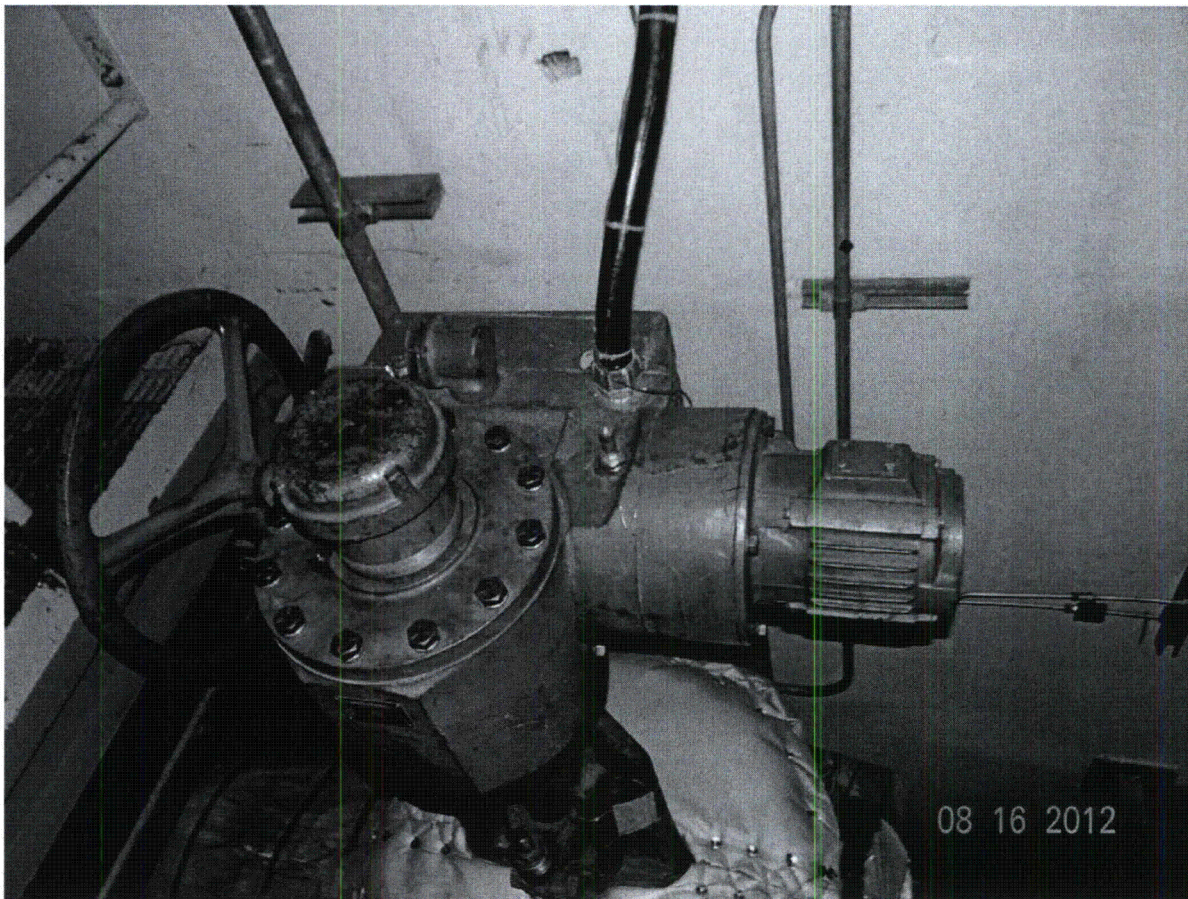
(Picture 6)

2. Is the anchorage free of bent, broken, missing or loose hardware? Y  N  U  N/A   
*The asset is not anchored to concrete. It is attached to its piping system via a flanged connection. (See picture 6.)*

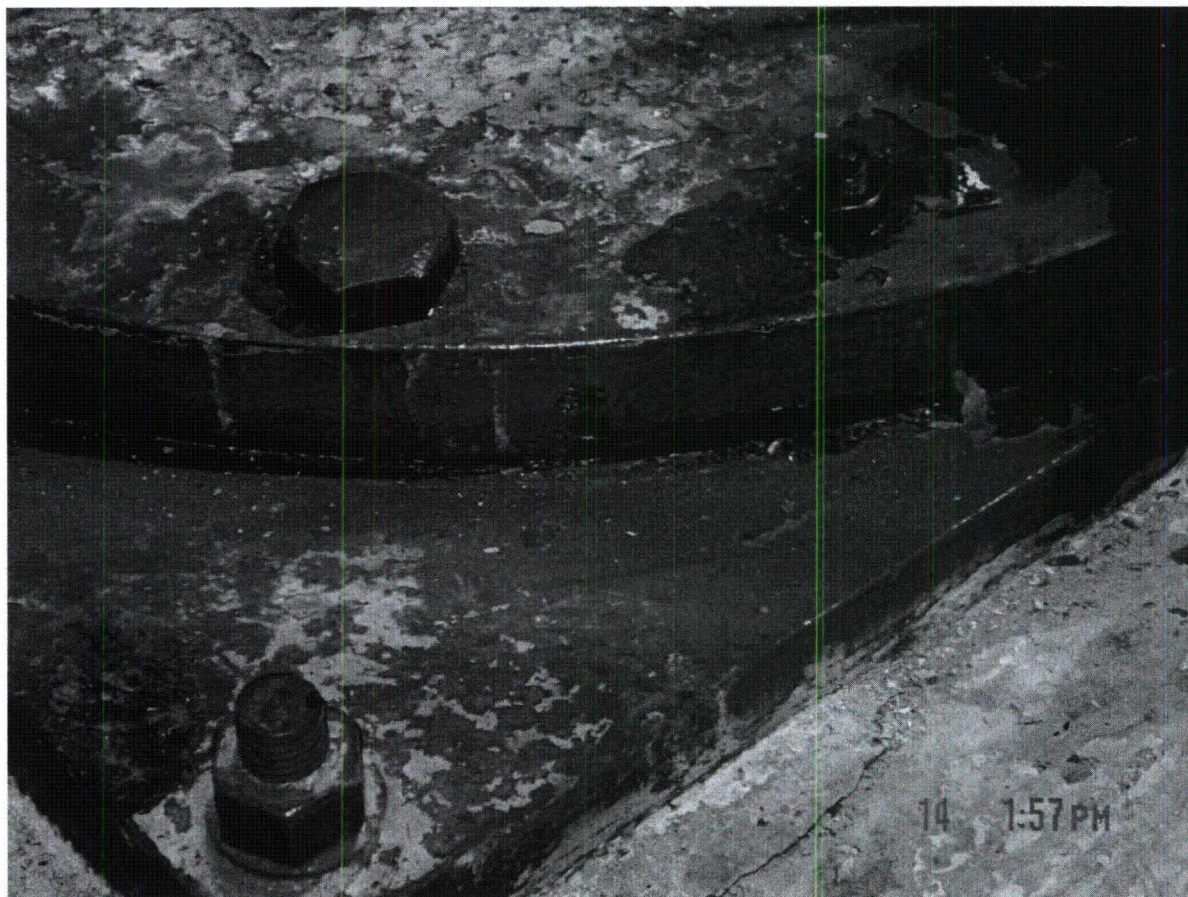
(DSC 01355)

3. Is the anchorage free of corrosion that is more than mild surface oxidation?  Y  N  U  N/A  
*Bolts are painted (see photo DSC 01355).*

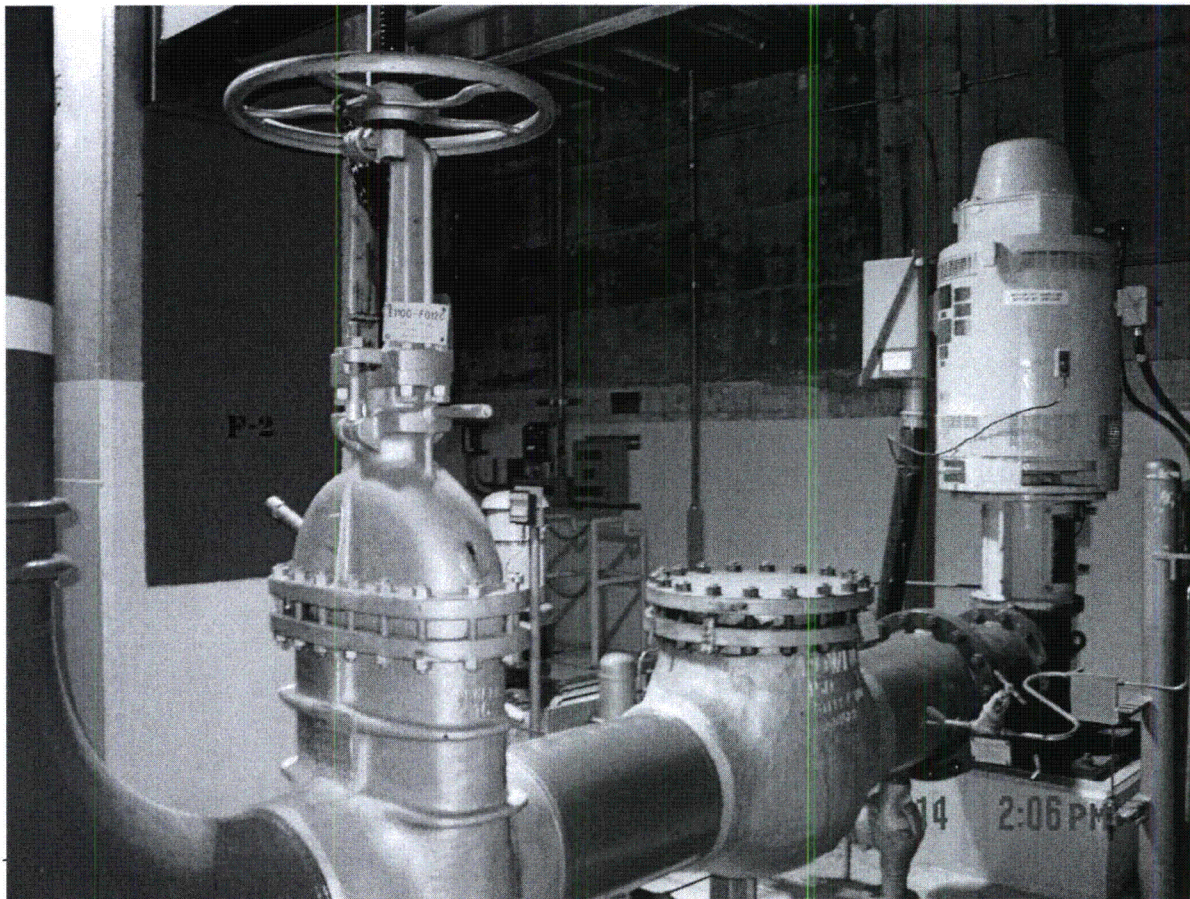
(DSC 01357)

7. Are soft targets free from impact by nearby equipment or structures?  Y  N  U  N/A  
*No nearby equipment, cable trays or piping to impact the pump. (See photo DSC 01357).*
8. Are overhead equipment, distribution systems, ceiling tiles and lighting, and masonry block walls not likely to collapse onto the equipment?  Y  N  U  N/A  
*No equipment, ceiling tiles, lighting, and masonry block walls. Conduits/cables are adequately supported.*
9. Do attached lines have adequate flexibility to avoid damage?  Y  N  U  N/A  
*Lines have adequate flexibility. (See photo DSC 01351).*
10. Based on the above seismic interaction evaluations, is equipment free of potentially adverse seismic interaction effects?  Y  N  U

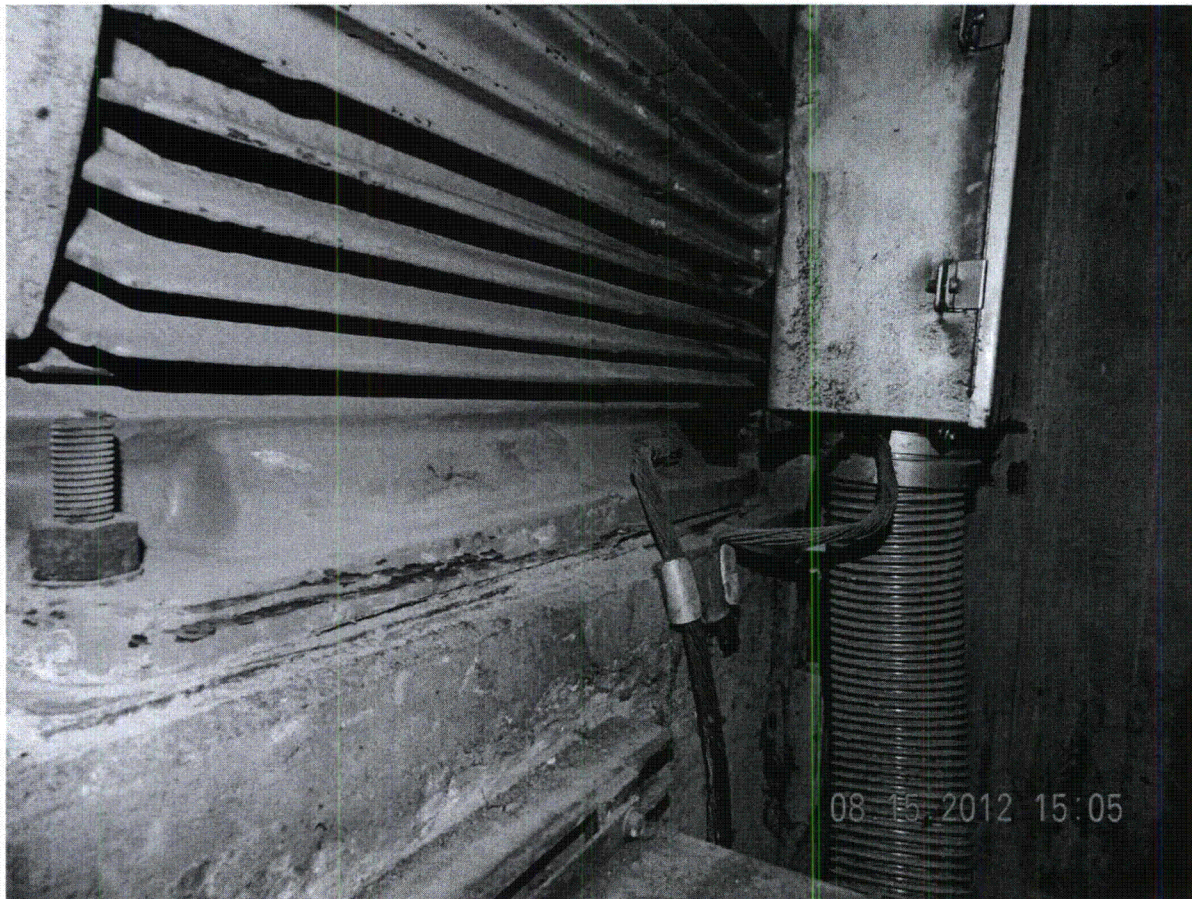
(DSCN 0414)

2. Is the anchorage free of bent, broken, missing or loose hardware?  Y  N  U  N/A   
*Anchors in good condition. See photos DSCN 0414 & 0420.*

3. Is the anchorage free of corrosion that is more than mild surface oxidation?  Y  N  U  N/A   
*No corrosion or mild surface oxidation. See photos DSCN 0414 & 0420.*

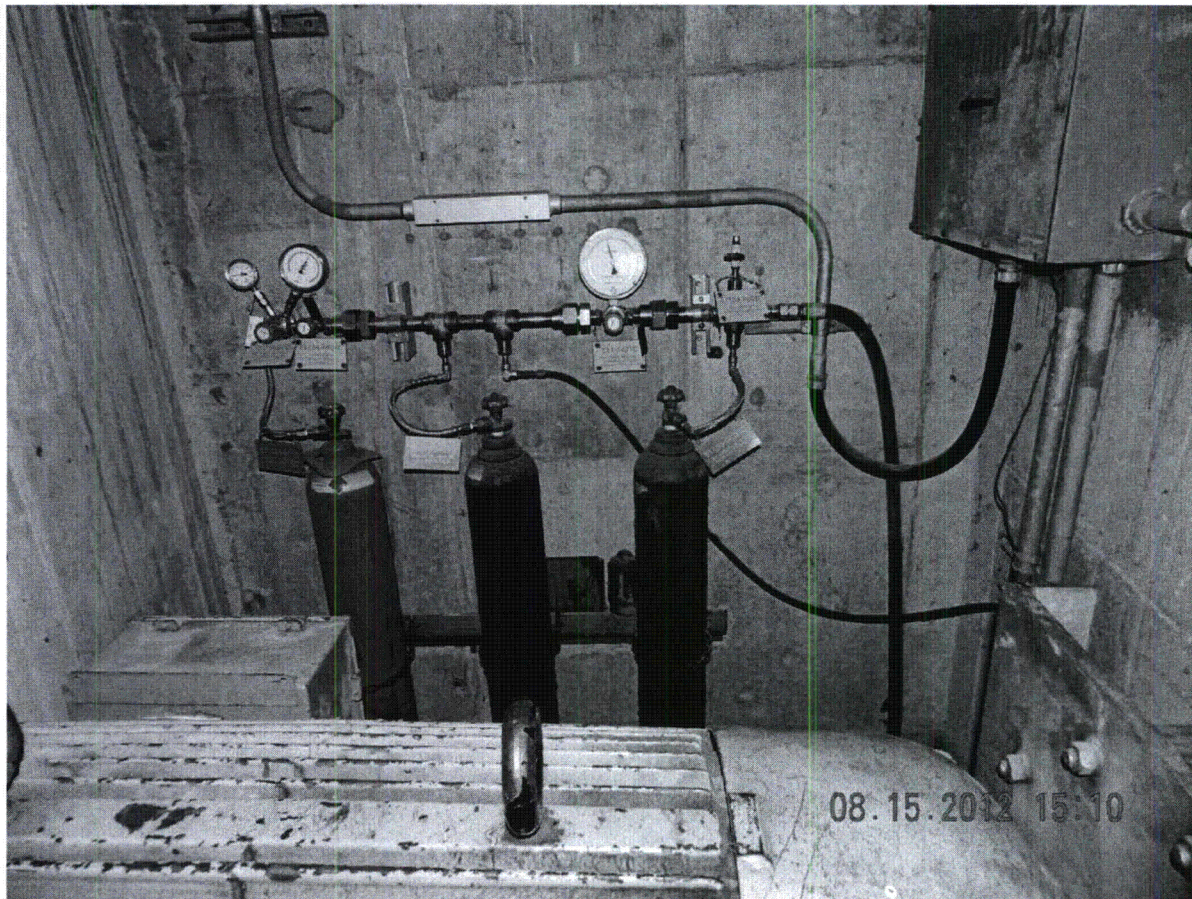
(DSCN 0418)

7. Are soft targets free from impact by nearby equipment or structures?  Y  N  U  N/A  
*Existing cylinders nearby are securely fastened. Junction boxes are also adequately supported. No potential impact on the fan (see photo DSCN 0418).*
8. Are overhead equipment, distribution systems, ceiling tiles and lighting, and masonry block walls not likely to collapse onto the equipment?  Y  N  U  N/A  
*Area has no observed equipment, ceiling tiles or lighting.*
9. Do attached lines have adequate flexibility to avoid damage?  Y  N  U  N/A  
*Attached lines have flex conduit or loops. Attached lines attached to cylinders.*
10. Based on the above seismic interaction evaluations, is equipment free of potentially adverse seismic interaction effects?  Y  N  U
-

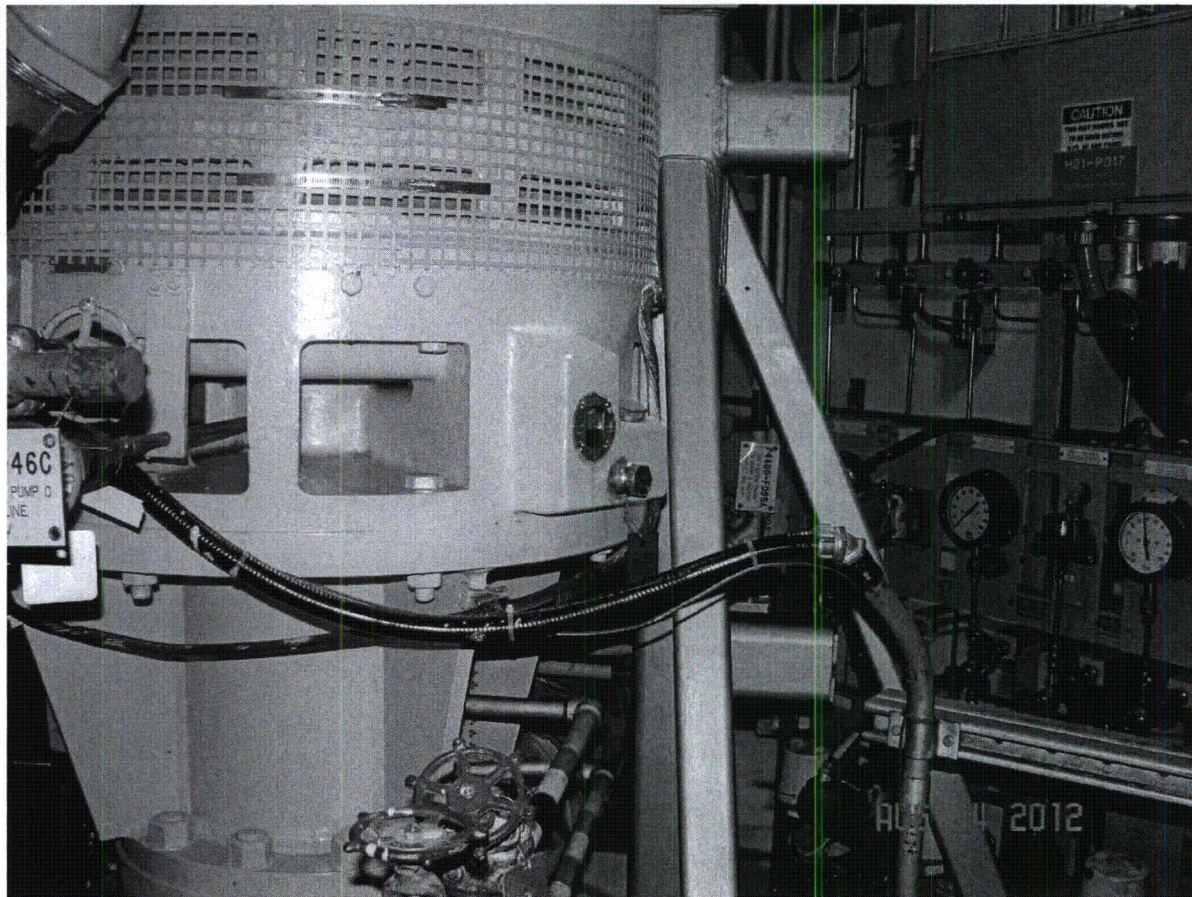
(Picture 18)

9. Do attached lines have adequate flexibility to avoid damage?  Y  N  U  N/A   
*Attached lines are made of a flexible material or are looped to provide adequate flexibility. (See Picture 18.)*

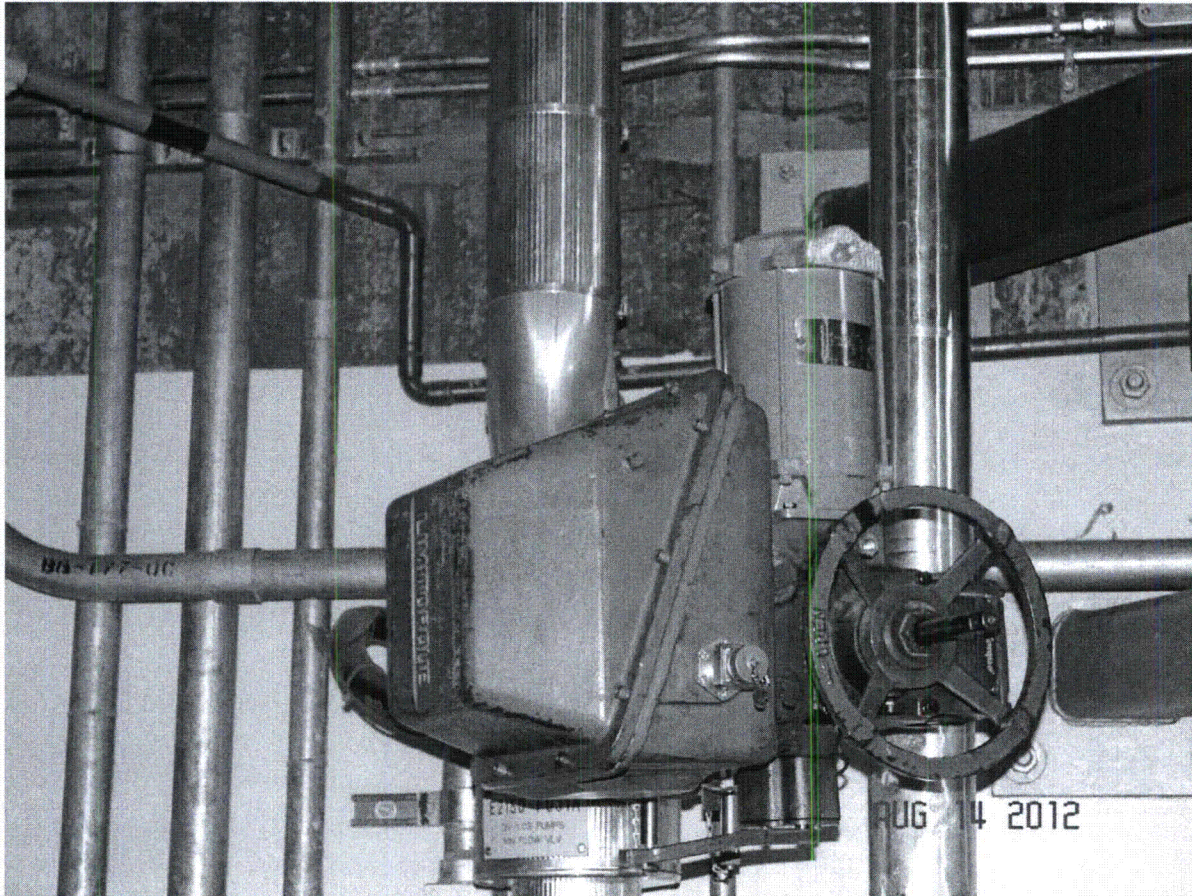
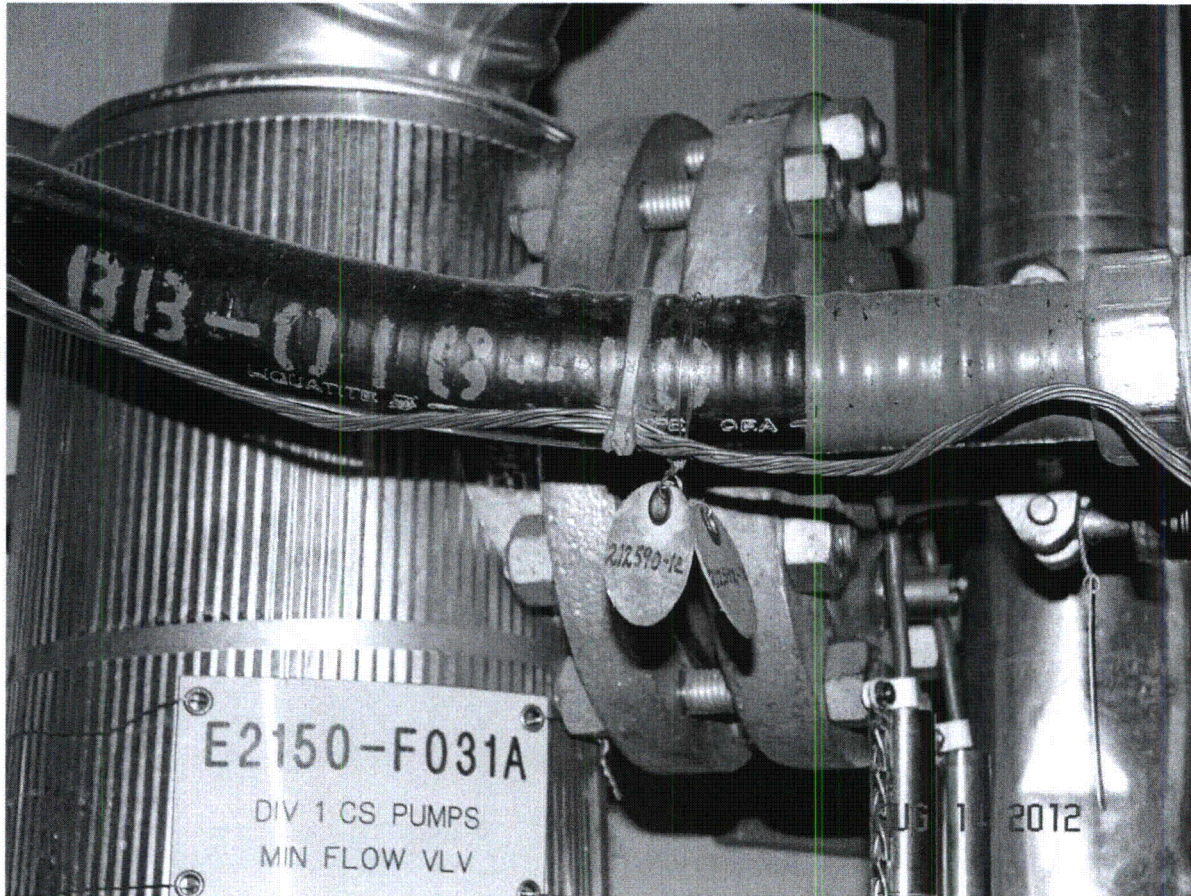
2. Is the anchorage free of bent, broken, missing or loose hardware? Y  N  U  N/A   
*Asset is attached to piping system via a flange with 10 - ( 1/2" or 5/8" ) diameter bolts on an 8" diameter bolt circle. (See pictures 1 and 2.)*
