**Area Walk-By Checklist (AWC)**

Fermi 2 Seismic Walkdown Guideline  
Area Walk-By-Checklist

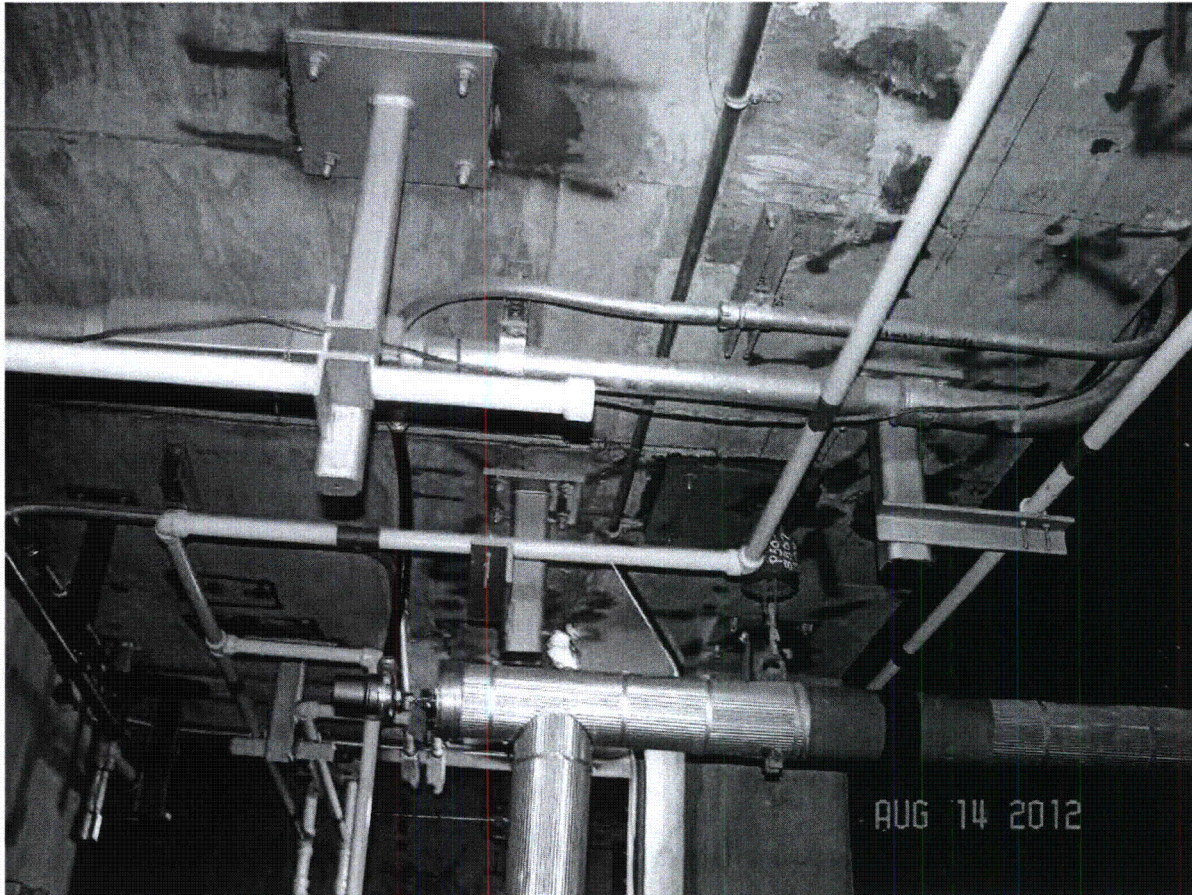
(Picture #6)

*Cable trays and conduit are too far away. Asset is protected from above by a concrete ceiling. (See Picture 6).*

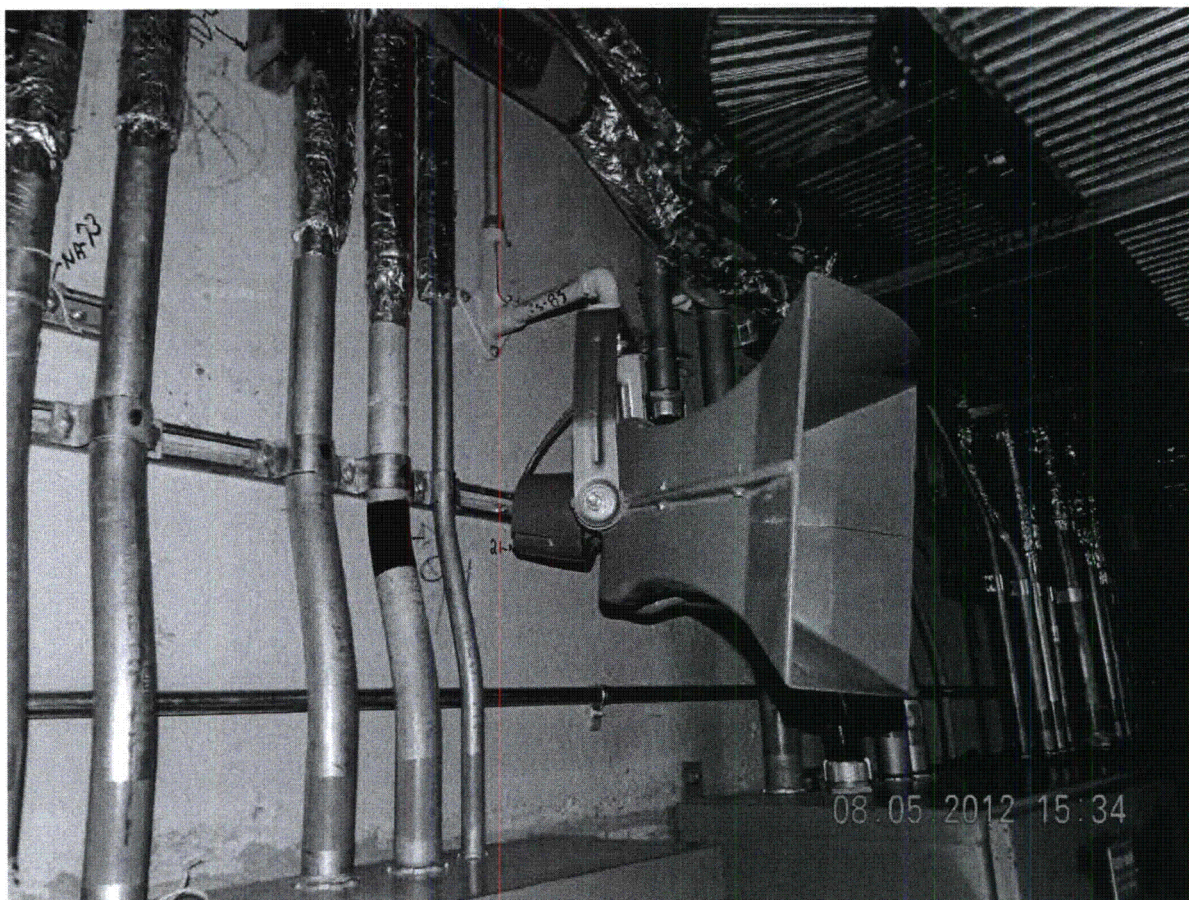
(DSCN0071)

*Lights on chains & cables. Fire wrap around cables loose in places, but not a seismic concern. Foil outer casing is light weight and would not fall or cause damage in a seismic event. HVAC mounted on seismic supports. Gatronics mounted on rigid conduit over Div. II breaker panel - See CARD 12-26630. (SEE PICTURES DSCN0071, DSCN0072) ~ DSK 10/10/12*

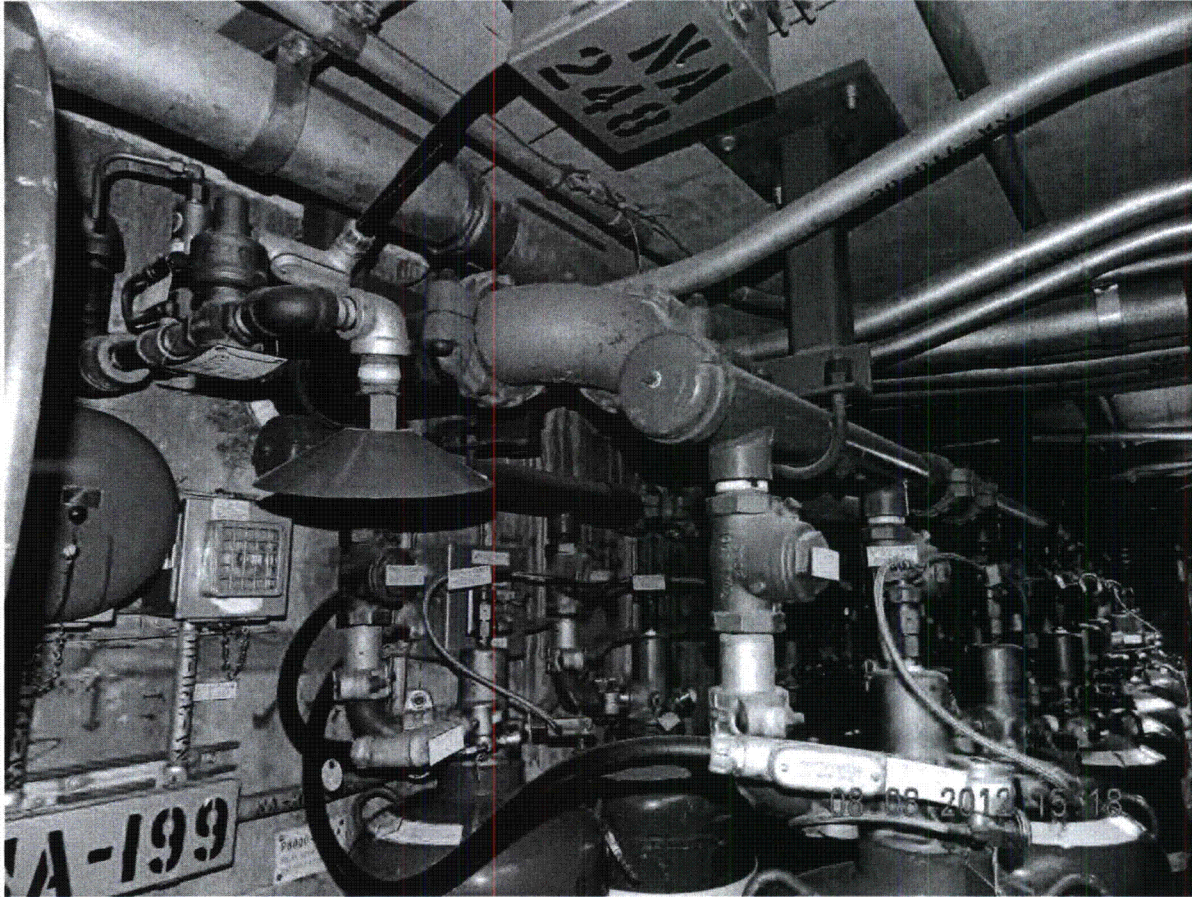
(DSCN0203)

"Halon Piping above, Ref. Dwg. M-5327"

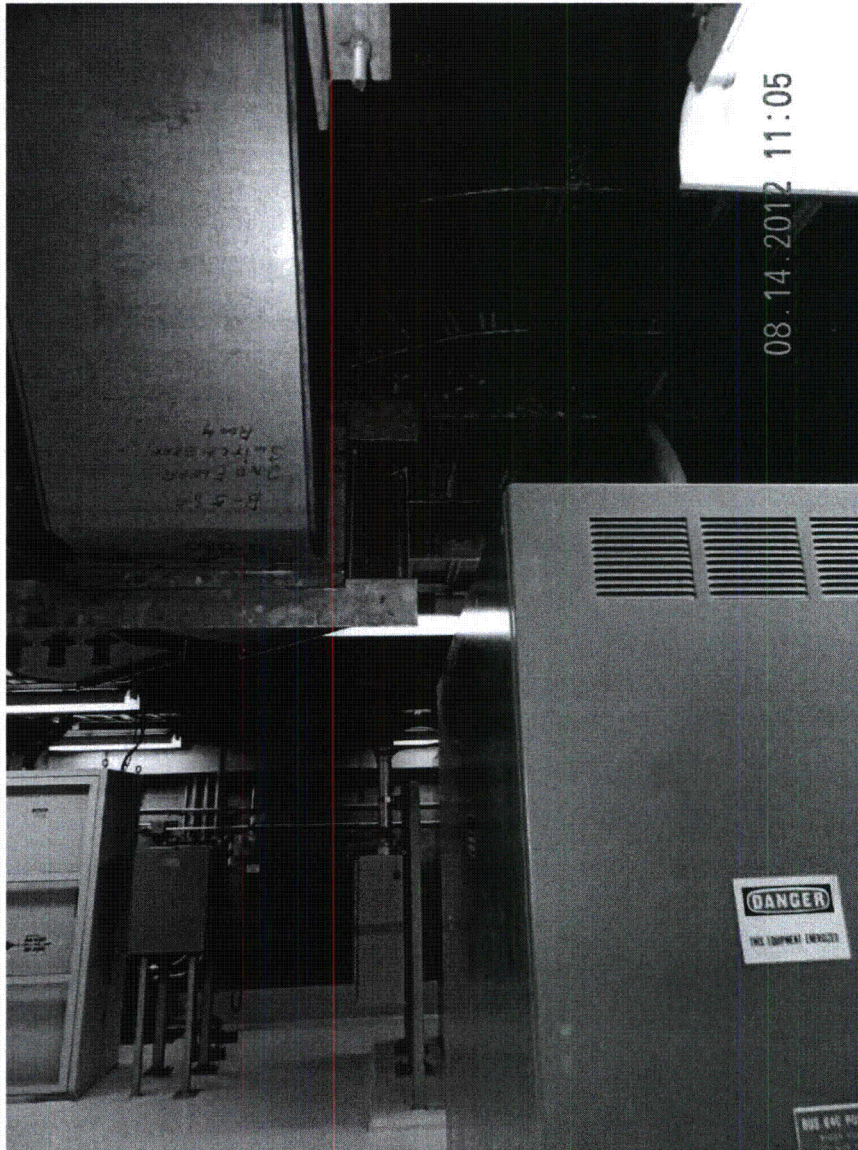
(Photo DSCN 0319)

Seismic Gap between HVAC Duct and Cabinet R1400S001C

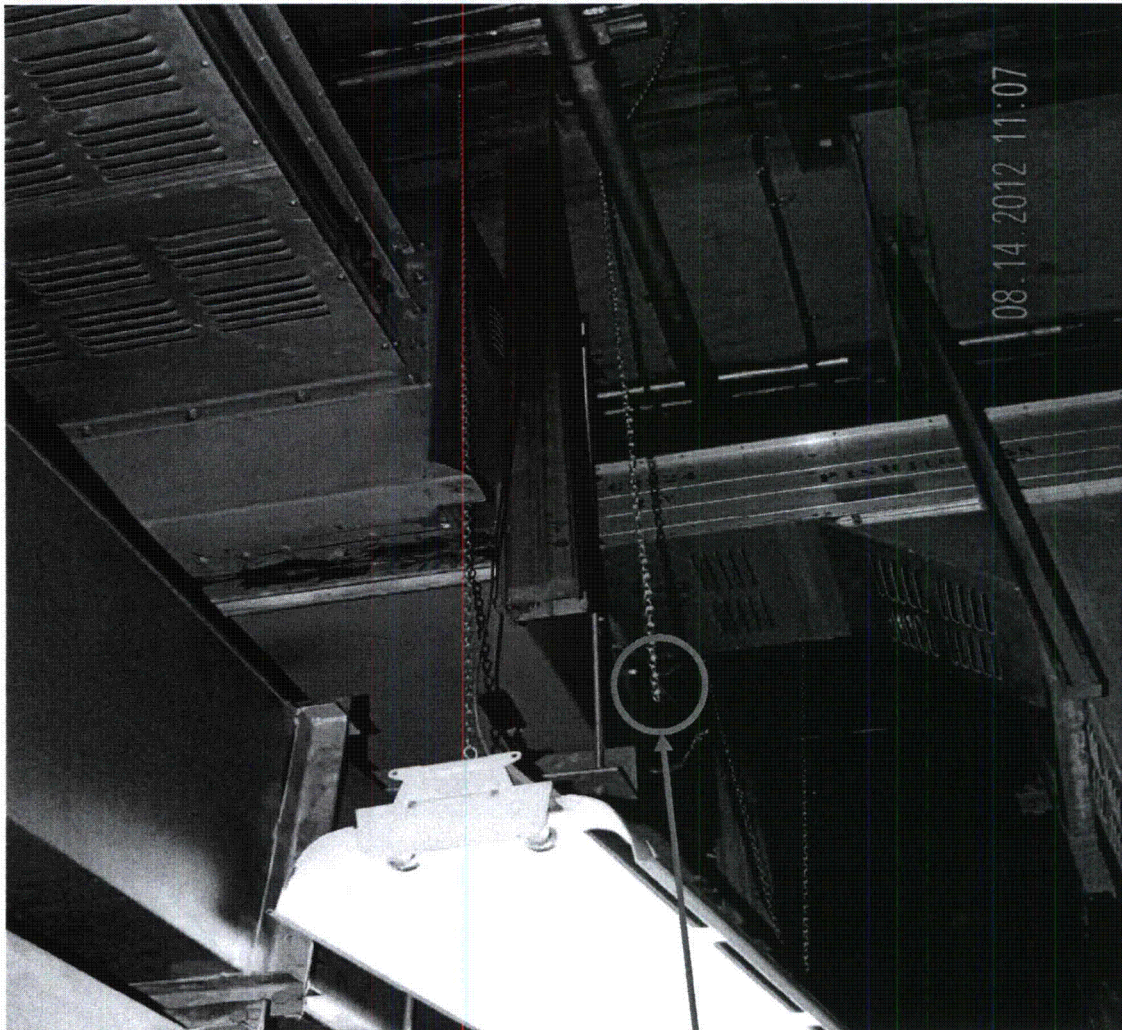
(Photo DSCN 0323)

*No ceiling tiles in the area. With one exception, lights are supported by cables and chains. Light fixture to and south of asset R1400S001C has one chain detached (see Photo DSCN 0323). Fixture is resting against stiffener on nearby HVAC duct. Cable is supporting fixture where chain is detached. CARD 12-27093 was initiated to correct condition.*

Detached Light Chain by R1400S001C

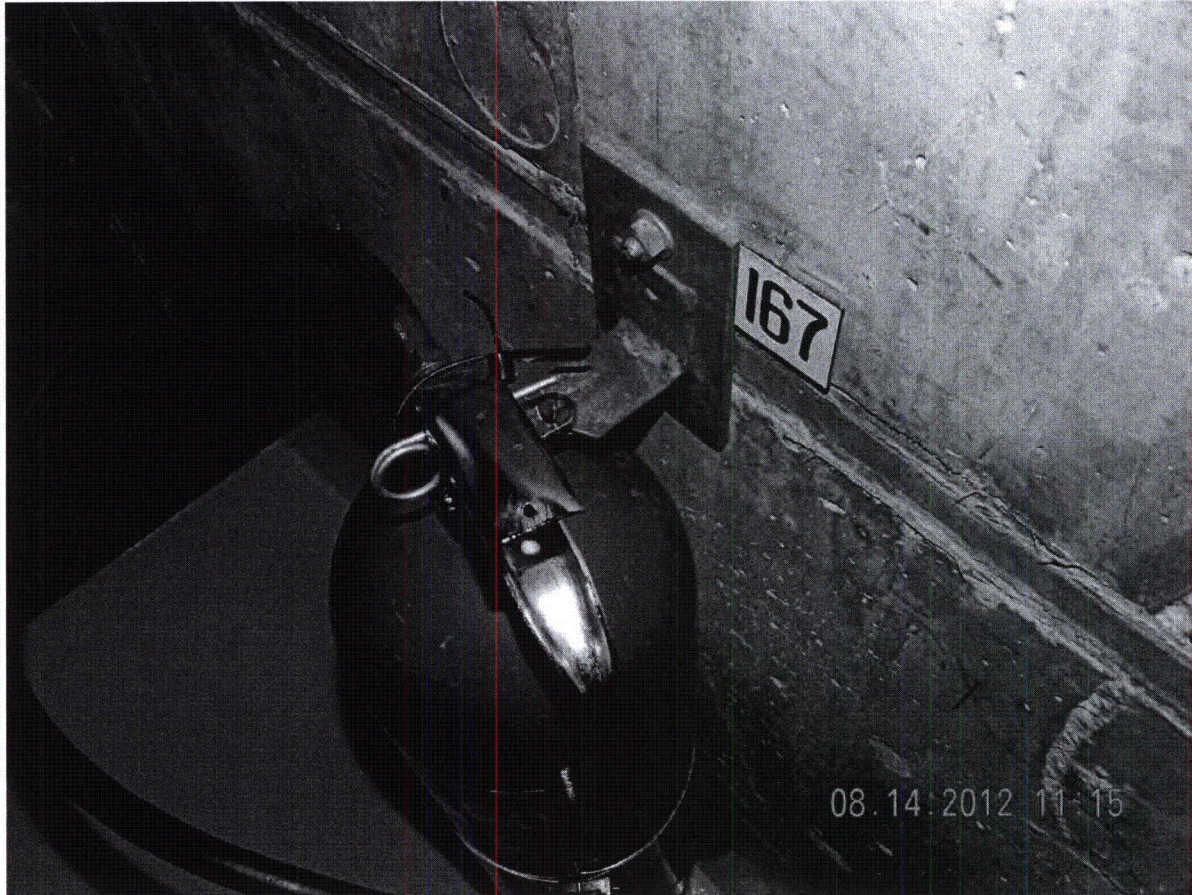
(Photo DSCN 0330)

8. Have you looked for and found no other seismic conditions that could adversely affect the safety functions of the equipment in the area? Y  N  U   
*Reviewed adequacy of brackets securing portable fire extinguishers to concrete walls and columns (see Photo DSCN 0330). Determined bracket was evaluated and found adequate in Calc. DC-3277 Vol. II, Rev. 0.*

Fire Extinguisher Mounting Bracket

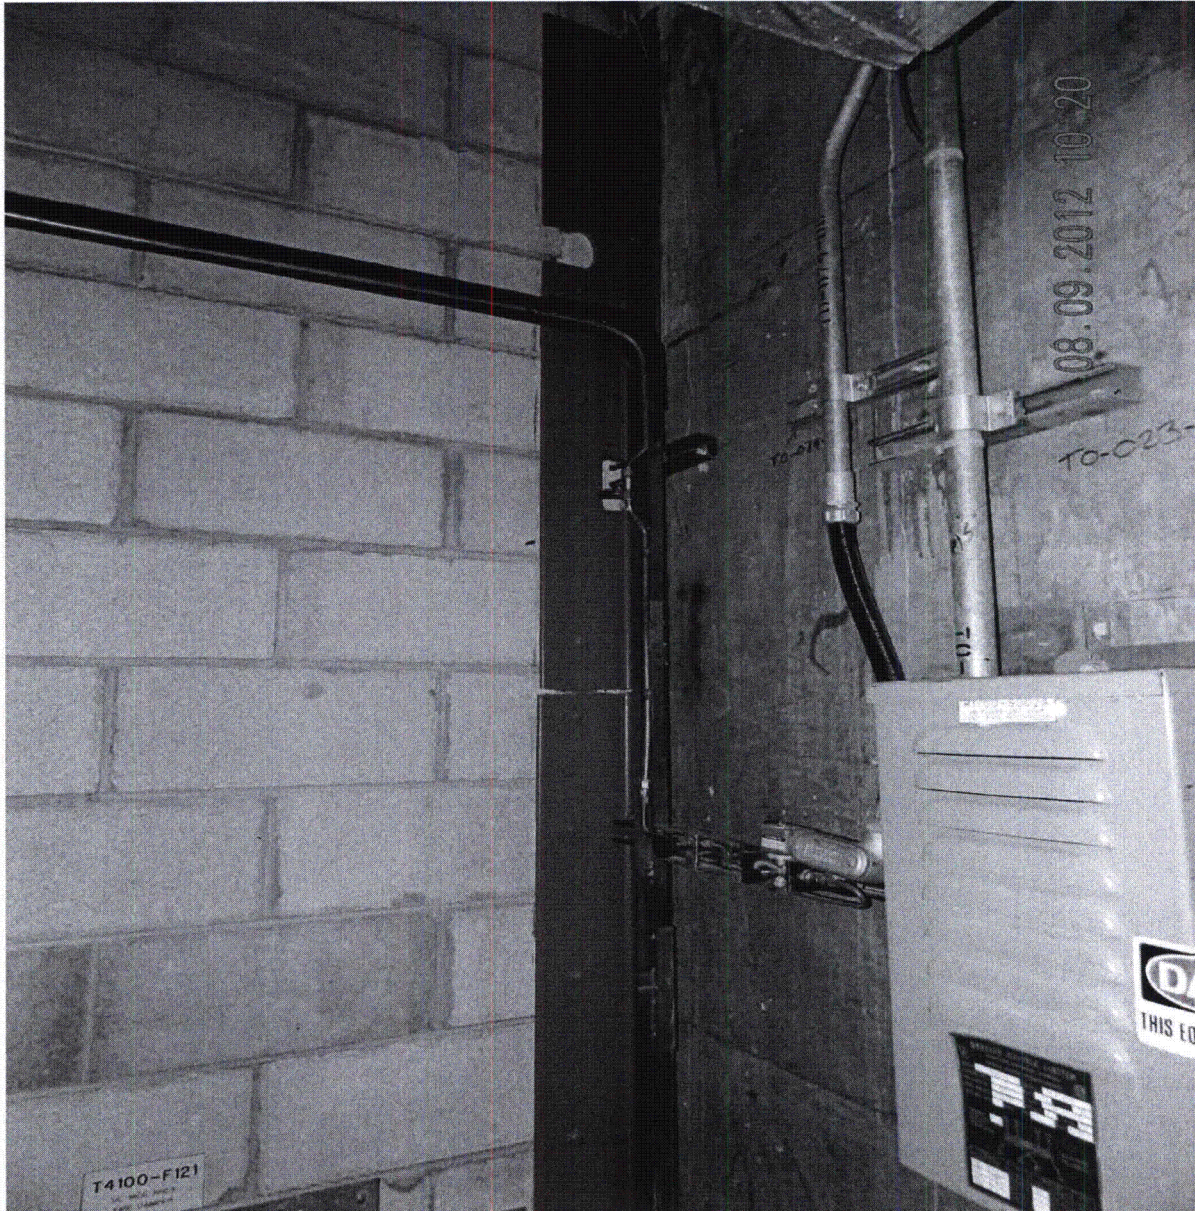
(DSCN0208)

*Adjacent fire wall anchored to the floor. Adjacent Div. I cabinet anchored to the floor. Air handling unit T4100B033 approximately 15" from R3200S016 evidence of corrosion at the base. Corrosion is minor, and condensation moisture issues are being addressed by placement of absorbent socks at condensation location.  
(See Photo DSCN0209, DSCN0208, DSCN0217 and DSCN0224)*

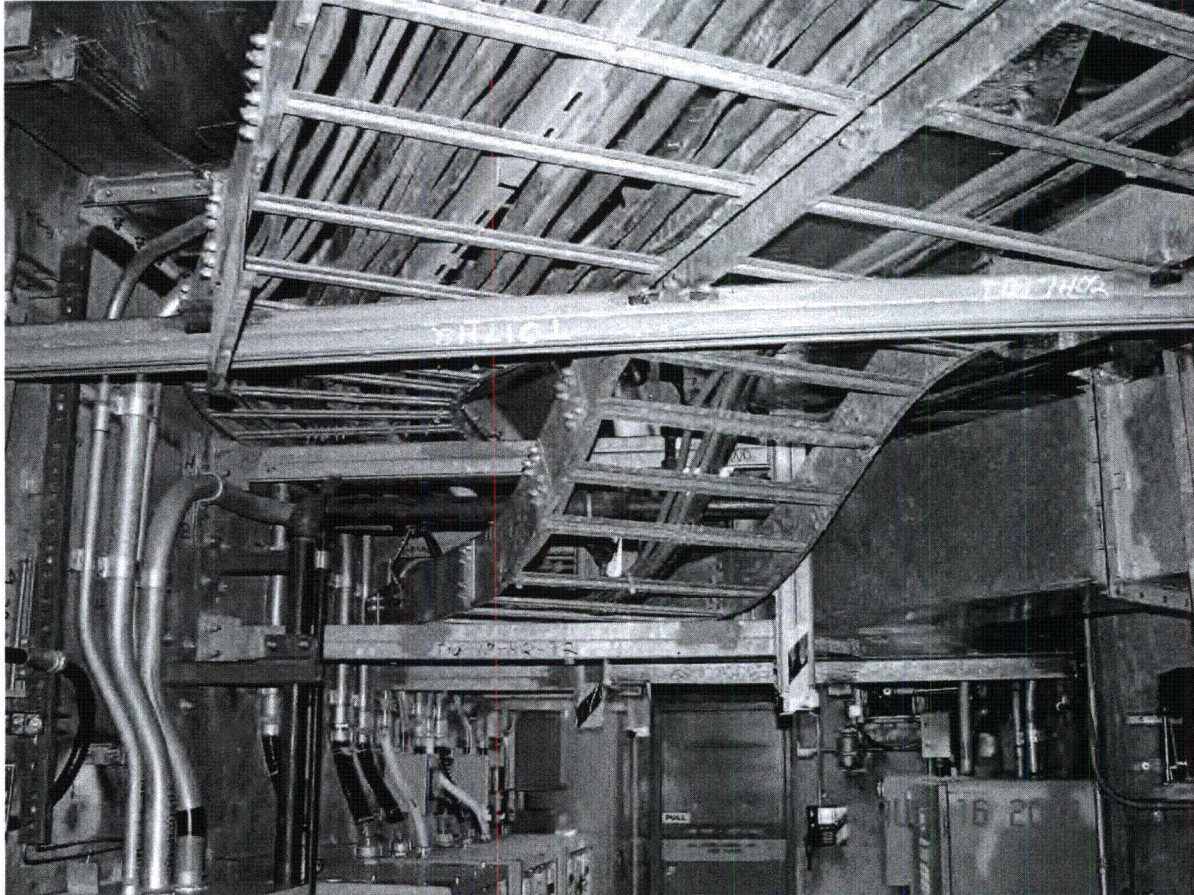
(DSC00074)

Overhead Cable Trays and HVAC Ducts

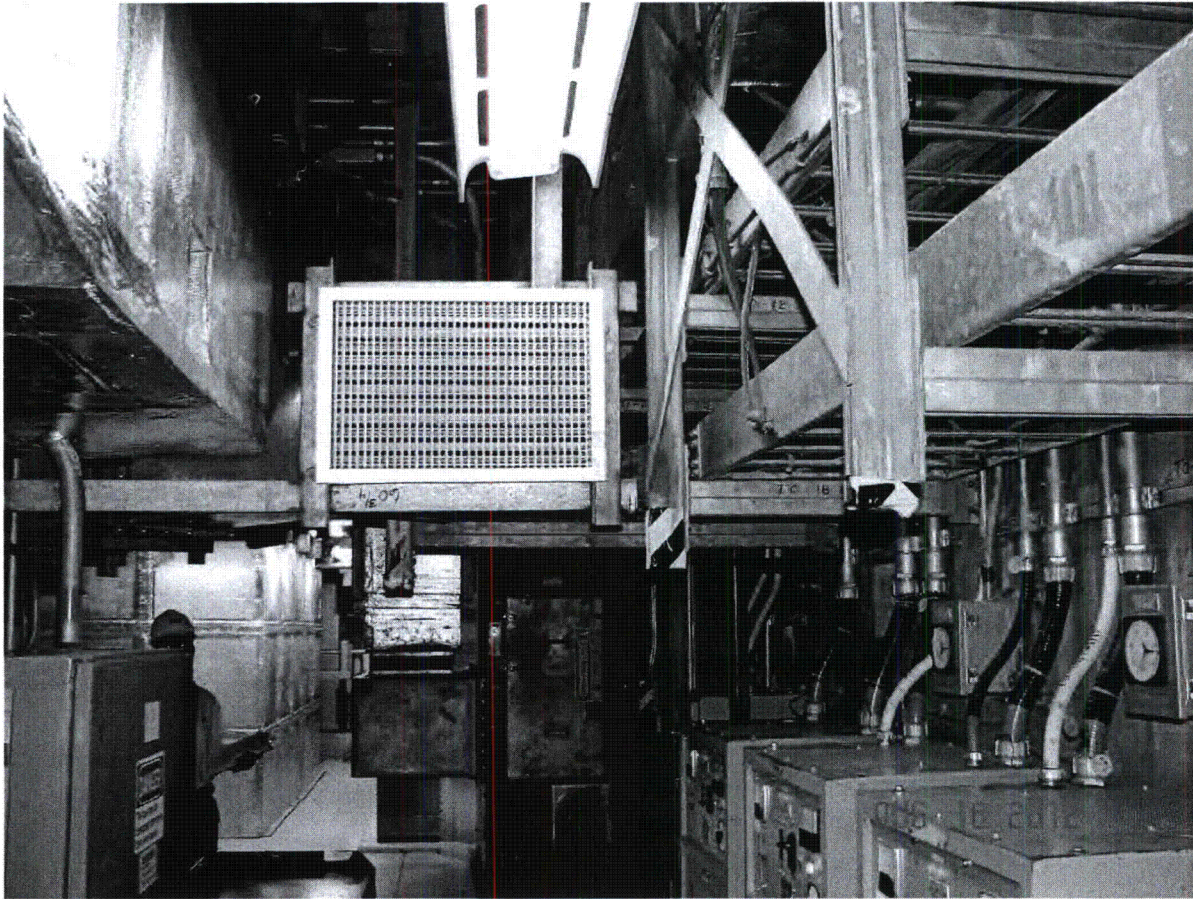
(DSC00075)

Overhead Cable Trays, HVAC Ducts and Light

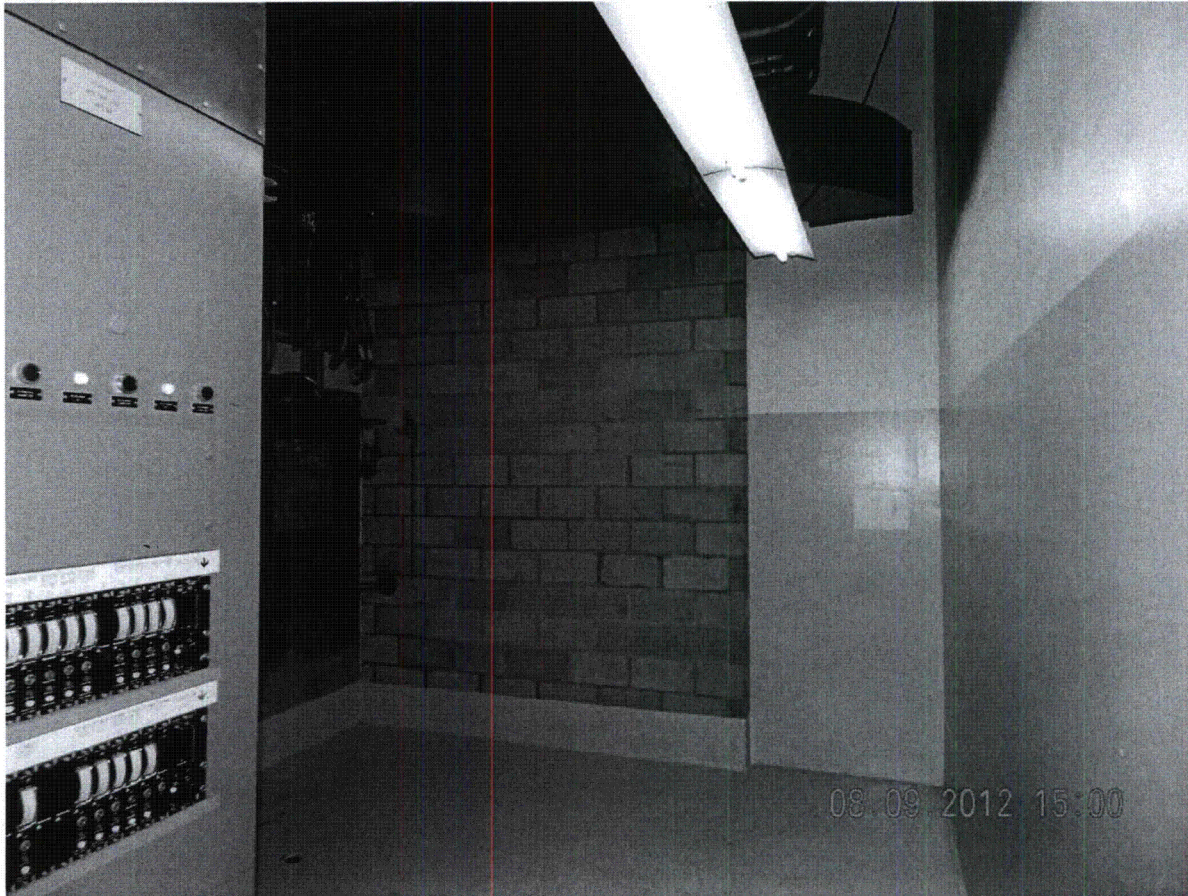
(DSCN0237)

CMU Block Walls – Seismically Reinforced

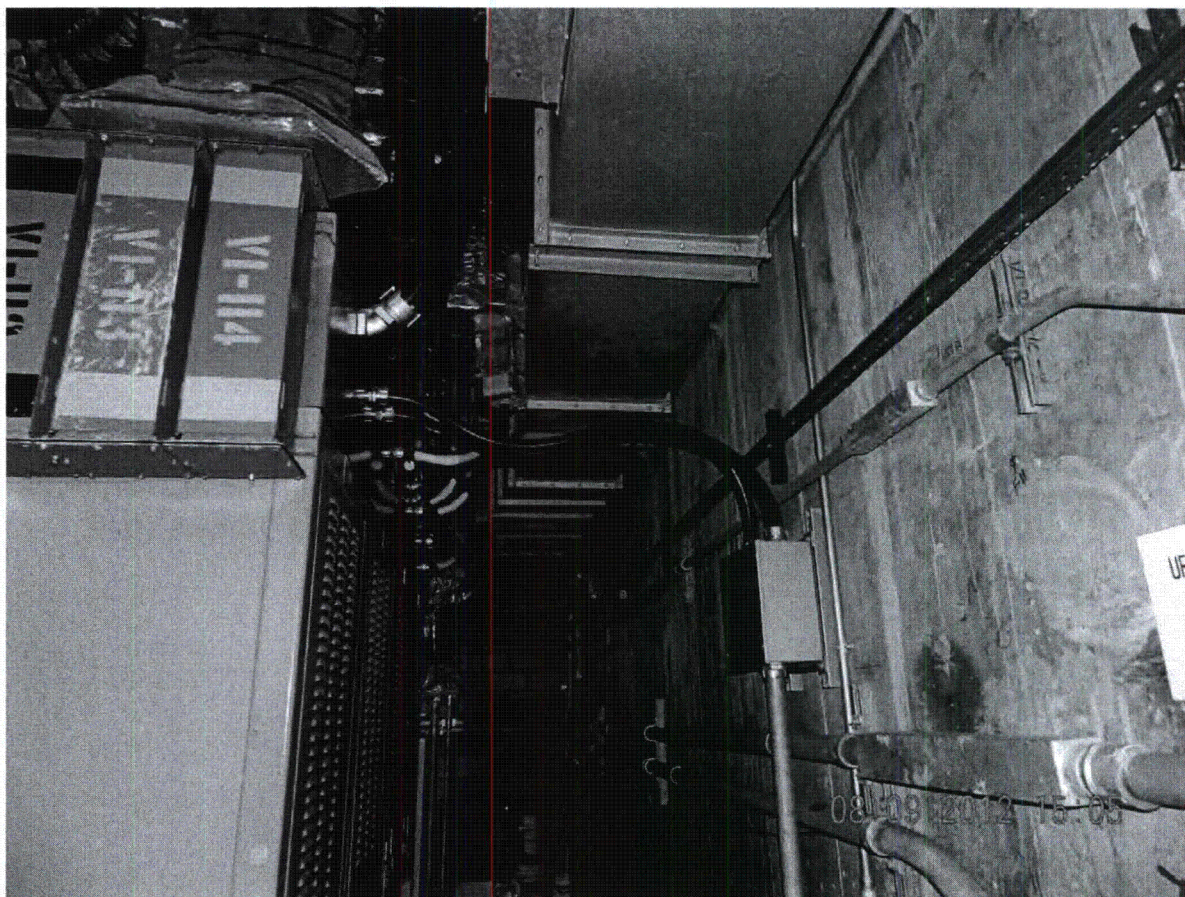
(DSCN0244)

HVAC and Raceways in the Area

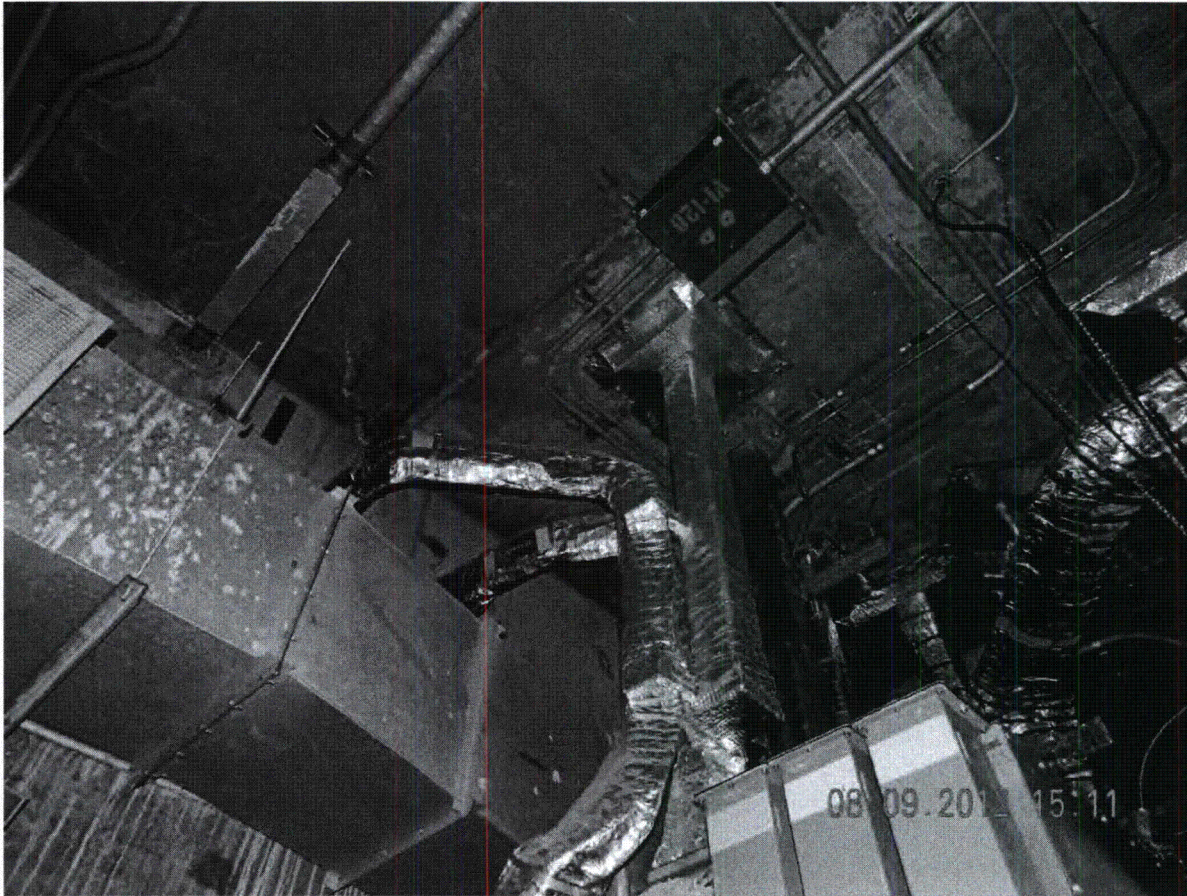
(DSCN0245)

HVAC, Raceways & Equipment Adequately Anchored to Slab or the Walls

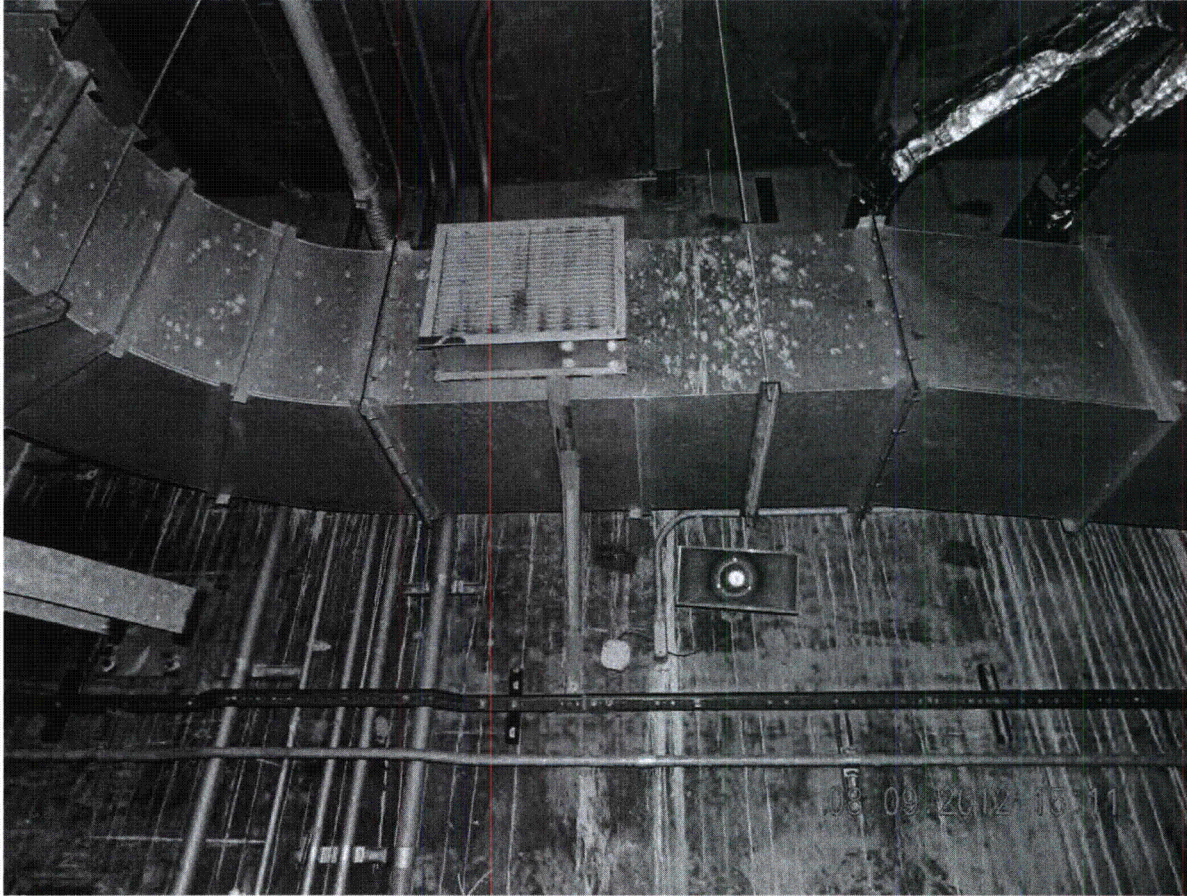
(DSCN0247)

HVAC and Raceways Adequately Supported

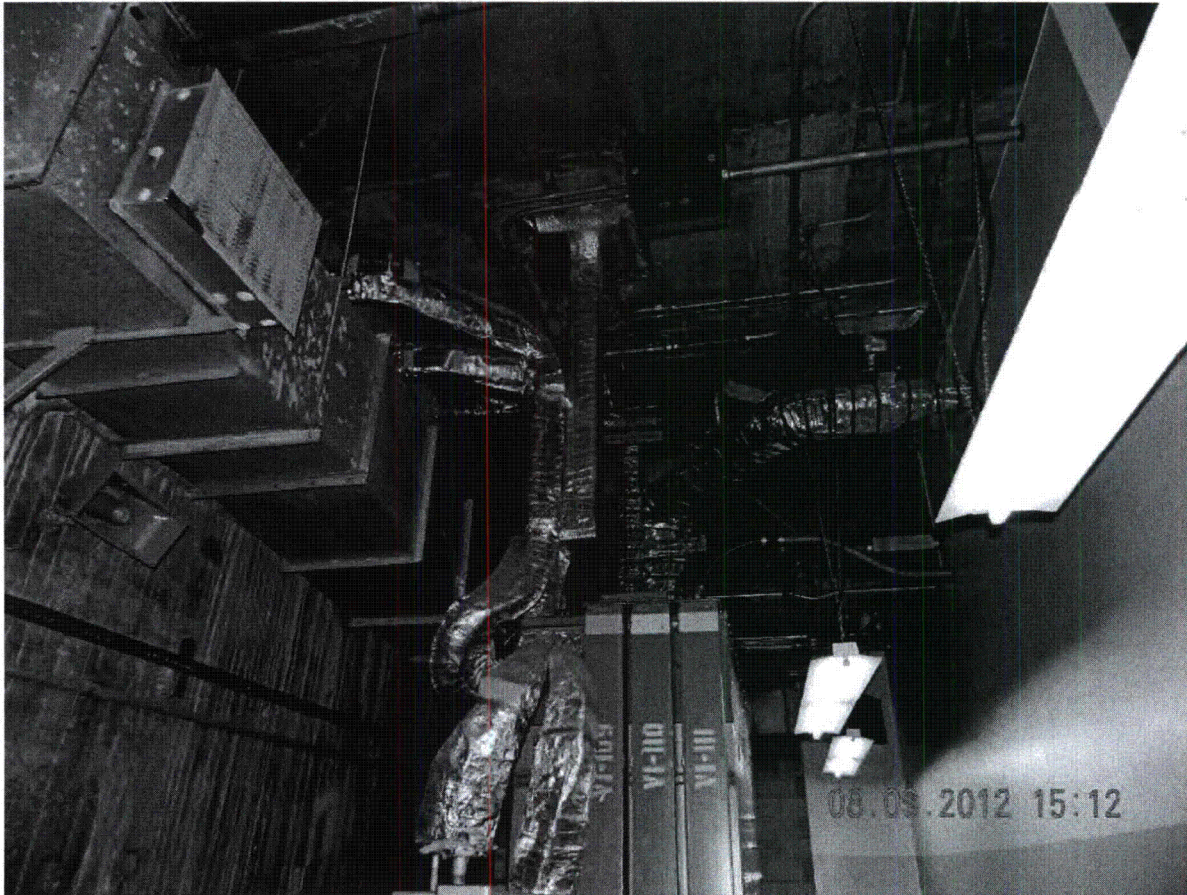
(DSCN0248)

HVAC, Raceways & Equipment Anchored Adequately to the Walls & Slab

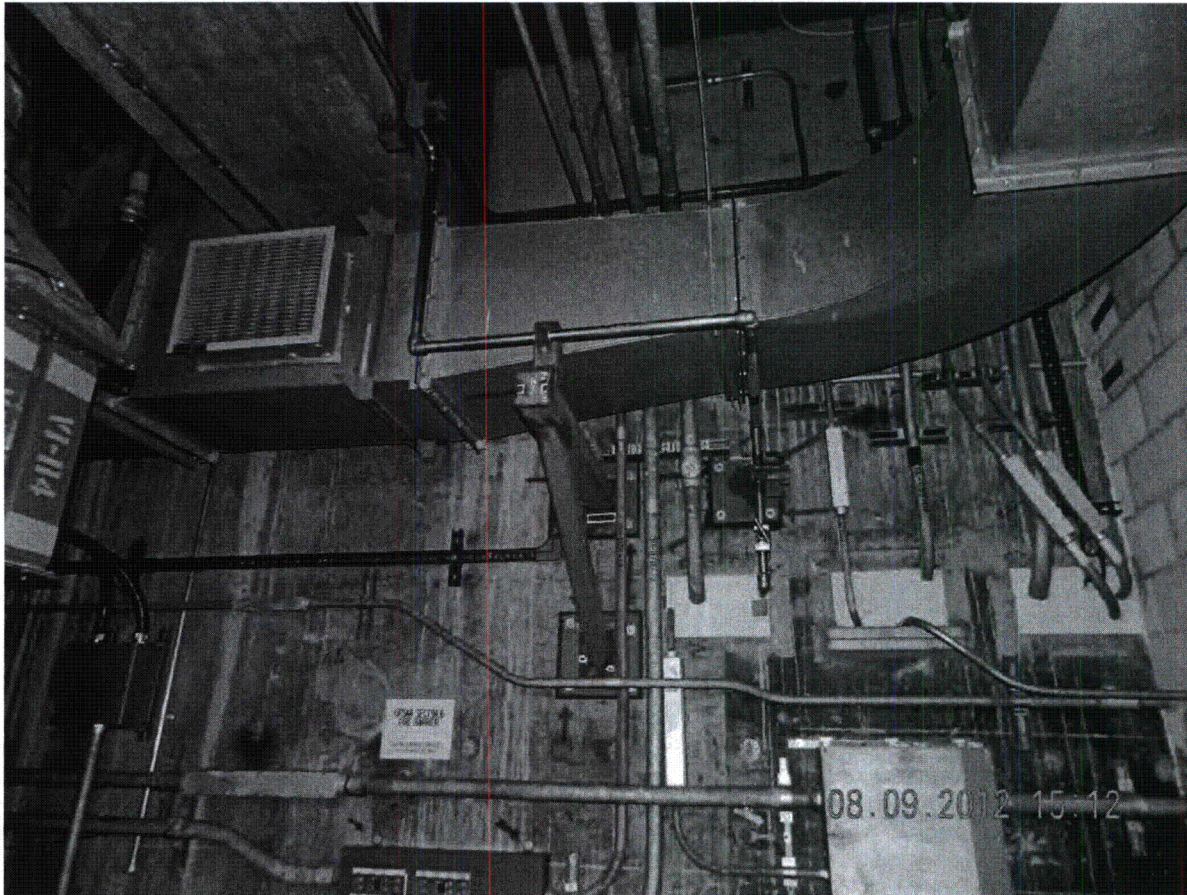
(DSCN0249)

HVAC and Raceways are Adequately Supported in the Area

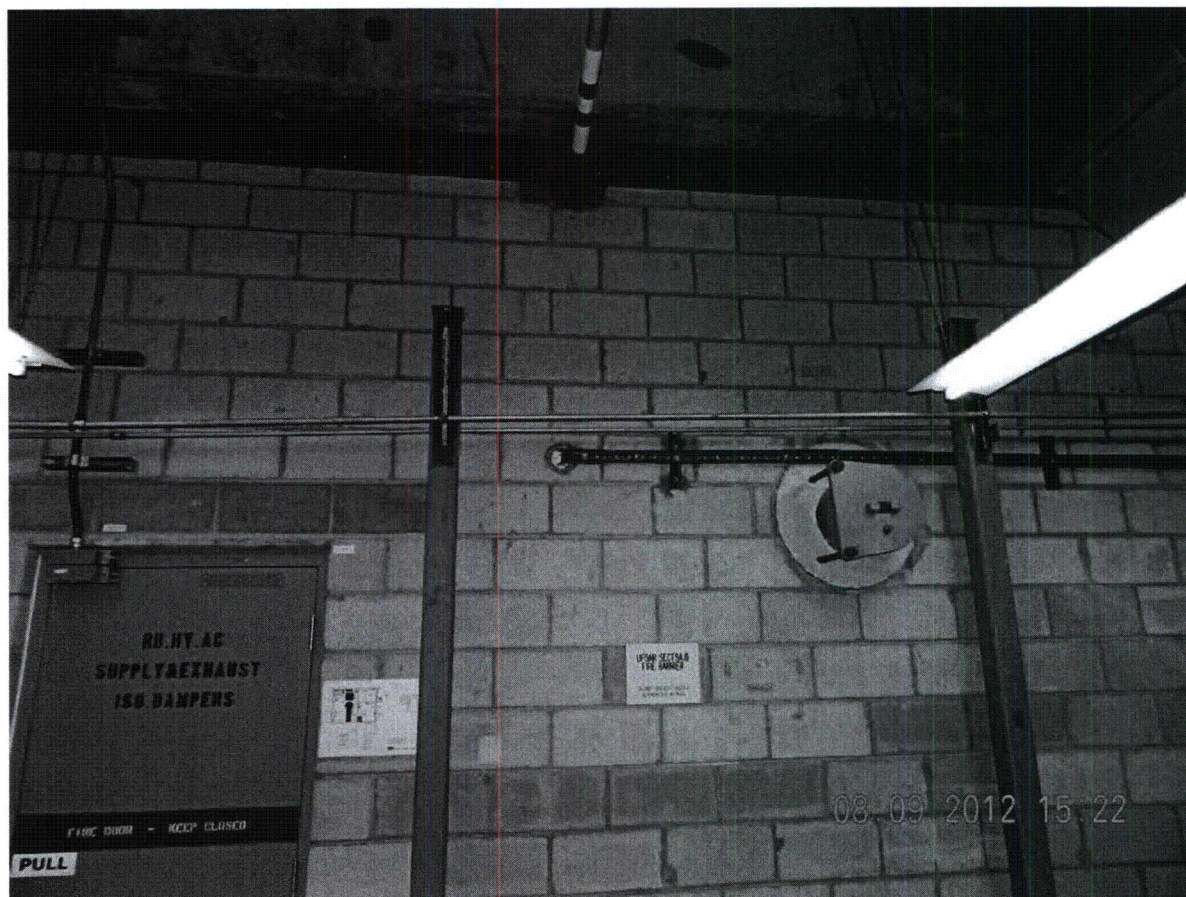
(DSCN0252)

CMU Block Walls – Reinforced Seismically

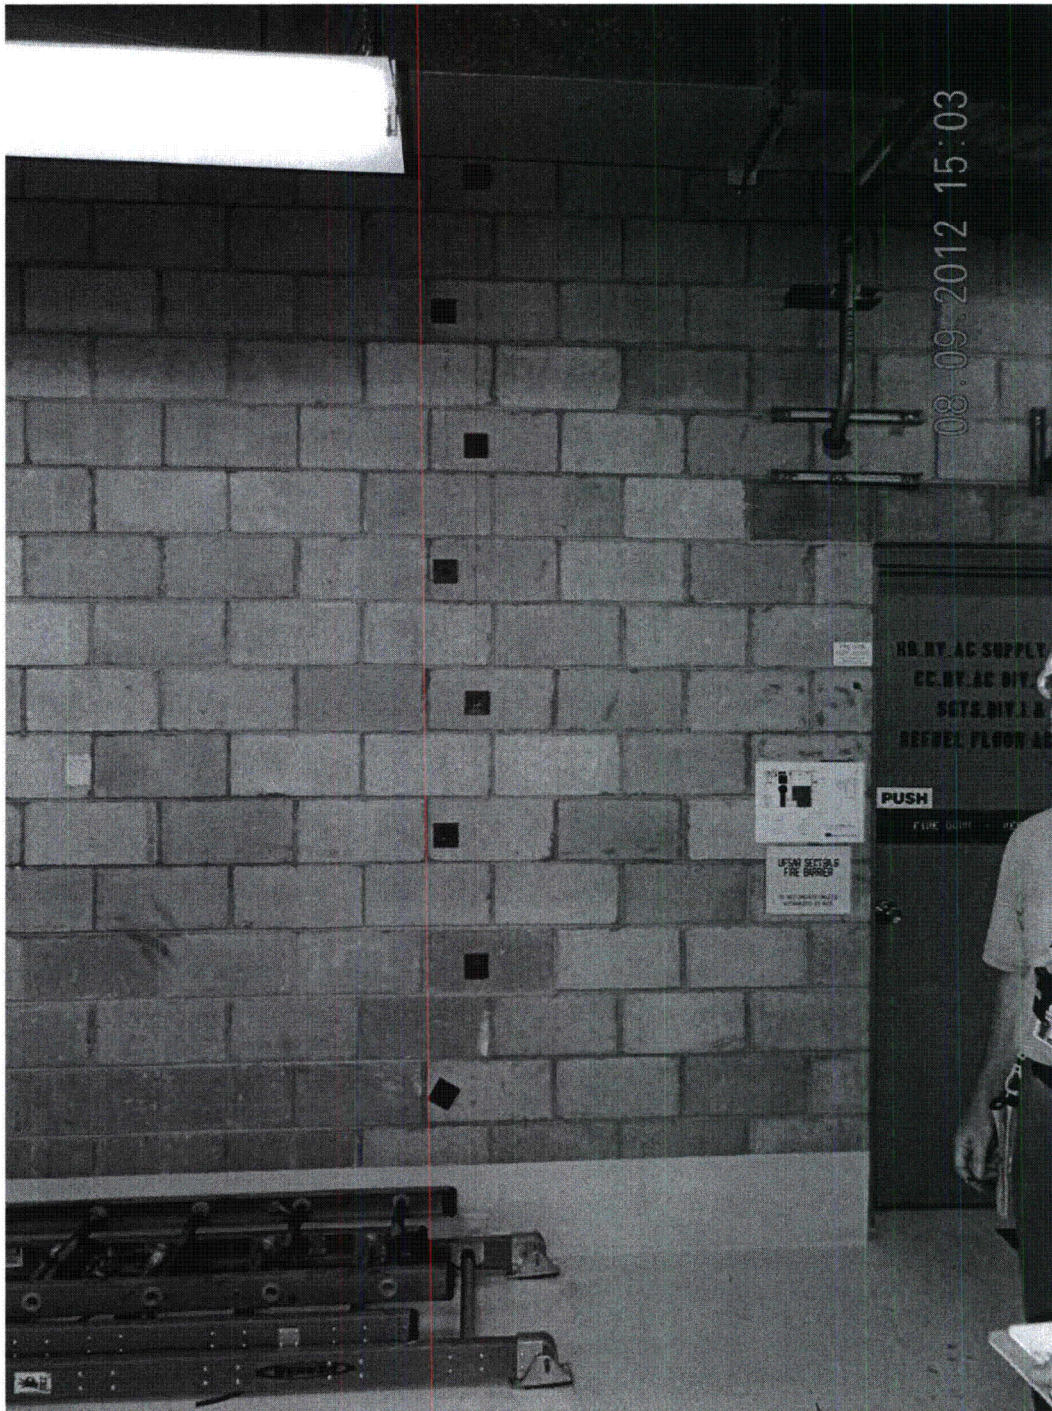
(DSCN0243)

Ladders Adequately Supported. CMU Block Walls – Reinforced Seismically

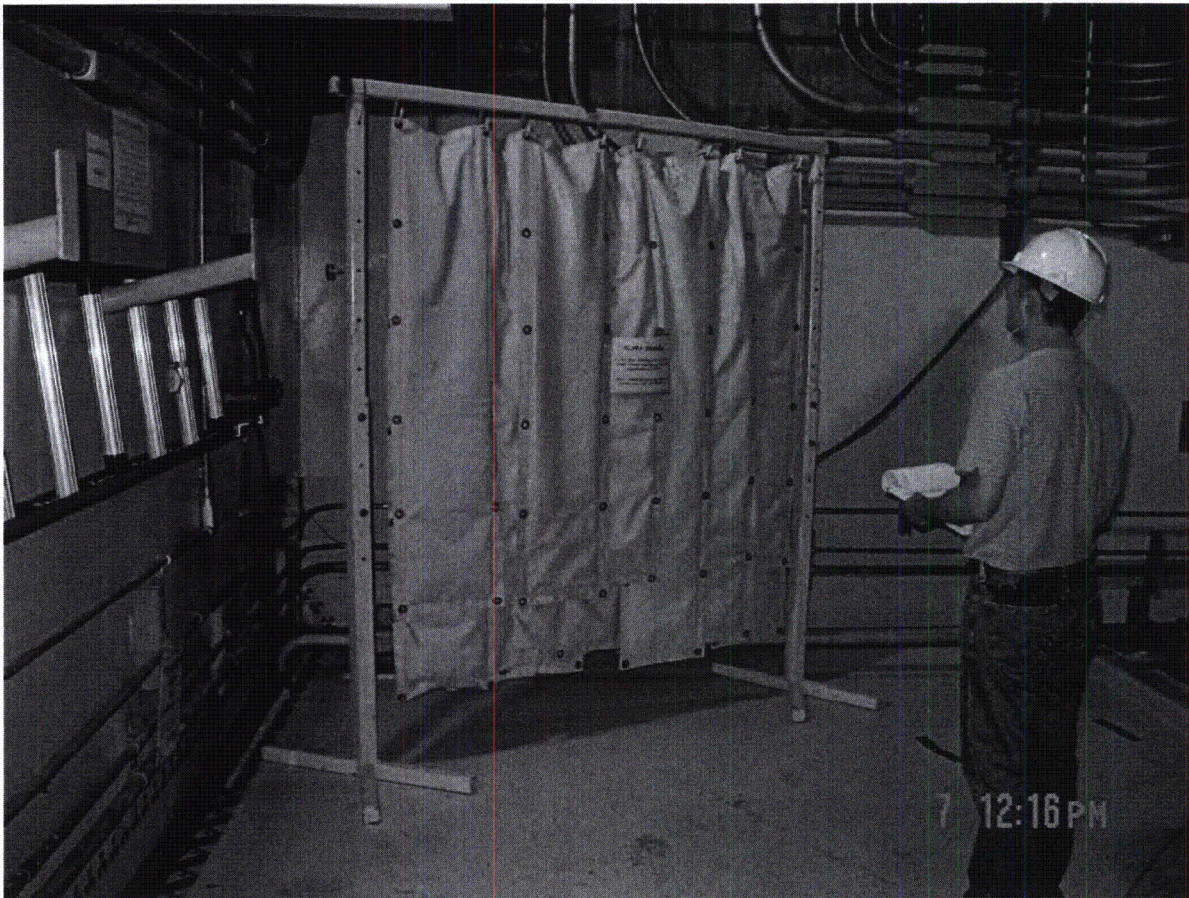
(Picture B1)

ALARA Shielding and Mounted Ladder Racks

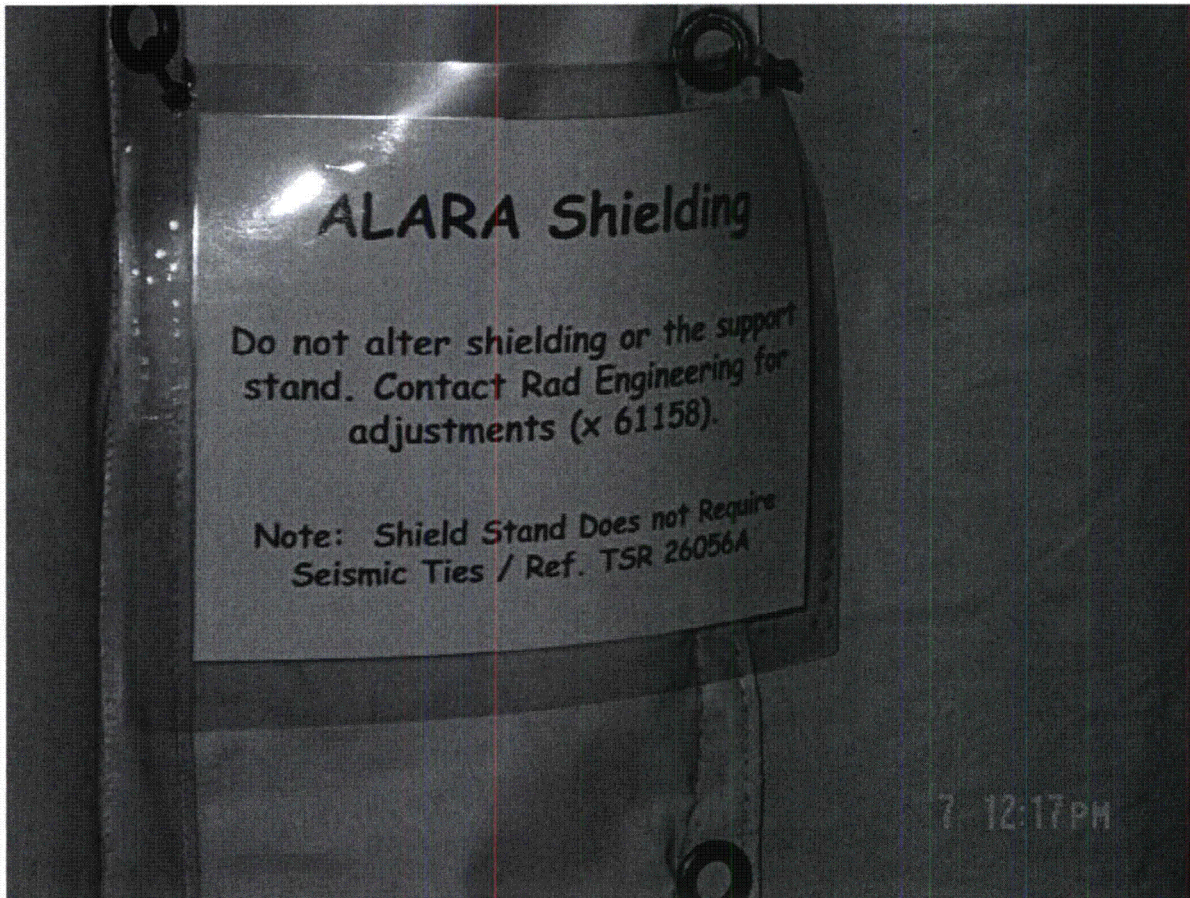
(Picture B2)

ALARA Shielding

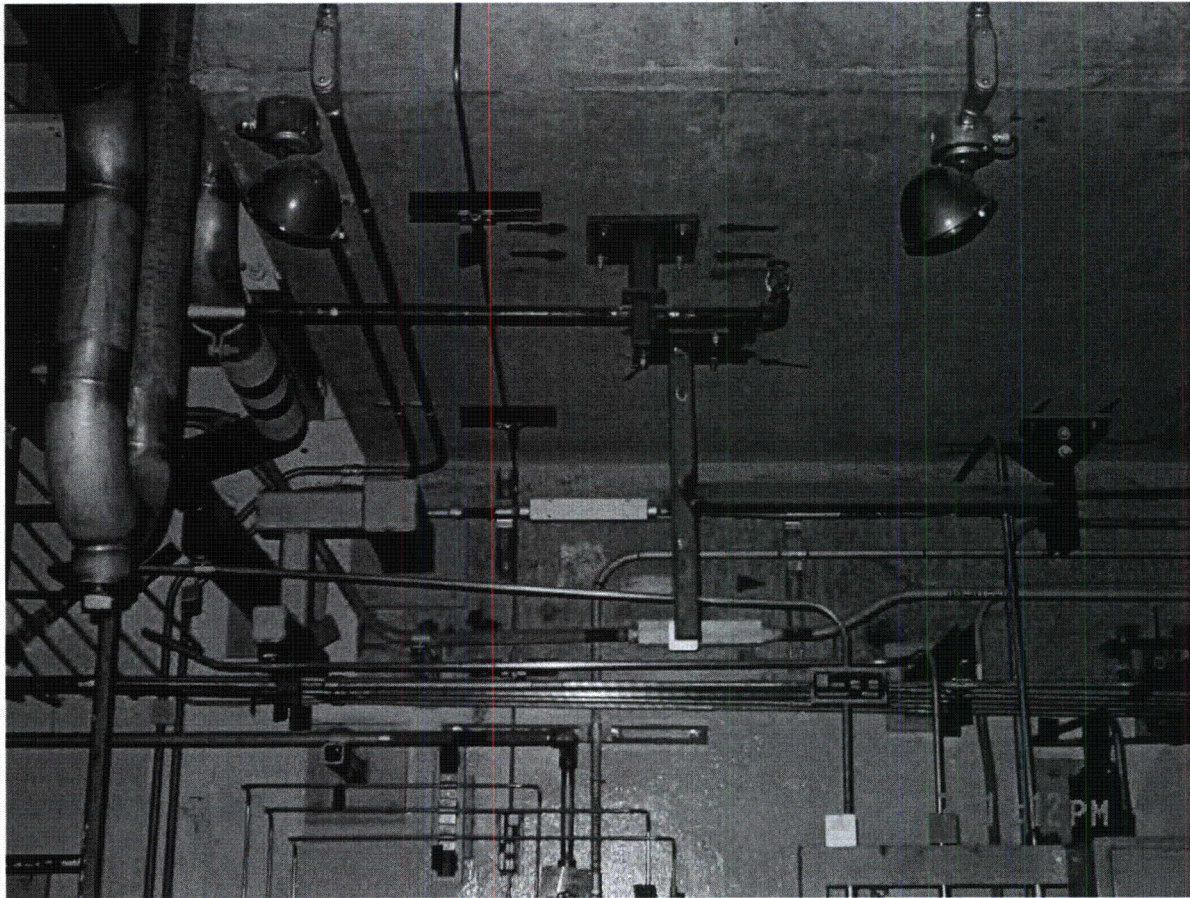
(Picture B3)

Overhead Fire Sprinkler
