Area Walk-By Checklist (AWC)

Assets: *H21P614B*

Location: Bldg. RB Floor El. 540'-0" Room, Area¹ A-02, Col. B-9

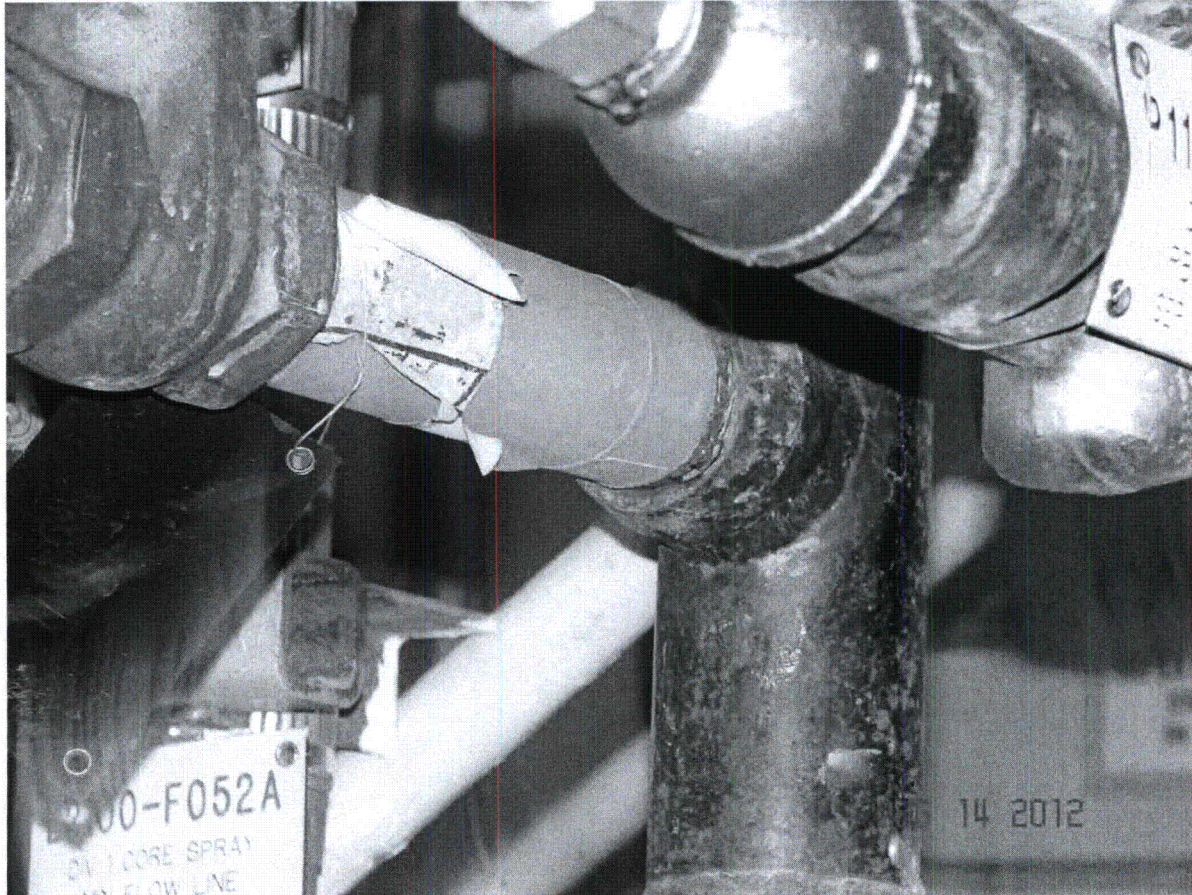
PICTURE #8

Nearby pipe valve is leaking (P1100F099D). It is not currently a source of potential spray or flooding. (See pictures 8 and 11.) CARD 12-26997 issued for this on 08/21/2012.

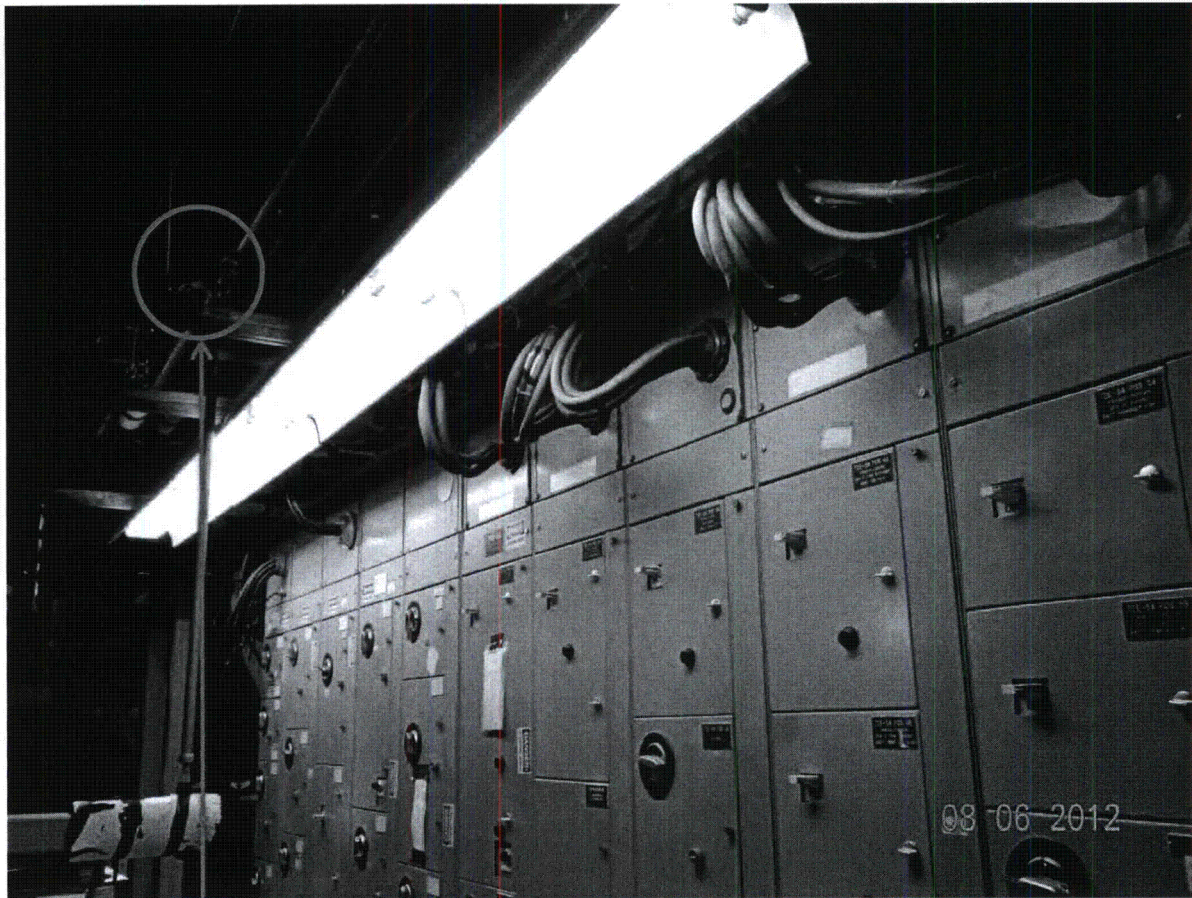
(DSC00186)

There are no ceiling tiles, with one exception, lighting is well-supported and cannot swing into equipment. See CARD 12-26588 and photos of broken cable that supports lighting on north side of MCC 72E-5A.

Broken cable on support for lighting near MCC 72E-5A was reported on CARD 12-26588 and will be tracked using CARD system as an open item until closed. (See Photos DSC00186 & 189)

"Broken or Loose Cable"

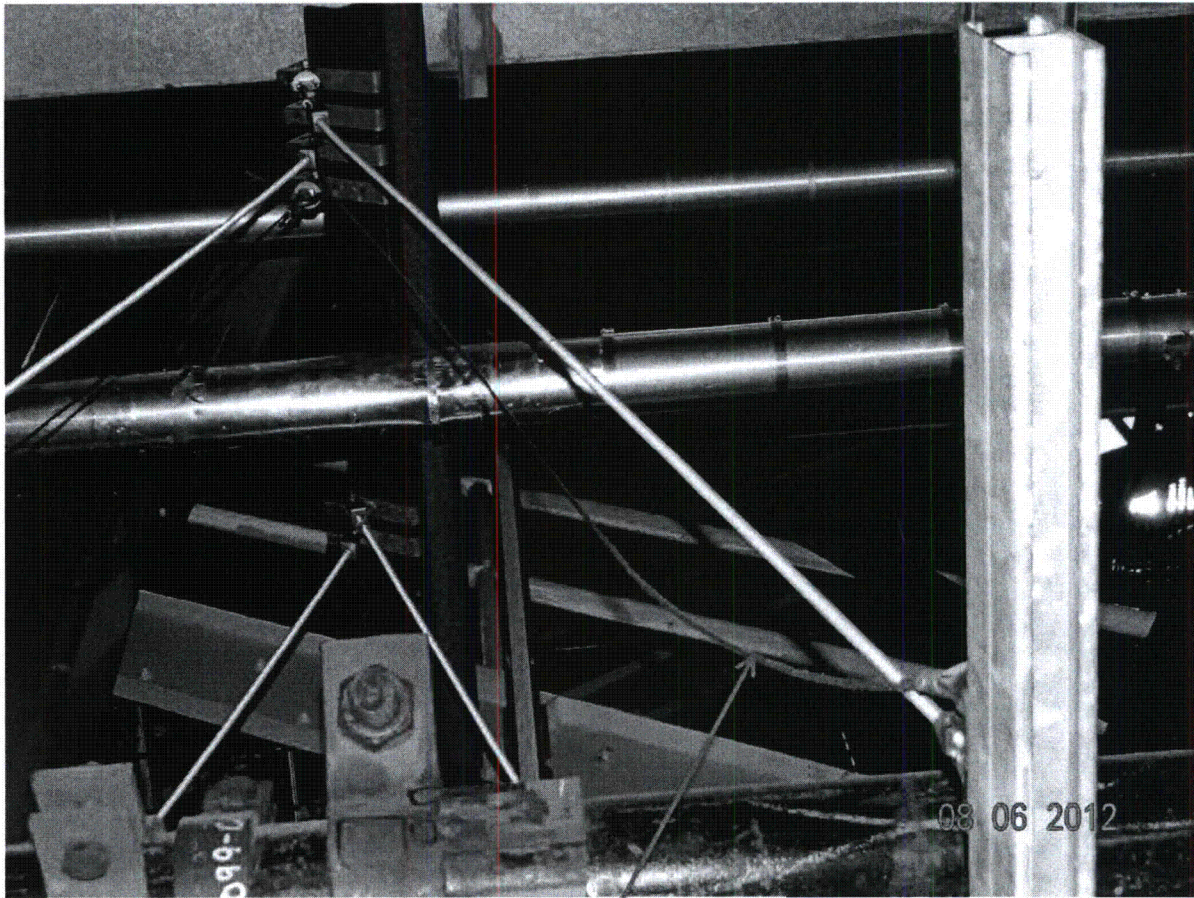
(DSC00189)

"Broken or Loose Cable"

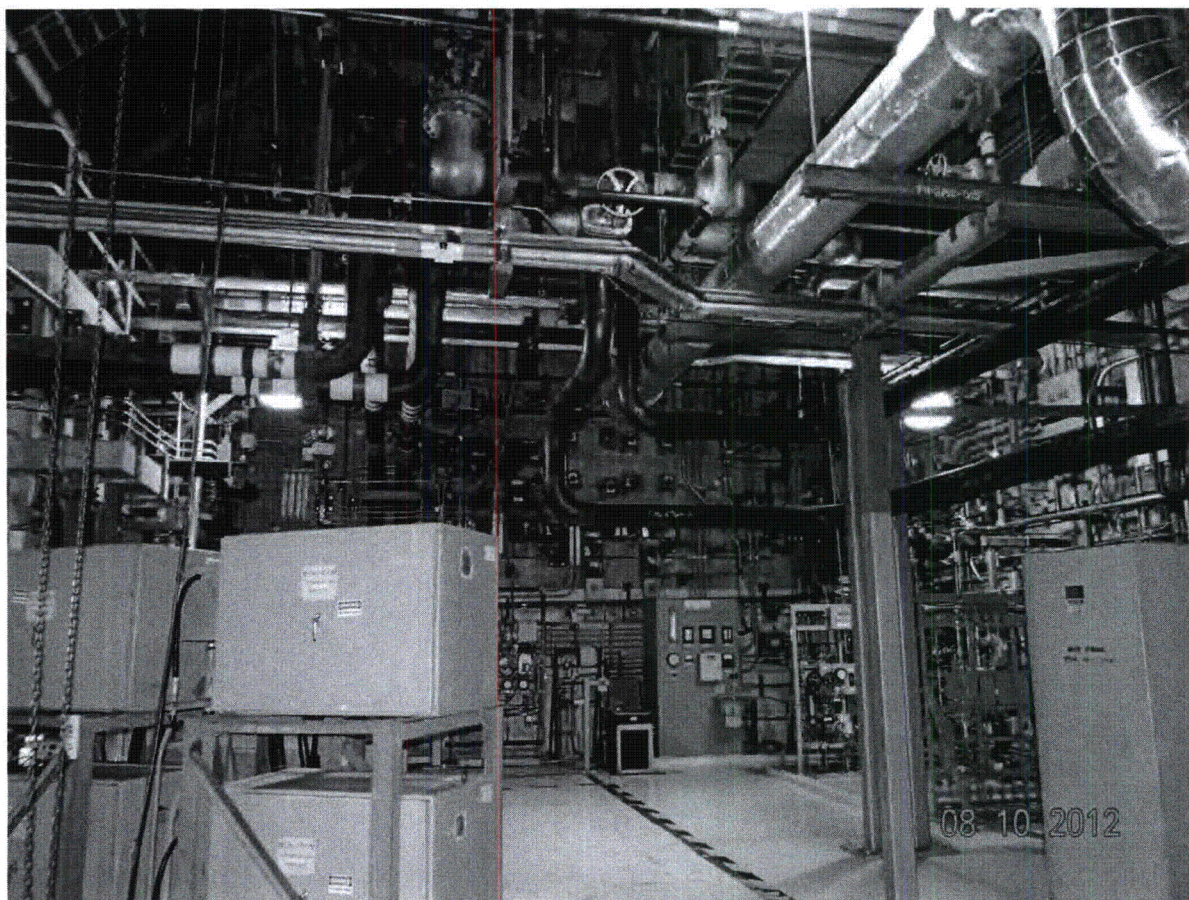
(DSC00394)

All anchorage appears to be free of potentially adverse conditions. See attached photo of general area DSC 00394.

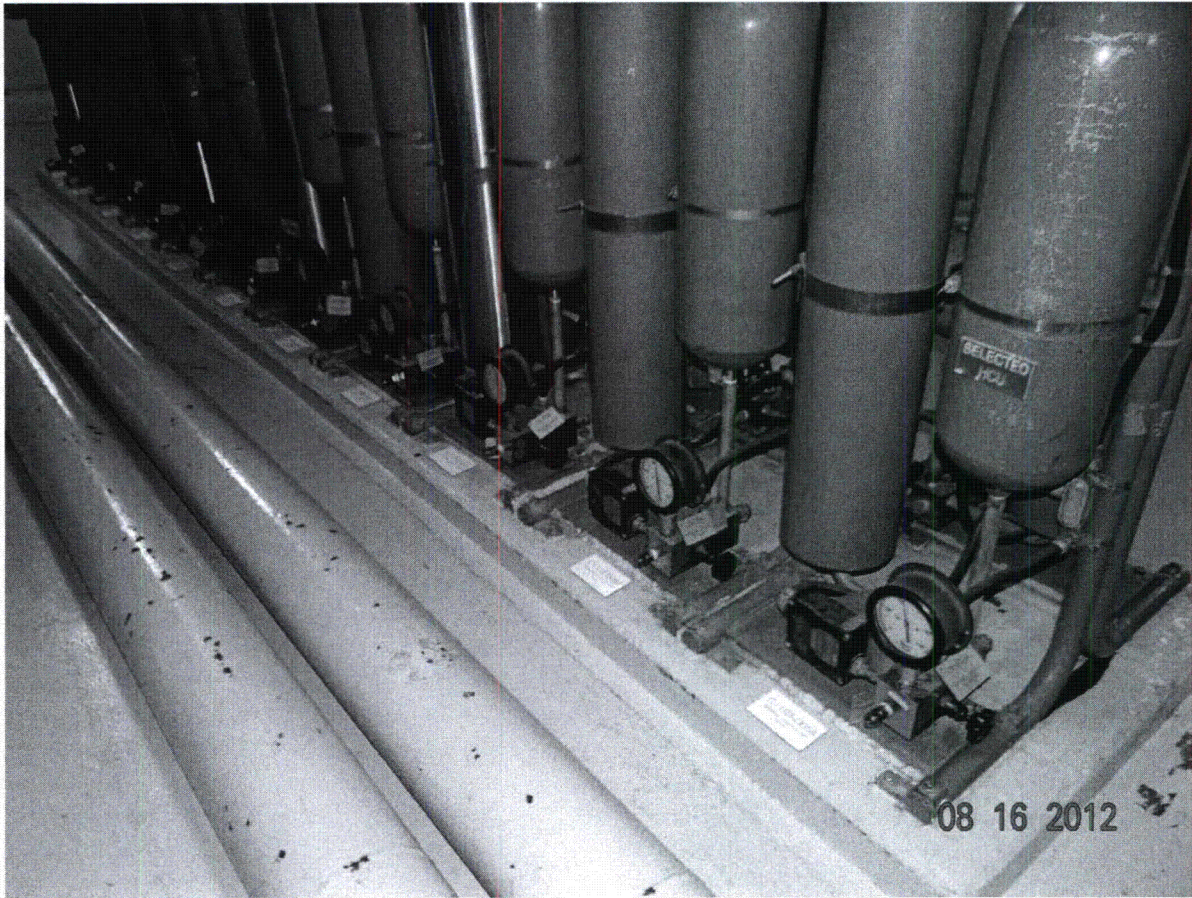
(Picture B6)

There is some rust in the 2nd anchor on the east side of the north set of the HCU's (C1103D059). This will not affect operability or adversely affect seismic functionality because the anchor is not significantly degraded. (see picture B6)

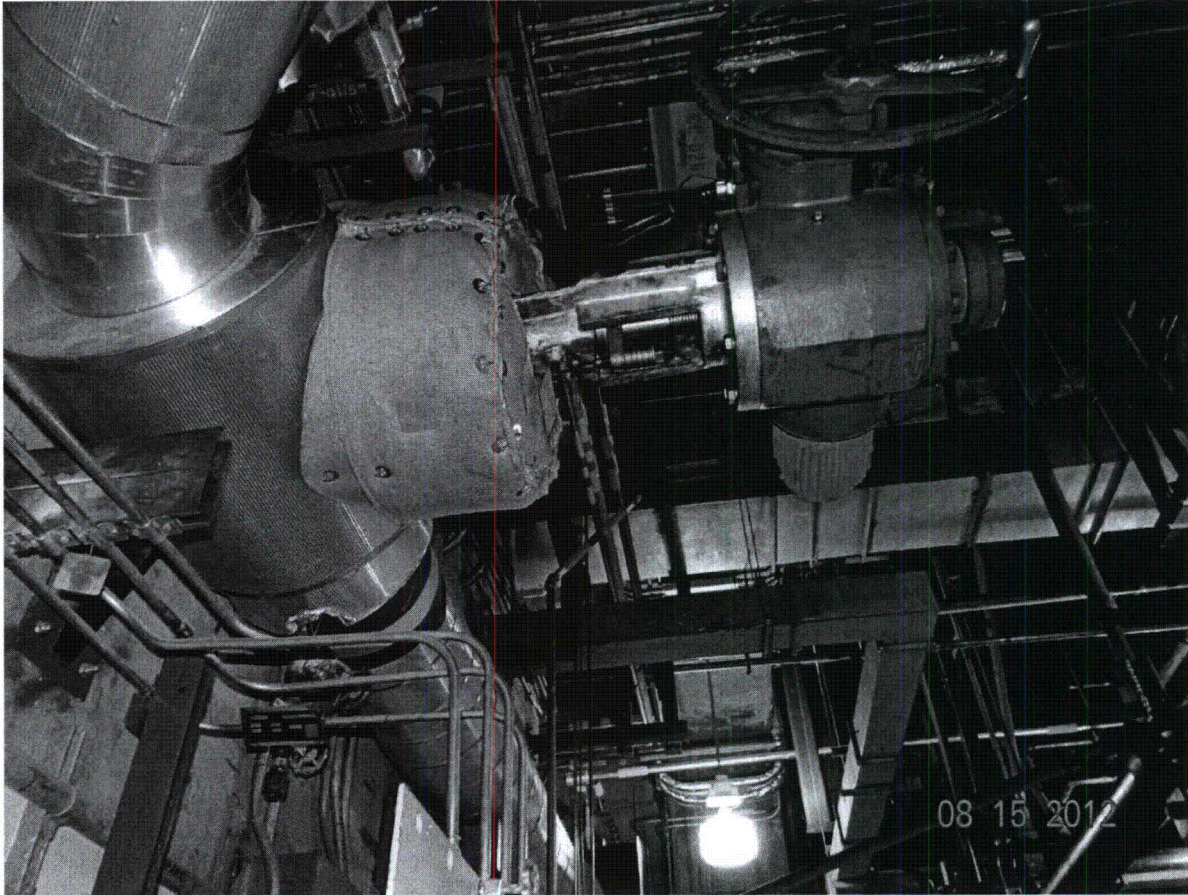
(Picture 7)

3. Based on a visual inspection from the floor, do the cable/conduit raceways and HVAC ducting appear to be free of potentially adverse seismic conditions (e.g., condition of supports is adequate and fill conditions of cable trays appear to be inside acceptable limits)? Y N U N/A
- There are no observed seismic concerns with any of the nearby cable/conduit raceways or HVAC ducting, including their supports. (See picture 7.)*

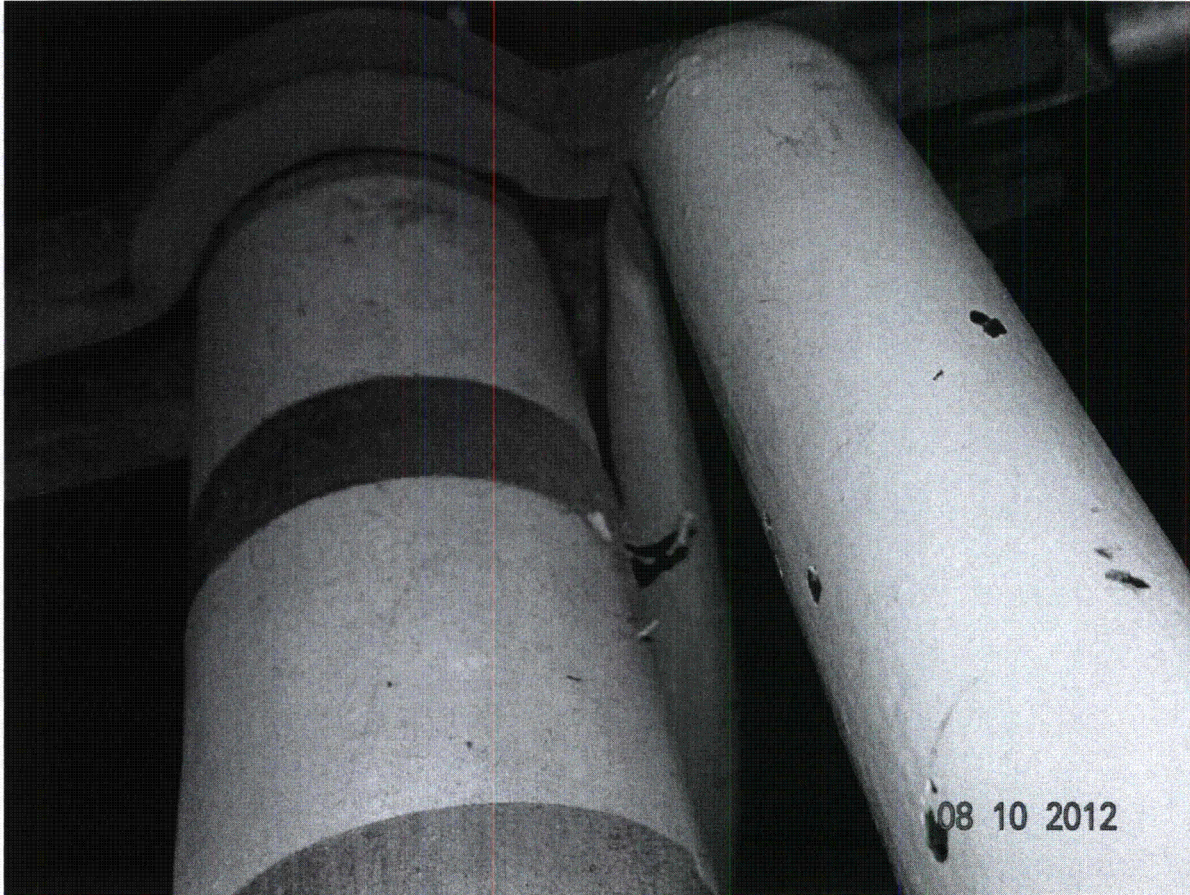
(DSC 00388)

A 3" keep-fill line to the Core Spray Discharge Header was found to be in contact with an adjacent handrail. Because the pipe in the Core Spray Line is larger (heavier) than the pipe in the handrail and the distance between the two is not enough to permit the development of any significant velocity or impact forces, the handrail will not damage the pipe. Nevertheless, a further evaluation is considered necessary. CARD 12-26586 was initiated. (See attached Photos DSC00388, 389, 391 and 393)

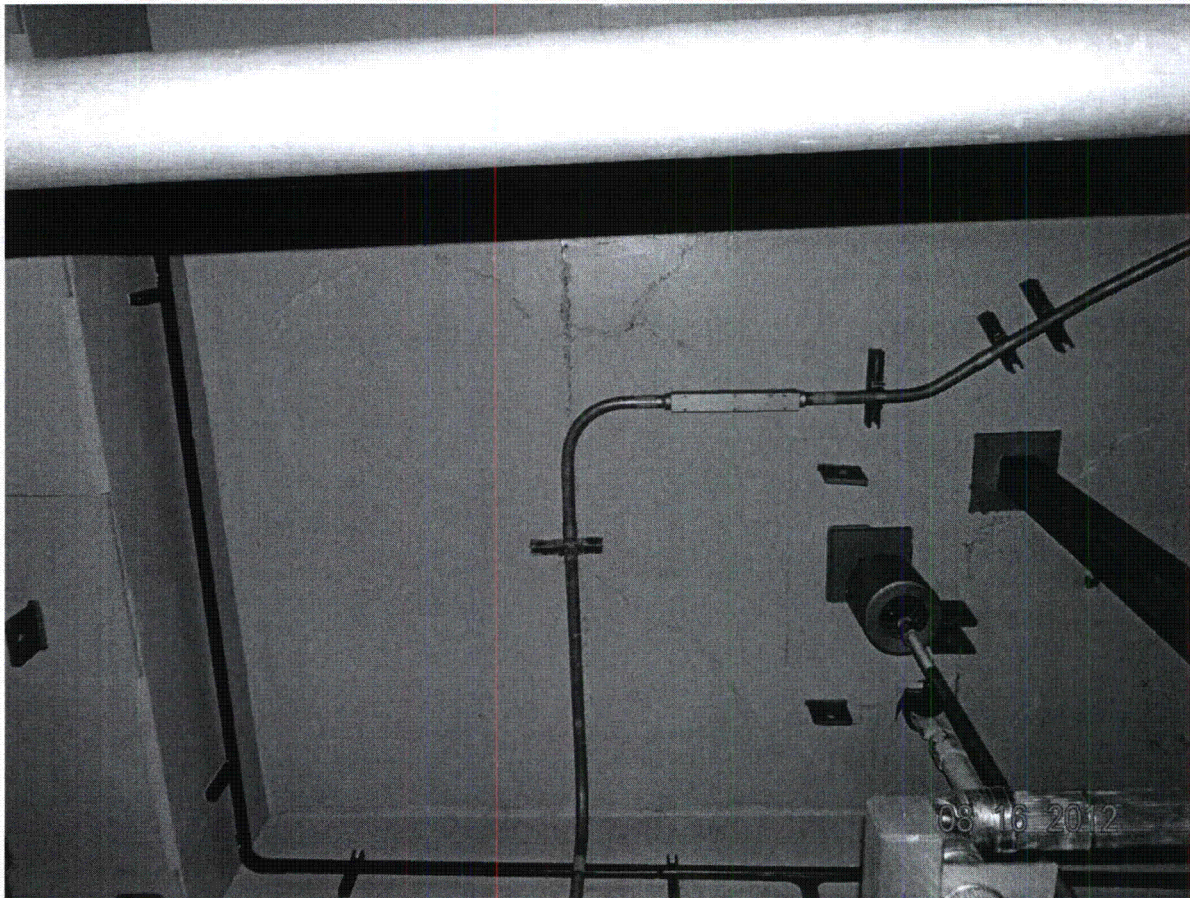
(Picture 10)

3. Based on a visual inspection from the floor, do the cable/conduit raceways and HVAC ducting appear to be free of potentially adverse seismic conditions (e.g., condition of supports is adequate and fill conditions of cable trays appear to be inside acceptable limits)? Y N U N/A
- Cable/conduit and HVAC ducts are adequately mounted and free of potentially adverse seismic conditions. (See picture 10.)*

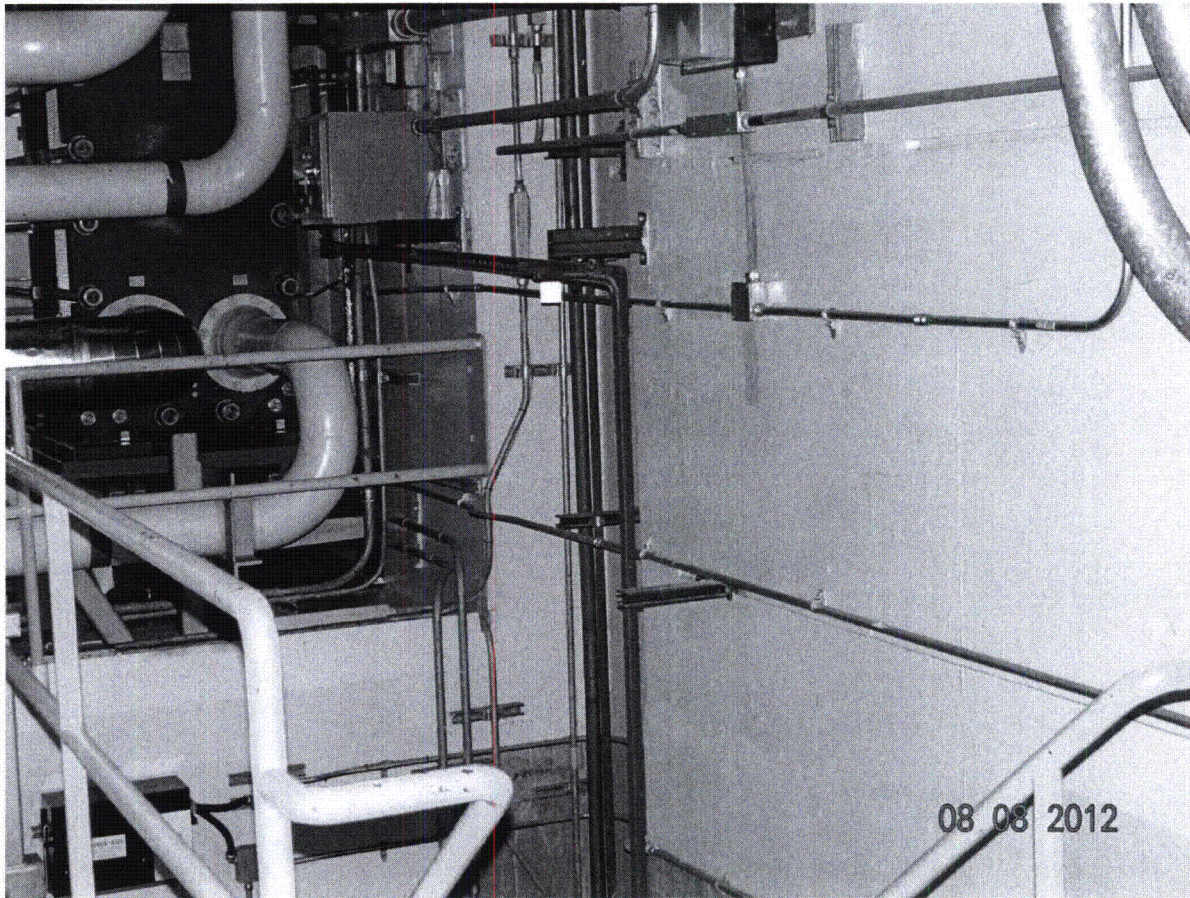
(DSC 00290)

Conduits Attached to Wall

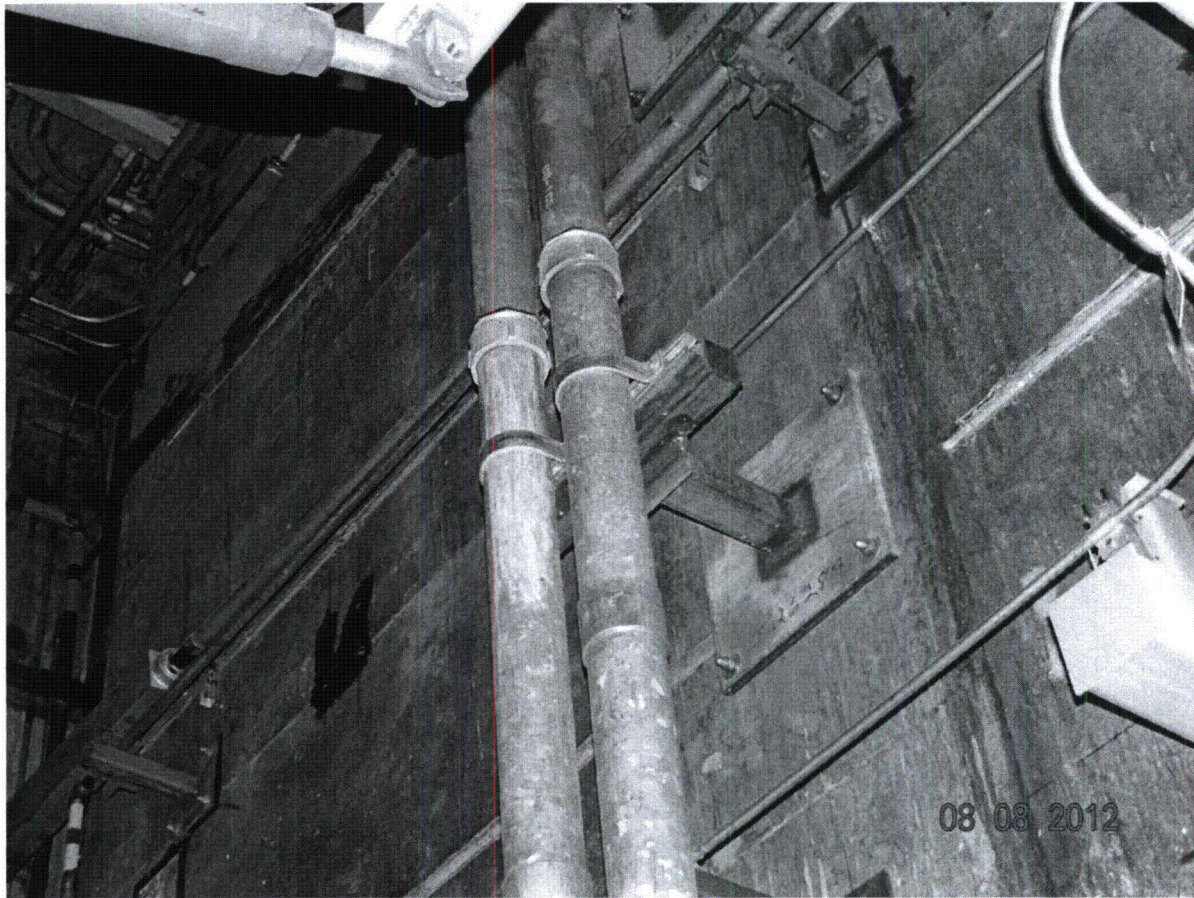
(DSC 00292)

Heavy-Duty Conduit Supports
