**Area Walk-By Checklist (AWC)**

Assets: *E1151C001C*

Location: Bldg. RHR Floor El. 590'-0" Room, Area<sup>1</sup> SRHRPR, Div. I Pump Room

Fermi 2 Seismic Walkdown Guideline  
Area Walk-By-Checklist

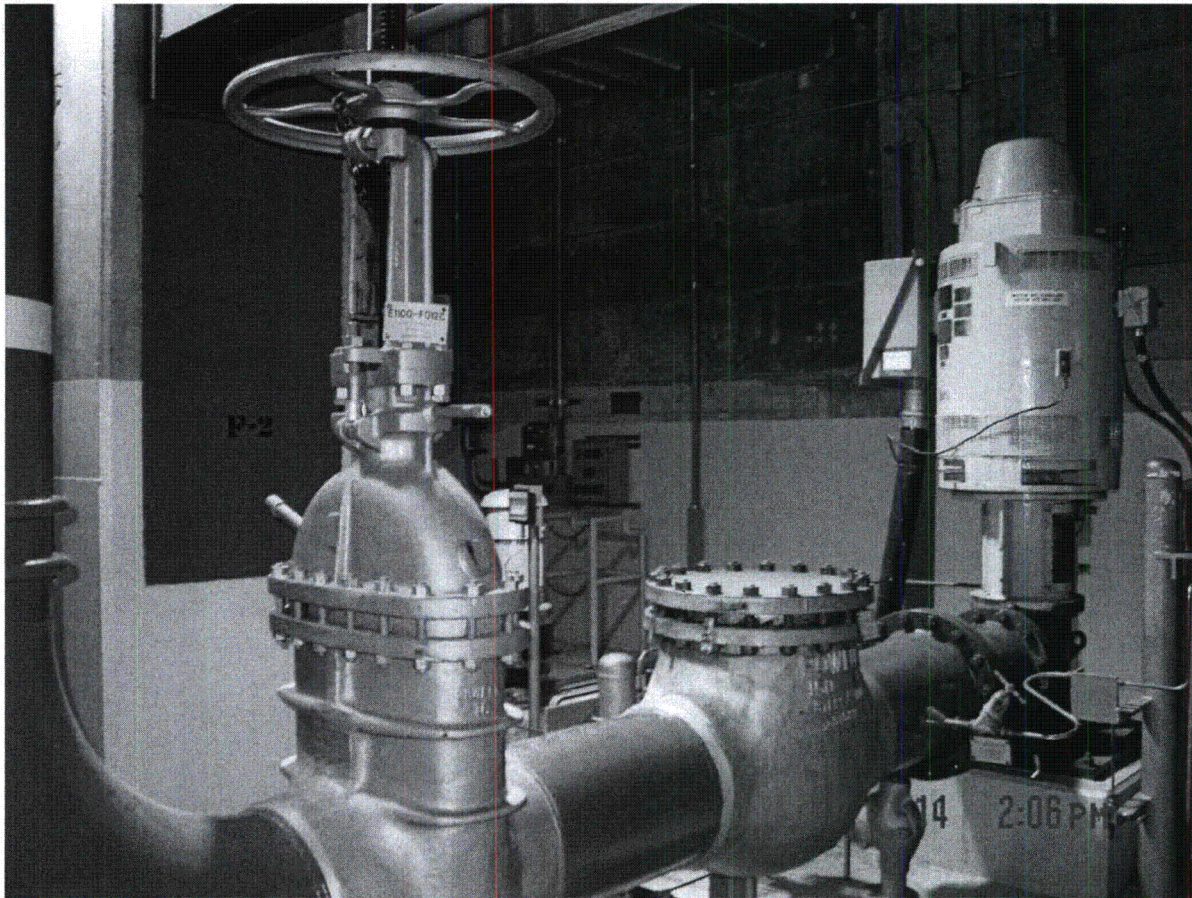
(DSC 01357)

*There are no observed adverse seismic conditions. See photo DSC 01357.*

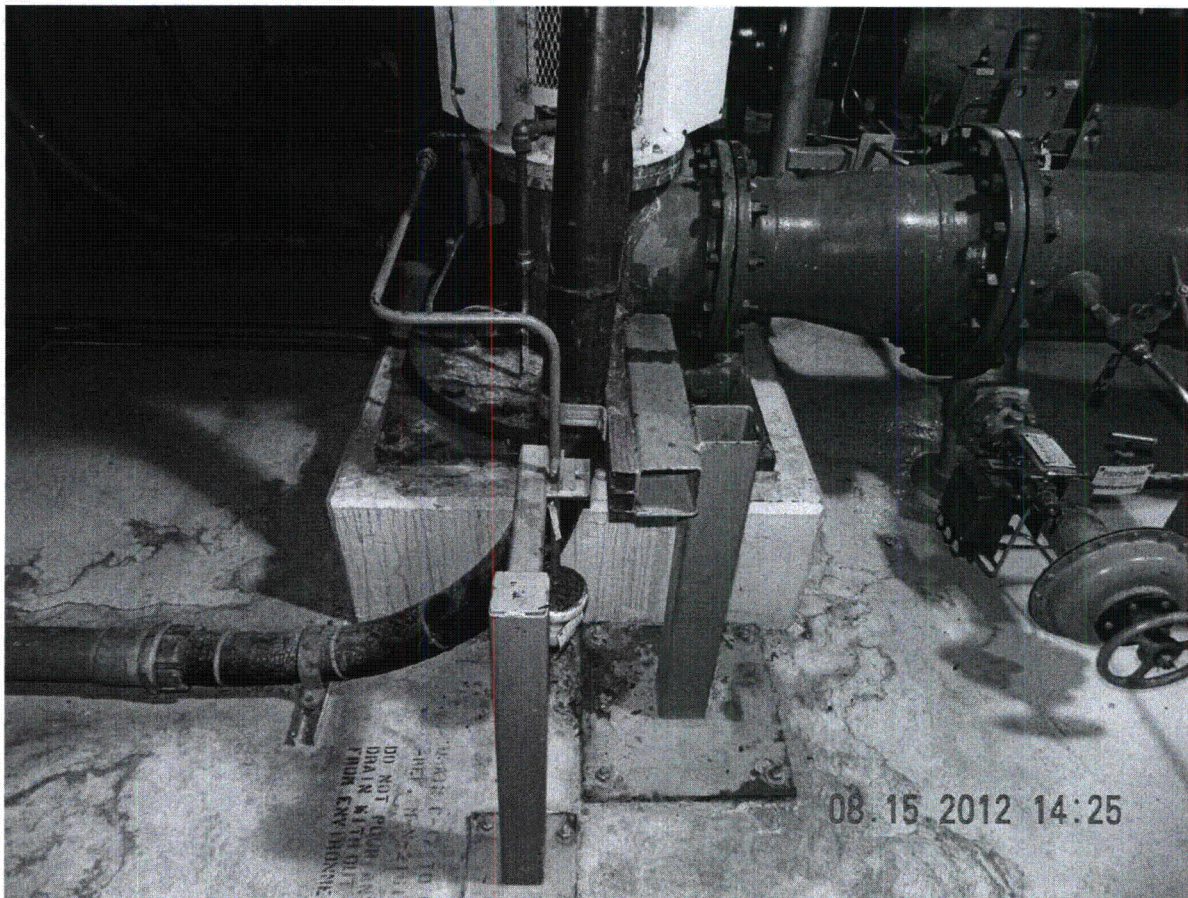
(DSCN 0389)

*Some stains and peeling paints, only minor corrosion. No loss of cross section. See photo DSCN 0389.*

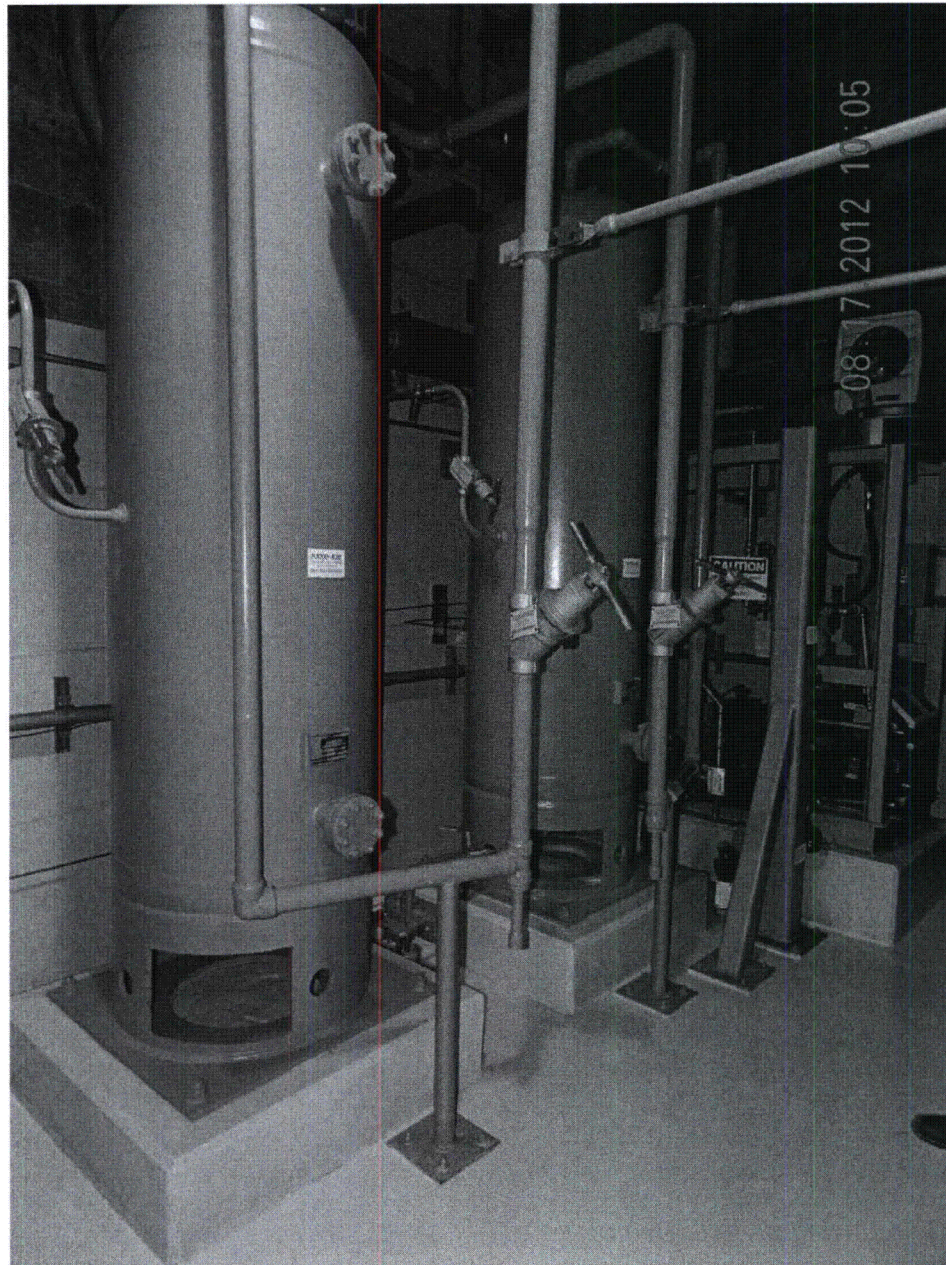
(DSCN0535)

5. Does it appear that the area is free of potentially adverse seismic interactions that could cause flooding or spray in the area? Y  N  U  N/A   
*The area does not have fire protection piping or sprinkler system. CO<sub>2</sub> lines and other piping are adequately supported. No concern with flooding or spray in this area (see Photo DSCN 0535).*

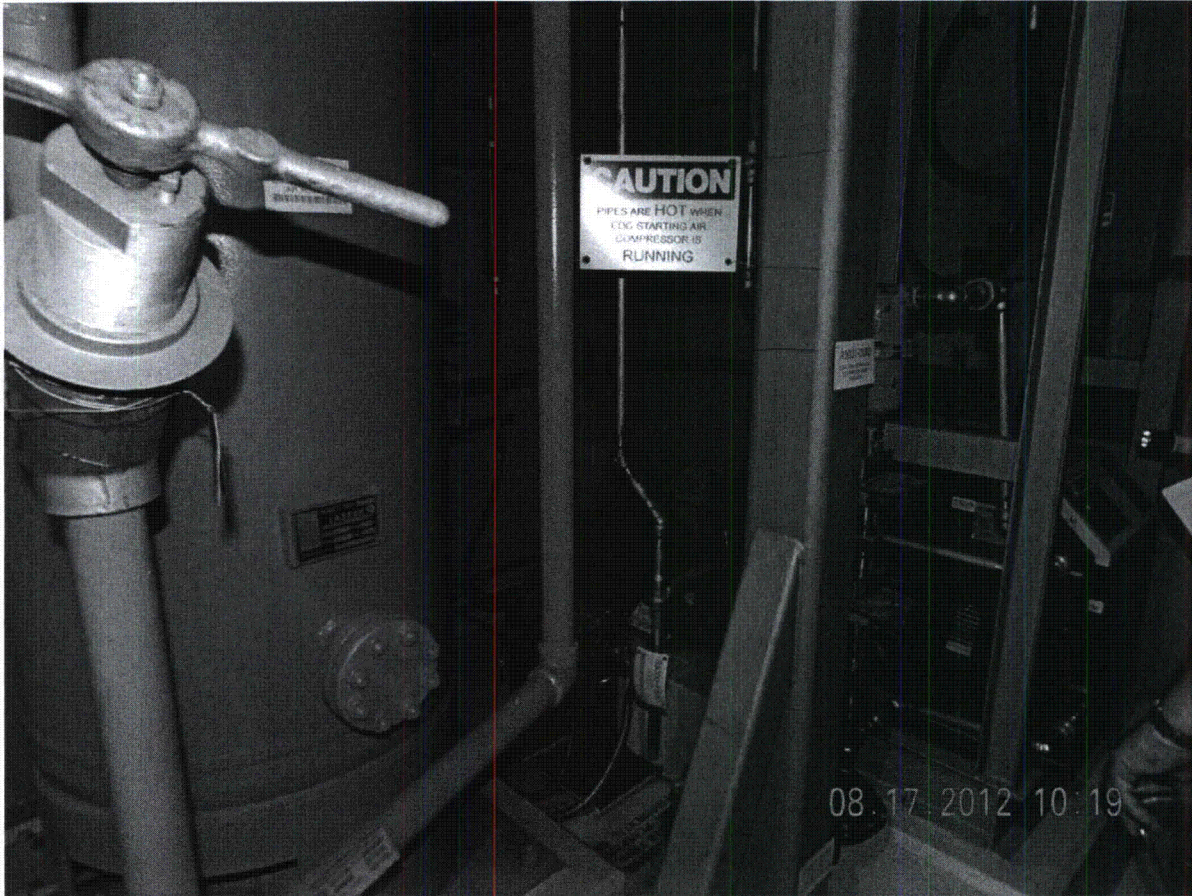
(DSCN0538)

- 
8. Have you looked for and found no other seismic conditions that could adversely affect the safety functions of the equipment in the area? Y  N  U   
*No adverse seismic conditions found (see Photo DSCN 0538).*
-

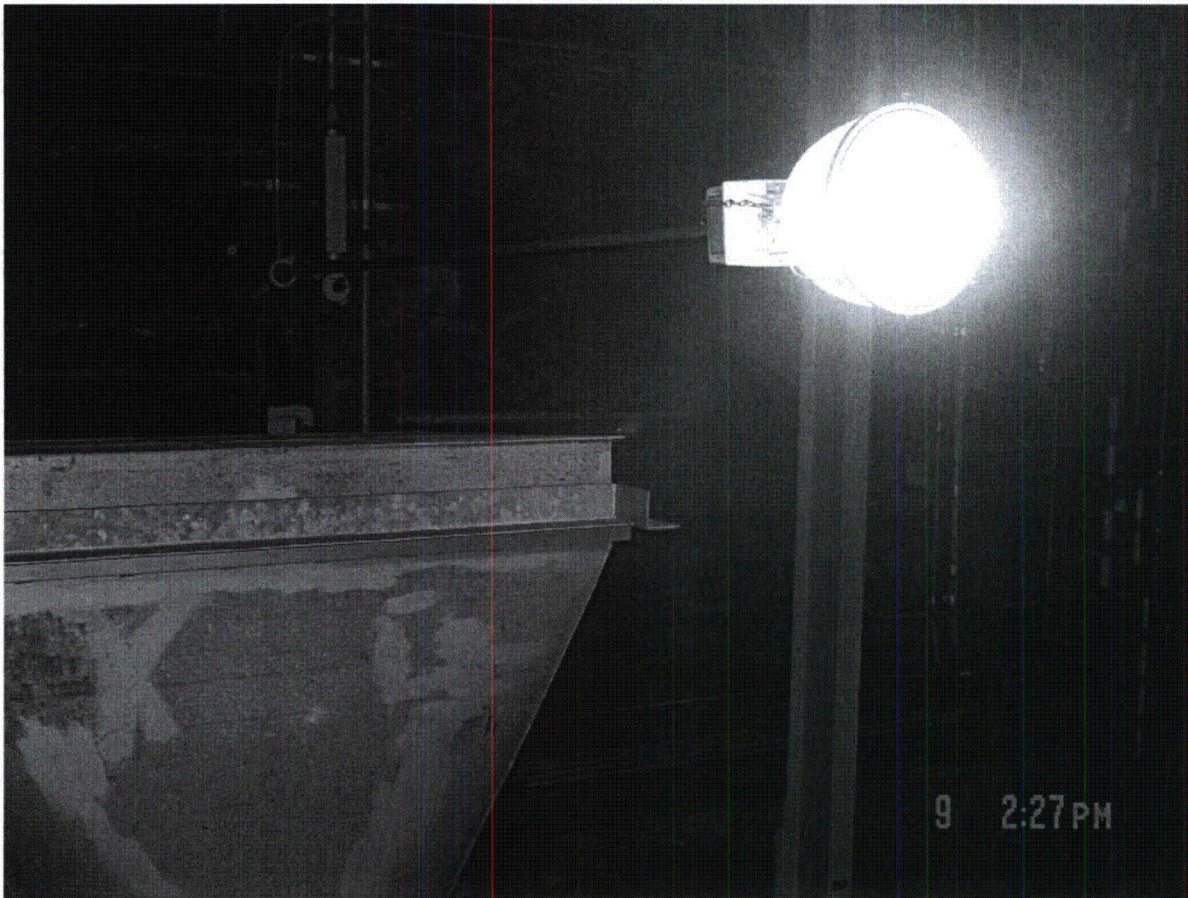
(Picture #B7)

*Lights in the area are on swivel rods that are designed to sway and not break. No other seismic spacial interactions were observed. (See Picture B7)*

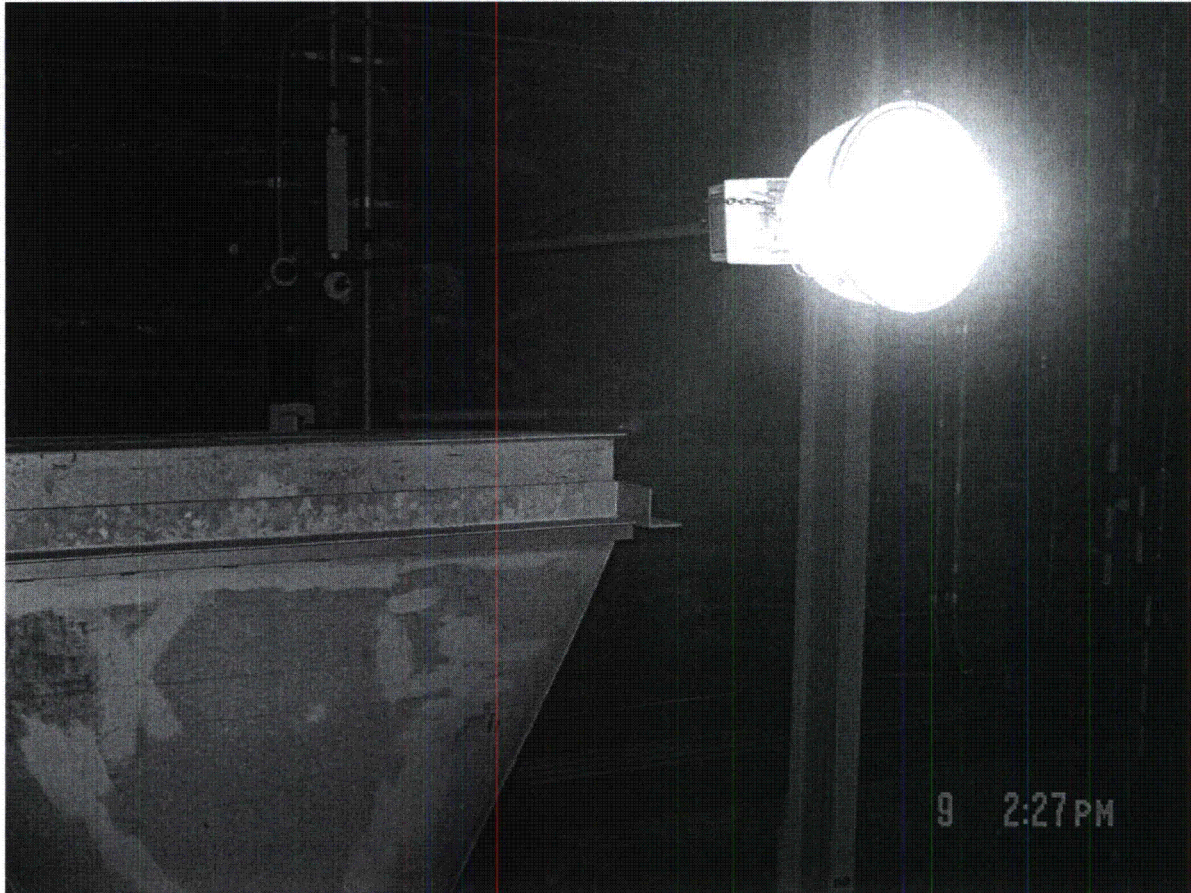
(Picture B7)

*Lights in the area are on swivel rods that are designed to sway and not break. No other seismic spatial interactions were observed. See picture B7.*

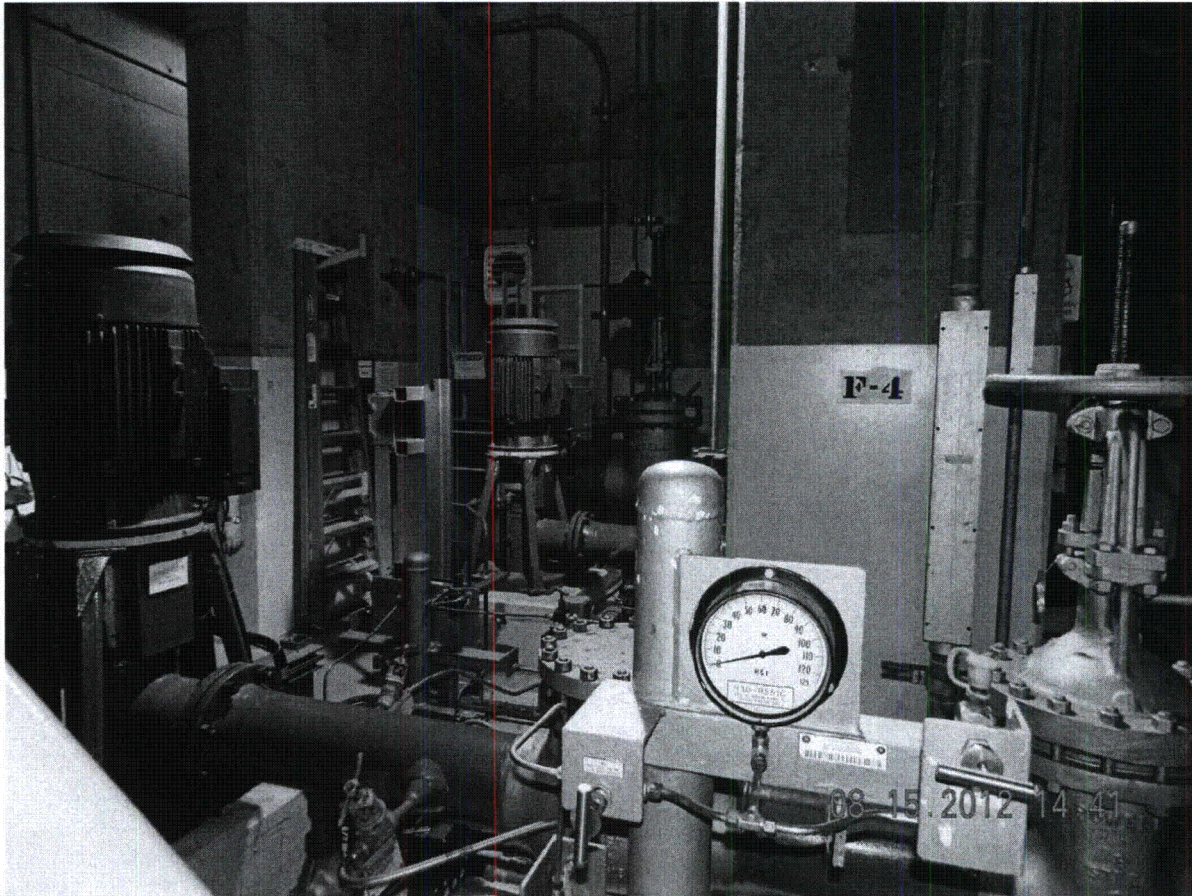
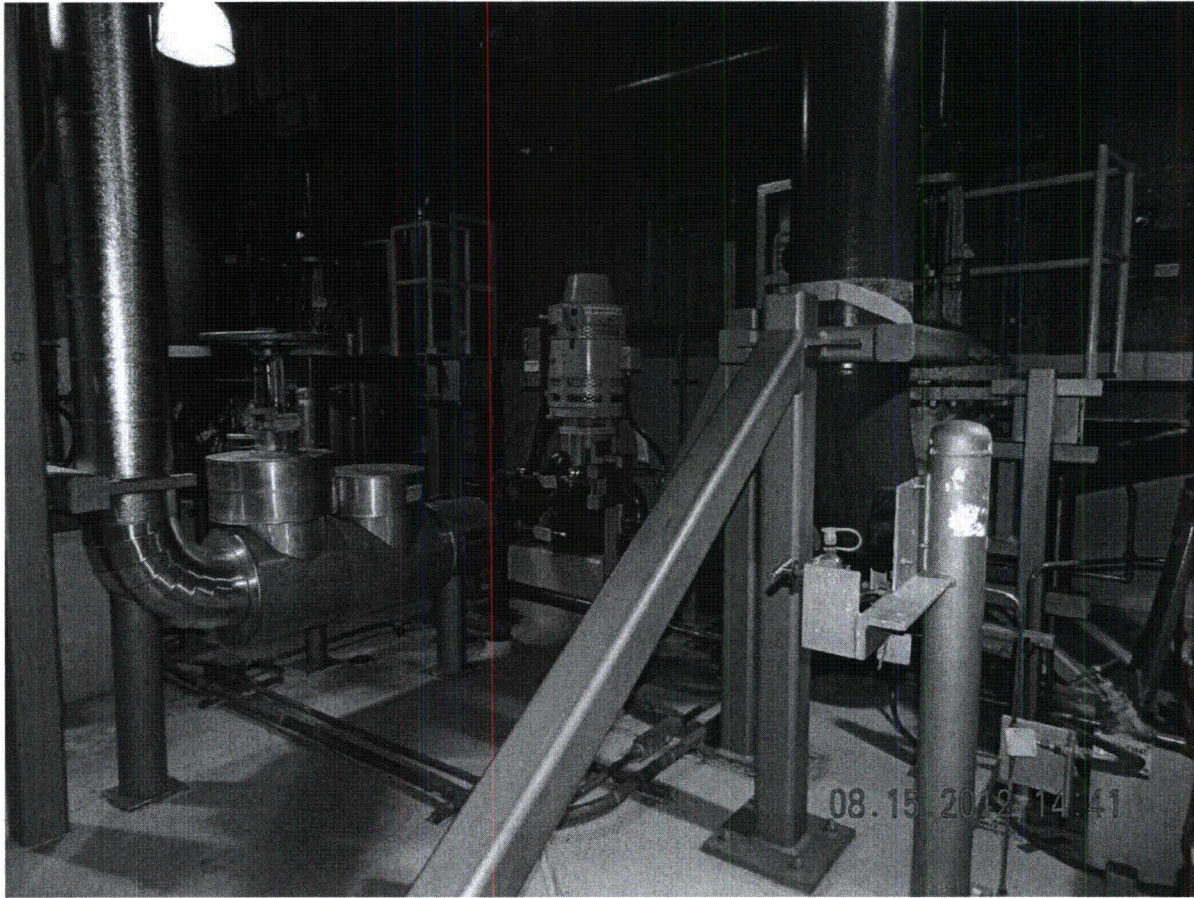
*Anchorage of equipment in the area is free of potentially adverse seismic conditions. See Photos DSCN 0396 & DSCN 0397.*

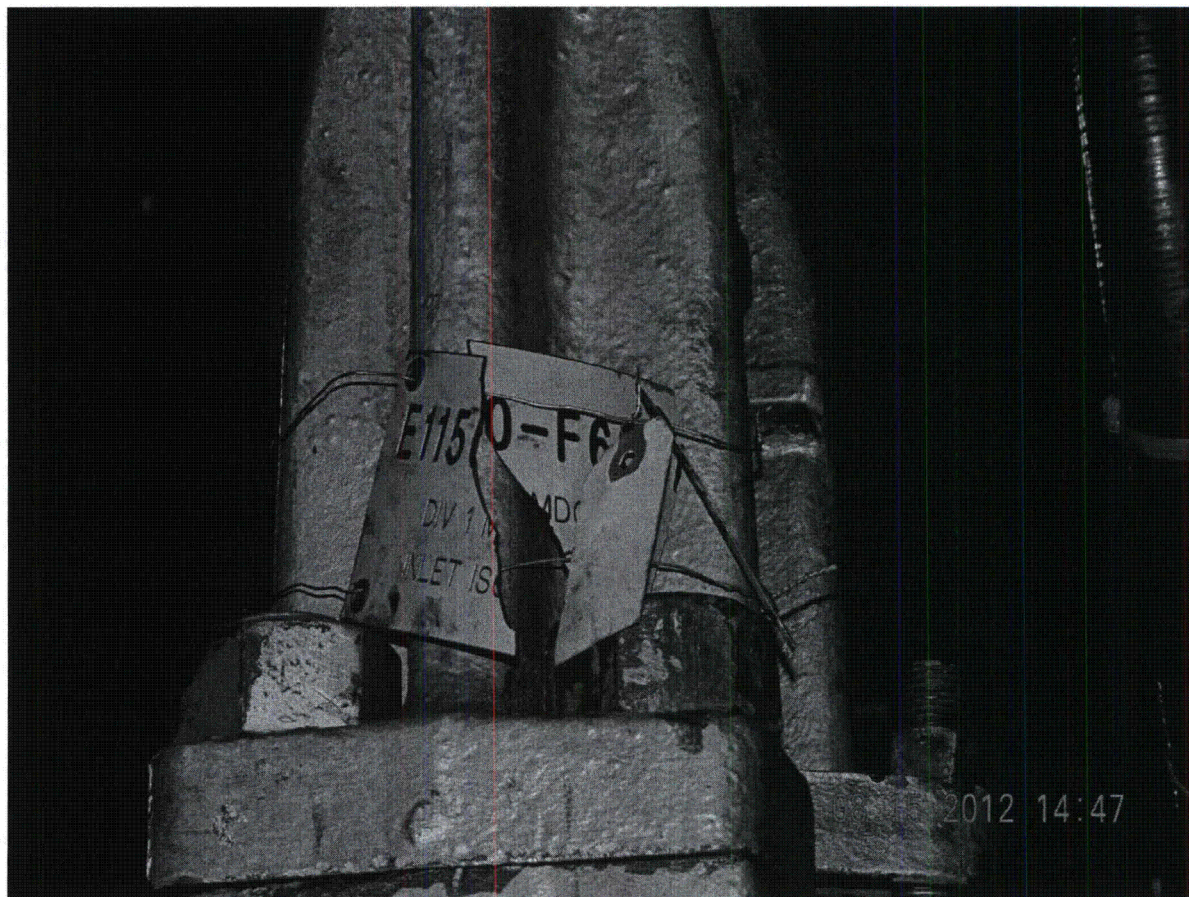
(DSCN 0406)

*During the walkdown, a broken label was found on Valve E1150F605A. See Photo DSCN 0406. CARD 12-27150 was written.*

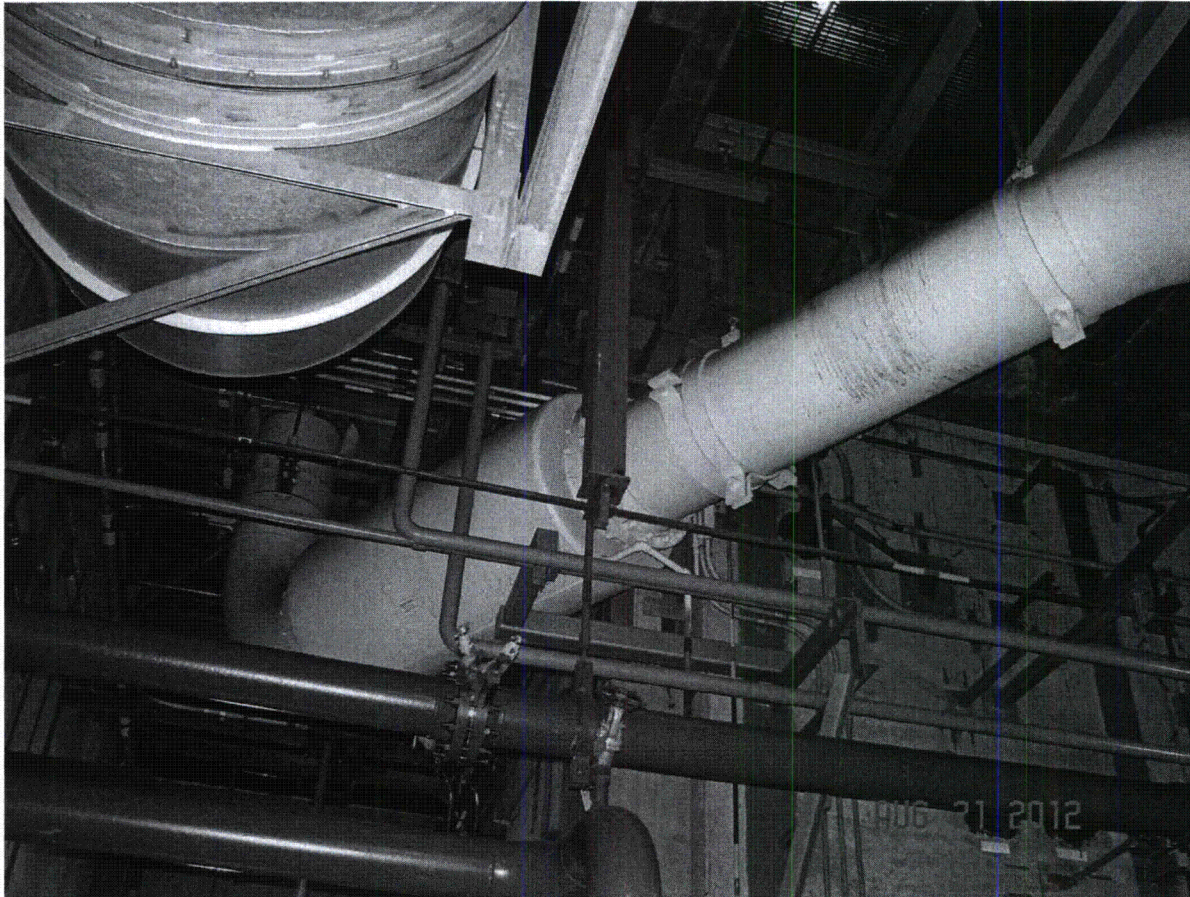
(DSC00087)

*HVAC ducts supported on robust hangers. All supports are in good condition.  
(See DSC00087)*

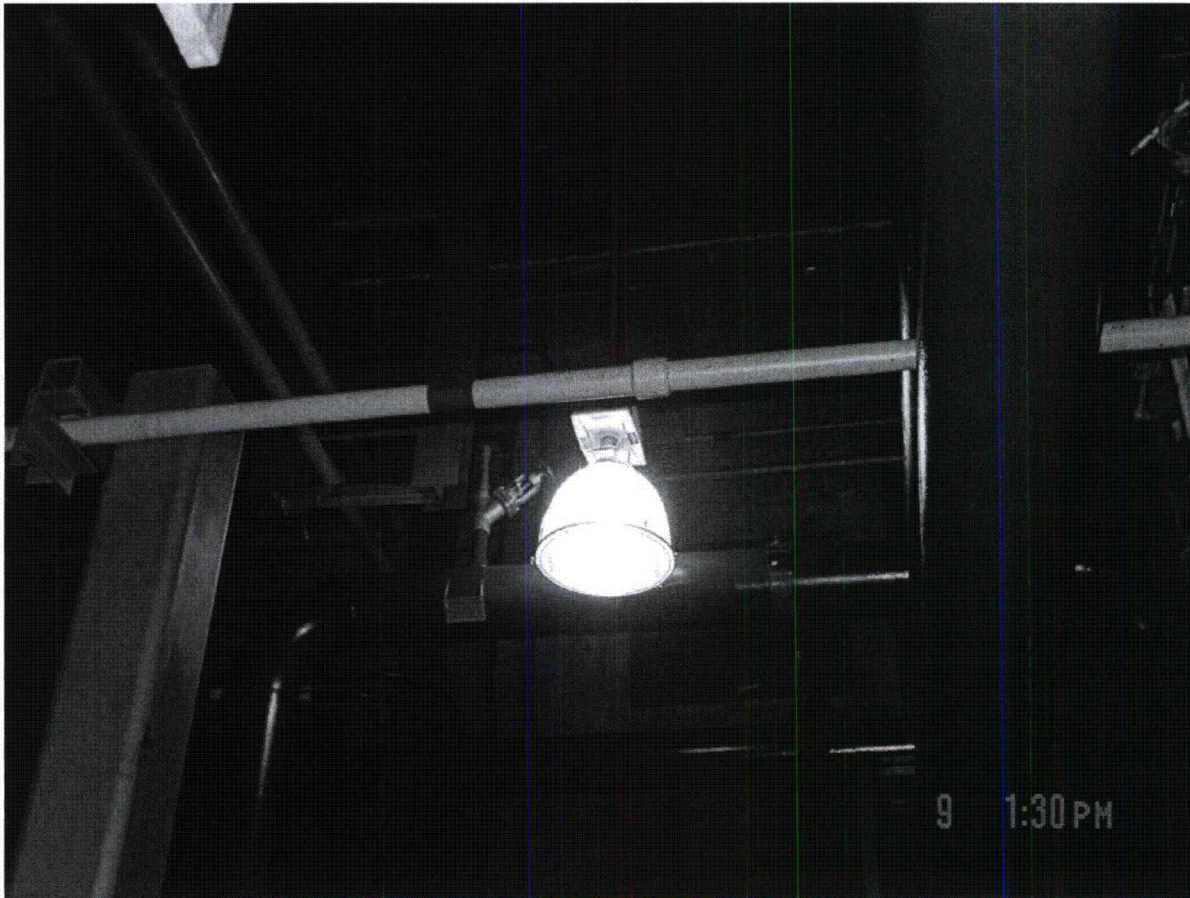
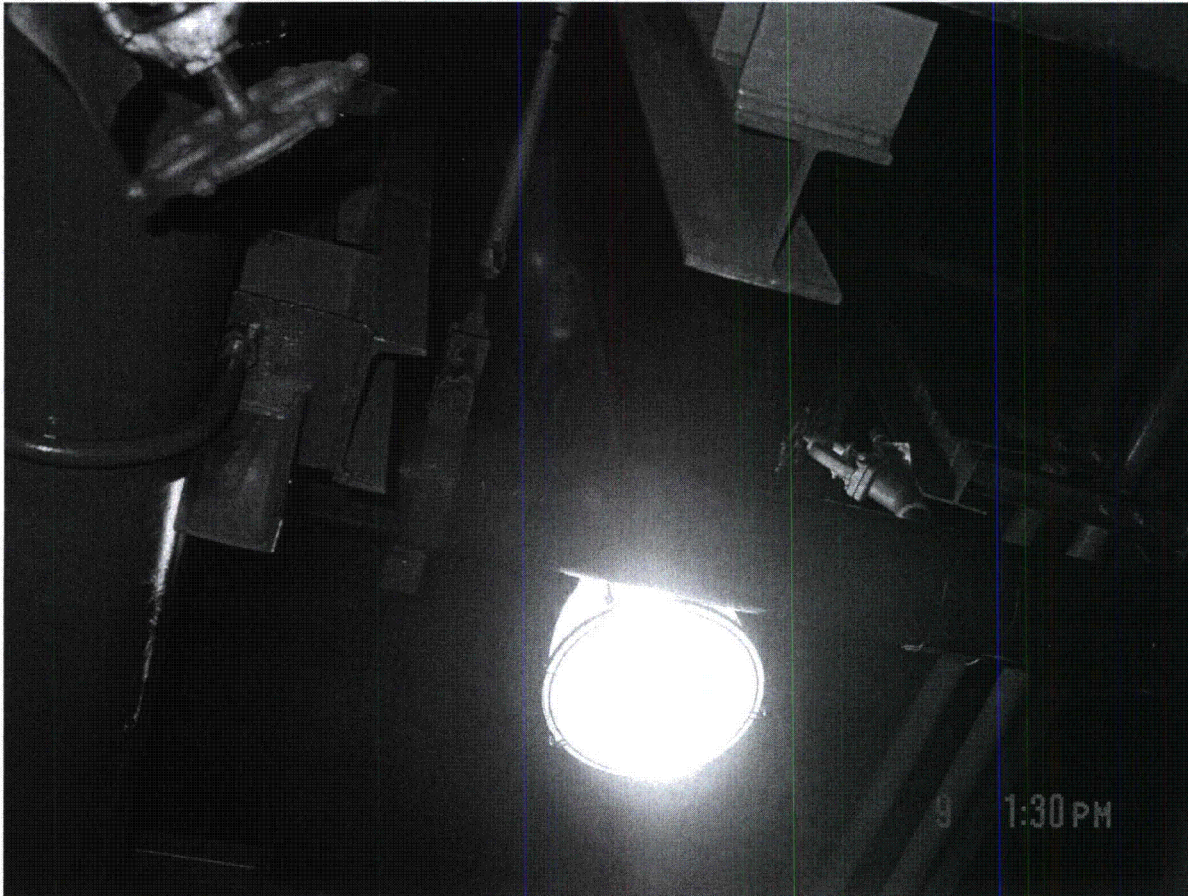
*The light on the north west corner of the room is installed right next to the large heat exchanger pipe. The pipe is approx. 10" in diameter and will not be subject to damage per Engineering Judgment. See pictures B1 and B2. The concern with the location of the light is documented under CARD 12-26861.*

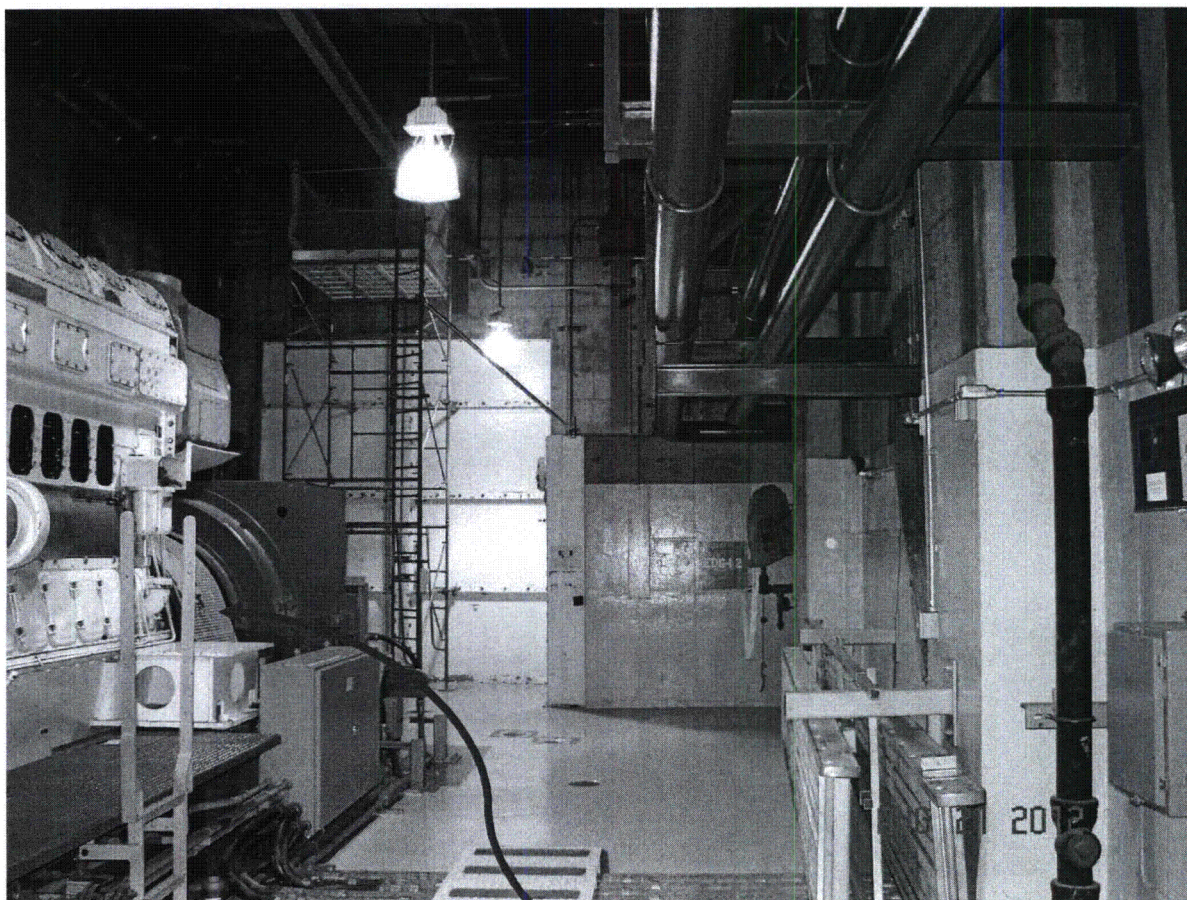
R30NA17A is located  
Behind this guard
