## SEISMIC WALKDOWN CHECKLIST FORM

Status: Y  N  U Seismic Walkdown Checklist (SWC) SWEL2-008Equipment ID No. 19P-1A Equip. Class 5. Horizontal pumpsEquipment Description: Fuel pool cooling recirc pump ALocation: Bldg. RB Floor El. 326 Room, Area Col 3 line T

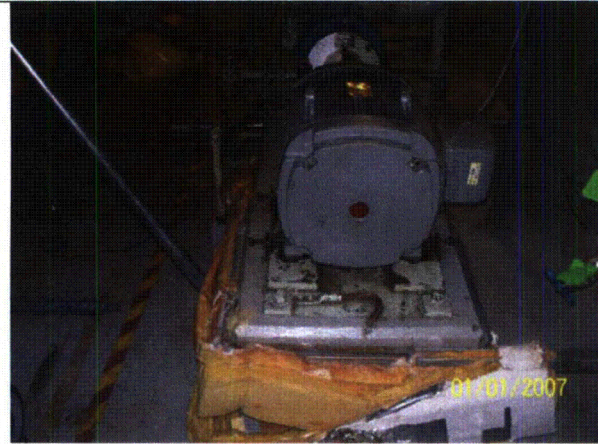
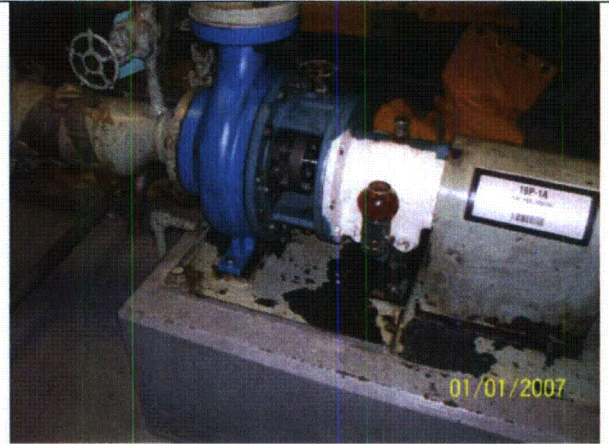
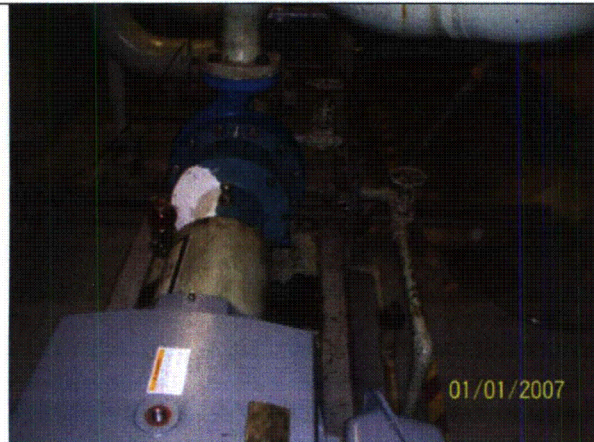
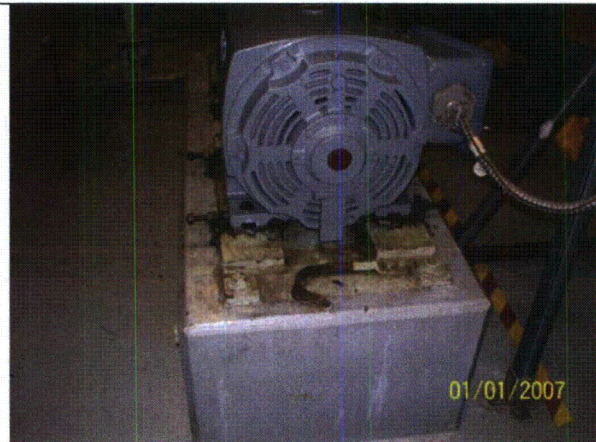
3. Is the anchorage free of corrosion that is more than mild surface oxidation? Y  N  U  N/A   
*Mild corrosion where paint is chipped*

4. Is the anchorage free of visible cracks in the concrete near the anchors? Y  N  U  N/A   
*Single hairline cracks less than 1/16" in foundation near each bolt.  
 These cracks are judged to have no adverse seismic impact on 19P-1A*

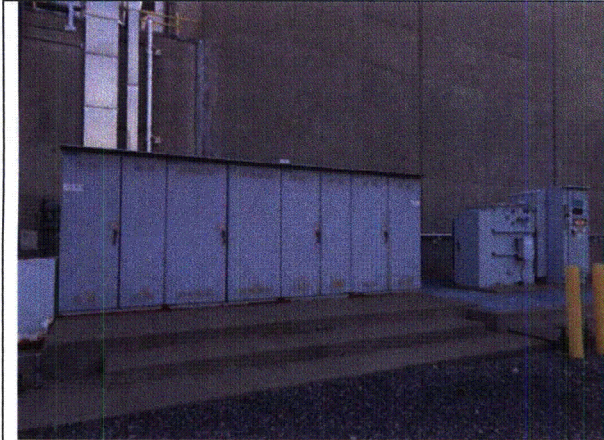
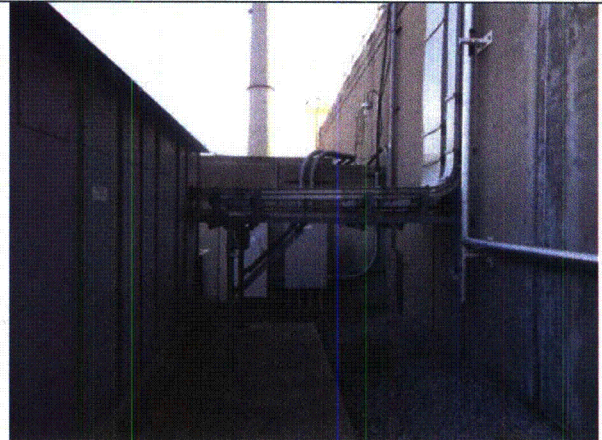
*Some rust present along baseboard of MCC cabinet. Will not affect structural integrity of equipment.*

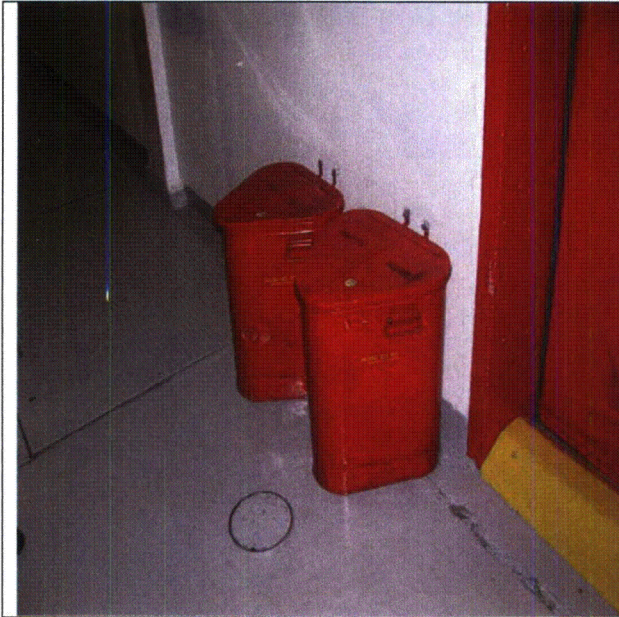
**Note:** *Picture of the clean/dirty rag bins.*

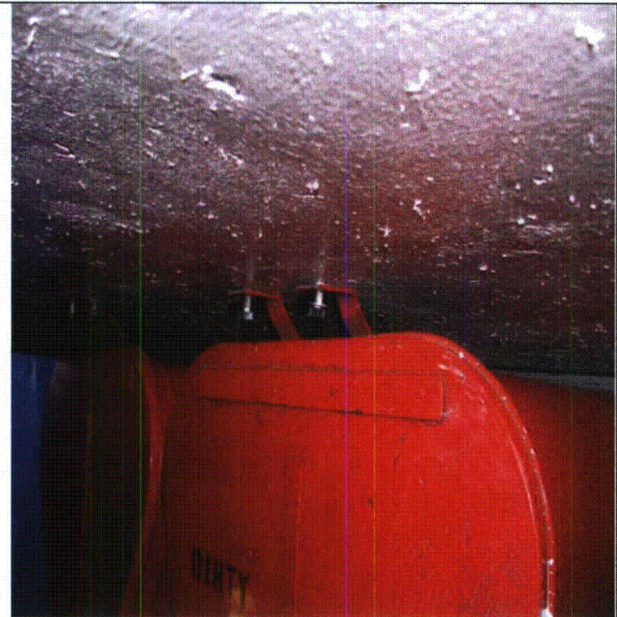
*The clean/dirty rag bins and a hand held fire extinguisher have anchors that are not tightened/loose. However, items are not close enough to any vital equipment to cause adverse behavior during a seismic event.*

**Note:** *Picture of the non-tightened/loose anchorage of the clean/dirty rag bins.*

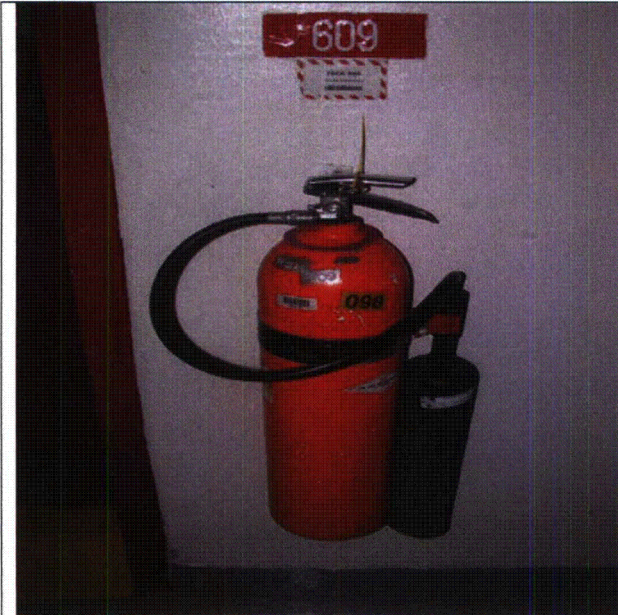
**Note:** PICTURE of the 76CX-609 hand held fire extinguisher.

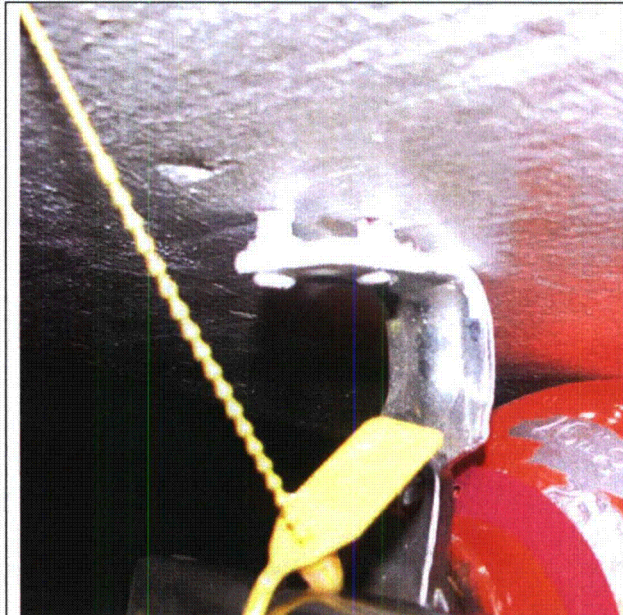
**Note:** PICTURE of the non-tightened/loose anchorage of the 76CX-609 hand held fire extinguisher.

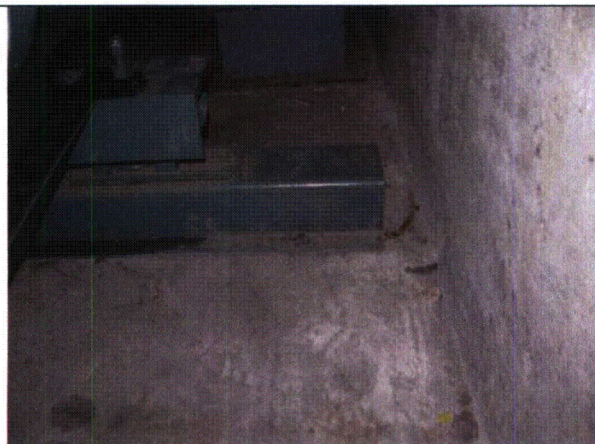
**Note:** Picture of a loose anchor for equipment 72FN-46D is loose.

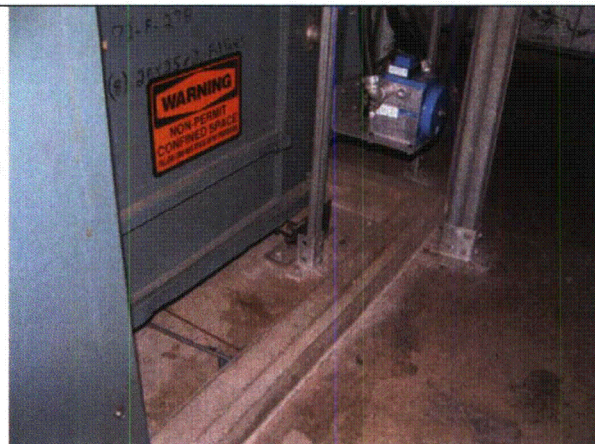
**Note:** Picture of a loose anchor in the UNISTRUT post base for equipment 72MOD-101B.

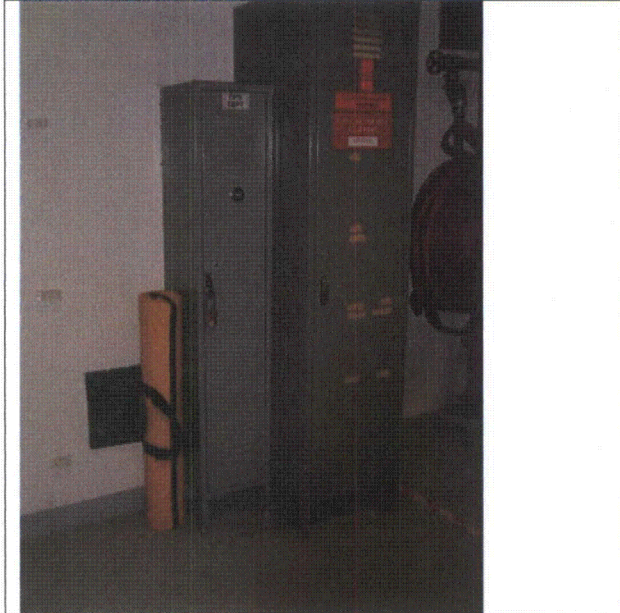
**Note:** *Unanchored Cabinets*

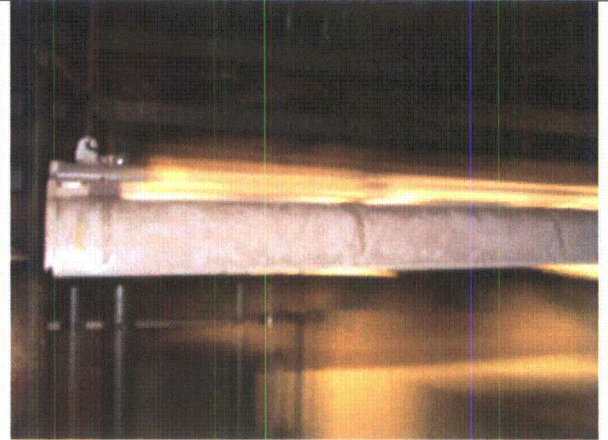
**Note:** *Improper light hooks.*

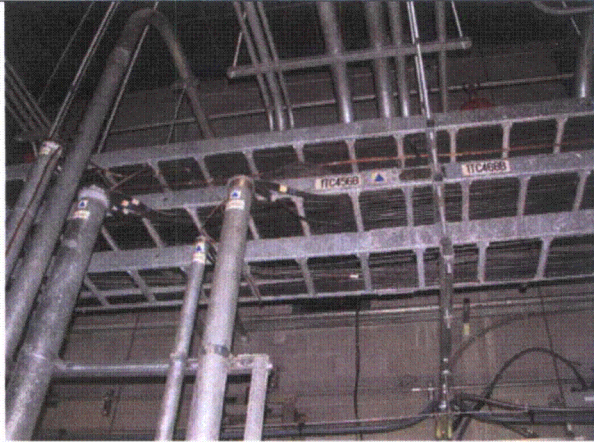
**Note:** *Overhanging cables.*

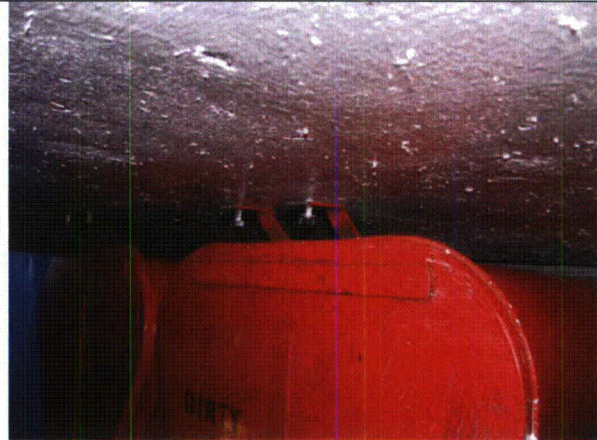
**Note:** *Picture of the non-tightened anchorage of the clean/dirty rags.*

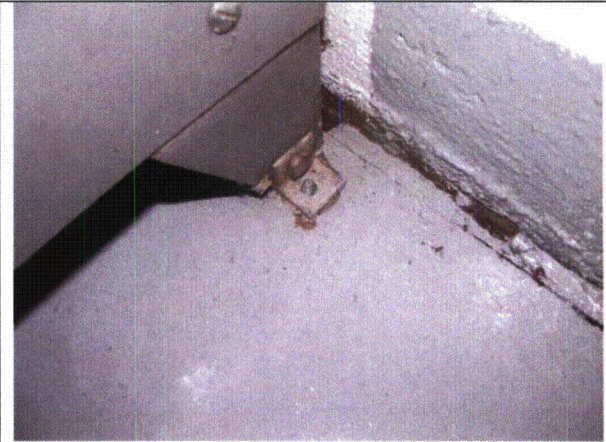
**Note:** *Picture of the missing anchorage of the work bench.*

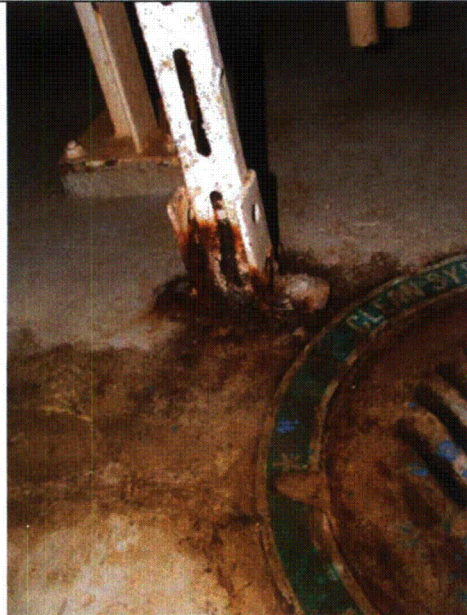
**Note:** *Picture of the degraded anchorage of the UNISTRUT support.*

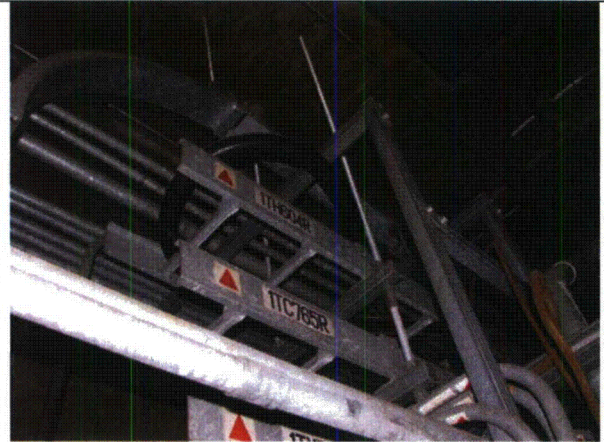
**Note:** *Picture of the conduit hanging over the side of cable tray 1TH604R1.*

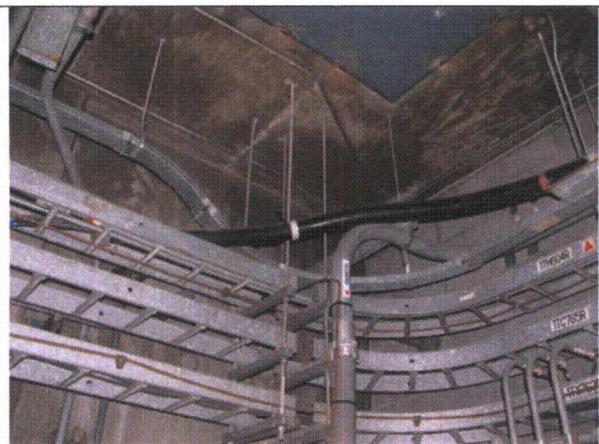
**Note:** Picture of the conduit tied to a rod hanger support the on cable tray 1TH604R1.

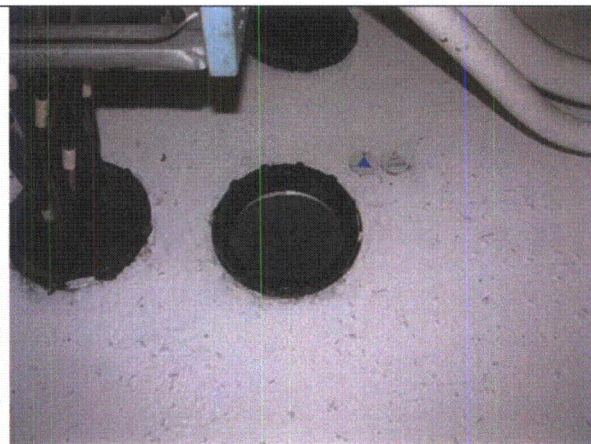
**Note:** Picture of uncovered penetration in Pump Rom B, West wall.

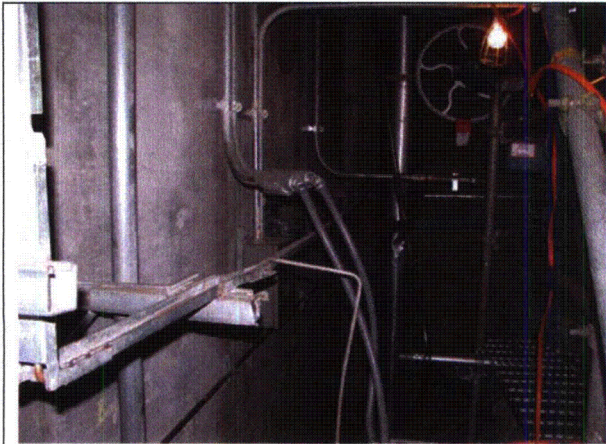
**Note:** *Picture showing the deflected shape of the instrumentation line resting on a strut support and the un-braced length.*

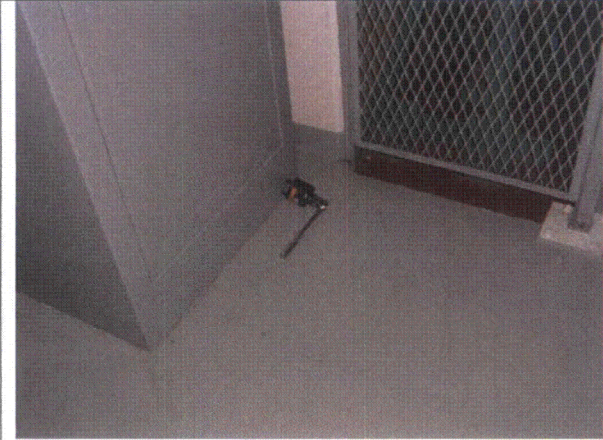
**Note:** *Picture showing the location of the improperly stored tool.*

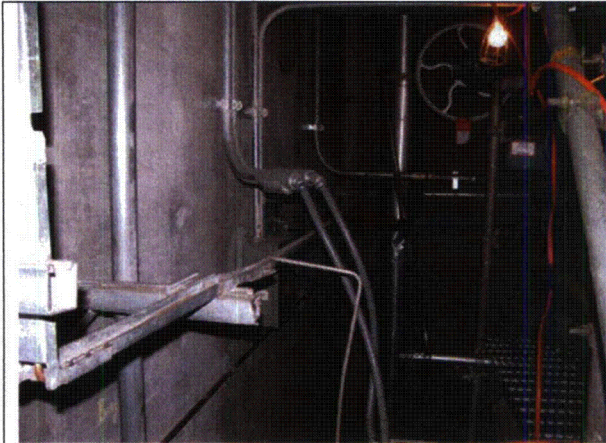
**Note:** *Picture showing the deflected shape of the instrumentation line and the unbraced length.*

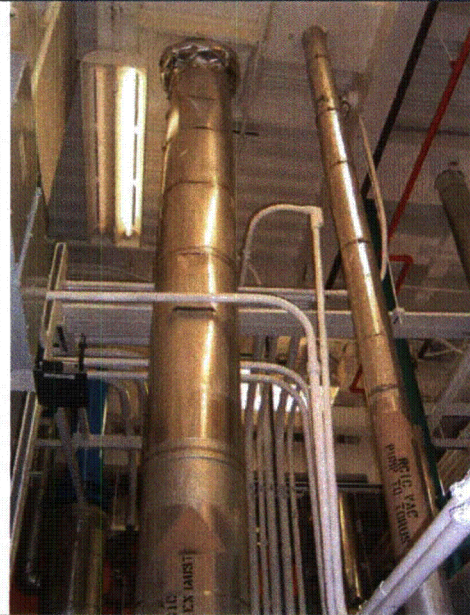
**Note:** *Unsupported vertical pipes and pipe/conduit interaction point.*

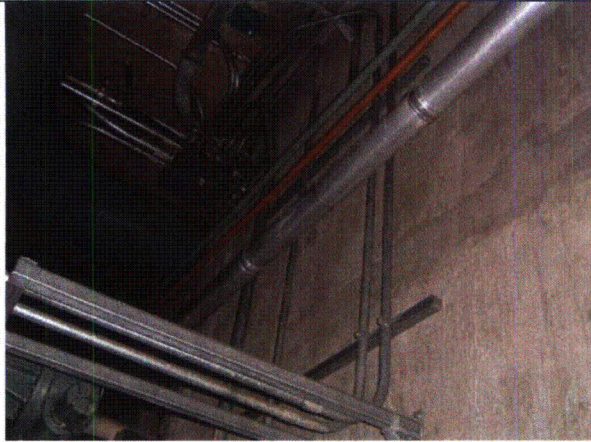
**Note:** *Unsupported Pipe Spans*

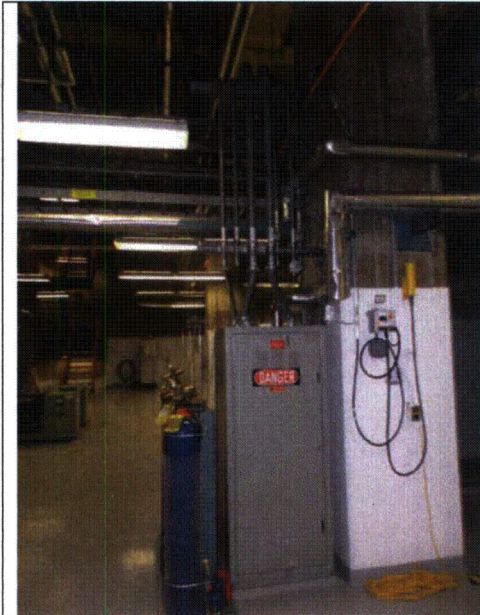
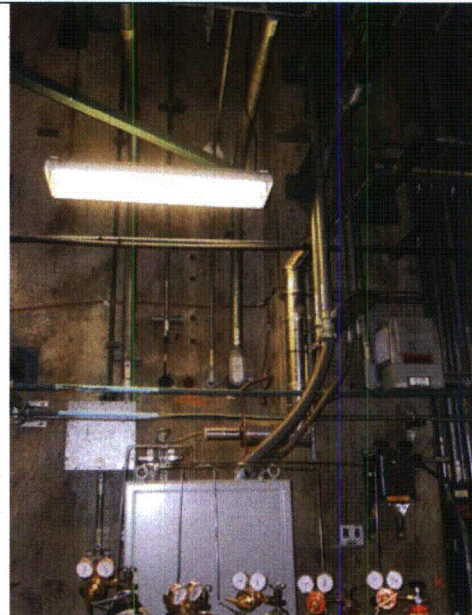
**Note:** Light fixture above 1/4" tubing from the gas tanks

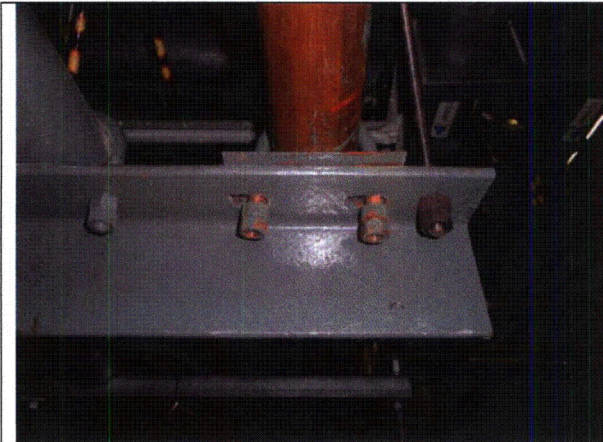
**Note:** *Loose nuts on the U-bolt connection.*

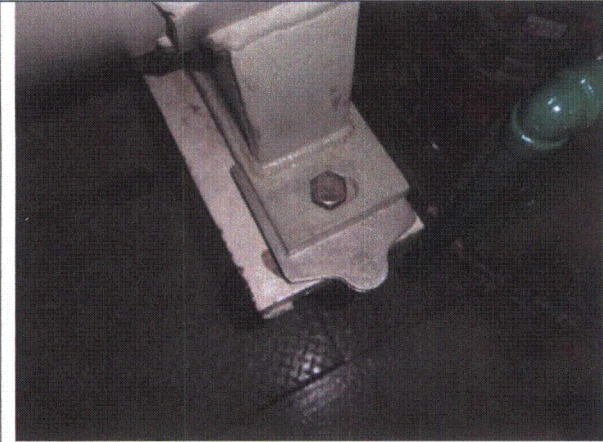
**Note:** Bolt missing washer on 93 WE-1A

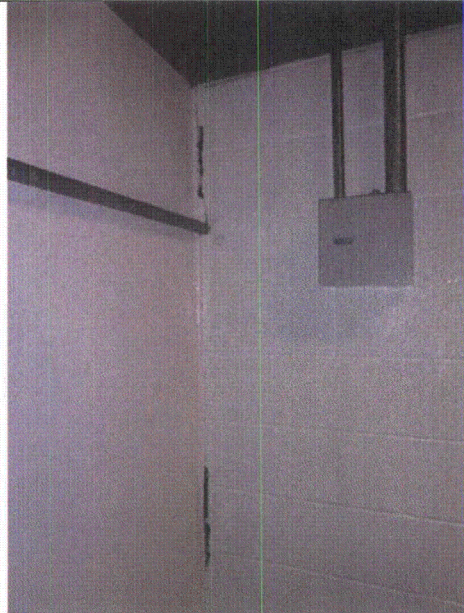
**Note:** Masonry wall joint with approx. 1/2" cracks.

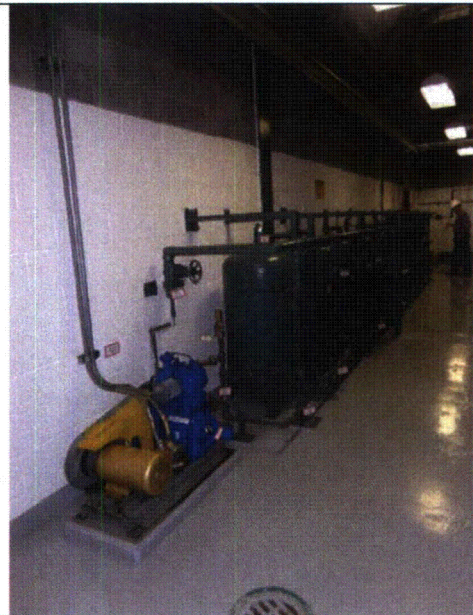
**Note:** 1/4" tubing along wall in tube track that is missing an anchor bolt

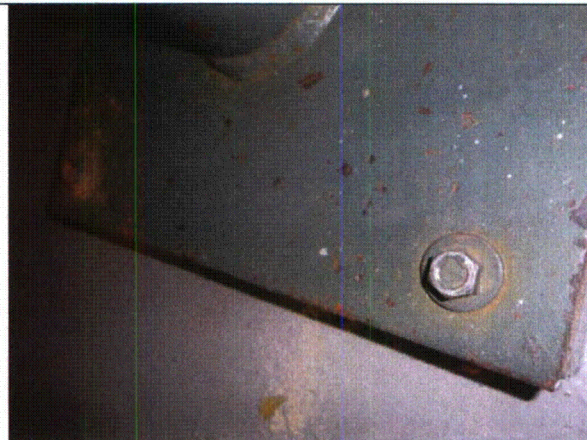
**Note:** 46FIS-102C anchorage. Less than full engagement by approx. 1 thread

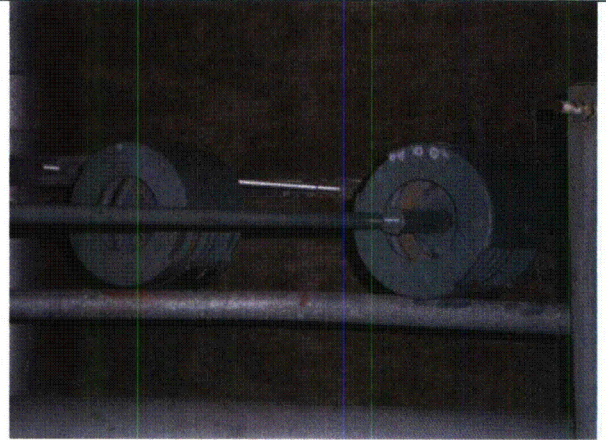
**Note:** South spring cans pipe support.

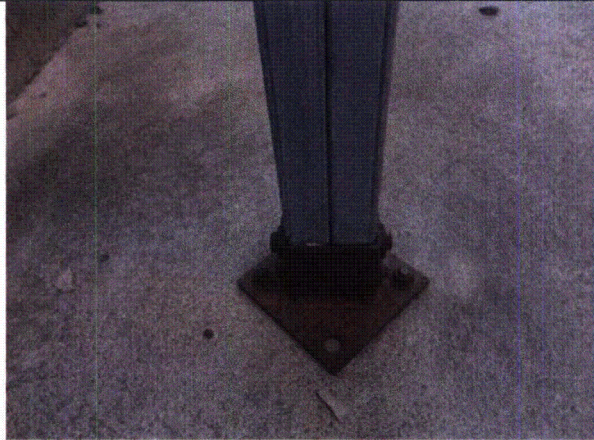
**Note:** Surface rust on baseplate for raceway support (back, i.e., west side, of 71MCC-120-OE1).

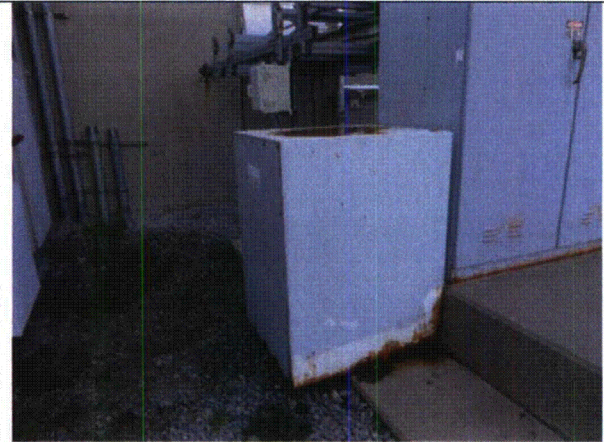
**Note:** Corrosion at base of JB Generator (box-like component in center of photo)
