Status: Y N U **Seismic Walkdown Checklist (SWC) SWEL1-065**Equipment ID No. F-52B Equip. Class¹ 17 – ENGINE GENERATORSEquipment Description DG2 ENGINE MOUNTED TURBO FILTERLocation: Bldg. RAB Floor El. 369 Room, Area 86Manufacturer, Model, Etc. (optional but recommended) Electro-Motive**Instructions for Completing Checklist**

Seismic Walkdown Checklist (SWC) SWEL1-065

Equipment Description DG2 ENGINE MOUNTED TURBO FILTER

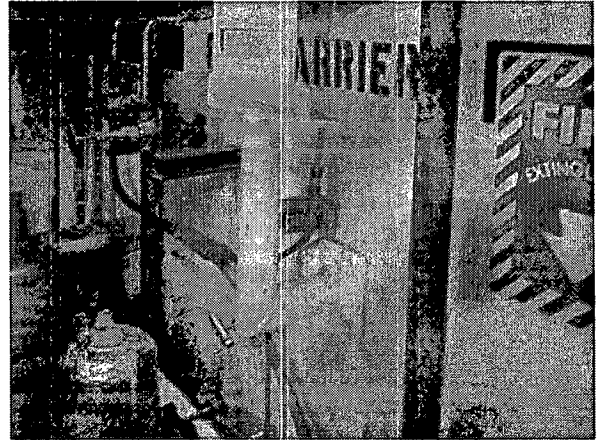
Note: Equipment is mounted on a pipe rack that is anchored by 4 1/2" bolts, as specified in the SEWS. As can be seen, the anchorage is in adequate conditions.

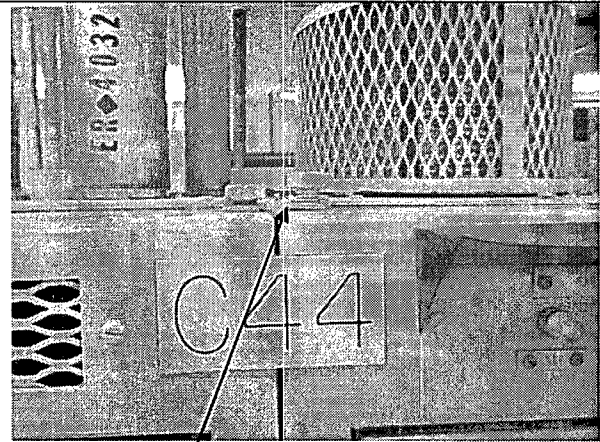
Loose bolt

Note: A loose bolt is shown on top of cabinet C44. The bolt was tightened at the time of inspection by Operations personnel.

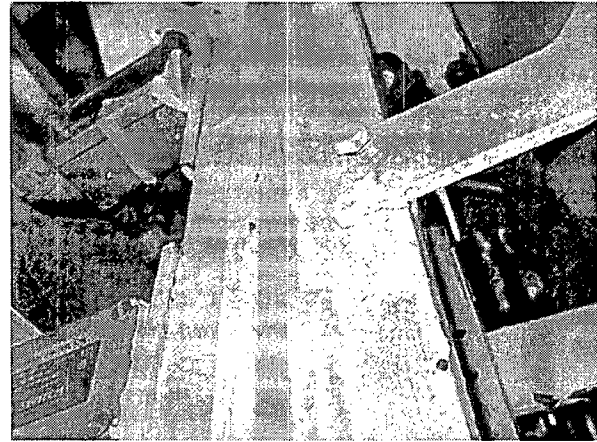
Note: It seems that there is one bolt that appears to be slightly loose. Although this may not show signs of an adverse seismic condition, it is advised that the bolt should be checked for tightness.

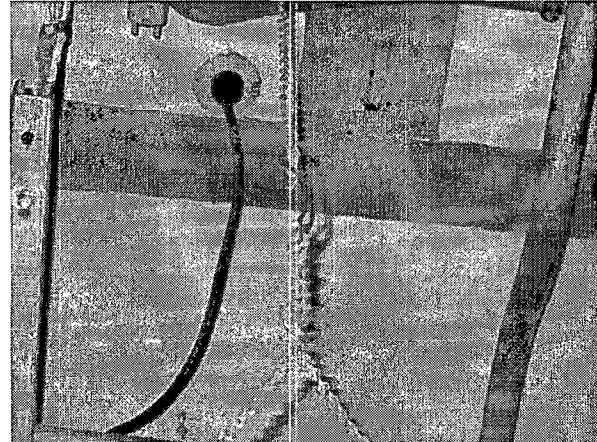
Note: *Observe unusual light support, however, this will induce no motion during a seismic event.*

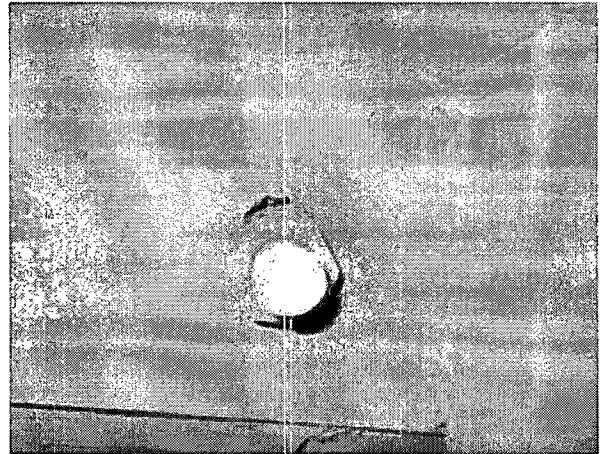
Note: *Significant degradation has been observed on two anchor bolts supporting the tank in the area. The degradation is evident in the steel plate below it.*

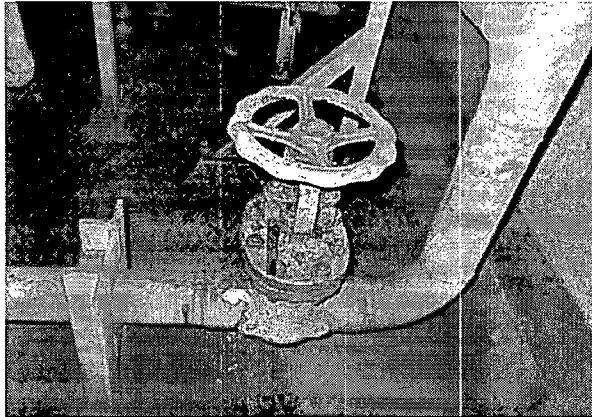
Note: *Some degradation in the bolts for Item FO-10B is evident.*

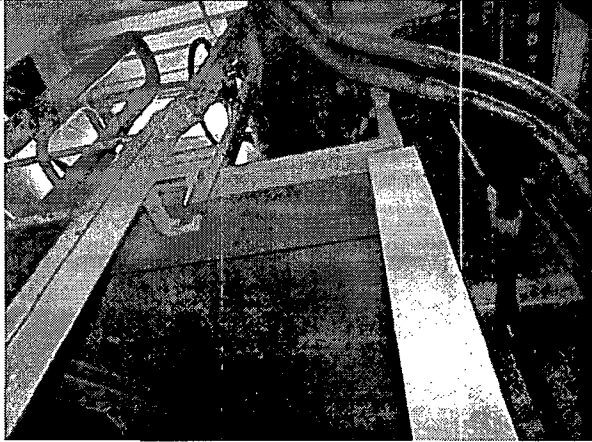
Note: *Feedwater Isolation Valve had a minor leak.*

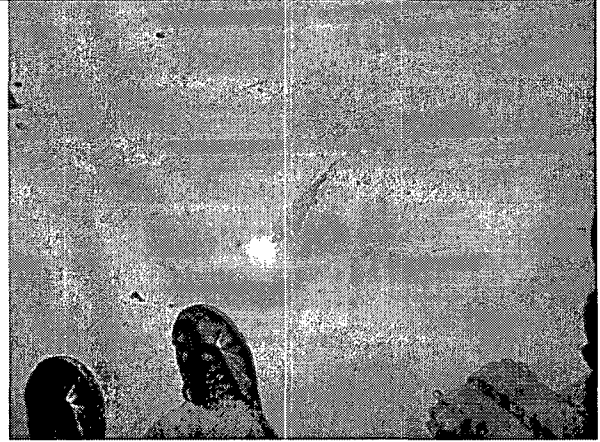
Note: *Image of the area with rust colored water from the feedwater valve overhead.*

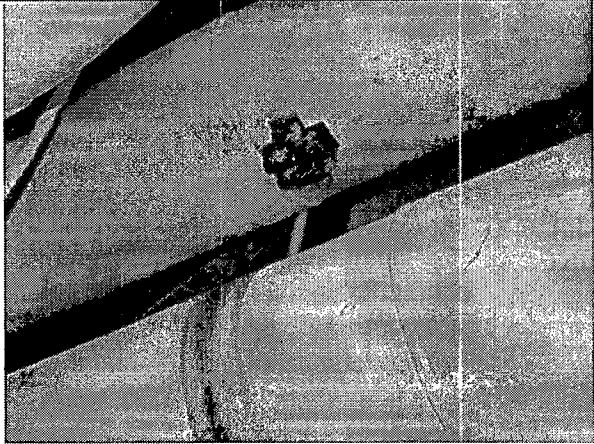
Note: *Image shows the piping in the end of the room that had some minor corrosion. This would not affect the safety functions of the system in case of seismic event.*

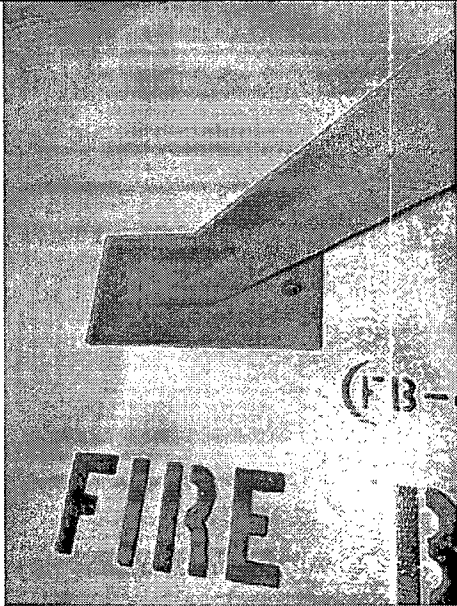
Note: *Support Missing Anchor Bolt*

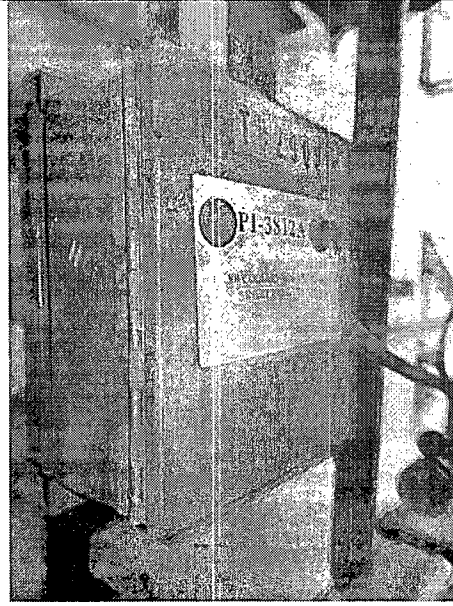
Note: *Component with Support Missing Anchor Bolt*

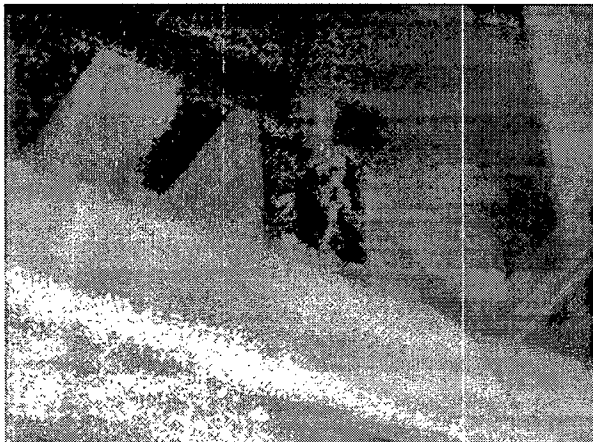
Note: *There is an open S-hook for one lighting fixture that is above Cabinet C115 in the area. This can easily collapse onto the cabinet during a seismic hazard.*

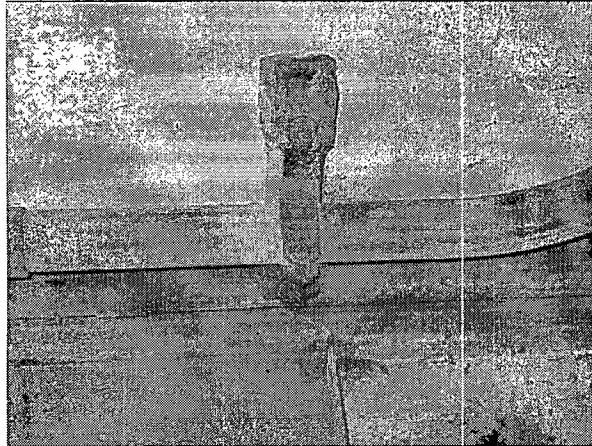
Note: *This image shows the conduits anchored to the WEST wall near the floor. It is evident through this image that there is a corrosion issue on this anchorage. This conduit is found in the lower level of the intake building.*

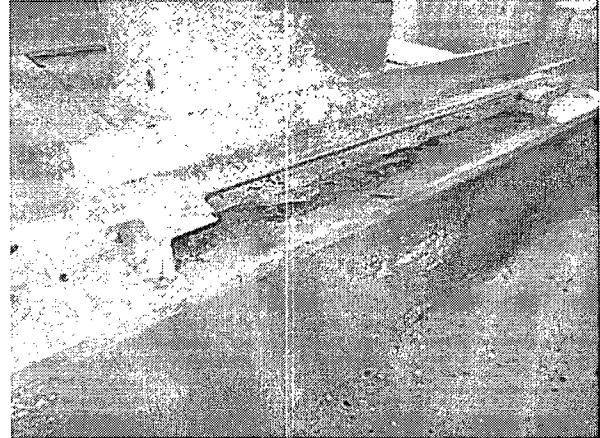
Note: *The anchorage for component HBD-14-H49 had signs of corrosion. This item is found in the lower level of the intake building.*

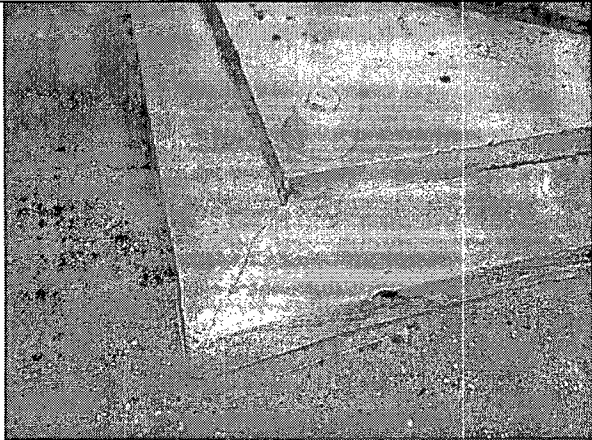
Note: General image showing a crack in the grout pad. Item is found in upper level of the intake building, below P-4A service water pump. Ruled to not be a seismic concern.

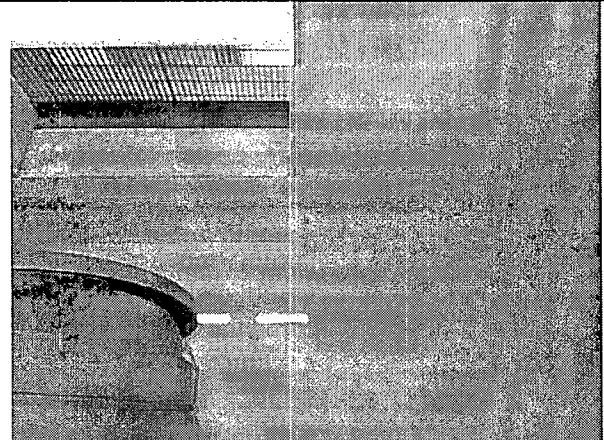
Note: General image showing a crack in a ceiling-wall intersection. Found in the upper level near southwest wall. This crack does not pose any seismic concerns.

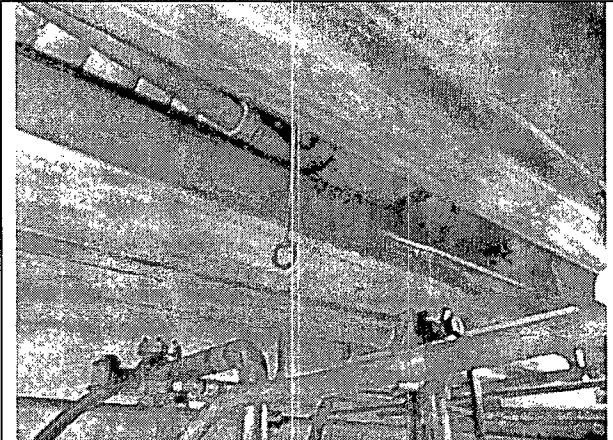
Note: *Image shows the free rigid support hanging from the ceiling. Although this is not a seismic hazard, it is not supporting any equipment.*

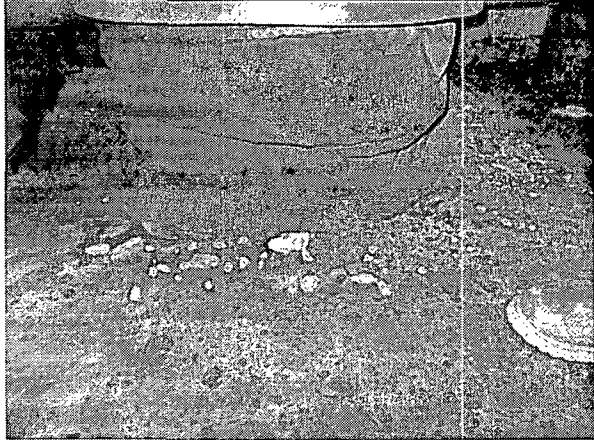
Note: Concrete spalling onto floor from deteriorated conditions at penetration above.

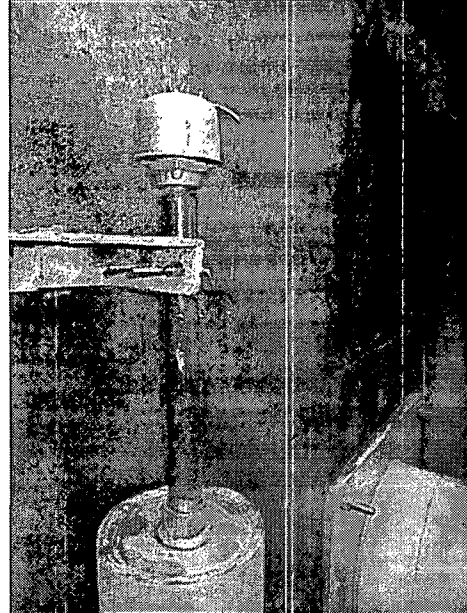
Note: Flame arrestor with oil spray marks on wall.
