AREA WALK-BY CHECKLIST

Area Walk-By Checklist (AWC) AWC-013

Location: Bldg. SWSTR PIT Floor El. 5'-9" Room, Area¹ Zem Strainer Pit

ATTACHMENT E – POTENTIALLY ADVERSE SEISMIC CONDITIONS

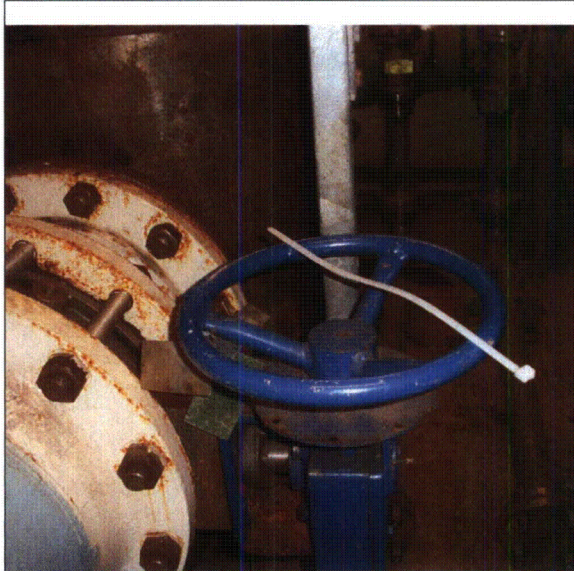
Note: Wire ties found lying loose in area.

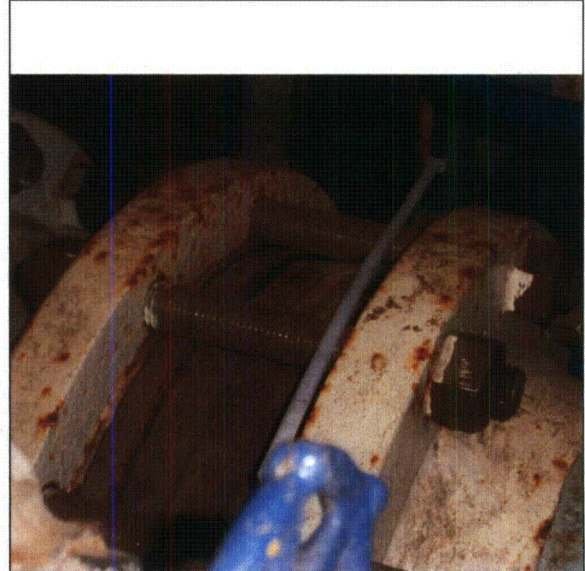
Note: Wire ties found lying loose in area.

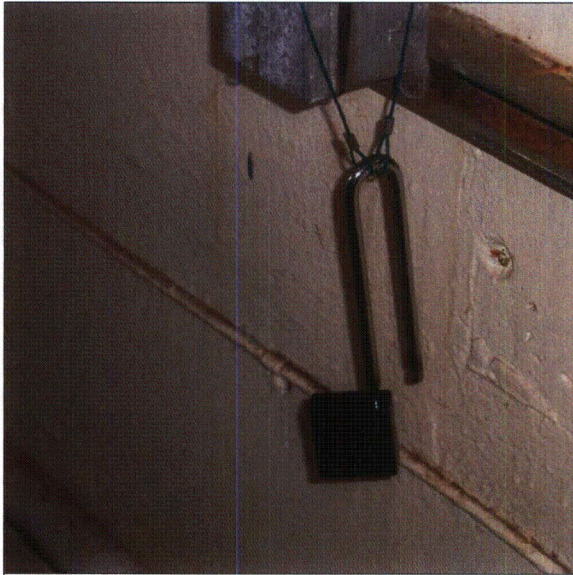
Note: Lock found open in area.

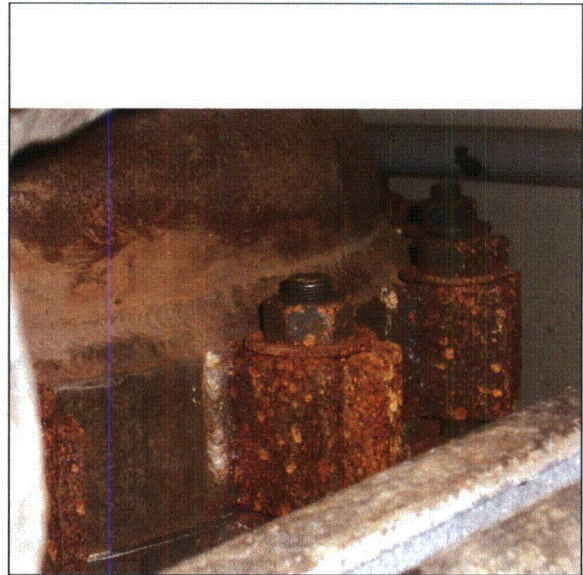
Mild surface corrosion observed. Judged acceptable.

Note: Example of the mild corrosion found.

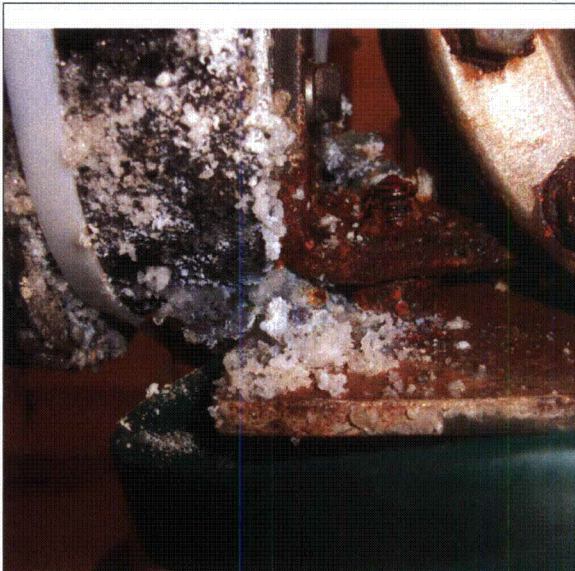
Note: Salt crystals found on SWN-625-X3 22SWP Equalizing valve DPI-5001-S.

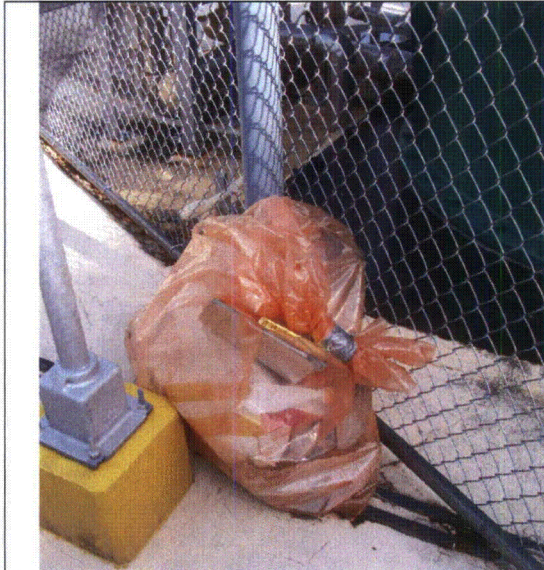
A bag of trash was left against the fence, and other scattered trash was found as well as a loose bolt not attached to anything. See photos below. CR IP2-2012-06649 issued to track resolution.

Note: Trash bag left in area with a loose bolt lying on top.

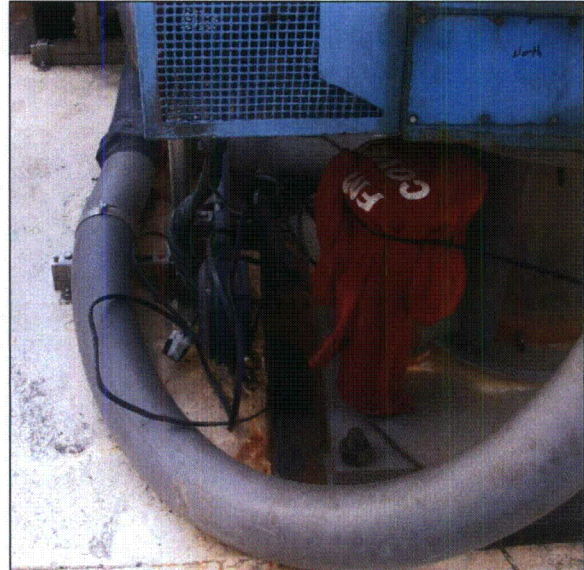
Note: FME cover left on pipe to service water pump 24.

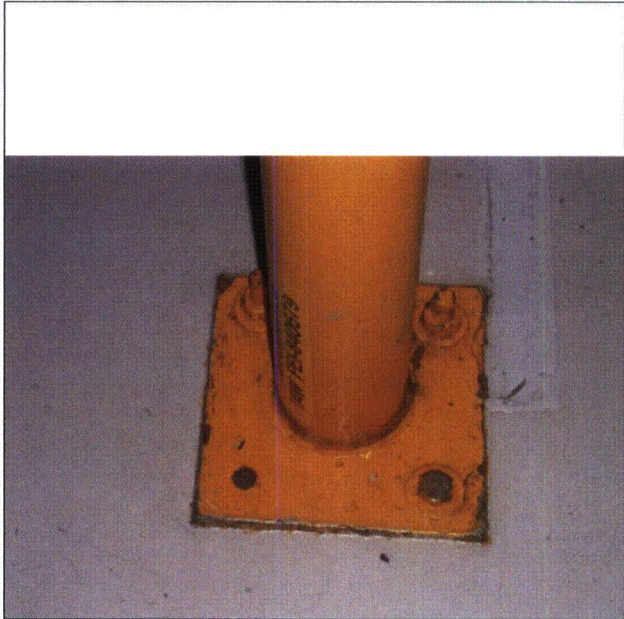
Note: Trolley stanchion with missing anchor bolt.

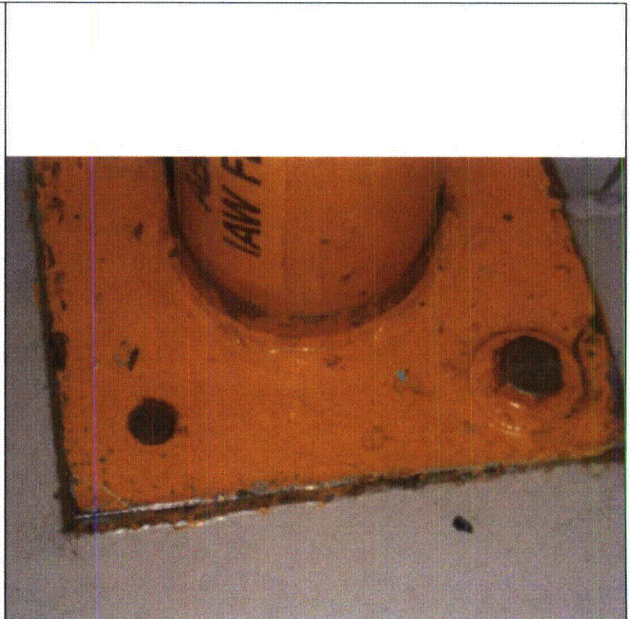
Note: Trolley stanchion with missing anchor bolt.

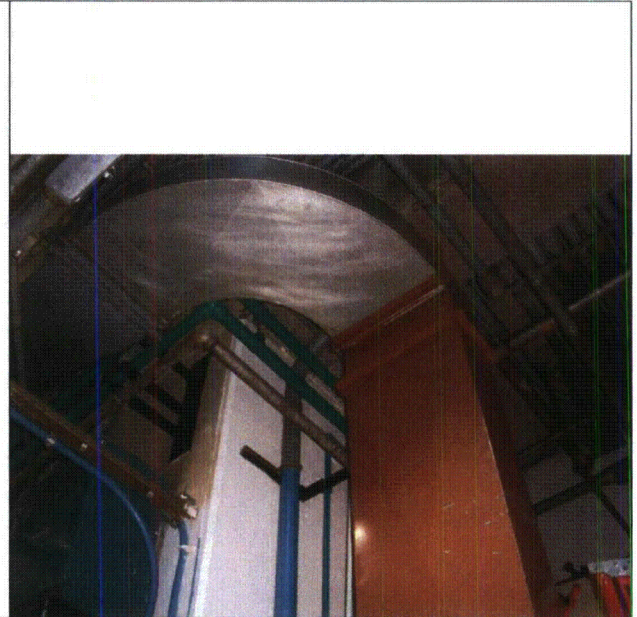
Note: Duct work with excessive span between supports.

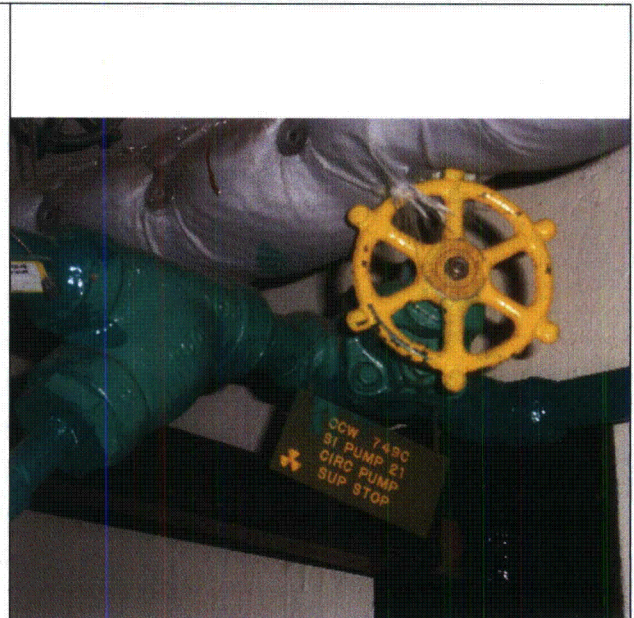
Valve CCW 749C (SI Pump 21 Circ Pump Sup Stop) hand wheel rubs insulation along west wall of room near end of 21 SI pump. The insulation is starting to show signs of damage due to the rubbing. Judged not to be a seismic issue given softness of insulation. CR IP2-2012-06576 issued to track resolution.

Note: Valve 749C SI Pump 21 Circ Pump Sup Stop rubbing and damaging pipe insulation.

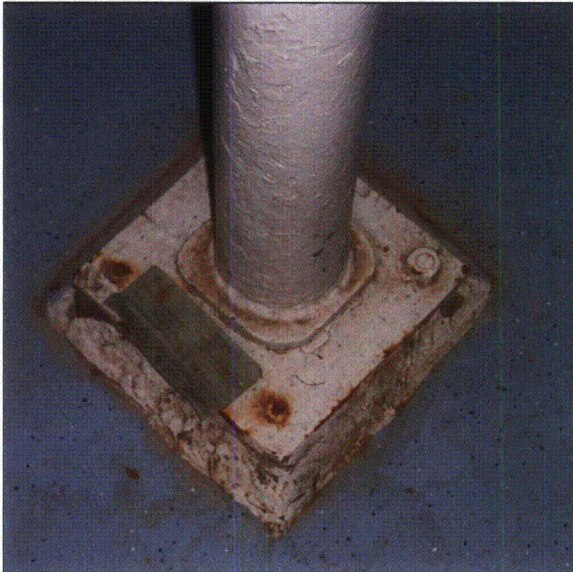
Note: Pipe support for CCW missing two anchor bolts. Existing work order tag is WRT IP2-05-0522.

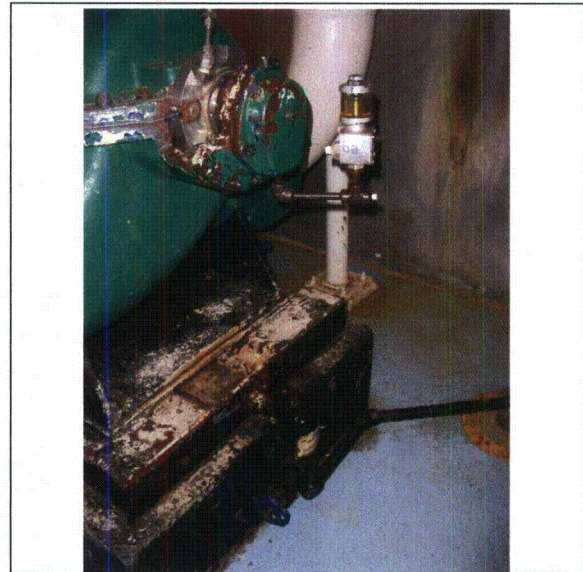
Note: Pump 23 CCW pump is leaking oil onto the floor.

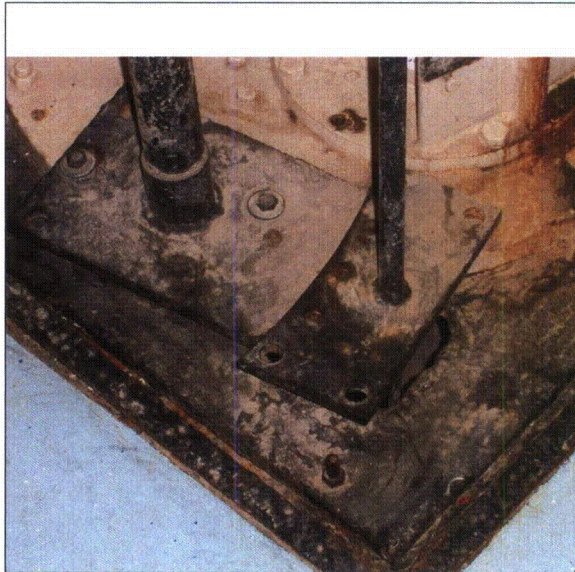
Note: 23 Sump Pump missing bolts on the float rod guide.

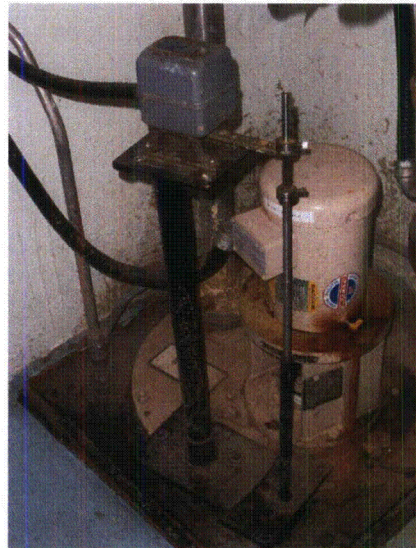
Note: 23 Sump Pump missing bolts on the float rod guide.

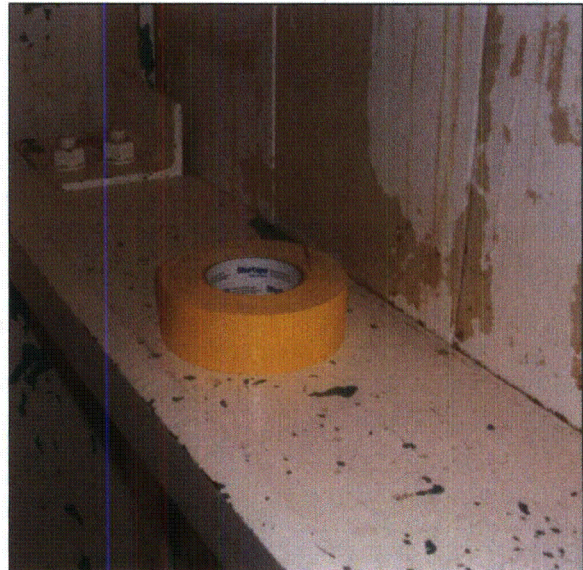
Note: Tape left loose around.

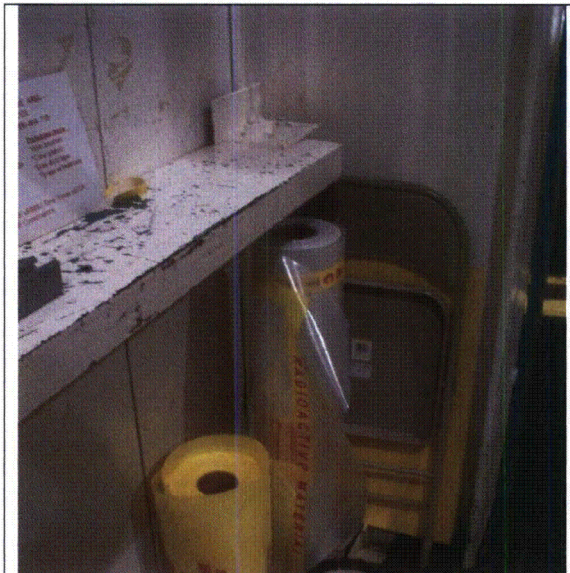
Note: Items left loose in corner, chair and plastic rolls standing up.

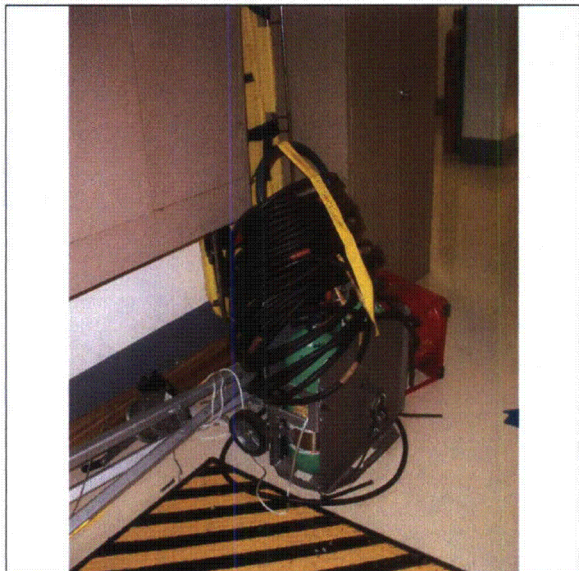
Note: Tools left loose near confined space rescue gear area. CR IP2-2012-06359 issued to track resolution.

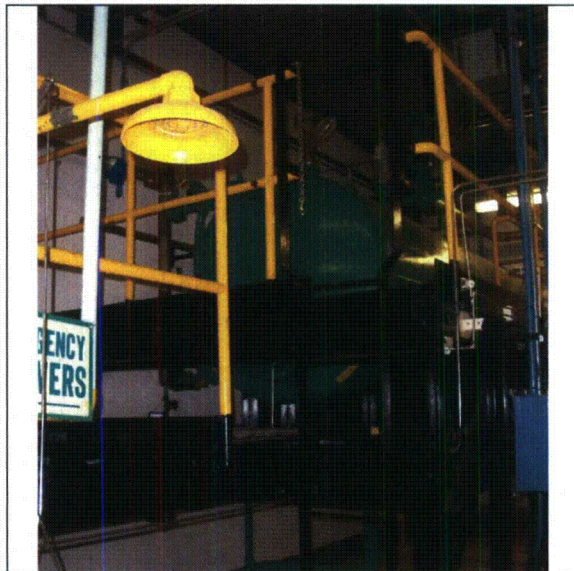
Note: Ladder safety chain kept unattached on Component Cooling Surge Tank platform ladder. CR IP2-2012-06354 issued to track resolution.

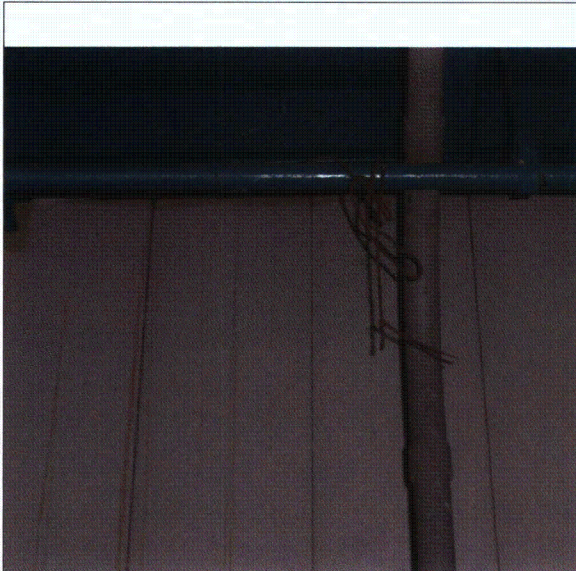
Note: Wire left hanging loose on a overhead conduit located in the north east corner of the room (Wall west of 22 Boric Acid Tank). CR IP2-2012-06354 issued to track resolution.

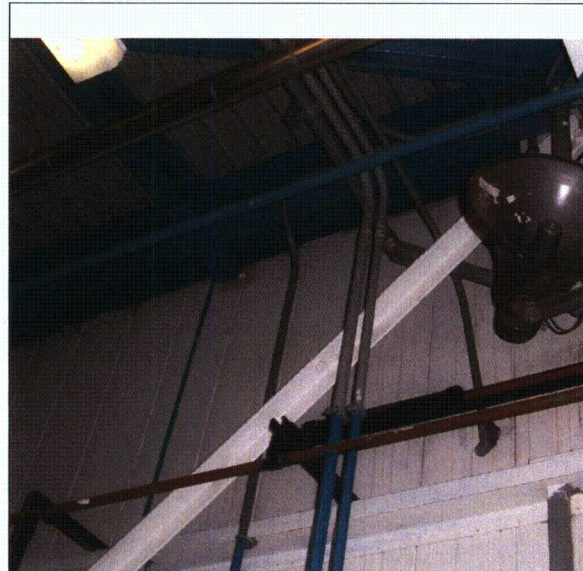
Note: Abandoned conduit left hanging loose. CR IP2-2012-06354 issued to track resolution.

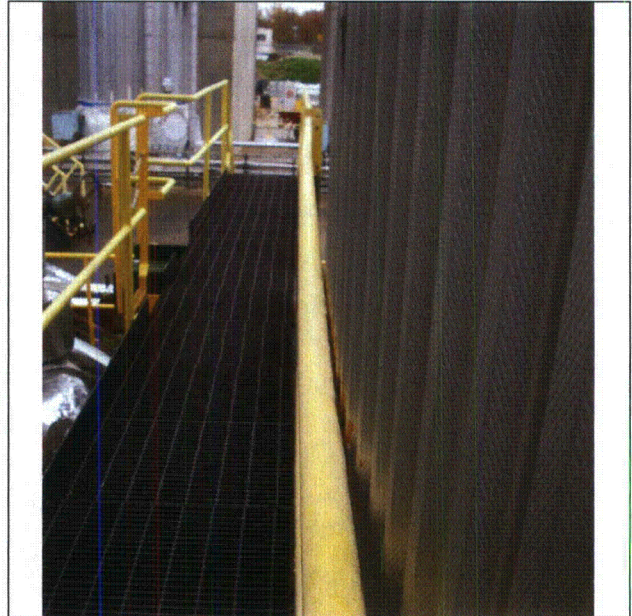
Note: Very small gap between platform and Primary Water Storage Tank.

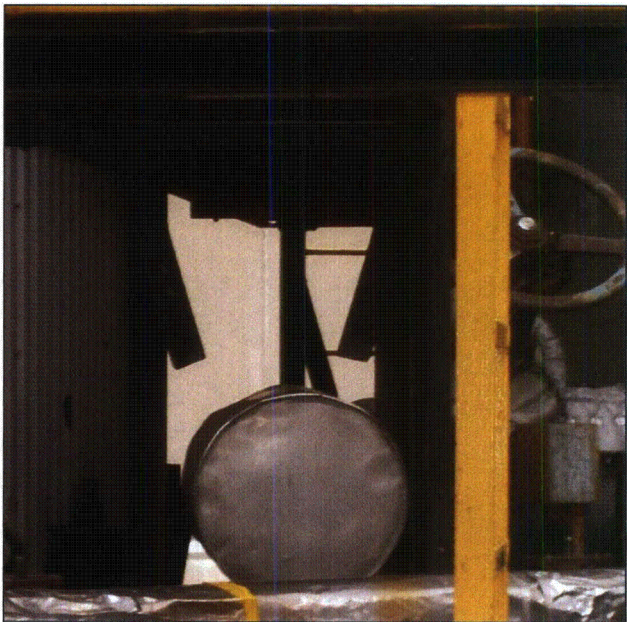
Note: Platform bracing has been cut just north of RWST bolt 29 for the RWST pipe end to pass.

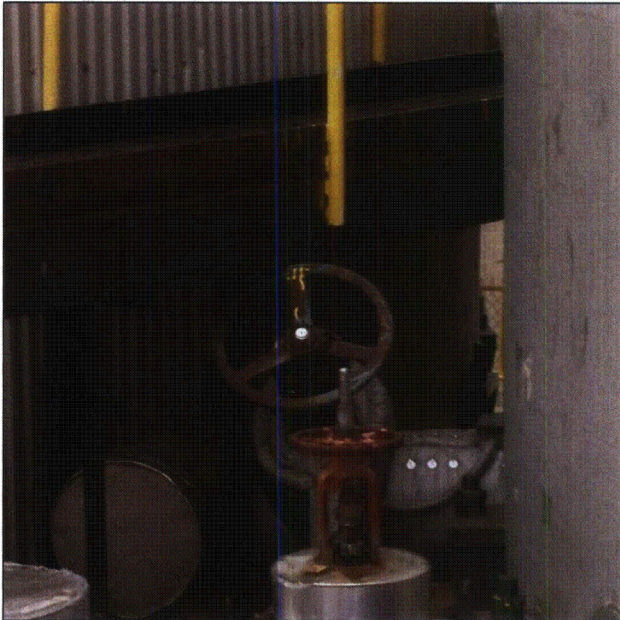
Note: Valve hand wheel at RWST anchor bolt 29 is very close to touching the platform at frame with cut bracing. Gap is very narrow, almost 1/8". Platform could potentially hit valve handle.

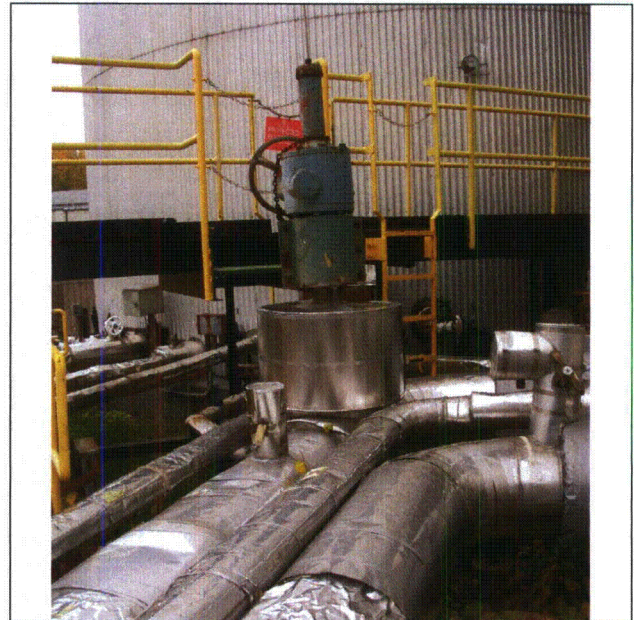
Note: Piping insulation & insulation flashing damaged in multiple places.

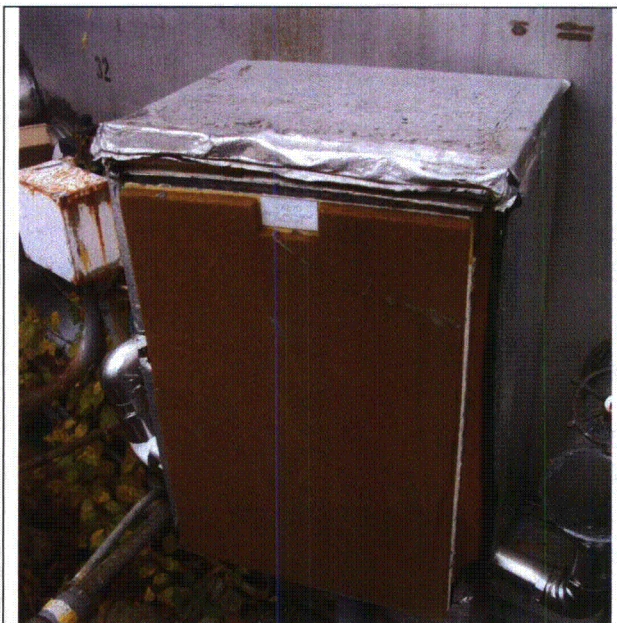
Note: *Insulation on EWD70 RWST Instrument Panel needs repair.*

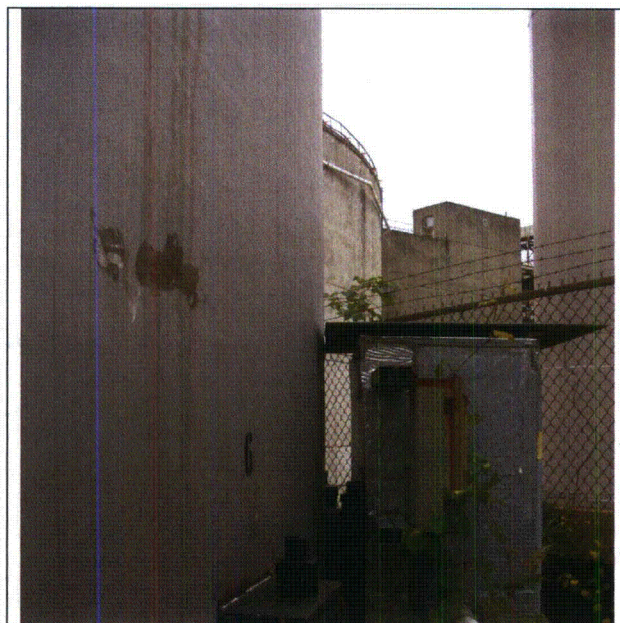
Note: *Roof cover on cabinet EPA-20 is close to RWST. Gap judged acceptable given components involved.*

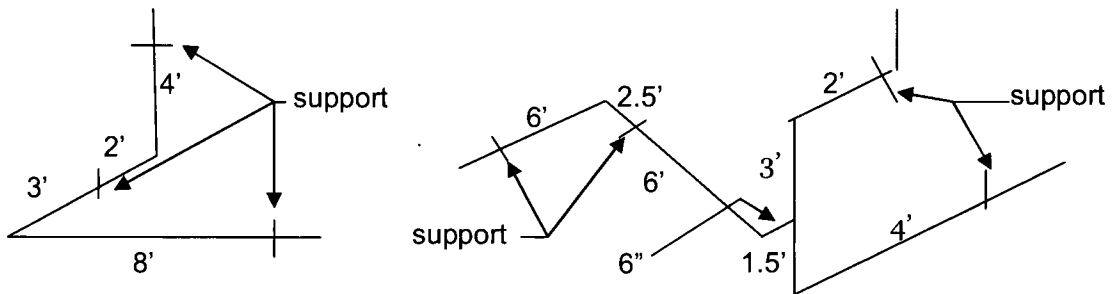
At the entry to the room there is 5/8" OD tubing which has relatively long unsupported spans as noted in the isometrics below.

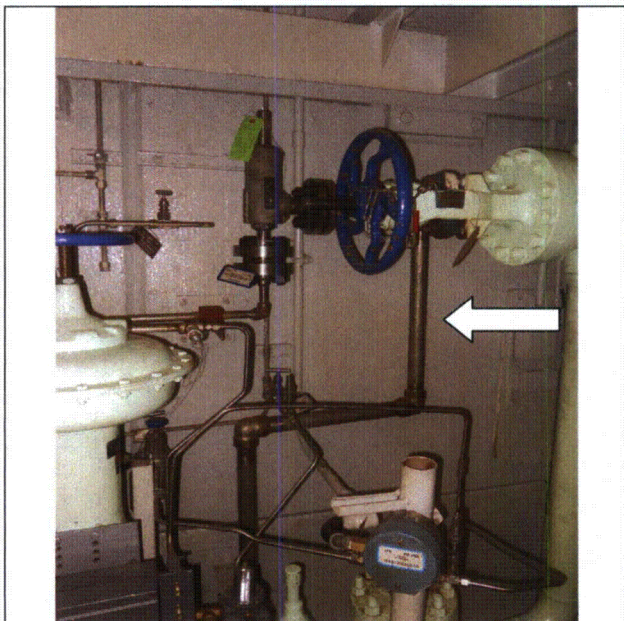
Note: 2"± diameter pipe connecting to PCV-1284 has excessive unsupported length.

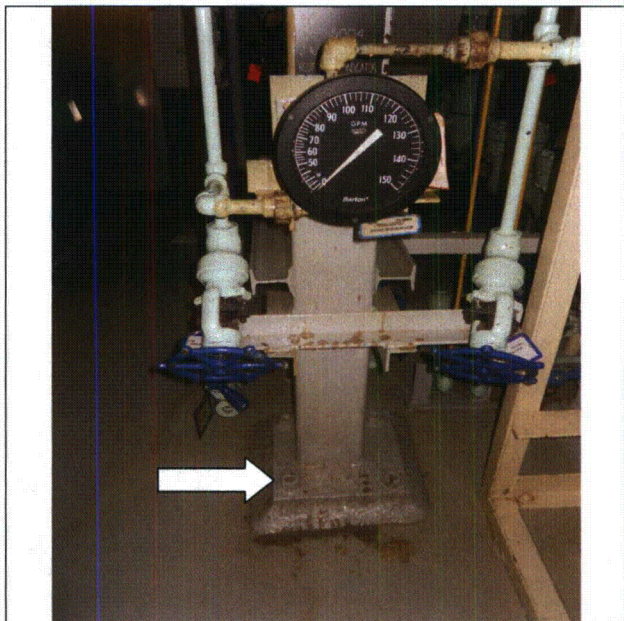
Note: 5/8"± diameter anchor bolts of F1-5004 support column are not fully engaged. (Missing about 1/4").

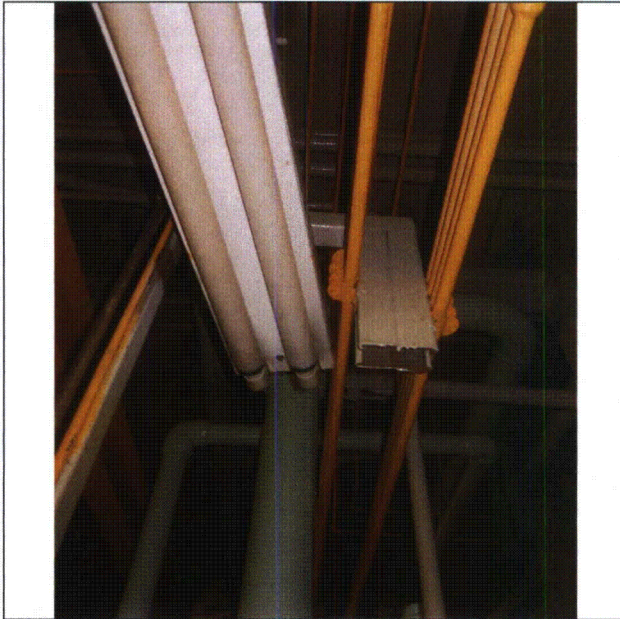
Note: *Fluorescent light is too close to the tubing.*

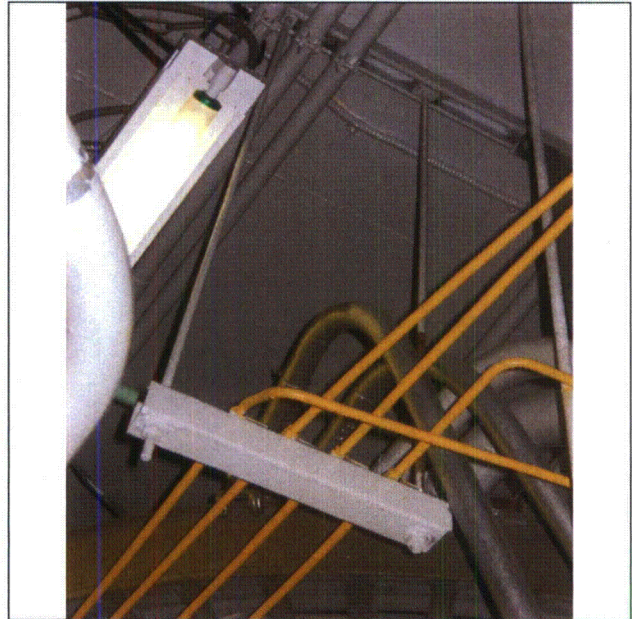
Note: *Fluorescent light is too close to the cable tray (other end of the same light) and support hanger.*

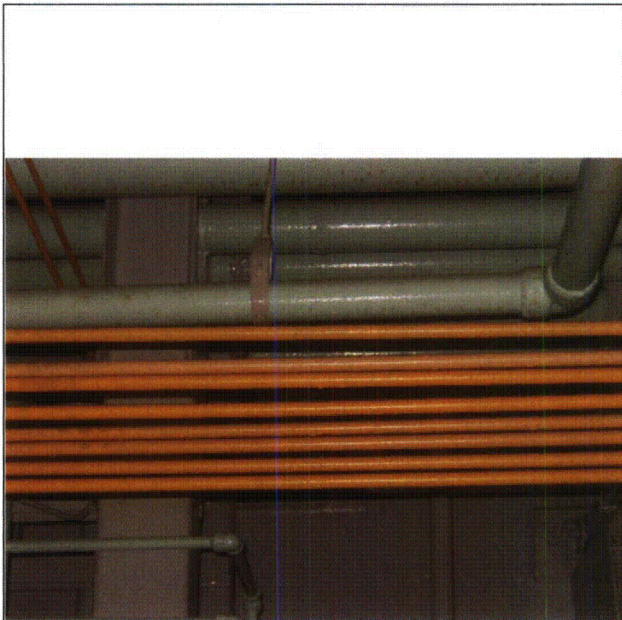
Note: Long span tubing has little separation (<1/2"). They will be interactive each other during seismic event.

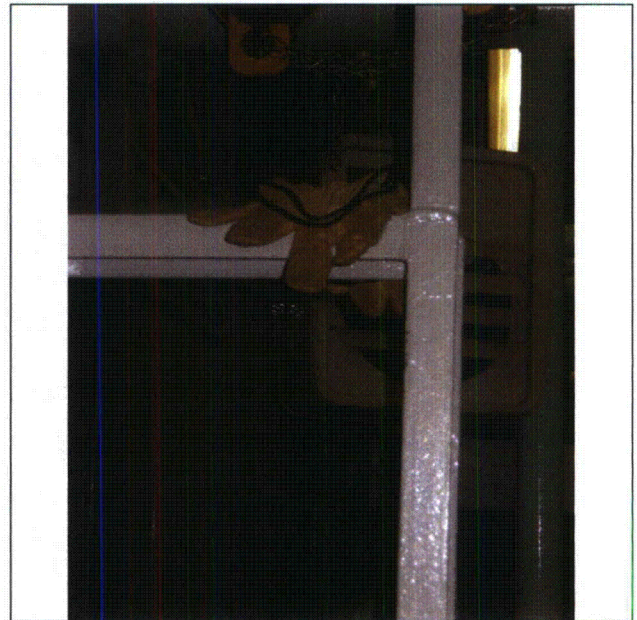
Note: Used glove is found in the area.

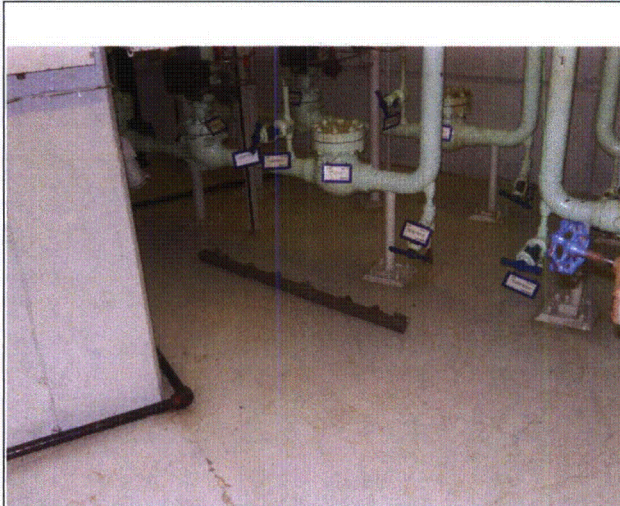
Note: Leftover scaffold part is found in the area.

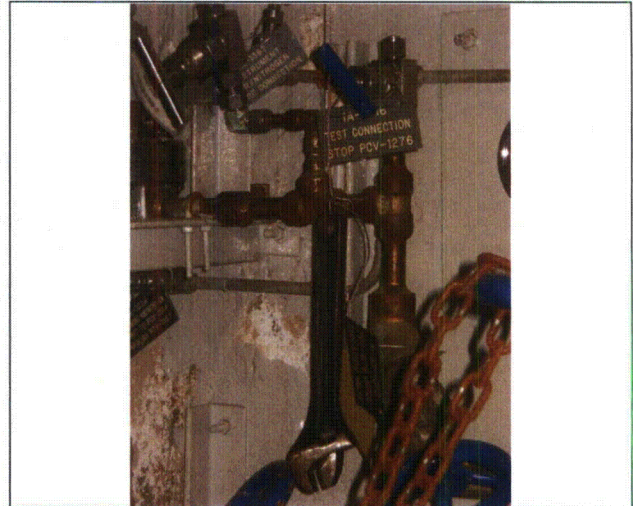
Note: Wrench hung by a wire in front of the instrument panel.

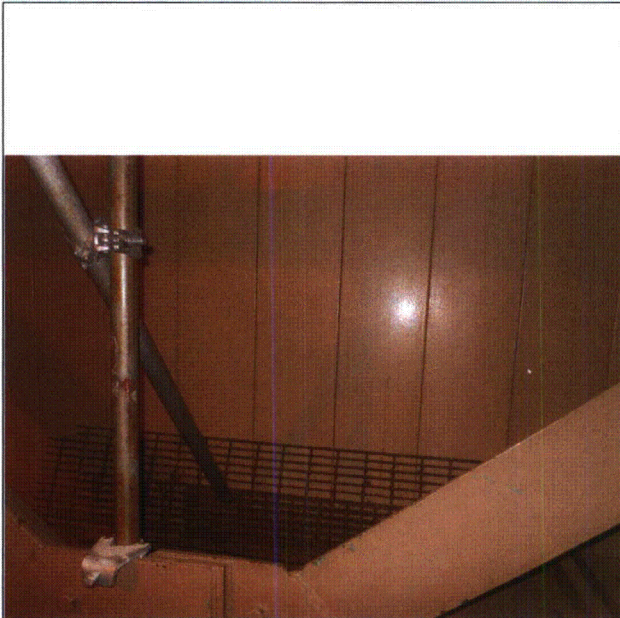
Note: Grating stored on concrete ledge and adequately restrained using scaffold poles.

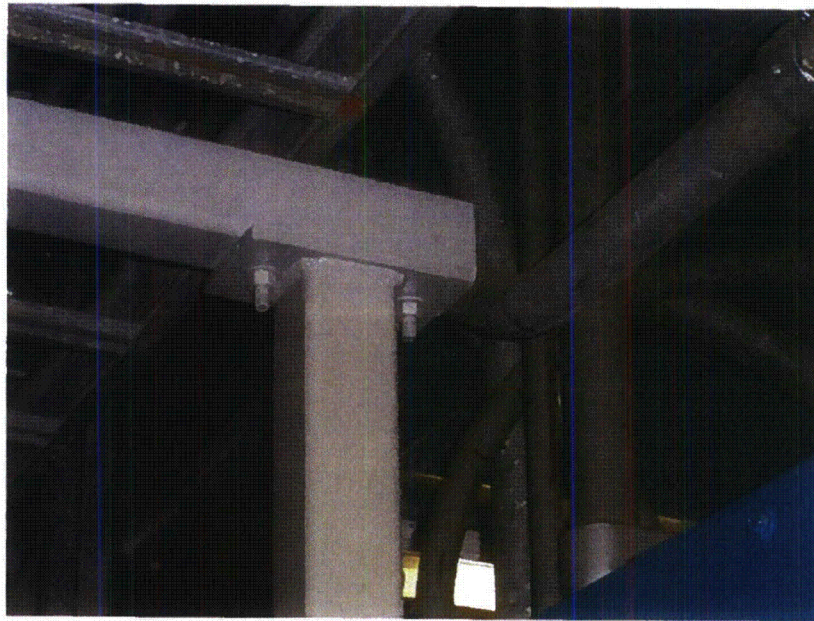
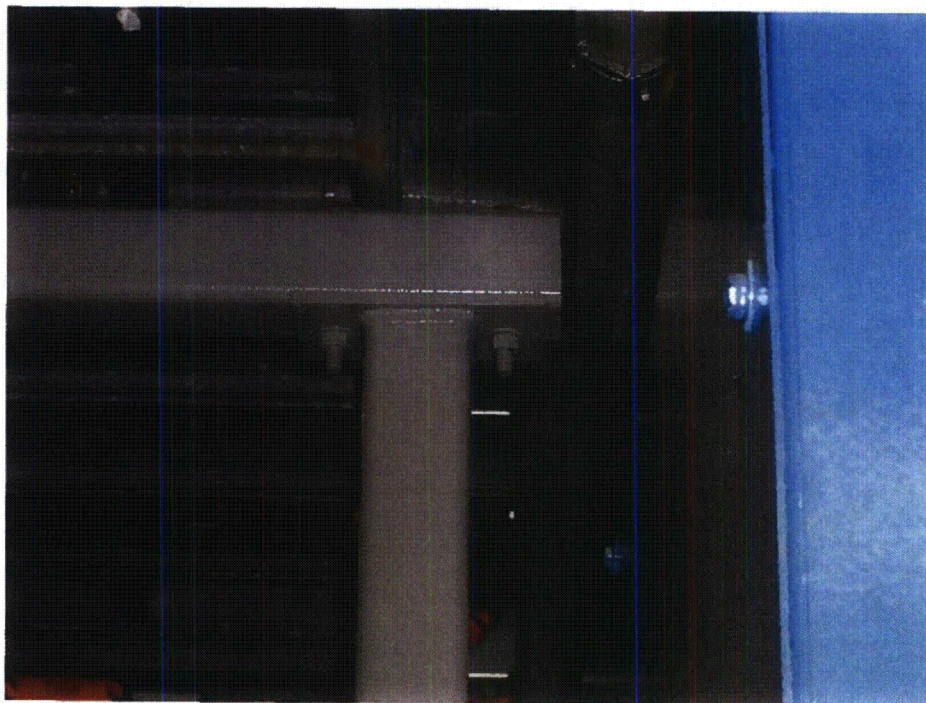
Two views of the conduit found to be approximately 3/4 inches away from the western end of the frame are shown below:

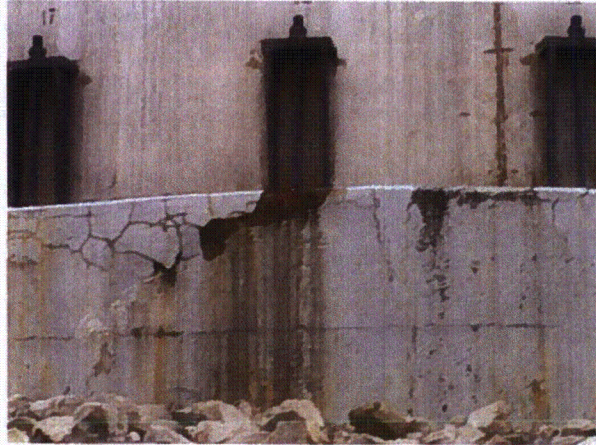
The CR noted that: "During the Fukushima Seismic Walkdowns of the 21 Refueling Water Storage Tank, it was noted that small cracks of the concrete exist near bolt nos. 30, 24 & 25. These are acceptable and not a seismic concern. The walkdown team also noted significant concrete spalling and numerous cracks near bolt nos. 16,17,18,19. A picture depicting these type of cracks is provided below.

Significant Spalling and cracks near bolts 16 and 17" (Note the spall/cracks shape appears to be at the same location as the plastered area note in 2001 and shown below on Page 7)

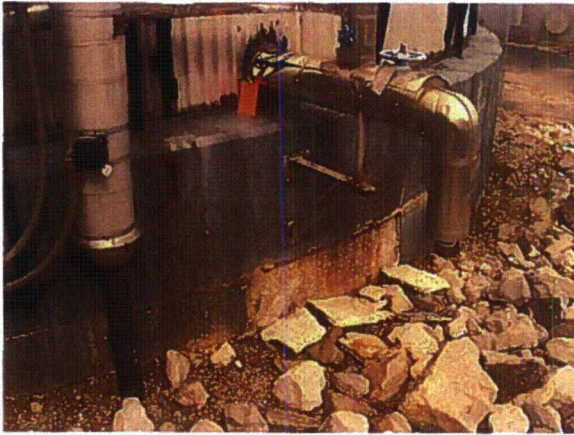
Shown in the photograph to the left, the largest spall exists on the southern side of the Primary Water Storage Tank ring wall.

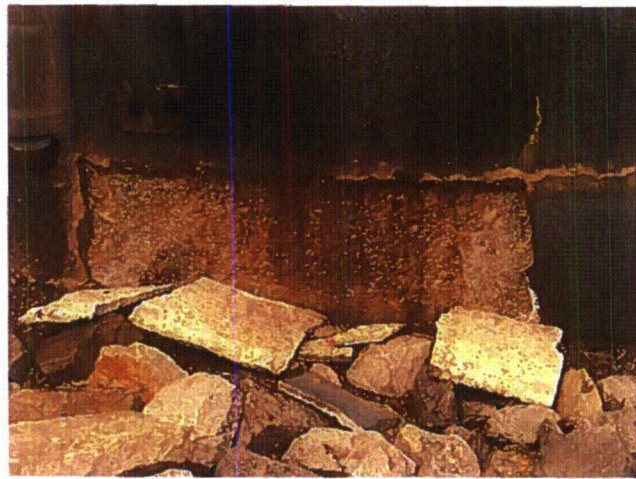
A close-up picture of the area shows the spalled concrete protective cover pieces that fell, and the "curling of the remaining pieces at the edges where the delamination of the protective cover is visible.

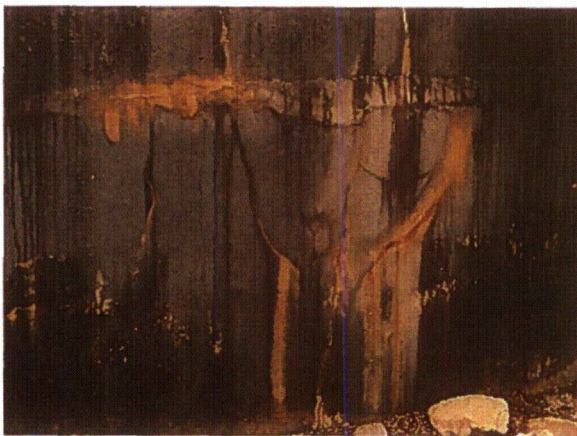
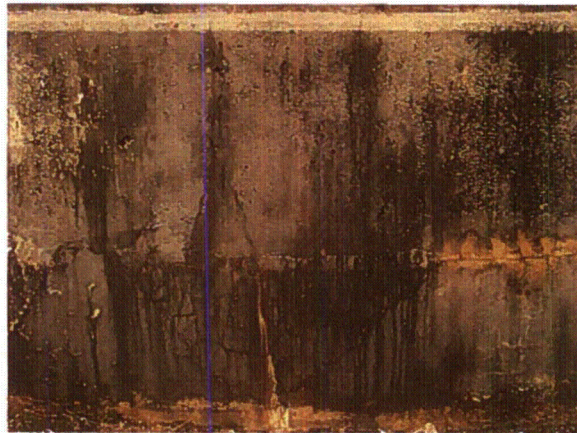
Cracking and bulging of the protective cover on the Primary Water Storage Tank ring wall is apparent at numerous locations. Some of the typical cases are pictured below.

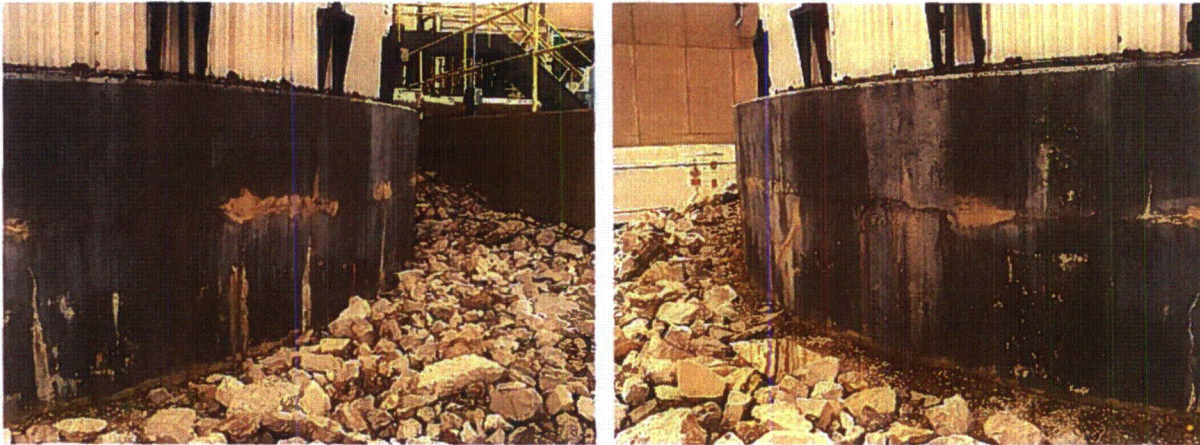
Also for the Primary Water Storage Tank ring wall, the pictures below depict the horizontal crack that seems to have developed between the upper protection cover and the lower portion

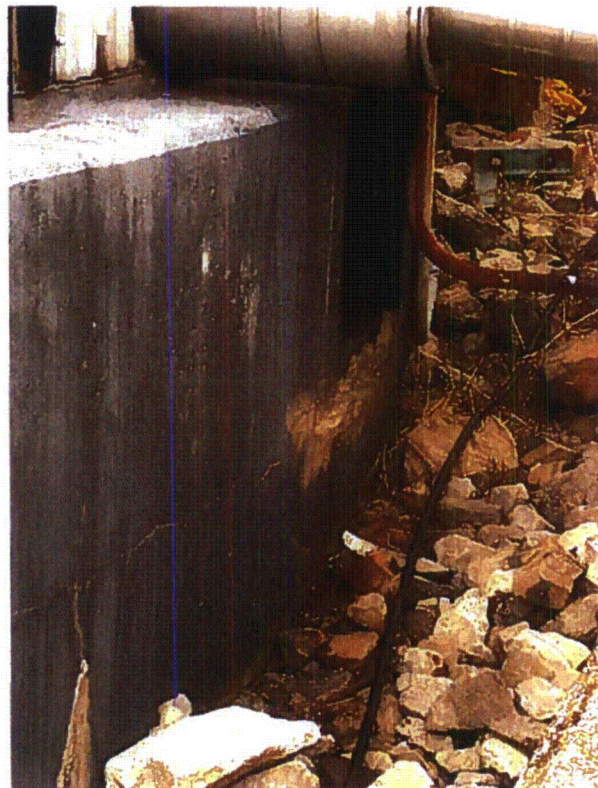
The pictures above cover the eastern portion of the Primary Water Storage Tank ring wall. In the adjacent picture we show a similar area in the northern portion of the ring wall where pipes penetrate the tank.

The mid-height area along the horizontal crack appears to have been previously grouted immediately below the pipe.

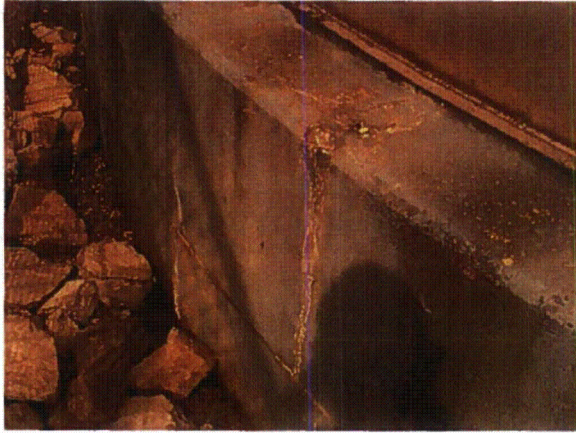
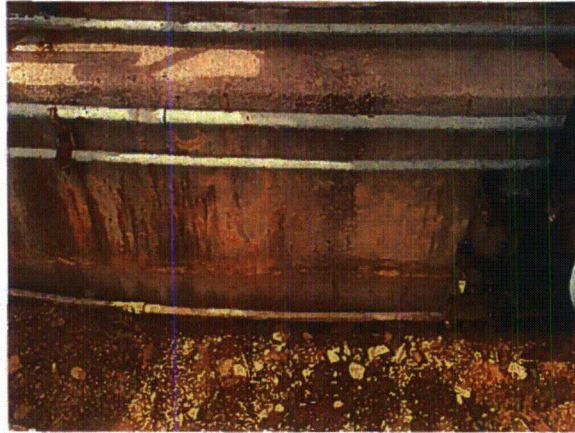
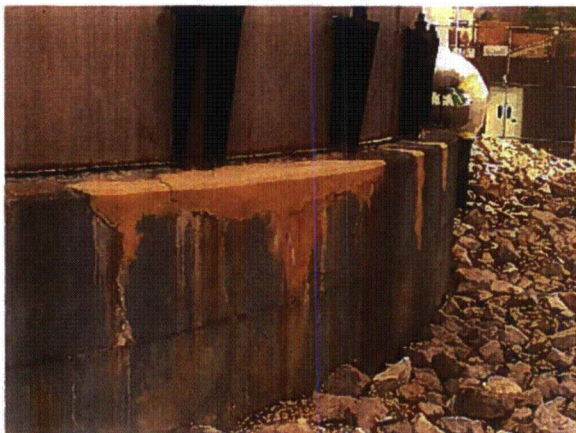
While the Refueling Water Storage Tank ring wall support has smaller spall areas, it displays the same horizontal crack between the two protective layer "courses," vertical cracks, and small

delaminated areas, as depicted in the pictures that follow.

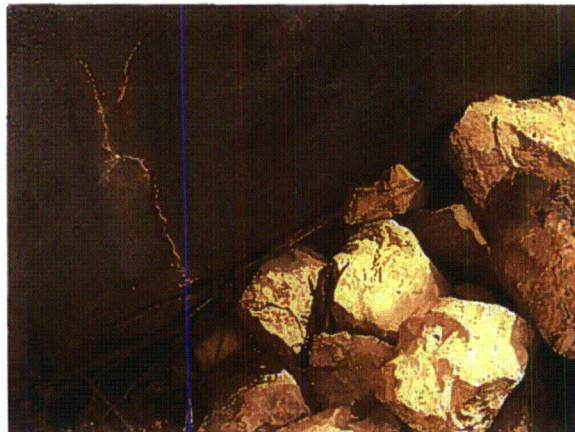
The adjacent picture shows vertical cracks in the protective layer. At the bottom of the crack, along the separation between the upper and lower protective layer courses (which, at this western location is close to grade), a separation of the lower protective course is apparent, as well as delaminations of the protective layer away from the crack zone.

While for both tanks the protective layer appears to be in rather poor condition, and would be expected to separate from the ring wall, the concrete behind the protective layer appears to be in excellent shape. There are no reinforcing bars exposed at any of the spall locations, confirming that the layer that is spalling is a protective layer.

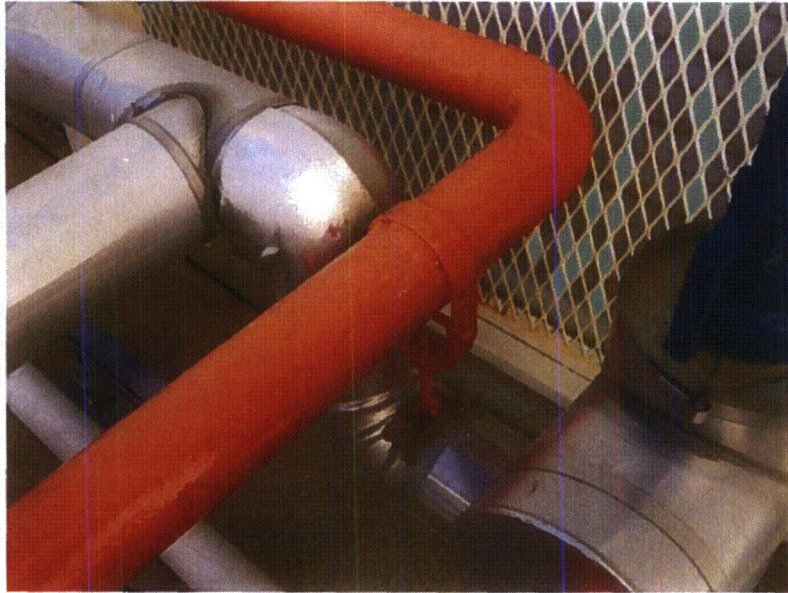
*One pipe is supported from another pipe. This is a none typical pipe support.
One pipe (insulated pipe) runs to the Emergency Domestic truck fill stop valve and the other orange pipe from the EDG building into ground near 23FOTP.*

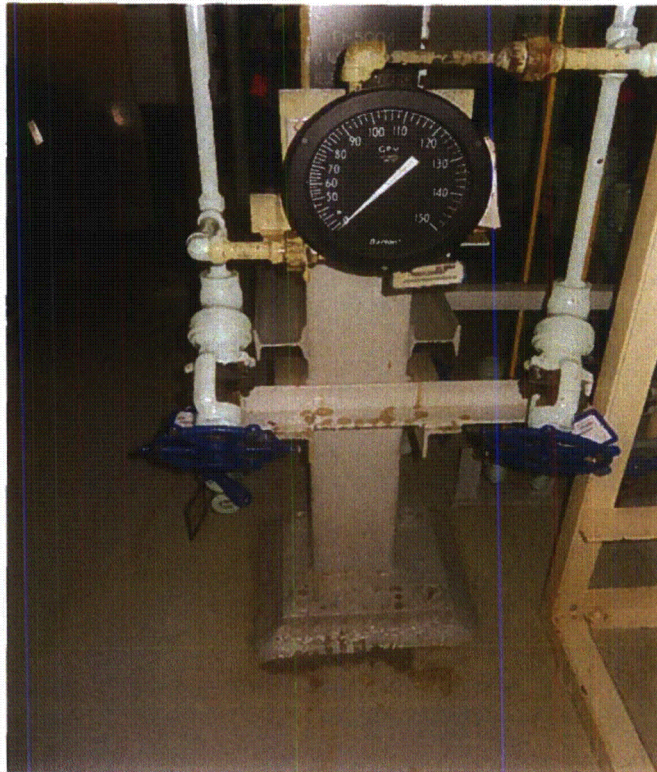
The Seismic Walkdown Team noted that the $5/8'' \pm$ diameter anchor bolts of F1-5004 support column are not fully engaged. (top of bolt is approximately $1/4''$ below the top of the nut).

5/8'' ± diameter anchor bolts of F1-5004 support column are not fully engaged. (Missing about 1/4'').

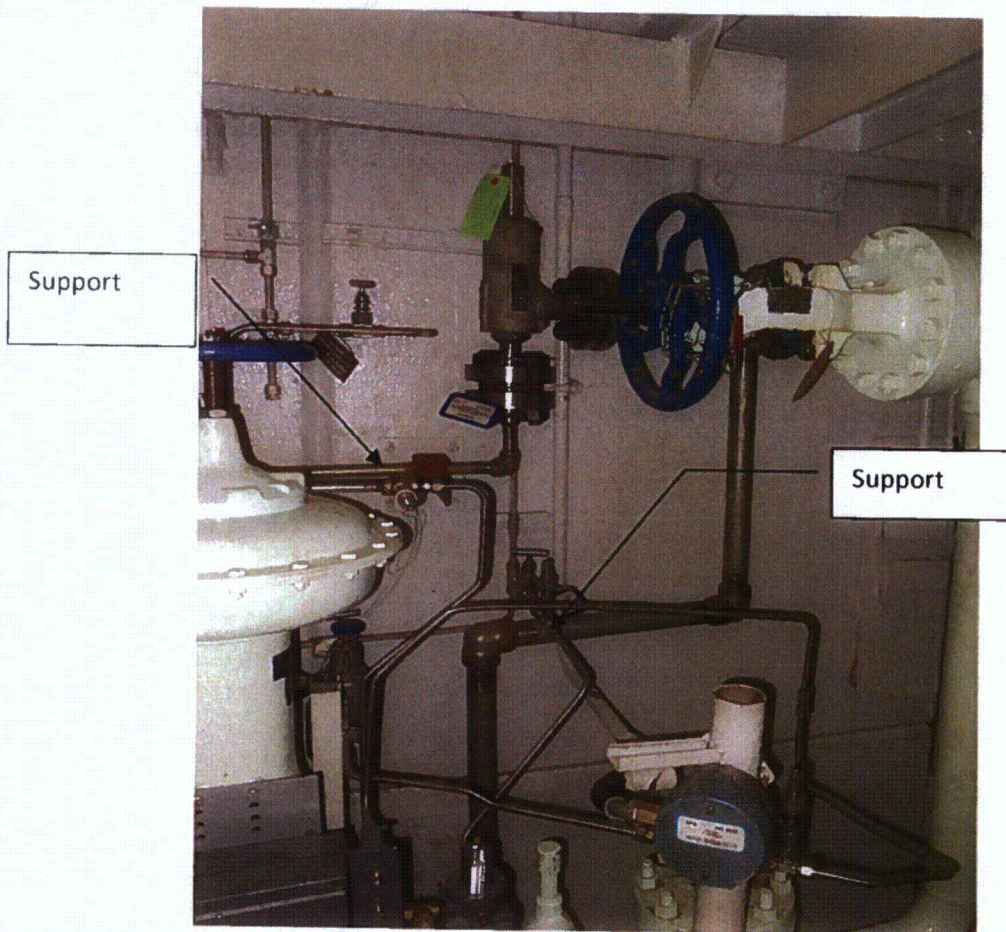
A subsequent walkdown of the pipe location by members of the IPEC Design Engineering Department certified for performance of the Seismic Walkdowns, assessed the configuration and found that: (1) spans are not excessive for the 2 3/4" diameter pipe, for which a span of 8'-0" would not be questionable, (2) the in-line loads are not excessive, and (3) the configuration is acceptable.

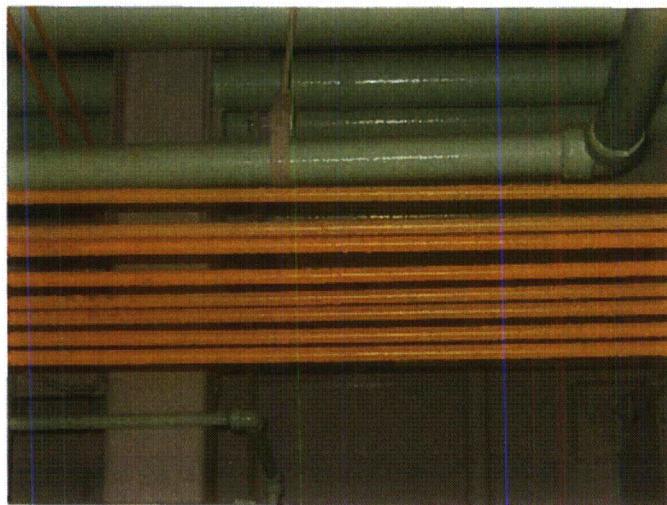
The Seismic Walkdown Team noted that Long span 5/8" OD" tubing has little separation and typical span length of eight feet .The tubes will interact with each other during seismic event. There are also 3/8" OD tubes also in close proximity to each other which have similar unsupported spans. Photographs of the tubing configurations, contained in AWC-35 are provided below:

Long span tubing has little separation (<1/2") .They will be interacting with each other during a seismic event.

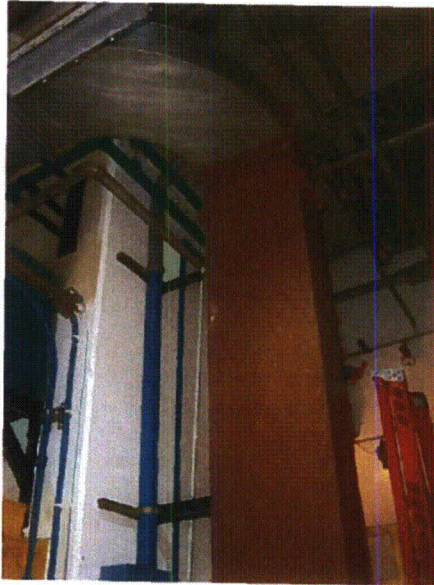
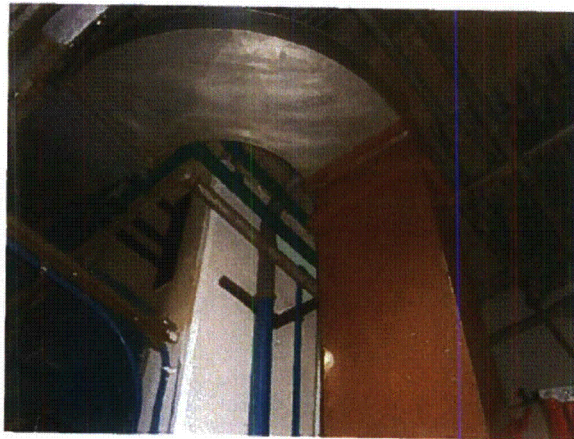
Based on Section D-D of Dwag. 9321-F-4039, the duct is anchored at the 59'-0" floor with the top of duct at Elev. 60'-4" and the bottom of the top duct extending from the support shown in the picture above is at Elevation 74'-11" - 10" \approx 74'.
