Seismic Walkdown Checklist (SWC) SWEL1-074

SEISMIC WALKDOWN CHECKLIST FORM

IP2

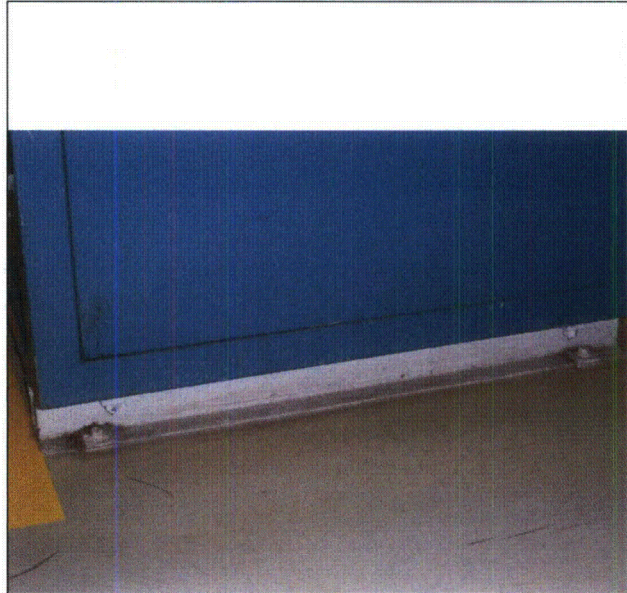
Right side anchorage.

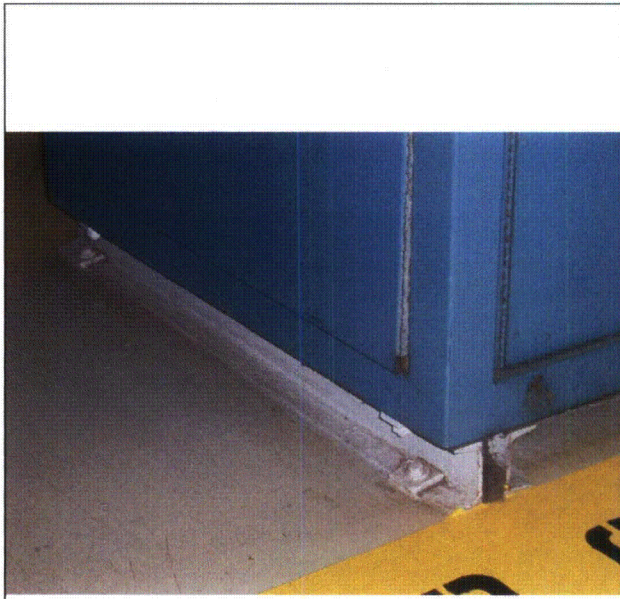
Left side anchorage.

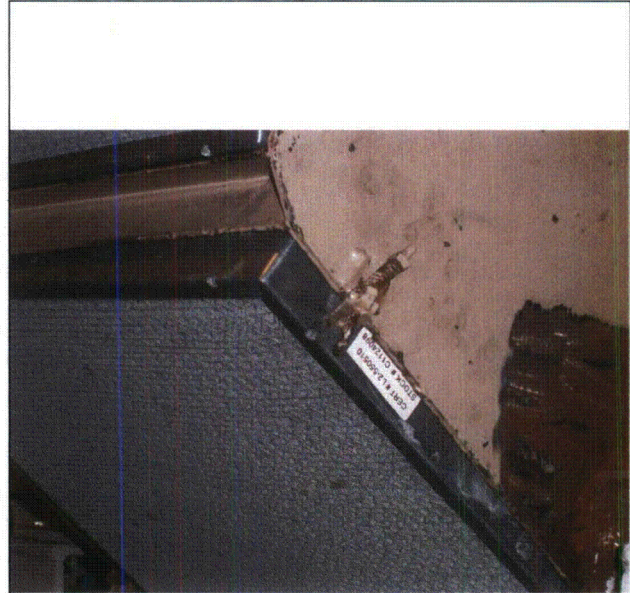
LOWER AIR FILTER NOT FULLY LATCHED.

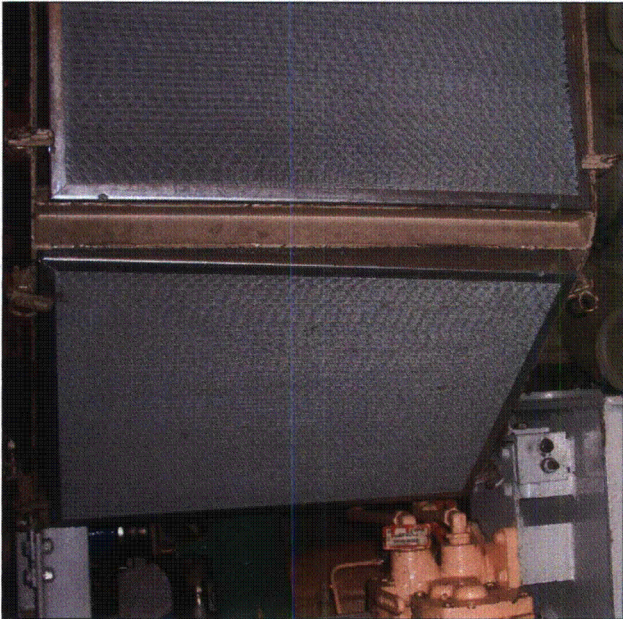
Note:
LOWER AIR FILTER NOT FULLY LATCHED.

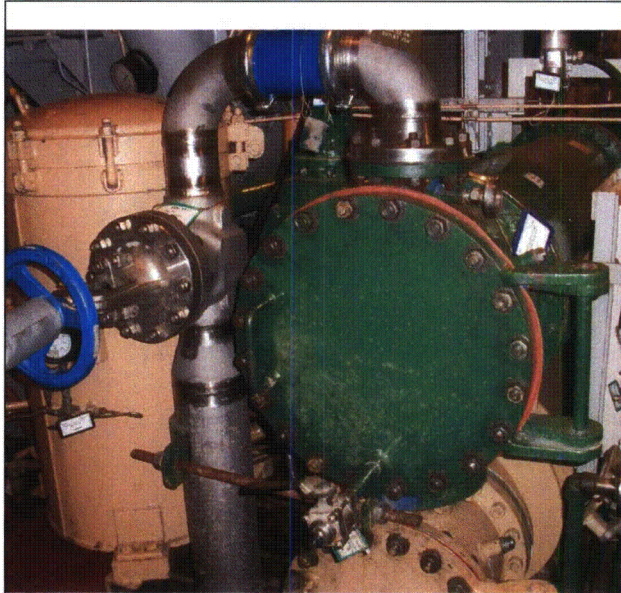
Note: Flange on 22EDG JW & LO Coolers cooling WTR outlet with flush nut and showing minor surface corrosion.

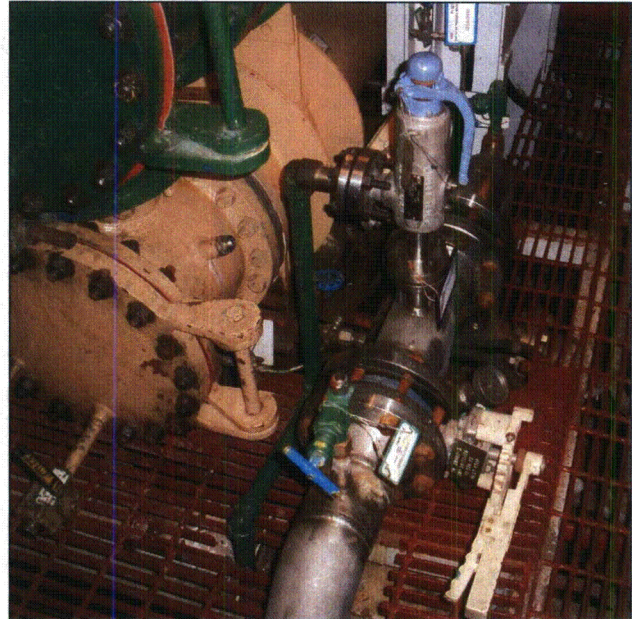
Note: Minor surface corrosion on flange couplings. Possible galvanic corrosion stainless steel pipe and carbon steel bolts.

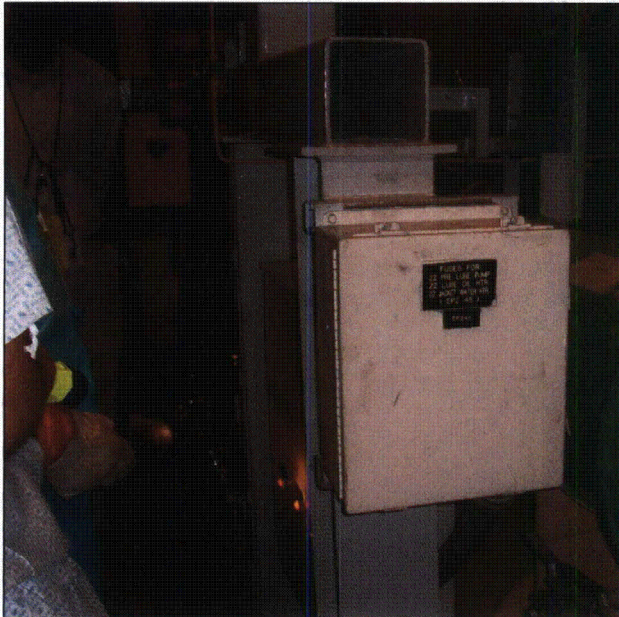
EDG exhaust pipe is supported on a post frame that also supports fuse panel for 22 Pre Lube Pump, 22 Lube oil HTR, and 22 Jacket Water HTR. This support has damaged & missing grout under the eastern post base plate. LB-11 was issued to resolve.

Note: Shows fuse panel for 22 Pre Lube Pump, 22 Lube oil HTR, and 22 Jacket Water HTR that has damaged & missing grout under the eastern (close) posts base plate.

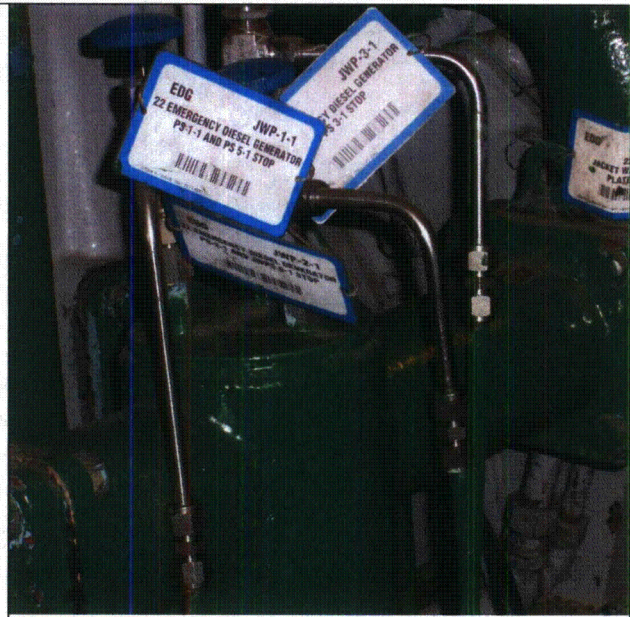
Note: Example of tubing touching a pipe.

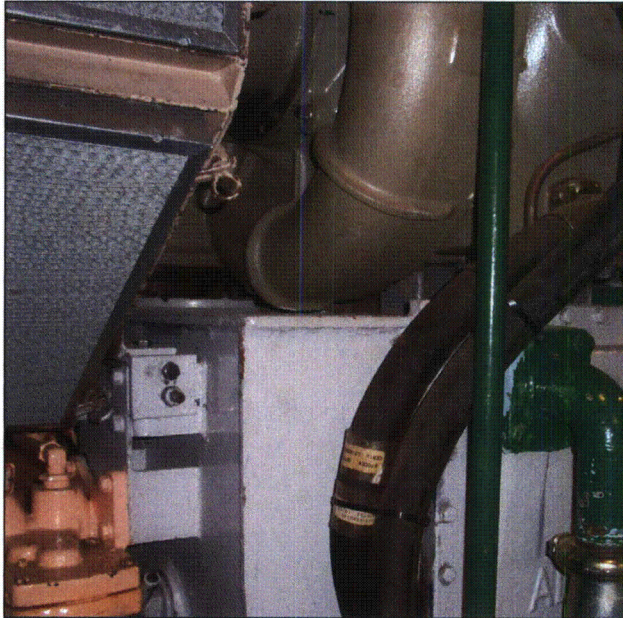
Note: *Example of rubber tubing touching.*

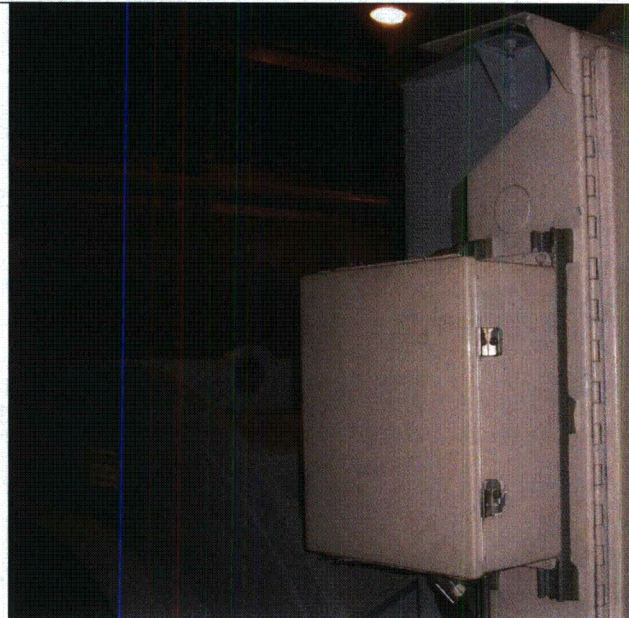
Note: *Latch on 22EDG Gauge board cover panel on north side is not latched.*

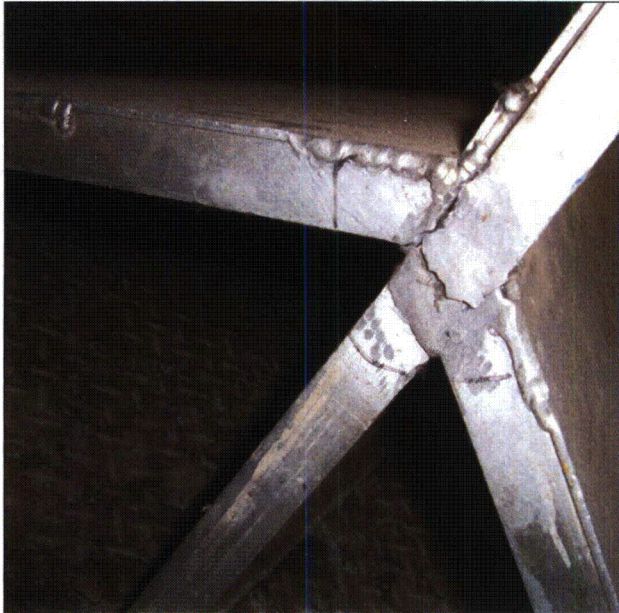
Note: Cracked wels on partition wall between diesels.

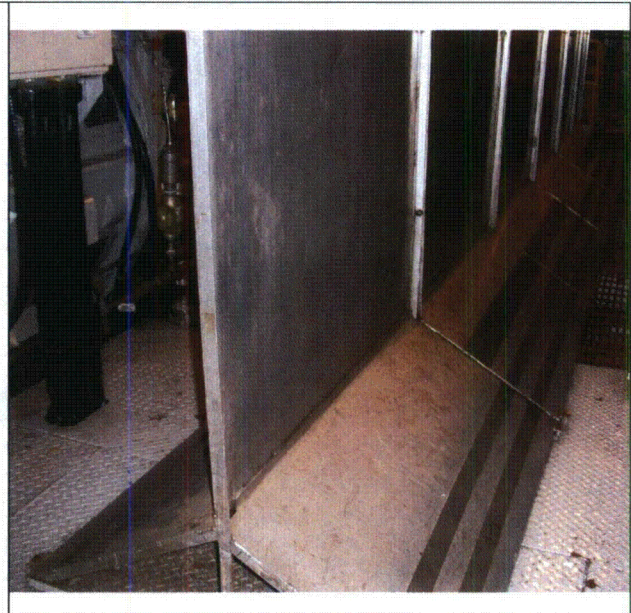
Note: Flimsy partition wall between diesels that needs verification of seismic design.

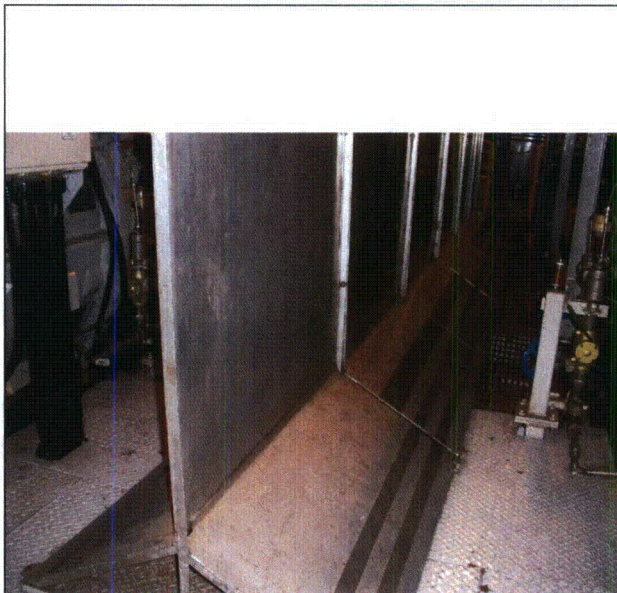
PARTITION WALL BETWEEN GENERATORS.

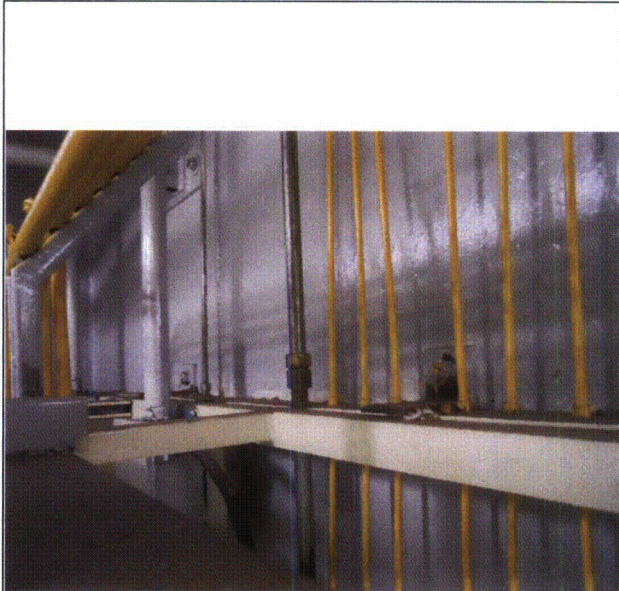
Note: View at the top of rack 5 showing the two clip angle supports attaching the rack to the wall.

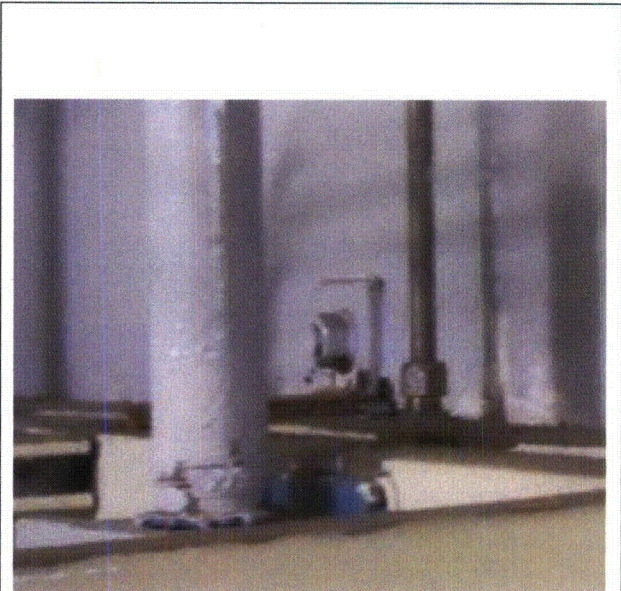
Note: Close up view of far top connection

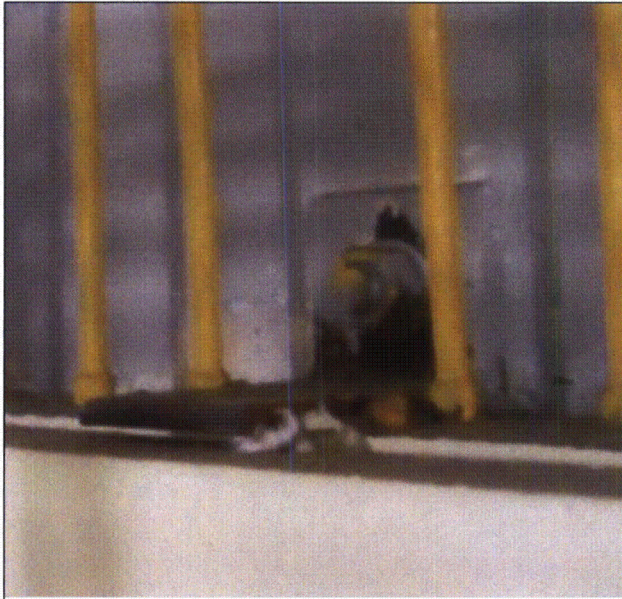
Note: *Close up view of near top connection*

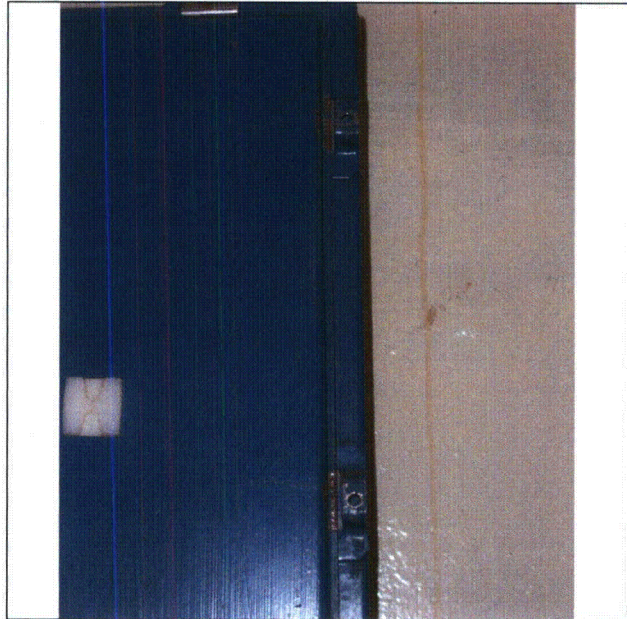
Note: Missing latches.

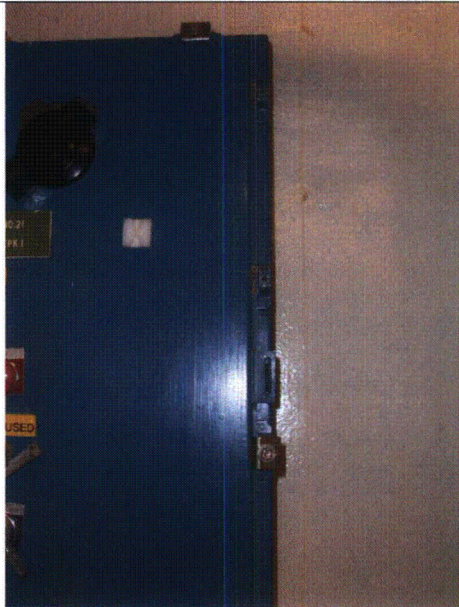
Note: *Missing latches.*

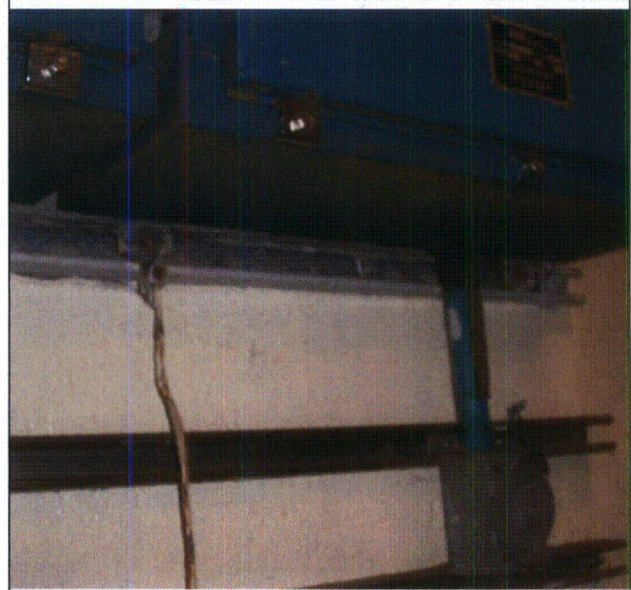
Note: *Anchorage at bottom of panel.*

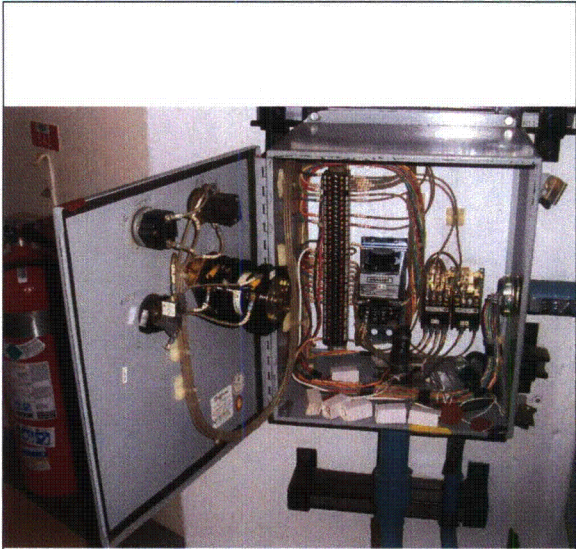
Note: Open panel EPA10 / Anchorage.
Replacement bulbs for the panel are laying on the bottom inside of the panel. Walkdown engineers judged this acceptable.

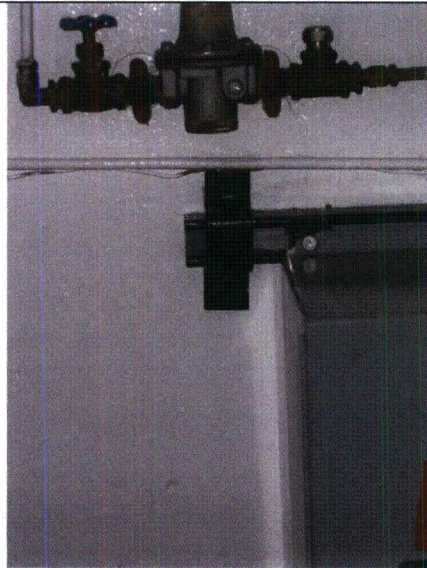
Note: Panel anchorage.

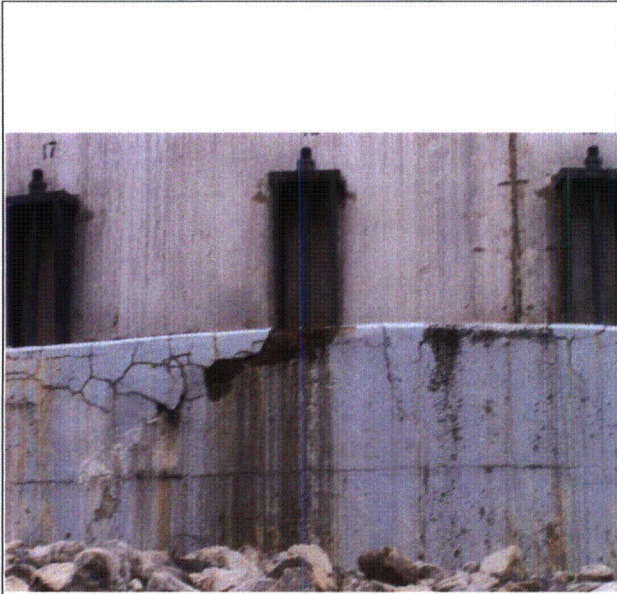
Note: Significant Spalling and cracks near bolts 16 and 17

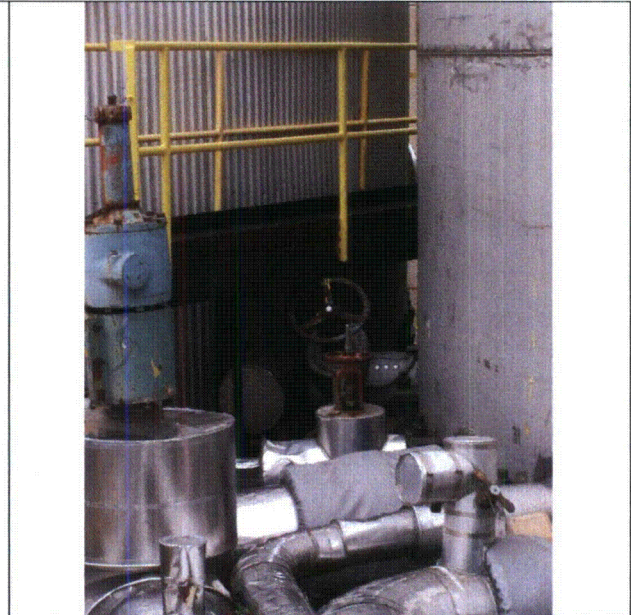
Note: The tank valve handle almost touching the platform steel and the cut bracing on the platform legs.

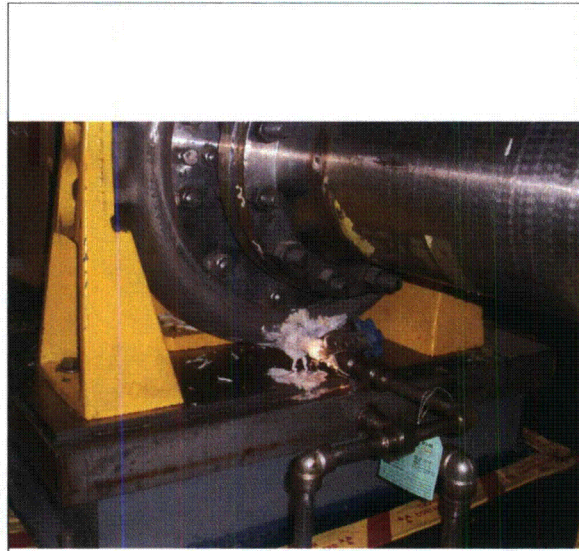
BORIC ACID LEAK

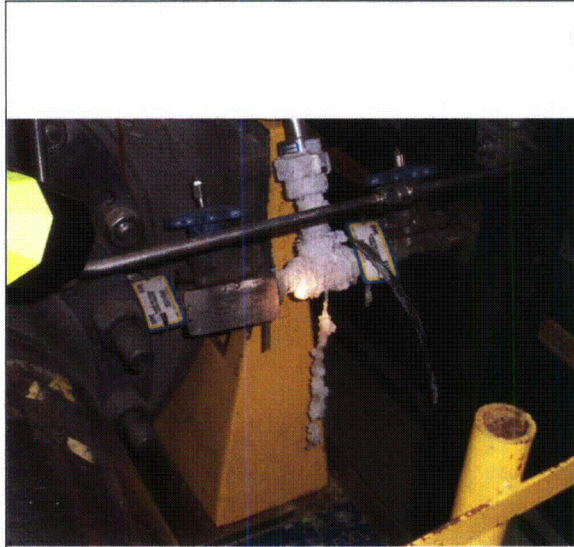
Note:
BORIC ACID LEAK

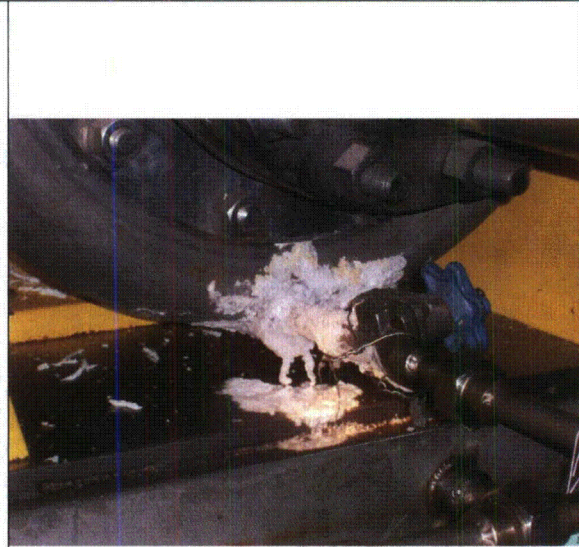
Note:
BORIC ACID LEAK

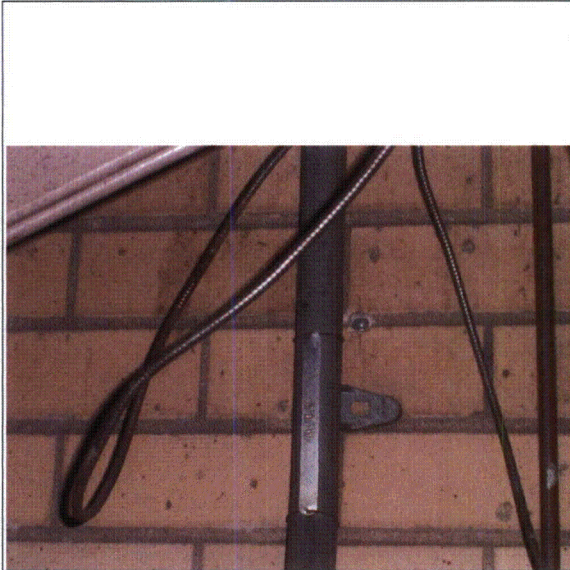
Note: Missing conduit anchor on instrument air SOV-1199.

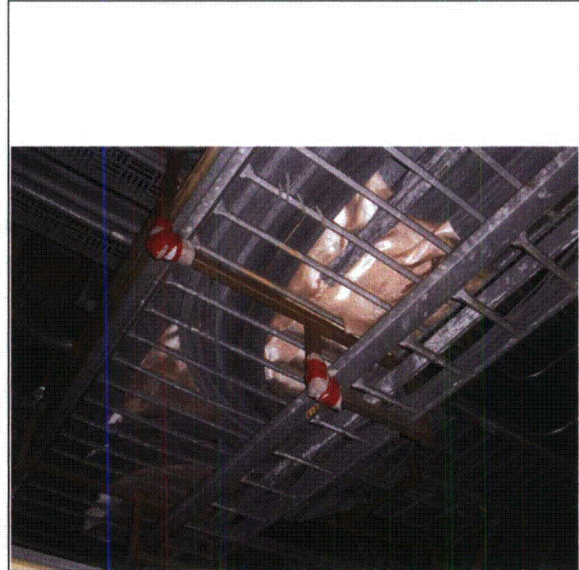
Note: Taped and paper rapped unistrut connections supporting cable tray.

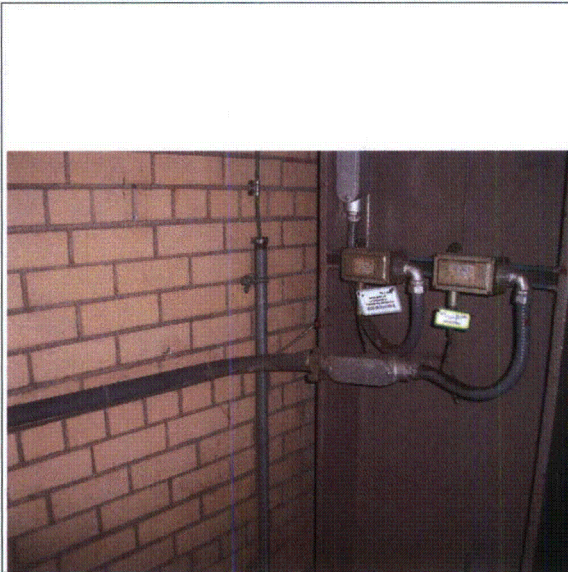
Note: Missing conduit anchor on IACC TC-1106S.
Conduit support spacing judged acceptable.
CR IP2-2012-06495 issued for tracking.

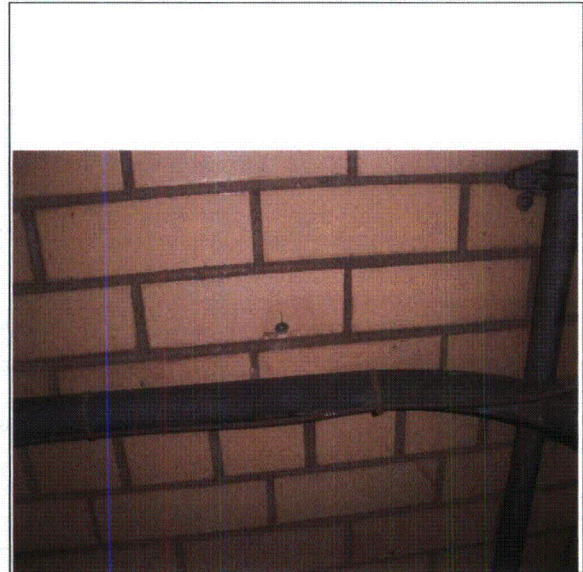
Note: Missing conduit anchor on IACC TC-1106S

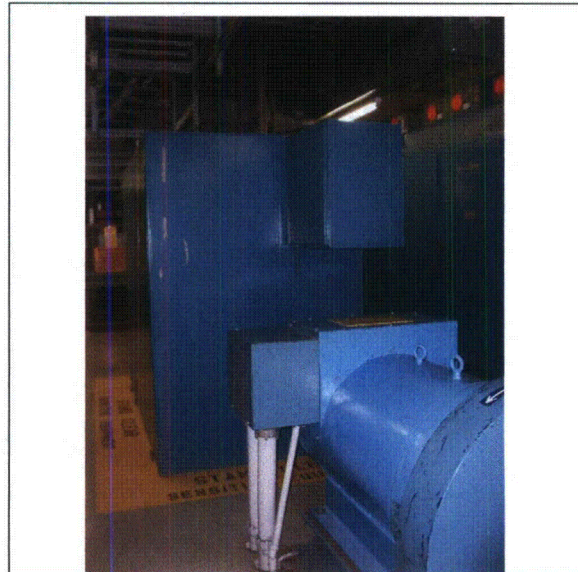
Note: Panel on west side of reactor/turbine trip cabinet missing 2 bolts.

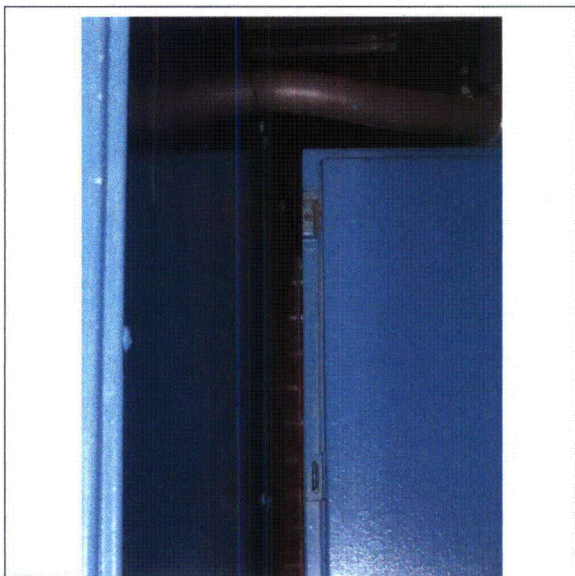
Note: Cabinet hanging on west side of reactor/turbine trip cabinet missing top latch.

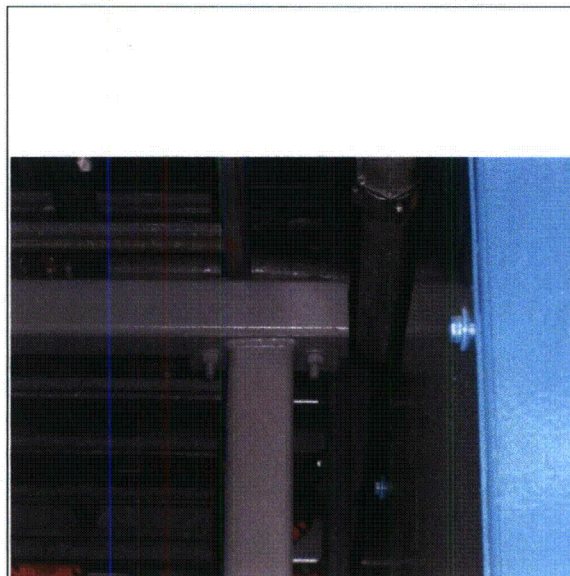
Note: Cable tray support over top of 22 MG SET and next to Reactor Trip Breaker cabinet appears to be none seismically designed and appears to have a seismic separation issue with the conduit pictured. Tray support is the tube steel pictured.

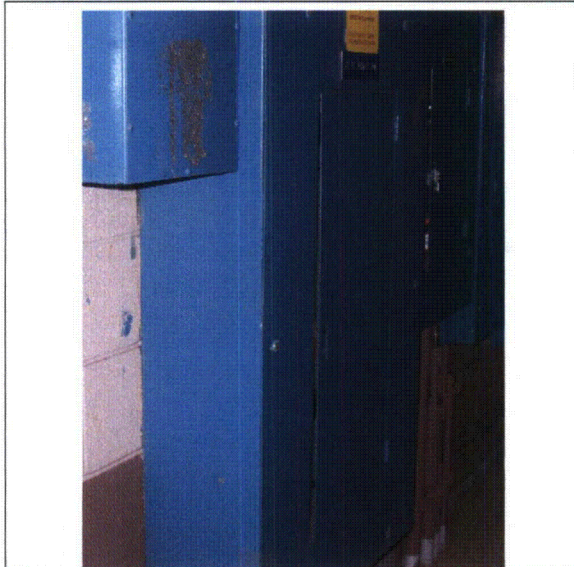
Note: 23DC Power Panel door not closed. Latch is broken and latch is missing parts.

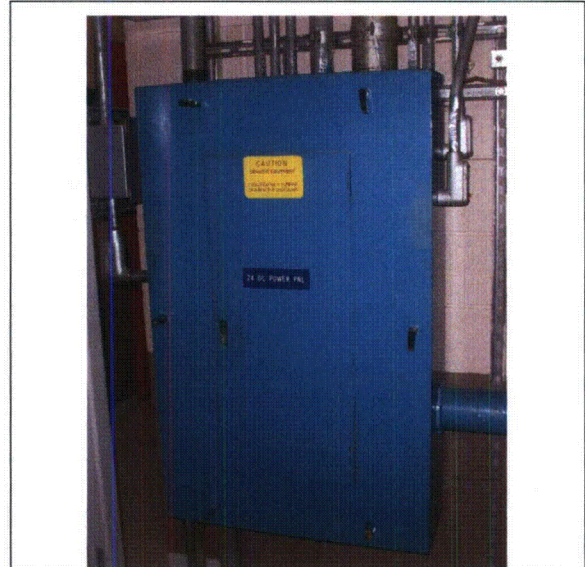
Note: 24DC Power PNL has latches in the open position. Door is shut and multiple other latches on door are in closed position.

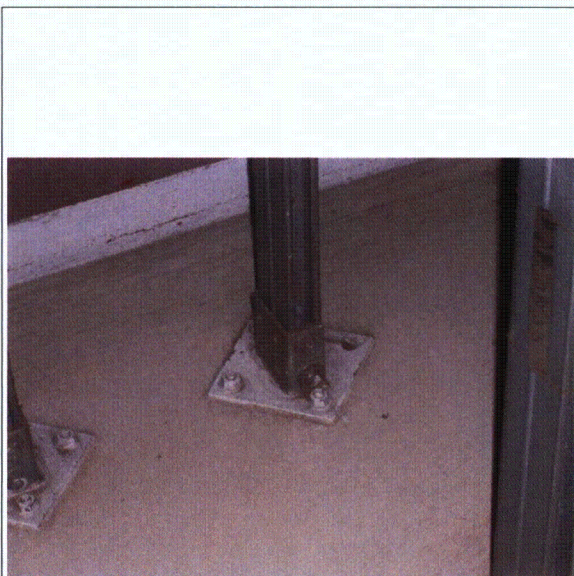
Note: Anchor bolt is missing on baseplate for EL1A & EL4A support along north wall.

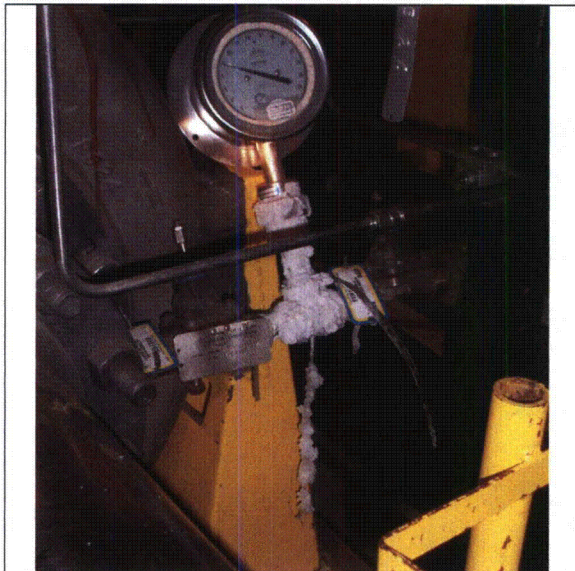
Note: Boric acid leak noted in SWEL2-003 forms.

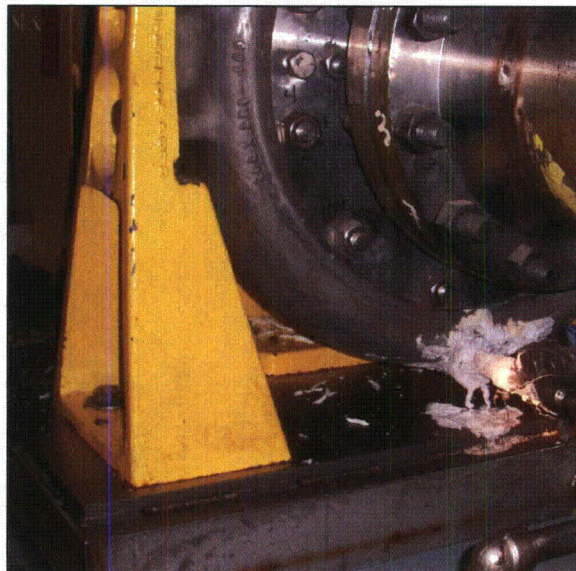
Note: Boric acid leak noted in SWEL2-003 forms.

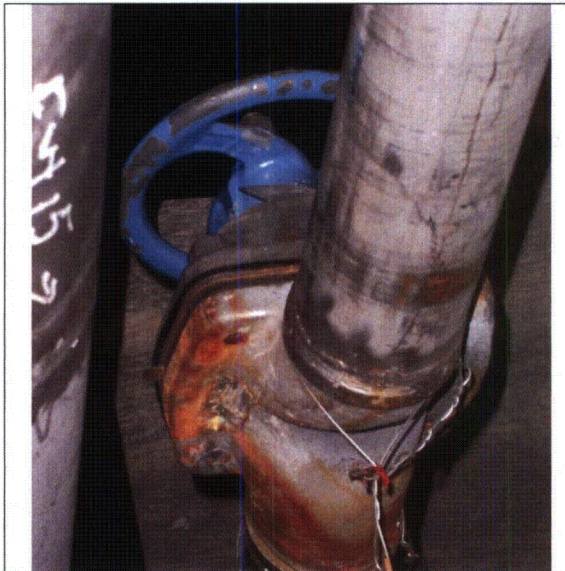
Note: Valve SFP 719A outlet to SFP Demin Stop shows slight surface rust.

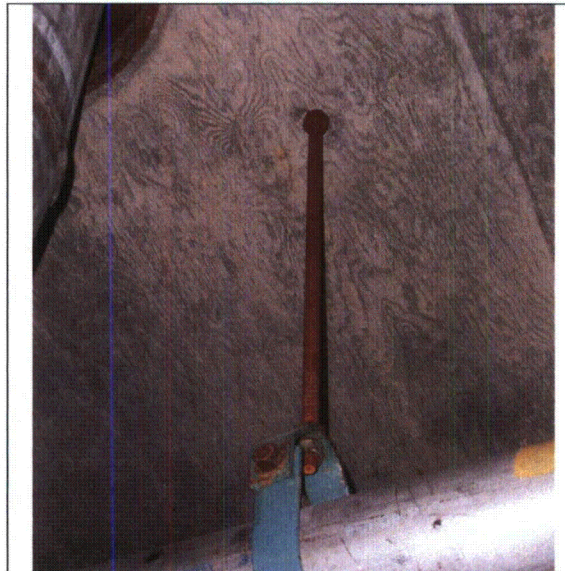
Note: Pipe hanger near valve SFP 719A shows slight surface rust.

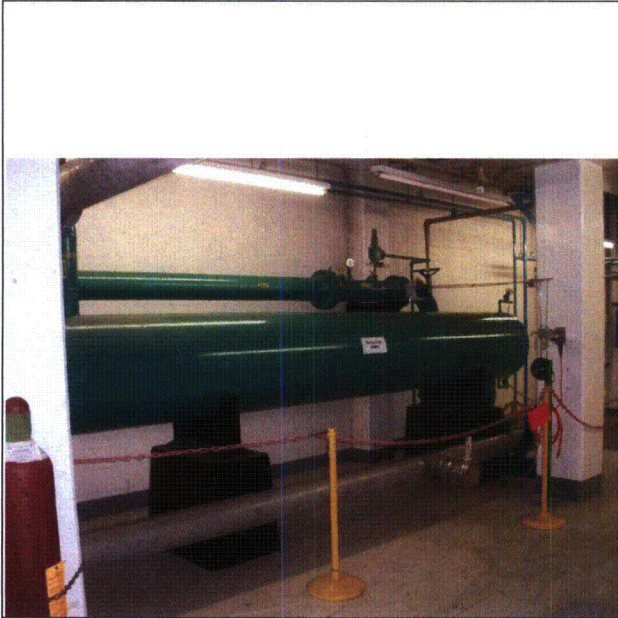
Note: Picture of heat exchanger. Tubing in question is in the top right of photo running from the concrete column to near the gage on the large bore pipe shown.

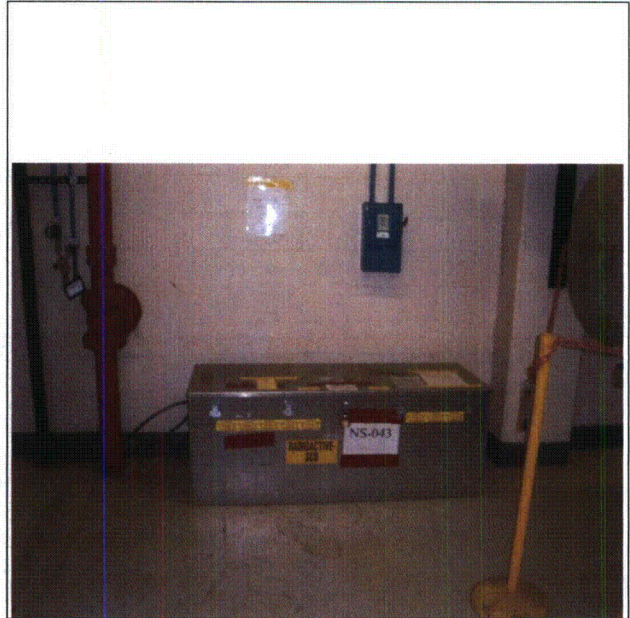
Note: Tool box secured on left side only could damage the fire water pipe causing flooding. Tool box should be tied back at both left and right sides.

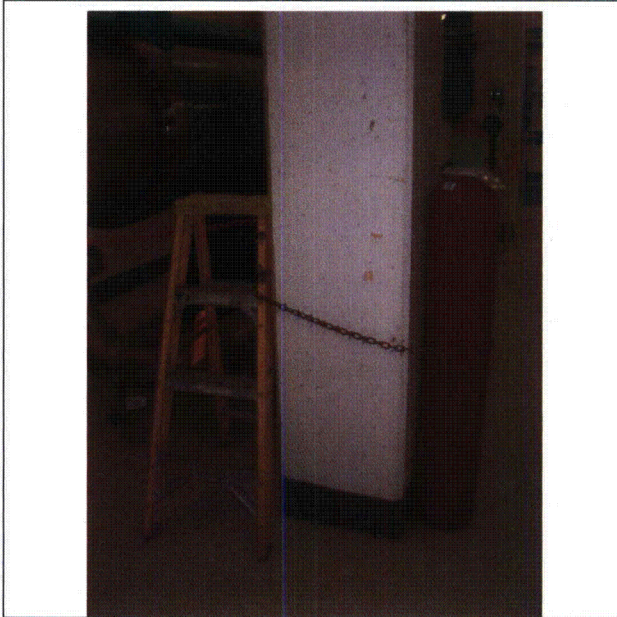
Note: Gas bottle secured to moveable ladder on other side of column. Bottle and ladder can move easily in a seismic event.

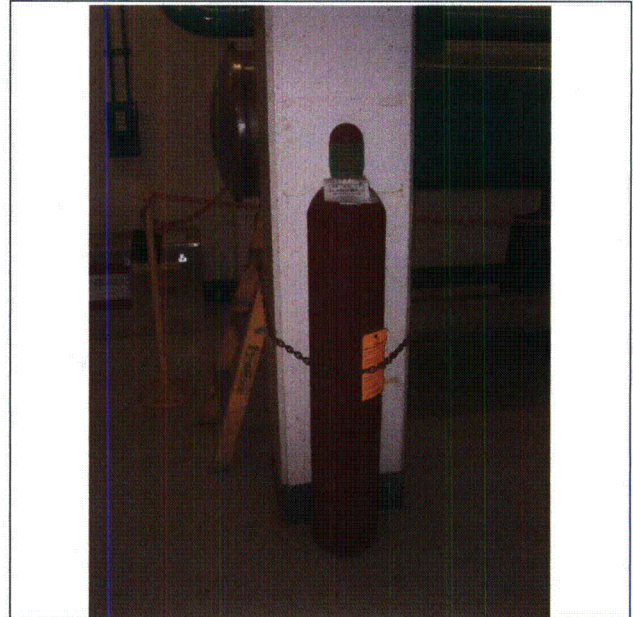
Note: Gas bottle secured to moveable ladder on other side of column. Bottle and ladder can move easily in a seismic event.

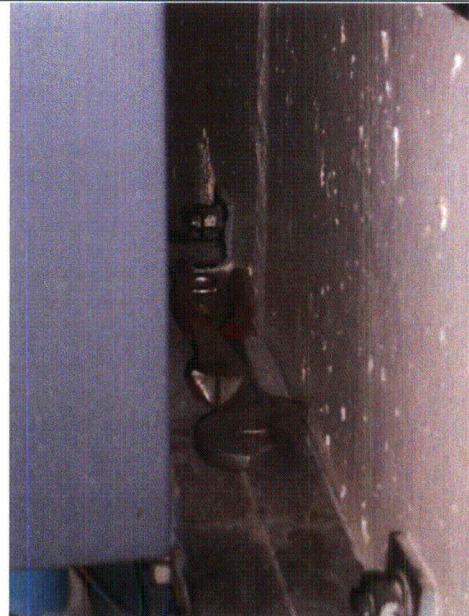
Note: Miscellaneous tools left loose behind 21 Spent Fuel Pit Pump switch.

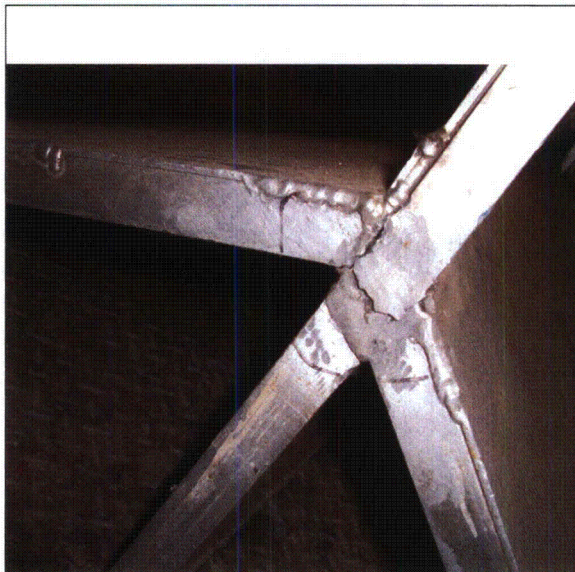
Note: Multiple cracked welds on the partitions between EDG's.

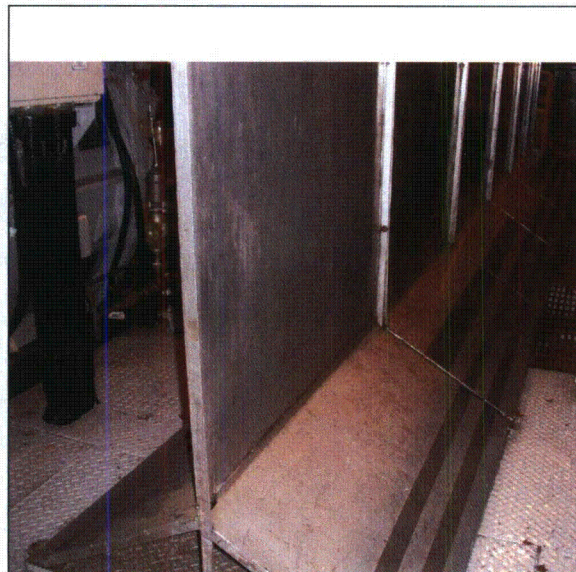
Note: Partitions between EDG's

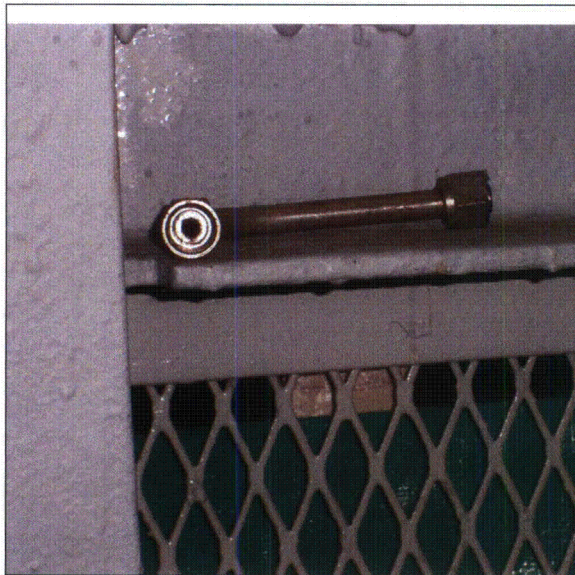
Note: Loose parts scattered around platform in north east corner of EDG's.

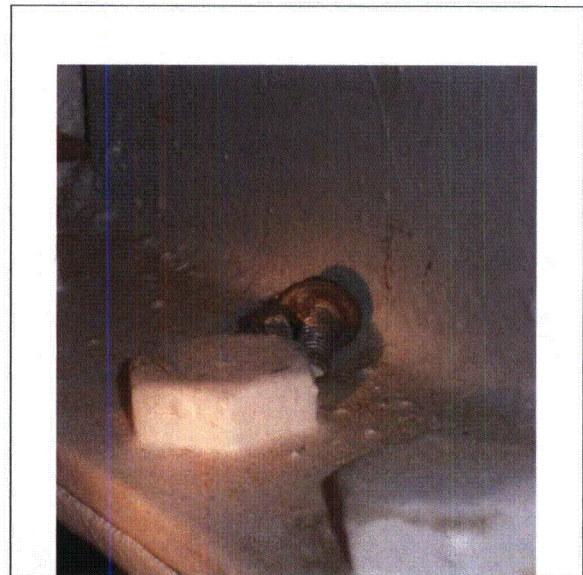
Note: Loose parts scattered around platform in north east corner of EDG's.

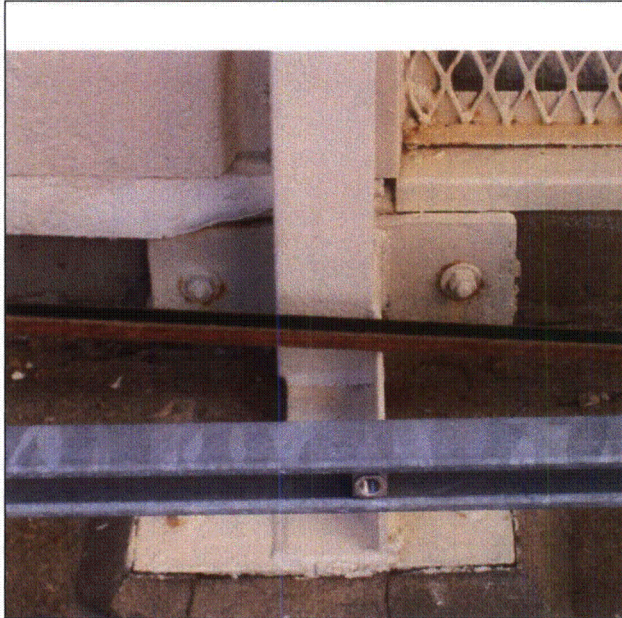
Note: Cracked grout pad under baseplate for the orange pipe.

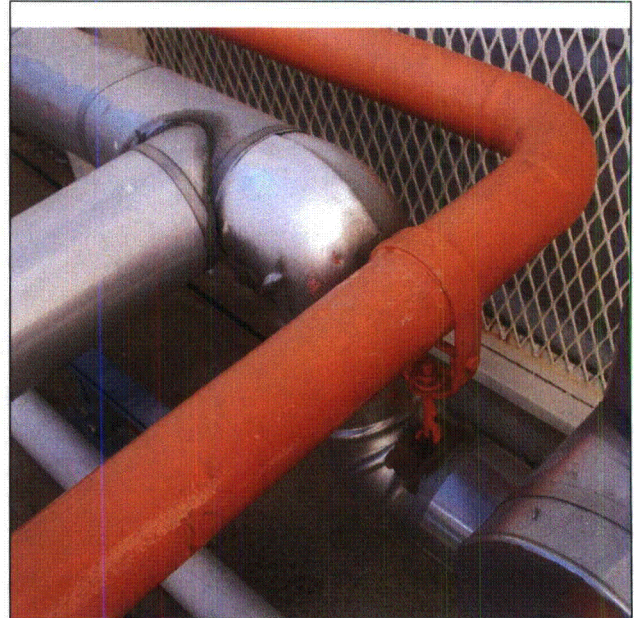
Note: One pipe is supported from another pipe. This is a none typical pipe support. One pipe (insulated pipe) runs to the Emergency Domestic truck fill stop valve and the other orange pipe from the EDG building into ground near 23FOTP.

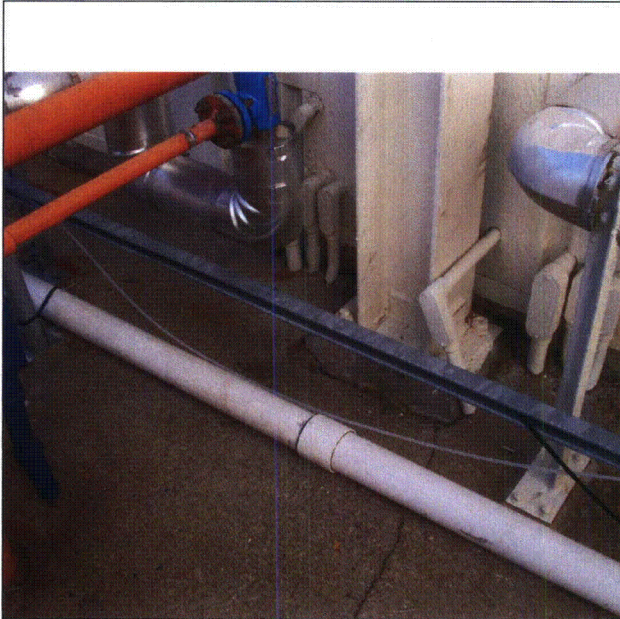
Note: Clear tubing lying on ground should be wire tied inside of the horizontal unistrut.

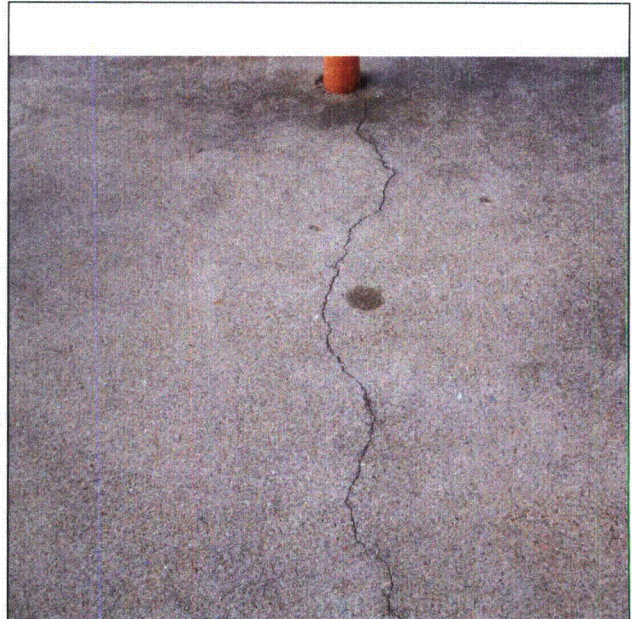
Note: Example of on grade slab crack.

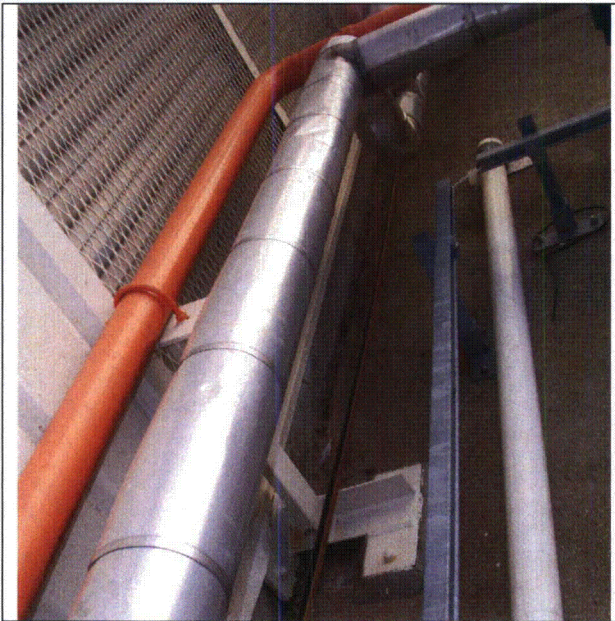
Note: Wood stick laying on ground next to EDG building.

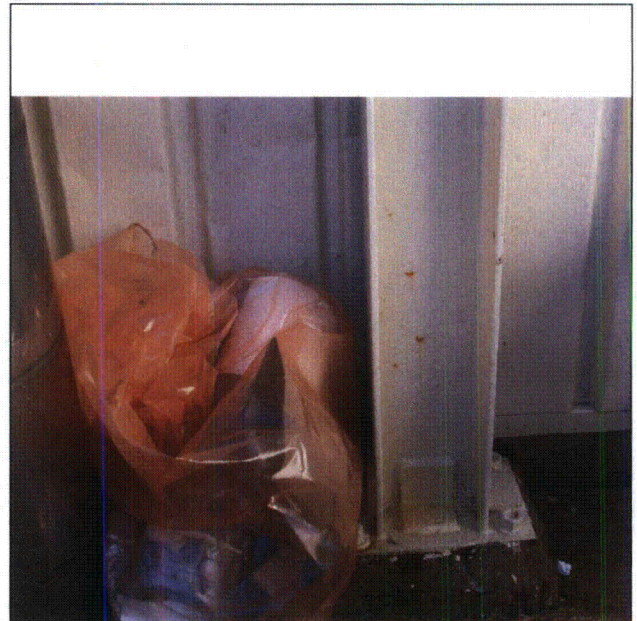
Note: Trash bag full of construction trash lying next to pump 21FOTP.

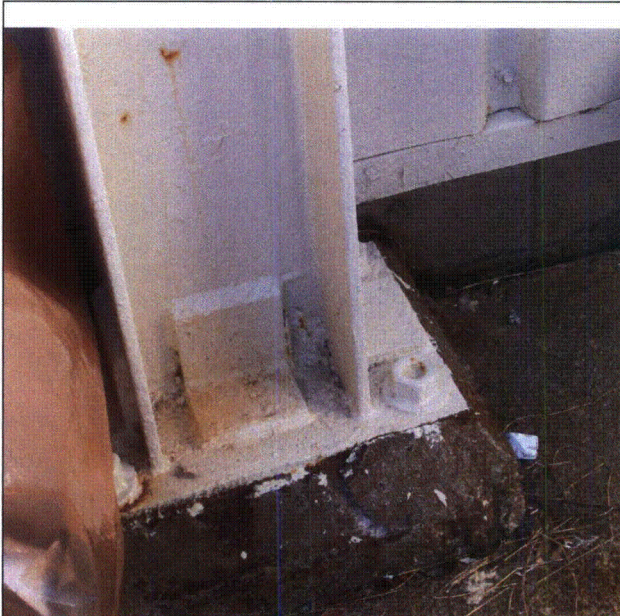
Note: One of the baseplates for the overhead pipe that do not have full thread engagement.

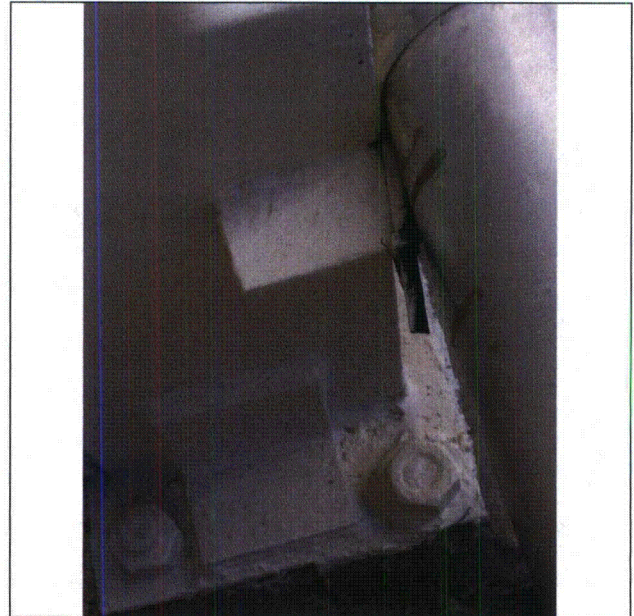
Note: Another one of the baseplates for the overhead pipe that do not have full thread engagement.

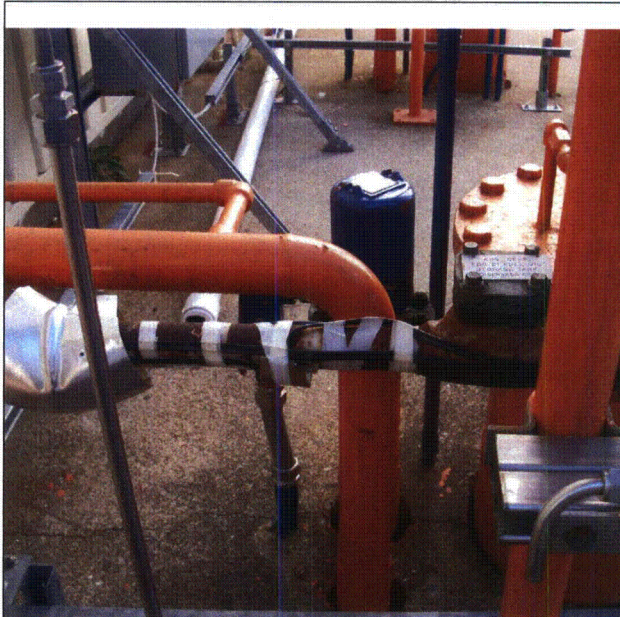
Note: Pipe to pump 21FOTP that has damaged and missing insulation.
