# **Attachment D**

## ***AREA WALK-BY CHECKLISTS (AWCs)***

Status: Y  N  U **Area Walk-By Checklist (AWC) AWC- 001**Location: Bldg. AB Floor El. 93 Room, Area<sup>1</sup> 1A102,07**SWEL Components: SWEL1- 024,030****Instructions for Completing Checklist**

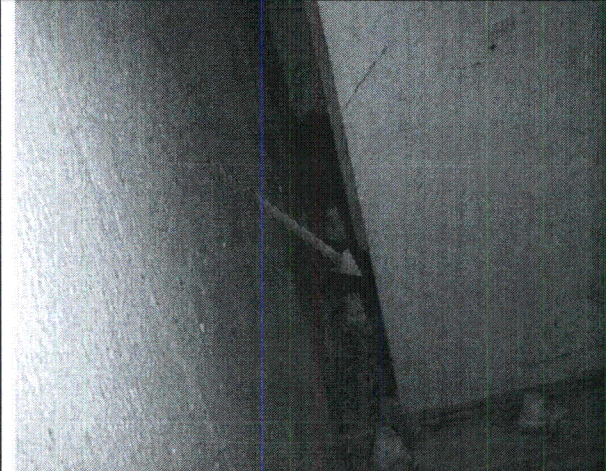
**Note:** *Pry bar*

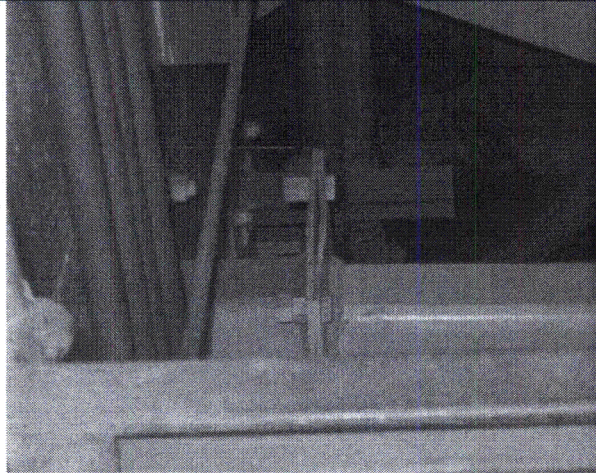
8. Have you looked for and found no other seismic conditions that could adversely affect the safety functions of the equipment in the area? Y N U  
*Bent pipe support base plate CR-GGN-2012-11343.*

**Note:** *Bent base plate.*

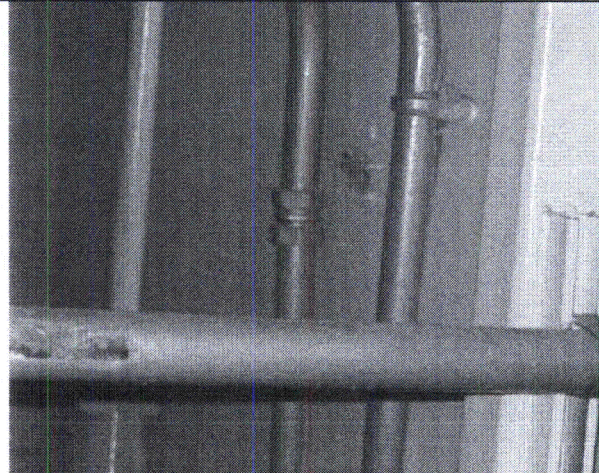
**Note:** *Broken conduit support.*

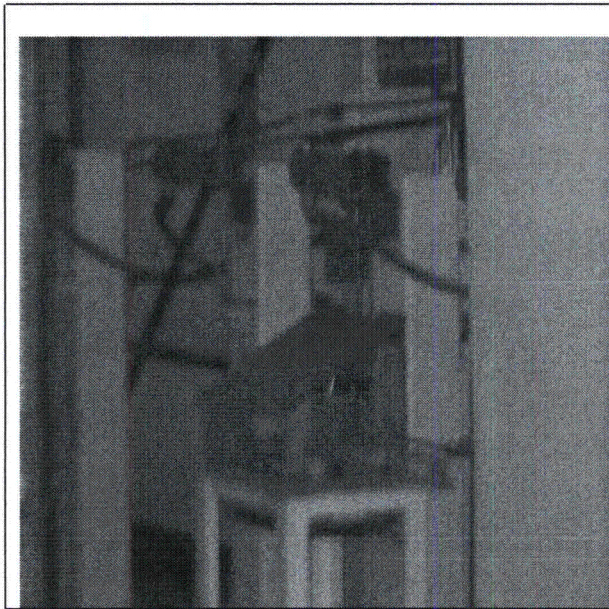
*Temporary scaffold in area. Plastic sink cover is not anchored, but does not cause any adverse seismic conditions.*

**Note:** *Sink with cover*

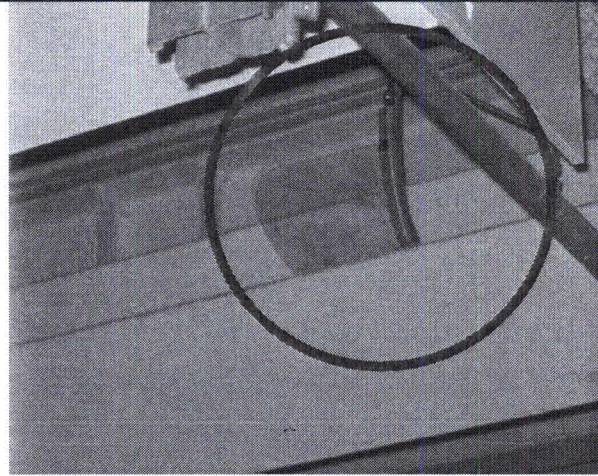
**Note:** *Grinding Shield.*

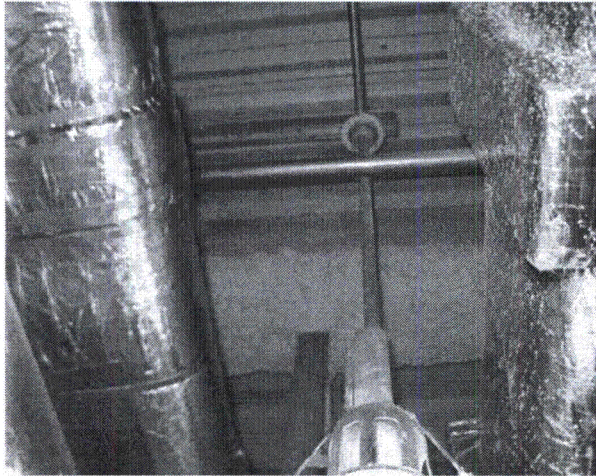
**Note:** *Potential contact, no adverse seismic condition*

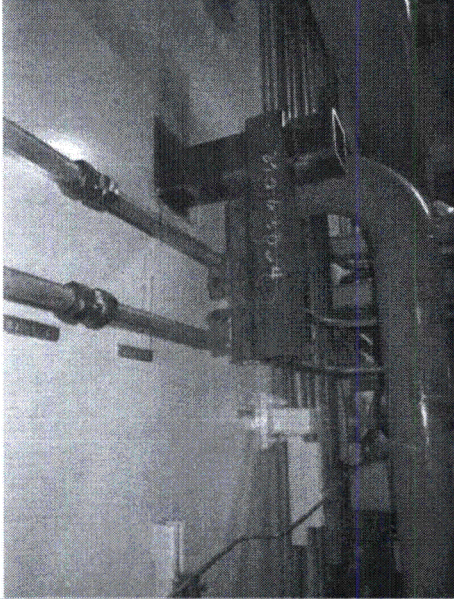
*Tube steel members supporting conduits running to the P11-F064 and P11-F065 shows surface corrosion. The corrosion was visually inspected and determined to be limited in extent and depth. Therefore, it is judged to have negligible affects on the ability of the affected components. See photo.*

**Note:** *Surface corrosion on conduit support members*

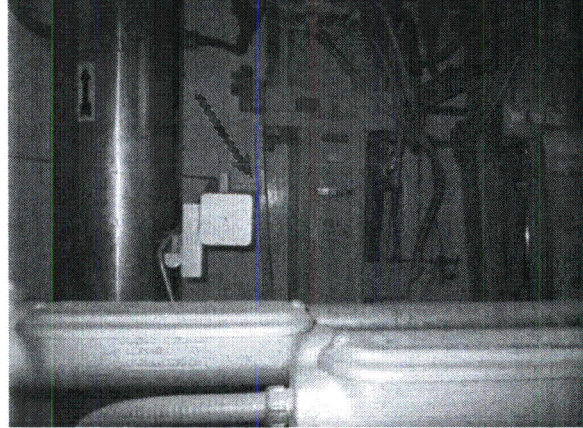
**Note:** *Small gap between TS member and yoke of actuator (~1/2")*

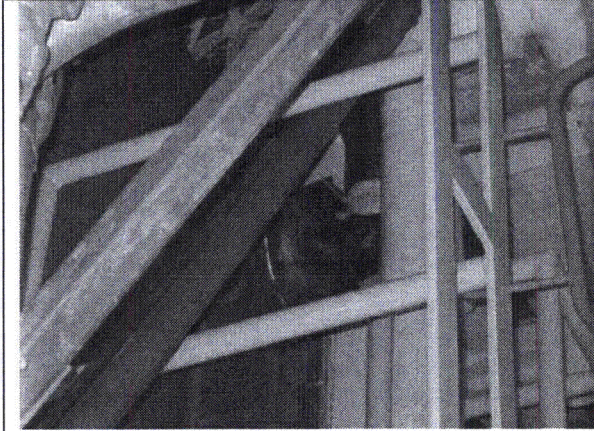
**Note:** *Surface corrosion on pipe*

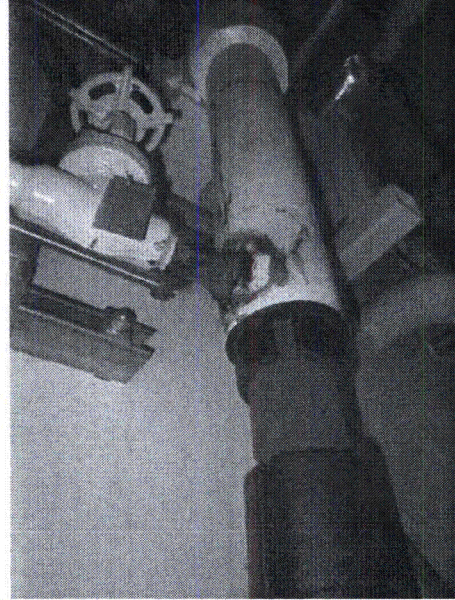
**Note:** *Surface corrosion on pipe*

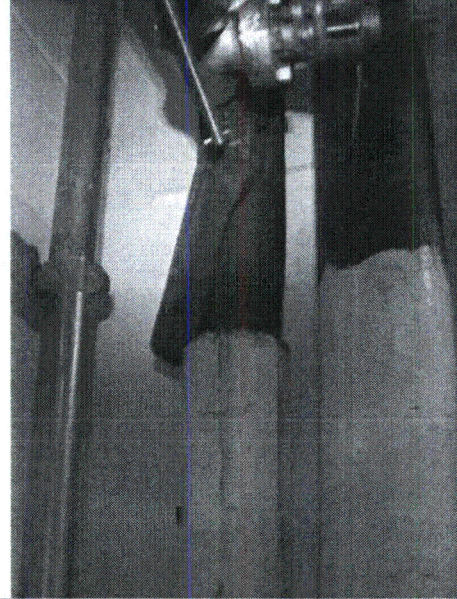
**Note:** *Surface oxidation on pipe*

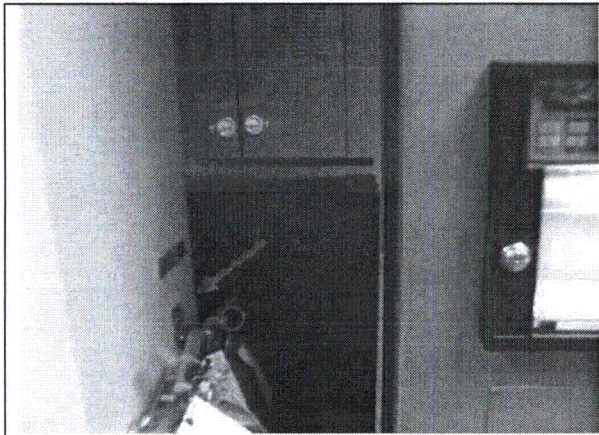
**Note:** Loose bracket on the wall supporting fire extinguisher

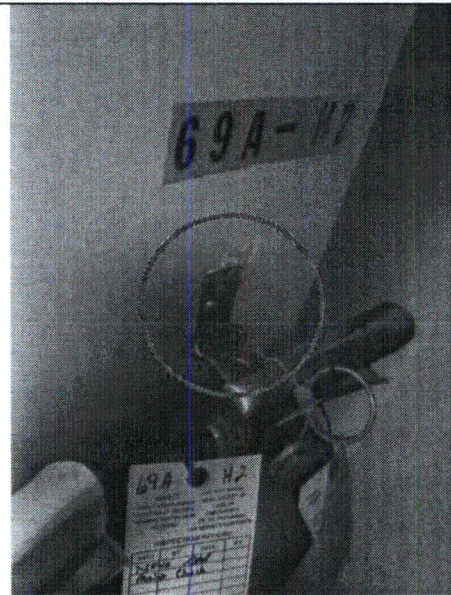
**Note:** Loose bracket on the wall supporting fire extinguisher

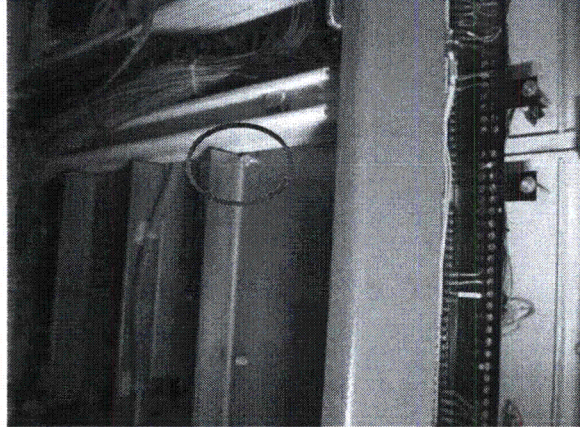
**Note:** *Loose bolt supporting E31AT5 (Isolator) inside the panel 1H13P642*

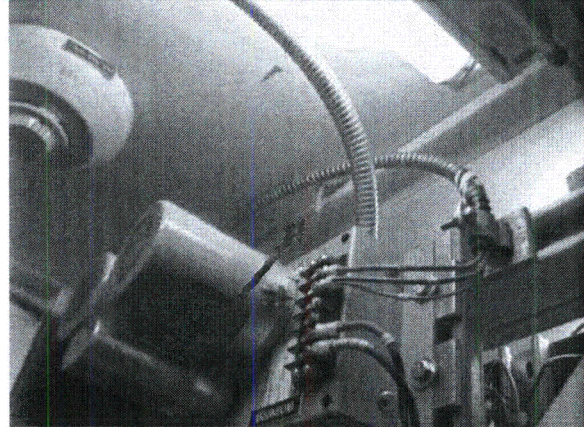
**Note:** *Loose/open tie-wrap (not supporting any cable)*

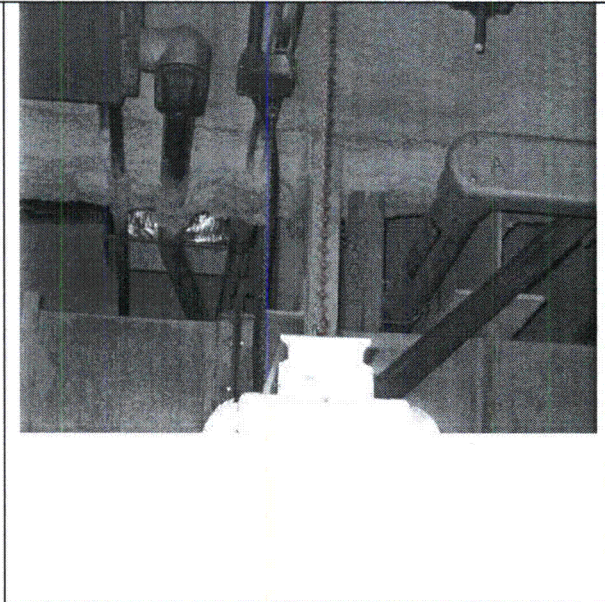
**Note:** Light fixture hung with chain using S-hook.

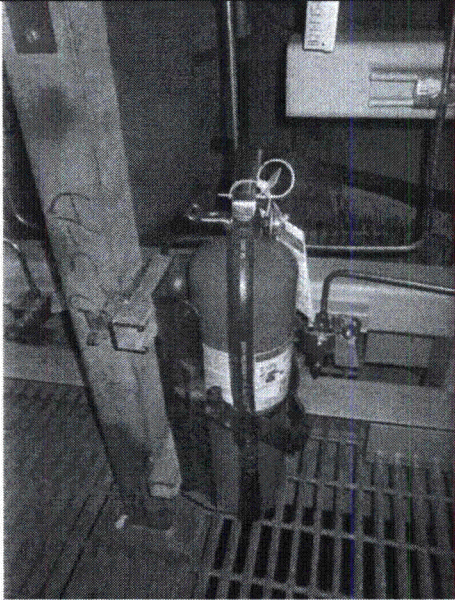
**Note:** Broken strap for fire extinguisher

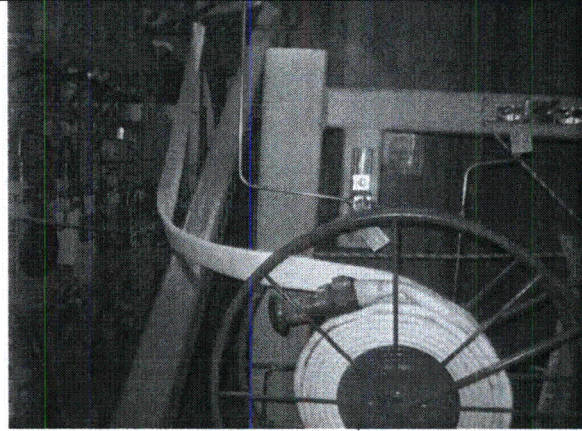
**Note:** Loose fire hose

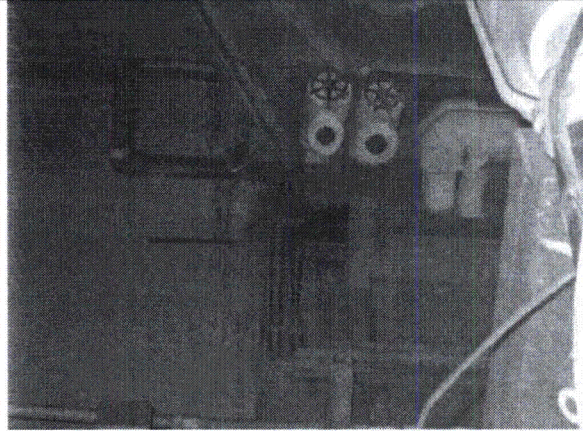
**Note:** *Rusted pipe*

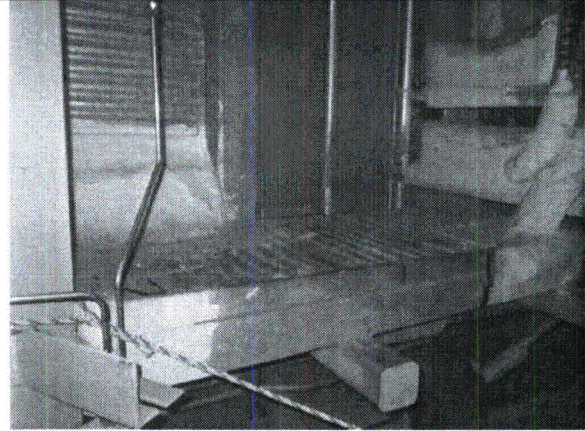
**Note:** *Pencil and trash on top of cable tray*

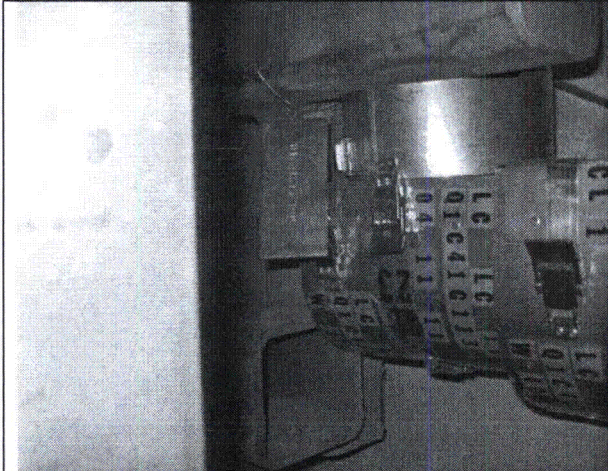
**Note:** *Potential contact with tube steel and insulation. Tube steel and pipe are adequately supported and pipe has adequate clearance.*

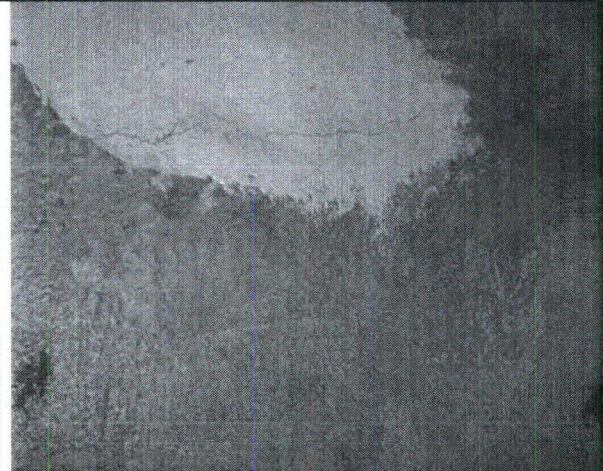
**Note:** *Surface crack.*

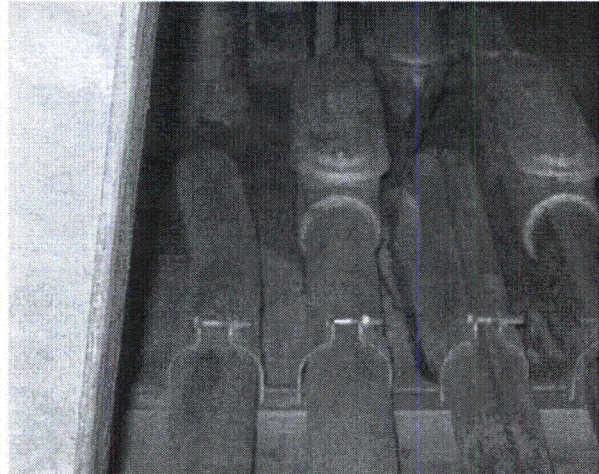
**Note:** *Exposed copper wire.*

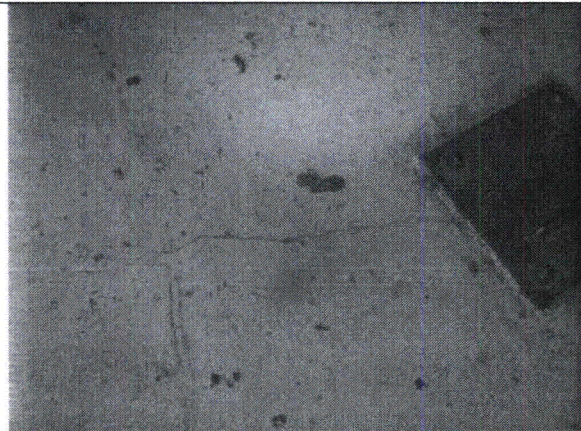
**Note:** *Hairline crack on coating of the concrete floor*

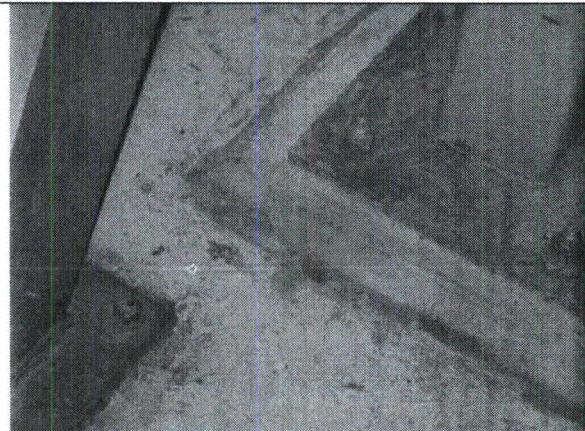
**Note:** *Hairline crack on coating of the concrete floor*

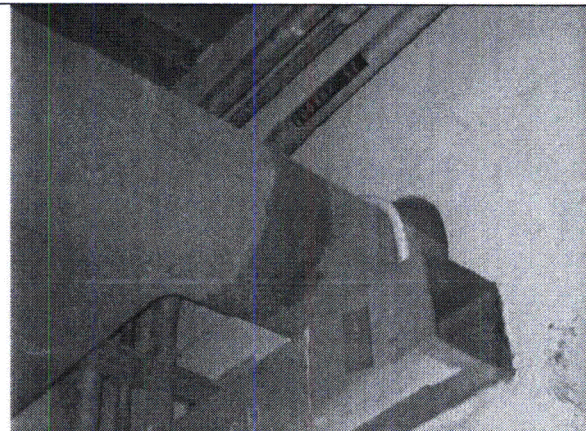
**Note:** *Surface corrosion on pipe*

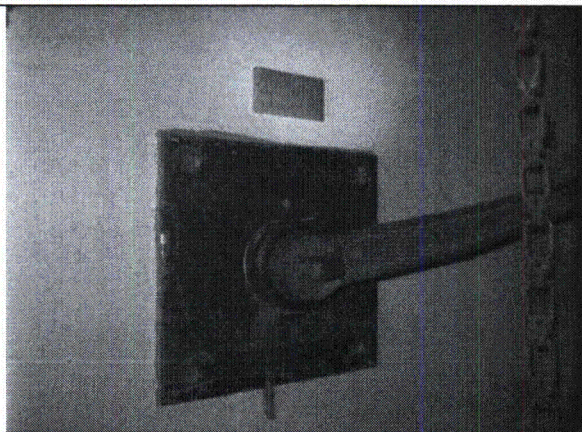
**Note:** *Missing anchor bolts / missing nut on the manual operator handle*

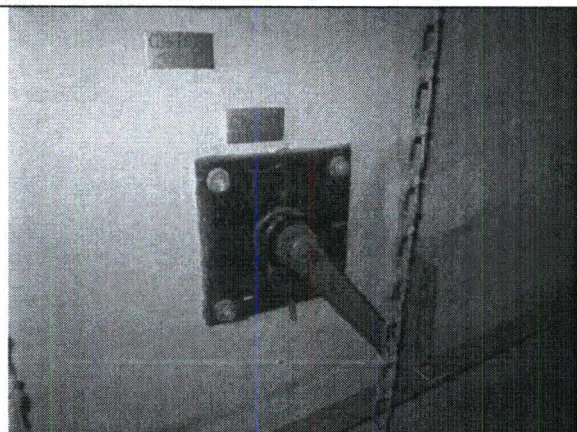
**Note:** *Surface corrosion*

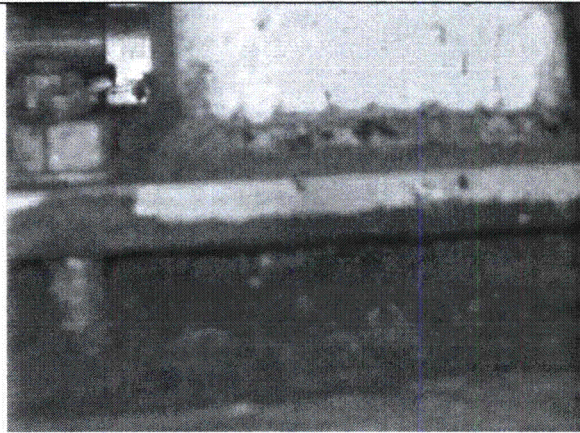
**Note:** *Degraded grout under the baseplate of pipe support*

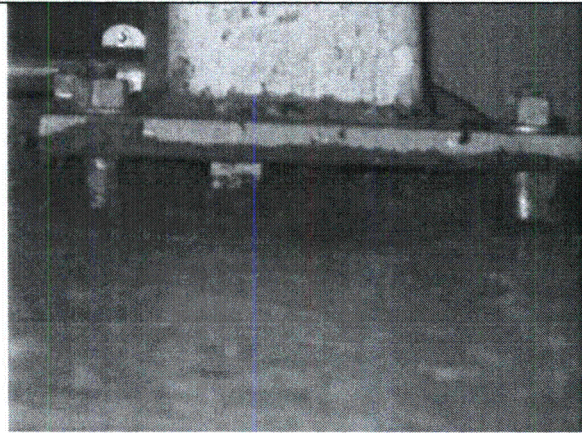
**Note:** *Degraded grout under the baseplate of pipe support*

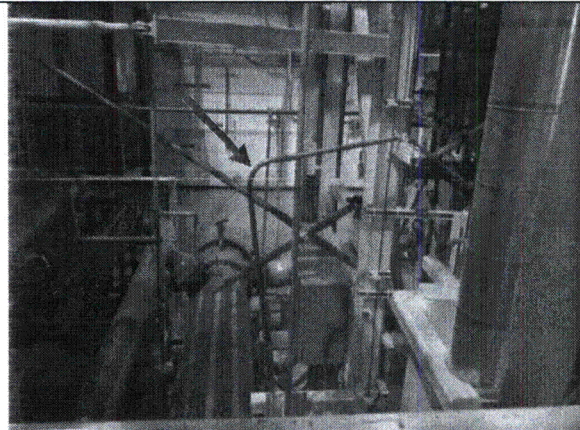
**Note:** *1" conduit with potential overspan concern and uncommon way of routing conduit*

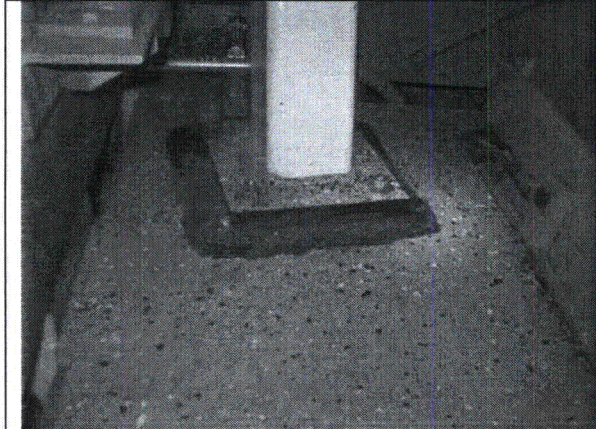
**Note:** *Degraded grout under the baseplate of pipe support*

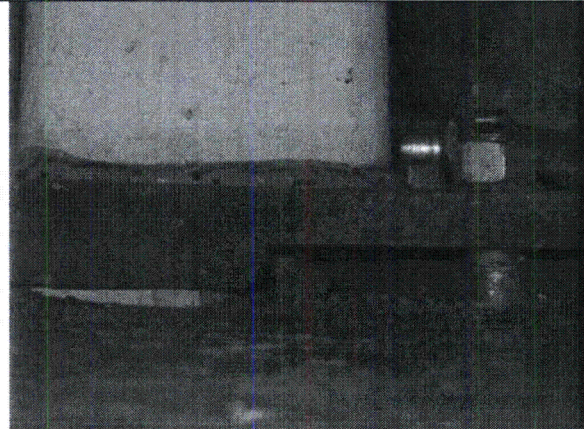
**Note:** *Degraded grout under the baseplate of pipe support*

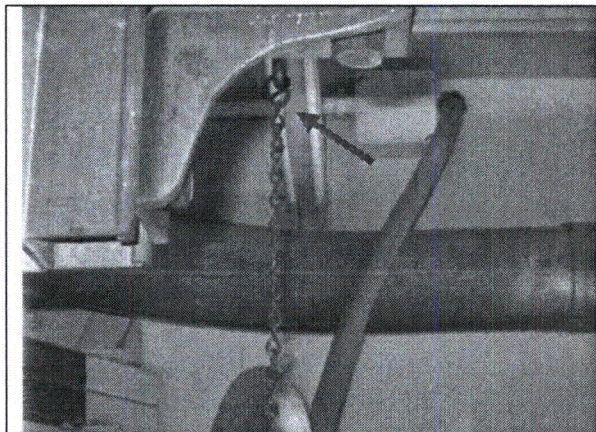
**Note:** *Light fixture mounted using S-hook*

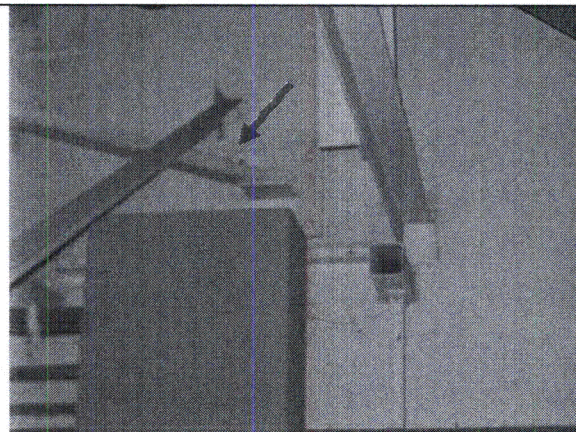
**Note:** Baseplate missing one anchor bolt, couldn't verify whether weld exists at that location.

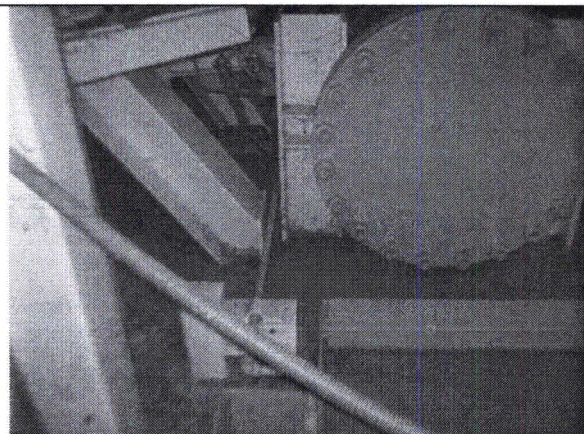
**Note:** Coating deficiencies and surface corrosion found on column/baseplate of pipe supports

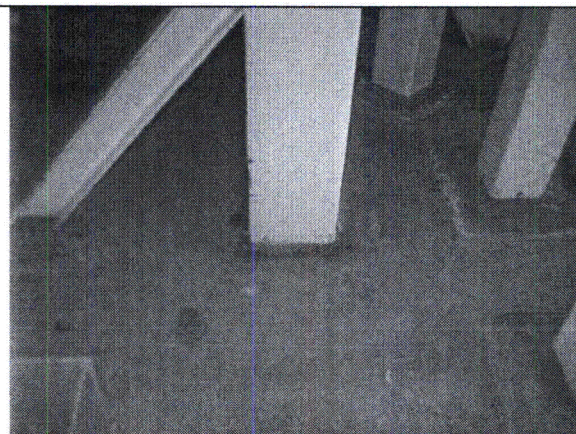
**Note:** Coating deficiencies and surface corrosion found on column/baseplate of pipe supports

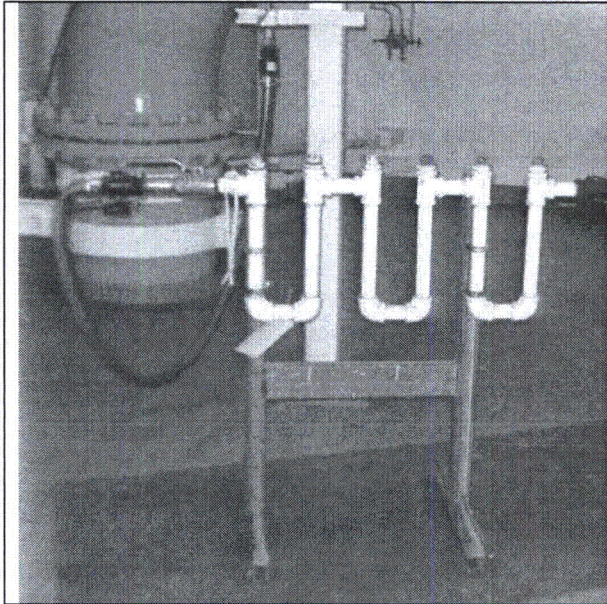
**Note:** *Temporary Coupon Rack*

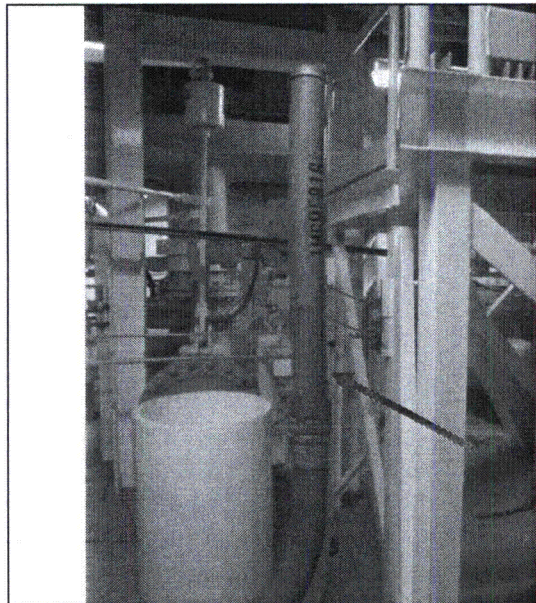
**Note:** *Abandon conduit*

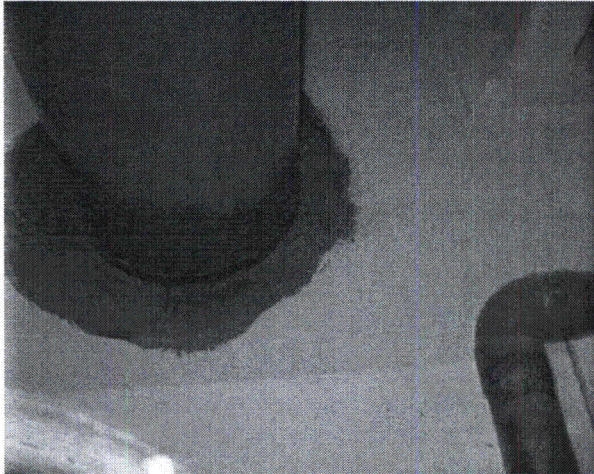
**Note:** *Visible crack in penetration grout.*
