Area Walk-By Checklist (AWC)

Plan for Future Seismic Walkdown of Inaccessible Equipment

Peer Review Report
for
Near Term Task Force (NTTF) Recommendation 2.3
Seismic Walkdown Inspection
of
LaSalle County Generating Station Unit 1

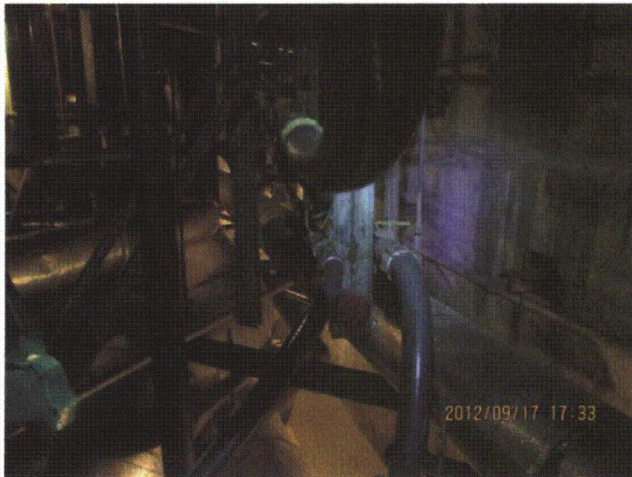
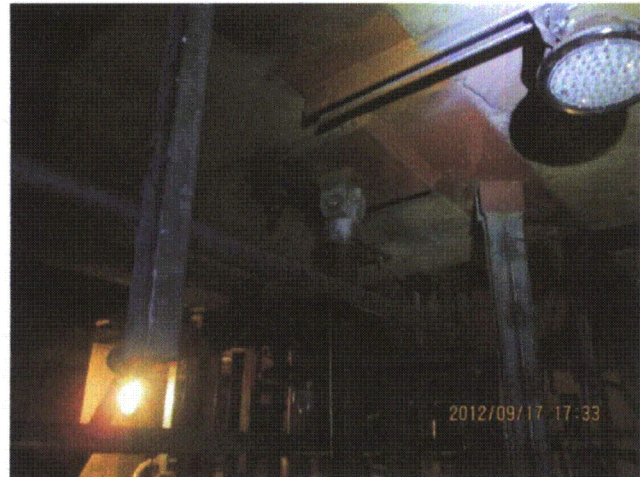
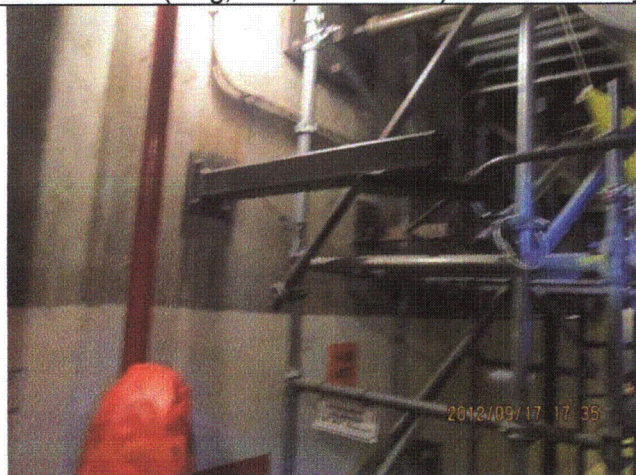
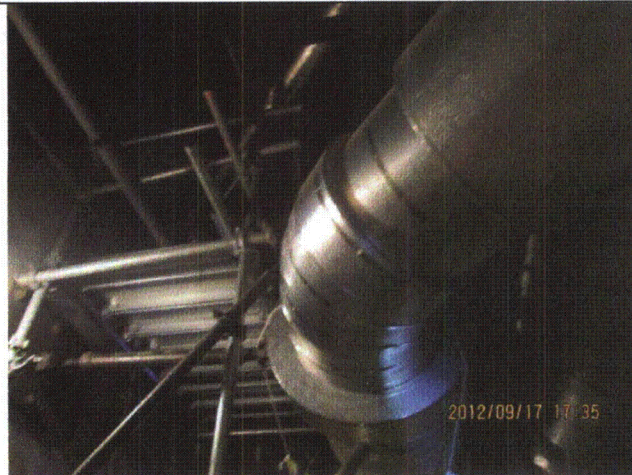
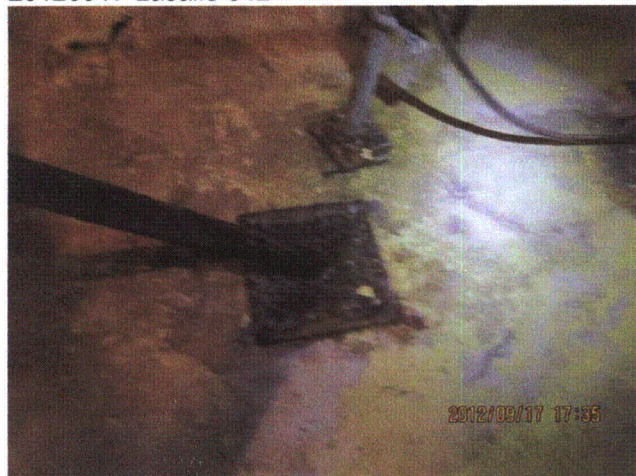
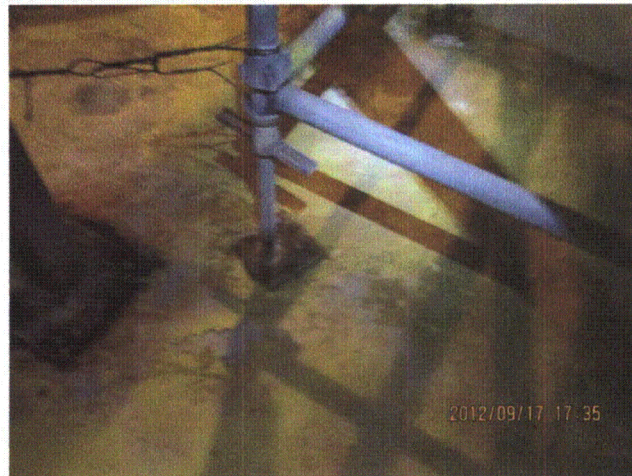
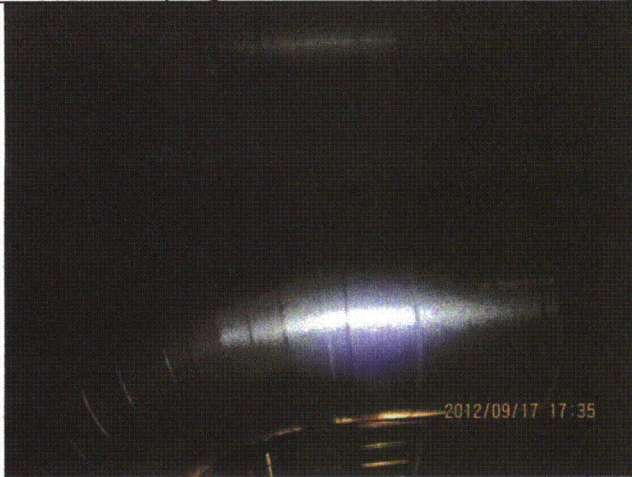
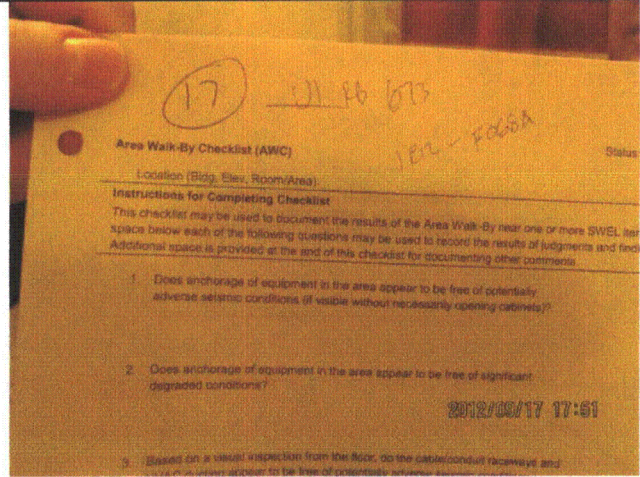
2. Does anchorage of equipment in the area appear to be free of significant degraded conditions? Yes
More than minor corrosion of auxiliary steel base plates beneath valve 1E12-F068A due to leakage. Scale only; no separation of material observed. Judged to be acceptable. Station is aware of leak per WO 01432087.

8. Have you looked for and found no other seismic conditions that could adversely affect the safety functions of the equipment in the area? Yes
More than minor corrosion of auxiliary steel beneath valve 1E12-F068A due to leakage. Scale only; no separation of material observed. Judged to be acceptable. Per Operations, station is aware of leak.

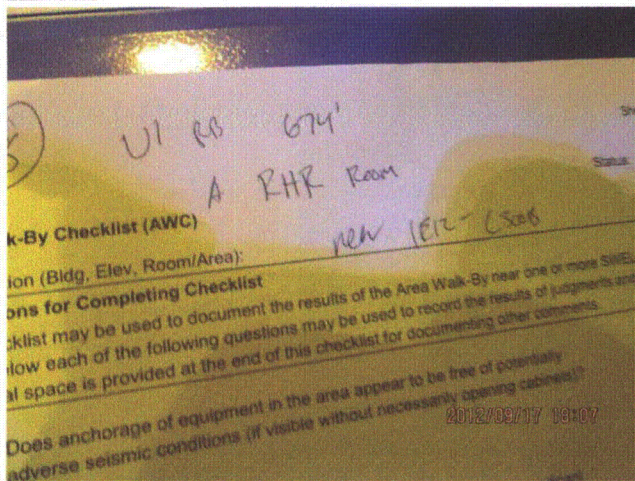
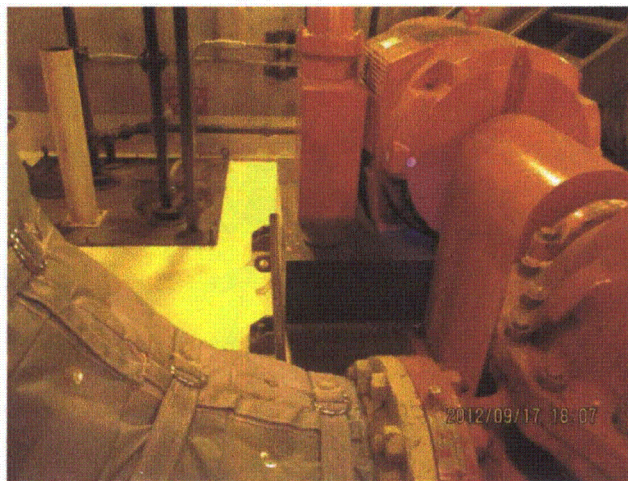
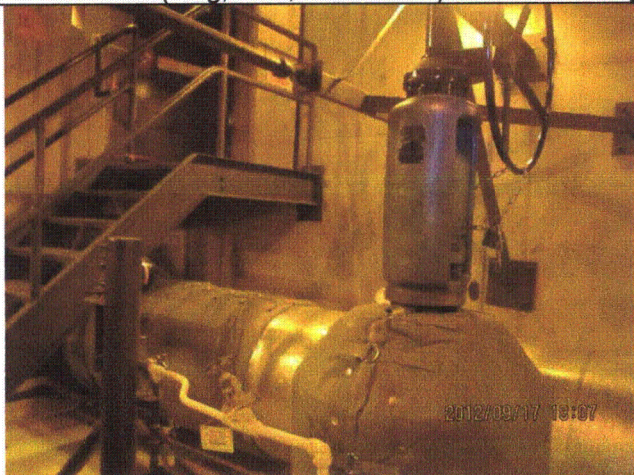
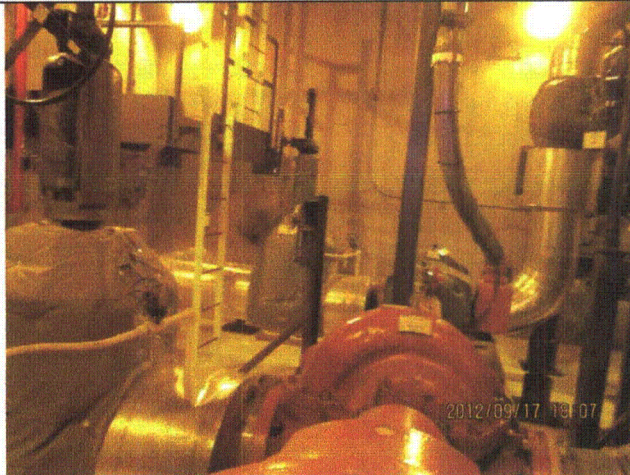
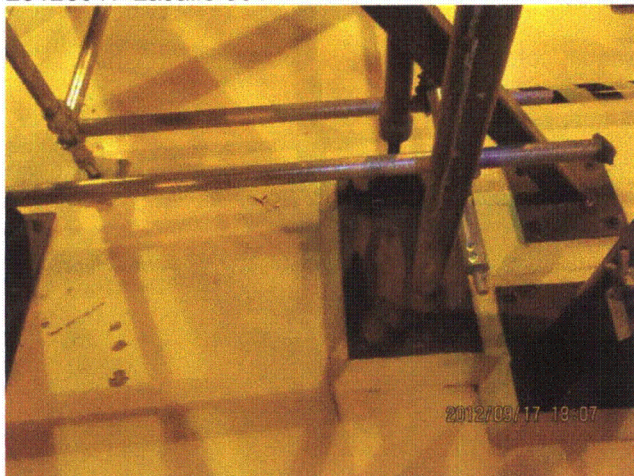
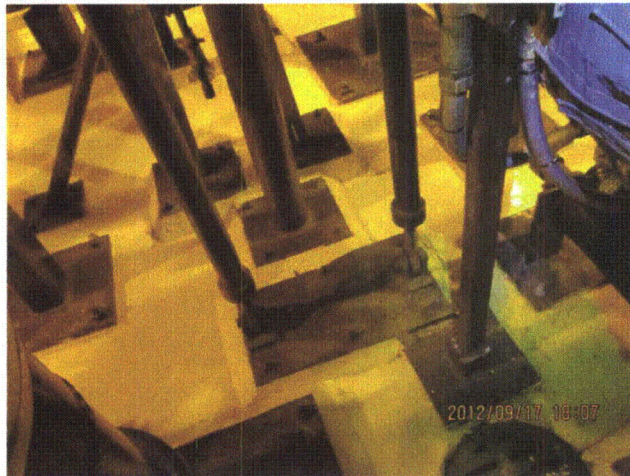
2. Does anchorage of equipment in the area appear to be free of significant degraded conditions? Yes
Minor corrosion in several base plates judged to be acceptable.

4. Does it appear that the area is free of potentially adverse seismic spatial interactions with other equipment in the area (e.g., ceiling tiles and lighting)? Yes
Insulated, non-safety-related pipes in contact. Judged to be acceptable.

5. Does it appear that the area is free of potentially adverse seismic interactions that could cause flooding or spray in the area? Yes
Deluge system with threaded pipe is dry; requires signal to activate. Judged to be acceptable. Remaining piping is welded and judged to be acceptable.

7. Does it appear that the area is free of potentially adverse seismic interactions associated with housekeeping practices, storage of portable equipment, and temporary installations (e.g., scaffolding, lead shielding)? Yes
Scaffold adequately restrained to auxiliary steel.

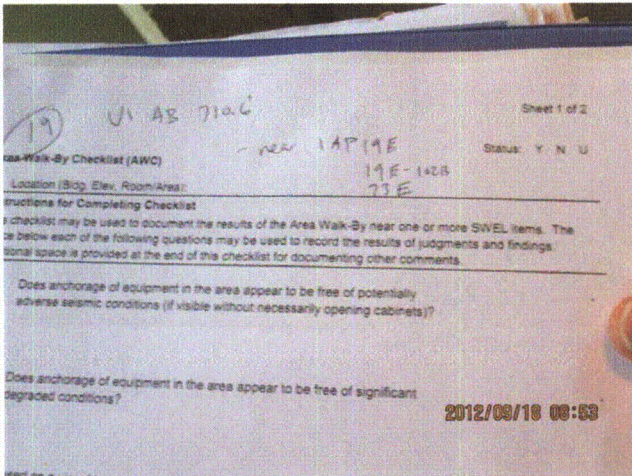
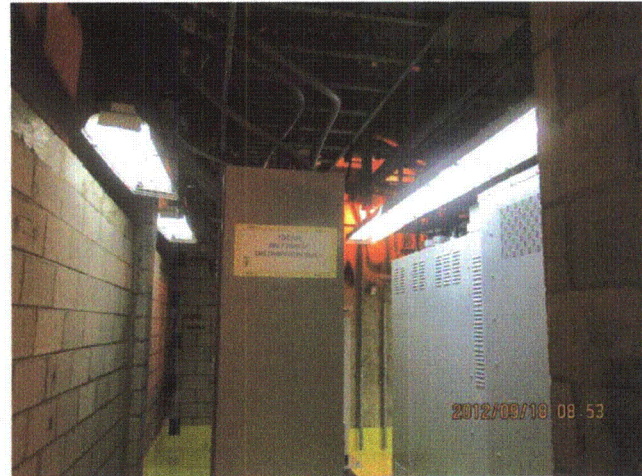
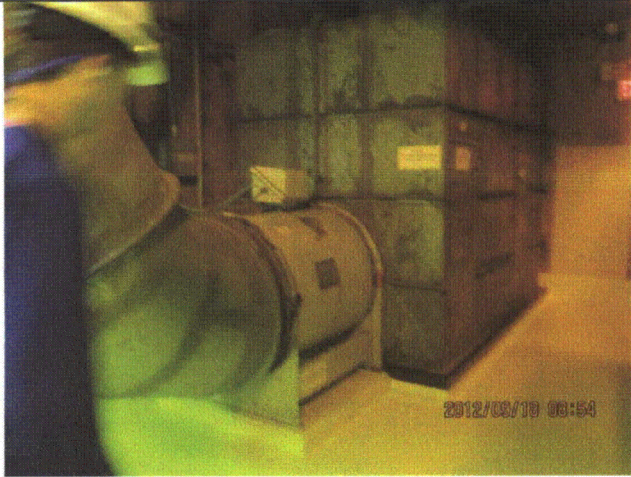
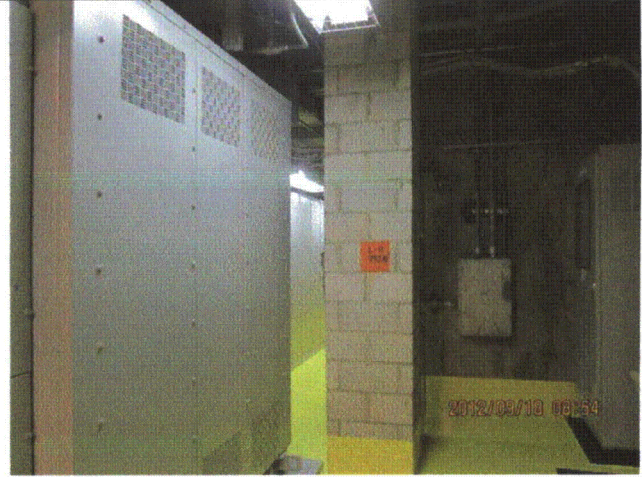
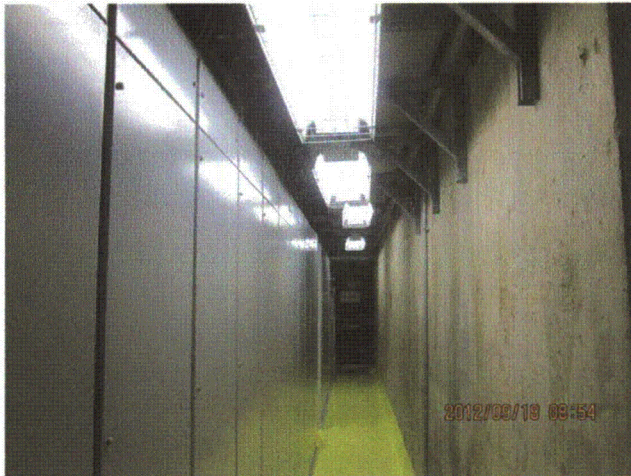
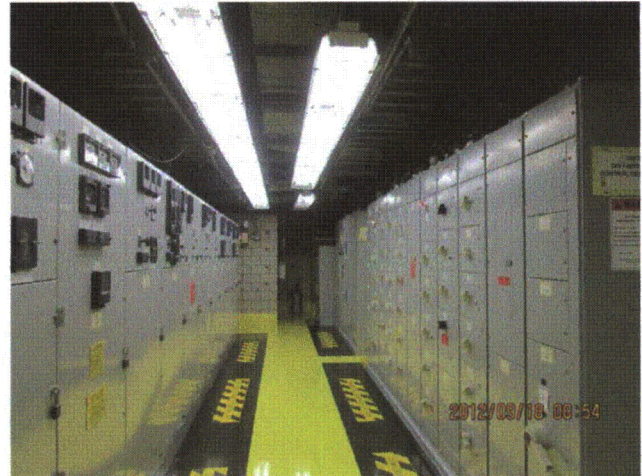
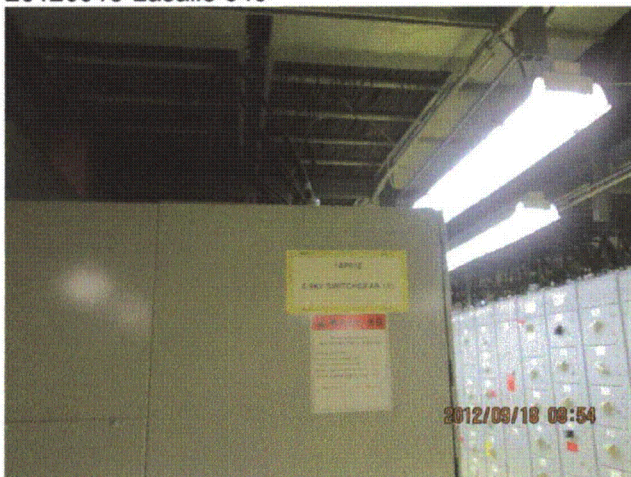
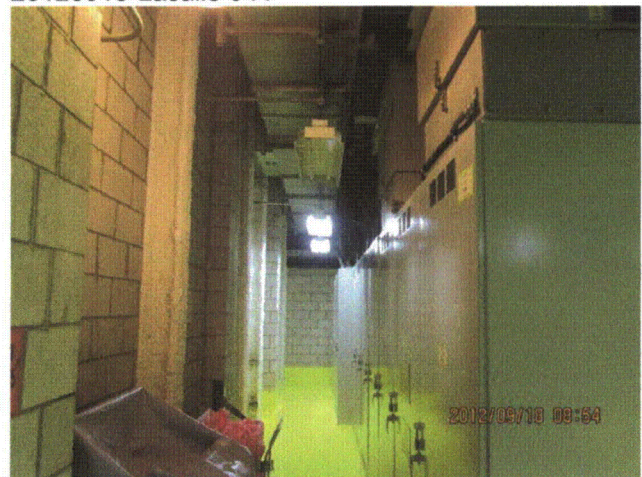
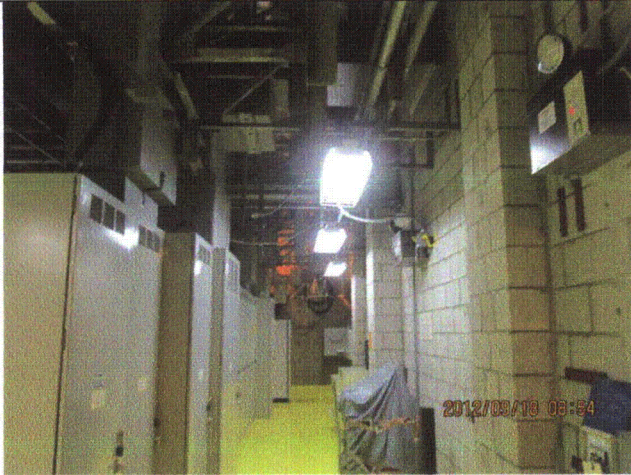
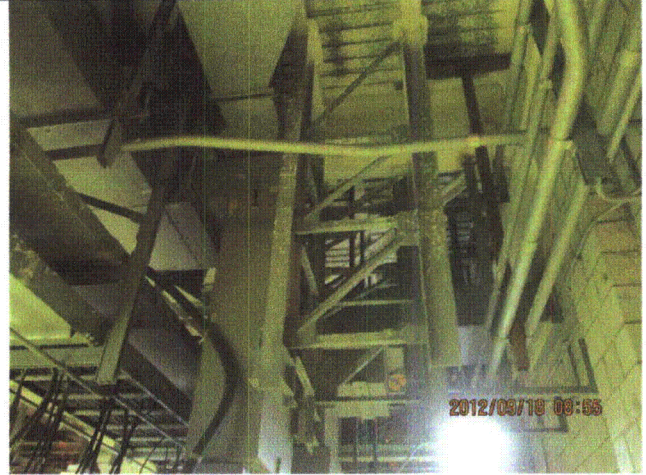
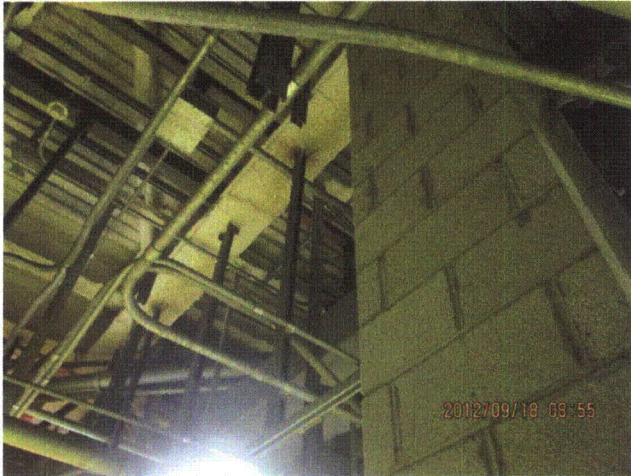
4. Does it appear that the area is free of potentially adverse seismic spatial interactions with other equipment in the area (e.g., ceiling tiles and lighting)? Yes
Overhead chain-hung light fixture prevented from interaction with transformer by short hanging chain, conduit, and chain restraint.

7. Does it appear that the area is free of potentially adverse seismic interactions associated with housekeeping practices, storage of portable equipment, and temporary installations (e.g., scaffolding, lead shielding)? Yes
Wheeled breakers adequately restrained to wall.

Eyewash station adequately restrained to column on opposite side of 19E transformer.

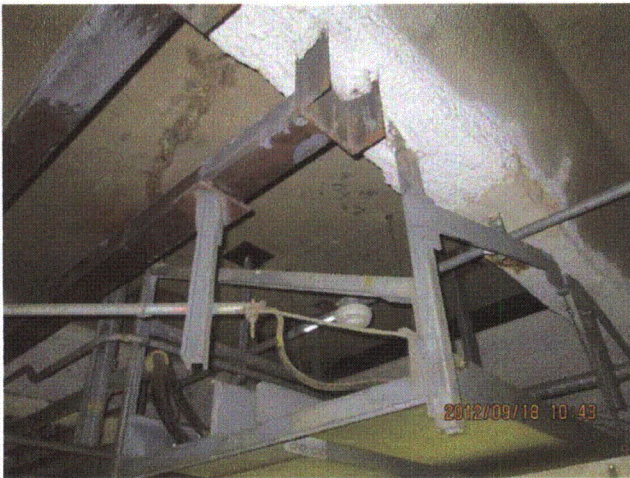
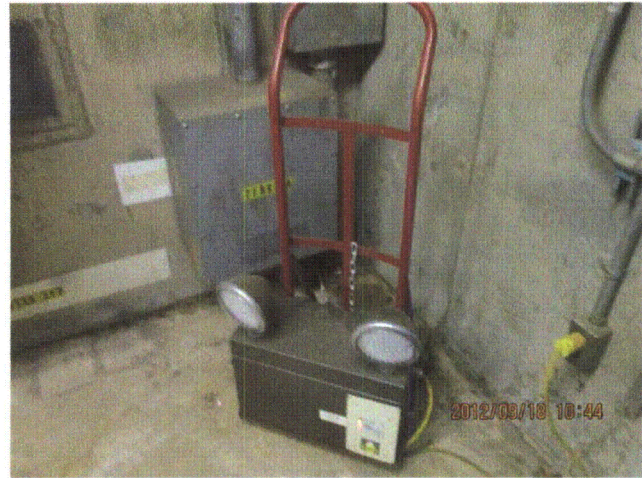
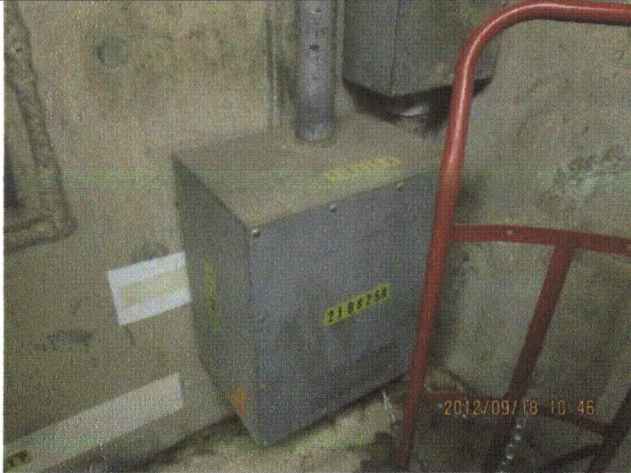
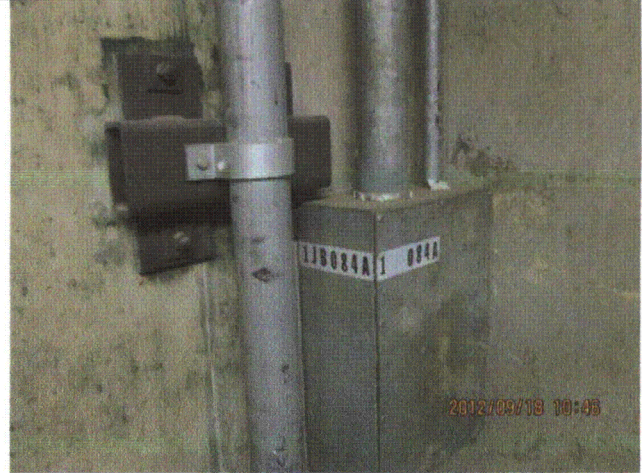
4. Does it appear that the area is free of potentially adverse seismic spatial interactions with other equipment in the area (e.g., ceiling tiles and lighting)? Yes
Masonry wall in area adequately restrained.
Overhead light fixtures judged to be acceptable.

7. Does it appear that the area is free of potentially adverse seismic interactions associated with housekeeping practices, storage of portable equipment, and temporary installations (e.g., scaffolding, lead shielding)? Yes
Emergency light fixture near non-safety-related junction box judged to be acceptable.
