Area Walk-By Checklist (AWC)

Location (Bldg, Elev, Room/Area): Area Walk-by 4-24

Peer Review Report
for
Near Term Task Force (NTTF) Recommendation 2.3
Seismic Walkdown Inspection
of
LaSalle County Generating Station Unit 2

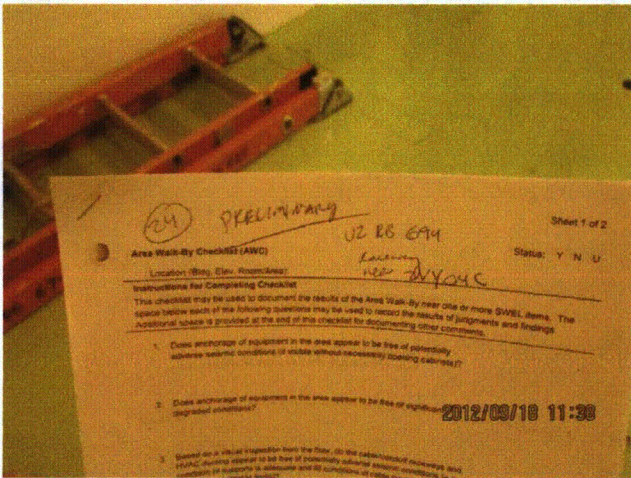
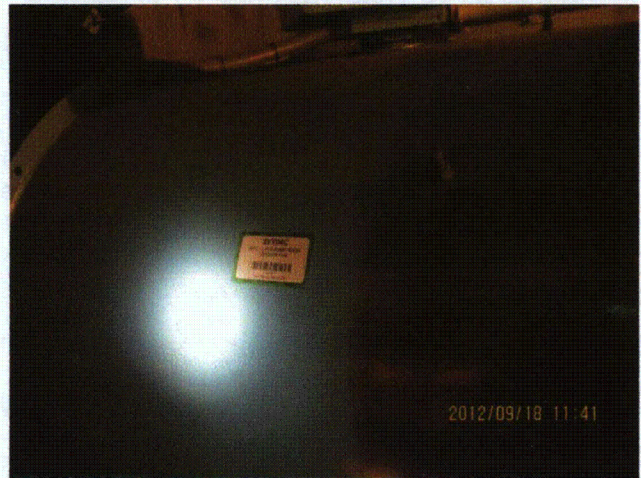
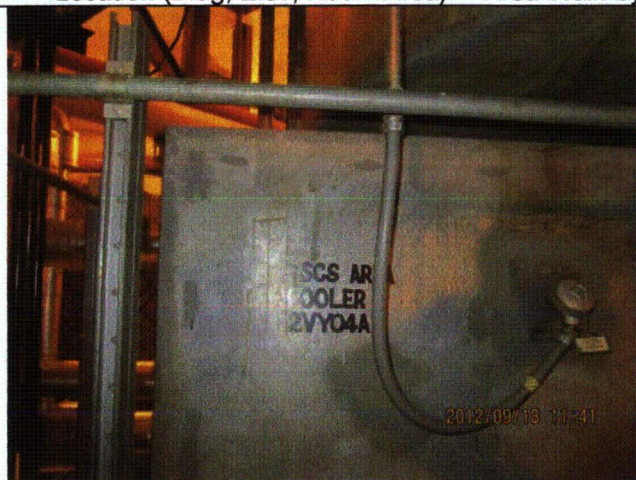
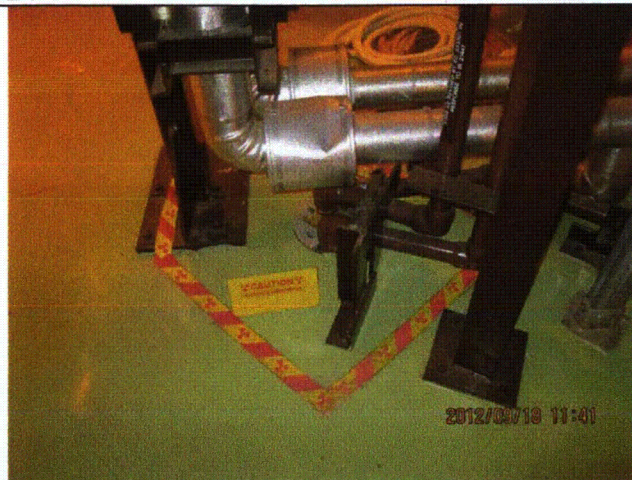
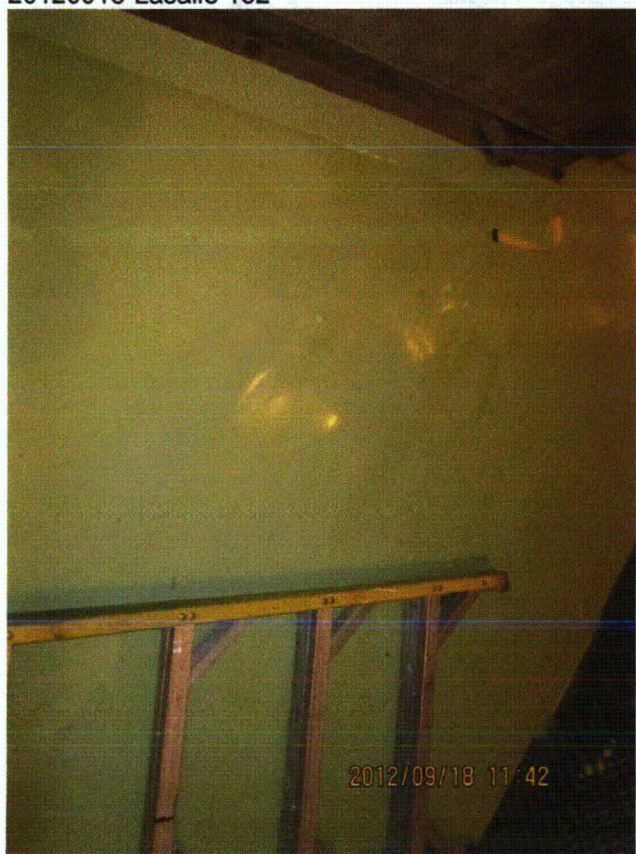
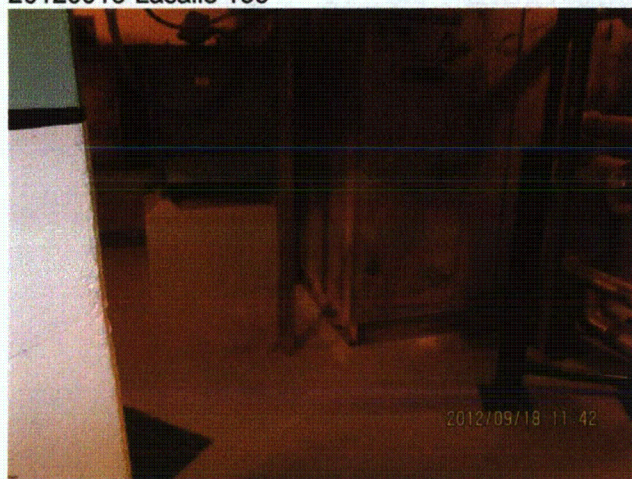
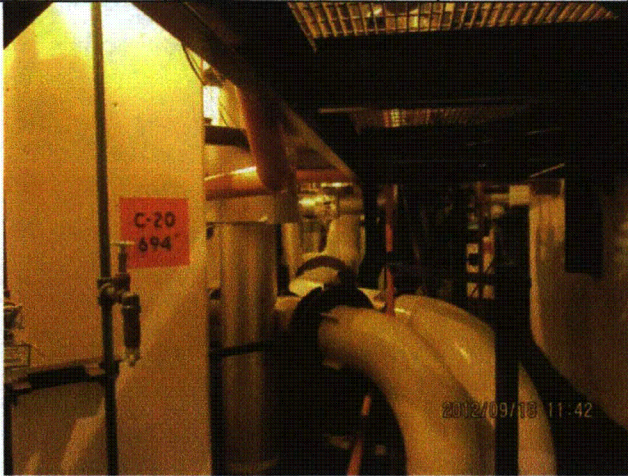
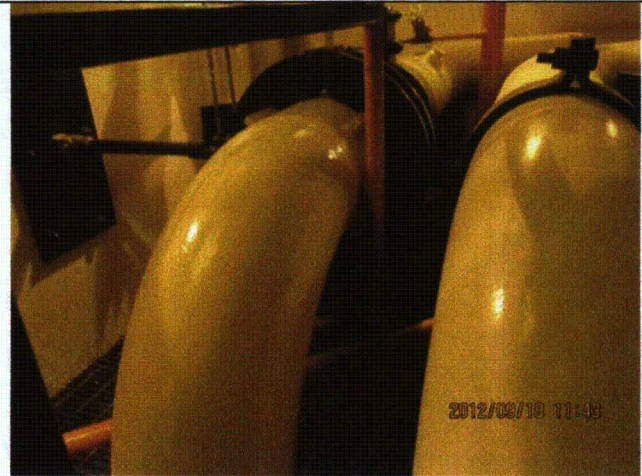
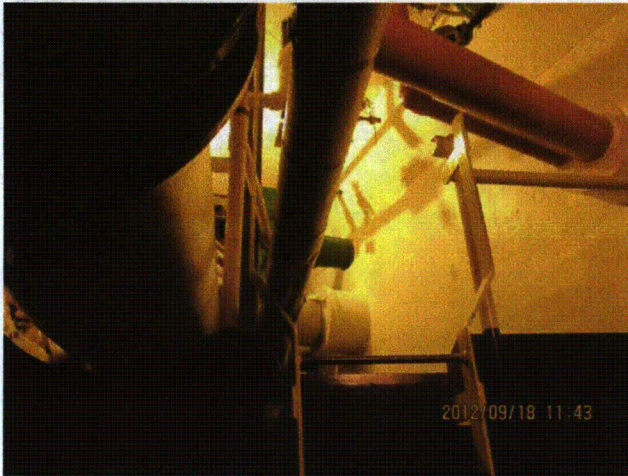
4. Does it appear that the area is free of potentially adverse seismic spatial interactions with other equipment in the area (e.g., ceiling tiles and lighting)? Yes
Overhead light fixtures judged to be acceptable.

5. Does it appear that the area is free of potentially adverse seismic interactions that could cause flooding or spray in the area? Yes
All piping is welded and judged to be acceptable.

7. Does it appear that the area is free of potentially adverse seismic interactions associated with housekeeping practices, storage of portable equipment, and temporary installations (e.g., scaffolding, lead shielding)? Yes
Ladder storage corrected during walk-by by Radiation Protection.
-

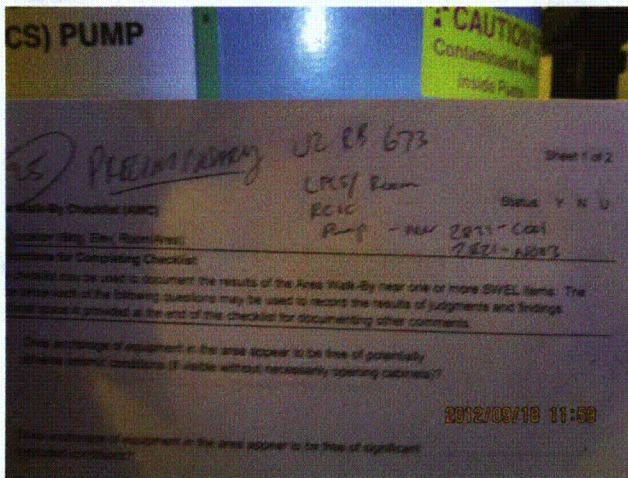
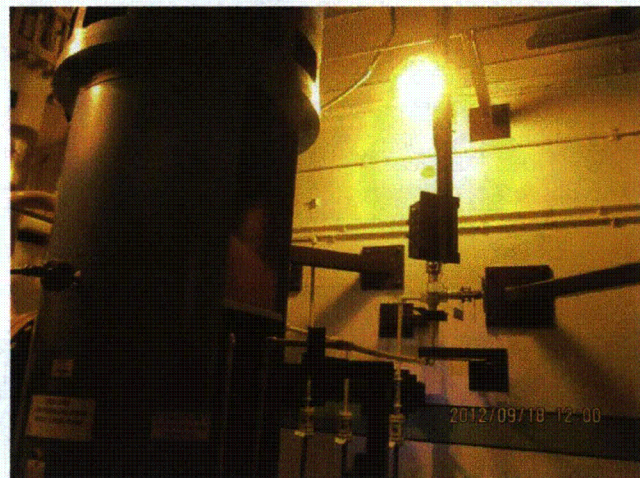
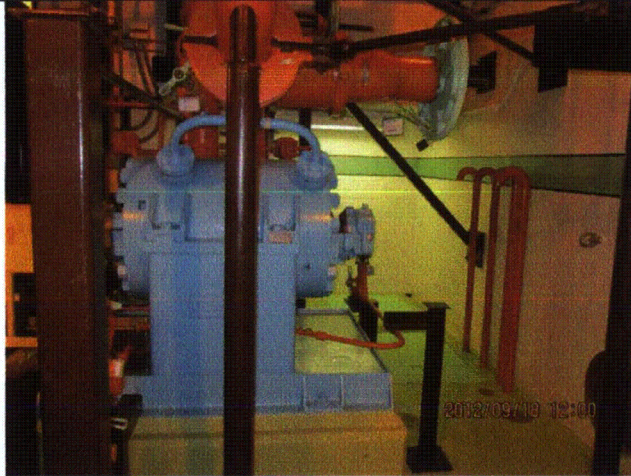
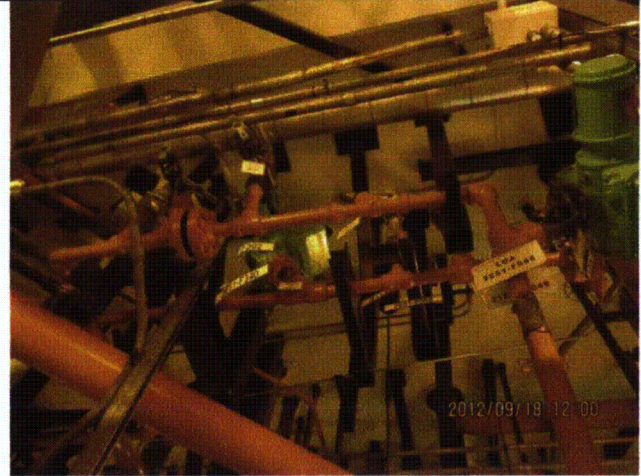
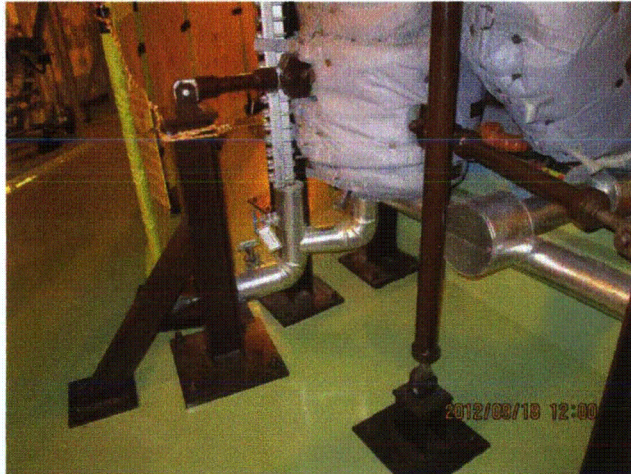
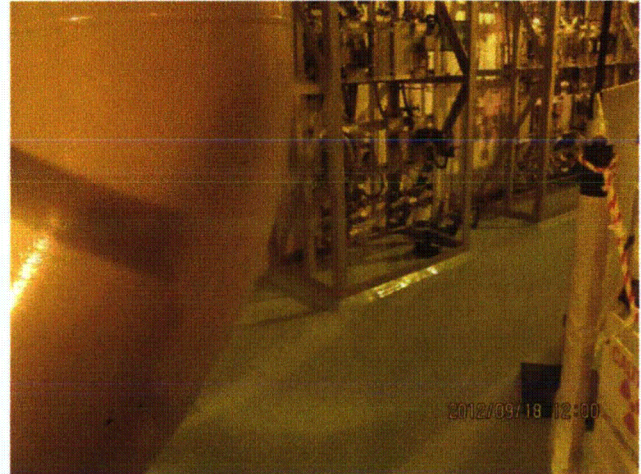
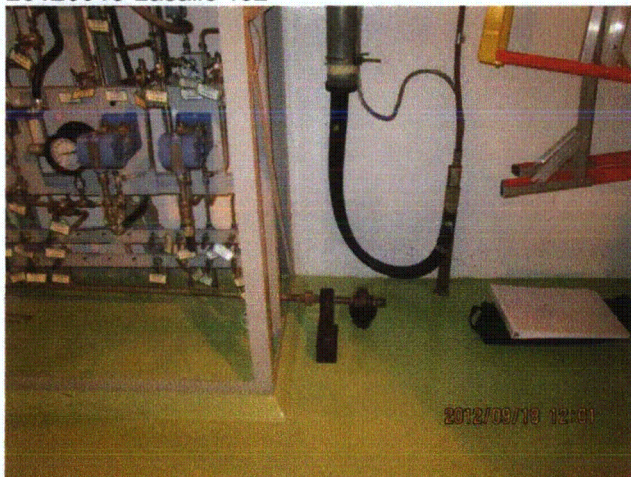
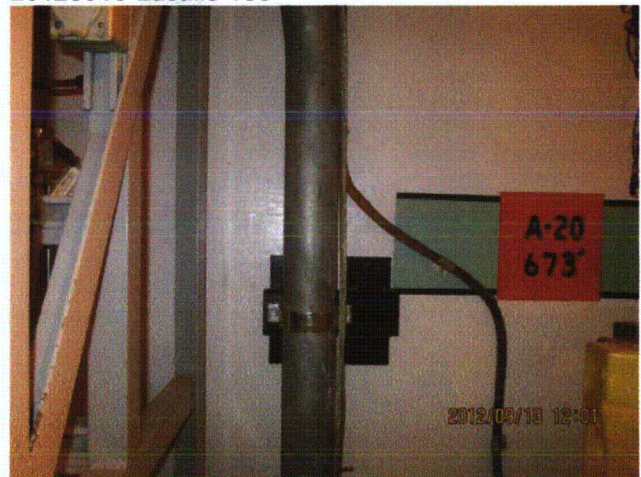
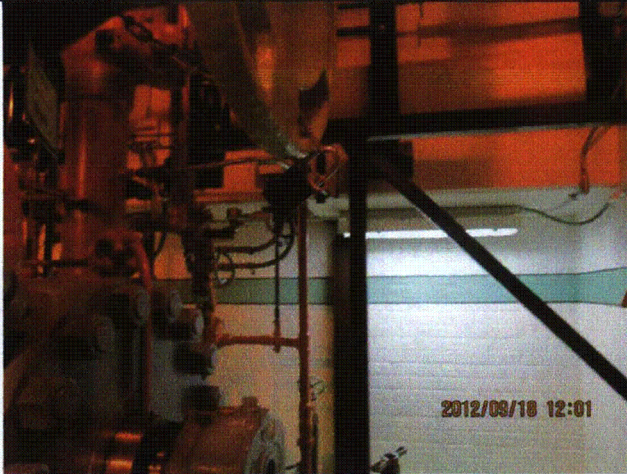
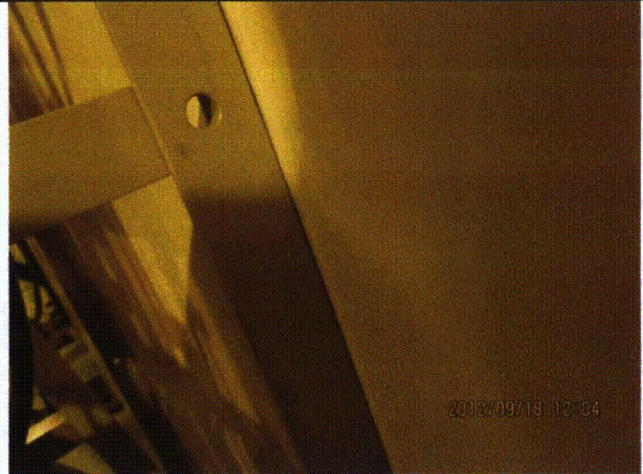
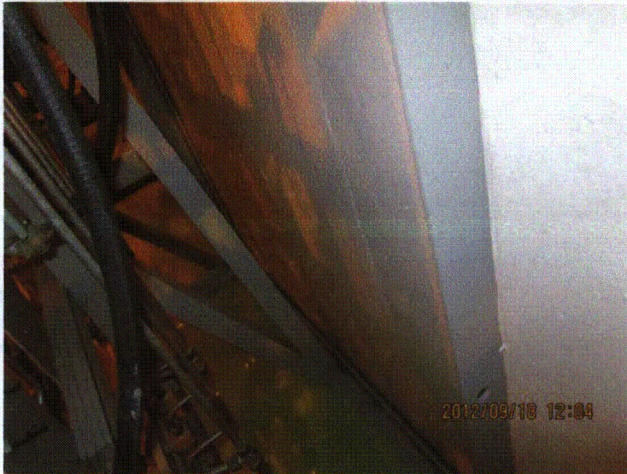
4. Does it appear that the area is free of potentially adverse seismic spatial interactions with other equipment in the area (e.g., ceiling tiles and lighting)? Yes
Masonry walls near raceway door and outside walls adequately restrained.
Overhead light fixtures judged to be acceptable.
Rack 2H22-P029 has adequate clearance to wall.
 5. Does it appear that the area is free of potentially adverse seismic interactions that could cause flooding or spray in the area? Yes

7. Does it appear that the area is free of potentially adverse seismic interactions associated with housekeeping practices, storage of portable equipment, and temporary installations (e.g., scaffolding, lead shielding)? Yes
Ladders adequately stored.
-

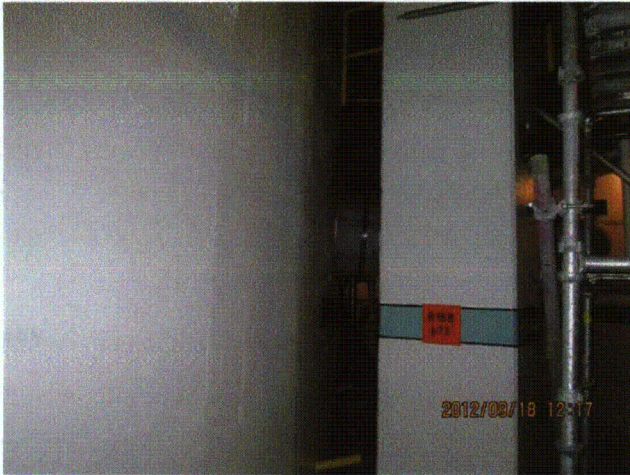
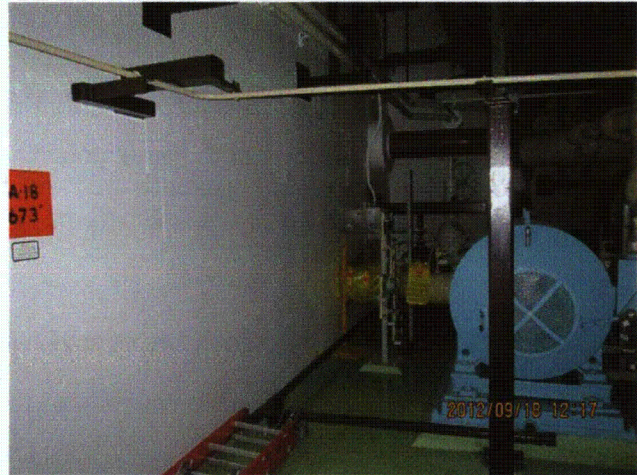
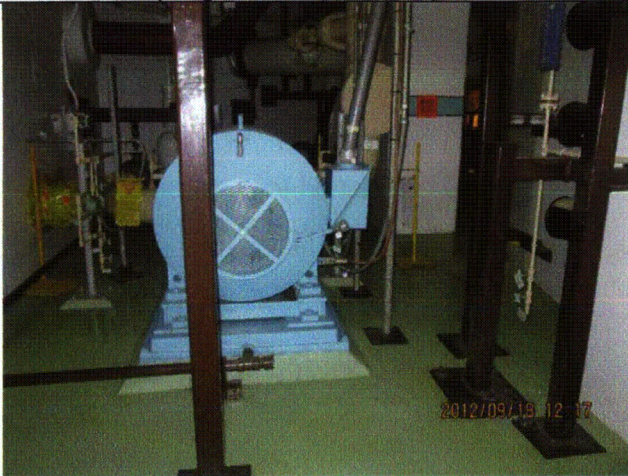
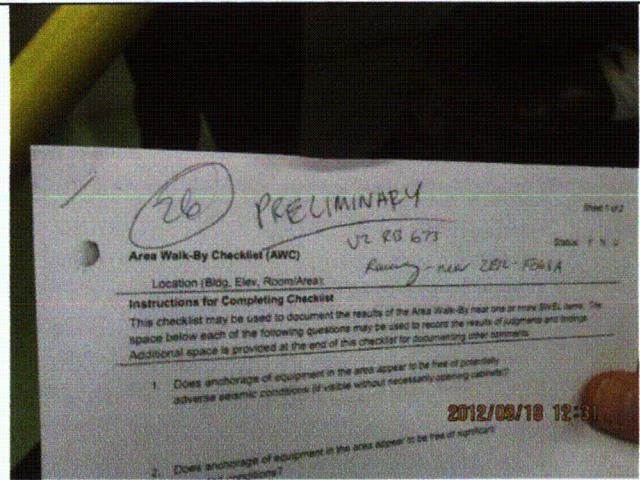
4. Does it appear that the area is free of potentially adverse seismic spatial interactions with other equipment in the area (e.g., ceiling tiles and lighting)?
Flexible pipes in contact with scaffold judged to be acceptable. Yes

5. Does it appear that the area is free of potentially adverse seismic interactions that could cause flooding or spray in the area?
All piping is welded and judged to be acceptable. Yes

7. Does it appear that the area is free of potentially adverse seismic interactions associated with housekeeping practices, storage of portable equipment, and temporary installations (e.g., scaffolding, lead shielding)? Yes
Scaffold wired to auxiliary steel in one location. Scaffold is framed against RHR HX outlet line such that movement is restrained. No soft targets are in vicinity. Judged to be acceptable.
-
