Seismic Walkdown Checklist (SWC)	
Equipment ID No. 2X41-C010A Equip. Class 9	and the second s
Equipment Description DG 2C ROOM FAN 2A	
Location: Bldg. DIESEL Floor El. 150 Room, Area ROOF	
Manufacturer, Model, Etc. (optional but recommended)	
Instructions for Completing Checklist	
This checklist may be used to document the results of the Seismic Walkdown of SWEL. The space below each of the following questions may be used to record findings. Additional space is provided at the end of this checklist for documenting the space is provided at the end of this checklist for documenting the space is provided at the end of this checklist for documenting the space is provided at the end of this checklist for documenting the space is provided at the end of this checklist for documenting the space is provided at the end of this checklist for documenting the space is provided at the end of this checklist for documenting the space is provided at the end of this checklist for documenting the space is provided at the end of this checklist for documenting the space is provided at the end of this checklist for documenting the space is provided at the end of this checklist for documenting the space

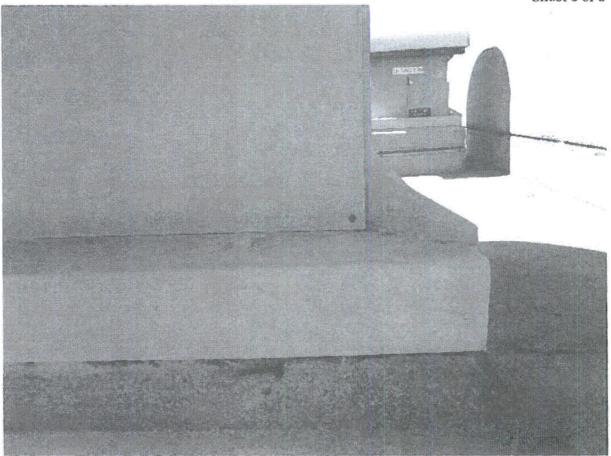
11. Have you looked for and found no other seismic conditions that could adversely affect the safety functions of the equipment? A screw on the east side cover plate that the head has been sheared off (see photograph 4). There are three other screws supporting the plate, which is judged to be adequate to secure it in place. The damaged screw is not a seismic concern. CR 523328 has been written to replace the screw.	Y⊠ N□ U□
Comments (Additional pages may be added as necessary)	
None.	
	No. 1
Evaluated by: Juan Vizcaya	Date: 09/24/2012
Patrick Kelly Cath	09/24/2012

4: Cover Plate with Sheared Screw Head (2X41-C010A)

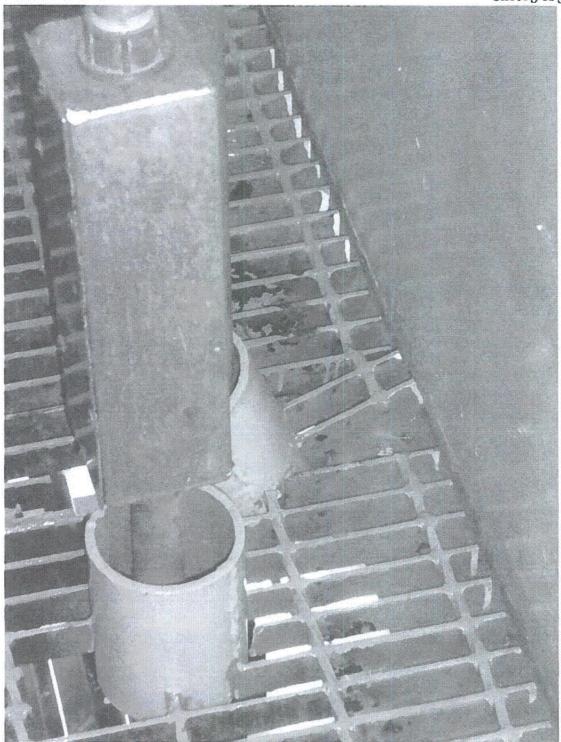
11. Have you looked for and found no other seismic conditions that could adversely affect the safety functions of the equipment?	Y⊠ N□ U□
Comments (Additional pages may be added as necessary)	
There is a small section of grating broken near the corner of the 2T41-BC Cooler. The section of grating is extremely small and is welded to the kid going through the grating at that location. The grating is not in immedia becoming an impact hazard and does not affect the larger grating panel's Therefore, it has been judged to be seismically adequate.	ck plate around the pipe te danger of separating and
See Component 2E11-B001A for the Area Walk-by Checklist.	<u></u>
Evaluated by: John McFarland	Date: 09/12/2012
Jeff Horton Il Korton	09/12/2012

Figure 3 – Broken Grating Section (2T41-B003B)

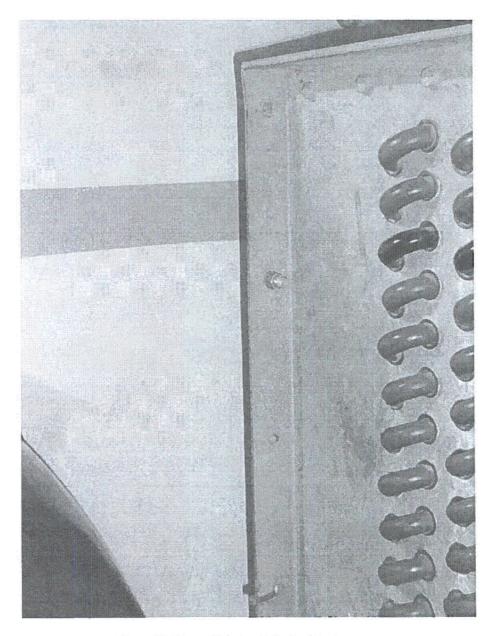
Anchorage 1. Is the anchorage configuration verification required (i.e., is the item one of the 50% of SWEL items requiring such verification)?	Y⊠ N□
2. Is the anchorage free of bent, broken, missing or loose hardware? Holes with missing anchors but replaced with tabs and new anchors. SWE's have determined that this configuration is acceptable and consistent with anchorage shown in SQUG package based on referenced SEWS package and Calculation	Y⊠ N□ U□ N/A□

Figure 4 View of Casing Missing Cap Screws

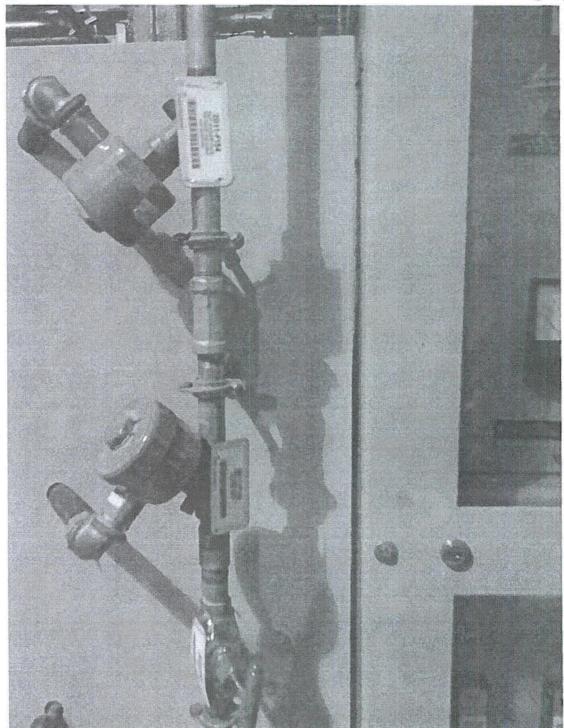
7. Are soft targets free from impact by nearby equipment or structures? Panel 2D11-P010 sits next to H2/02 Analyzer Sample Chiller 2P33- B001B. There is between a 1/16" and a 1/8" gap between the two components, and the components are not tied together. During a seismic event, it is likely that the two will impact one another. However, per conversations with a recent former systems engineer for this system, there are no essential relays or similar sensitive equipment inside either cabinet, so the impact does not have the potential to create a condition that is adverse to plant safety. The impact between the cabinets will not have enough force to damage the rugged cabinets, so it is judged that there is no potentially adverse seismic condition.	Y□ N□ U⊠ N/A□

Figure 3 - Small Gap between Panels (2P33-B001B)
