Status: Y  N  U **Seismic Walkdown Checklist (SWC)**Equipment ID No. 2R43-B002A Equip. Class<sup>1</sup> 21Equipment Description DG 2A LUBE OIL HEAT EXCHLocation: Bldg. DIESEL Floor El. 130 Room, Area 2A

**Seismic Walkdown Checklist (SWC)**

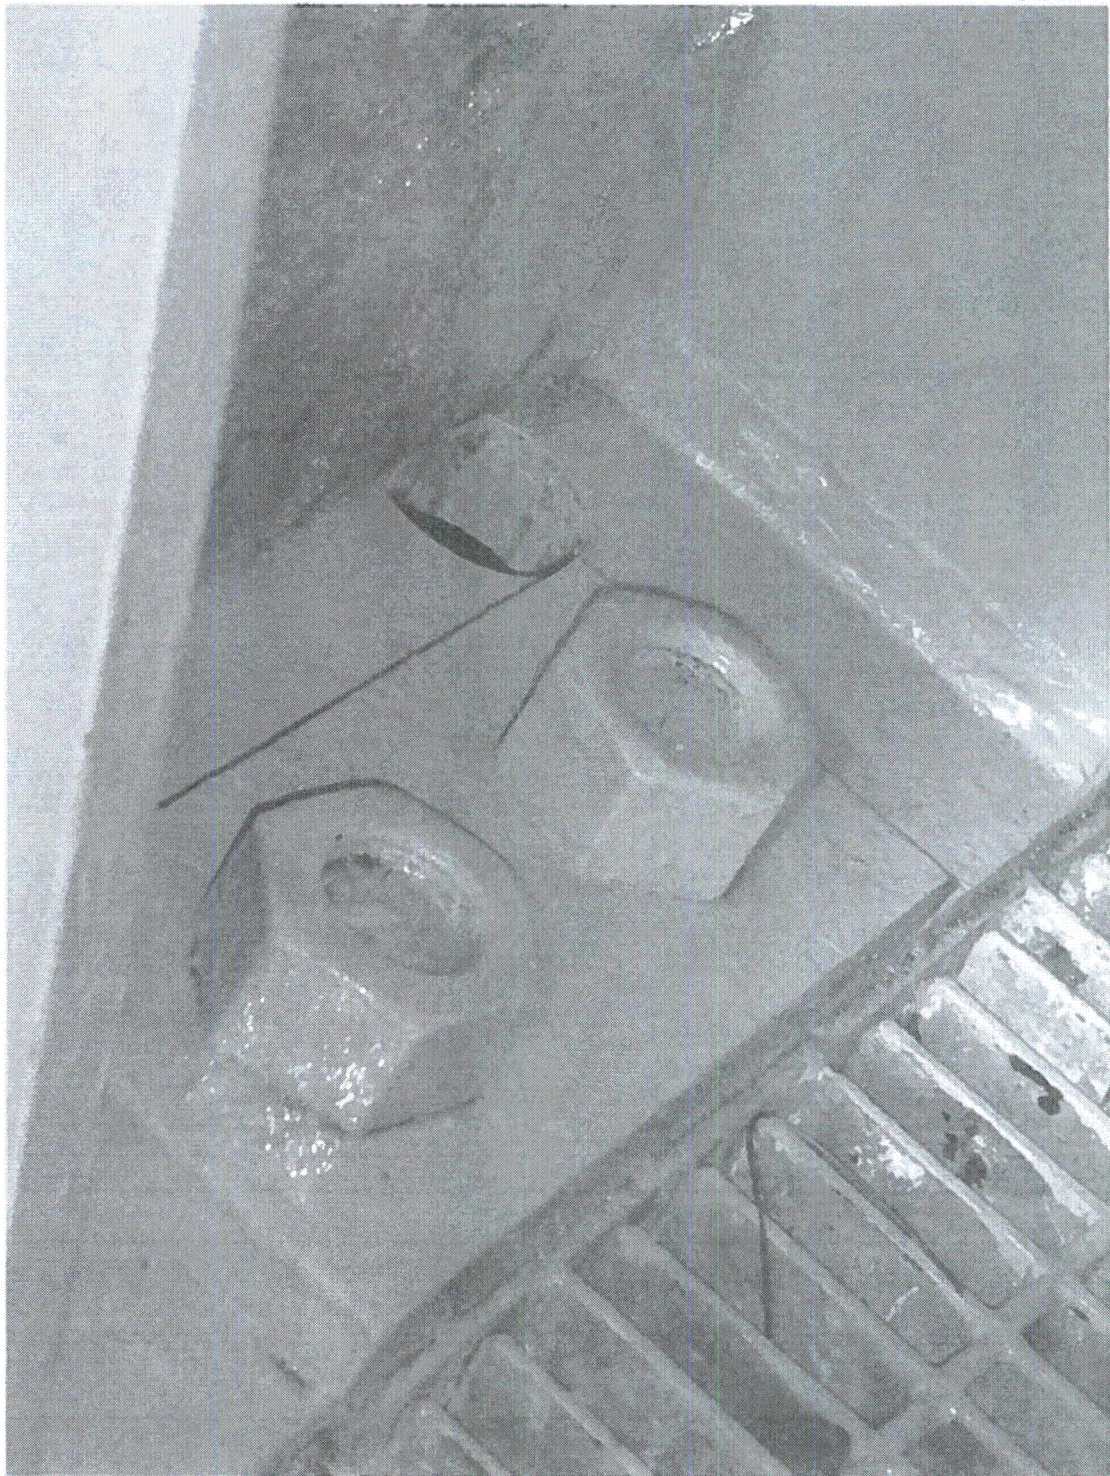
Figure 3 – Bolt Threads below Nut (2E11-B001A)

2. Is the anchorage free of bent, broken, missing or loose hardware? Y  N  U  N/A   
*There are eight anchors attached to the steel frame in four mounting chairs. Two of the bolts have full thread engagement but do not have the required minimum of two threads above the nut; an additional two bolts have bolts approximately 1/4" below the nuts and so do not have full thread engagement (CR 516593). The bolts are welded to the steel frame, providing additional support for the connection. In addition, the heat exchanger is also supported by four sway struts below the roof above to prevent overturning of the equipment. The shear strength is not impacted, overturning is restrained, and the center of gravity of the equipment is below the bolts and the vertical seismic acceleration at that level will not exceed 1.0, so the largest tension load the bolts will see is the preload, which is already applied. Therefore, the bolts are judged to be acceptable and do not create a potentially adverse seismic condition.*

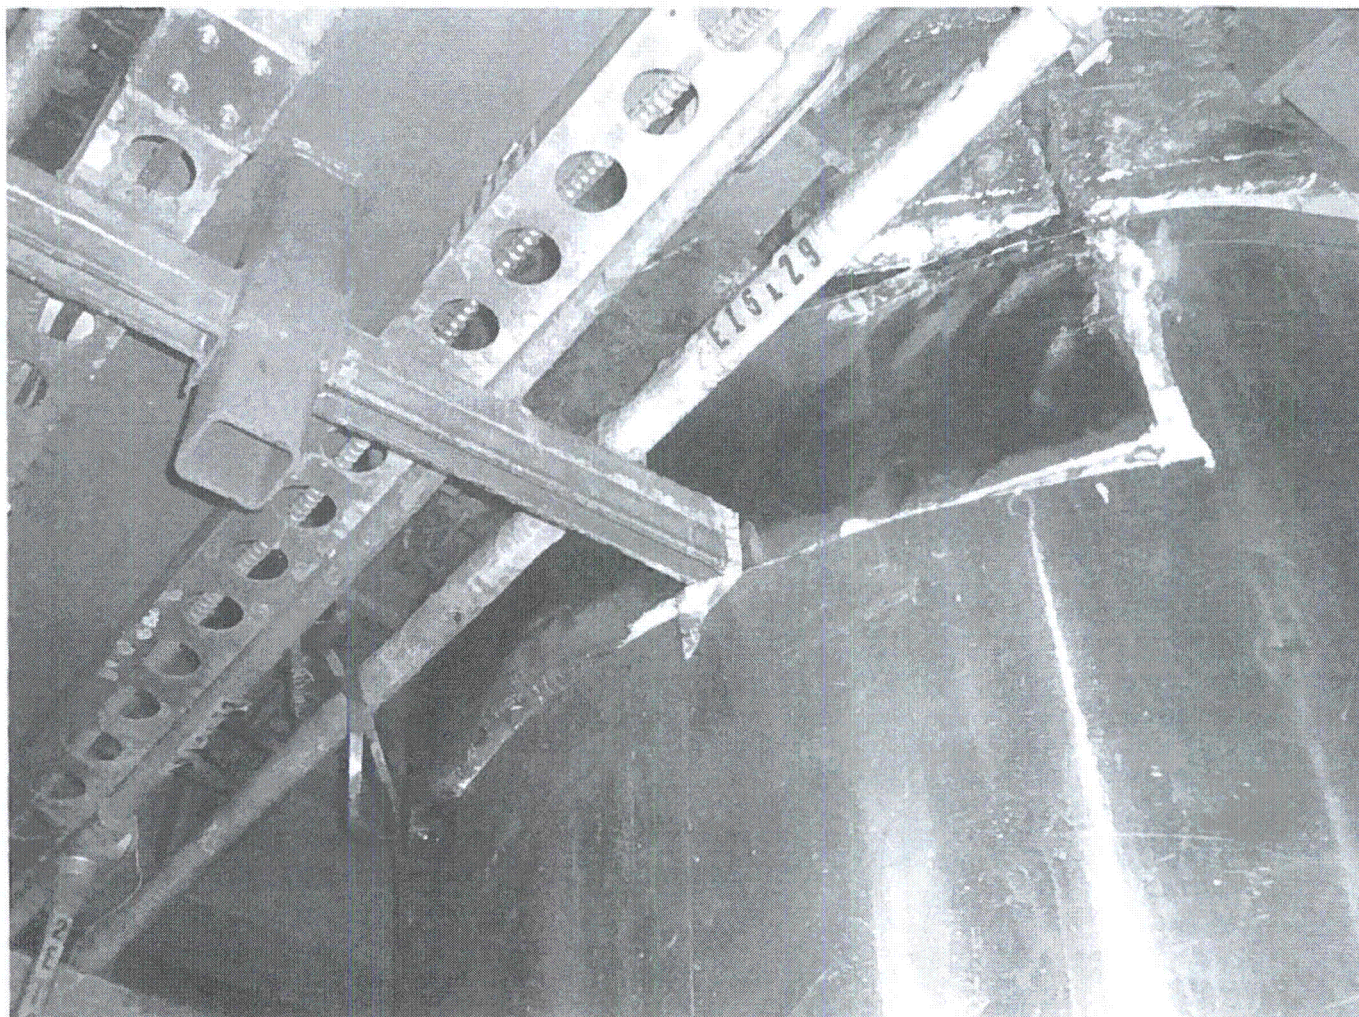
Figure 5 – Cable Raceway near Heat Exchanger (2E11-B001A)

- 10. Based on the above seismic interaction evaluations, is equipment free of potentially adverse seismic interaction effects? Y N U  
*The cable raceway support impinges on the RHR Heat Exchanger insulation, and the insulation has been cut away from the member. The raceway support only impacts the insulation, but is at least one inch from the body of the heat exchanger, so there will be no impact between the two components. Therefore, it is judged that there is no potentially adverse seismic condition.*

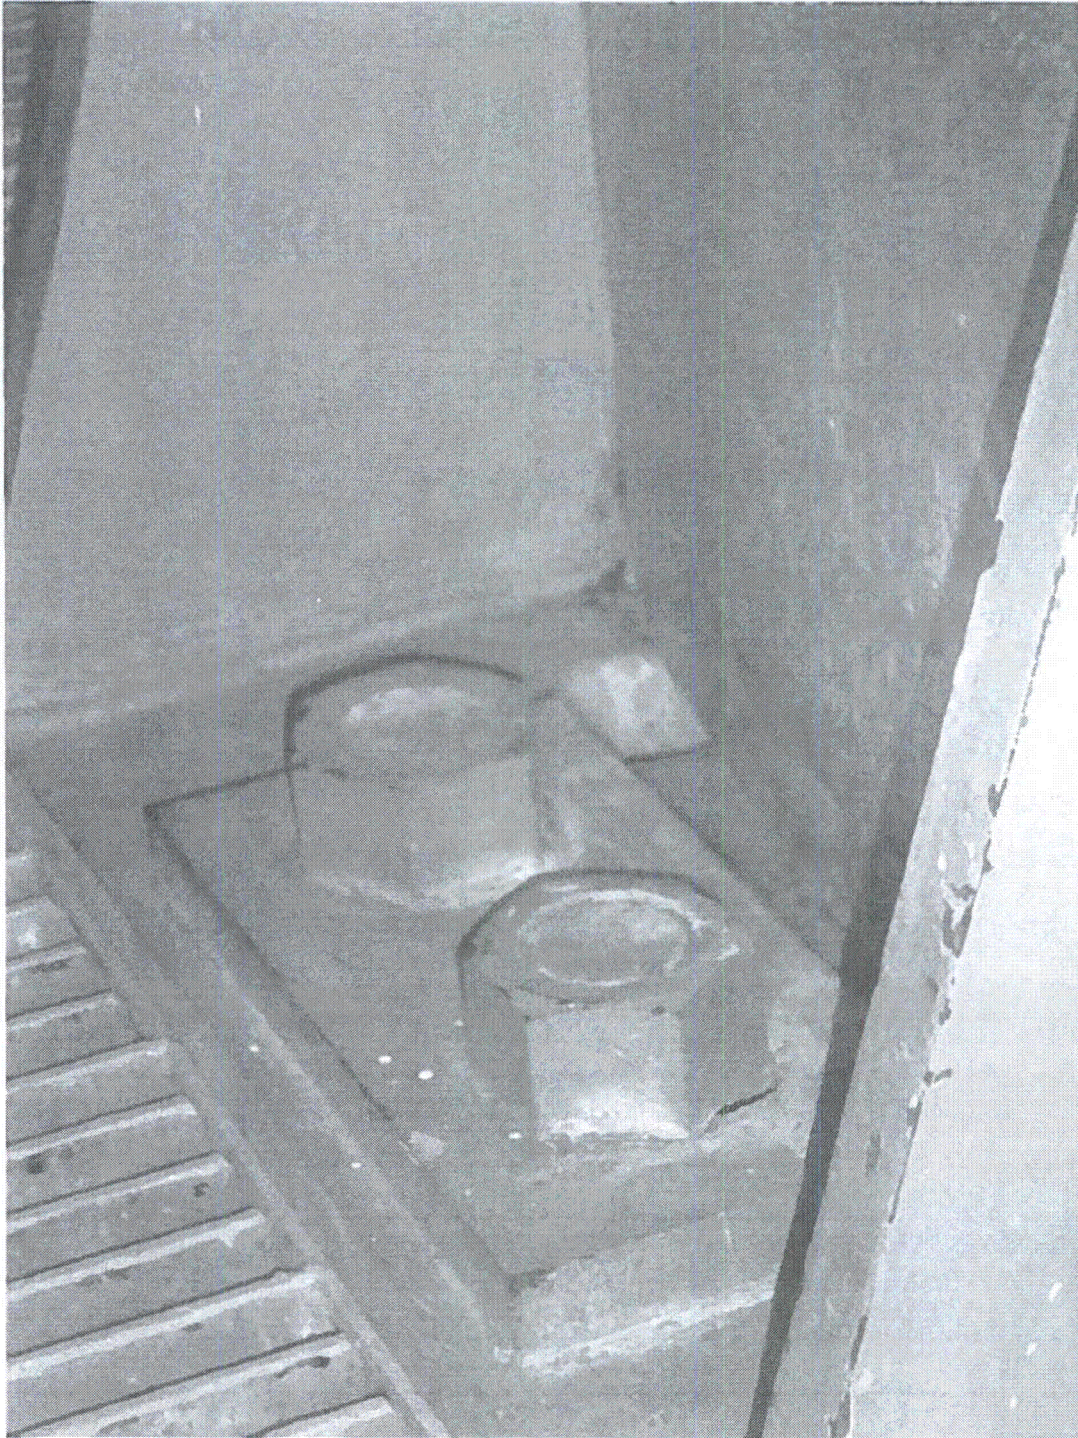
Figure 3 – Bolt Threads Flush with Nut (2E11-B001B)

2. Is the anchorage free of bent, broken, missing or loose hardware? Y  N  U  N/A   
*There are eight anchor connections to the steel frame in four mounting chairs. Two of the bolts have full thread engagement but do not have the required minimum of two threads above the nut (CR 516595). The bolts are welded to the steel frame, providing additional support for the connection. Also, each of the HX anchoring chairs have two additional holes drilled in them. These bolt holes appear to be the original holes for the installation of the RHR HX. Bolts installed in these holes would not be able to reach the structural steel flanges in the existing building structure. Therefore, new mounting holes have been provided for installing the RHR HX on the existing building structure. The current bolts used for the anchorage of this component are judged by the SWE's to be the same size and strength as the original connections for the holes on the bolting chairs for this component.*

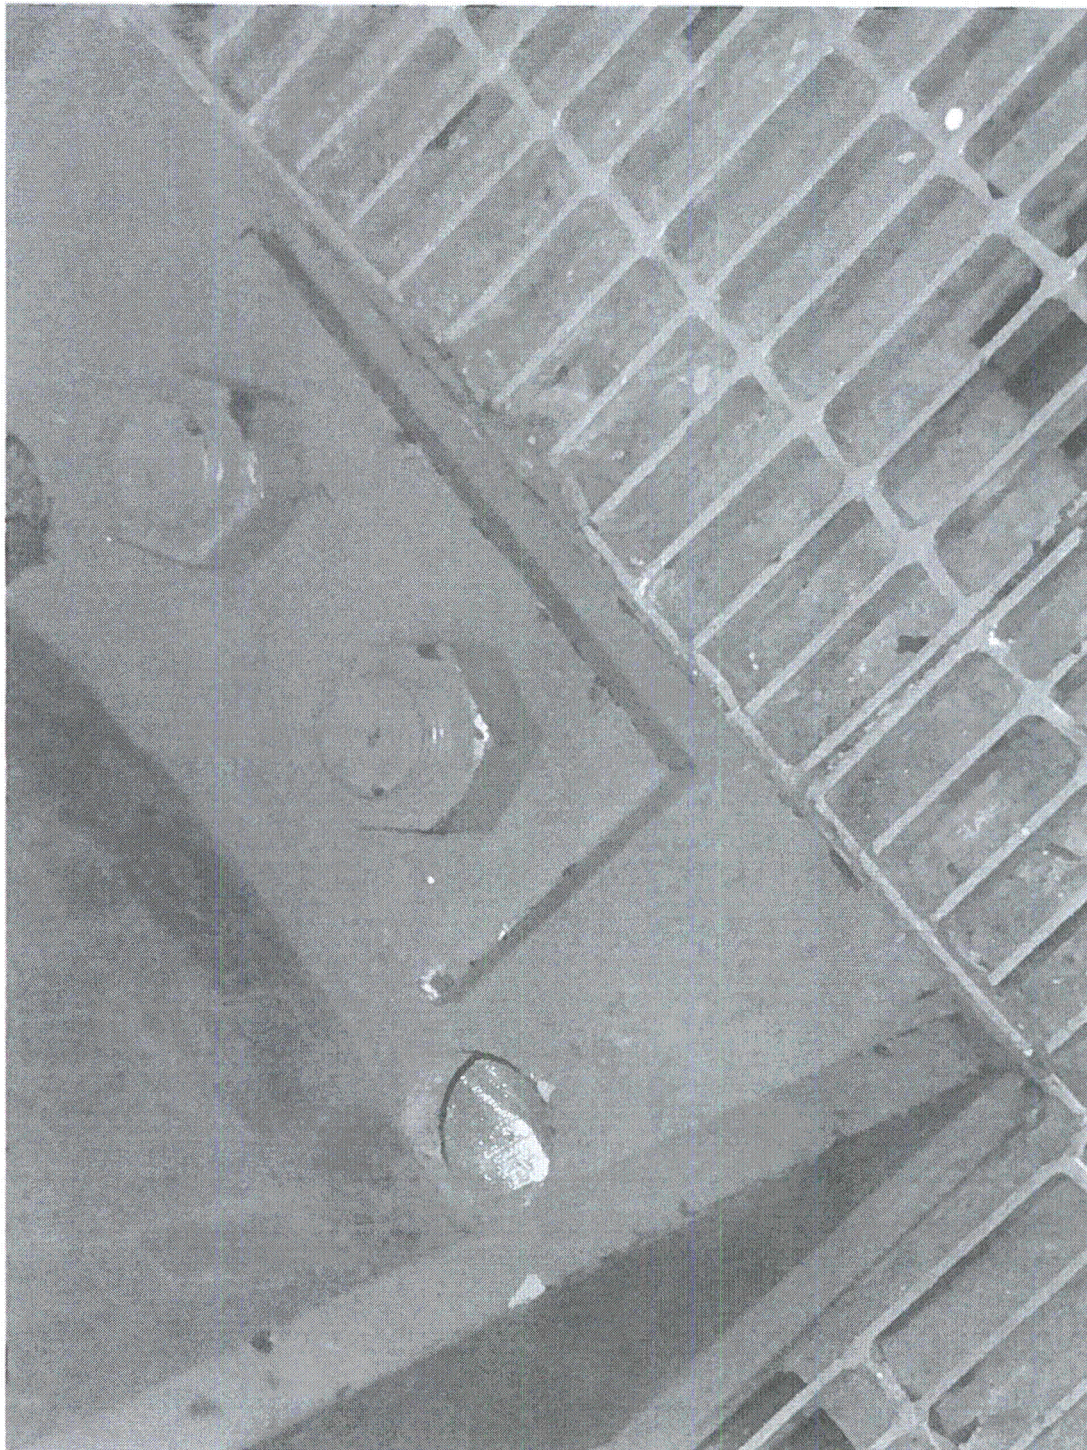
Figure 4 – Chipped Bolt Paint (2E11-B001B)

3. Is the anchorage free of corrosion that is more than mild surface oxidation? Y  N  U  N/A   
*The bolt paint chipped off in several places, resulting in mild surface oxidation. Since oxidation is only on the surface, the anchors are not degraded. Therefore, the anchors are judged not be a seismic concern.*

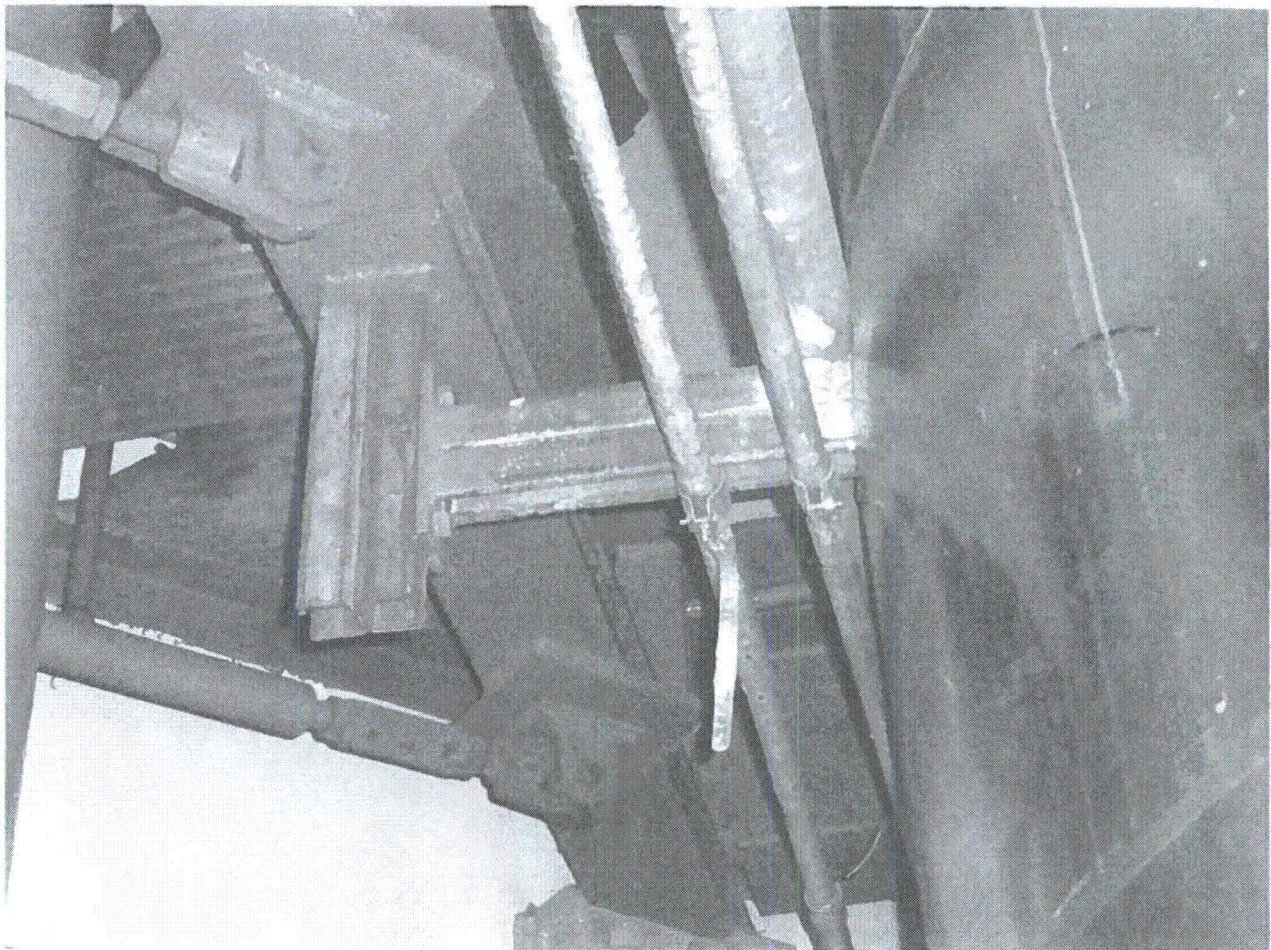
Figure 5 – Conduit Support near Heat Exchanger (2E11-B001B)

7. Are soft targets free from impact by nearby equipment or structures? Y  N  U  N/A
8. Are overhead equipment, distribution systems, ceiling tiles and lighting, and masonry block walls not likely to collapse onto the equipment? Y  N  U  N/A
9. Do attached lines have adequate flexibility to avoid damage? Y  N  U  N/A
10. Based on the above seismic interaction evaluations, is equipment free of potentially adverse seismic interaction effects? Y  N  U   
*The cable raceway support impinges on the RHR Heat Exchanger insulation, and the insulation has been cut away from the member. The raceway support only impacts the insulation, but is at least one inch from the body of the heat exchanger, so there will be no impact between the two components. Therefore, it is judged that there is no potentially adverse seismic condition.*

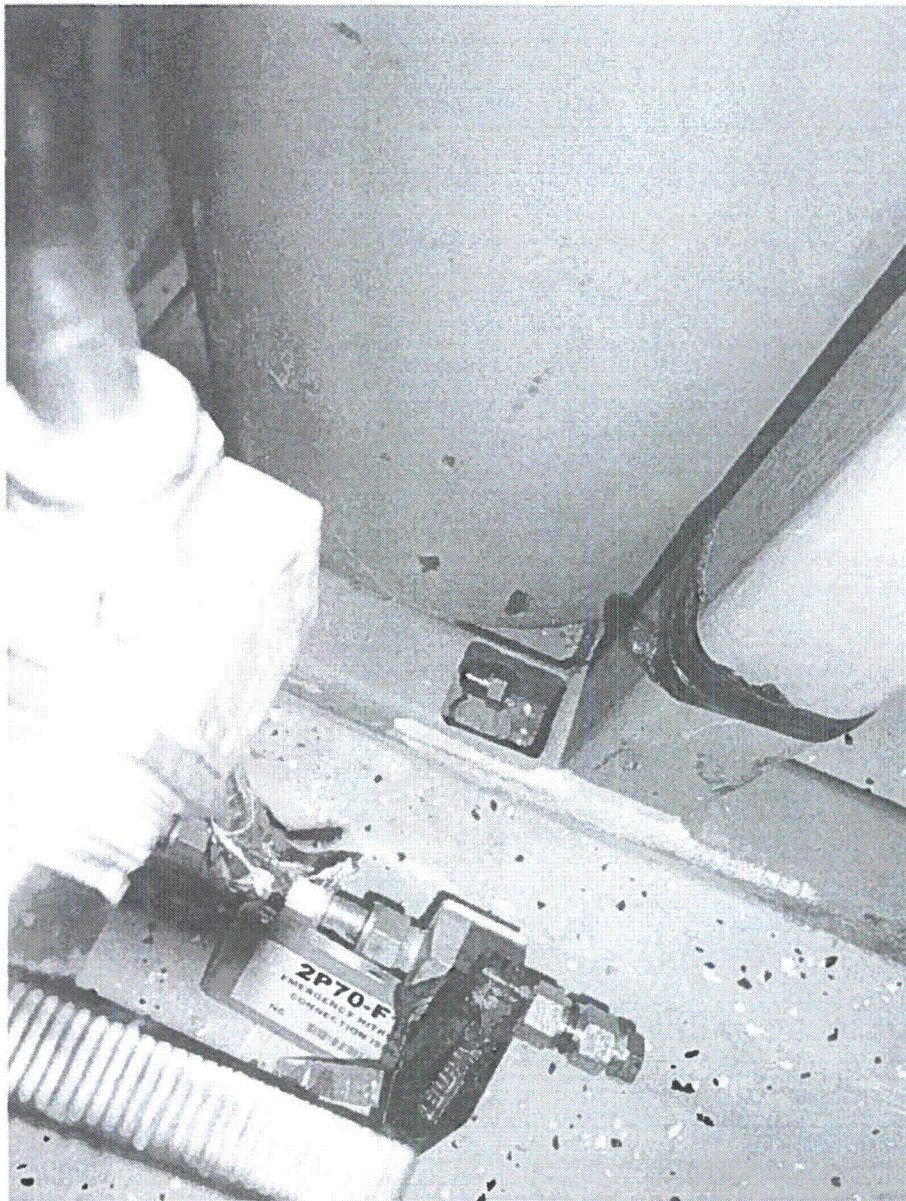
Figure 2 Threaded Fastener Located in Anchor Bolt Recess of Rack

2. Is the anchorage free of bent, broken, missing or loose hardware? Y  N  U  N/A   
*Loose bolt from other component or connection is stuck in the anchor bolt recessed tube area for the anchor. The SWE's have determined that this loose bolt will not damage the rack anchor during a seismic event nor is it likely that the bolt will exit the recessed tube area during a seismic event and damage other equipment. Therefore, the loose bolt at this location is seismically acceptable.*

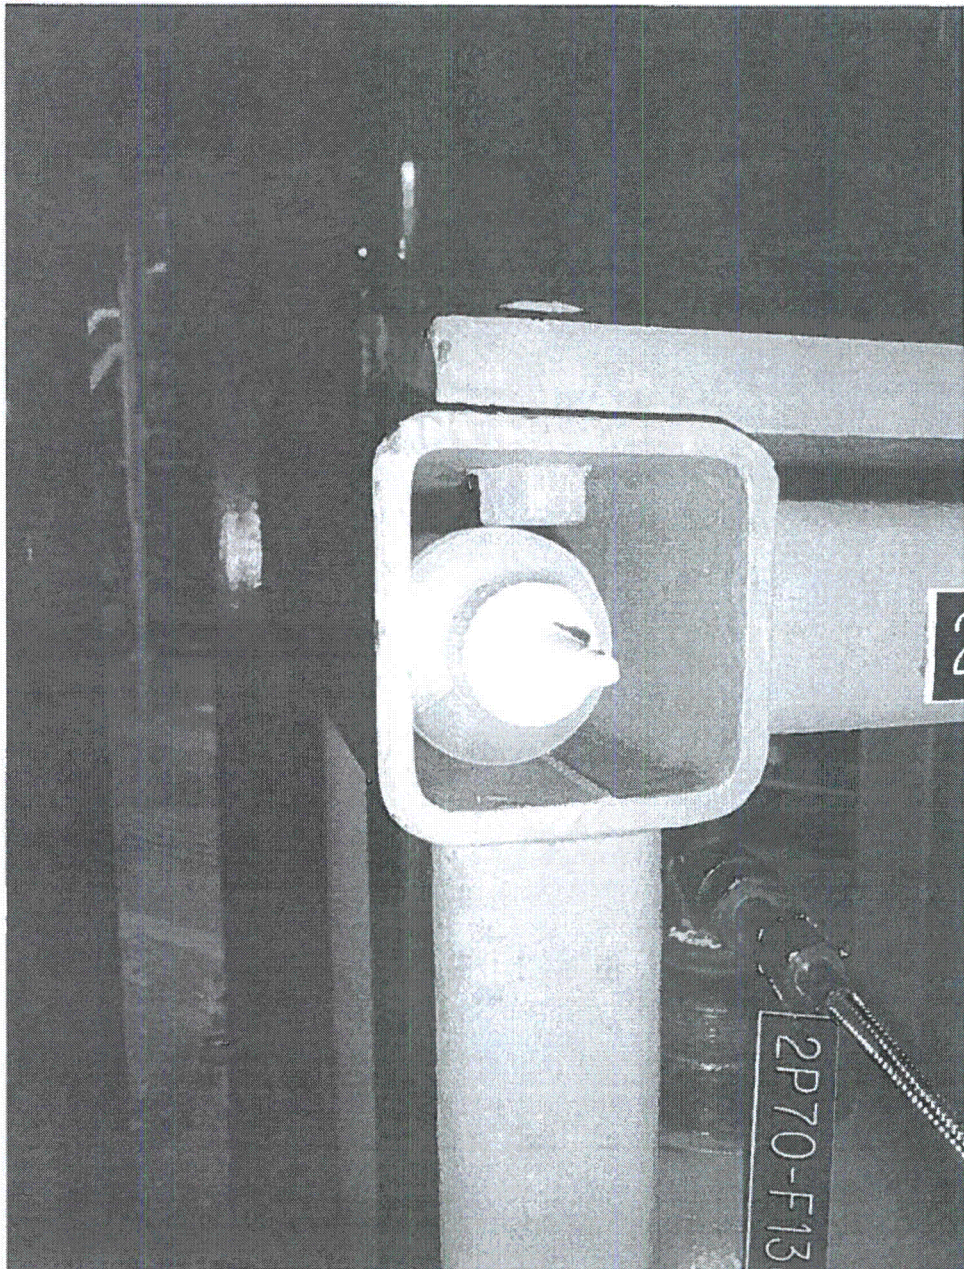
Figure 3 Squeeze Bottle in Top Structural Tube of Frame

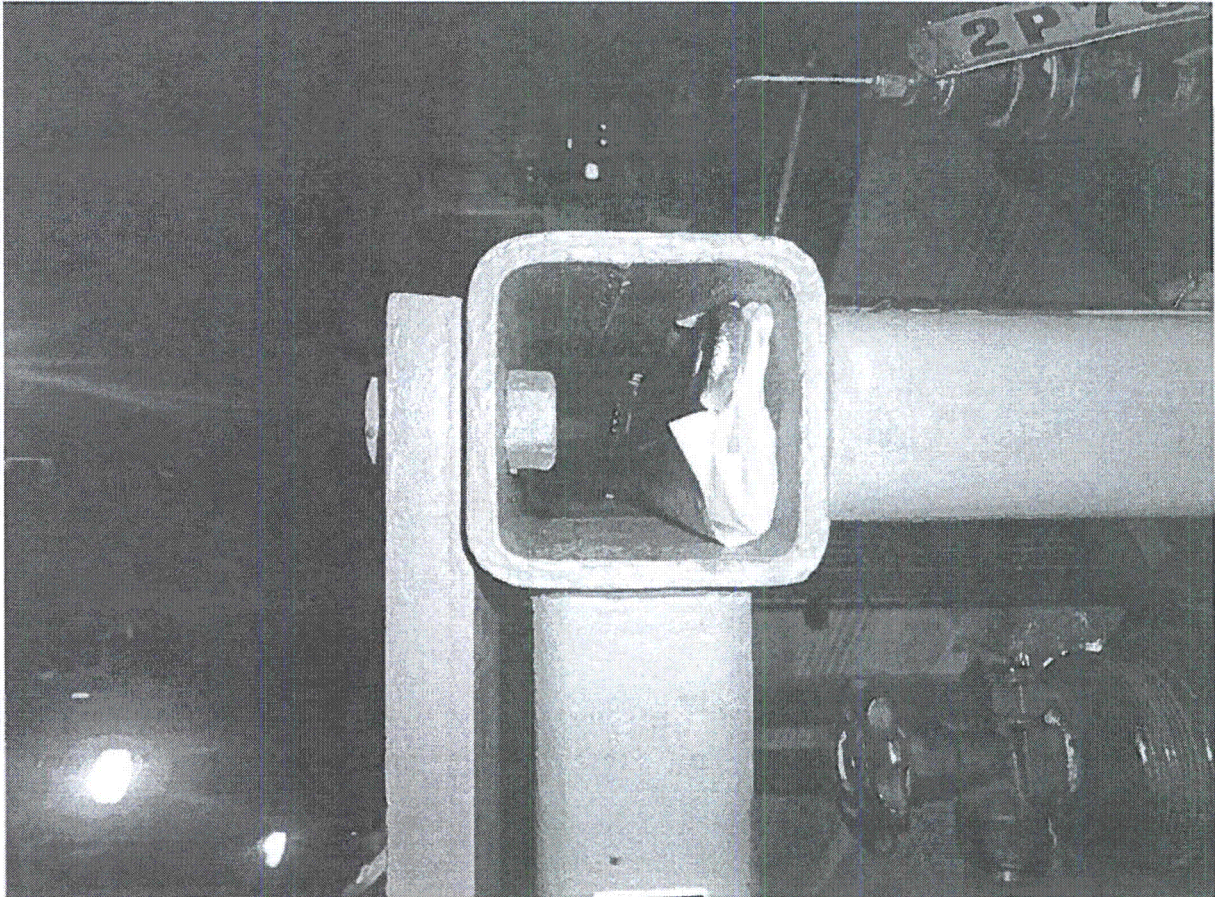
Figure 4 Wrench inside Top Structural Steel Tube of N2 Rack

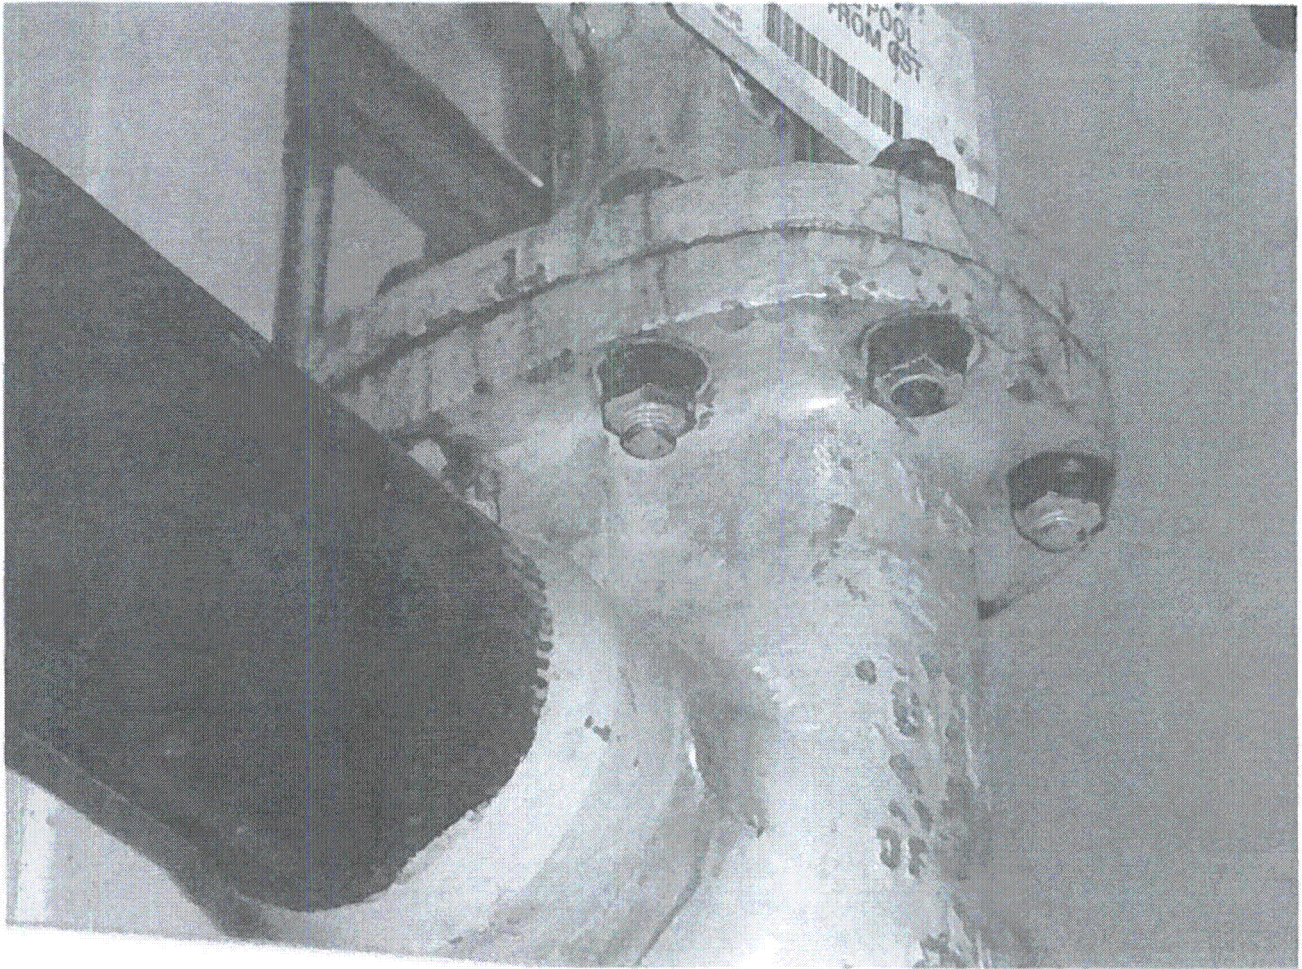
Figure 3 – Mild Surface Oxidation on Flange Bolts (2G41-F054)

*There is mild surface oxidation on the valve bonnet to body flange bolts. Since oxidation is only on the surface, the flange bolts are not degraded. Therefore, the bolts are judged not be a seismic concern.*

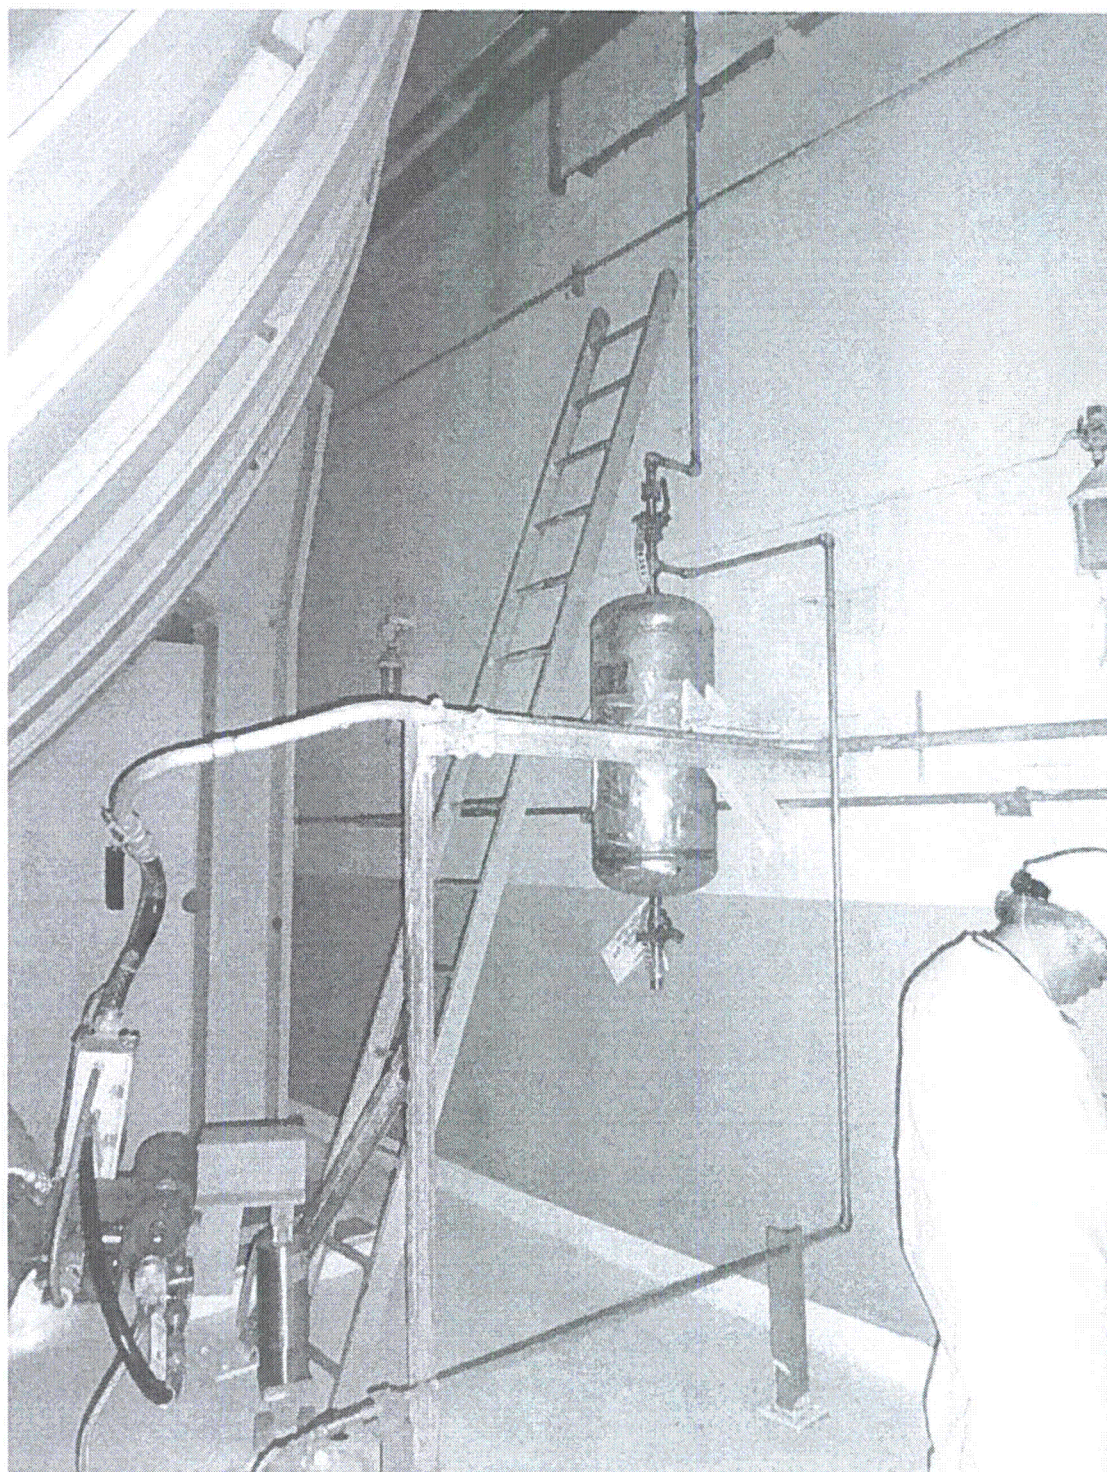
*There is a ladder in close proximity to 2P52-A001 that is not tied off to prevent movement (See CR 518746). The SWE's have determined that any movement of the ladder during a seismic event would not damage 2P52-A001 or its attached piping. Due to the light weight of the ladder and the ruggedness of the component and the fact there are no sensitive components in proximity to the ladder that could be impacted. Therefore, the ladder will not adversely affect the safety function of the component.*

Figure 3 Untied Ladder in Proximity to the Component

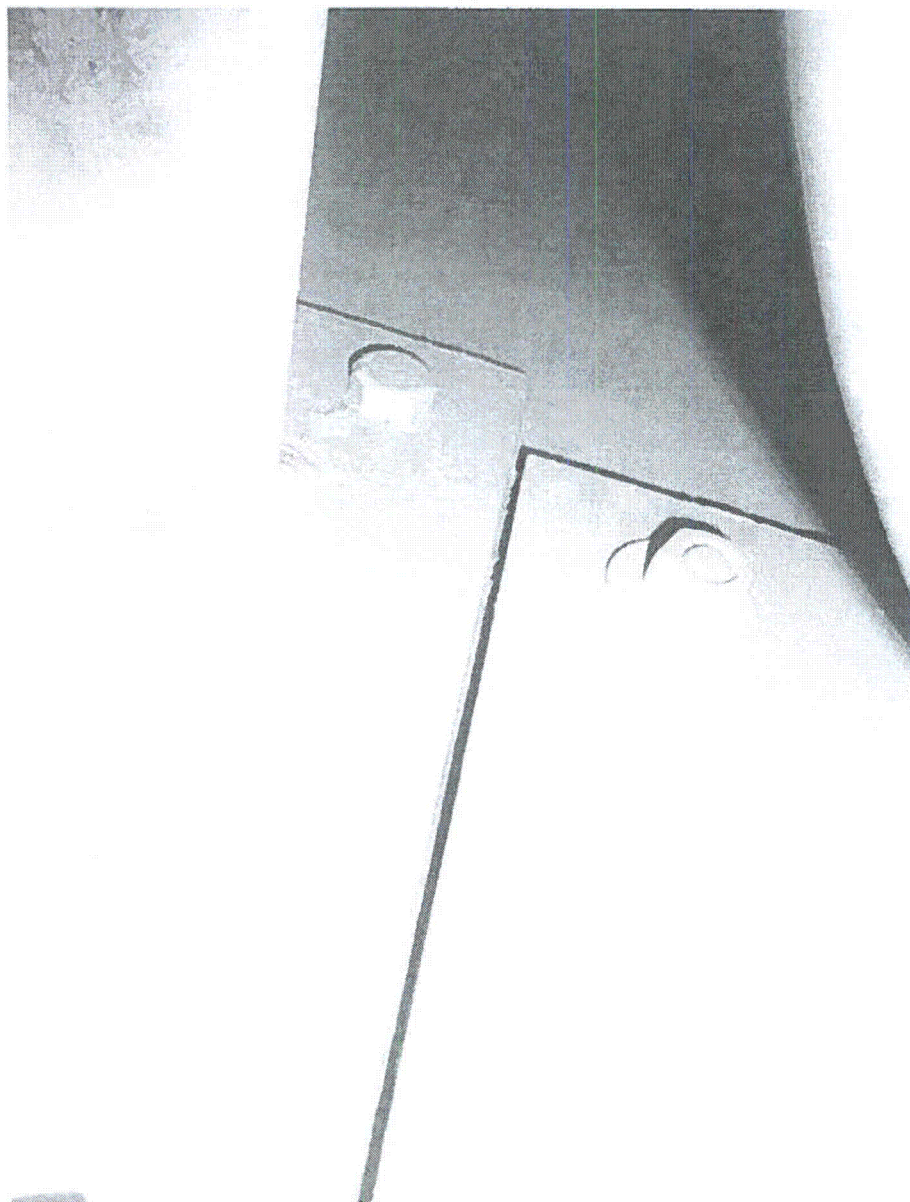
*The component support base-plate anchors are closely spaced to pipe support anchors (See Figure 4 for details). The SWE's have determined that the anchorage is still seismically acceptable with these closely spaced anchors. The component support contains four base-plates with four anchors each. The condition only affects one anchor on one of these plates.*

Figure 4 Closely spaced Anchor Bolts

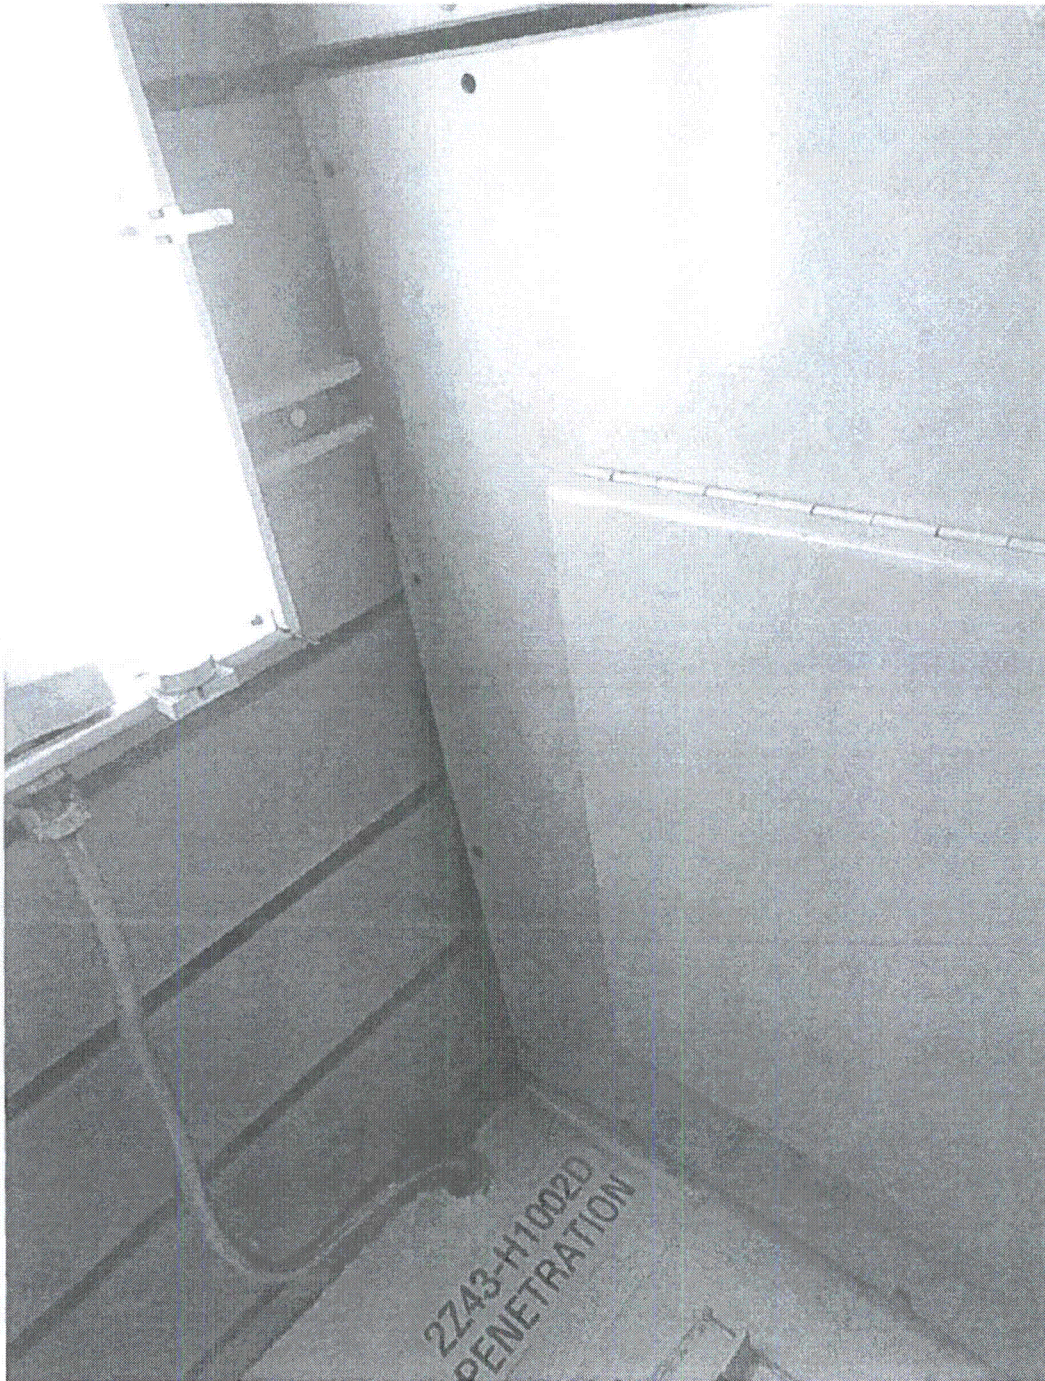
*There are eight screws missing (six on the top and two on the bottom) on the front panel cover adjacent to Penetration 2Z43-H1002D (CR 519565). The remaining screws are judged sufficient to restrain the panel cover in the case of a seismic event. Therefore, there is no potentially adverse seismic condition.*

Figure 1 – Missing Screws at Top of Panel (2L48-C34)

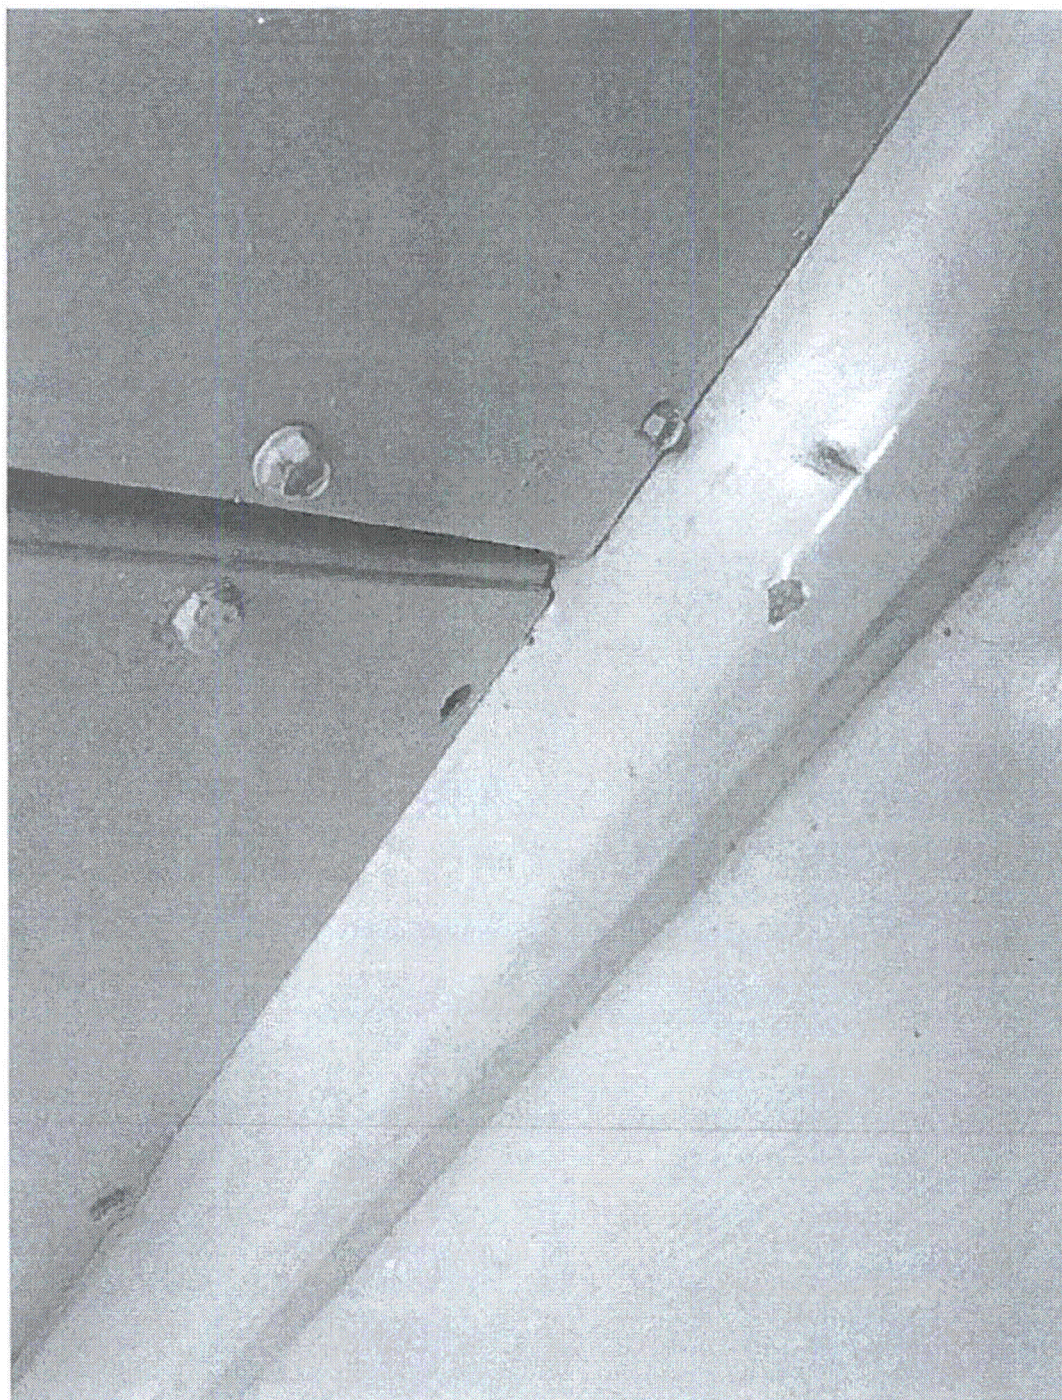
Figure 2 -- Missing Screws at Bottom of Panel (2L48-C34)
