Seismic Walkdown Checklist (SWC)	
Equipment ID No. <u>2H21-P021</u> Equip. Class ¹ <u>18</u>	
Equipment Description RHR Instrument Rack	- and the first and a second
Location: Bldg. <u>REACTOR</u> Floor El. <u>87</u> Room, Area <u>SE Diagonal</u>	Úniť 2
Manufacturer, Model, Etc. (optional but recommended)	una per de la companya de la company
Instructions for Completing Checklist This checklist may be used to document the results of the Seismic Walkdown of SWEL. The space below each of the following questions may be used to record findings. Additional space is provided at the end of this checklist for documentin	the results of judgments and
Anchorage

NO. SNCH082-RPT-02, VERSION 1.0 Sheet 4 of 5

ATTACHMENT 3: SEISMIC WALKDOWN CHECKLISTS

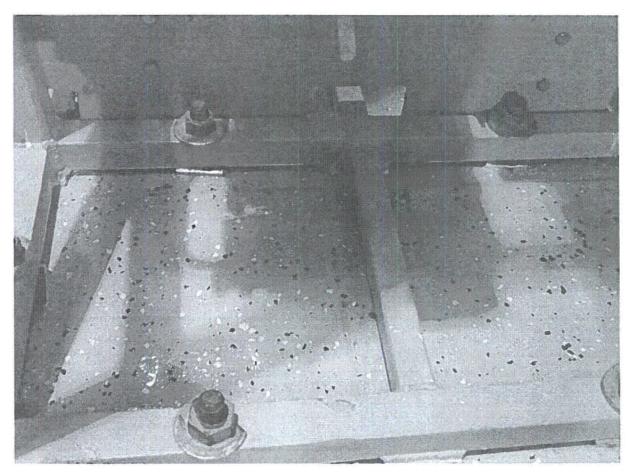
Figure 3 View of Anchors with Cut Washers

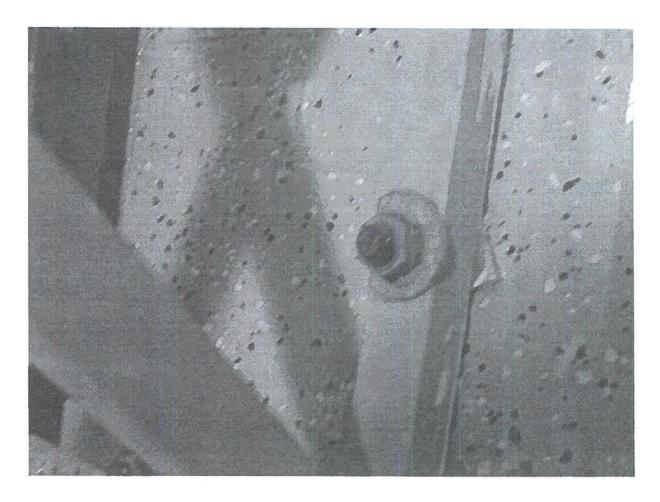
Figure 4 Additional Anchor with Cut Washer

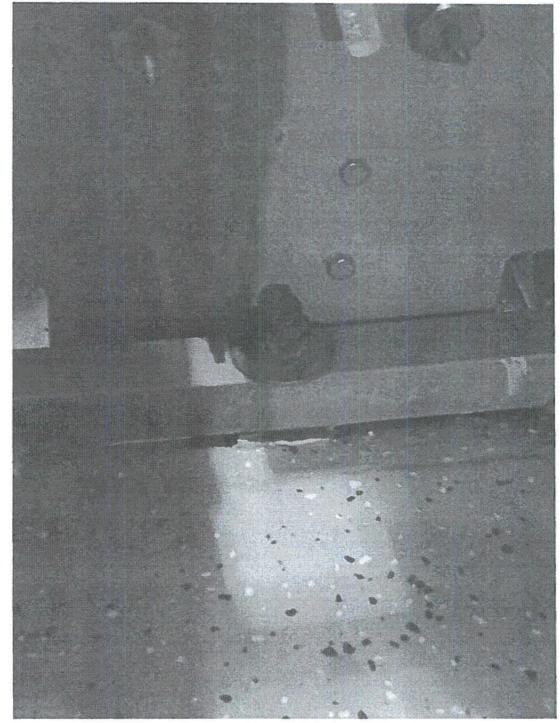
3.	Is the anchorage free of corrosion that is more than mild surface oxidation? There is mild surface corrosion on one of the anchors. SWE's determined that this is seismically acceptable due to minimal corrosion.	Y⊠ N□ U□ N/A□

Figure 5 Corroded Anchor

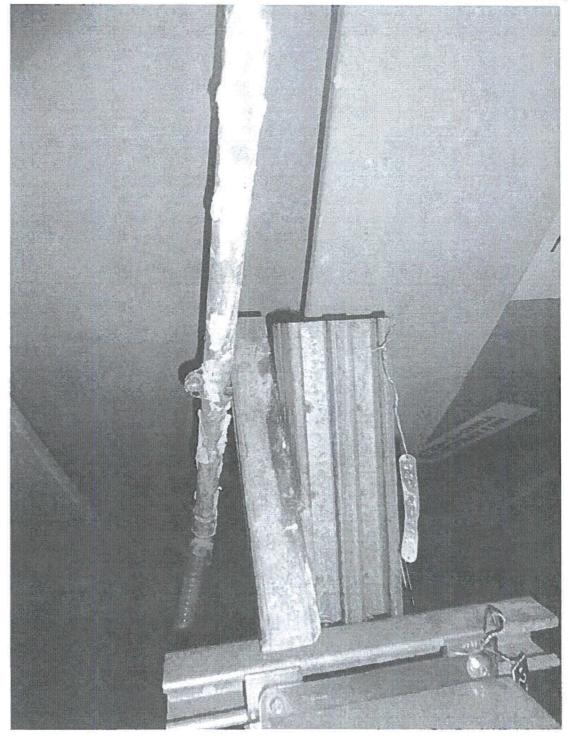
7. Are soft targets free from impact by nearby equipment or structures? There is a conduit running past the component to the wall that passes approximately 1" from the equipment. The conduit is attached to the same support as the temperature element, so the two components will move together. Since there will be no differential seismic motion between them, there is no potentially adverse seismic condition.	YN NO UO N/AO

Figure 3 - Gap Between Conduit and Component (2T48-N009A)

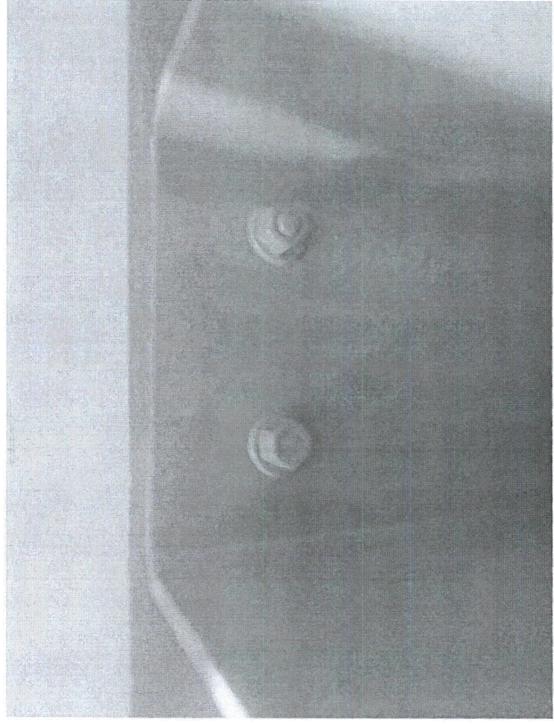
6. Based on the above anchorage evaluations, is the anchorage free of potentially adverse seismic conditions? The top left anchor does not have full engagement of the bolt. The end of the bolt is approximately 1/16" below the nut. The other three bolts are fully engaged 3/8" dia. anchors, and have enough capacity to support the small, light component. Therefore, there is no potentially adverse seismic condition.

Figure 3 - Bolt Lacking Full Thread Engagement (2T41-N020A)

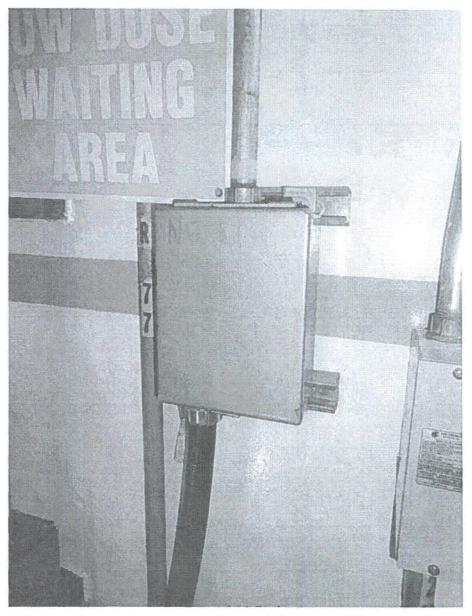
11. Have you looked for and found no other seismic conditions that could adversely affect the safety functions of the equipment?	YX II Ü
Comments (Additional pages may be added as necessary)	
Component tag is barely visible. The tag is a small embossed tag. Th a tag number written on it but the ink is fading. Low Dose Waiting area sign has one corner loose. SWE's have deter weight sign will cause no damage to the component. Therefore, the l acceptable.	rmined that this flexible light
Evaluated by: John Mcfarland	_ Date: <u>9/24/12</u>
Jeff Horton Juff Anton	9/24/12

Figure 3: Companion Junction Box for 2T41-N021A Note: Fading ink with component number.

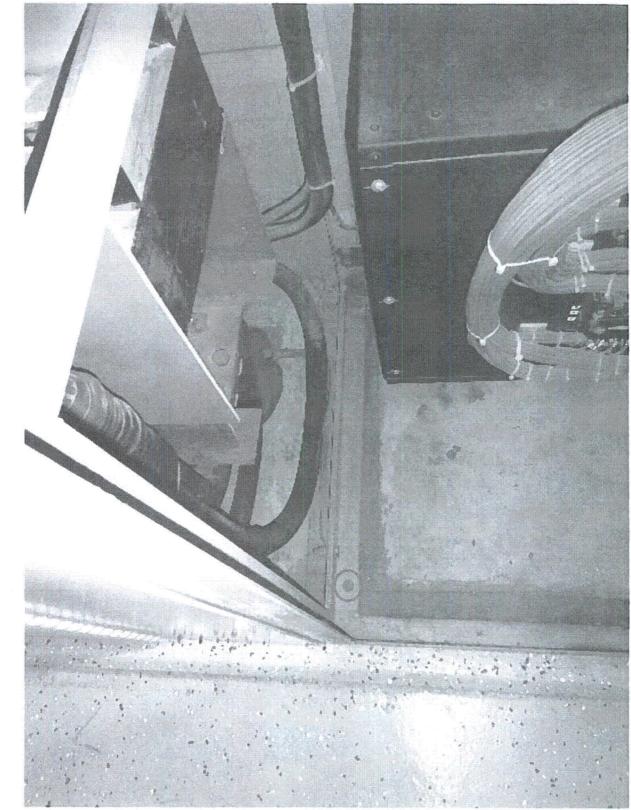
3: Missing Plug Welds (2R43-P001C)

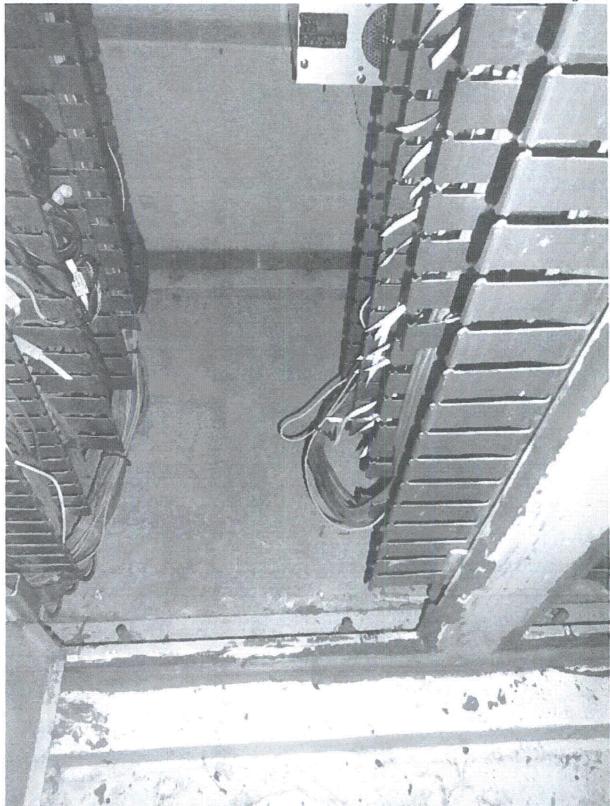
3: Loose Cables Inside Cabinet (2C82-P001)

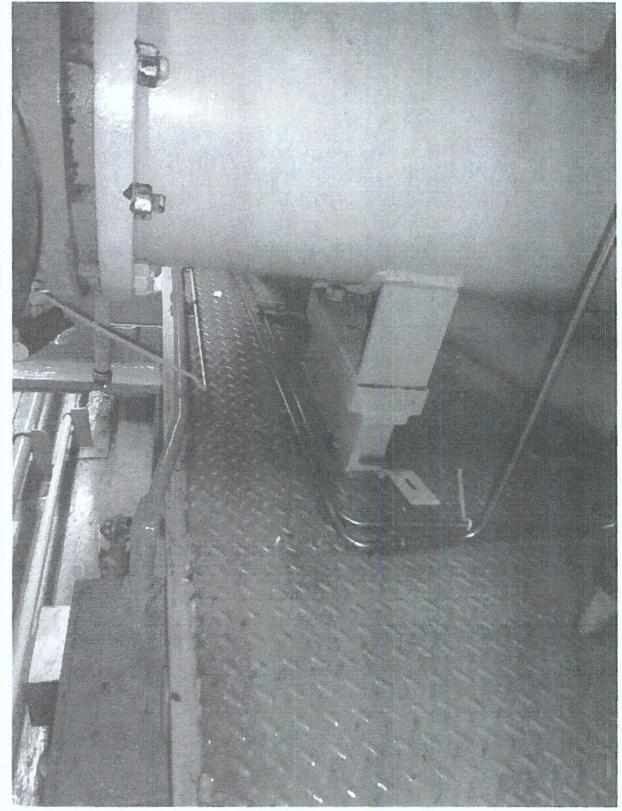
3. Is the anchorage free of corrosion that is more than mild surface oxidation?	Y⊠ N□ U□ N/A□
4. Is the anchorage free of visible cracks in the concrete near the anchors? Equipment is welded to steel beams supporting the diesel generator (see photograph 3).

3: Support Pedestal (2R43-B001A)

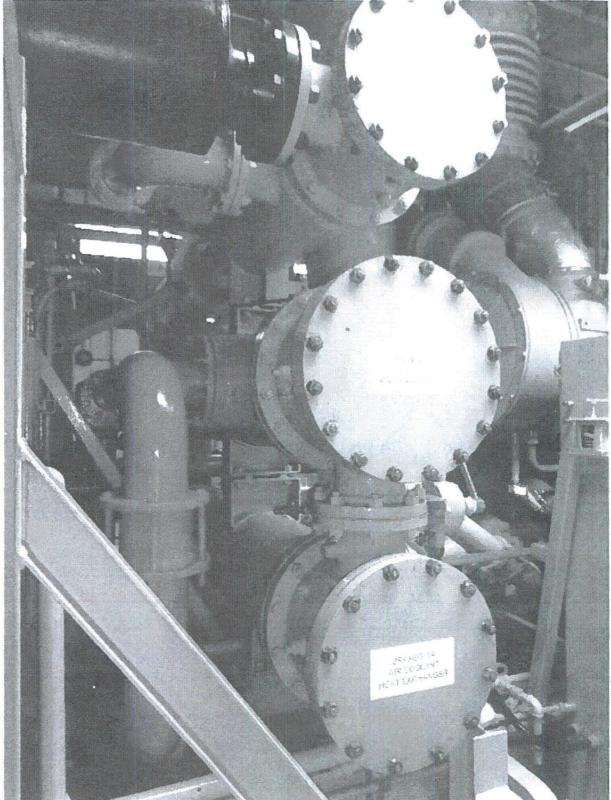
4: Three Heat Exchange System Supported Together (2R43-B001A)
