Area Walk-By Checklist (AWC)Location: Bldg. CONTROL Floor El. 112 Room, Area¹: TD-T13**Instructions for Completing Checklist**

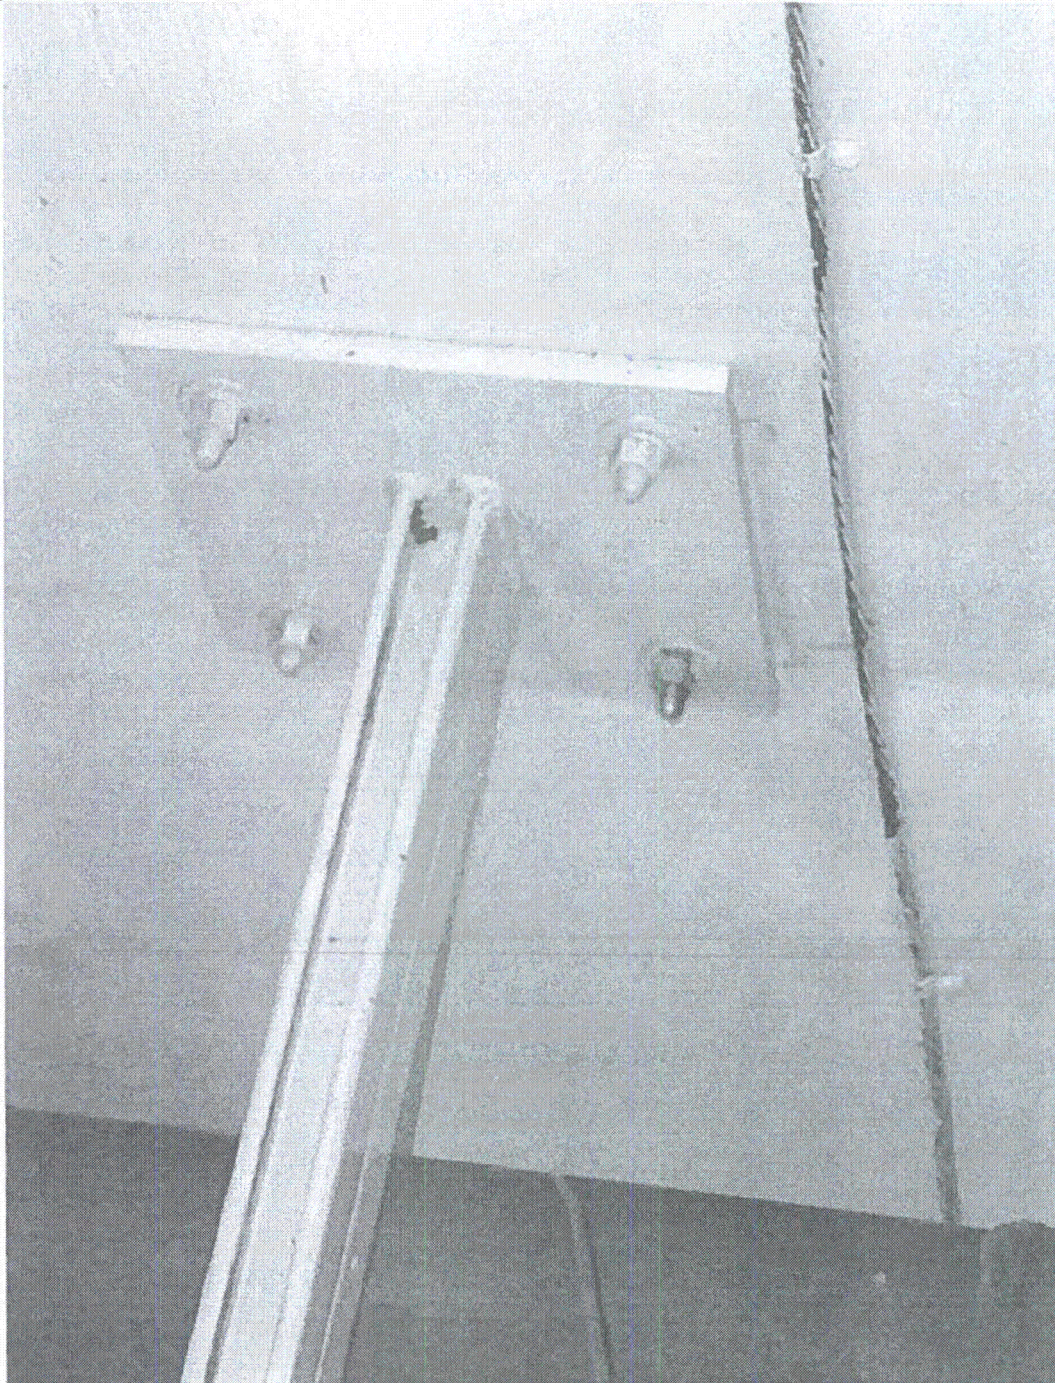
1. Does anchorage of equipment in the area appear to be free of potentially adverse seismic conditions (if visible without necessarily opening cabinets)? Y N U N/A
There is a crack in the concrete at the support for Conduit 2E21611 that appears to extend through the anchor bolt. The crack is a small surface crack and the anchor affected is in compression due to the orientation of the support. Therefore, the crack will not affect the structural adequacy of the anchors and there is no potentially adverse seismic condition.

Figure 1 – Surface Crack at Conduit Support on Wall (Unit 2 Control TD-T13)

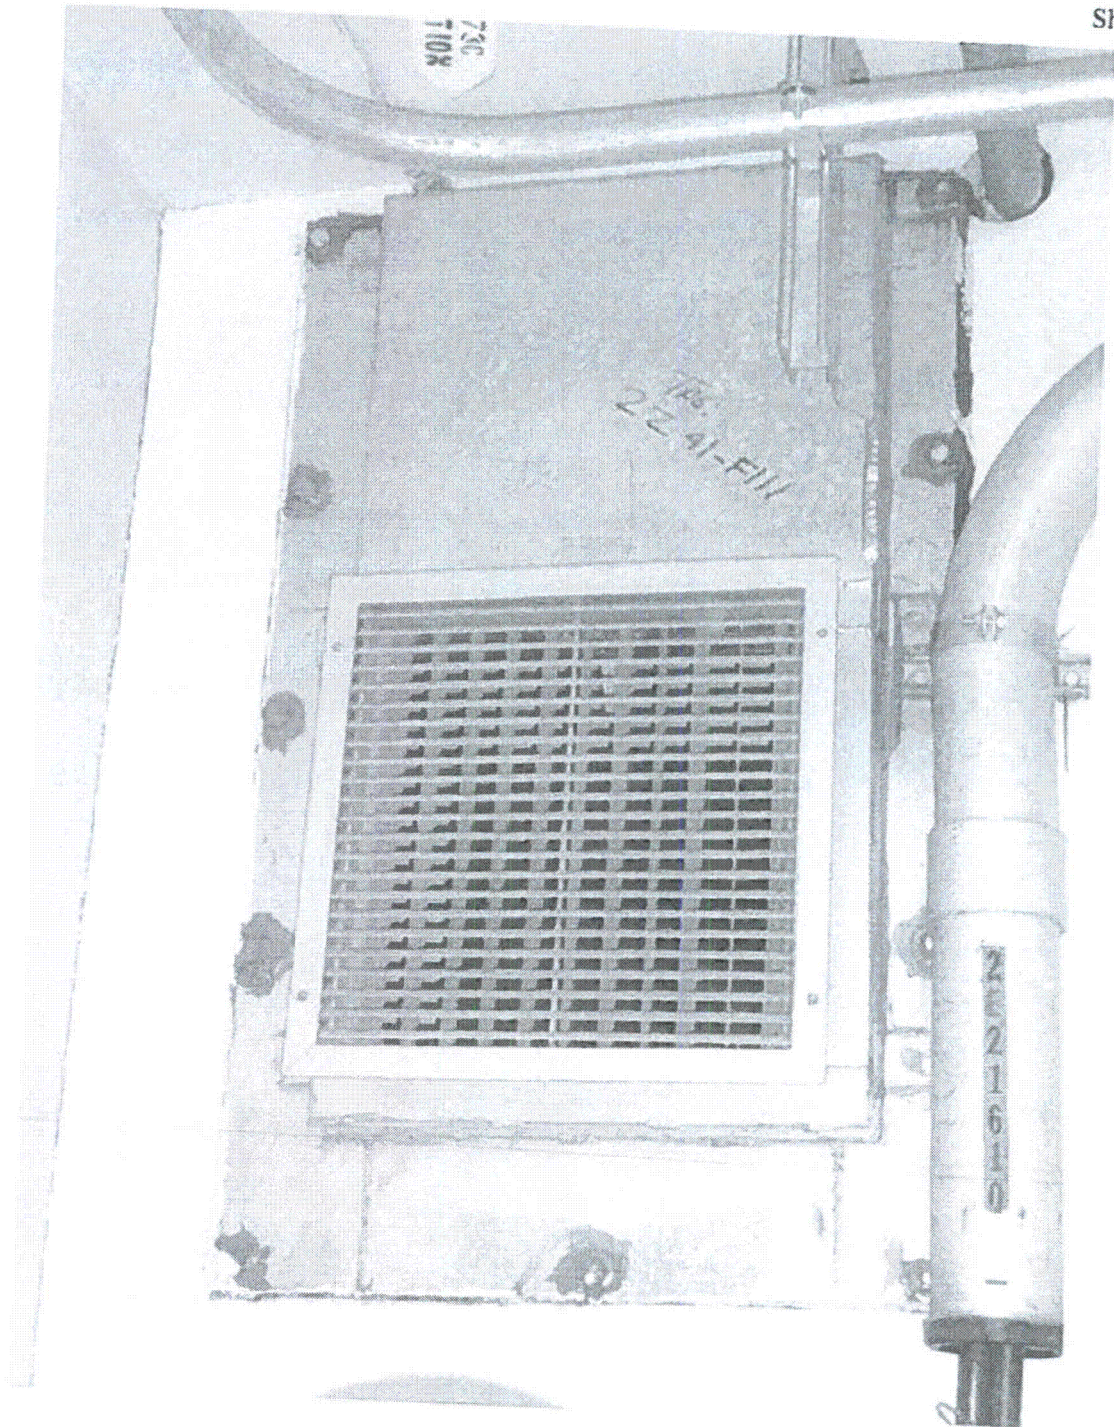
2. Does anchorage of equipment in the area appear to be free of significant degraded conditions? Y N U N/A
There appears to be galvanic corrosion around the anchor bolts for the HVAC support 2Z41-F111. Since the corrosion is only on the surface, the anchors are not impacted. Therefore, there is no potentially adverse seismic condition.
There is a loose nut on a conduit support for Conduit 2E21611 (CR 519680). The support is lightly loaded and the affected bolt will be in compression due to the configuration of the support. Therefore, it is judged that the other three anchors have sufficient strength to restrain the support during a seismic event, so there is no potentially adverse seismic condition.

Figure 2 – HVAC Galvanic Corrosion (Unit 2 Control TD-T13)

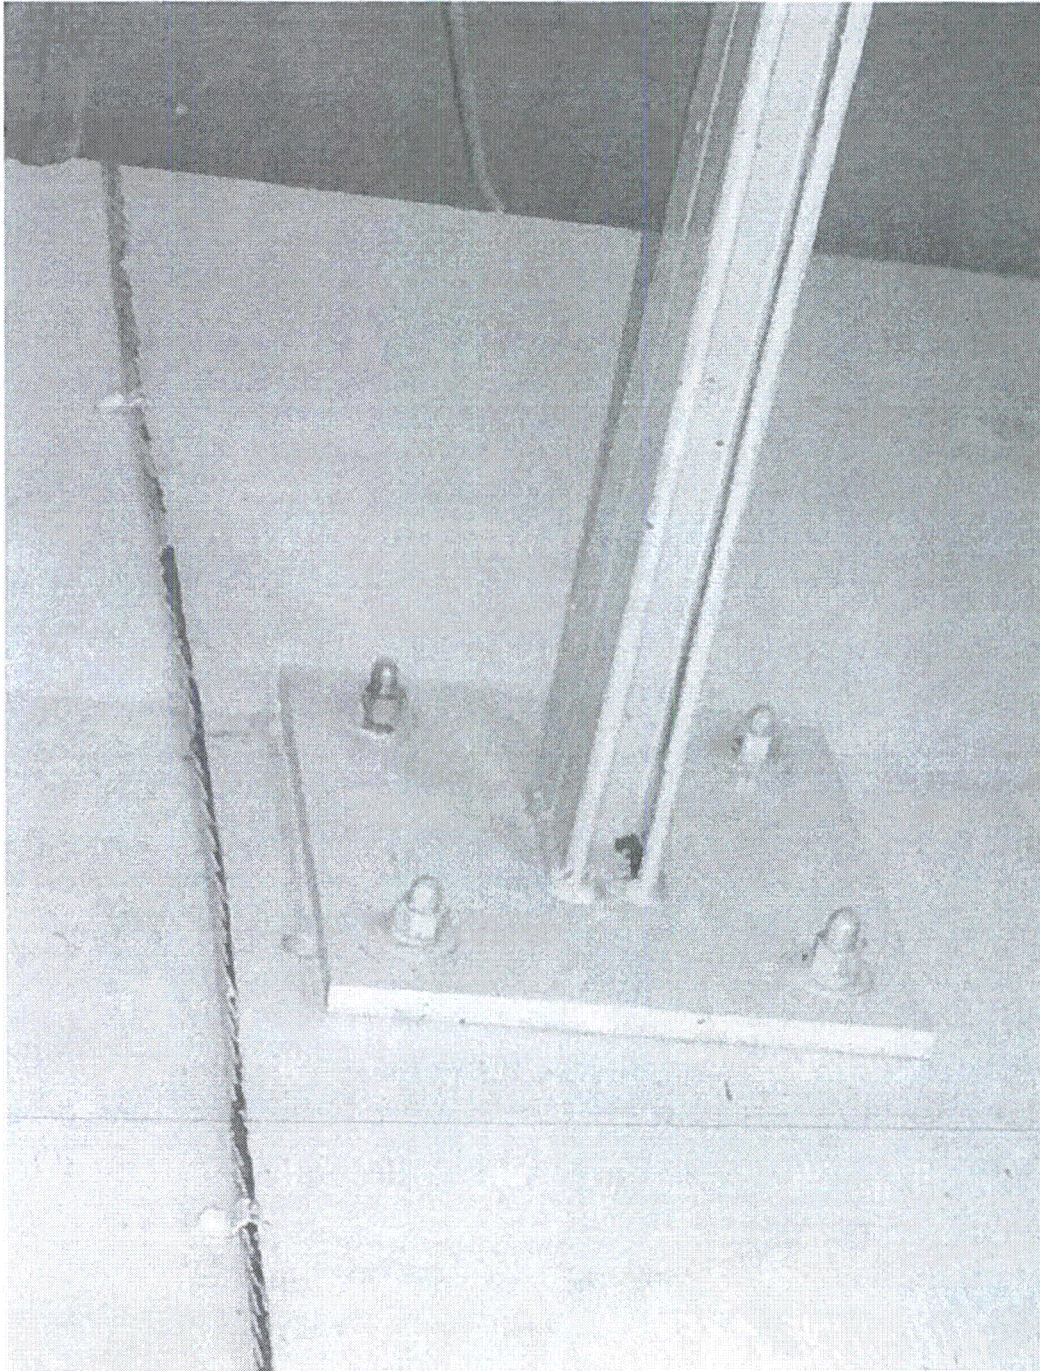
Figure 3 – Loose Nut on Conduit Support on Wall (Unit 2 Control TD-T13)
(Note: Vertical up is from left to right in picture)

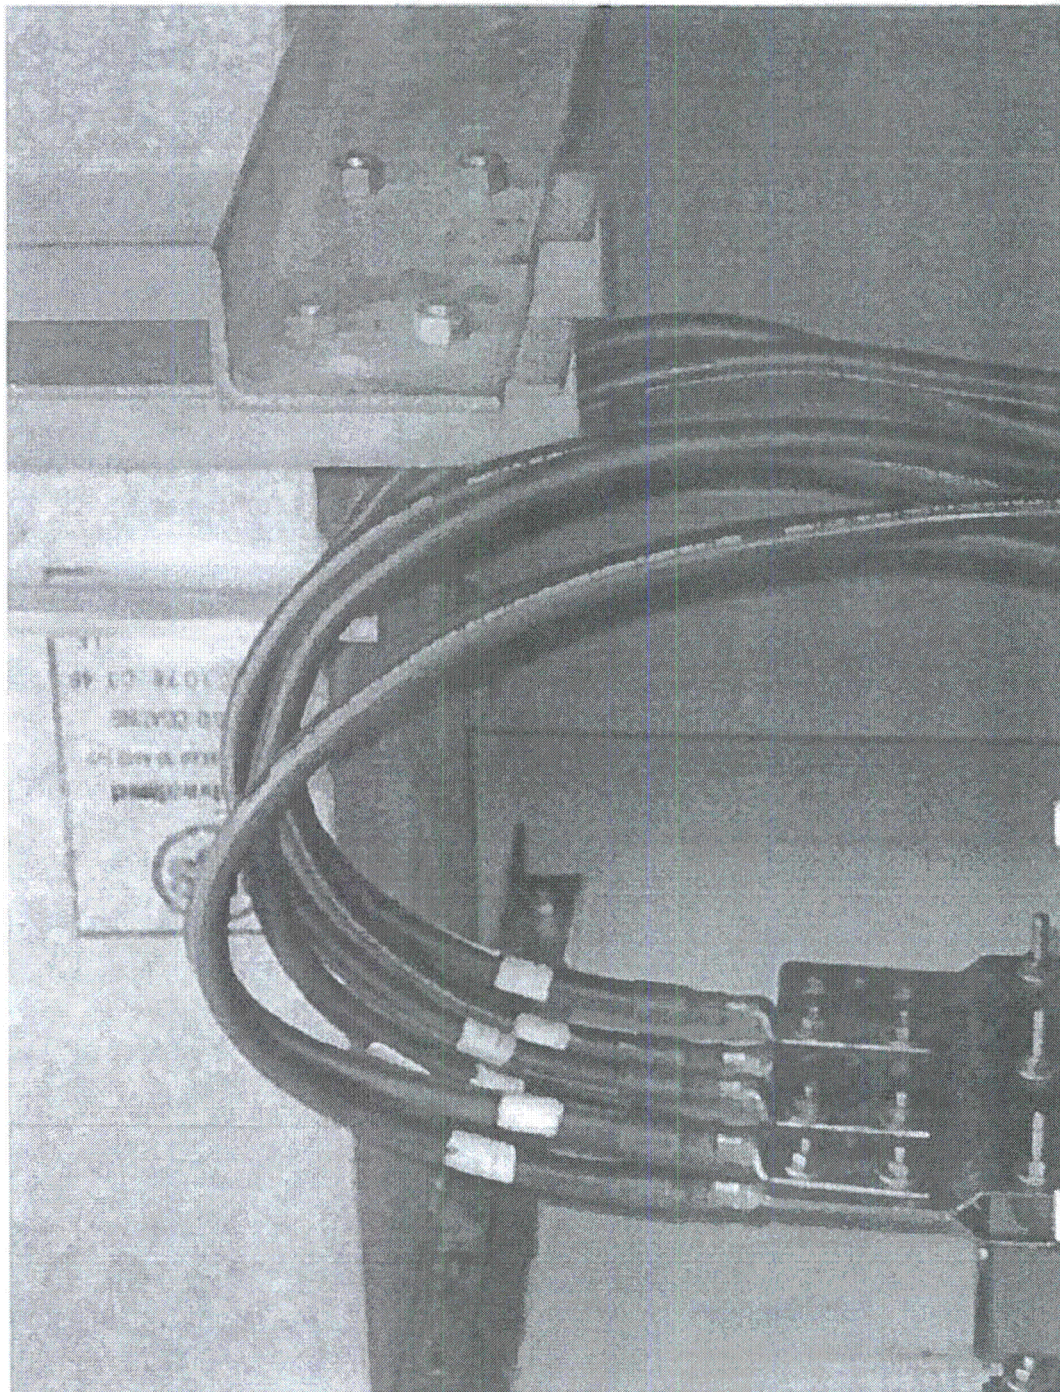
4. Does it appear that the area is free of potentially adverse seismic spatial interactions with other equipment in the area (e.g., ceiling tiles and lighting)? Y N U N/A
The cables for one of the battery racks and the HVAC unit overhead are extremely close to one another. The HVAC unit is very large and rigidly attached to the ceiling, so there will be very little movement of the component and will not have the potential to damage the battery cables. The impact is therefore judged not to be significant, so there is no potentially adverse seismic condition.

Figure 4 – Battery Cable and HVAC Spacing (Unit 2 Control TD-T13)

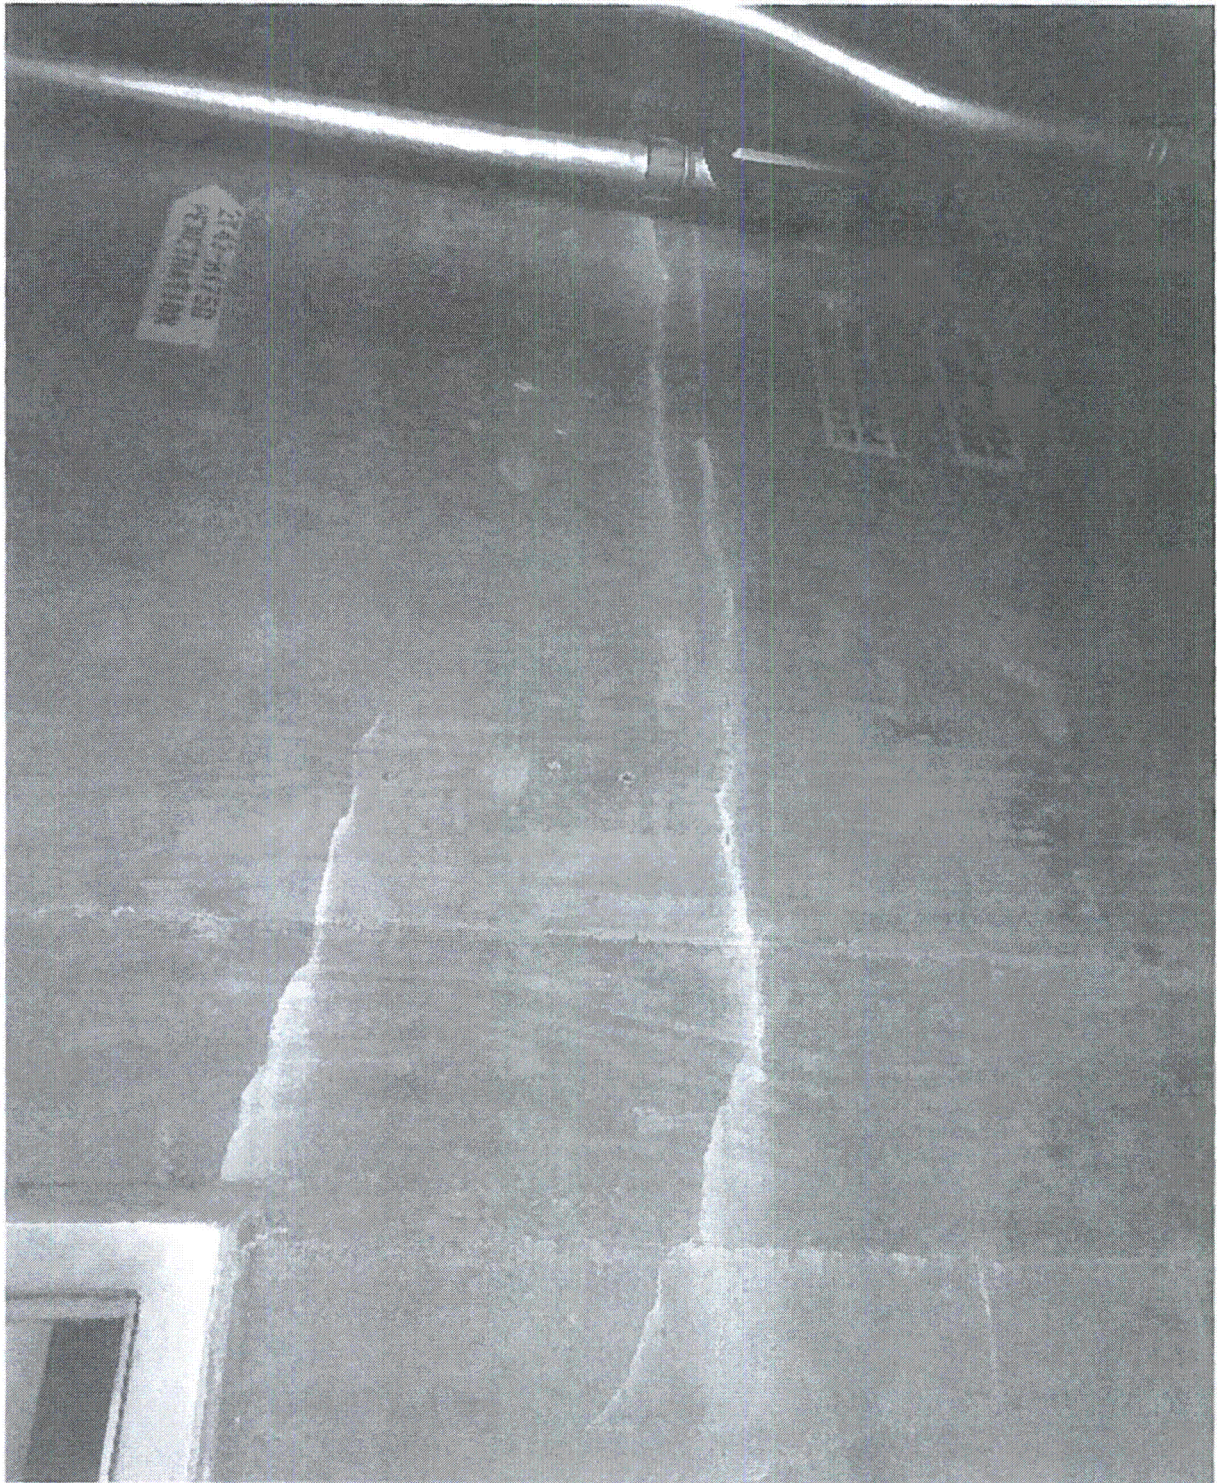
8. Have you looked for and found no other seismic conditions that could adversely affect the safety functions of the equipment in the area? Y N U
The west wall exhibited cracks above the door opening to the room. These cracks do not appear to go through any anchors to equipment mounted on the wall (see photograph 1). This is judged to not be a seismic concern.

1: Cracks on West Wall (Battery Room 2A)

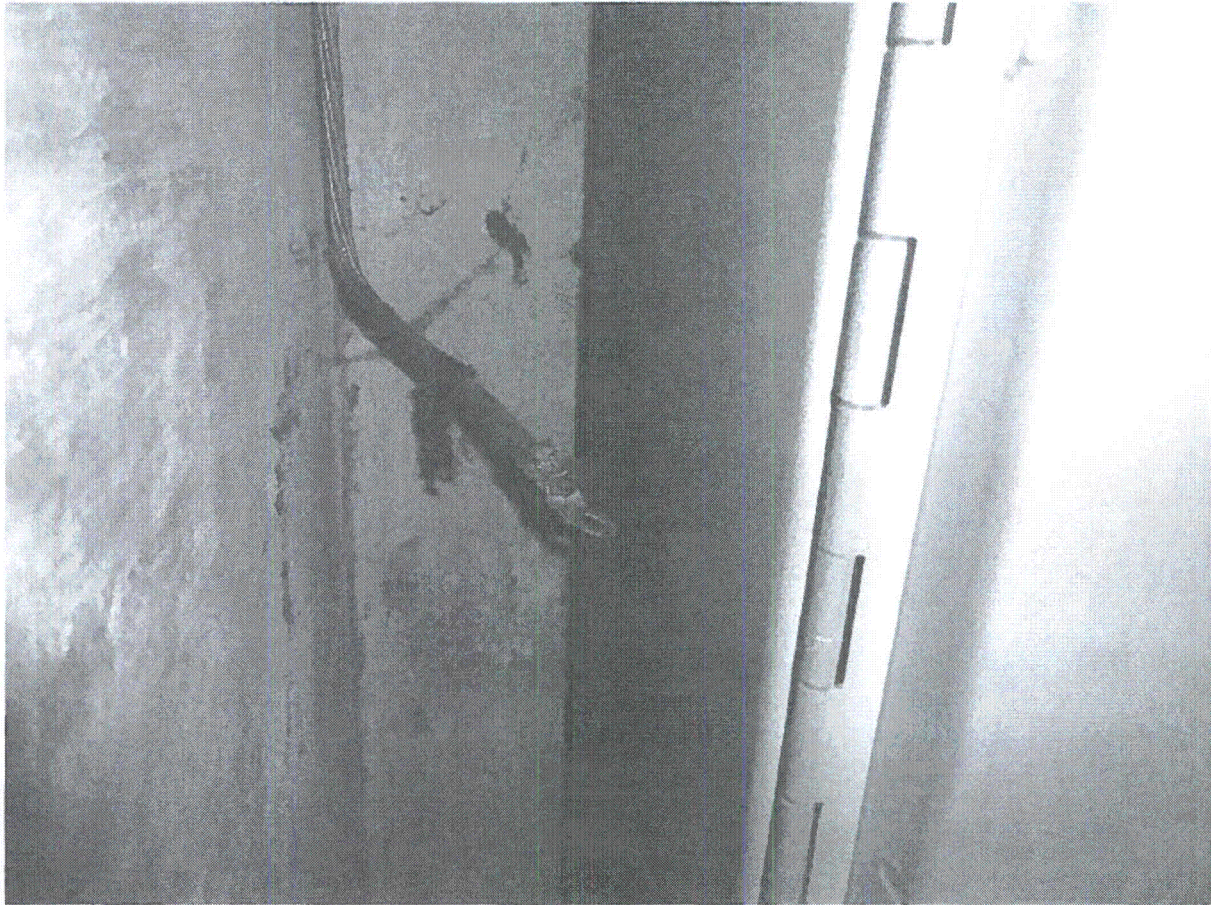
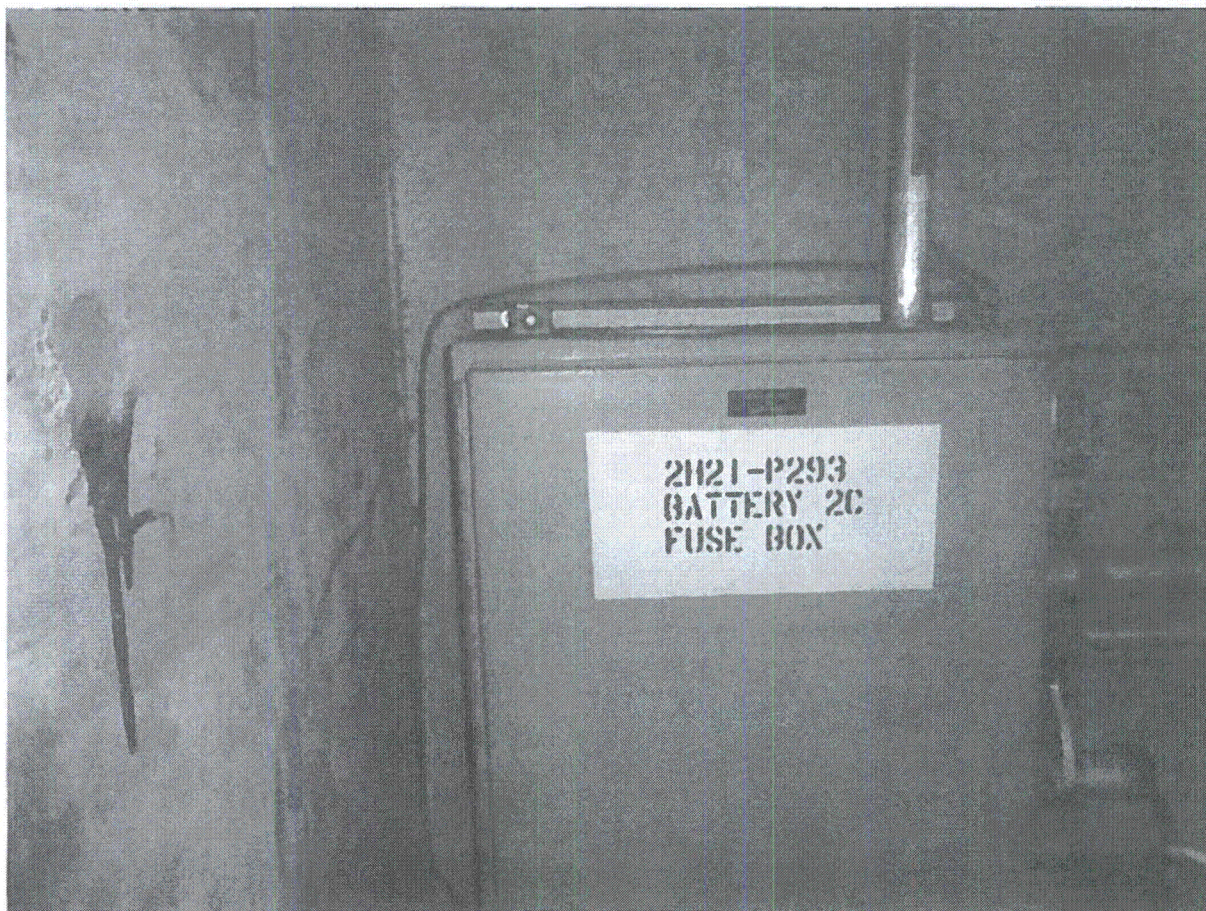
1: Unattached Ground Cable to 2H21-P293 (Battery Room 2C)

2: Unattached Ground Cable to 2H21-P293 (Battery Room 2C)

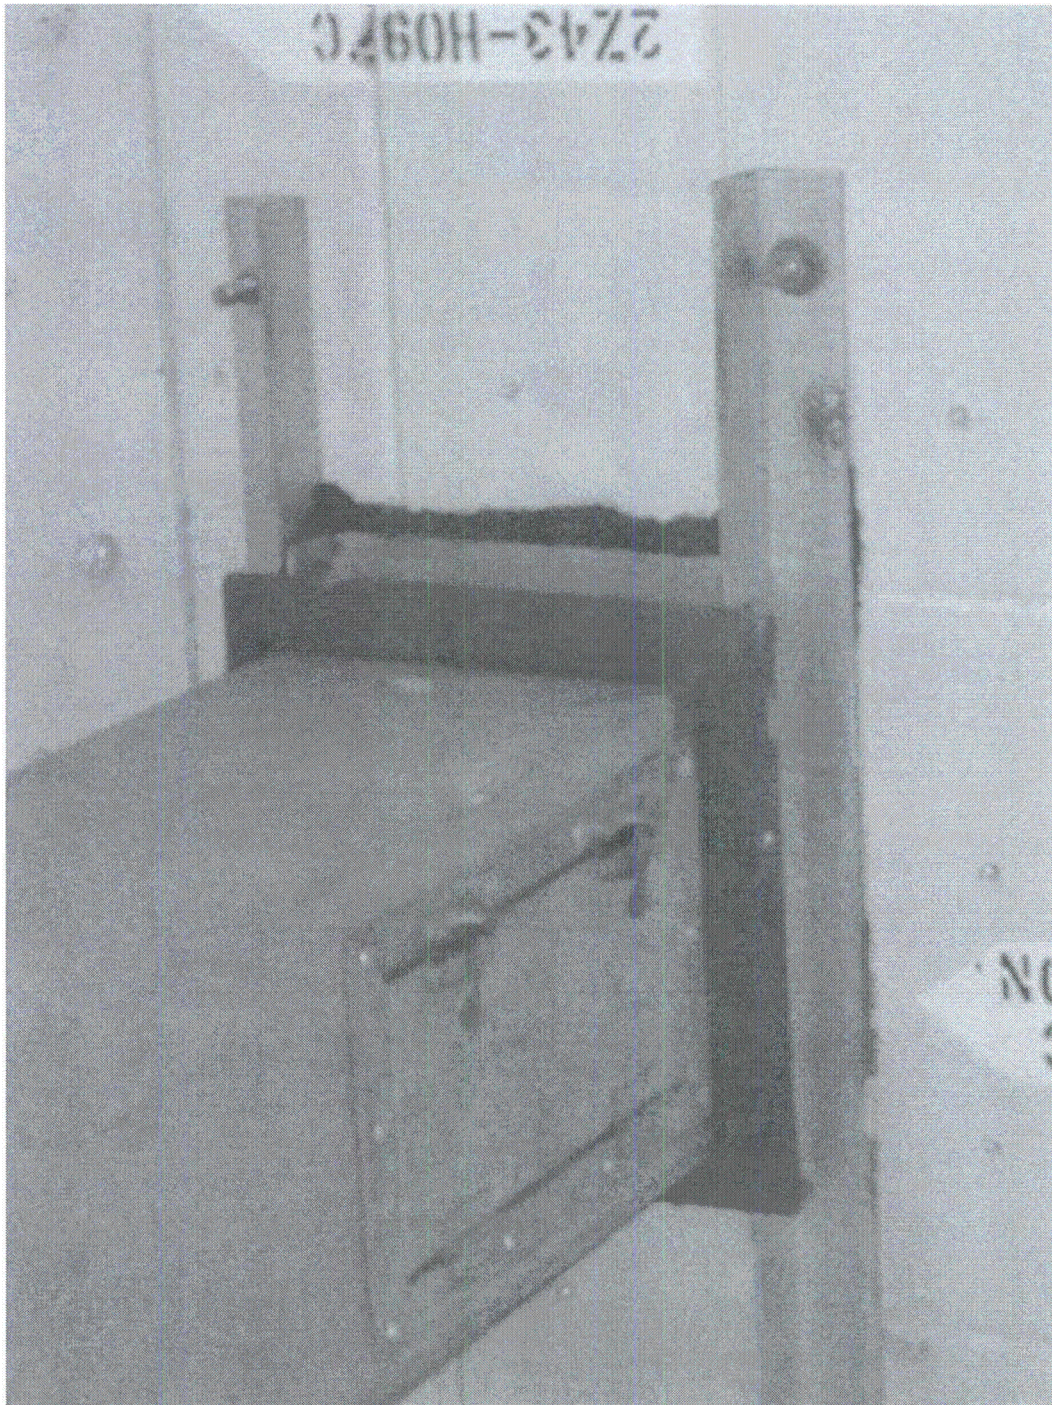
The top right bolt on the HVAC support over the room door appears to be missing a nut. On closer inspection, it was determined that the nut is new and so blends in to the support from the front, but is visible from an angle. Since no hardware is missing, there is no potentially adverse seismic condition.

Figure 1 – Difficult to See Nut on Anchor Bolt (Room C-027)

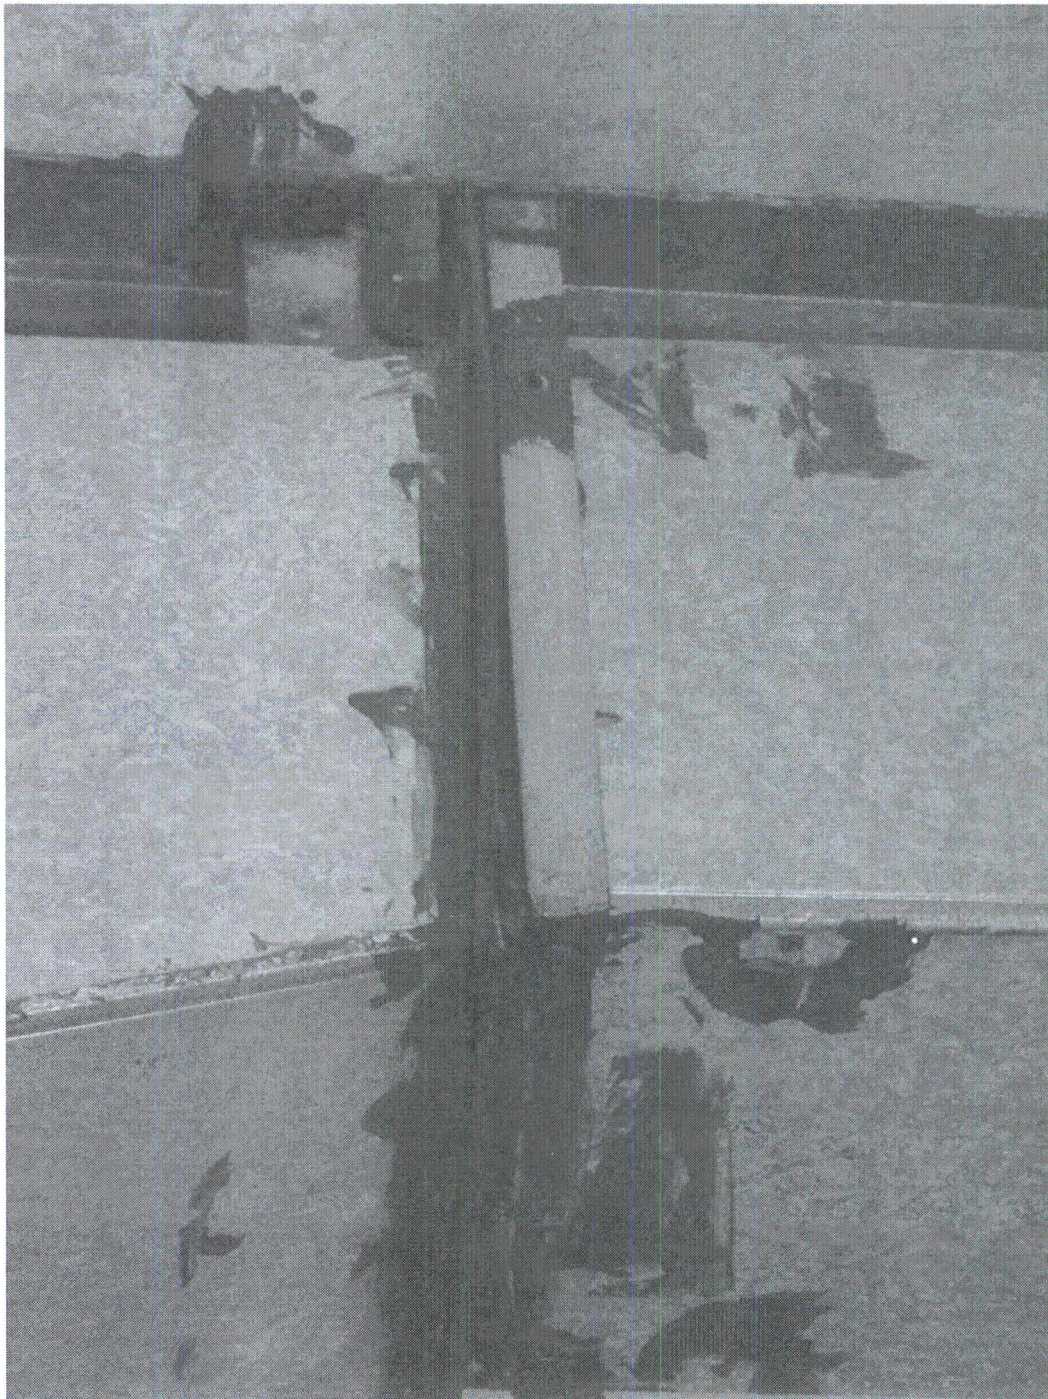
There is a screw missing on the side of the HVAC strap near Penetration 2Z43-H182C (CR 524311). The strap is screwed to the HVAC on the bottom of the strap. The single remaining screw is judged adequate to maintain the connection between the strap and the HVAC, so there is no potentially adverse seismic condition. However, in accordance with good engineering practice, the screw should be replaced so there are two screws for the support.

Figure 2 – Missing Screw on HVAC Strap (Room C-027)
(Note: Hole in strap on top of HVAC, at top left of picture, is a misdrilled hole that was not utilized. No screw is missing from this strap.)

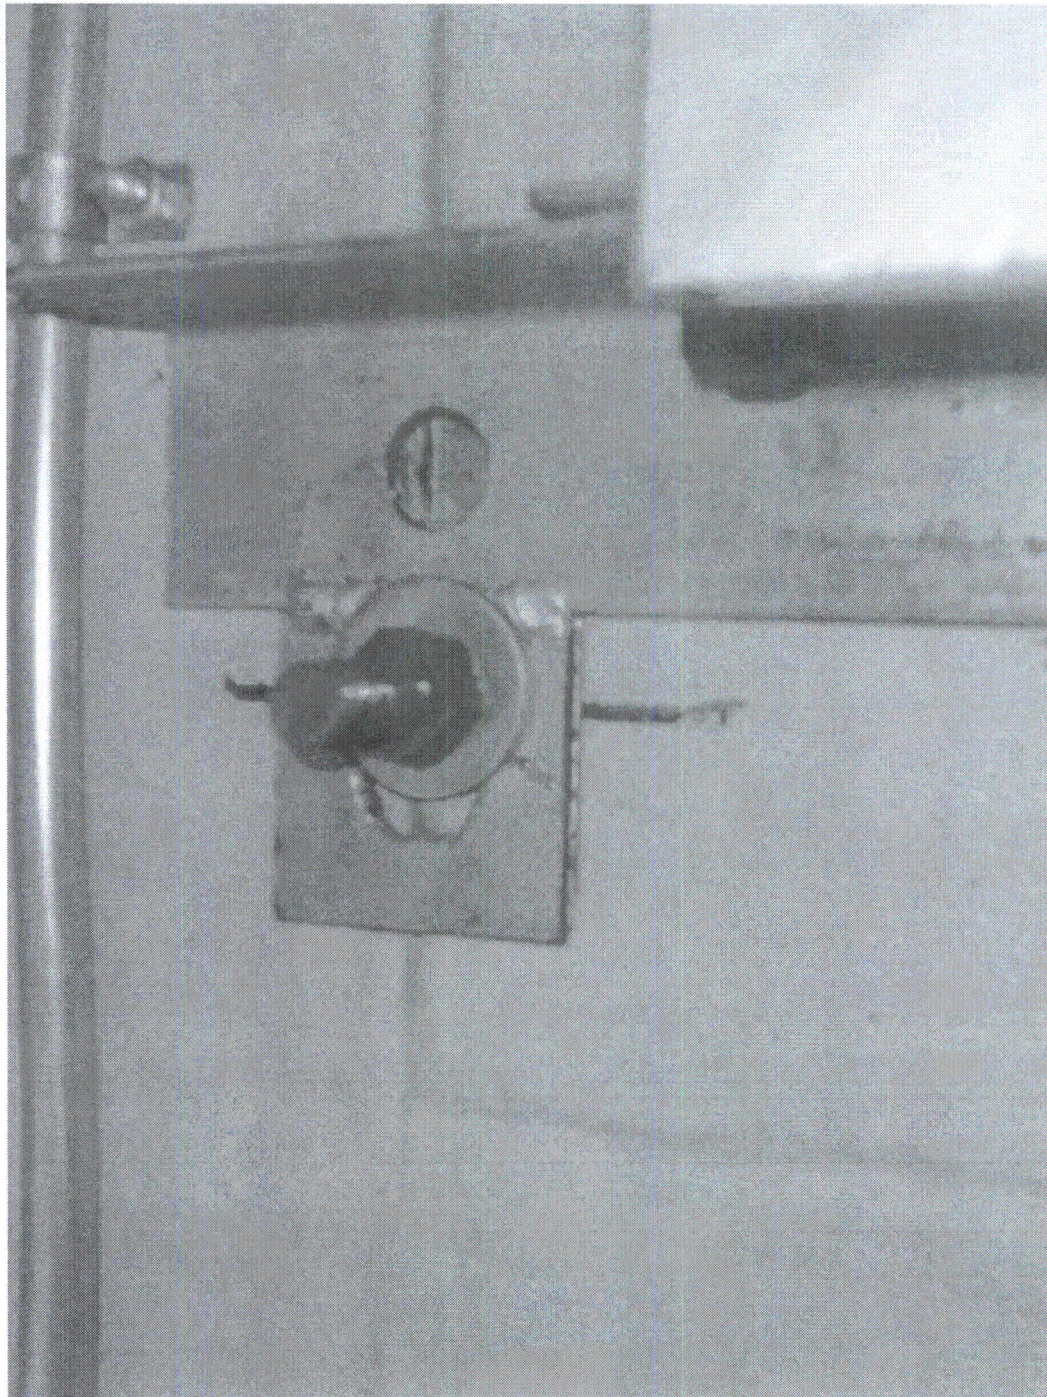
The ventilation duct between the room and the hallway has an empty anchor hole in the frame. The anchor has been removed and a welded tab has been added to the frame for the replacement through-bolt. The spacing between the anchor and the hole is close enough to reduce the capacity of the anchor. The duct is very small and light, and even without the reduced anchor bolt, the remaining three anchors are sufficient to hold the duct, so there is no potentially adverse seismic condition.

Figure 3 – Reduced Anchor Bolt Spacing (Room C-027)

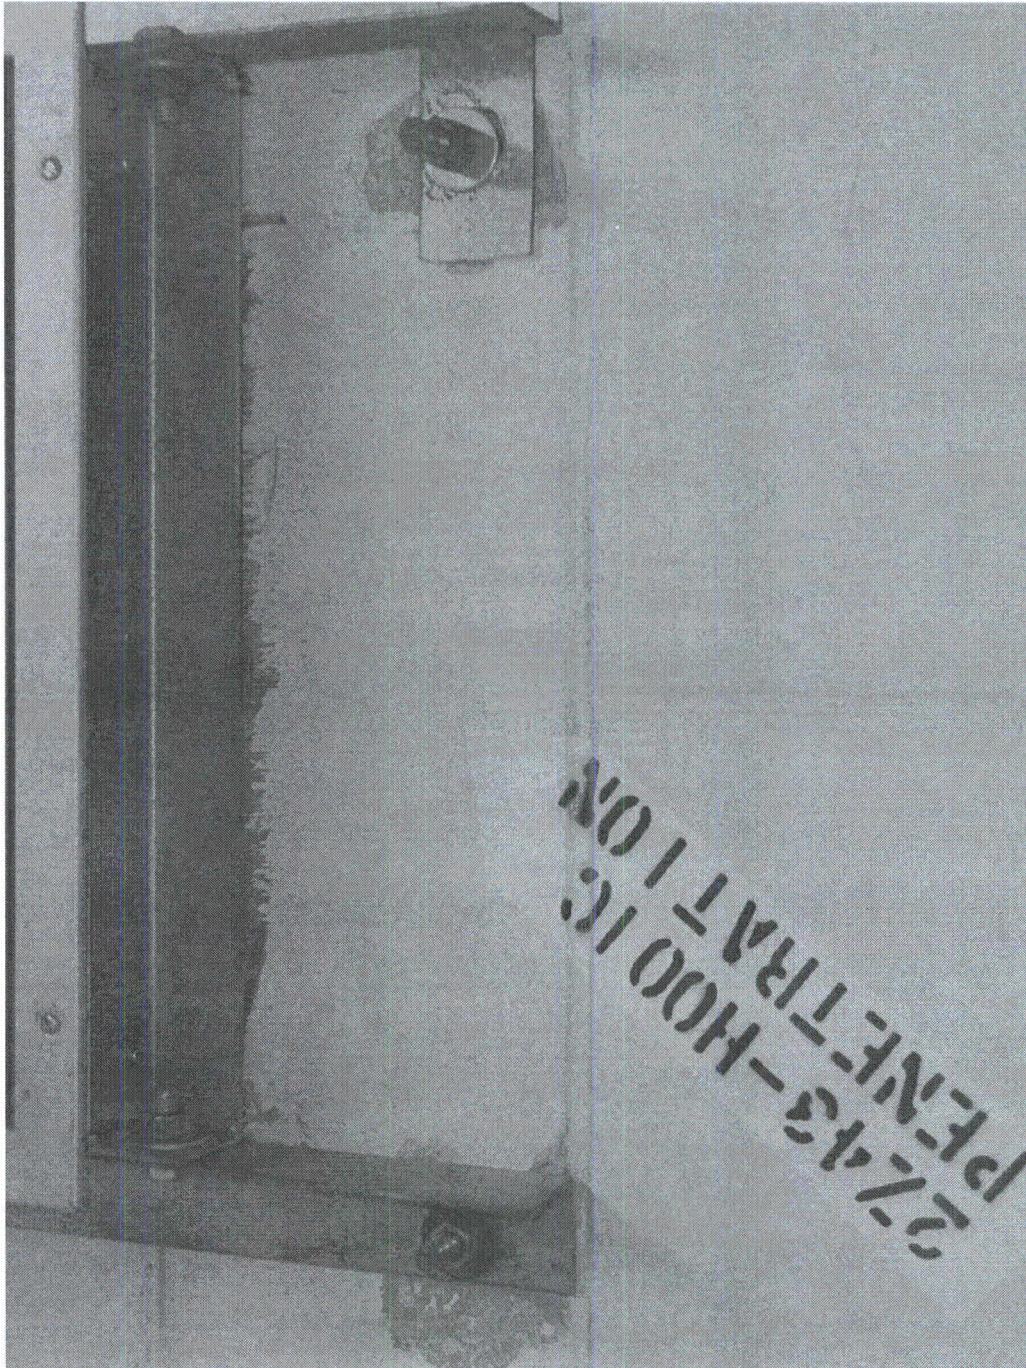
The HVAC damper at penetration 2Z43-H001C has block spalling at the two lower anchors. The duct is not safety related. Only one of the four anchor bolts has a double nut. The amount of spalling around the anchors is minor and the bolts are through-bolted. The spalling appears to have been caused by the drill during installation and not by the anchors. There is no spalling on the other side of the foot thick wall at the anchor support and there is no sensitive equipment beneath the HVAC damper. Therefore, the anchors are judged sufficient to restrain the damper and there is no potentially adverse seismic condition.

Figure 1 – Spalling at HVAC Support (TC-T12 Control 112)

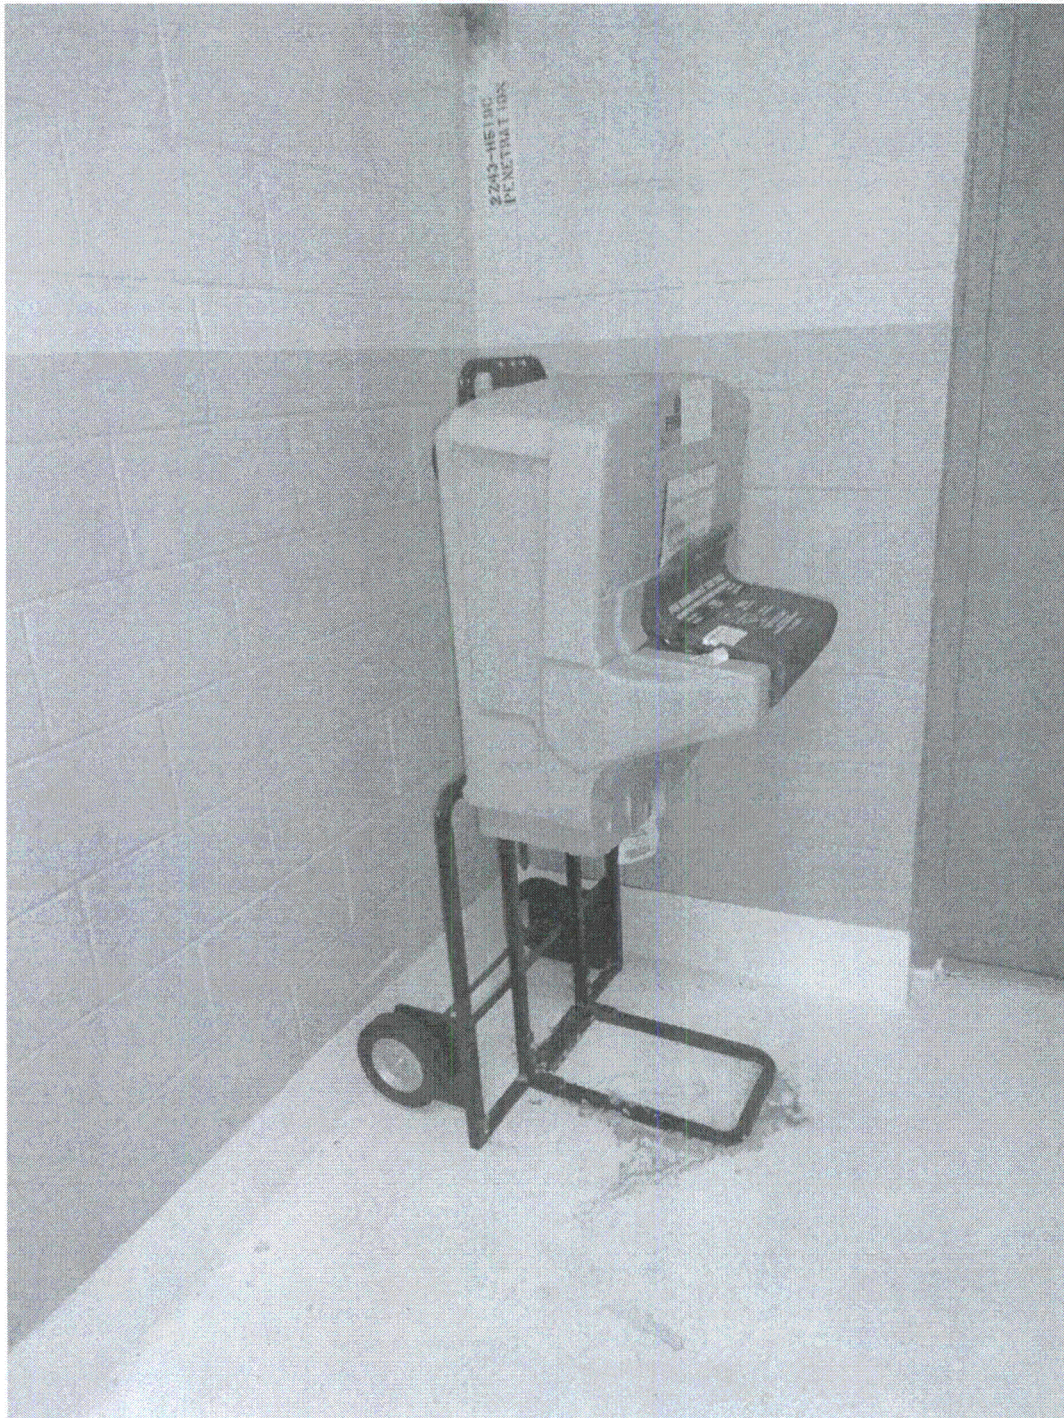
There is a broken portable eyewash station located in the room near the door (CR 519566). The tamper evident seal is broken, the top cover is broken and there is evidence of significant leakage. The eyewash station is not restrained against movement, but it is not near any sensitive equipment. Therefore, it is judged not to be a potentially adverse seismic condition, but the eyewash station needs to be repaired or replaced.

Figure 2 – Broken Eyewash Station (TC-T12 Control 112)

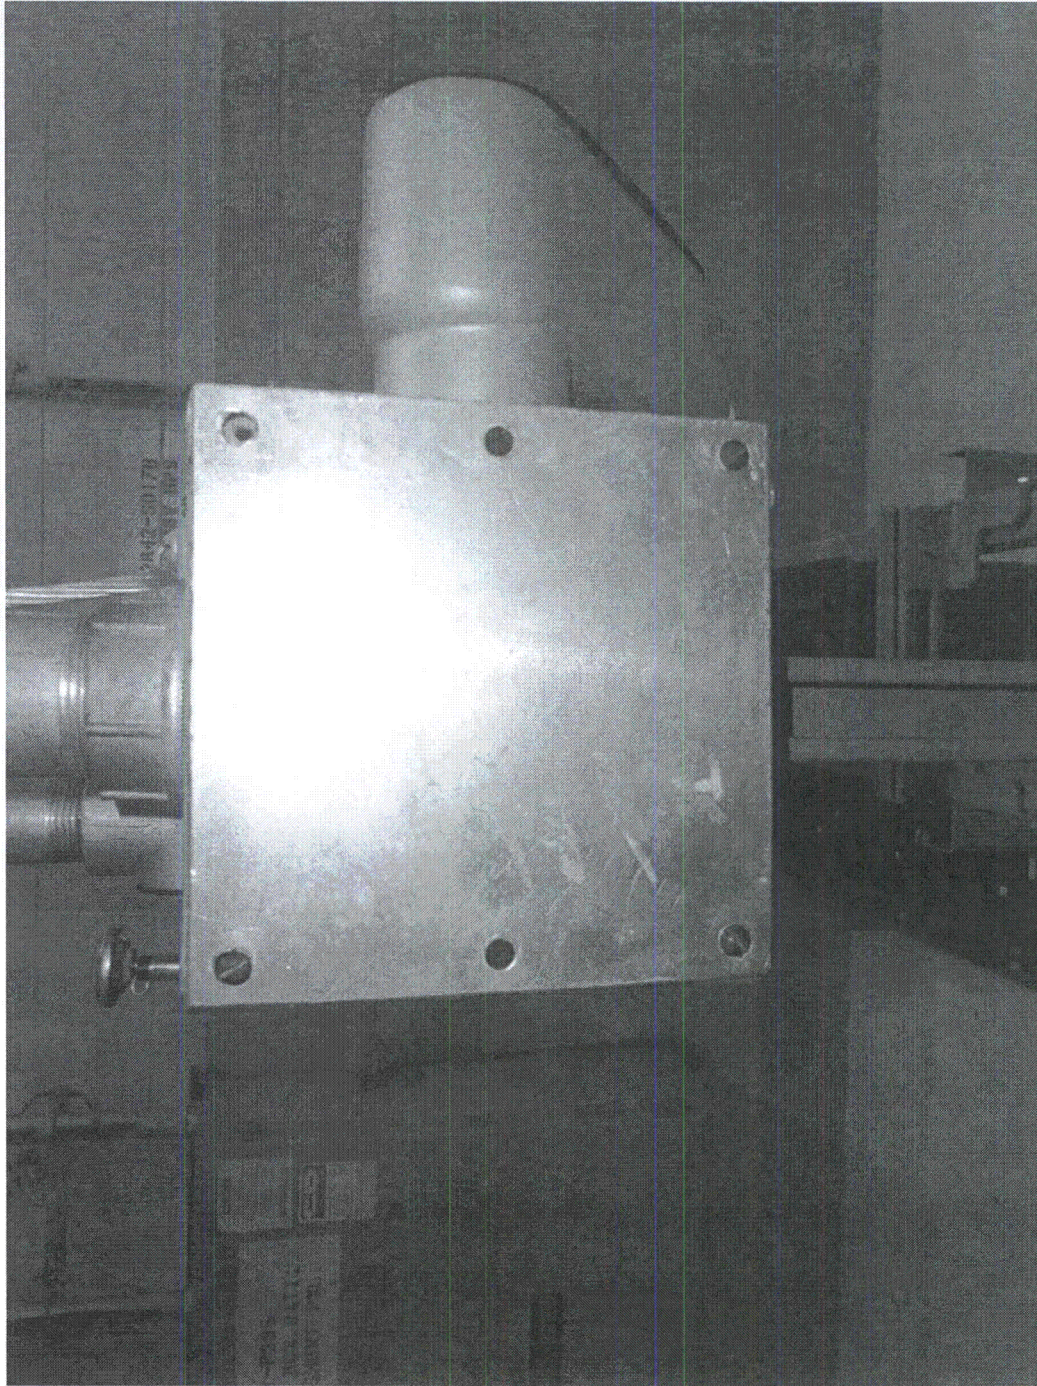
The junction box attached to battery rack 2R42-S017B is missing one screw in the top right corner of the cover plate (CR 519568). There are three existing screws and two holes in the cover plate that are not meant to have screws. The existing screws are judged to be sufficient to hold the cover plate in the case of a seismic event. Therefore, it is judged that there is no potentially adverse seismic condition.

Figure 3 – Missing Cover Plate Screw (TC-T12 Control 112)

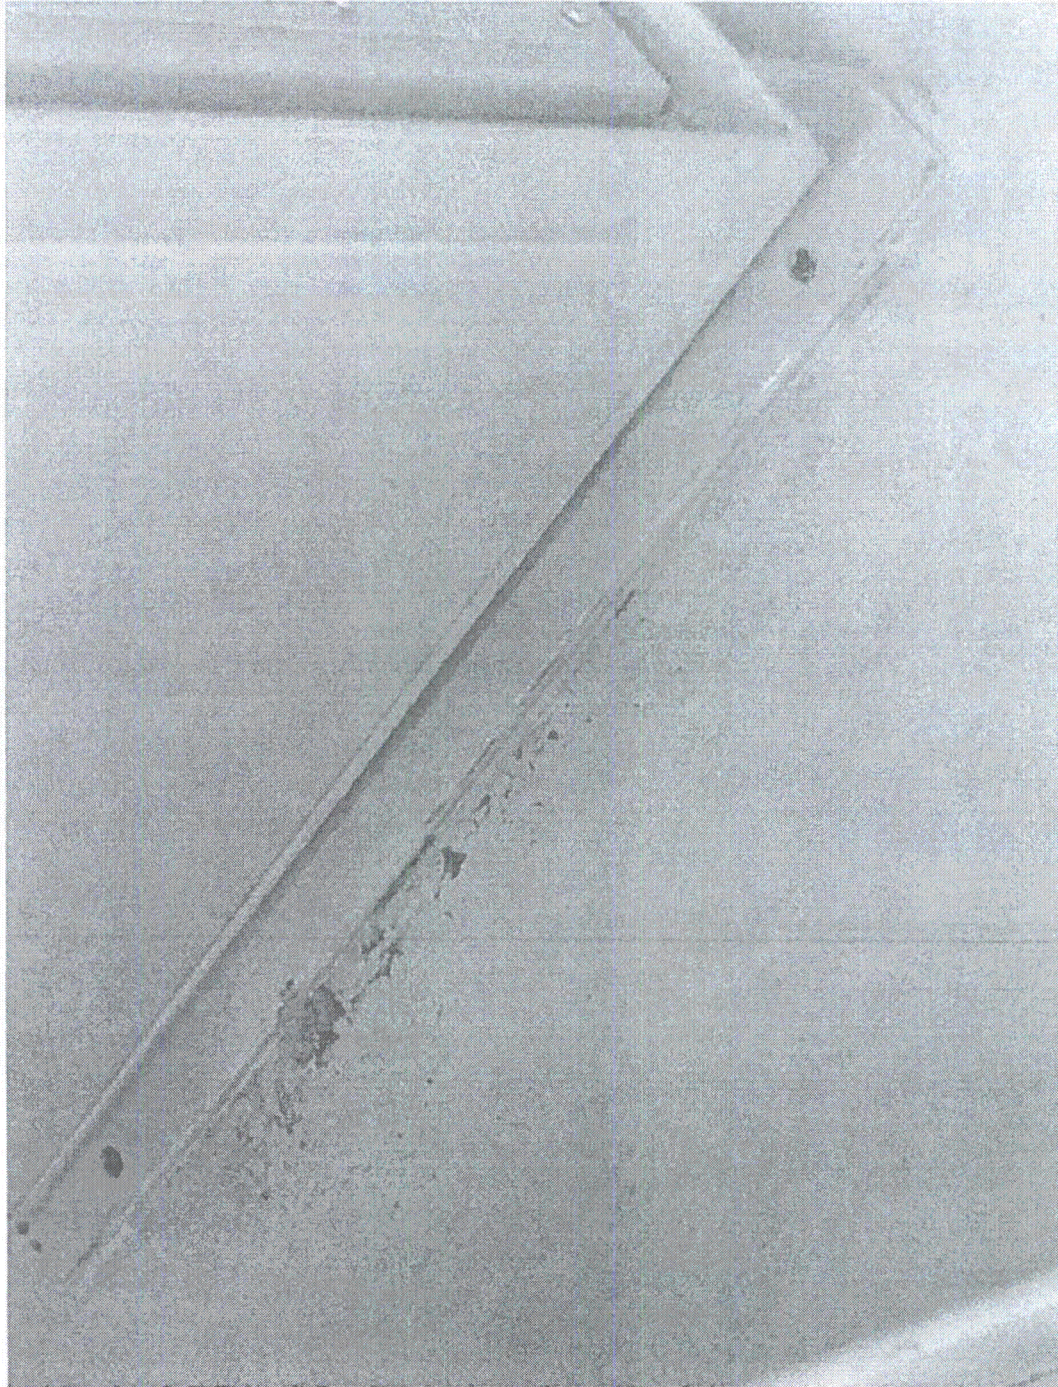
1. Does anchorage of equipment in the area appear to be free of potentially adverse seismic conditions (if visible without necessarily opening cabinets)? Y N U N/A
There are two anchor bolt holes without anchor bolts on 2R42-S028. However, review of SEWS package 2R42-S029 and adjacent battery chargers show that the anchors were replaced with welds, so there are no missing anchors. The existing welds have been verified against the SEWS packages and found to be in compliance. Therefore, there is no potentially adverse seismic condition.

Figure 1 – Replacement Welds (Room C-114)
