Area Walk-By Checklist (AWC)Location: Bldg. CONTROL Floor El. 112 Room, Area¹: TD-T13**Instructions for Completing Checklist**

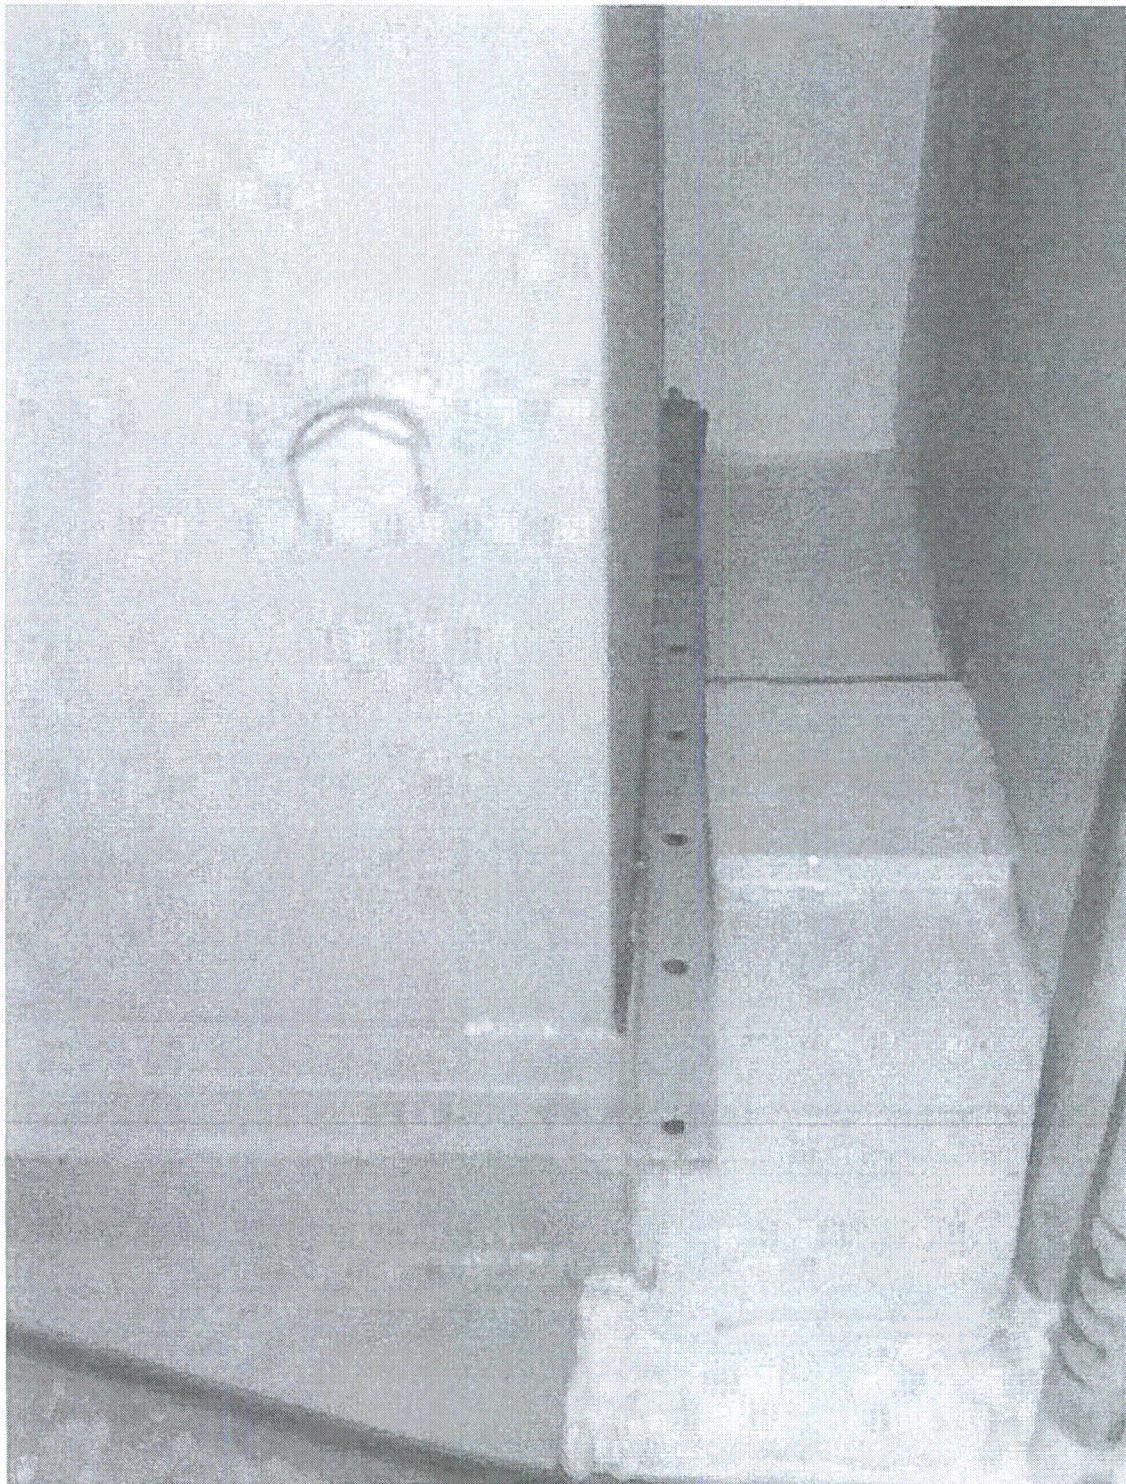
2. Does anchorage of equipment in the area appear to be free of significant degraded conditions? Y N U N/A
3. Based on a visual inspection from the floor, do the cable/conduit raceways and HVAC ducting appear to be free of potentially adverse seismic conditions (e.g., condition of supports is adequate and fill conditions of cable trays appear to be inside acceptable limits)? Y N U N/A
There are eight bolts missing from the north flange of the 56" x 30" HVAC duct at Penetration 2Z43-H750D on the west wall (CR 524552). The HVAC is supported at the wall by the flanged connection to the fire damper in the wall and by a strap support about two feet east of the flanged connection. Therefore, there is negligible load from the duct on the flanged connection. Eighteen bolts properly installed on the other visible sides of the duct at the flanged connection are judged sufficient to restrain the duct. The fire damper is not adversely affected by the flanged connection with the missing bolts. Therefore, there is no potentially adverse seismic condition created by the missing bolts. However, the missing bolts should be replaced.

Figure 2 – Missing HVAC Bolts (Room C-114)

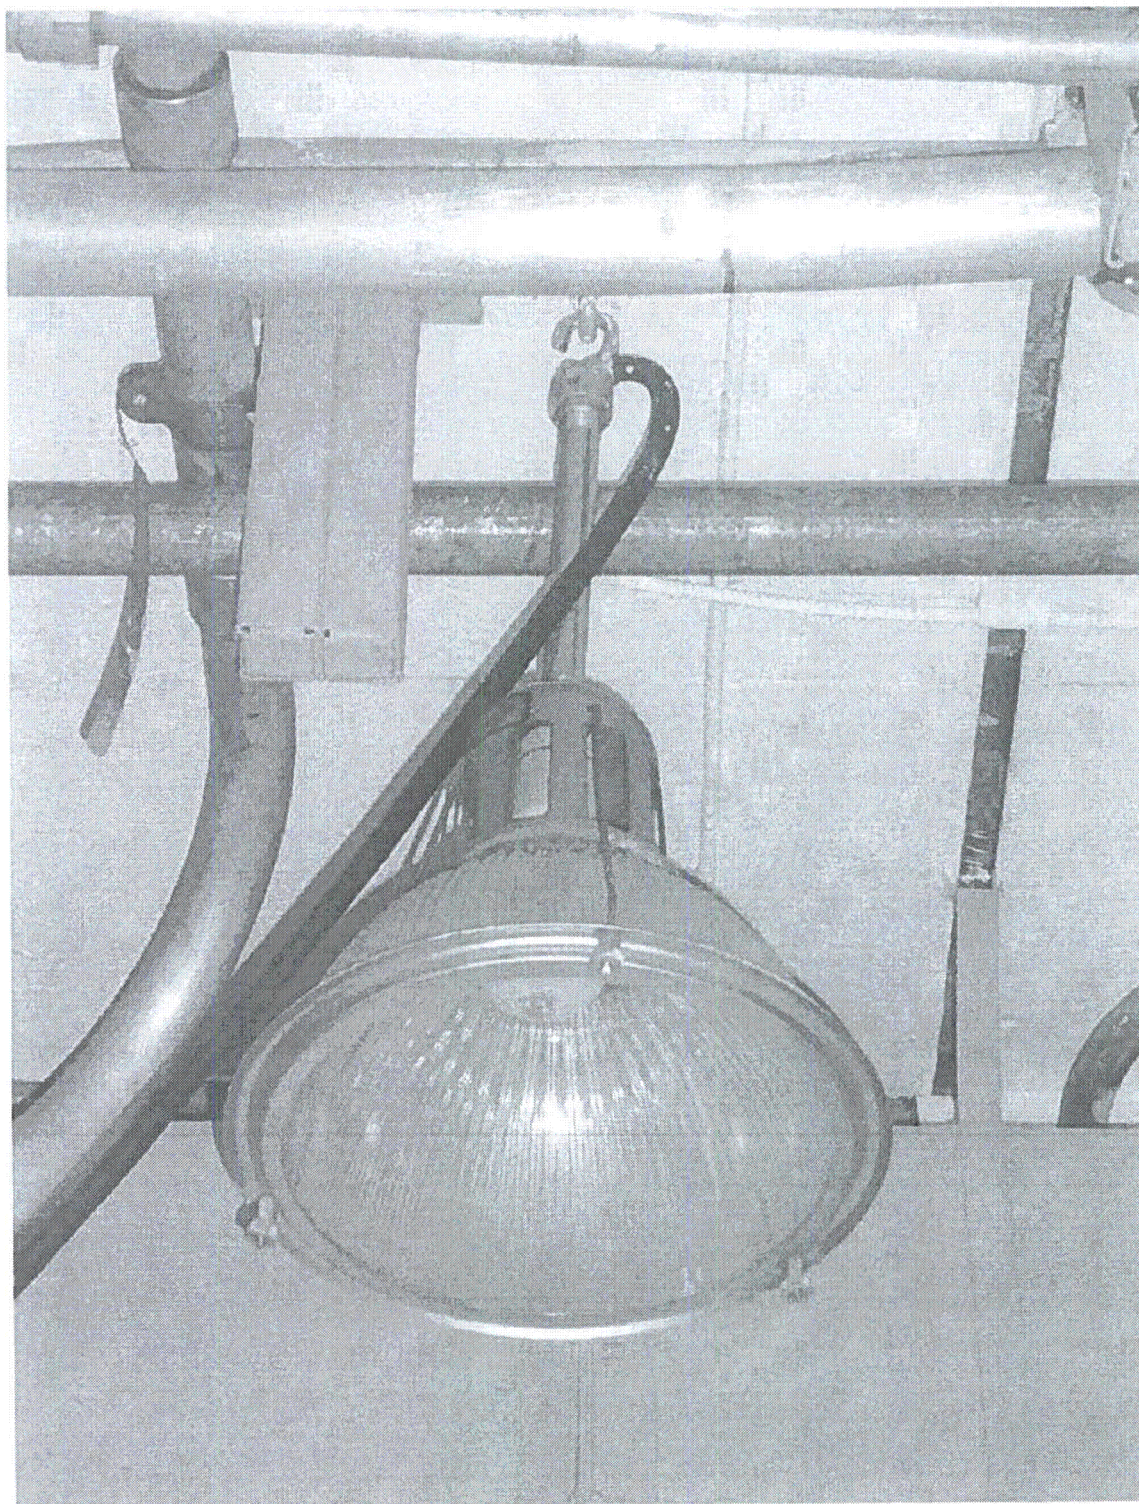
4. Does it appear that the area is free of potentially adverse seismic spatial interactions with other equipment in the area (e.g., ceiling tiles and lighting)? Y N U N/A
There is a hanging rod light suspended near 2R22-S016 with an open hook and no safety chain. The light is over open floor, and so has no potential to fall on sensitive equipment. Therefore, there is no potentially adverse seismic condition.

Figure 3 – Hanging Rod with Open Hook (Room C-114)

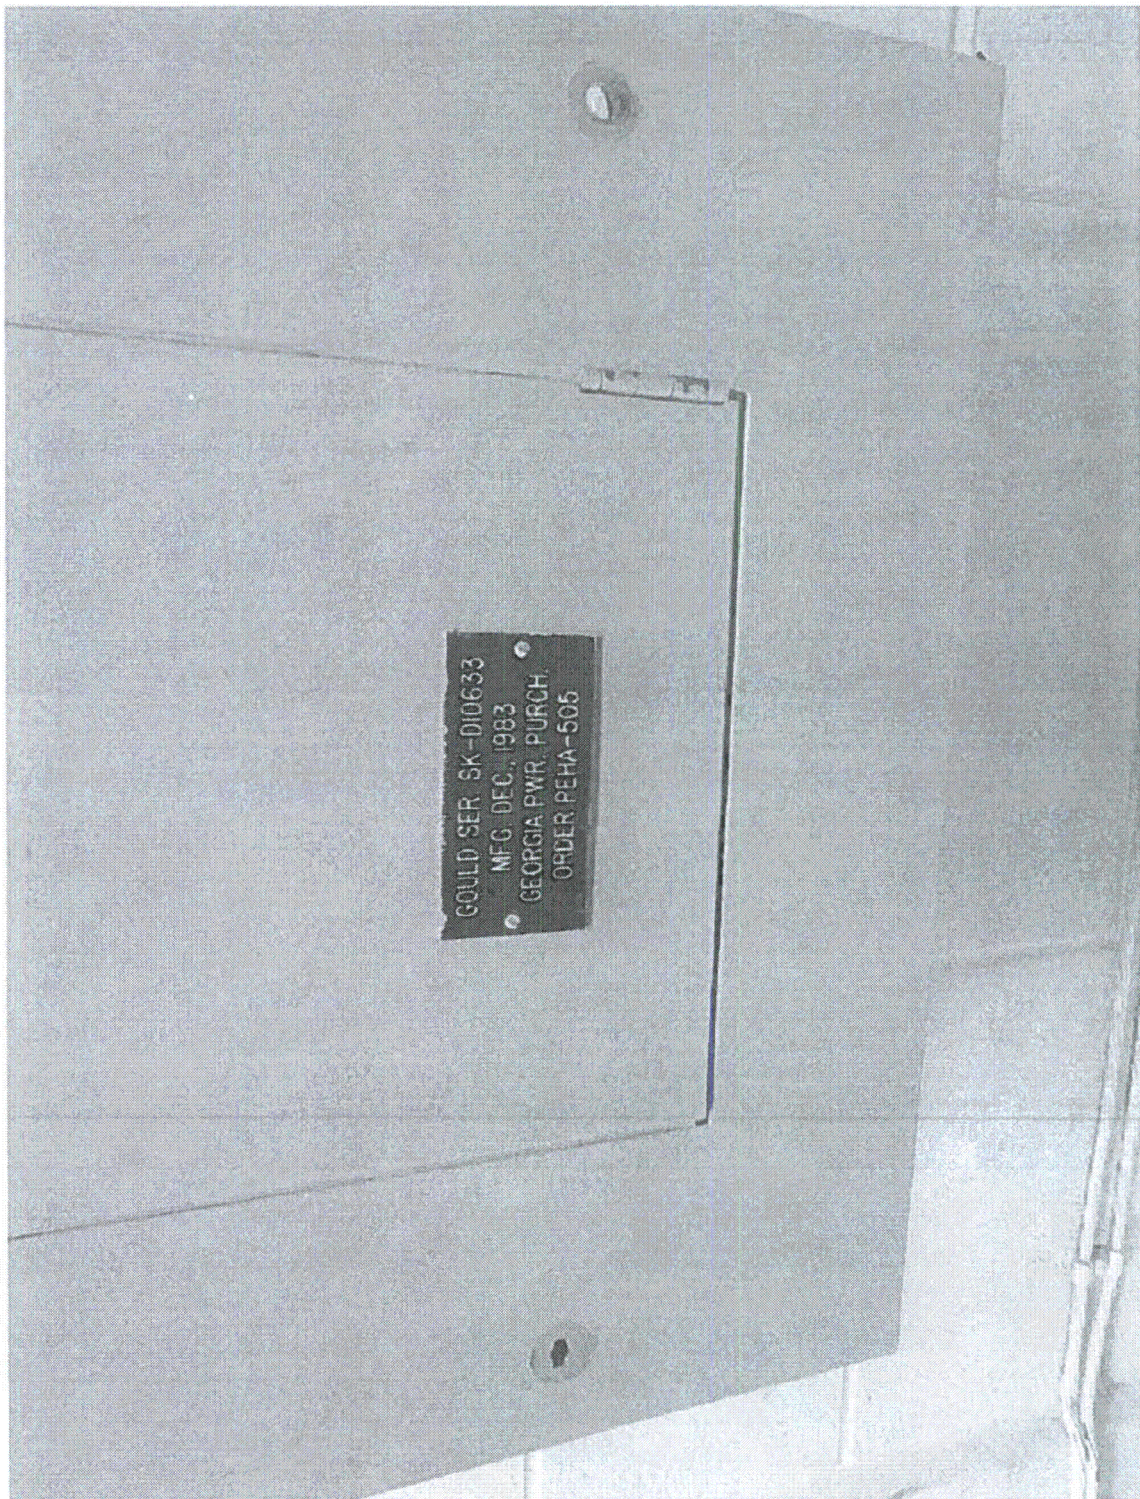
8. Have you looked for and found no other seismic conditions that could adversely affect the safety functions of the equipment in the area? Y N U
There is one screw missing and one screw missing a washer on the Q2R25-S129 distribution panel (CR 524321). The remaining four screws are sufficient to hold the light gauge cover plate, so there is no potentially adverse seismic condition and operability is not affected. However, the missing screw and washers should be replaced.

Figure 4 – Missing Screw and Washer (Room C-114)

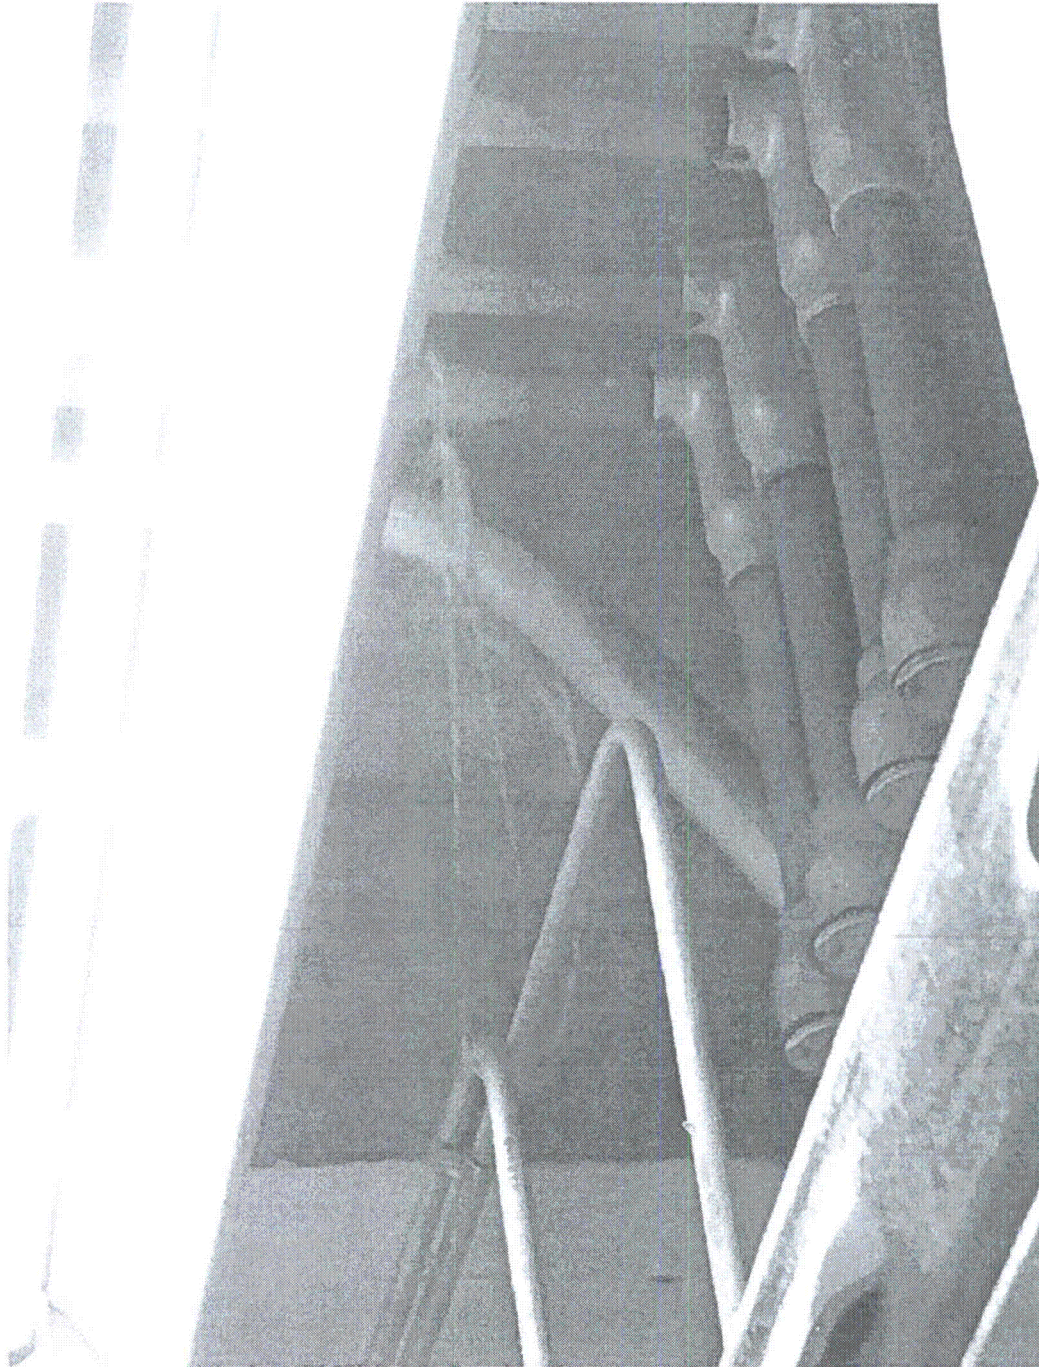
2. Does anchorage of equipment in the area appear to be free of significant degraded conditions? Y N U N/A
3. Based on a visual inspection from the floor, do the cable/conduit raceways and HVAC ducting appear to be free of potentially adverse seismic conditions (e.g., condition of supports is adequate and fill conditions of cable trays appear to be inside acceptable limits)? Y N U N/A
Instrument tubing is tied to an overhead conduit with a frayed piece of rope (see CR 513977). The tubing is supported by Unistrut members on either side of the rope, so the rope does not provide any restraint for the tubing. It is judged to be seismically adequate.

Figure 1 – Instrument Tubing Tied to Conduit (C140)

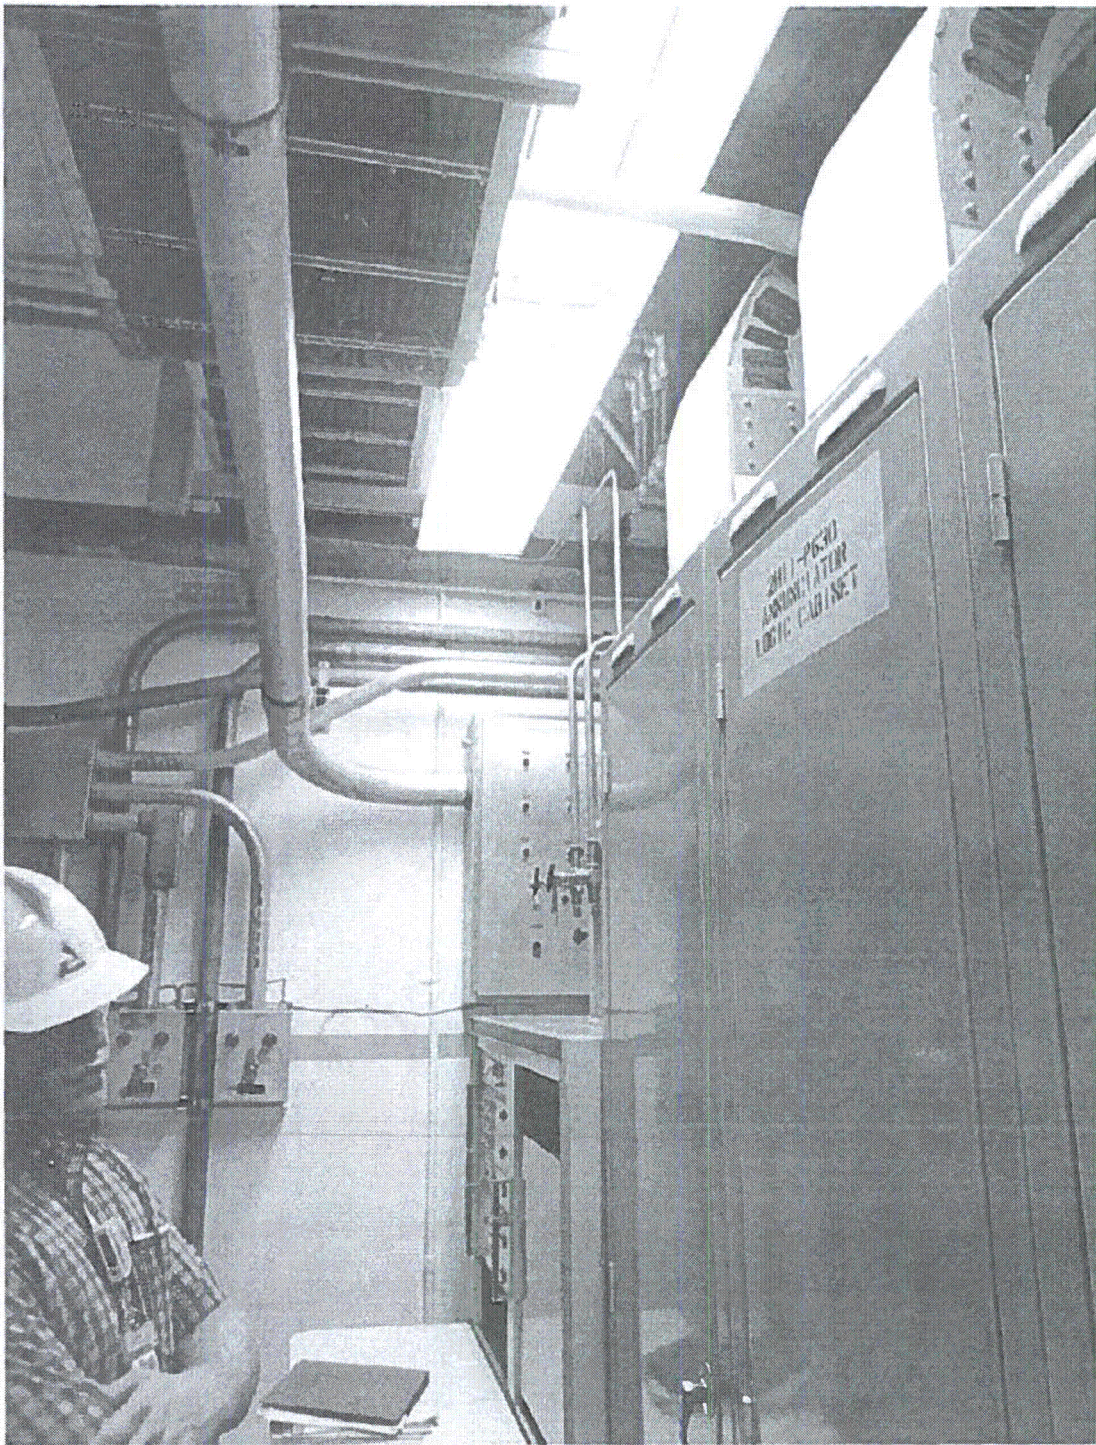
Figure 2 – Light Fixture over Cabinet (C140)

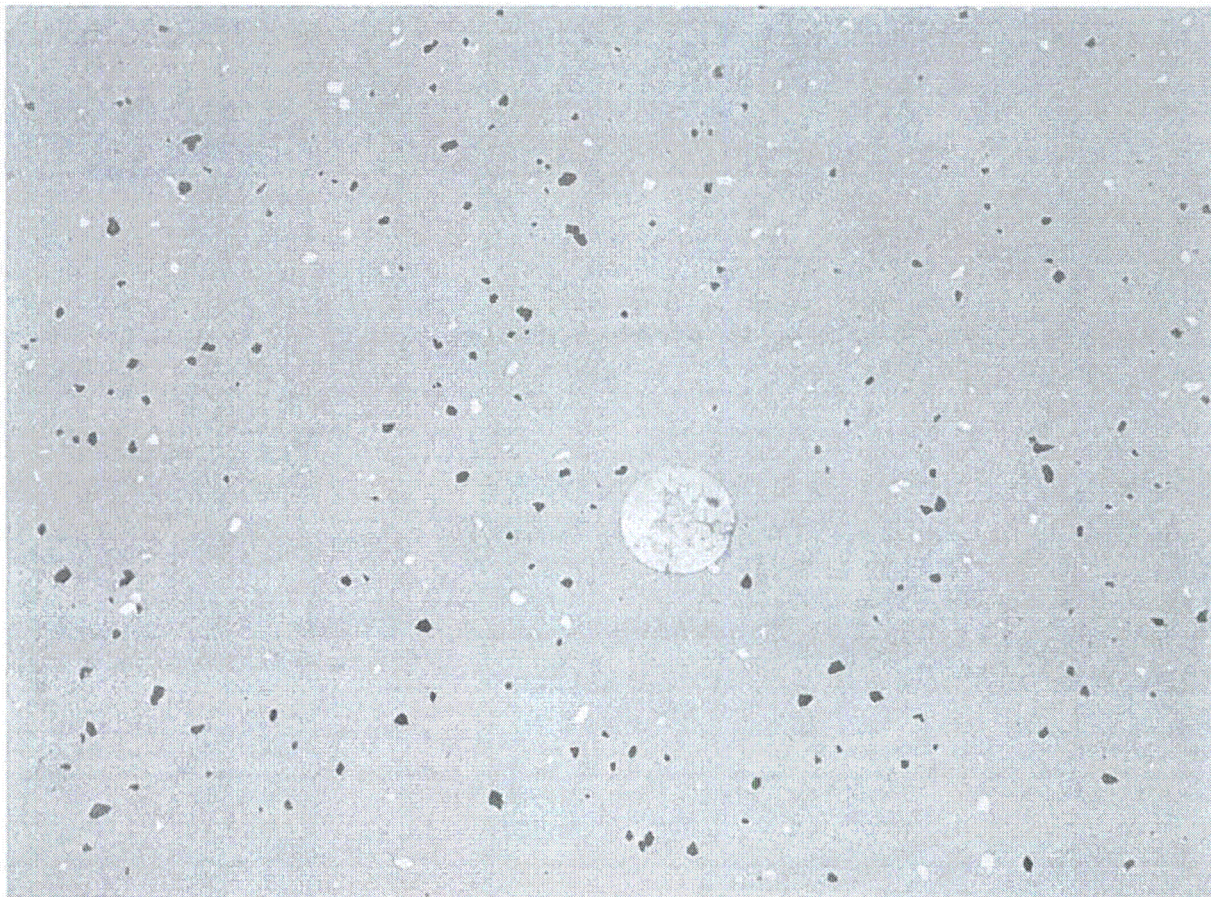
There is an Equipment Tag laying on the 130' elevation floor near 2H21-P410. The SWE's have determined that the tag is small and will not cause an adverse seismic interaction with safety related equipment (See CR 518762).

Figure 1 Equipment Tag on Floor at 130' Elevation of the Reactor Building

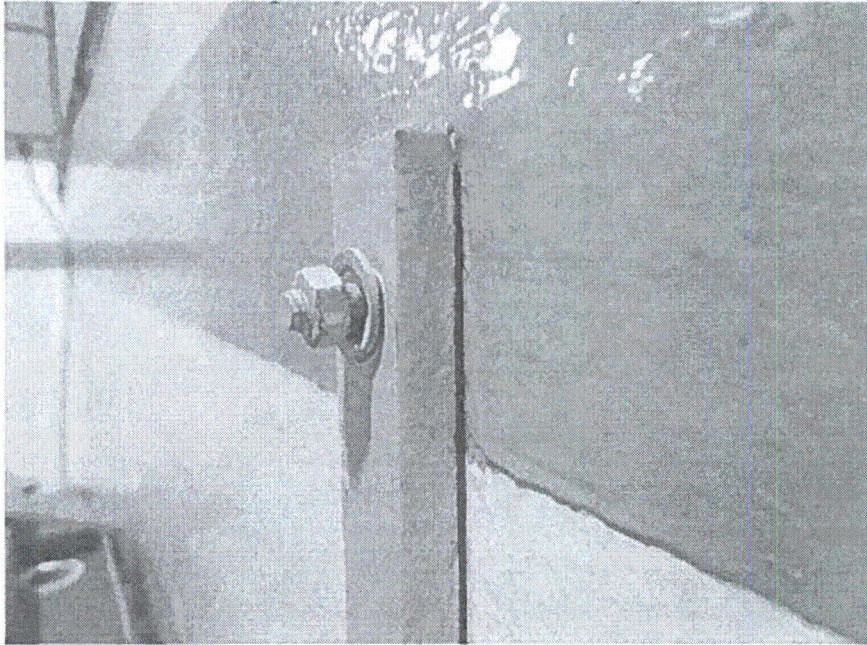
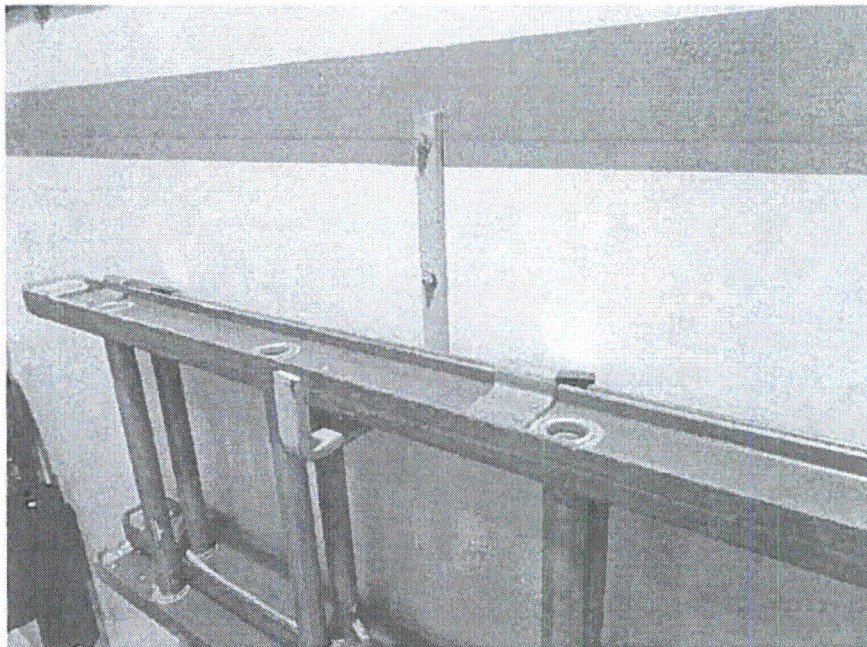
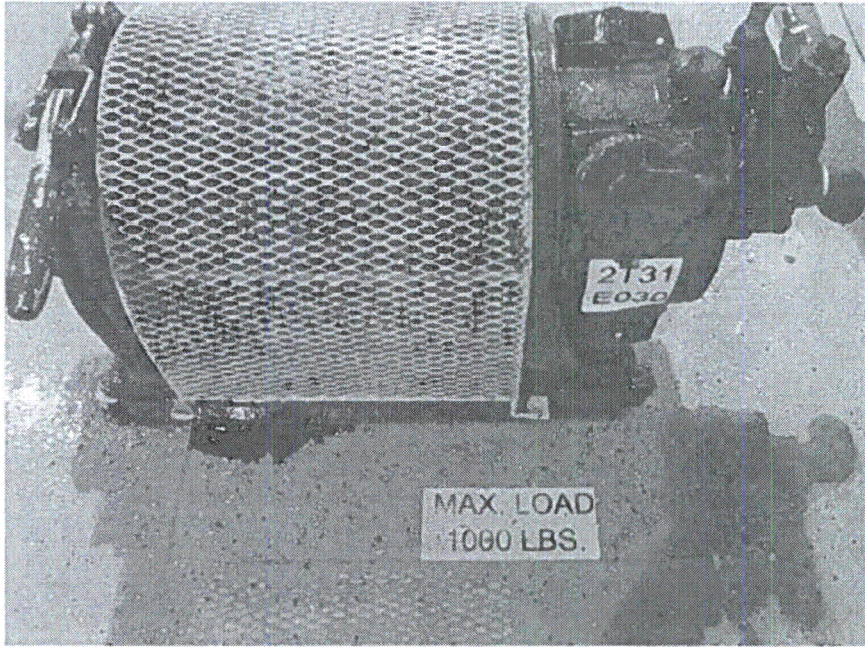
Top bolt of one of the supports for the ladder in the area has a loose nut. This was judged not to be a seismic concern since the ladder is far from other equipment in the area. CR523720 was initiated to tighten the nut on this bolt.

There is an oil leak on the floor next to item 2T31-E030. CR523723 was initiated for this purpose. This is not a seismic concern.

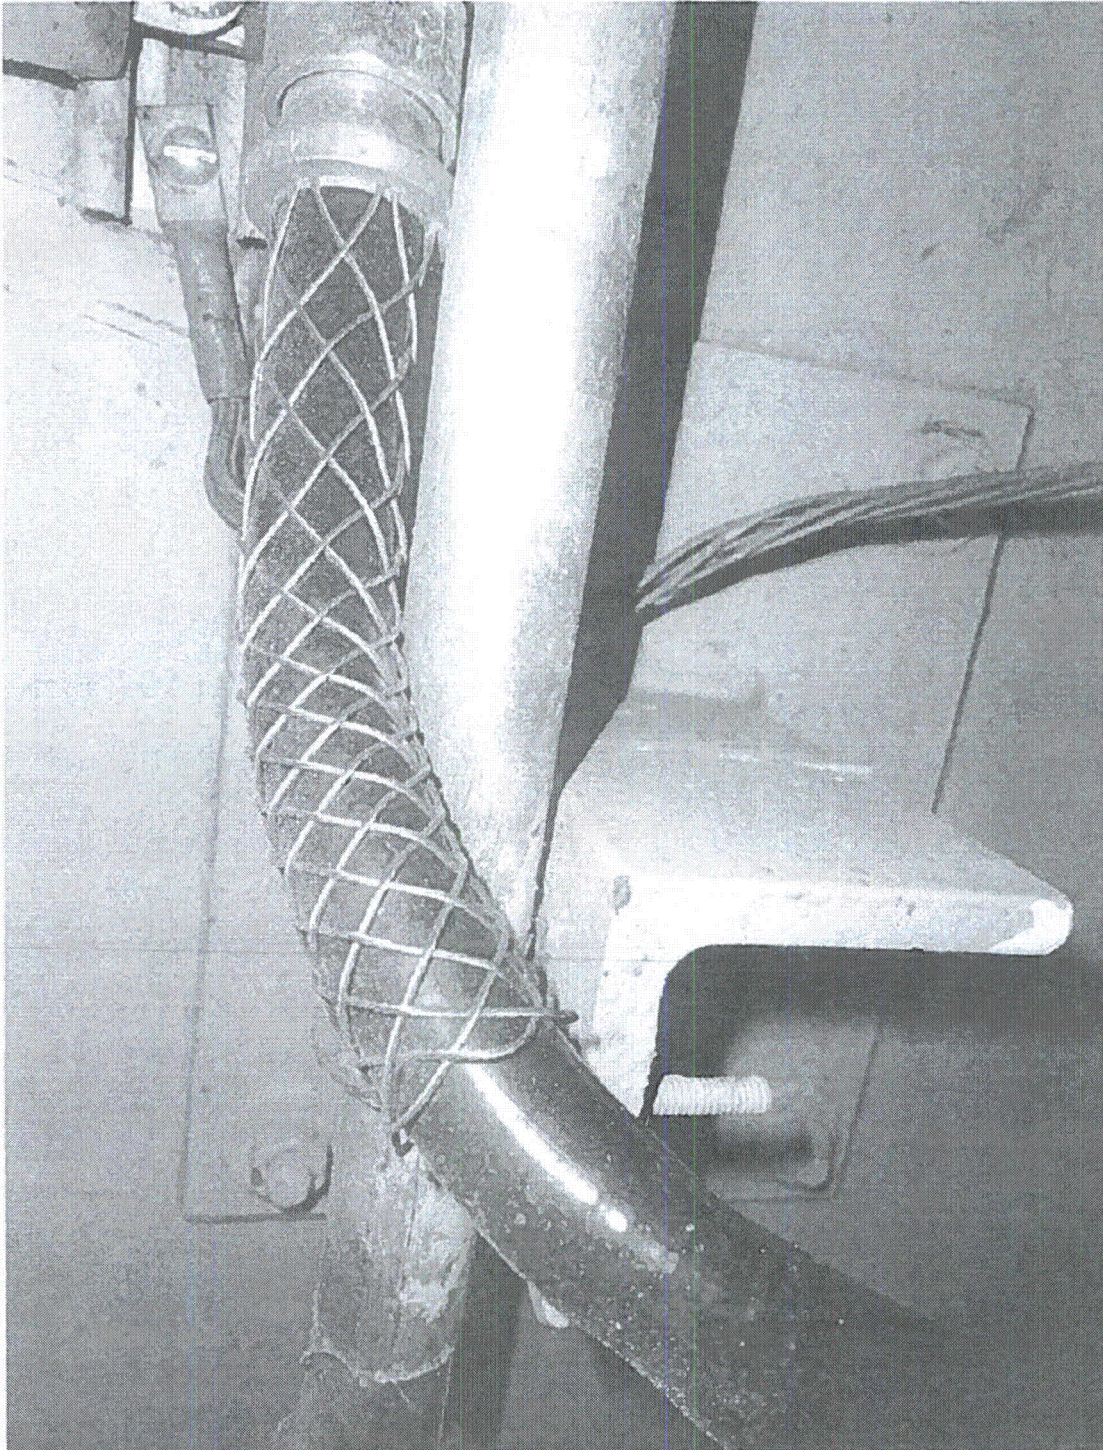
4. Does it appear that the area is free of potentially adverse seismic spatial interactions with other equipment in the area (e.g., ceiling tiles and lighting)? Y N U N/A
There are two flexible conduits attached to the 2G51-F012 Torus Water Cleanup Outboard Isolation that are touching adjacent conduits. In both cases, the pair of conduits are light and have adequate flexibility, and are at similar locations such that the conduit pairs will likely move together. The conduits are rugged enough that any incidental contact between the conduits will not cause damage to the cables inside, so there is no potentially adverse seismic condition.

Figure 1 – First Conduit Pair with Limited Gap (Unit 2 Torus Room Bay 9)

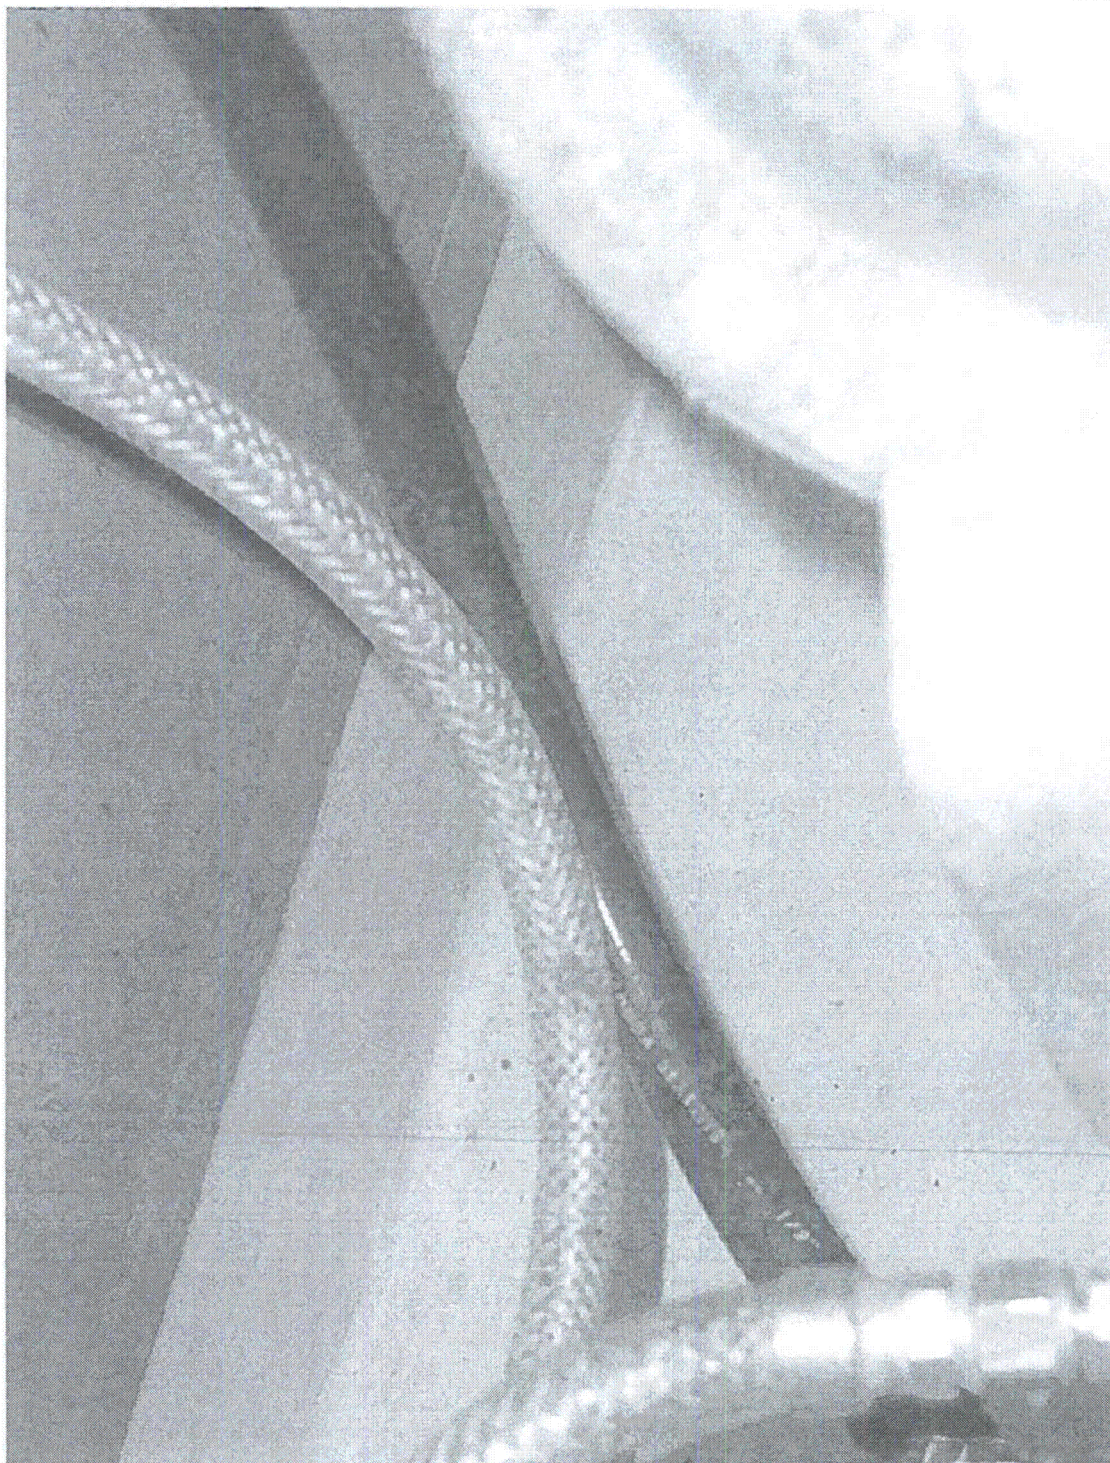
Figure 2 – Second Conduit Pair with Limited Gap (Unit 2 Torus Room Bay 9)

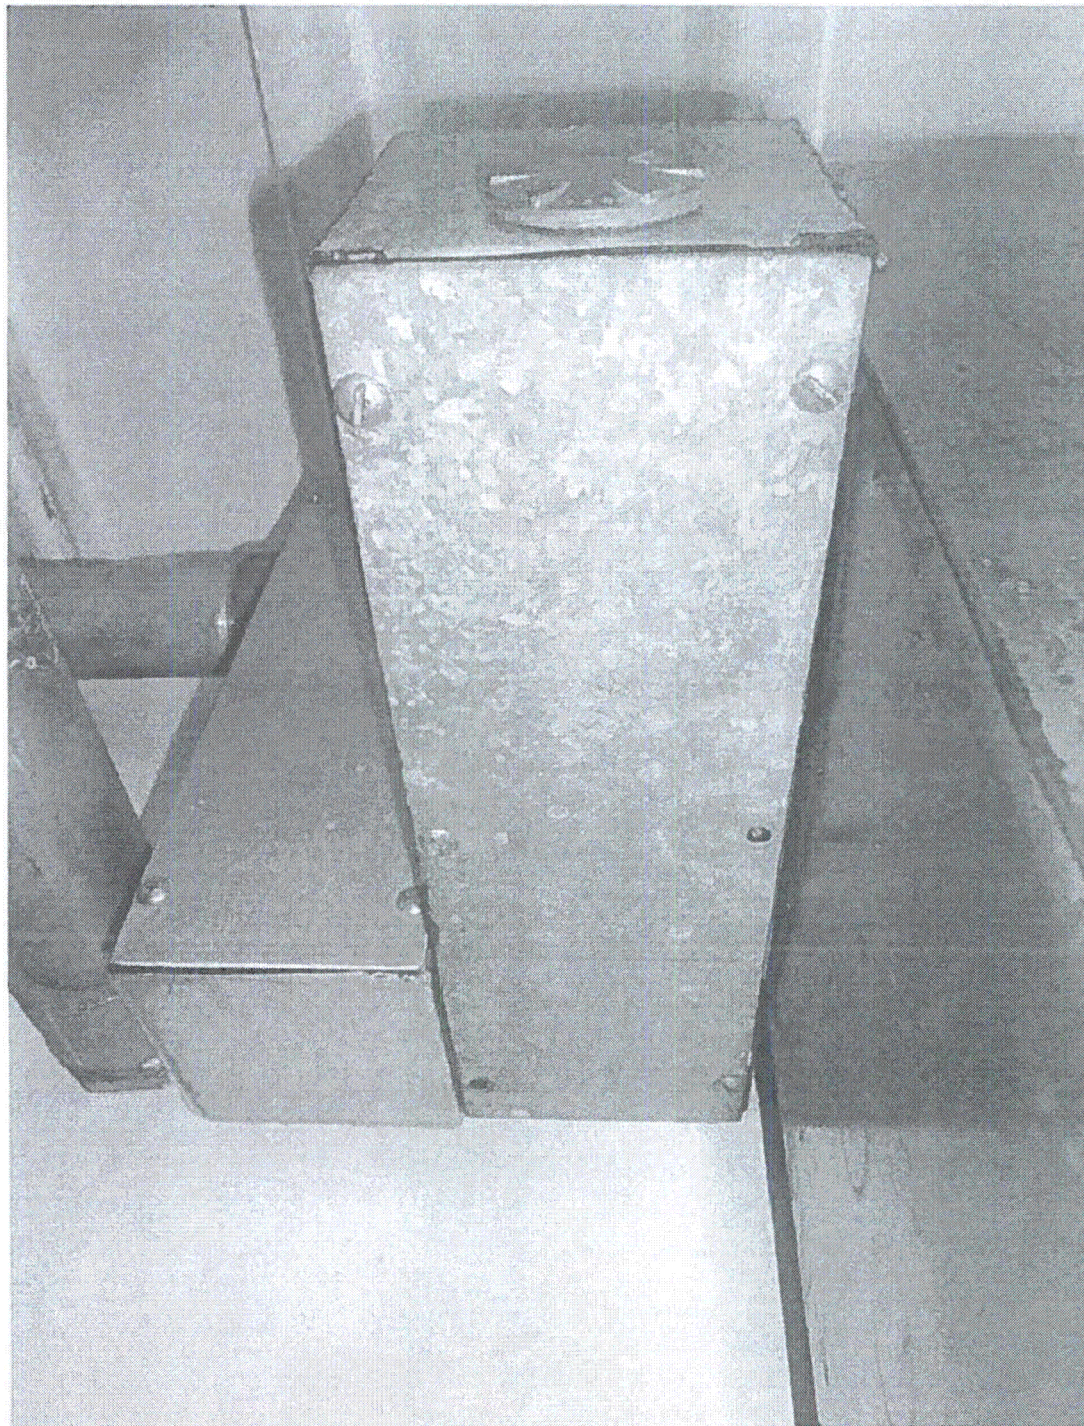
2. Does anchorage of equipment in the area appear to be free of significant degraded conditions? Y N U N/A
3. Based on a visual inspection from the floor, do the cable/conduit raceways and HVAC ducting appear to be free of potentially adverse seismic conditions (e.g., condition of supports is adequate and fill conditions of cable trays appear to be inside acceptable limits)? Y N U N/A
There is a junction box above conduit 2MR9314 with two out of six cover plate screws missing (CR 525221). The cover plate is very light, and the four remaining screws have sufficient capacity to restrain the cover plate, so there is no potentially adverse seismic condition.

Figure 1 – Missing Cover Plate Screws (Unit 2 SE Diagonal)

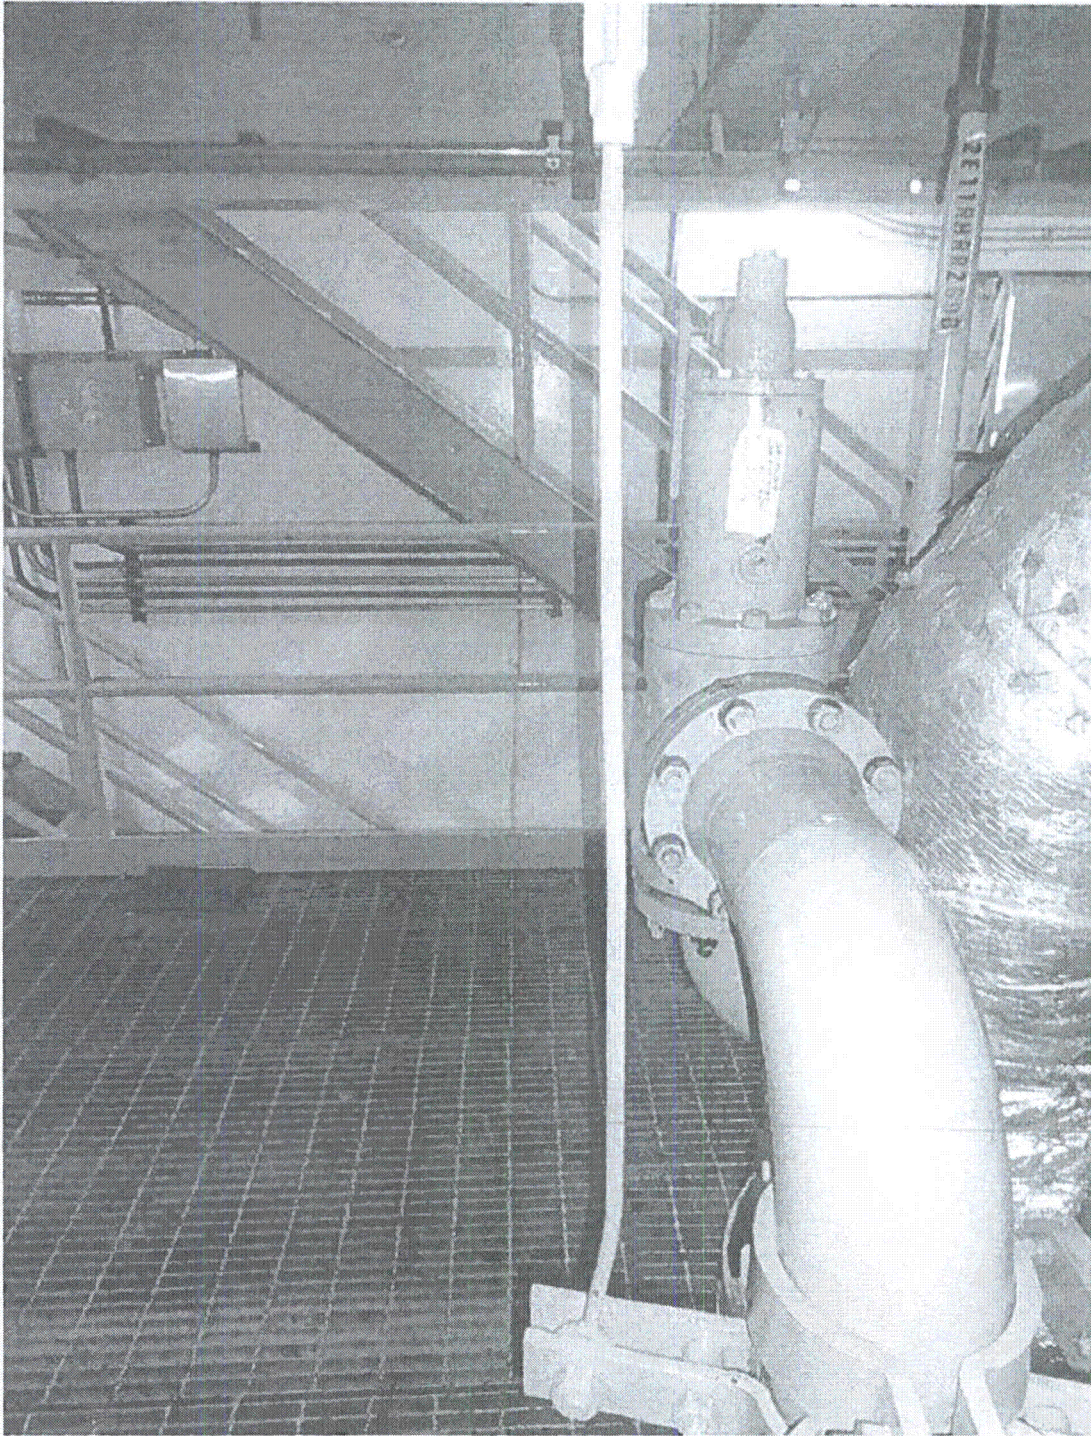
There is a bent tension rod on a pipe spring can support. Since the rod is clearly designed to resist tension loads only, the small bend in the rod will not adversely affect the rod's structural capacity. Therefore, there is no potentially adverse seismic condition.

Figure 2 – Bent Tension Rod (Unit 2 SE Diagonal)

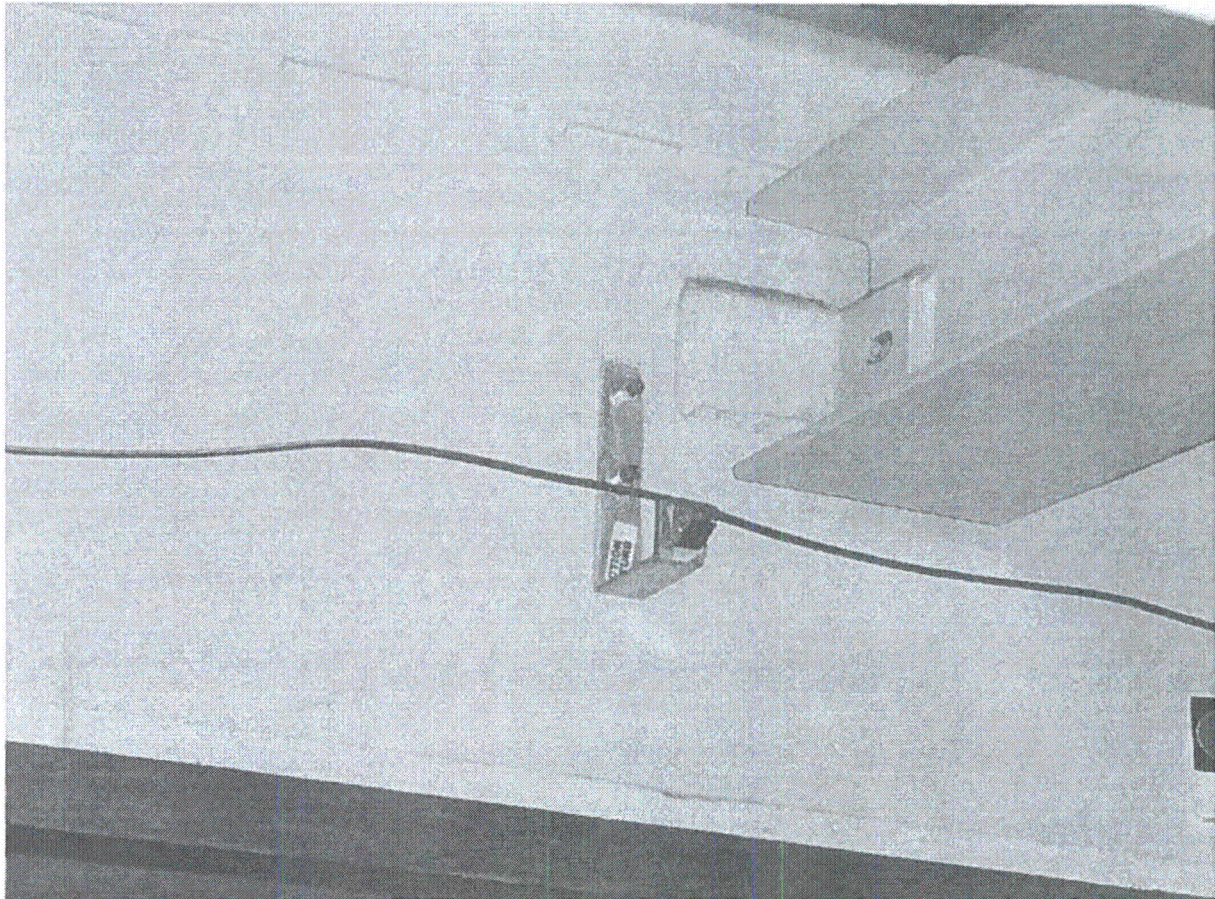
Figure 1: Drilled Clip Angle Welded to Web of Small Wide Flange

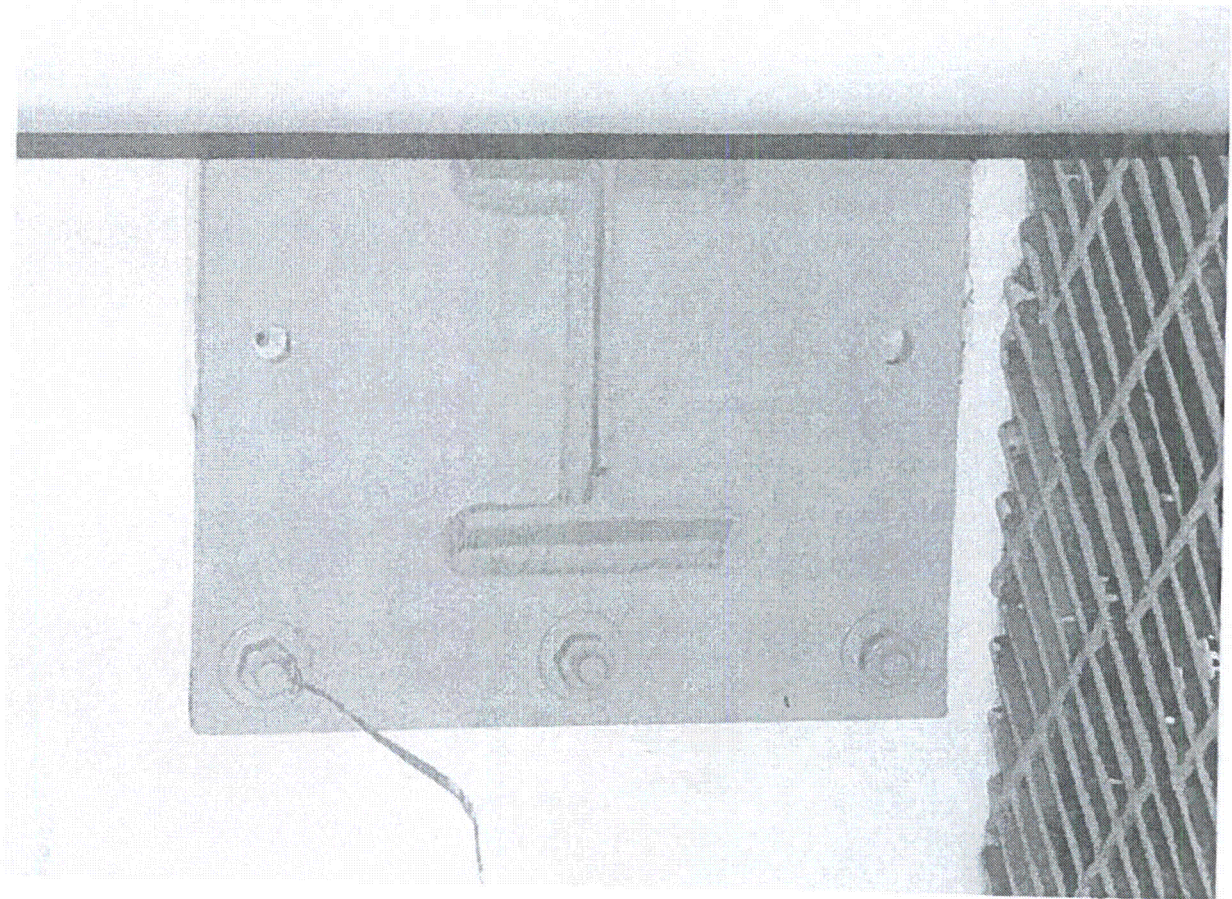
Figure 2: Abandoned in Place Base-Plate
