Status: Y N U **Area Walk-By Checklist (AWC)**Location: Bldg. REACTOR Floor El. 87 Room, Area¹ NW Diagonal Elevated Platform**Instructions for Completing Checklist**

ATTACHMENT 5

UNIT 2 - IPEEE VULNERABILITIES INFORMATION

NO. SNCH082-RPT-02

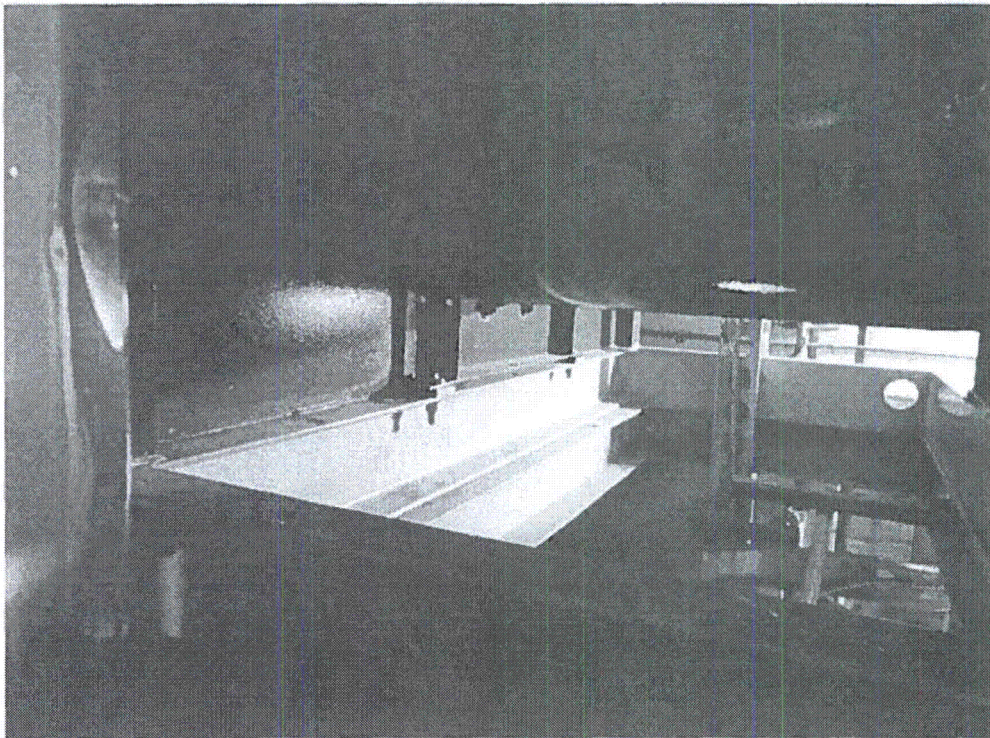
1. Does anchorage of equipment in the area appear to be free of potentially adverse seismic conditions (if visible without necessarily opening cabinets)? Y N U N/A
Equipment 2T41-B004B has a missing bolt. See picture for details. CR523718 has been initiated for this purpose.

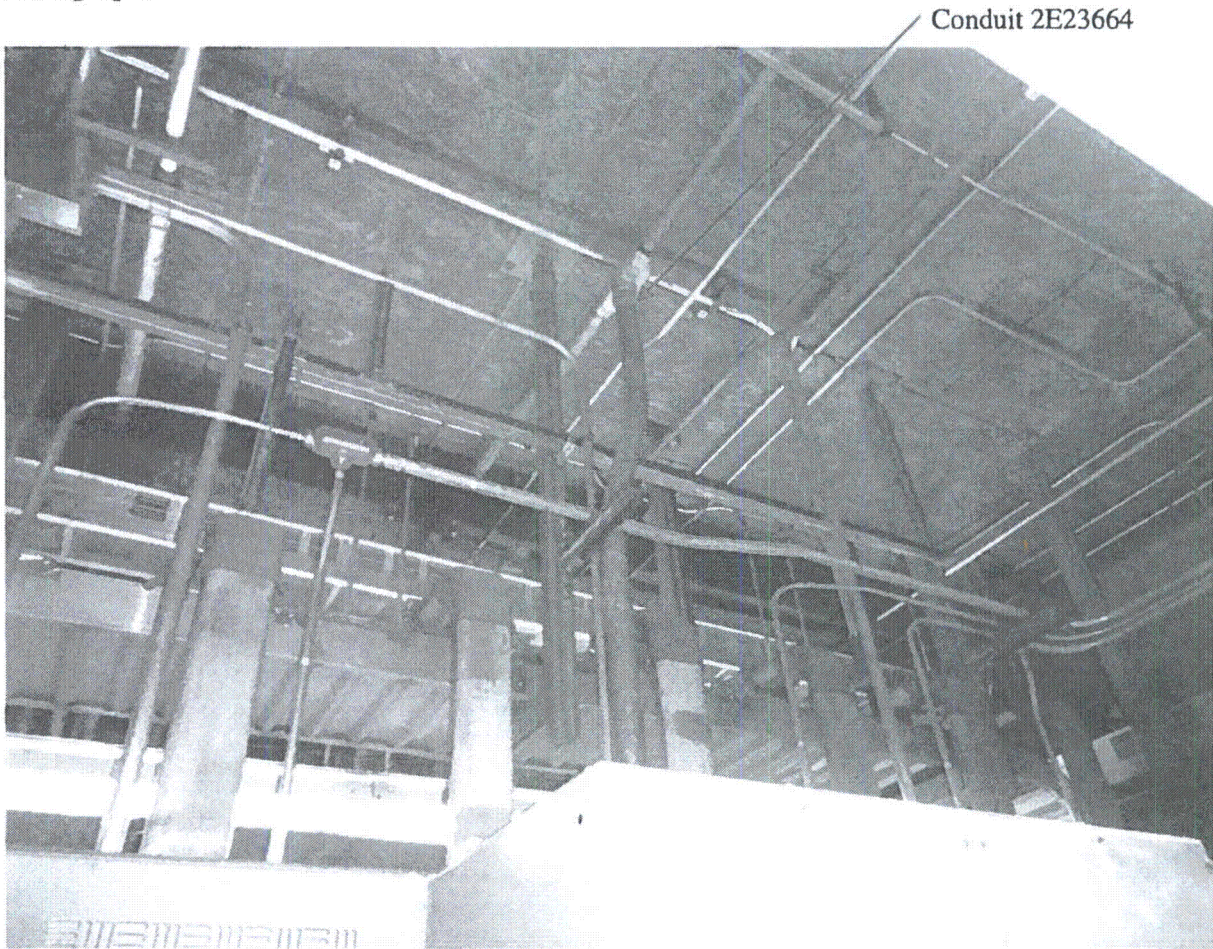
3. Based on a visual inspection from the floor, do the cable/conduit raceways and HVAC ducting appear to be free of potentially adverse seismic conditions (e.g., condition of supports is adequate and fill conditions of cable trays appear to be inside acceptable limits)? Y N U N/A
Two cases were observed where conduit spans appeared to be longer than standard practice (see pictures 1 and 2). However, those spans were judged to meet the intent of section 8.0 of the SQUG GIP which allows spans of 20 feet for conduits of this size. Thus, the conduits are seismically adequate.

1: Unsupported Conduit 2E23664 (Switchgear Room 2G)

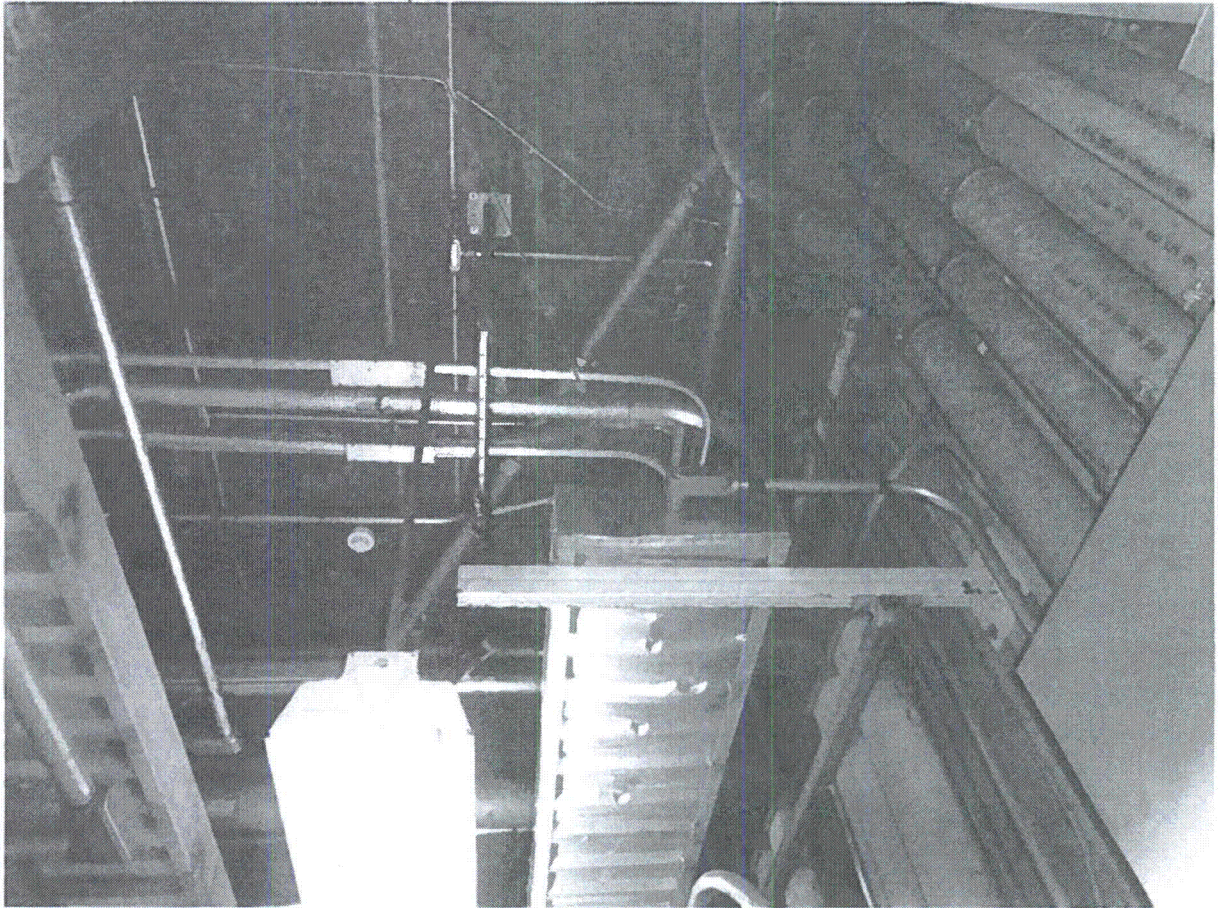
2: Unsupported Conduit 2E23472 (Switchgear Room 2G)

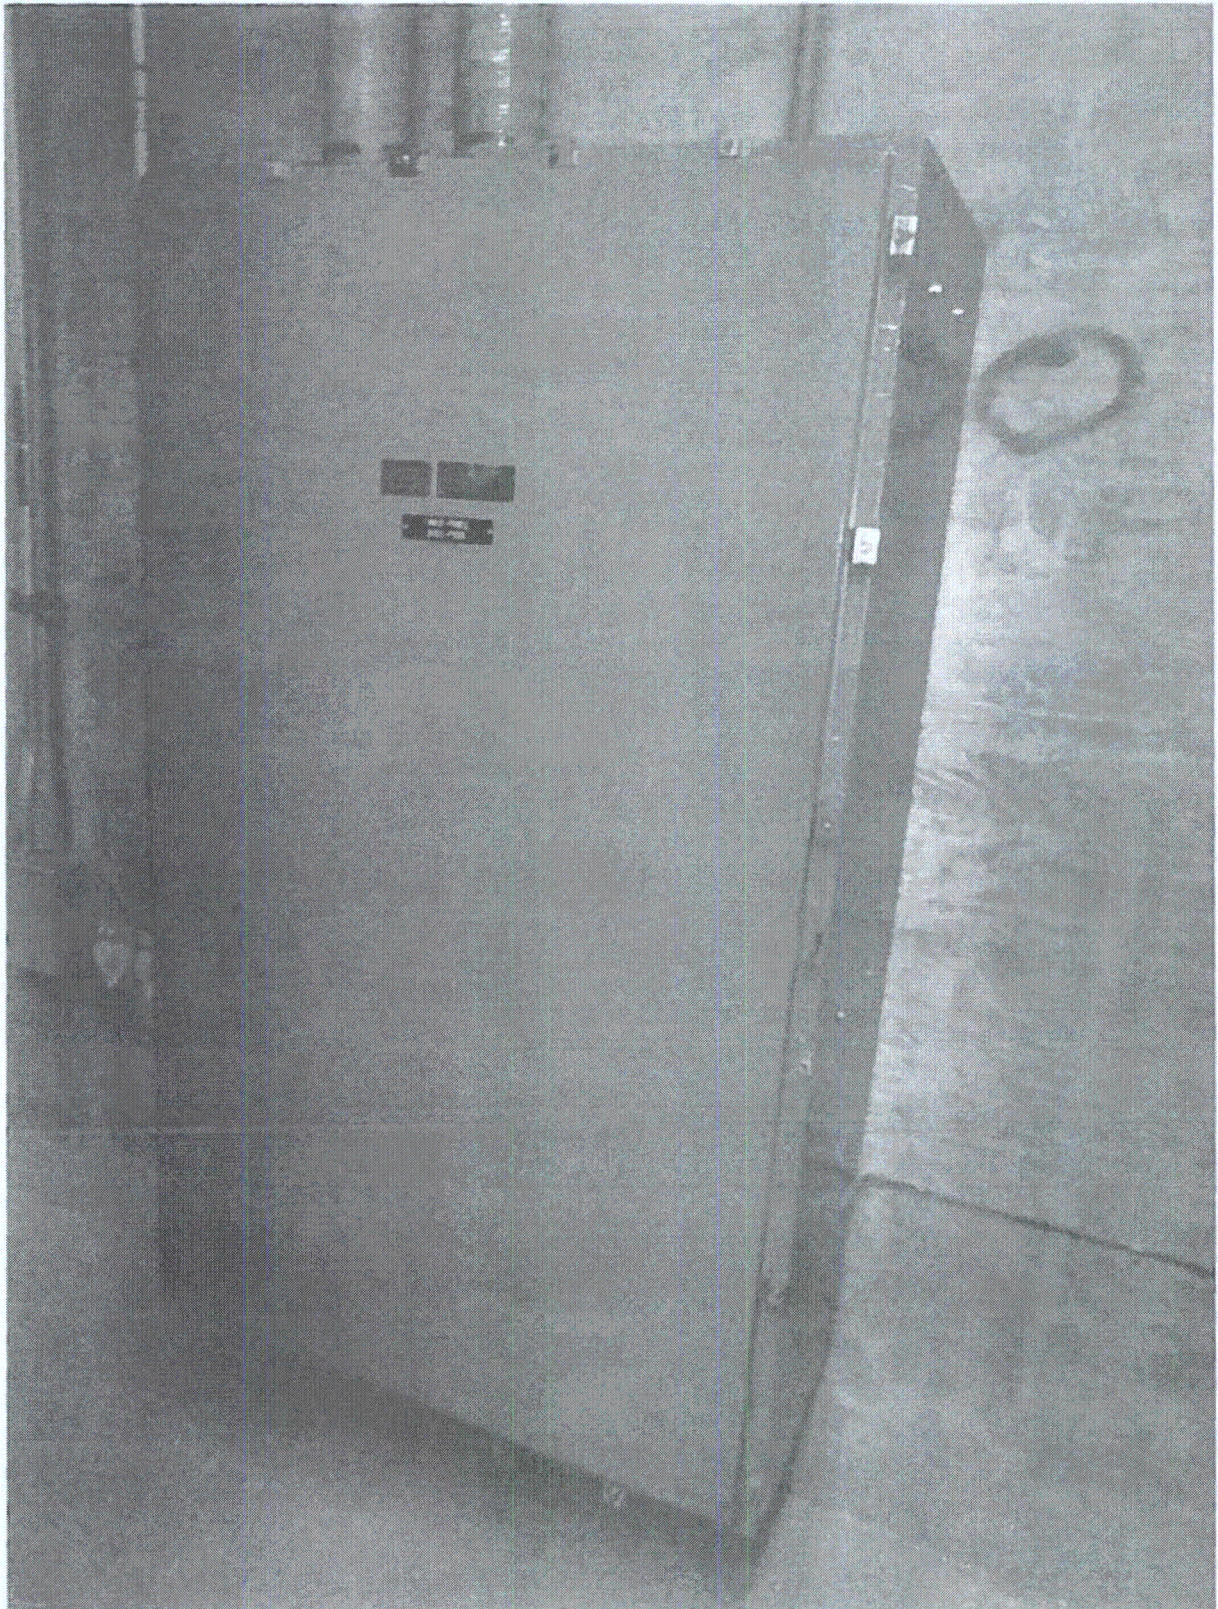
Timer panel 2H21-P305 had 5 missing slip connectors to keep the door of the cabinet closed. DOEJ-HX-35281-C001 "Evaluate Capacity of 4 Screws to Hold Door in Place" addressed this condition and it has been determined to be adequate in a seismic event. CR # 516713 has been written to resolve this issue.

3: Timer Panel 2H21-P305 Missing Connectors (Switchgear Room 2G)

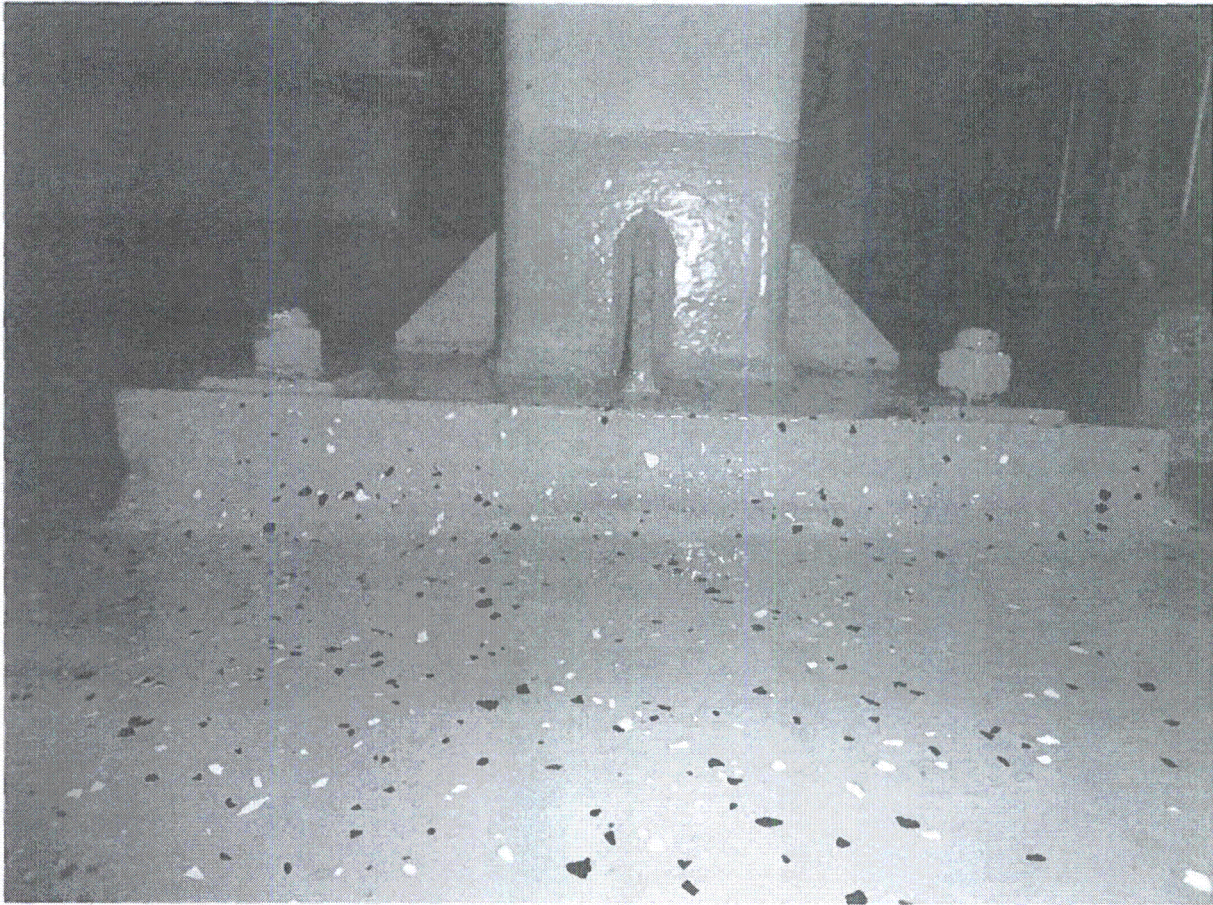
1: Nuts Not Fully Tightened for Conduit Column Support (2R103)

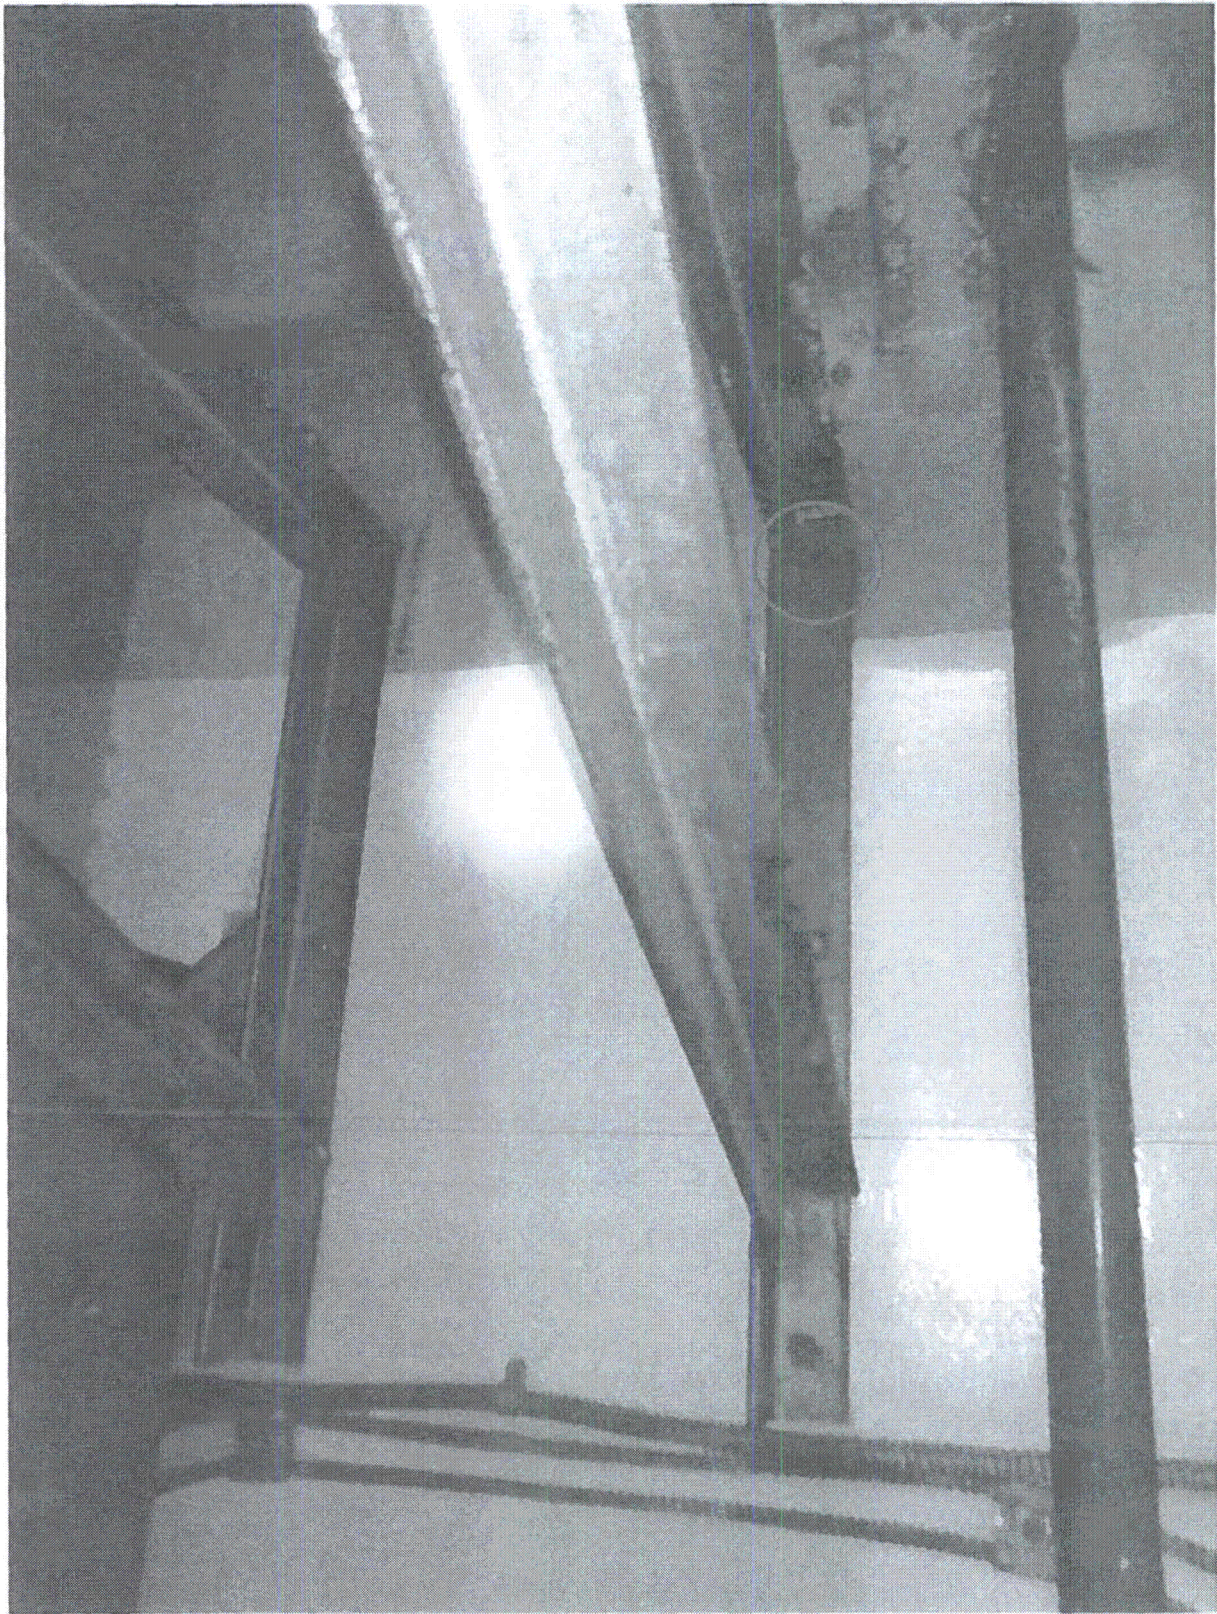
- There is a cantilevered frame supporting a circular duct on the west wall missing an anchor bolt (see photograph 2). The adjacent support has all three anchors though the top and bottom anchors are missing washers. The two anchors present allow for the tension/compression action to occur in the event of movement during a seismic event. The duct weight isn't significant over the span observed to be supported and the support is judged to be seismically adequate. CR 519729 has been written to install the missing anchor and washers.*

2: Missing Anchor for Cantilever Support Off West Wall (2R103)

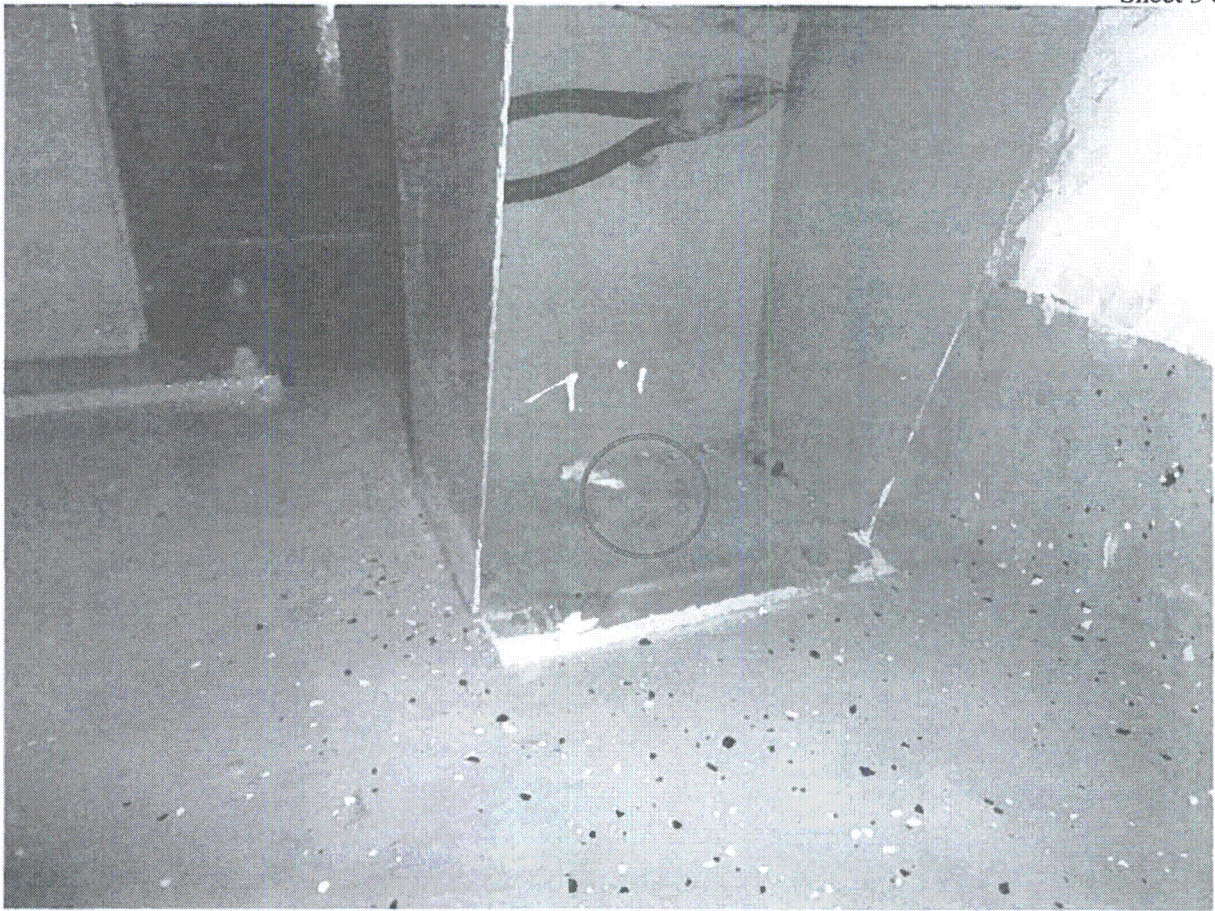
- There is a missing anchor on the south support for 2H21-P008 along the west wall (see photograph 3). It is judged to be seismically adequate as the two anchors provide enough strength to resist overturning of the equipment during a seismic event. CR 519996 has been written to reinstall the missing anchor.*

There is a pair of loose pliers underneath 2H21-P008 along the west wall (see photograph 3). This is not a seismic concern. CR 519996 has been written to remove the pliers.

3: Missing Anchor for 2H21-P008 and Pliers Not Stored Properly (2R103)

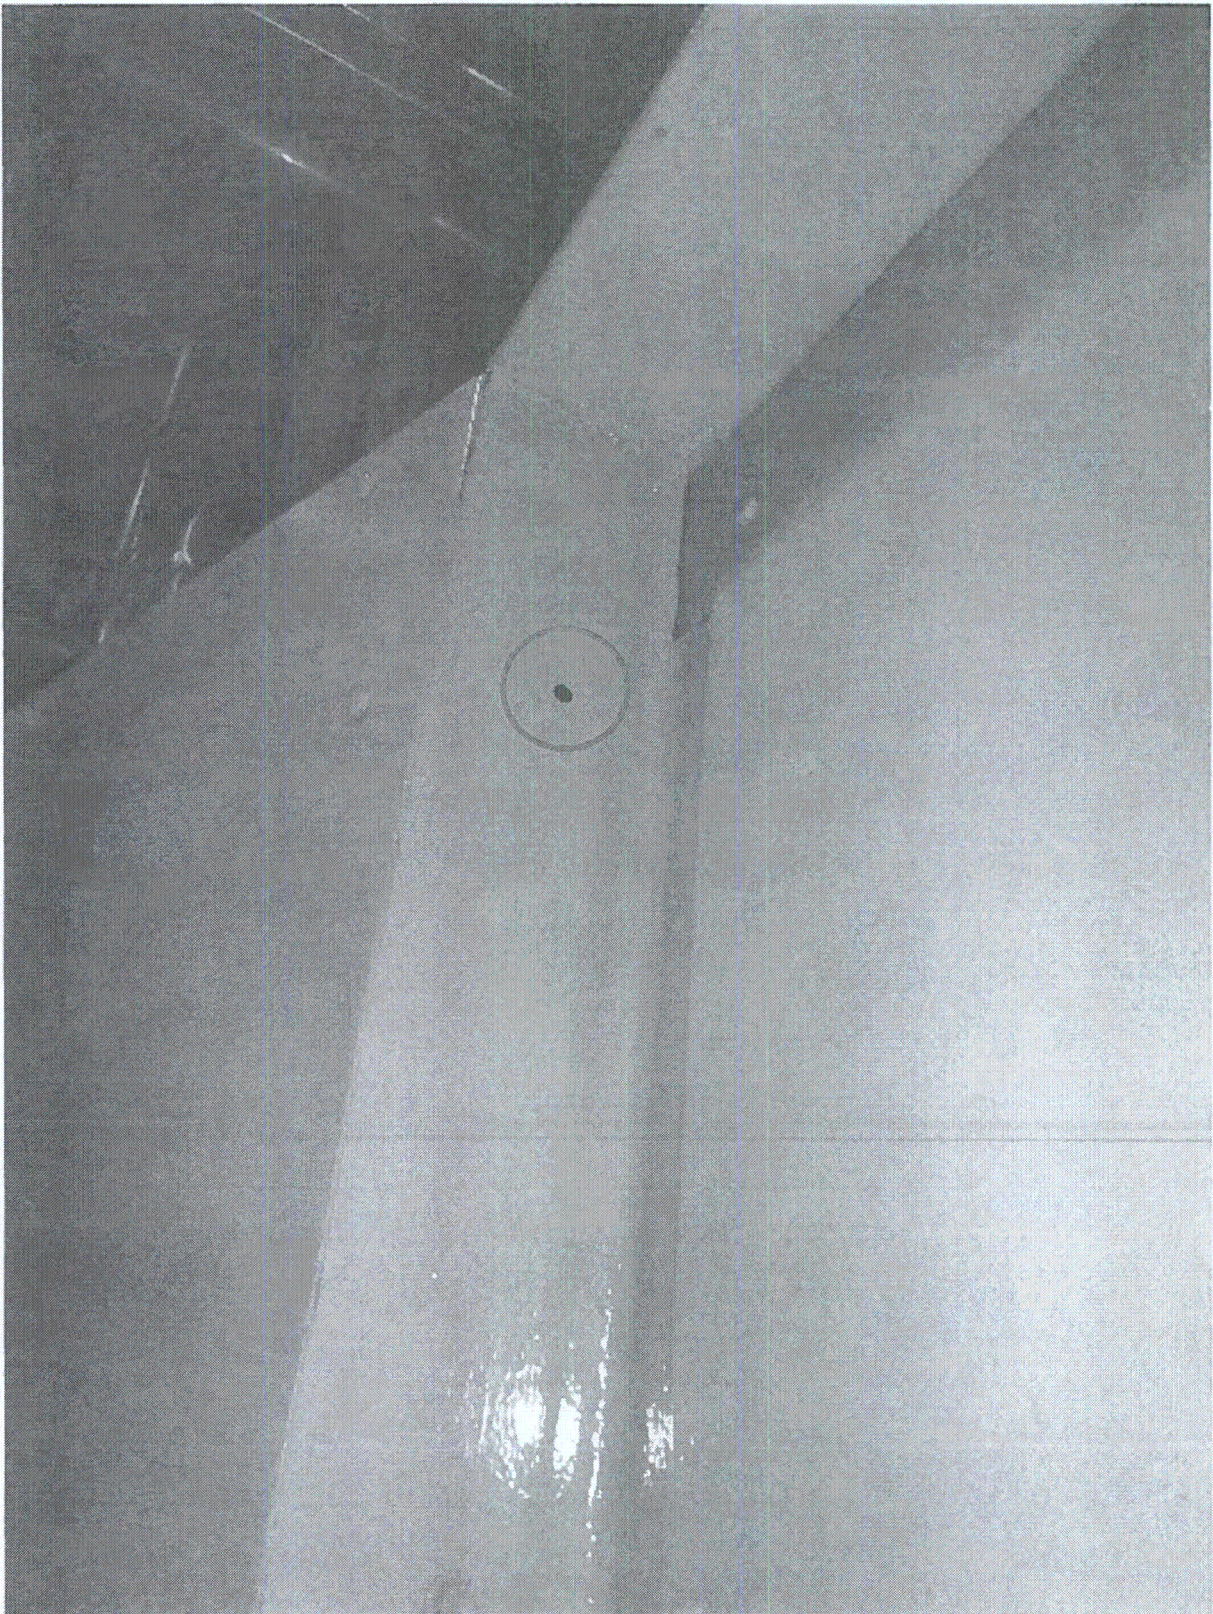
There is a missing bolt on the east side of the large enclosure that houses both 2H21-P173 and 2C82-P001 (see photograph 4). There are enough bolts present to provide enough strength to keep the enclosure together during a seismic event. It is judged to be seismically adequate.

4: Missing Bolt to Enclosure for 2H21-P173 and 2C82-P001 (2R103)

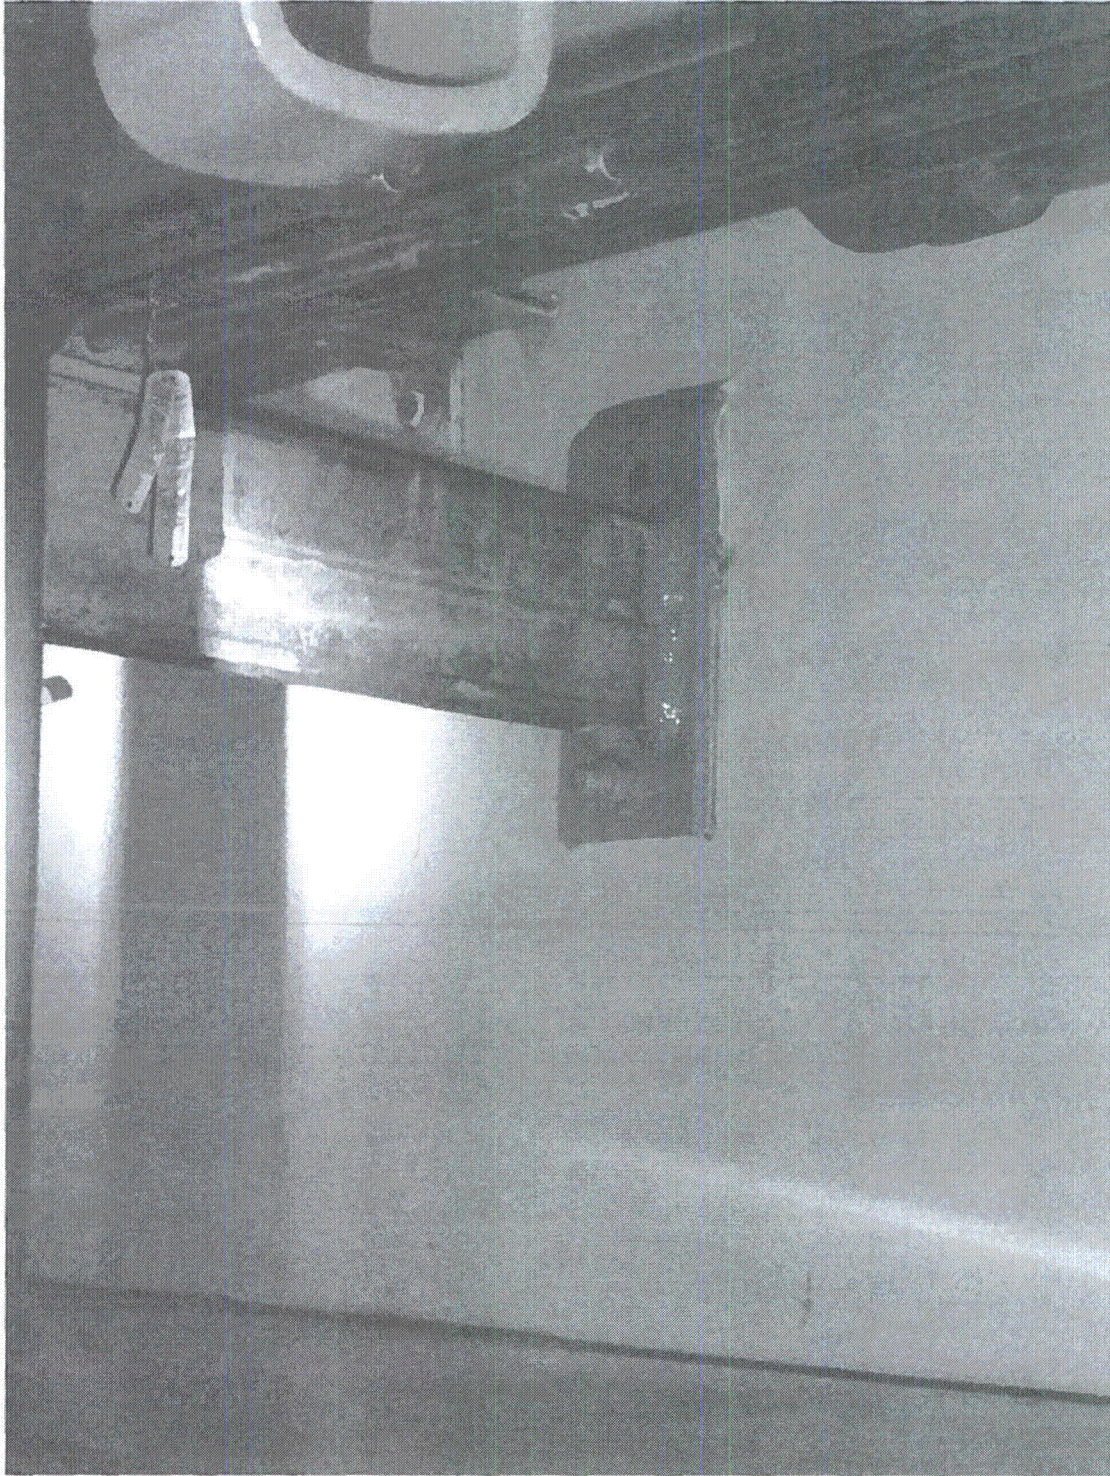
There is one anchor bolt missing from a two-bolt support for the tubing near valve 2E11-F252A. Figure 1 shows a weld along the edge of the base-plate closest to the location of the missing anchor bolt. This weld will carry the load that would be carried by the missing anchor. Therefore, the support is seismically acceptable.

Figure 1 – Tubing Support Missing Bolt (NE Diagonal Unit 2)

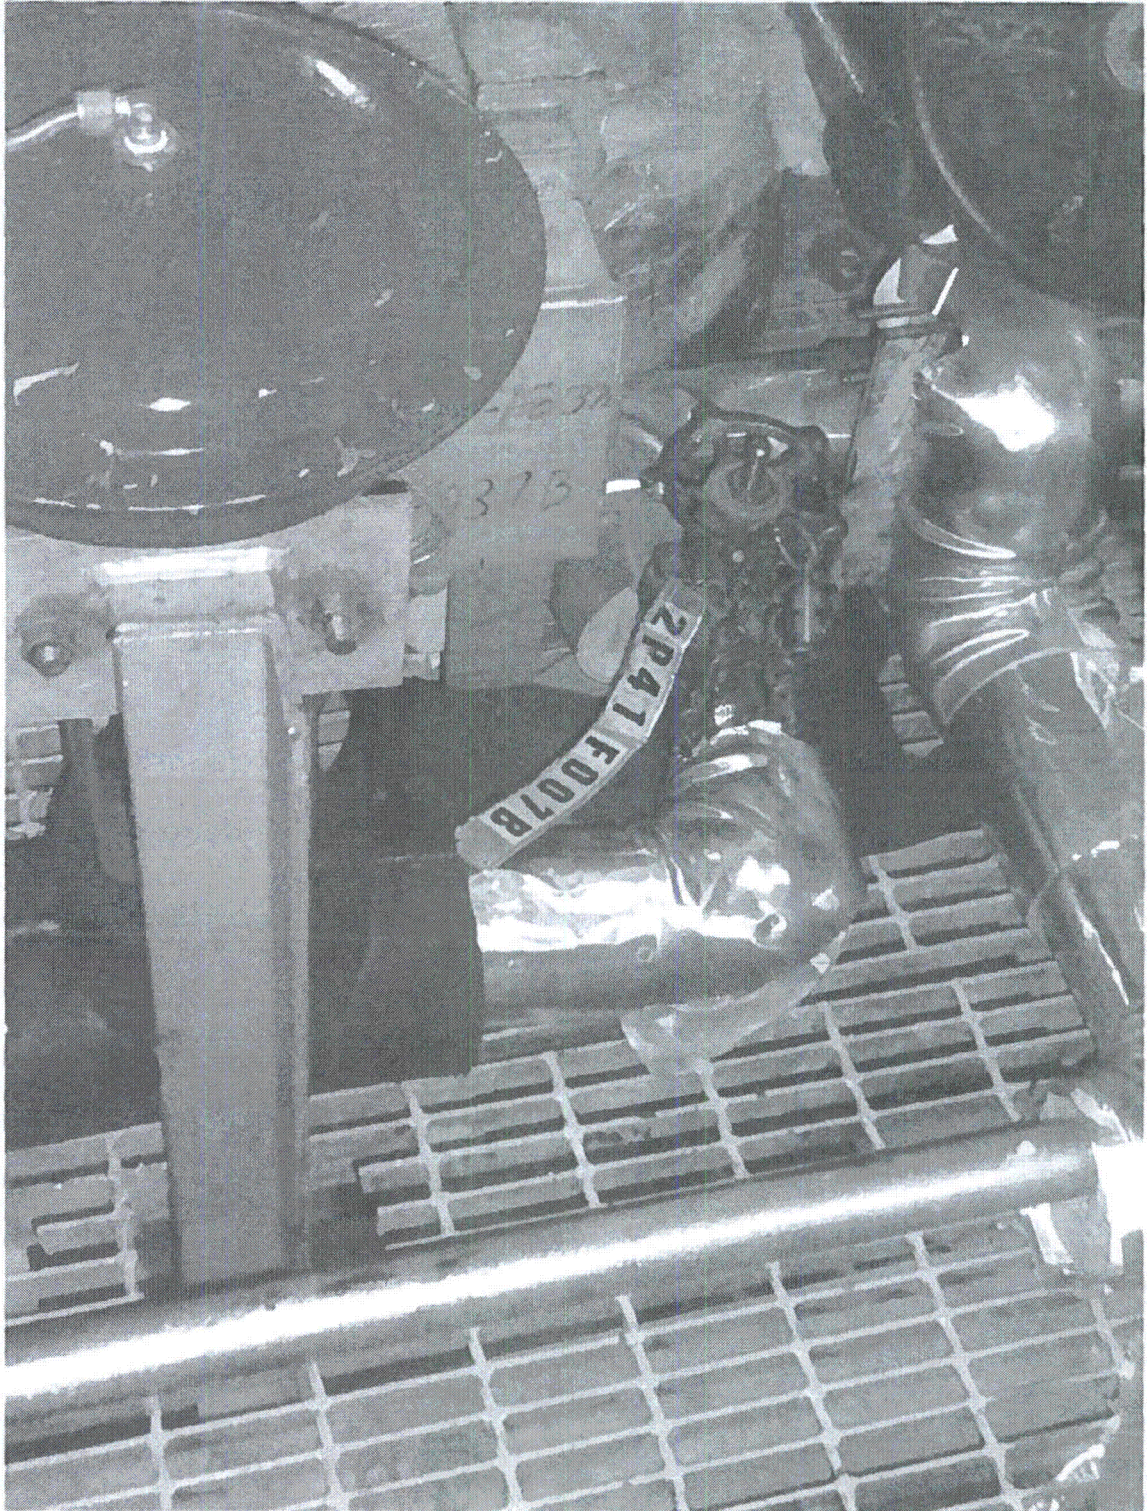
There are two loose items behind the 2E11-B001B Heat Exchanger: a small plastic nozzle and a piece of foam insulation that has become dislodged from around a valve. Both items are small and light, and are not near any sensitive equipment. Therefore, the items are judged to not be a potentially adverse seismic condition.

Figure 1 – Loose Pipe Insulation (SE Diagonal Unit 2)

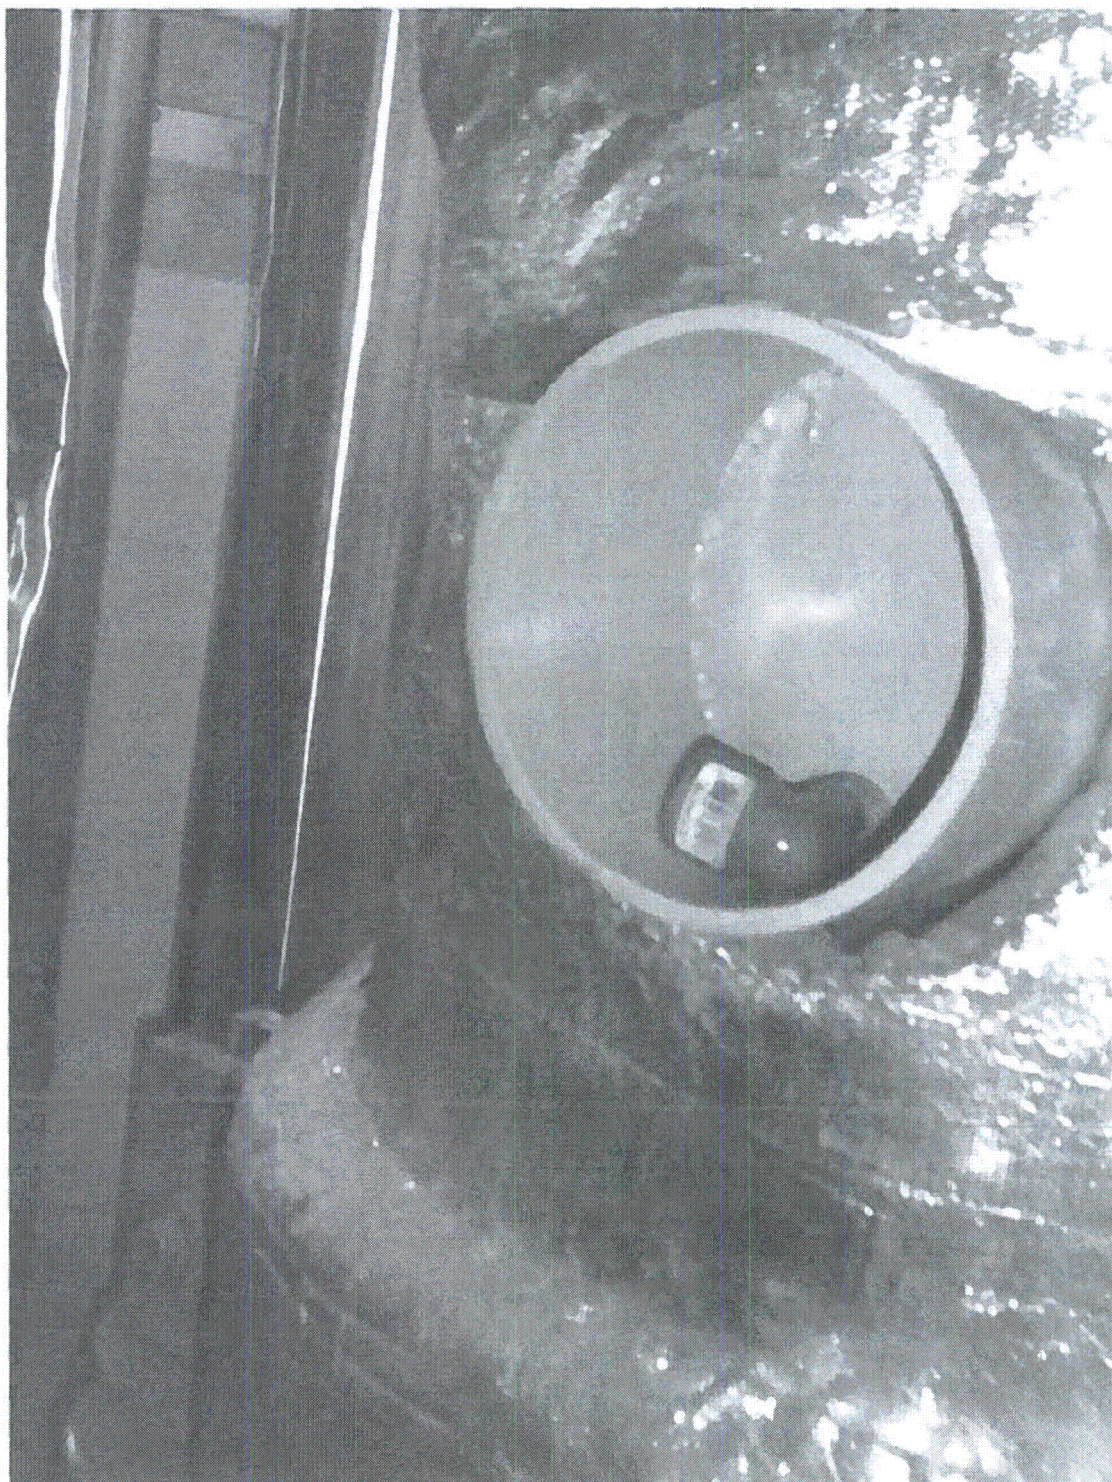
Figure 2 – Loose Plastic Nozzle (SE Diagonal Unit 2)

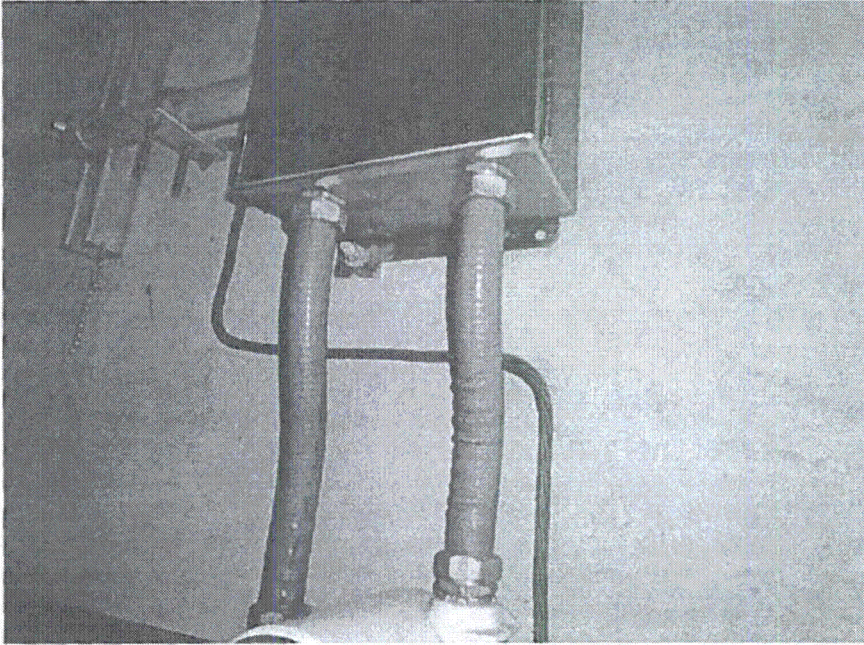
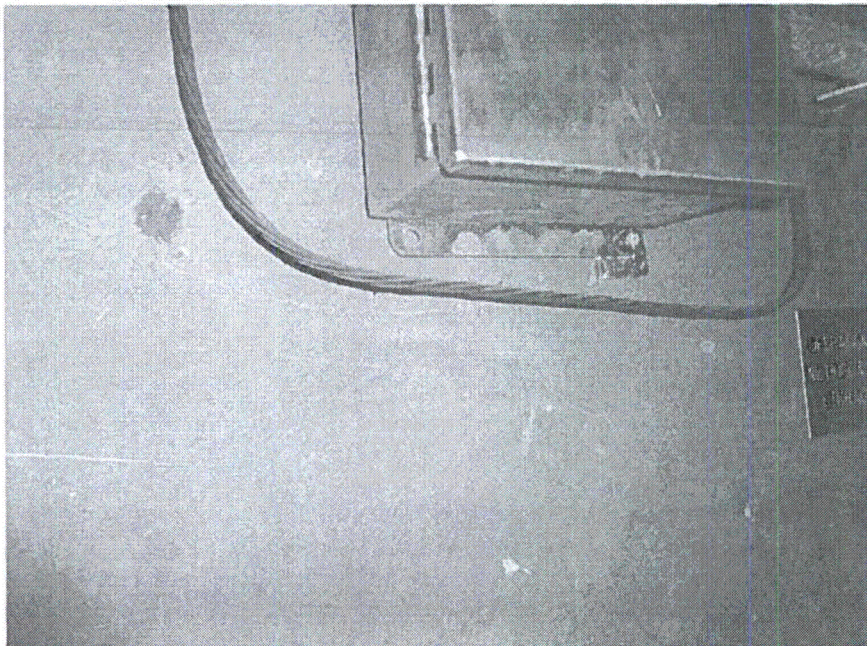
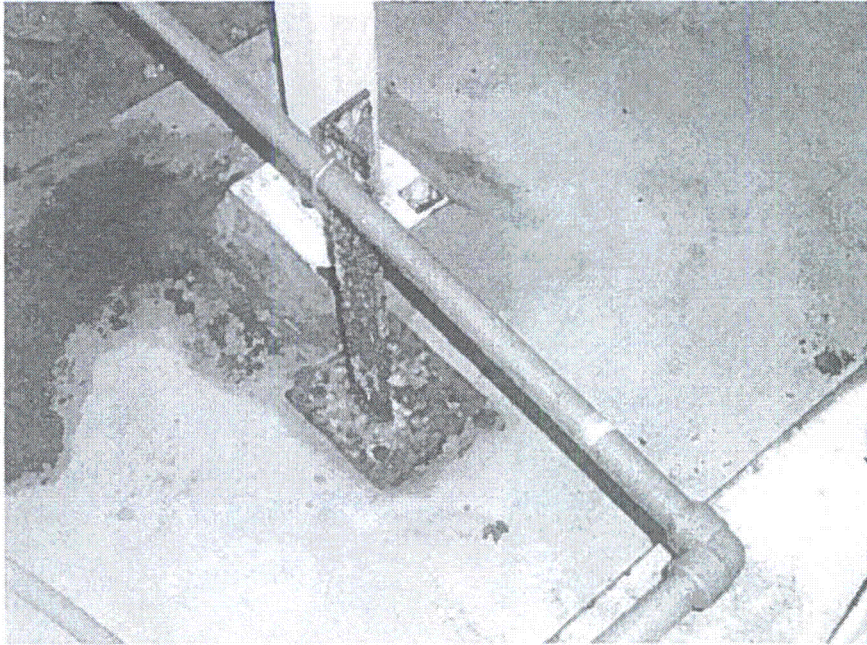
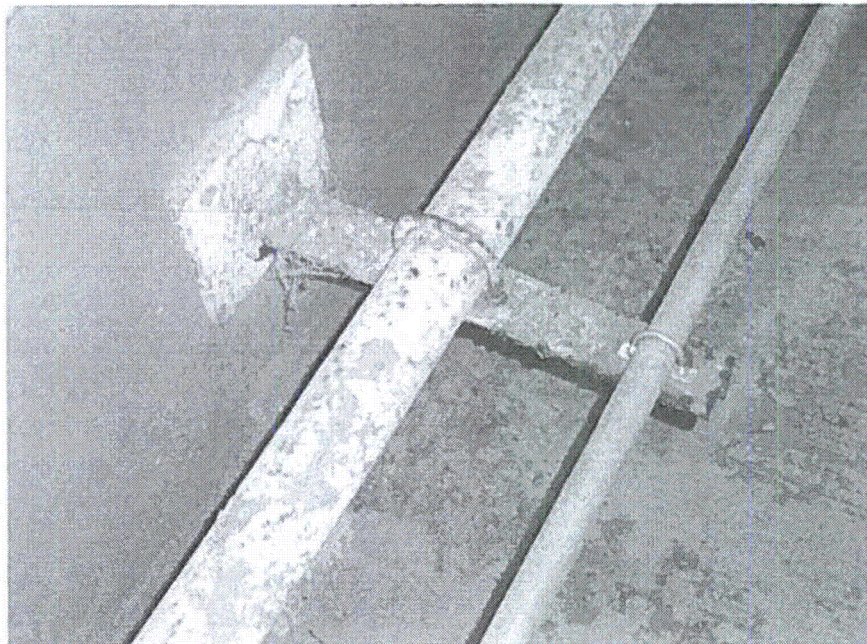
1. Does anchorage of equipment in the area appear to be free of potentially adverse seismic conditions (if visible without necessarily opening cabinets)? Y N U N/A
Oxygen Analyzer on the wall (2T48-R075) has 2 of the 4 bolts missing. Oxygen Analyzer on the wall (2T48-R076) has 1 of the 4 bolts missing. These items are rather light weight and SWEs judged these supports to be seismically adequate, however, CR525168 was initiated to replace these missing bolts.

2. Does anchorage of equipment in the area appear to be free of significant degraded conditions? Y N U N/A
Some surface corrosion on the nearby pipe supports was observed. These were judged to be seismically adequate by SWEs due to very light loads. However, CR525163 was initiated for this purpose to cover the corrosion issue in the area.

Nitrogen tank vaporizer anchored to floor nearby was judged okay by SWEs. Its anchors have mild surface corrosion but this is judged not to be a seismic concern.

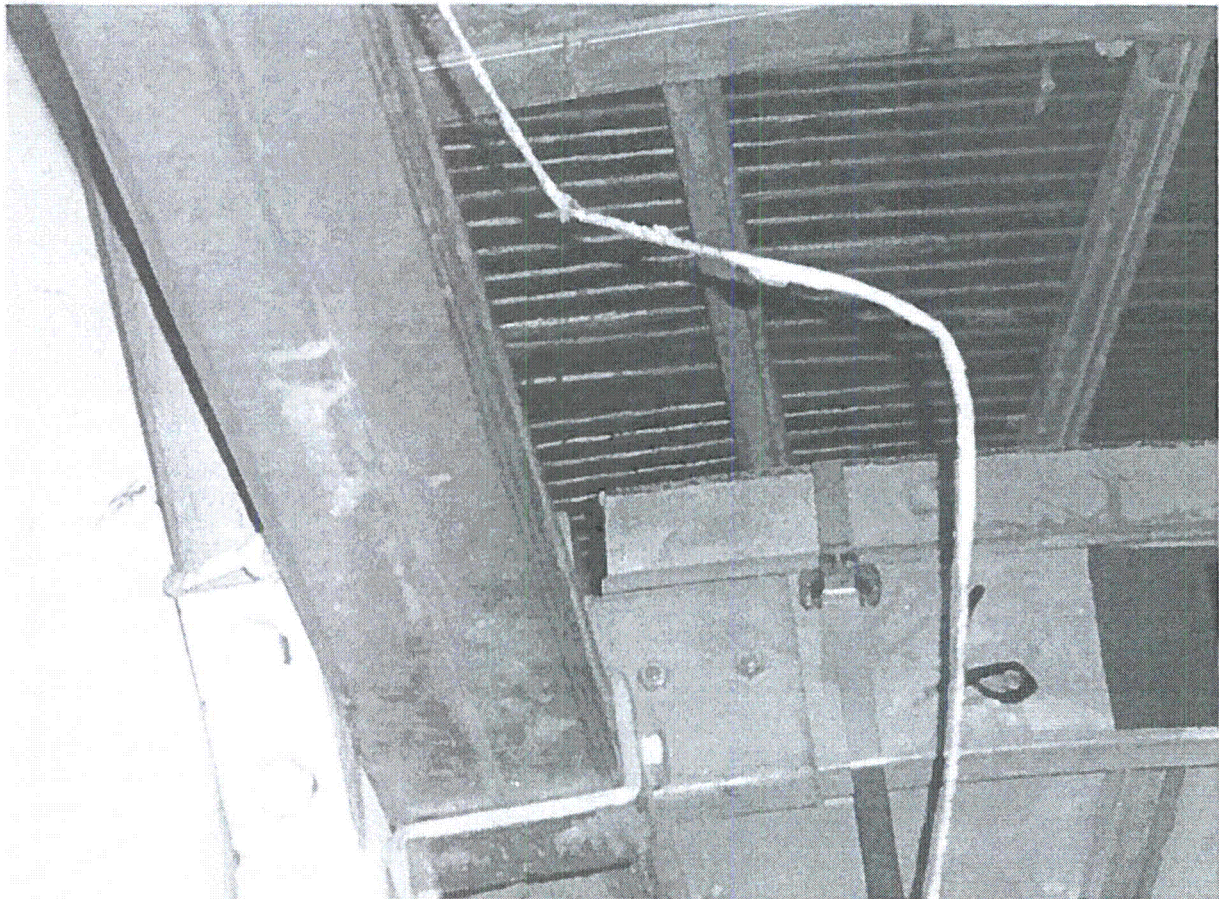
Figure 1 Frayed Wire

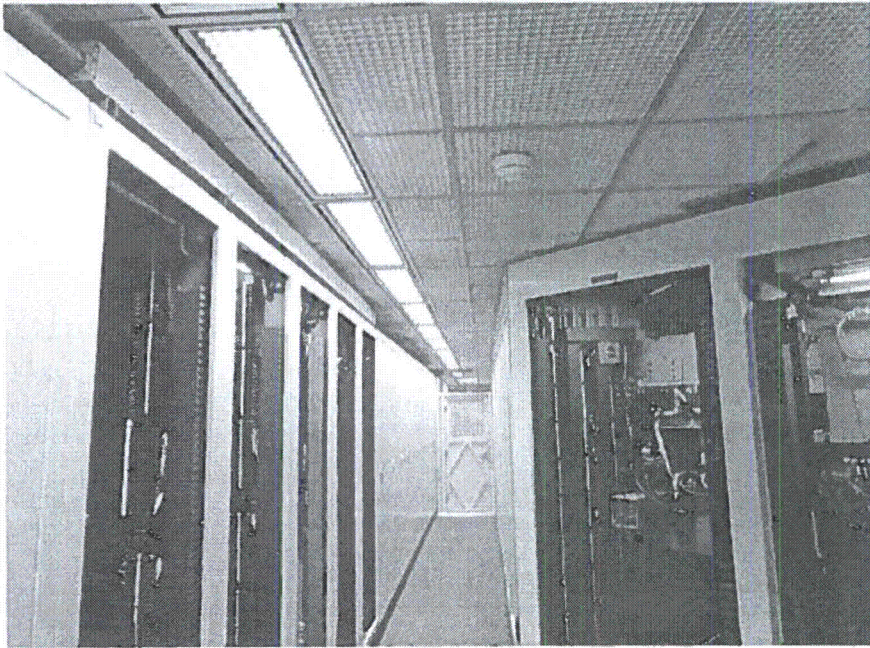
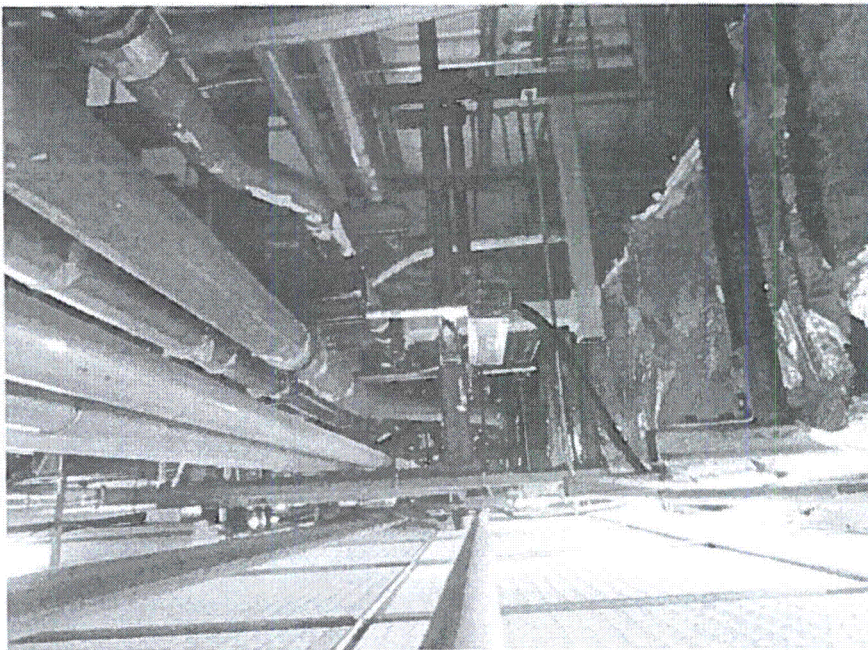
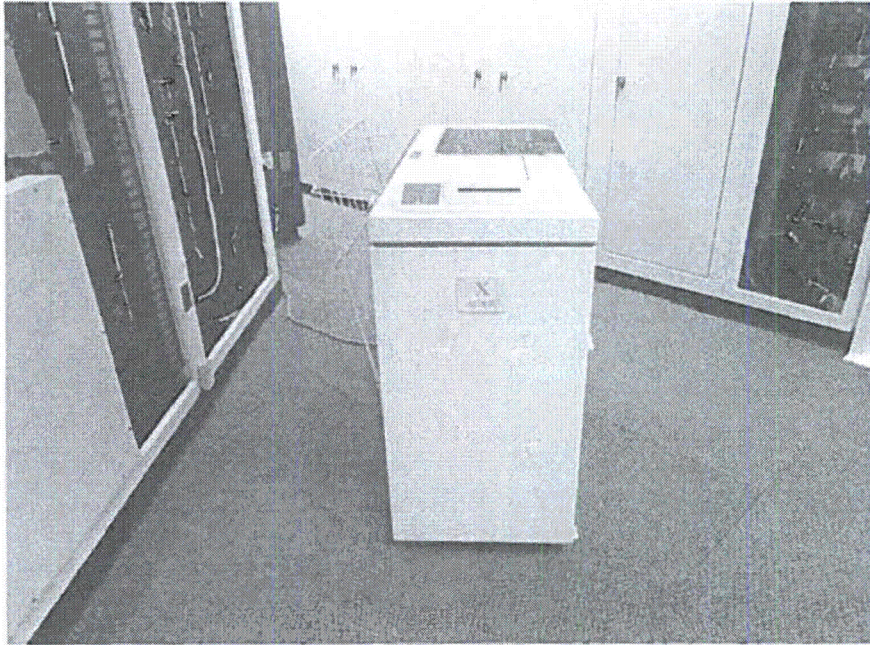
3. Based on a visual inspection from the floor, do the cable/conduit raceways and HVAC ducting appear to be free of potentially adverse seismic conditions (e.g., condition of supports is adequate and fill conditions of cable trays appear to be inside acceptable limits)? Y N U N/A
Ladder was used and permission was obtained to view area above the the hung ceiling. The ceiling was rod hung and tied into rigid structures. HVAC and electrical components in the overhead were properly restrained. See 2-H11-P602 SWC for more details.

4. Does it appear that the area is free of potentially adverse seismic spatial interactions with other equipment in the area (e.g., ceiling tiles and lighting)? Y N U N/A
Unlatched lighting covers were observed at three locations at the rear of the panels. This is not a seismic concern as discussed in the 2-H11-P602 SWC.
