Status: Y N U **Area Walk-By Checklist (AWC)**Location: Bldg. REACTOR Floor El. 87 Room, Area¹ NW Diagonal Elevated Platform**Instructions for Completing Checklist**

ATTACHMENT 5

UNIT 2 - IPEEE VULNERABILITIES INFORMATION

NO. SNCH082-RPT-02

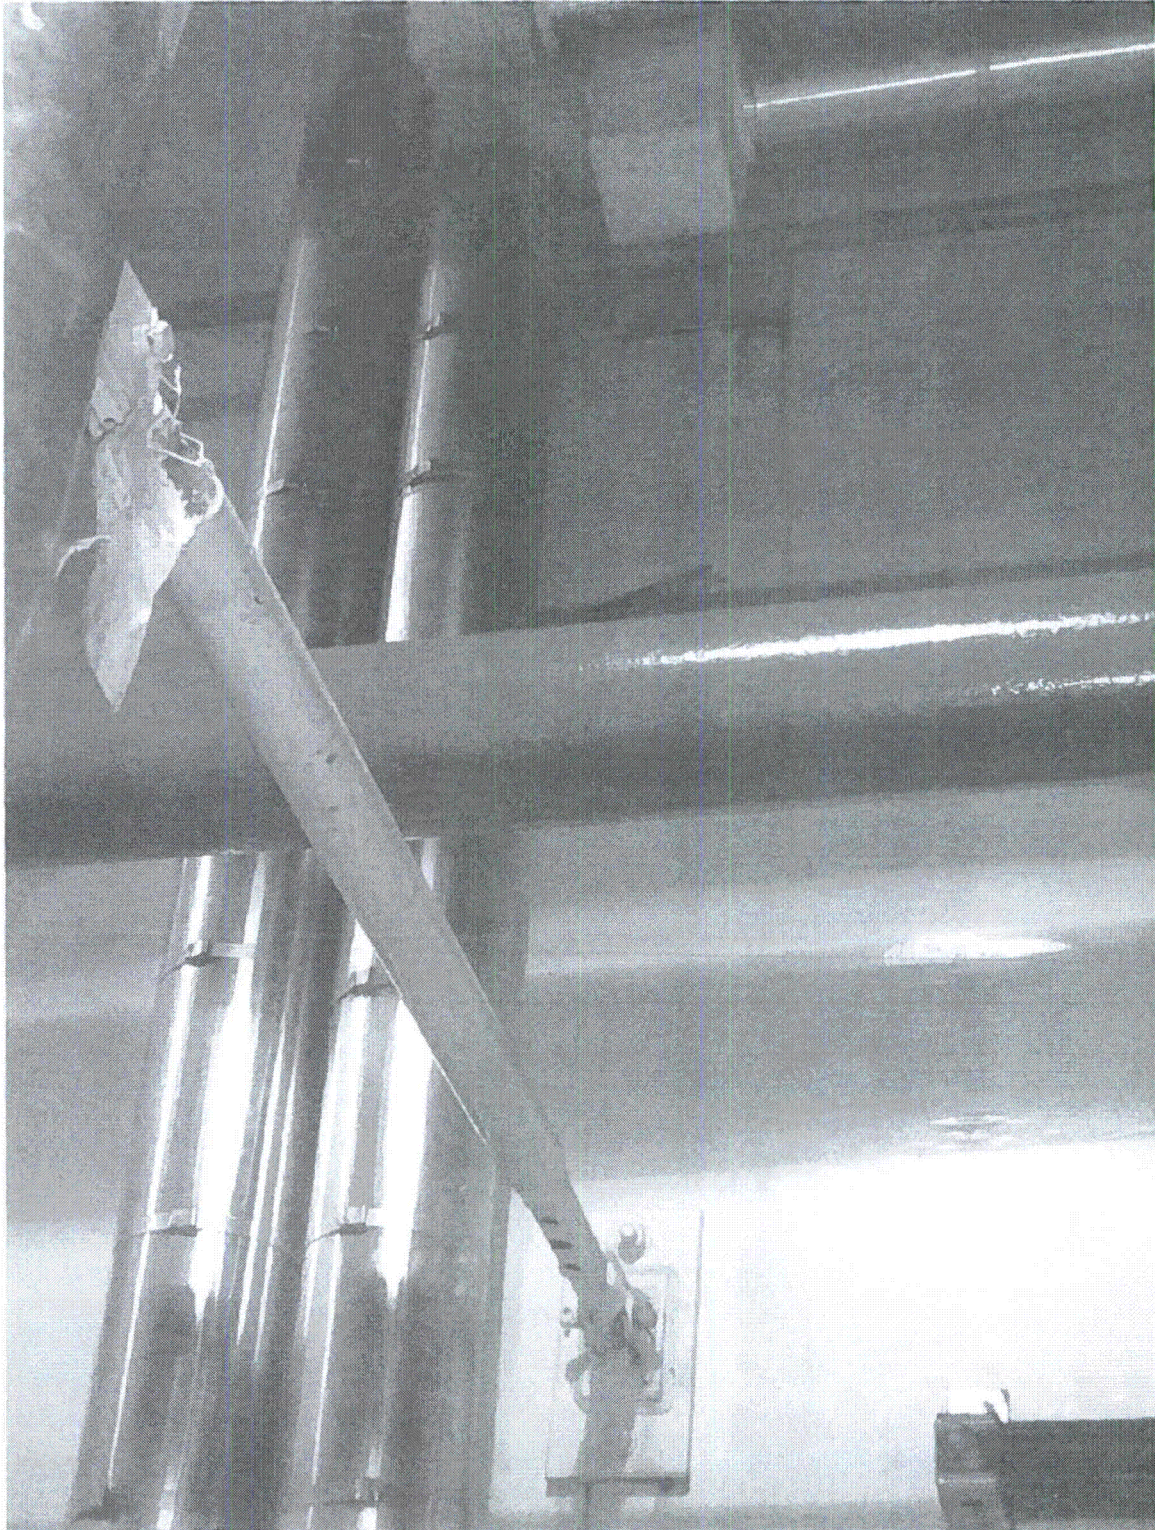
There is evidence of a water leak behind several of the base plates on the wall at R14. There is some mild corrosion of the bolts and base plates due to the leak, but the rust stains on the walls indicate that the corrosion is mild. Since oxidation is only on the surface, the anchors are not degraded. Therefore, the anchors are judged not be a seismic concern.

Figure 1 – Surface Corrosion behind Base Plates (RH-R18 Unit 2)

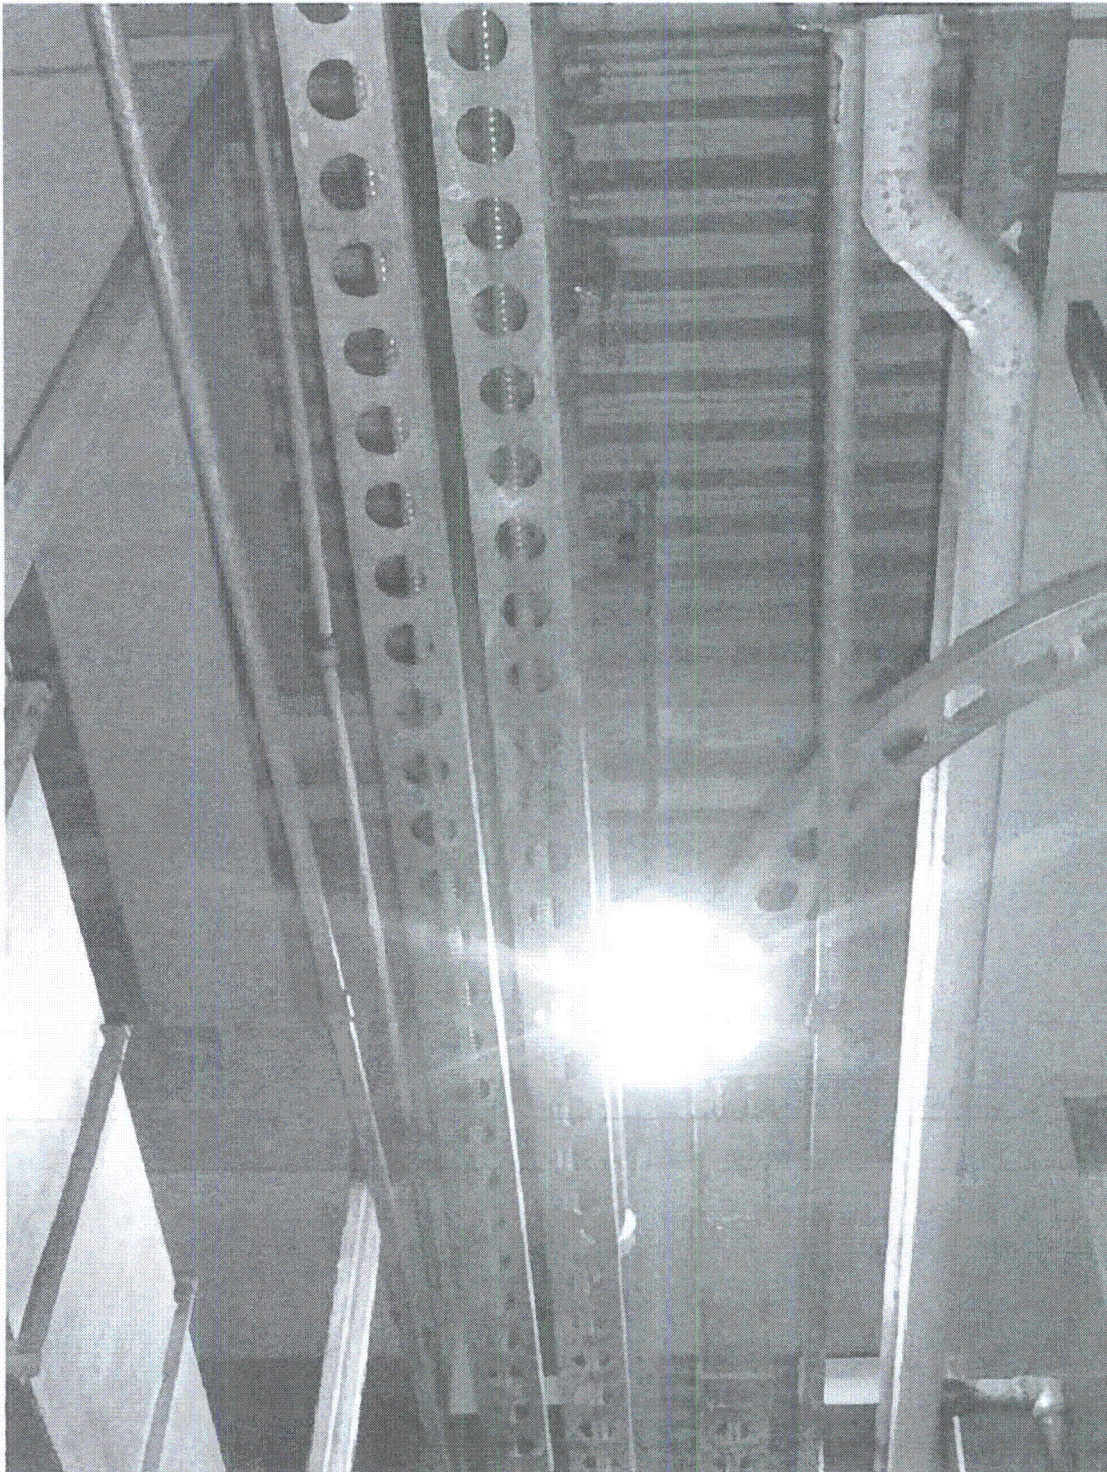
The suspended light above safety-related AOV 2G41-F054 on the 203' elevation of the Unit 2 Reactor Building is hung with an open hook and is not safety-wired to the supporting steel. During a seismic event, it is possible that the light will become dislodged from the hook. The light is powered with a twist lock connection, which will restrain the light in the event of a fall. Therefore, it is judged to not be a potentially adverse seismic condition.

Figure 2 – Suspended Light over Valve (RH-R18 Unit 2)

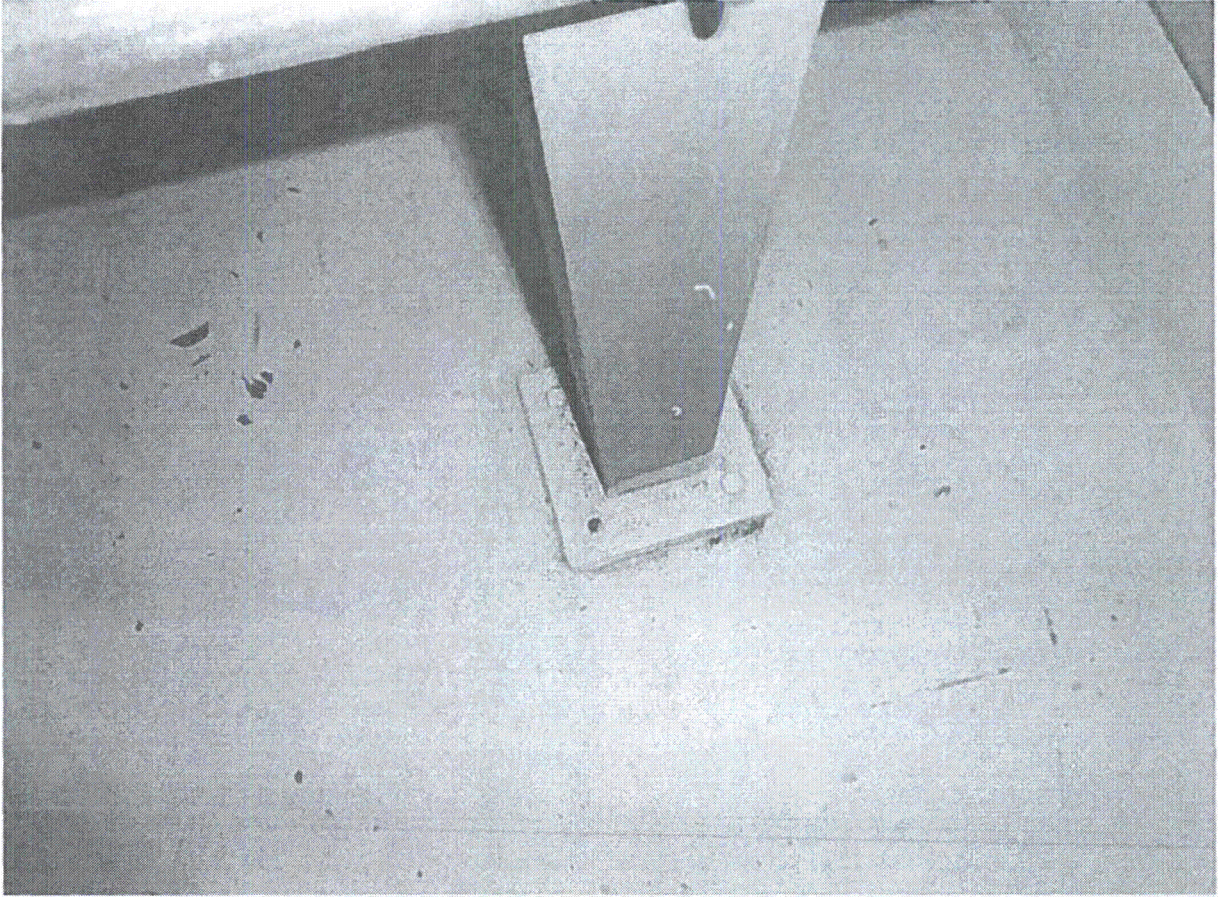
Figure 1 Conduit support in Torus Room Bay 10 with Missing Anchor

Note: Picture was taken looking down at the floor.

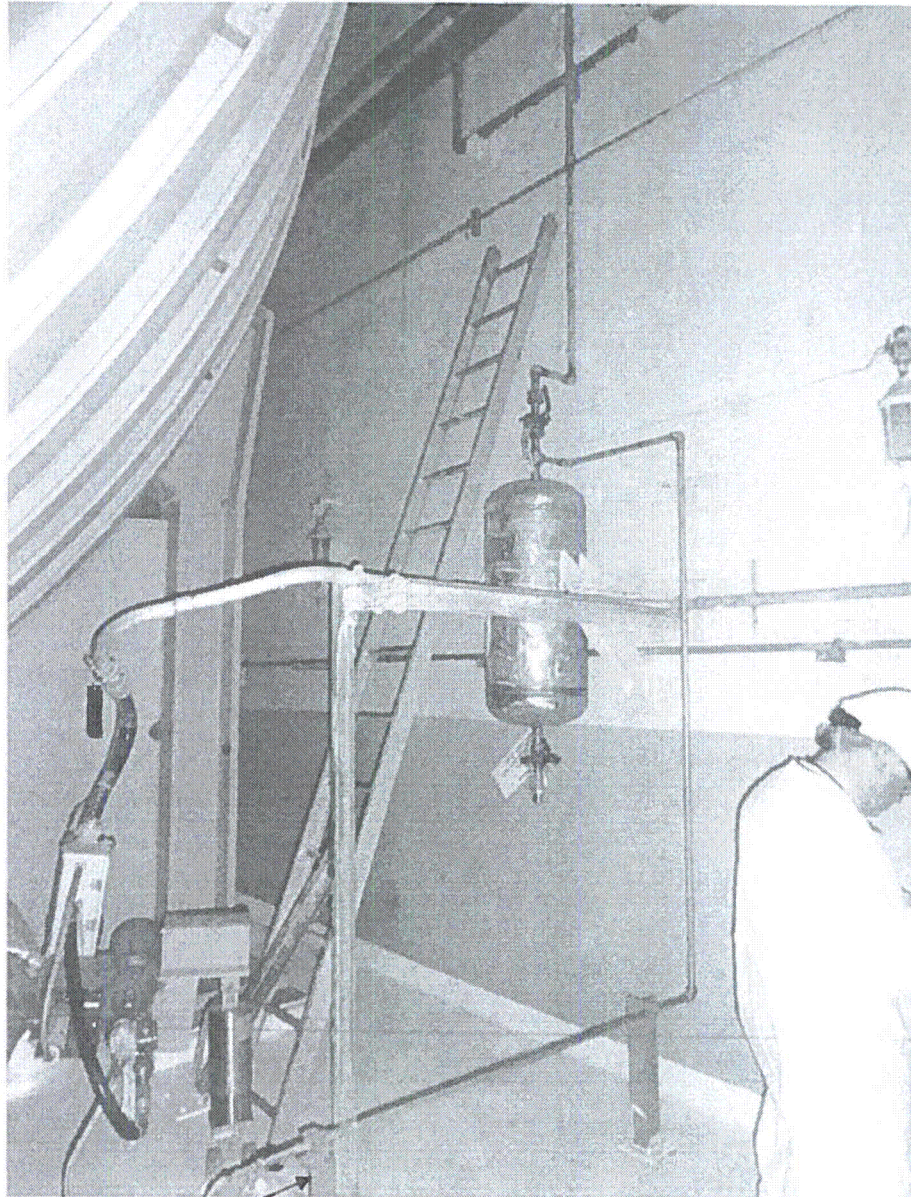
2. Does anchorage of equipment in the area appear to be free of significant degraded conditions? Y N U N/A
There is a four bolt base plate vertical support for a small bore air supply pipe running to 2E51-F003 that is missing one anchor bolt on the 87' elevation in Bay 10 of the Torus Room. This support is approximately 2 feet off the floor and it supports the end of the rigid pipe. The remaining portion of this system is flex hose to 2E51-F003 (See Figure 2). There is a similar support a short distance away that is intact. The pipe is well supported on the wall by its attachment to 2P52-A001. The support does not carry a large load and at this elevation would not see a significant seismic acceleration. Therefore, the SWE's have determined that the base-plate configuration is seismically acceptable. This bolt does not need to be installed.

Figure 2 Showing Air Line to 2E51-F003 and supports

Support with missing anchor bolt
shown in Figure 1

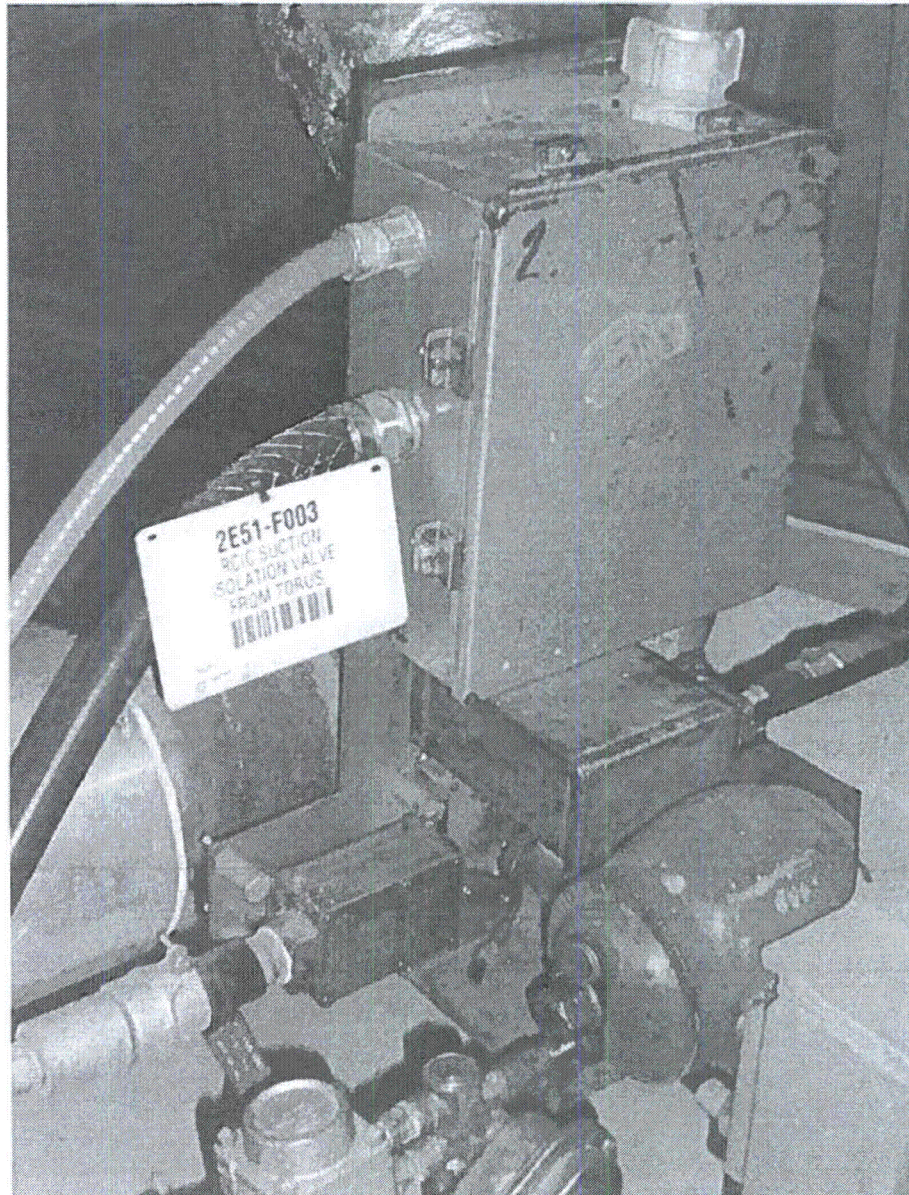
Figure 3 2E51-F003 Component that Conduit is connected
