Status: Y N U **Area Walk-By Checklist (AWC)**Location: Bldg. DIESEL Floor El. 130 Room, Area¹ SWITCHGEAR ROOM 2F**Instructions for Completing Checklist**

Area Walk-By Checklist (AWC)

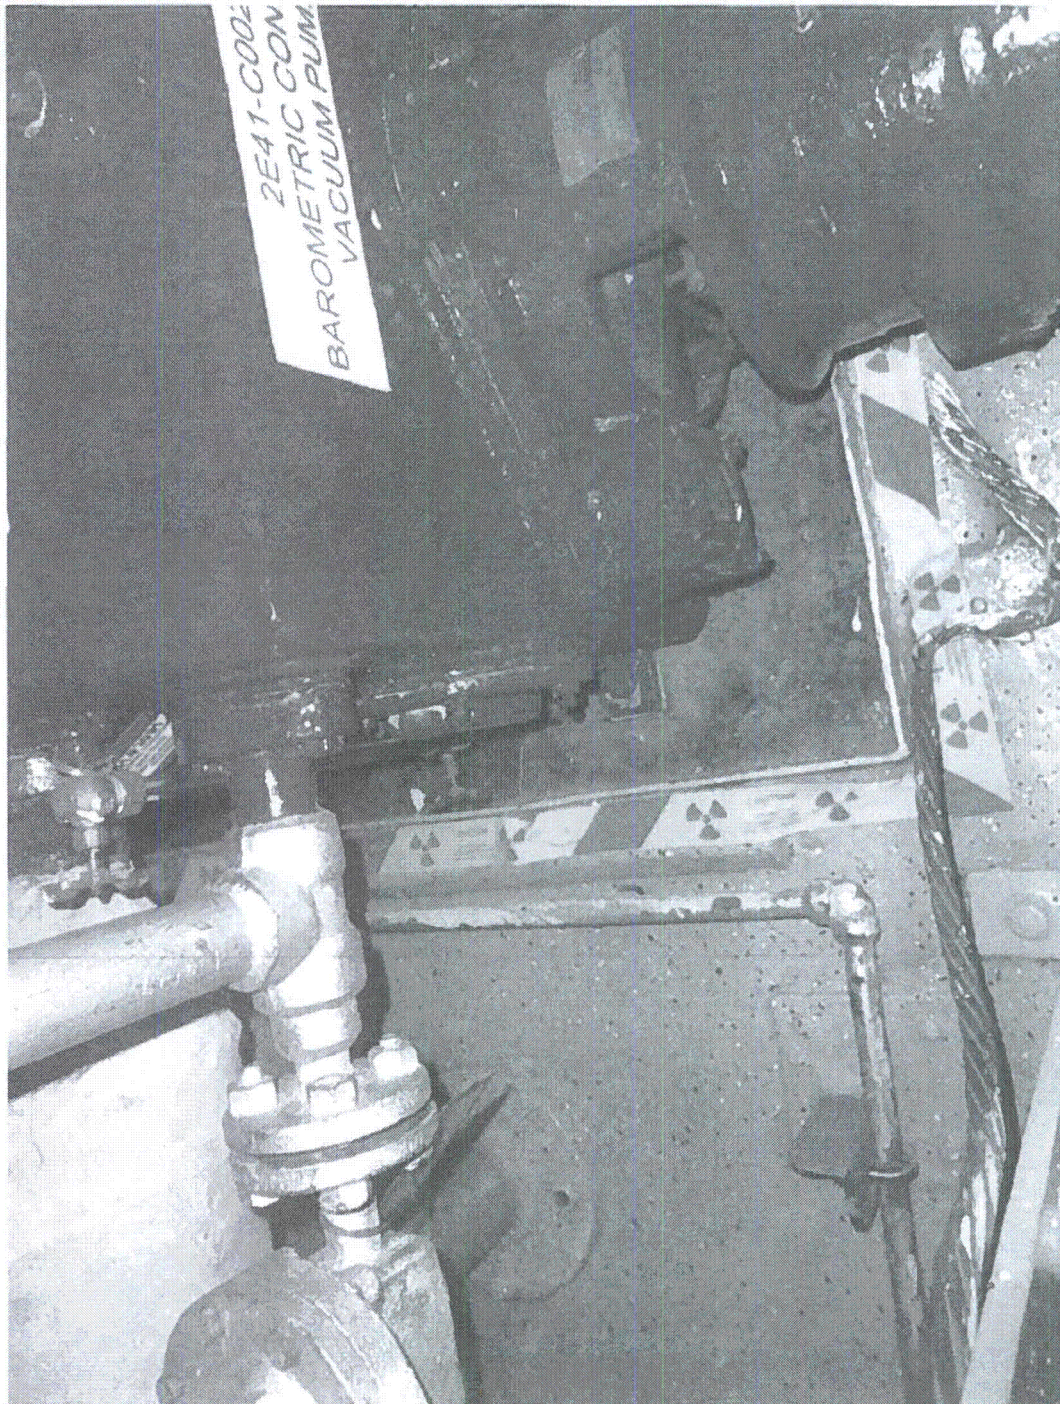
1. Does anchorage of equipment in the area appear to be free of potentially adverse seismic conditions (if visible without necessarily opening cabinets)? Y N U N/A
Mild surface oxidation present on anchors for 2E41-C002-2. Since oxidation is only on the surface, the anchors are not degraded. Therefore, judged to not be a concern.
2. Does anchorage of equipment in the area appear to be free of significant degraded conditions? Y N U N/A
3. Based on a visual inspection from the floor, do the cable/conduit raceways and HVAC ducting appear to be free of potentially adverse seismic conditions (e.g., condition of supports is adequate and fill conditions of cable trays appear to be inside acceptable limits)? Y N U N/A
4. Does it appear that the area is free of potentially adverse seismic spatial interactions with other equipment in the area (e.g., ceiling tiles and lighting)? Y N U N/A

Figure 1 – Surface Oxidation on 2E41-C002-2 Anchors (Unit 2 HPCI Room)

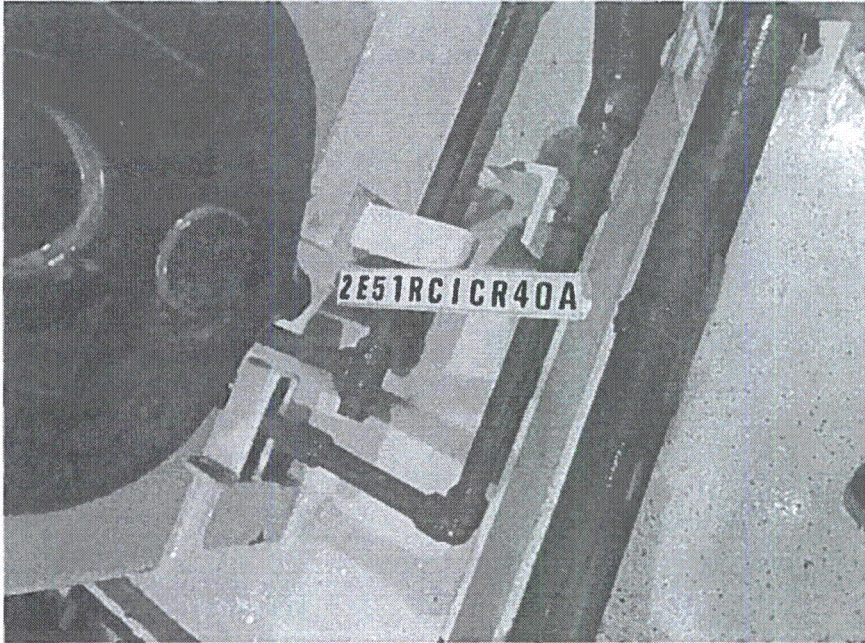
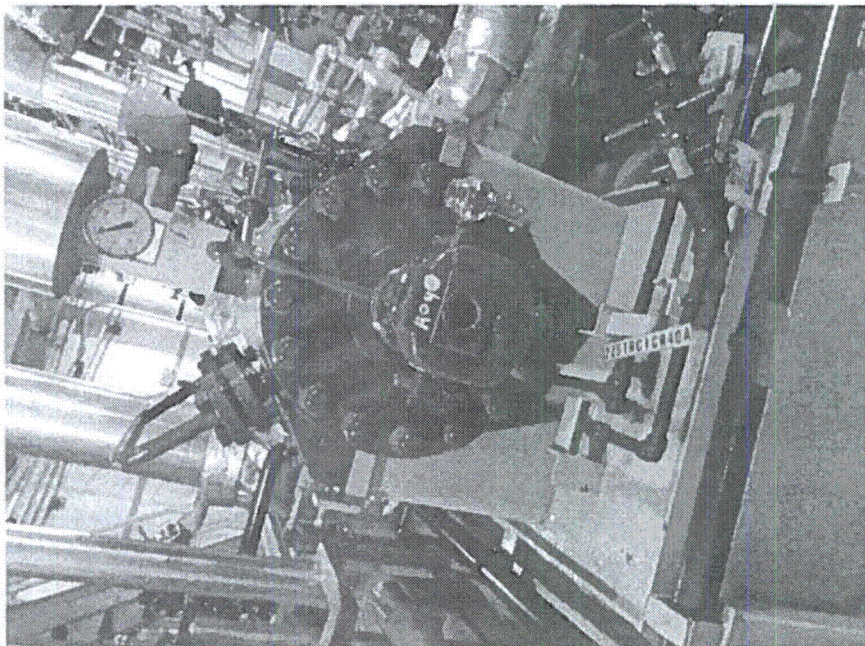
A loose tag was found near the pump. The tag number is 2E51RCICR40A. CR522945 has been initiated for this purpose.

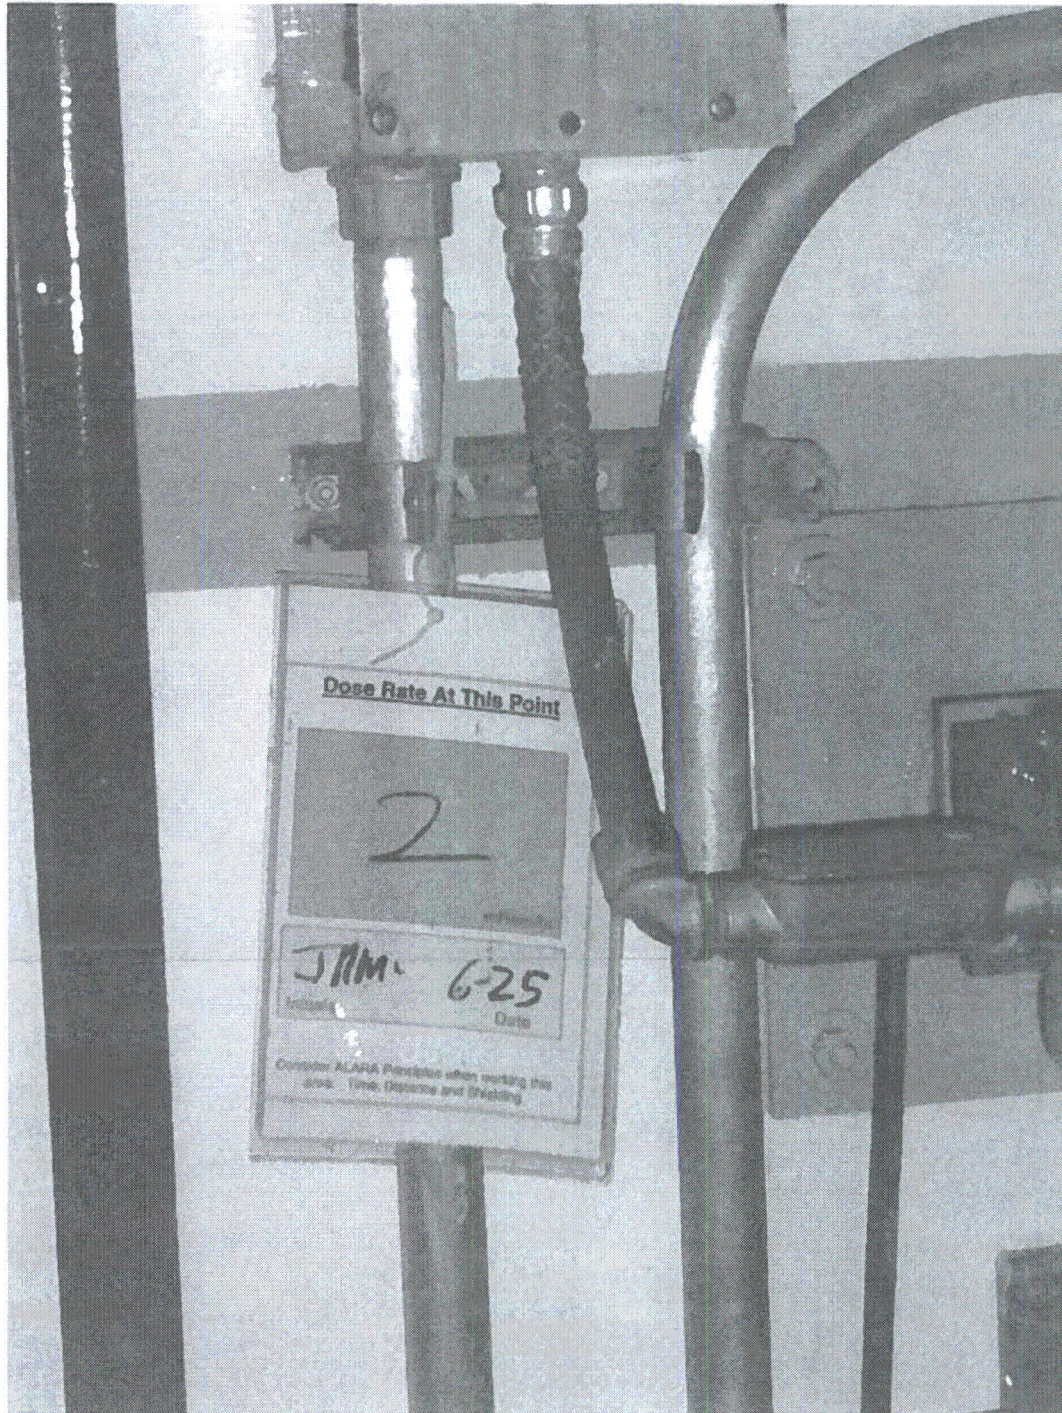
1. Does anchorage of equipment in the area appear to be free of potentially adverse seismic conditions (if visible without necessarily opening cabinets)? Y N U N/A
There is a Unistrut pipe clamp on the west wall missing a bolt. The pipe clamp is spread open, offering no restraint to the supported pipe (CR 515734). There are intact pipe clamps above and below the open clamp, so the unrestrained span of the conduit is small. The existing pipe clamps offer enough support to prevent significant movement during a seismic event.

Figure 1 – Pipe Clamp Missing Bolt (SE Diagonal Unit 2)

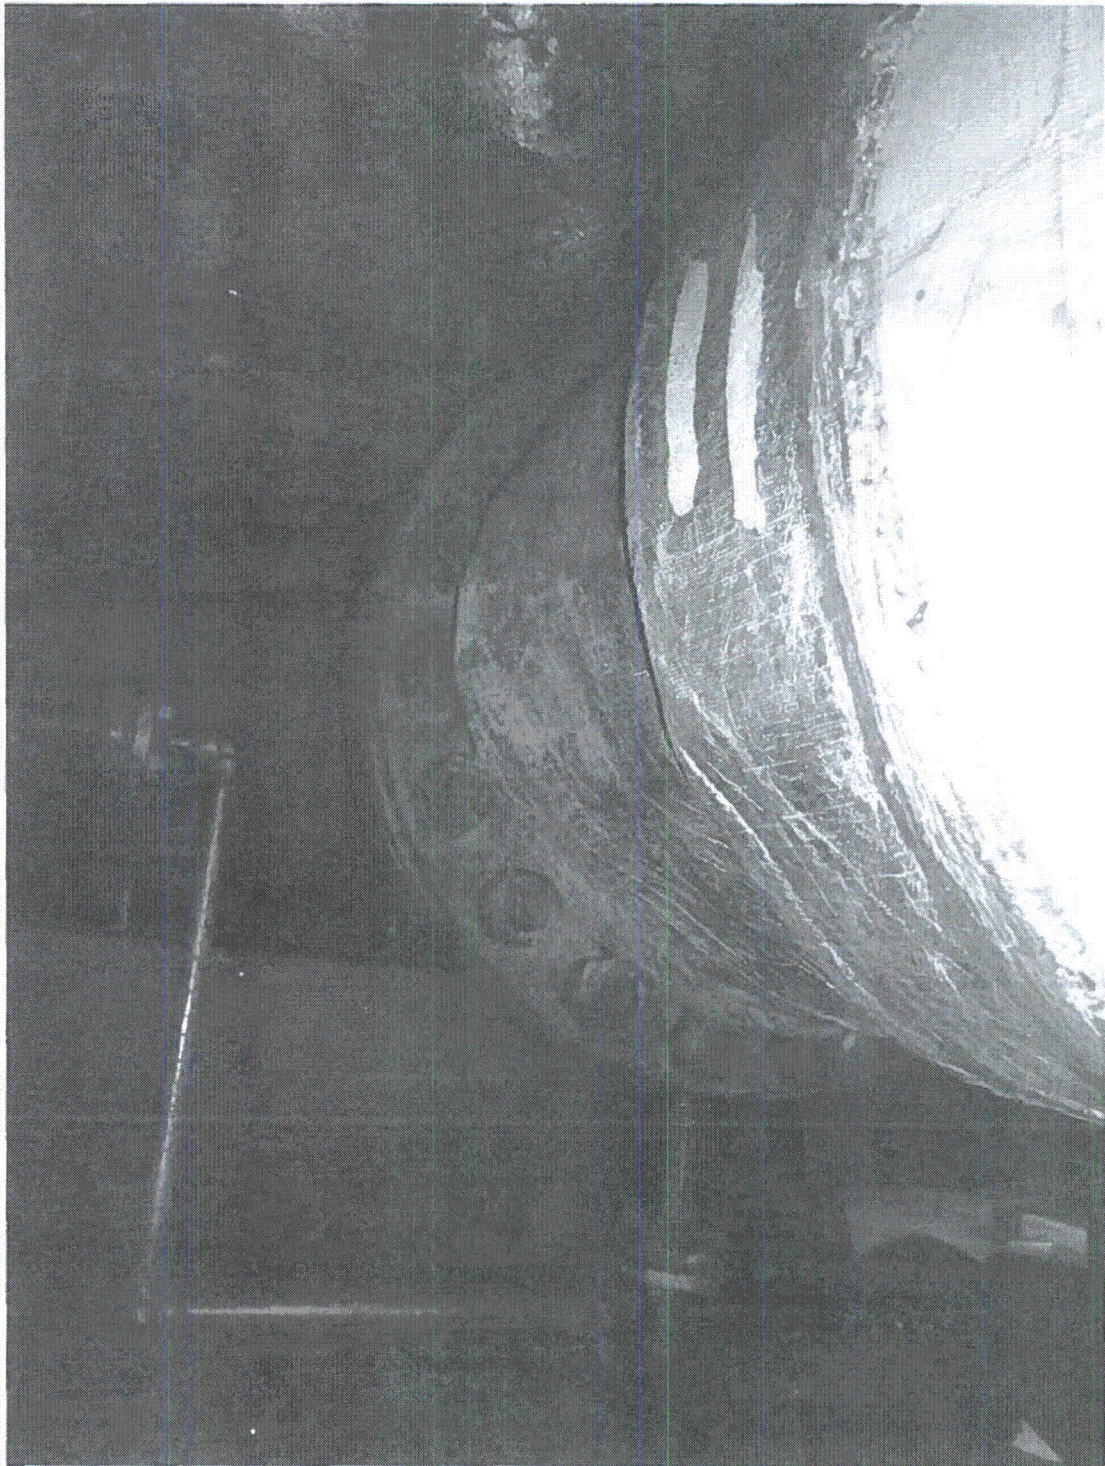
8. Have you looked for and found no other seismic conditions that could adversely affect the safety functions of the equipment in the area? Y N U
There is mild surface oxidation on the flange bolts for RHR Pump 2E11-C002D. Since oxidation is only on the surface, the bolts are not degraded. Therefore, judged to not be a concern.

Figure 2 – RHR Pump Bolt Oxidation (SE Diagonal Unit 2)

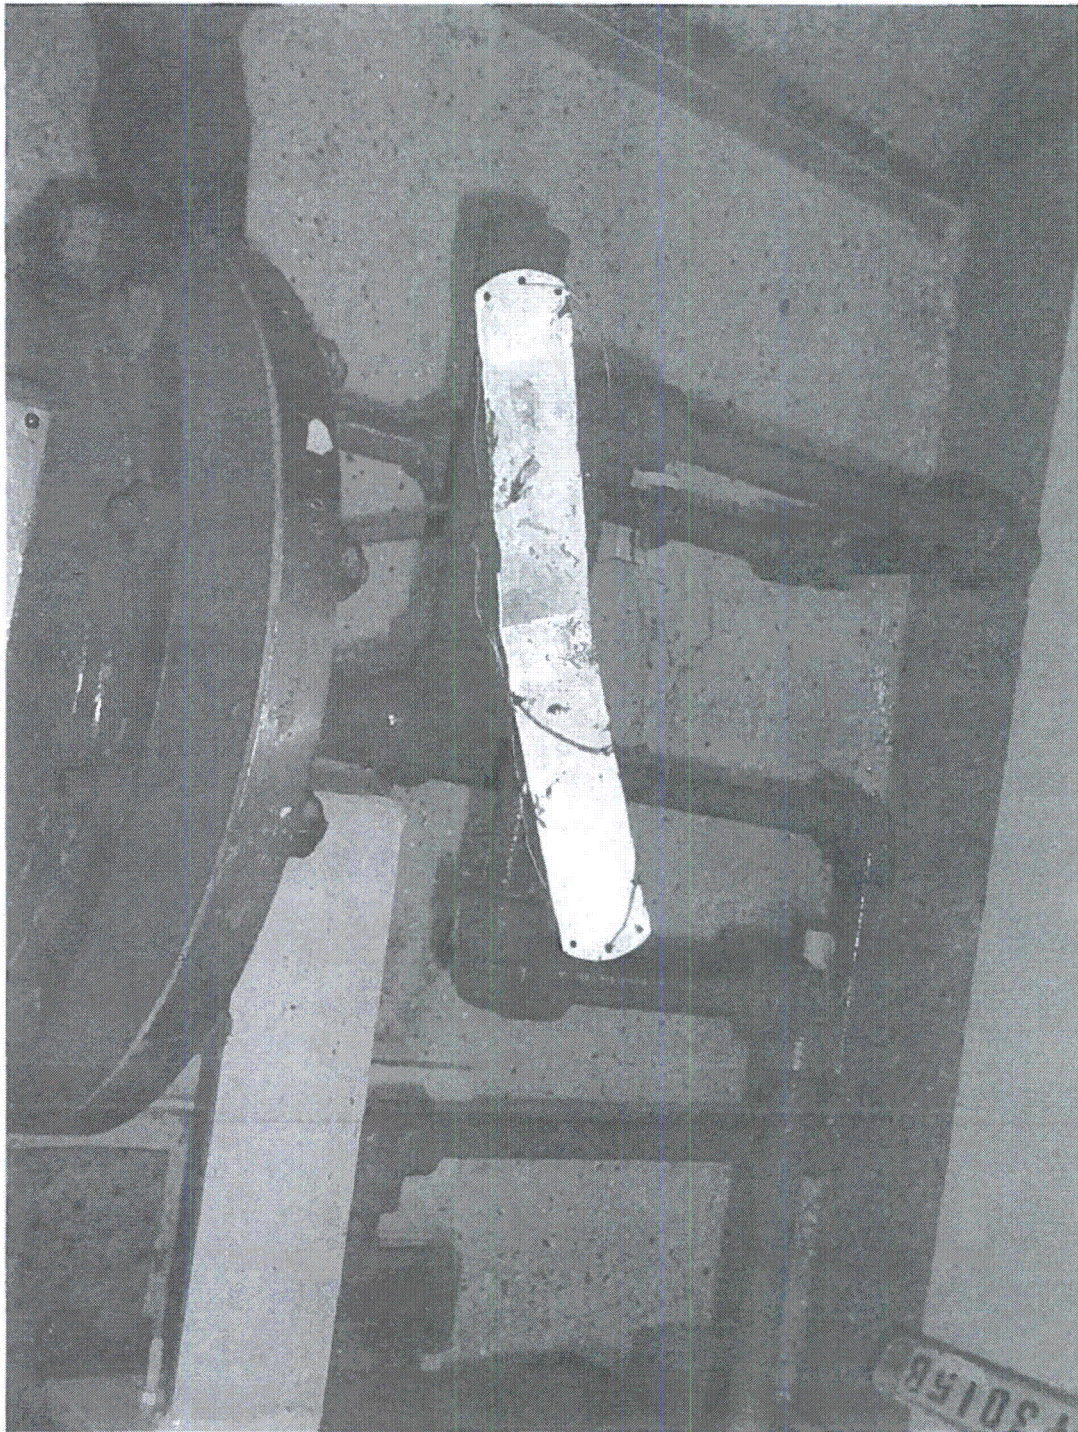
Figure 3 – Loose Equipment Tag (SE Diagonal Unit 2)

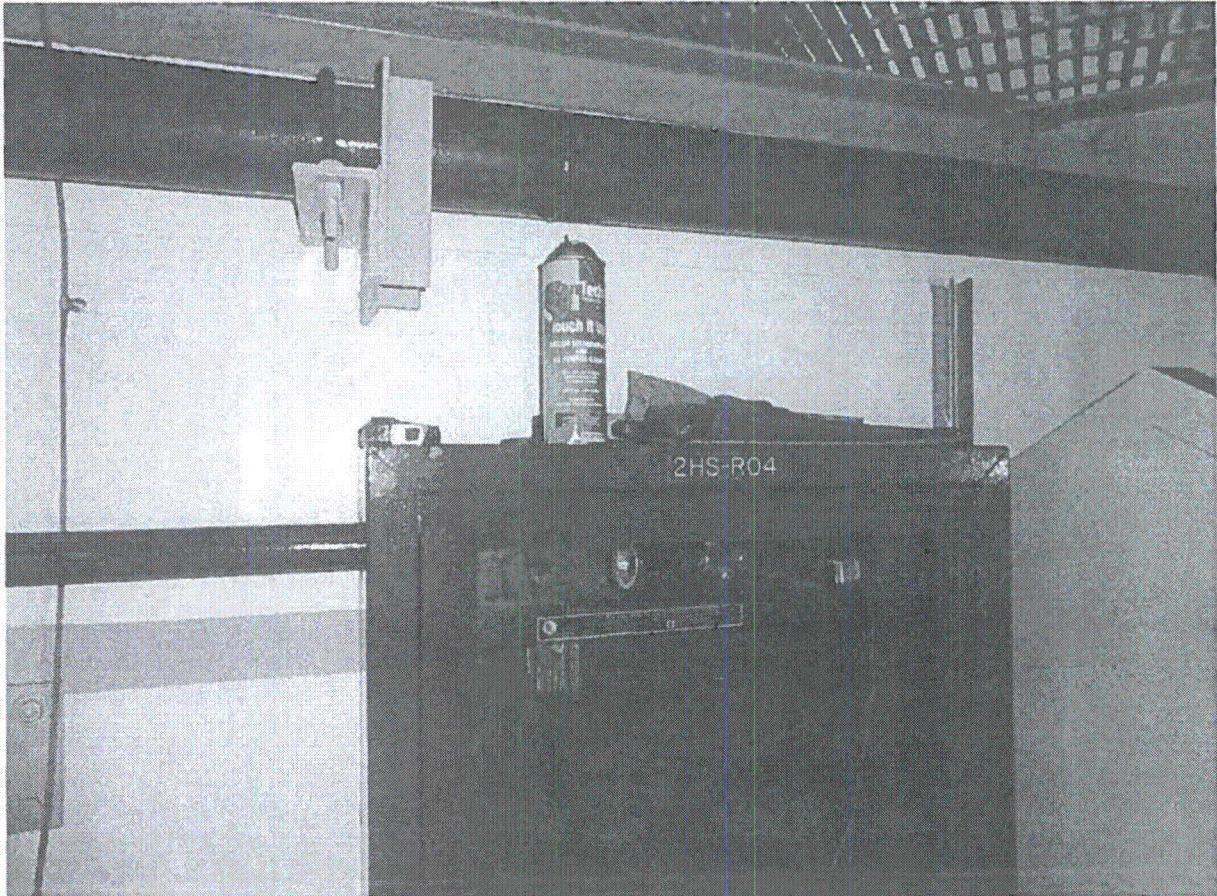
Figure 1: Items Stored on Hose Station

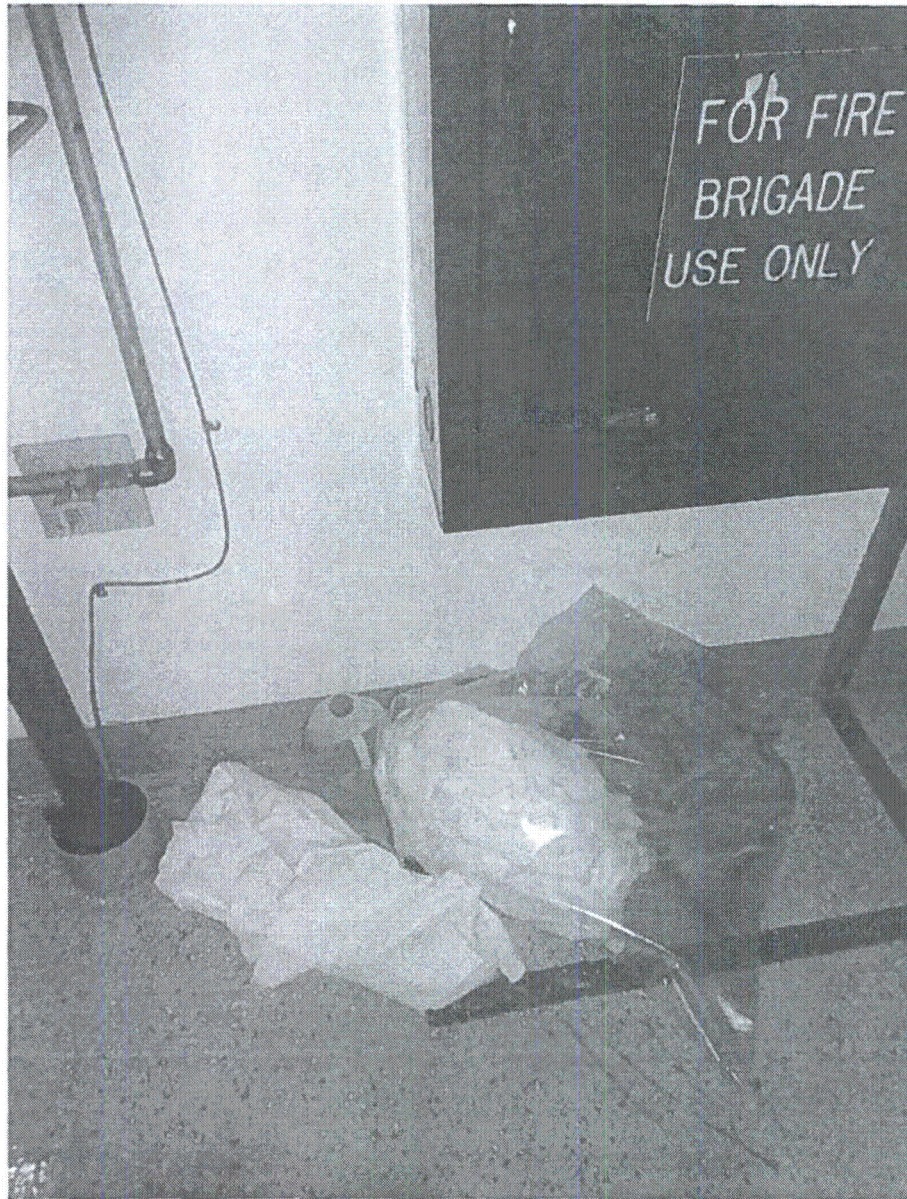
Figure 2 Radwaste Items on Floor in Contaminated Area near Hose Station

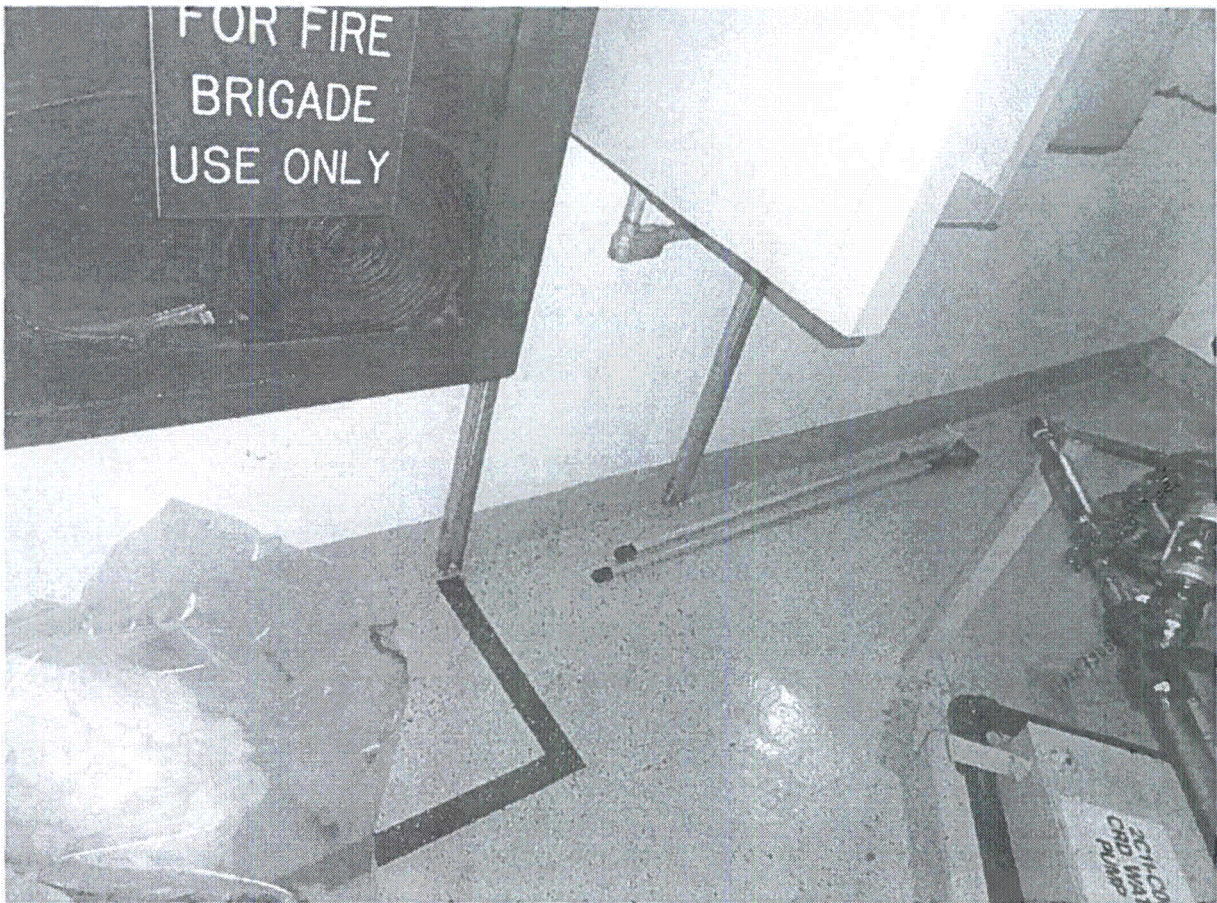
Figure 3 Poles/Handles Stored on Floor Near Hose Station

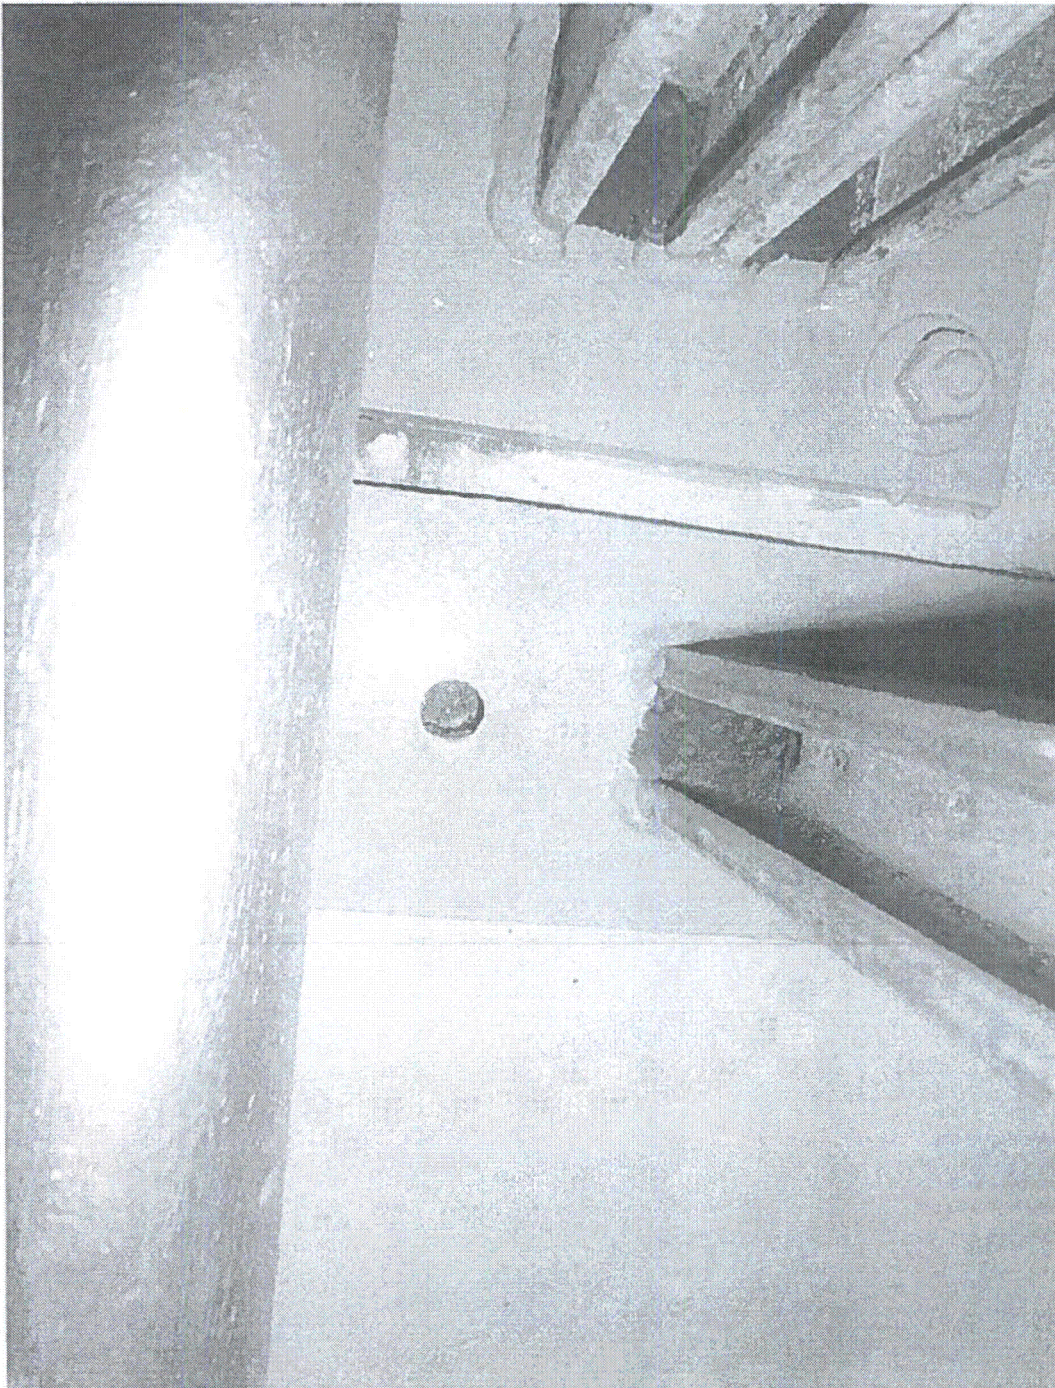
1. Does anchorage of equipment in the area appear to be free of potentially adverse seismic conditions (if visible without necessarily opening cabinets)? Y N U N/A
A knee-brace for conduit support near Valve 2E41-F007 near the 2T41-B005B HPCI cooler has only one anchor bolt (CR 515489). There is a hole in the base plate for the second bolt, but it appears that only one bolt was ever installed since there is no hole in the concrete. The knee-brace is one of a pair of supports for a small conduit near the wall. The second knee brace is fairly large and has all anchor bolts, so it is judged to have sufficient capacity to support the small conduit during a seismic event. This issue is addressed in CR 515489.

Figure 1 – Missing Knee Brace Anchor Bolt (Unit 2 HPCI Room)

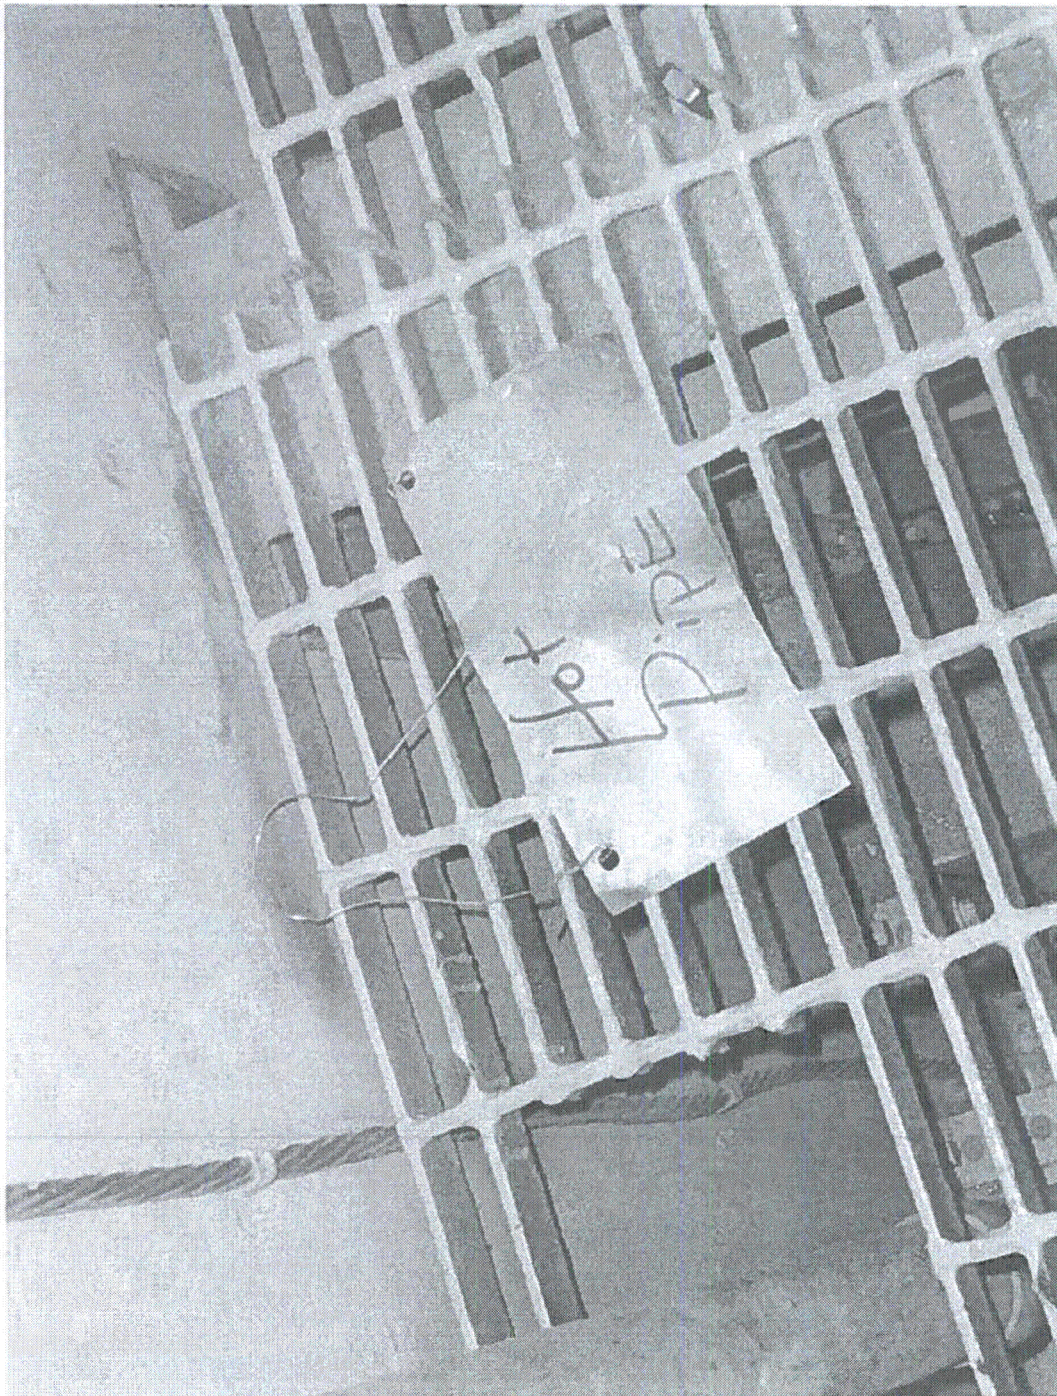
A "Hot Pipe" sign was found lying on the grating on the 96' elevation of the Unit 2 HPCI Room (on the Unit 2 HPCI Room Cooler Platform) next to the 2T41-B005A cooler but not attached to anything. The tag is light and not located near any sensitive equipment, so it is judged that there is no potentially adverse seismic condition due to this loose tag (CR 519707).

Figure 2 – Hot Pipe Sign (Unit 2 HPCI Room)

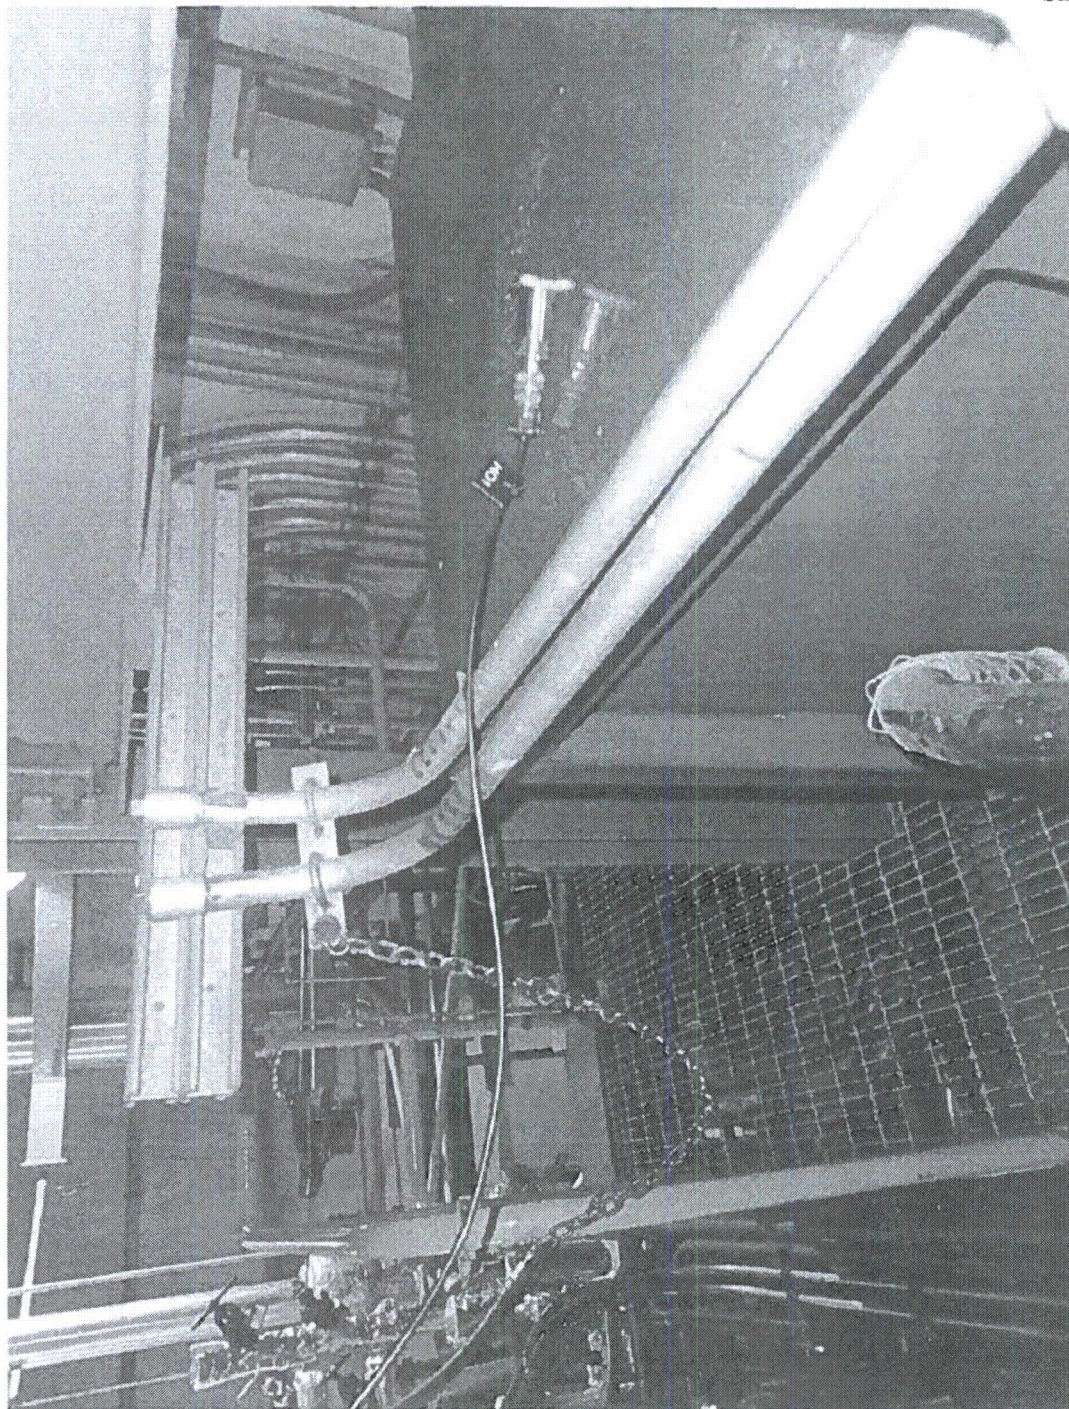
The H01 test connection lead was found lying on top of the 2T41-B005A cooler. The lead is very light and is attached by the connection cable to the body of the cooler. There is no delicate equipment in the vicinity of the lead, and the cooler is very rugged, so any impact will not be significant. Therefore, it is judged to not be a potentially adverse seismic condition. This item does not need to be moved.

Figure 3 – Loose H01 Testing Lead (Unit 2 HPCI Room)

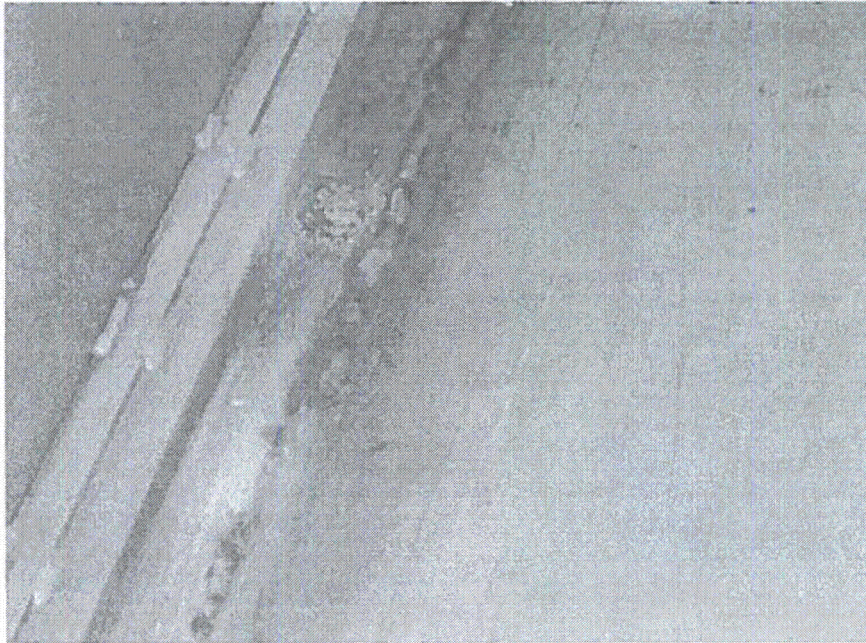
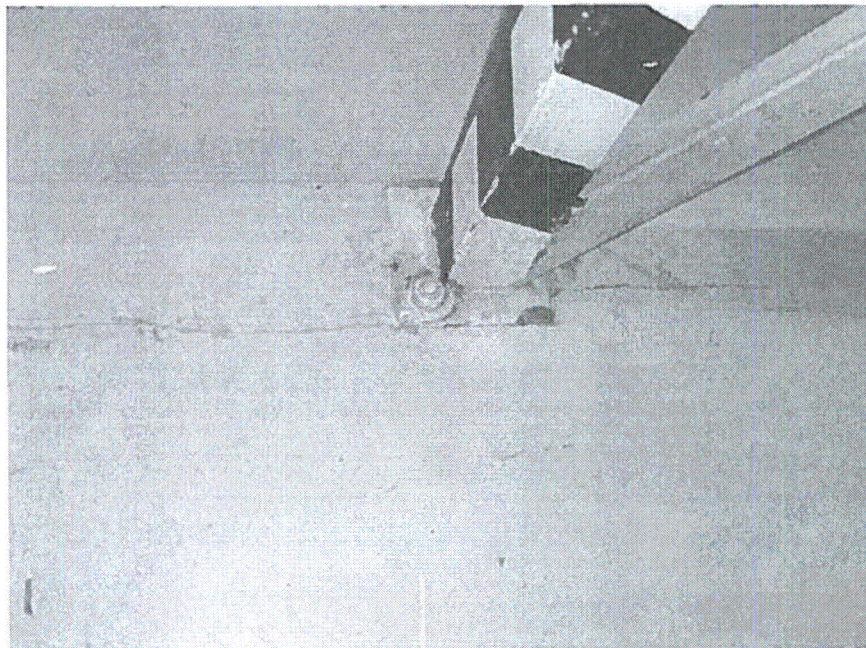
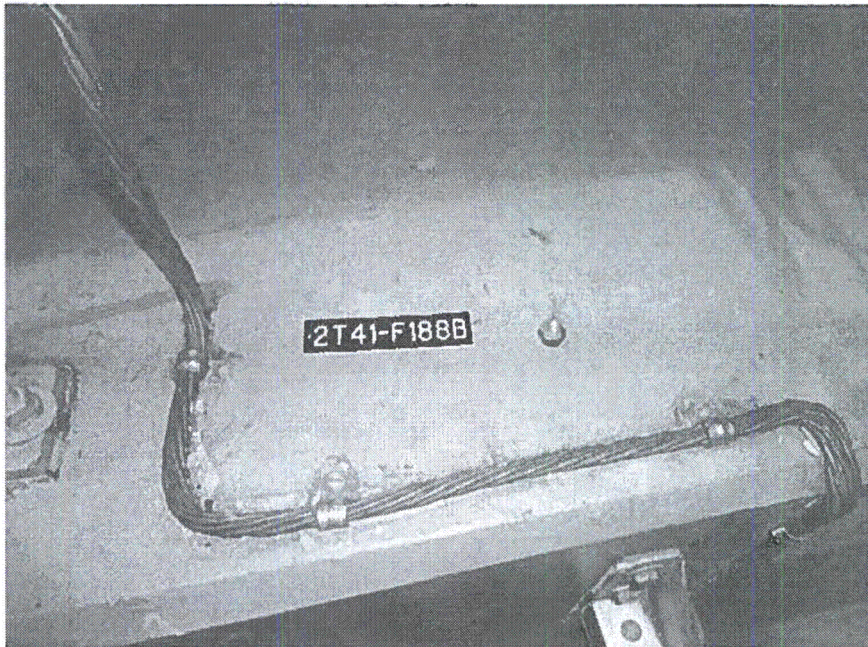
2. Does anchorage of equipment in the area appear to be free of significant degraded conditions? Y N U N/A
Filter Train 2T41-D007 and D008 have anchor bolts corroded as shown in the attached pictures. The corrosion appears to be severe enough to degrade the capacity of the some of the bolts. A CR has been initiated for this purpose (CR515661).
Support anchors on the floor for the exhaust fan (2T41-C005B) ducts have cracks in the concrete at one of the anchor bolts. See attached pictures. A CR has been initiated for this purpose (CR515779).

A loose tag was found in the room. A CR has been initiated for this purpose (CR515431). See attached picture.

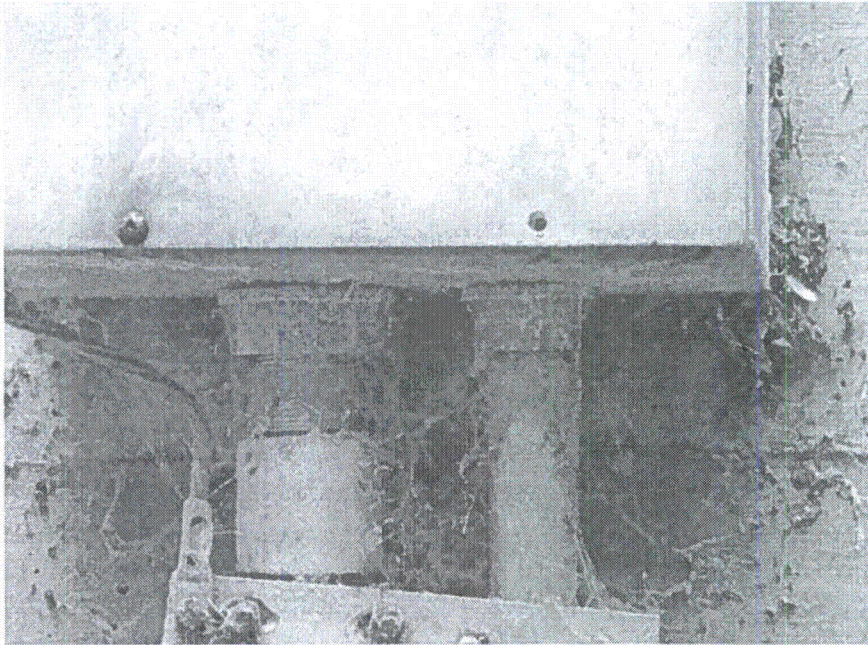
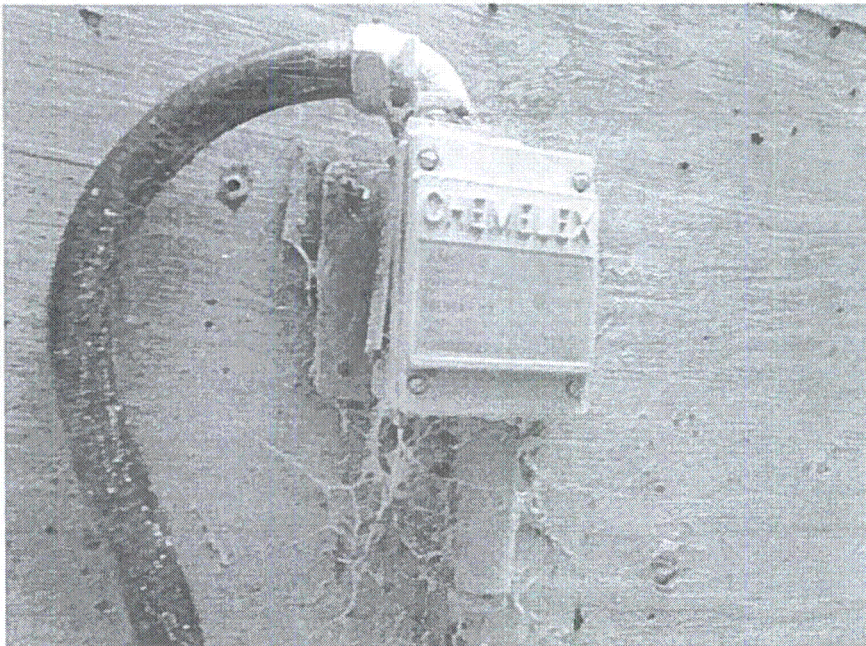
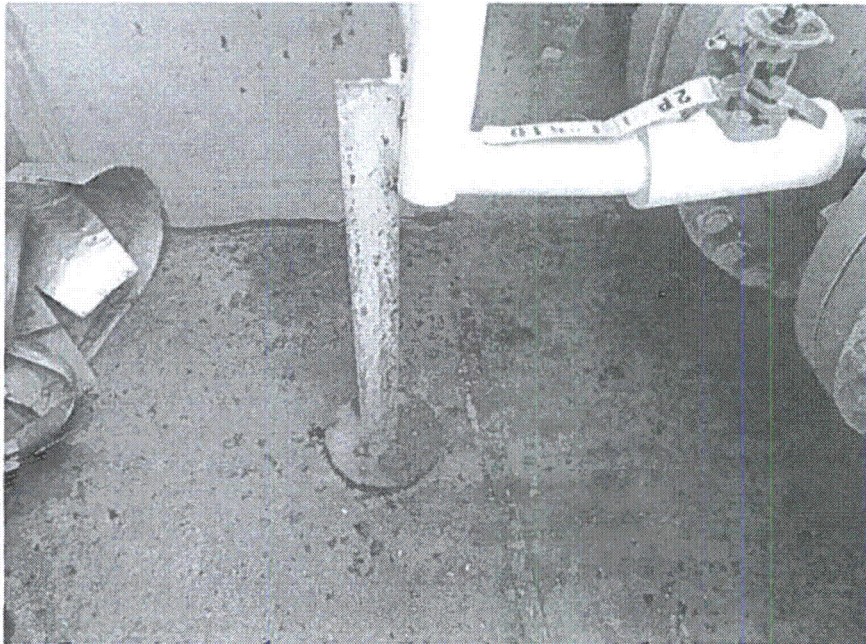
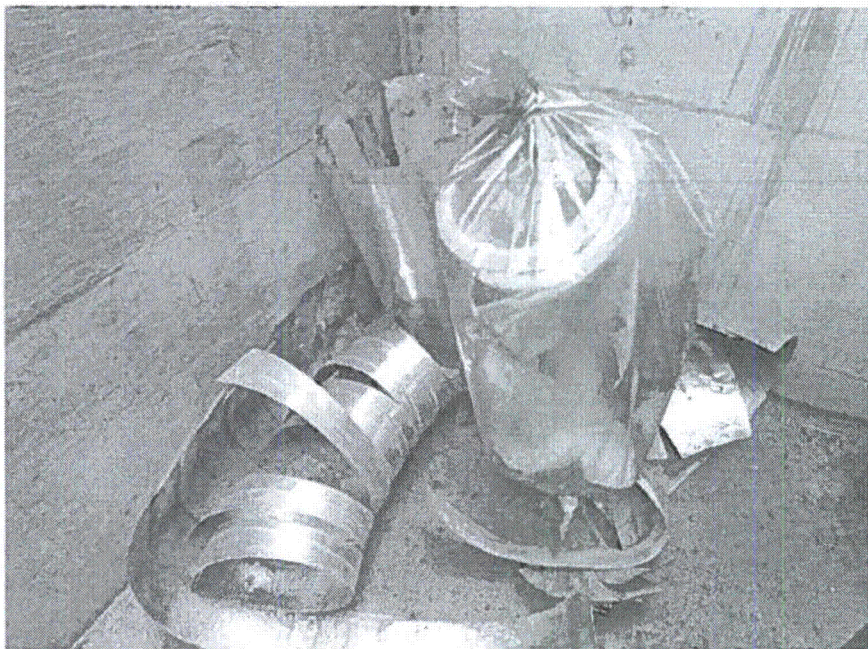
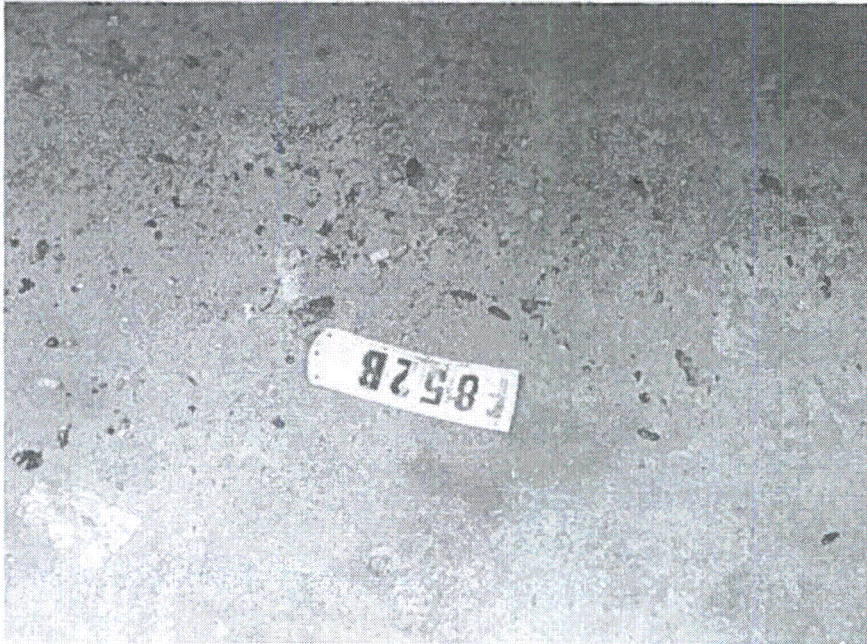
1. Does anchorage of equipment in the area appear to be free of potentially adverse seismic conditions (if visible without necessarily opening cabinets)? Y N U N/A
A missing screw was observed on the front cover of the splitter box and also on the Chemelex box support to the wall. SWEs judged these not to be potentially adverse seismic conditions. However, CR525473 was initiated to replace these screws.

2. Does anchorage of equipment in the area appear to be free of significant degraded conditions? Y N U N/A
Widespread corrosion was also observed in this pit. SWEs judged this not to be a potentially adverse seismic condition. However, CR525475 was initiated for this purpose.

Trash bags were noticed on the floor, but judged not to be a potentially adverse seismic condition by the SWEs.

A broken tag was found on the floor. SWEs judged this not to be a potentially adverse seismic condition. However, CR525476 was initiated to fix this issue.

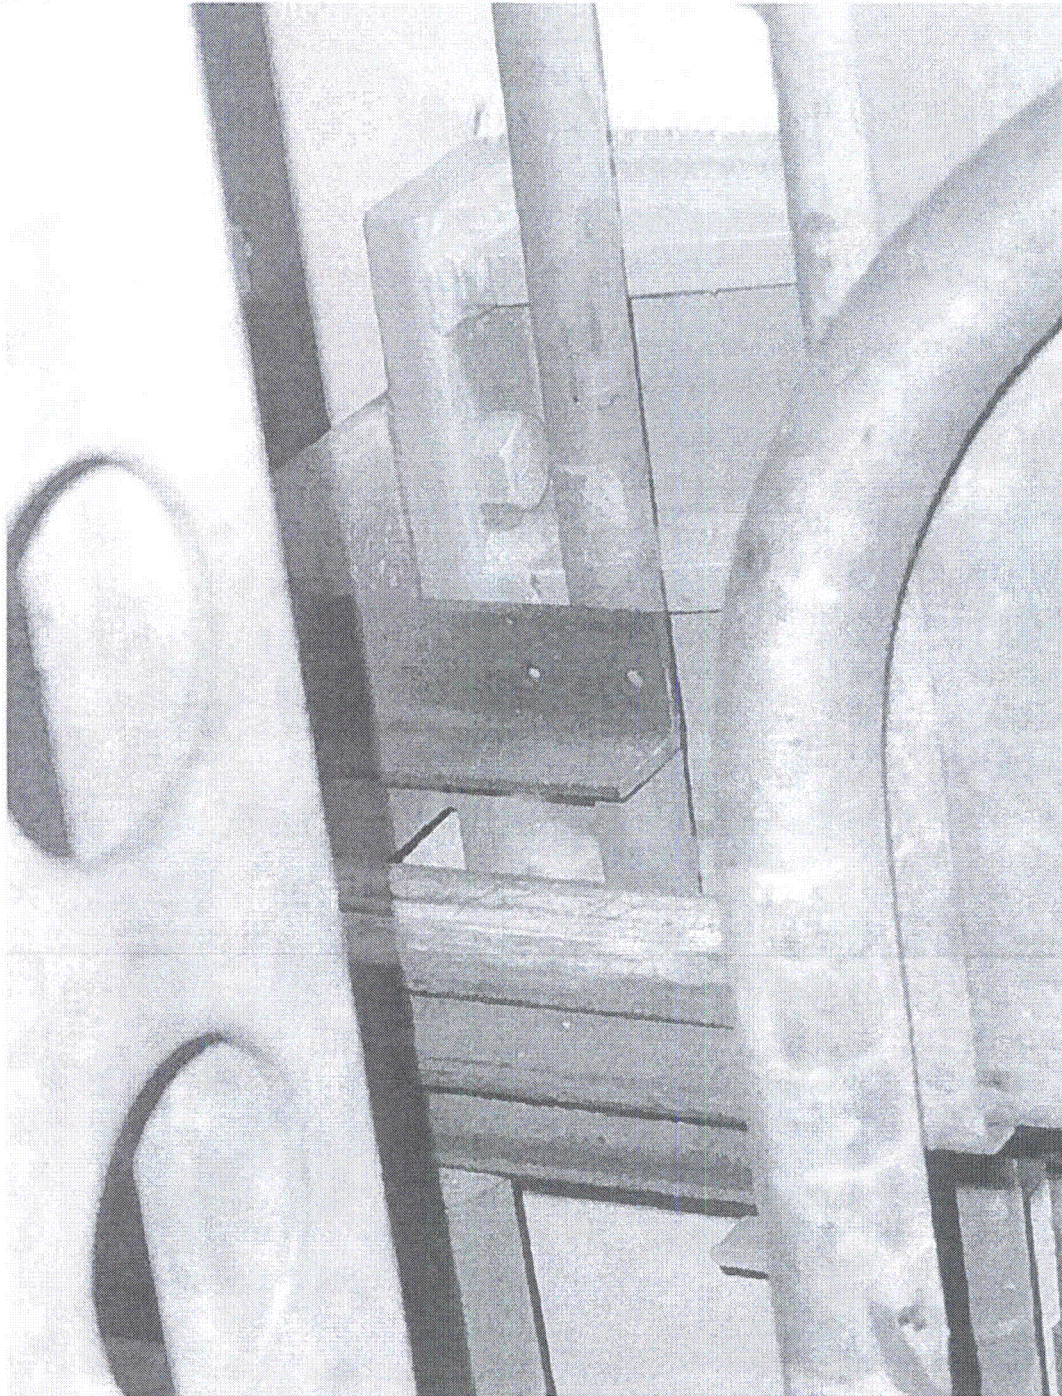
2. Does anchorage of equipment in the area appear to be free of significant degraded conditions? Y N U N/A
3. Based on a visual inspection from the floor, do the cable/conduit raceways and HVAC ducting appear to be free of potentially adverse seismic conditions (e.g., condition of supports is adequate and fill conditions of cable trays appear to be inside acceptable limits)? Y N U N/A
There was a 1" diameter demineralized water pipe discovered that appeared to be missing a U-bolt (CR 523085). There is an angle with two holes drilled in it immediately adjacent to the pipe above the 2H21-P001 instrument rack that looks like it was intended as a pipe support. The pipe has additional supports on either side of the missing support and is light, so it is judged that the existing supports have adequate capacity to support the pipe. Therefore, there is no potentially adverse seismic condition. However, the missing support needs to be reinstalled.

Figure 1 – Missing U-Bolt (Unit 2 87' NE Diagonal)
