Status: Y N U **Area Walk-By Checklist (AWC)**Location: Bldg. DIESEL Floor El. 130 Room, Area¹ SWITCHGEAR ROOM 2F**Instructions for Completing Checklist**

Area Walk-By Checklist (AWC)

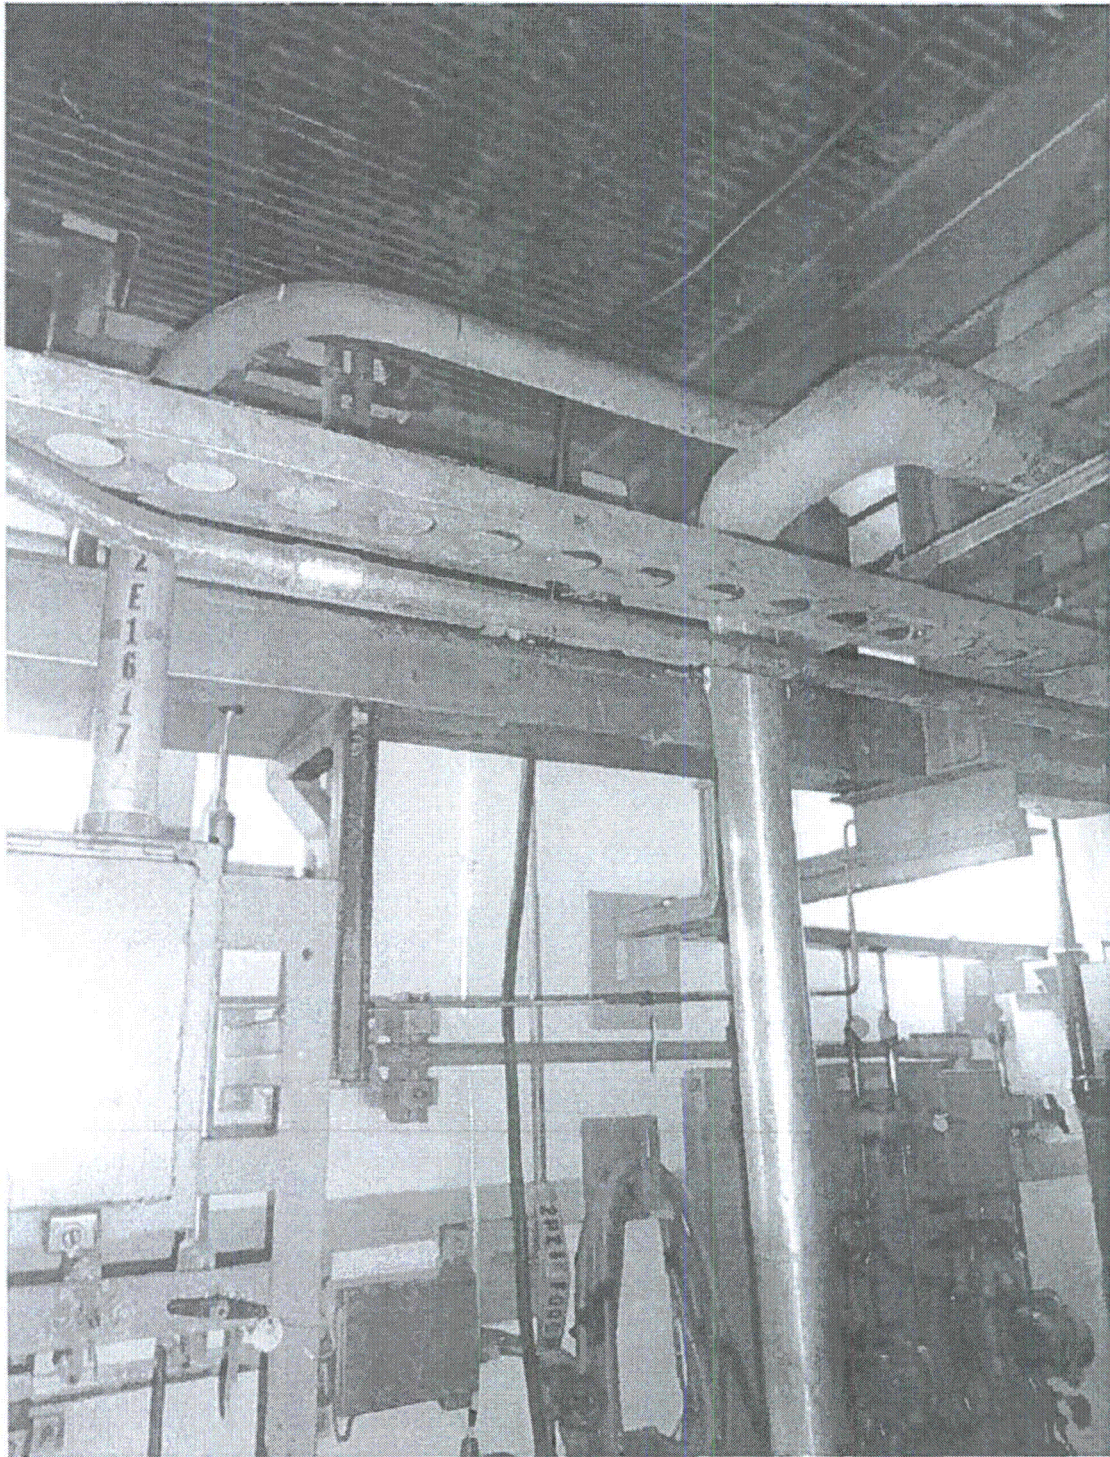
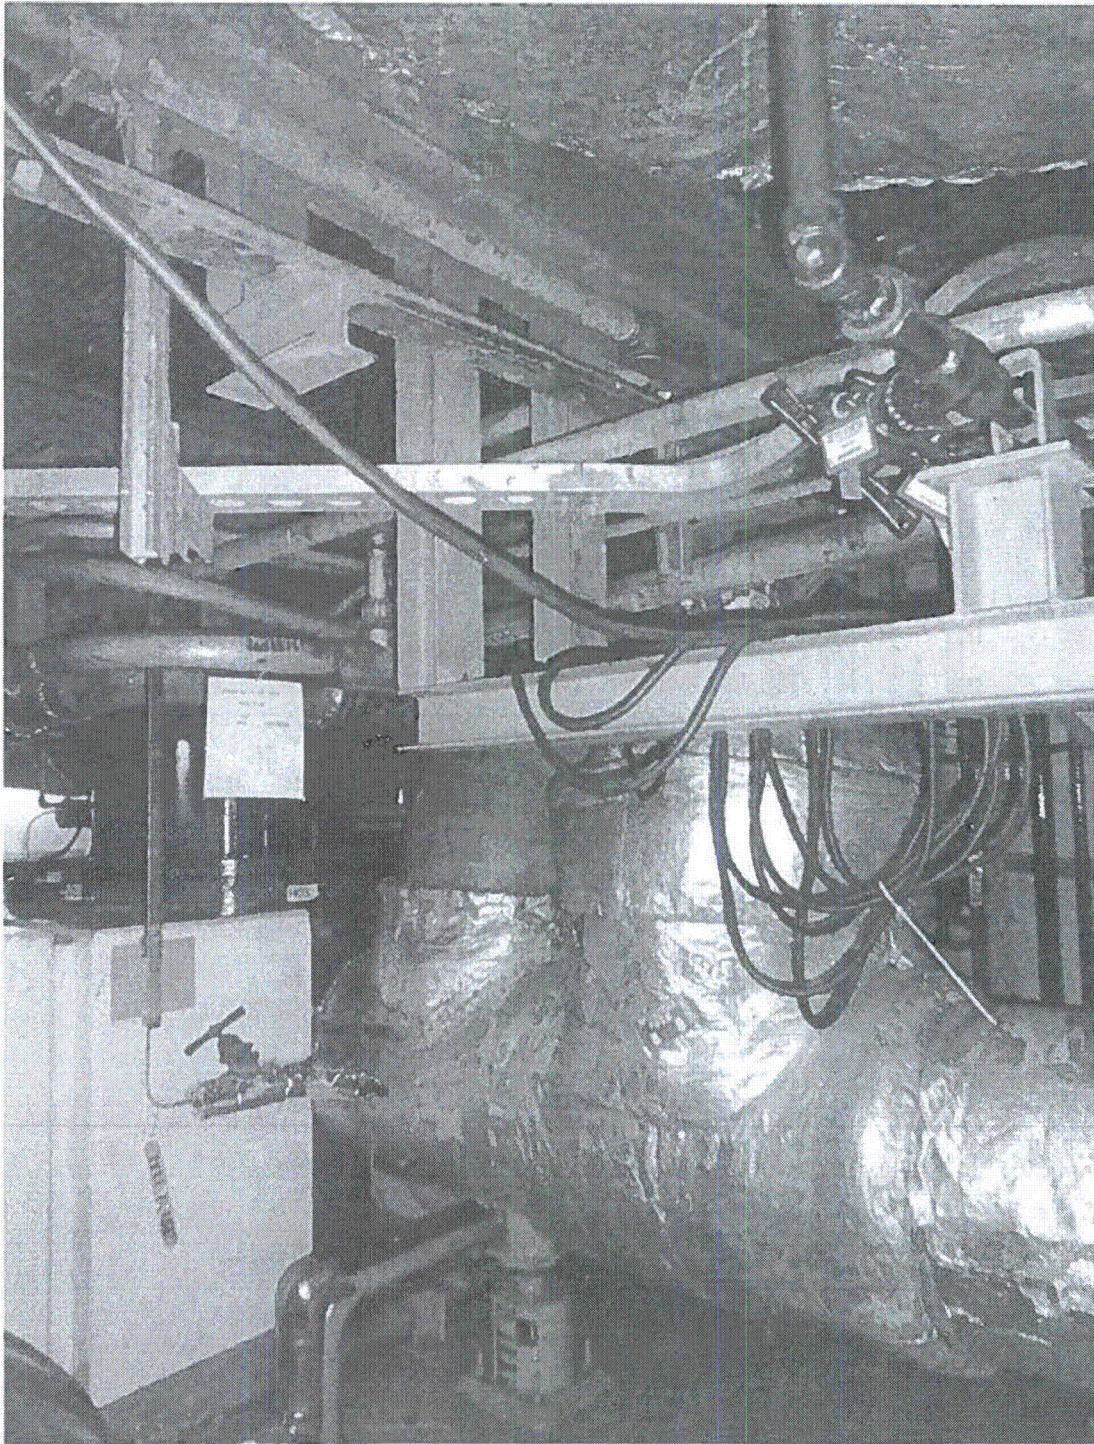
Figure 2 – Temporary Power Cord (Unit 2 87' NE Diagonal)

Figure 3 – Temporary Power Cord (Unit 2 87' NE Diagonal)

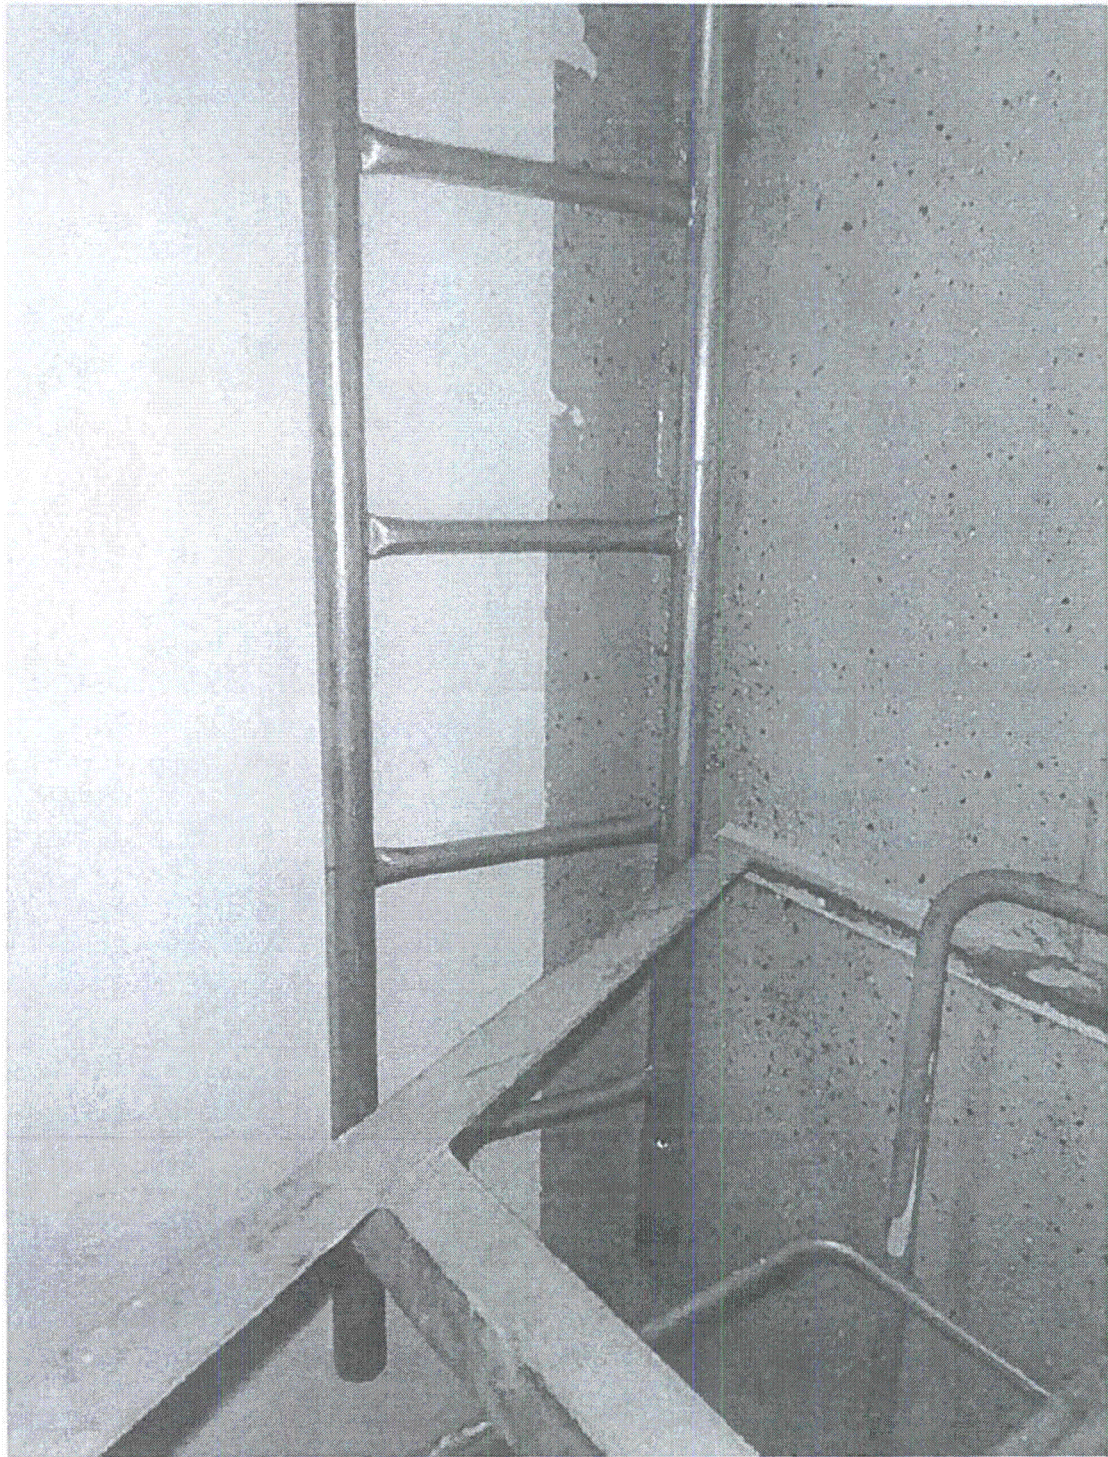
There was a 6' metal ladder left unrestrained behind the 2H21-P018 RHR Instrument Rack (CR 522935). The ladder was placed behind the diagonal support for the rack and a steel column, such that during a seismic event, the ladder would not be able to impact anything except support steel. The impact is judged by the SWEs to be credible but not significant. Therefore, there is no potentially adverse seismic condition.

Figure 4 – Unrestrained Metal Ladder (Unit 2 87' NE Diagonal)

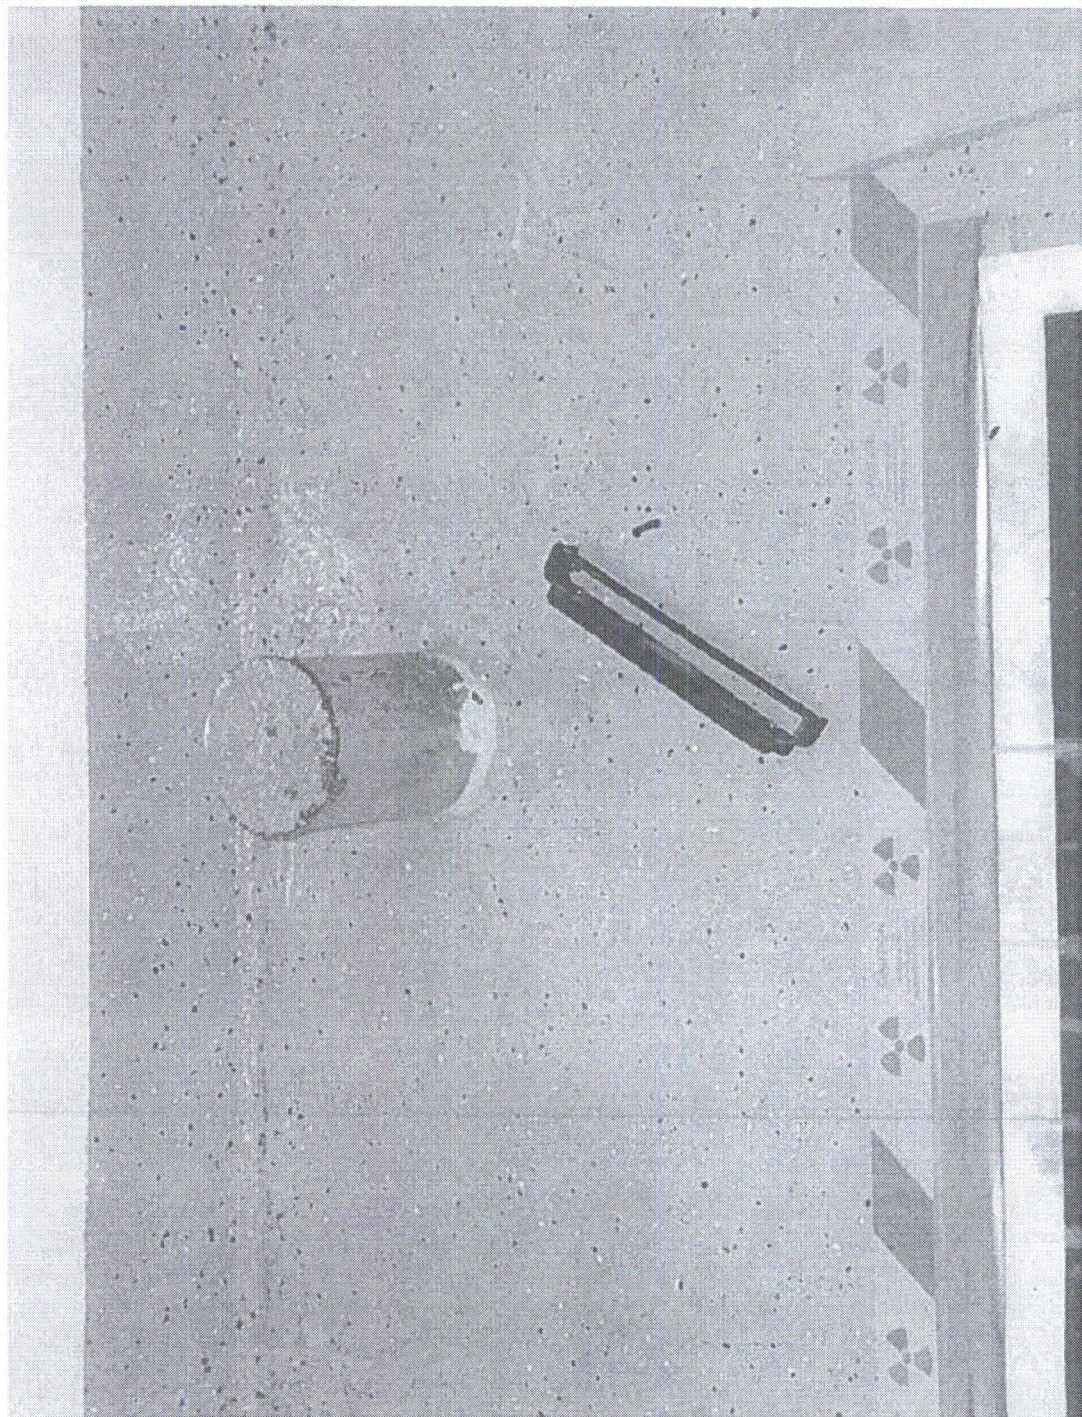
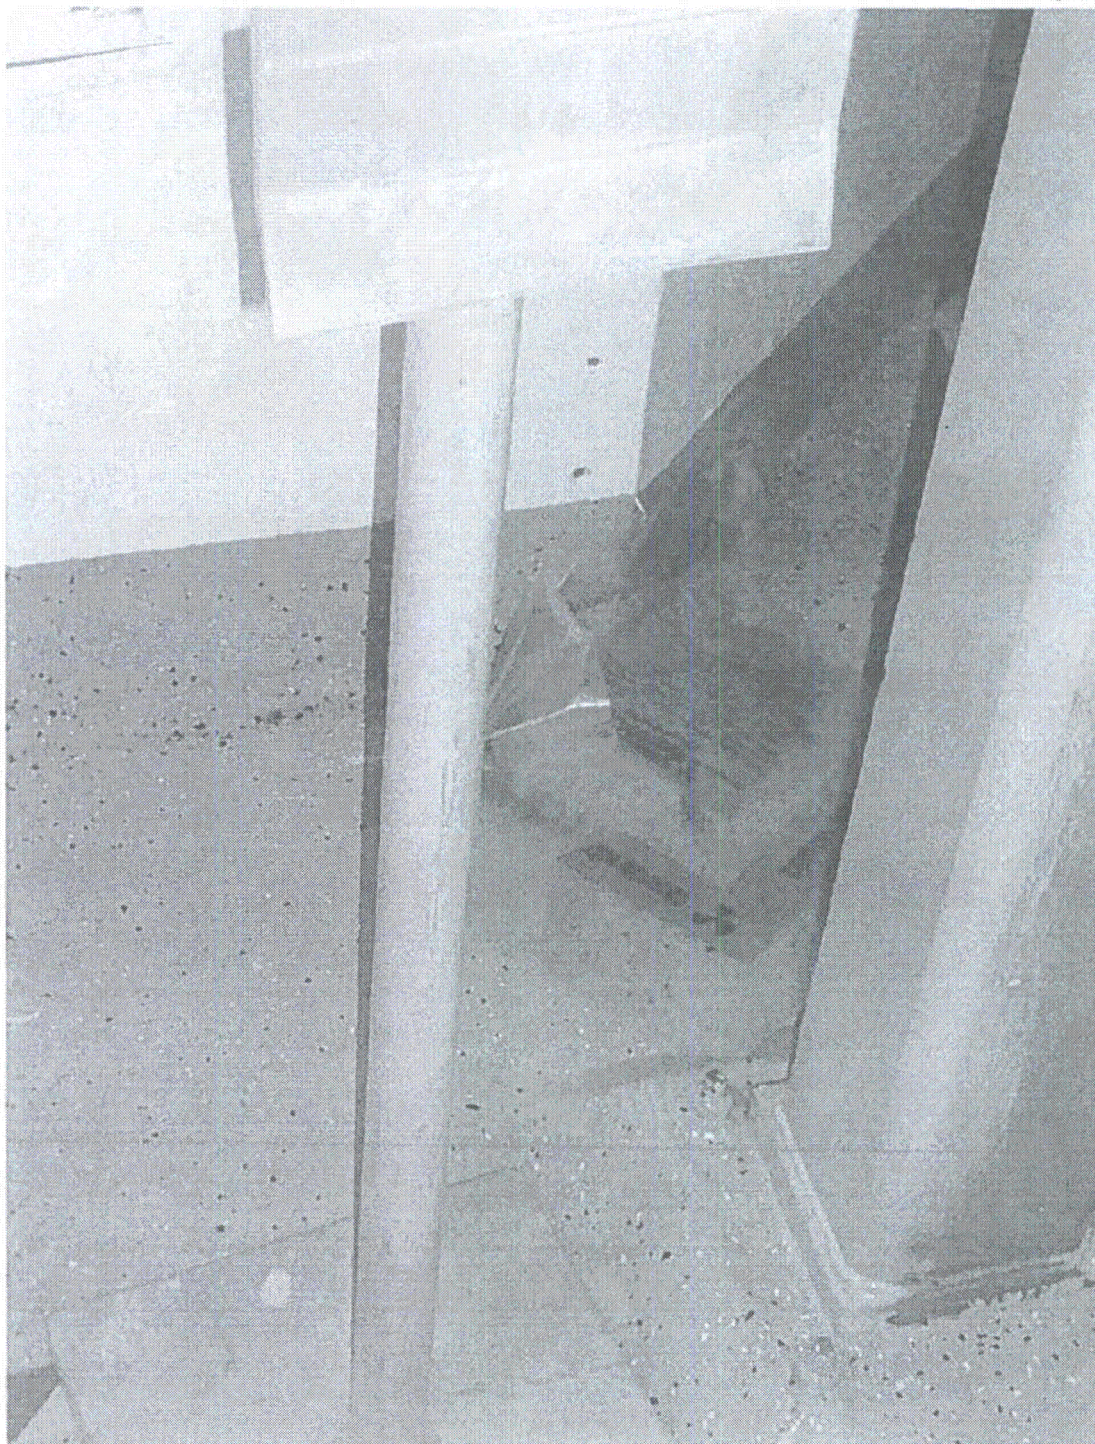
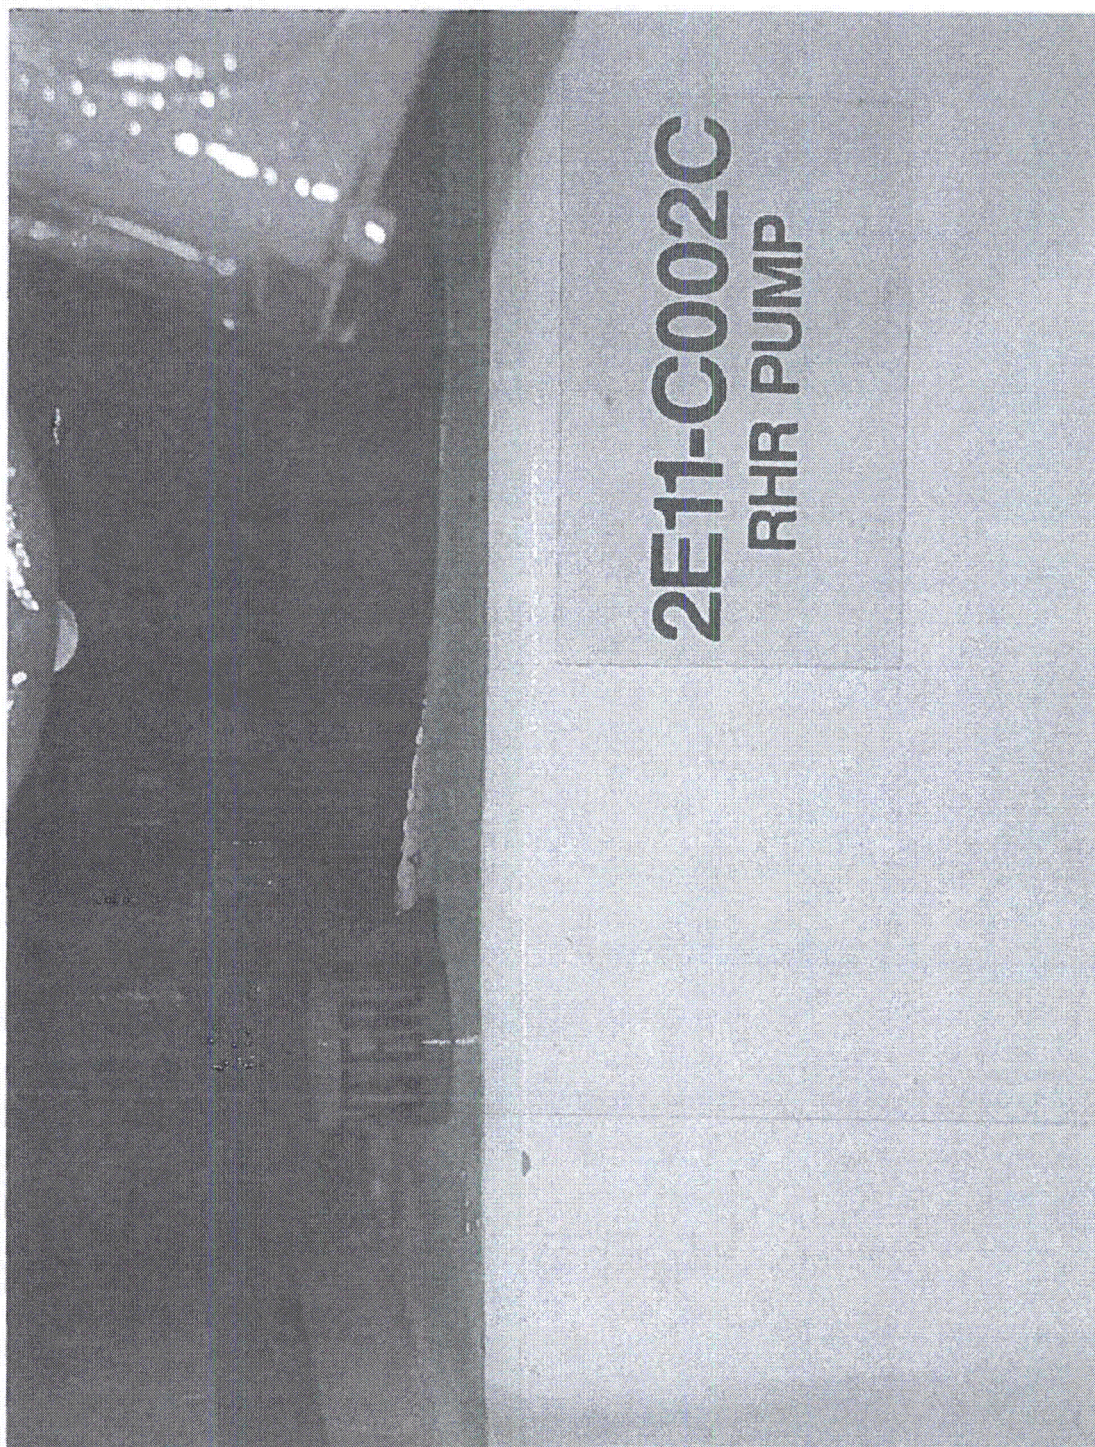
There are a few items (a plastic bag, a roll of caution tape and a small metal piece) left loose in the contaminated area around the 2E11-C002C RHR Pump. All of the items are small and light and located away from sensitive equipment, so are judged to not create a potentially adverse seismic condition.

Figure 5 – Loose Items in Contaminated Area (Unit 2 87' NE Diagonal)

Figure 6 – Loose Items in Contaminated Area (Unit 2 87' NE Diagonal)

Figure 7 – Loose Items in Contaminated Area (Unit 2 87' NE Diagonal)

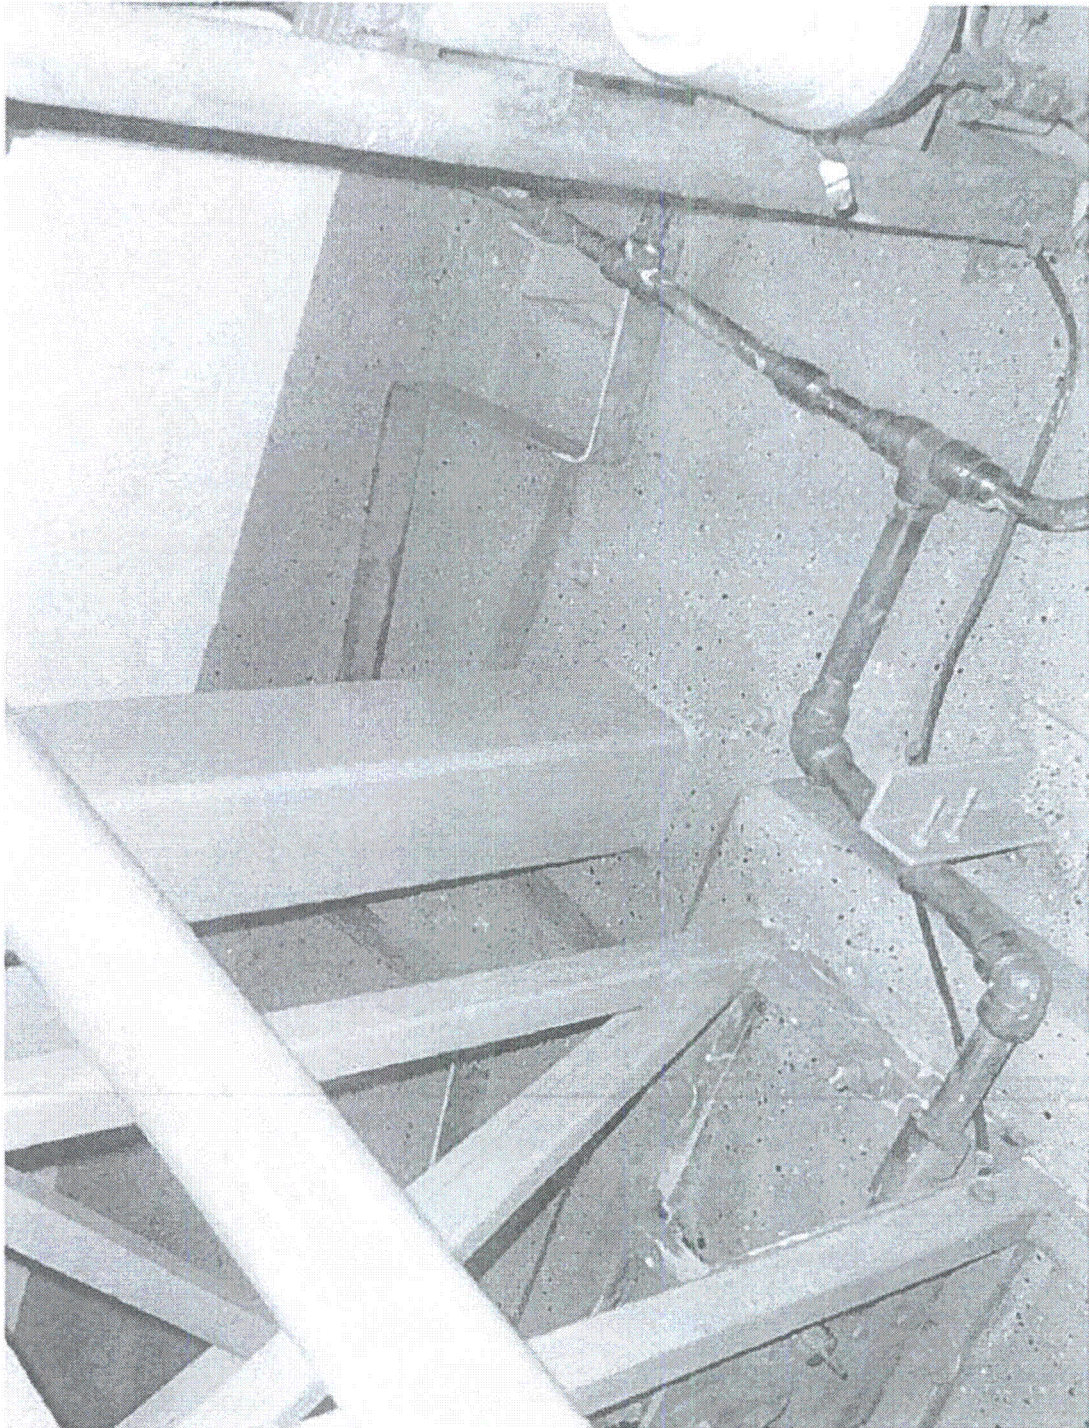
There was a 3' long bent steel support that was sitting on the floor next to the 2H21-P001 instrument rack (CR 523087). The support is small and light, and is not located near any sensitive equipment, so it is judged that there is no potentially adverse seismic condition. It was not readily apparent where the support belonged or whether it needed to be reinstalled.

Figure 8 – Loose Bent Steel Support (Unit 2 87' NE Diagonal)

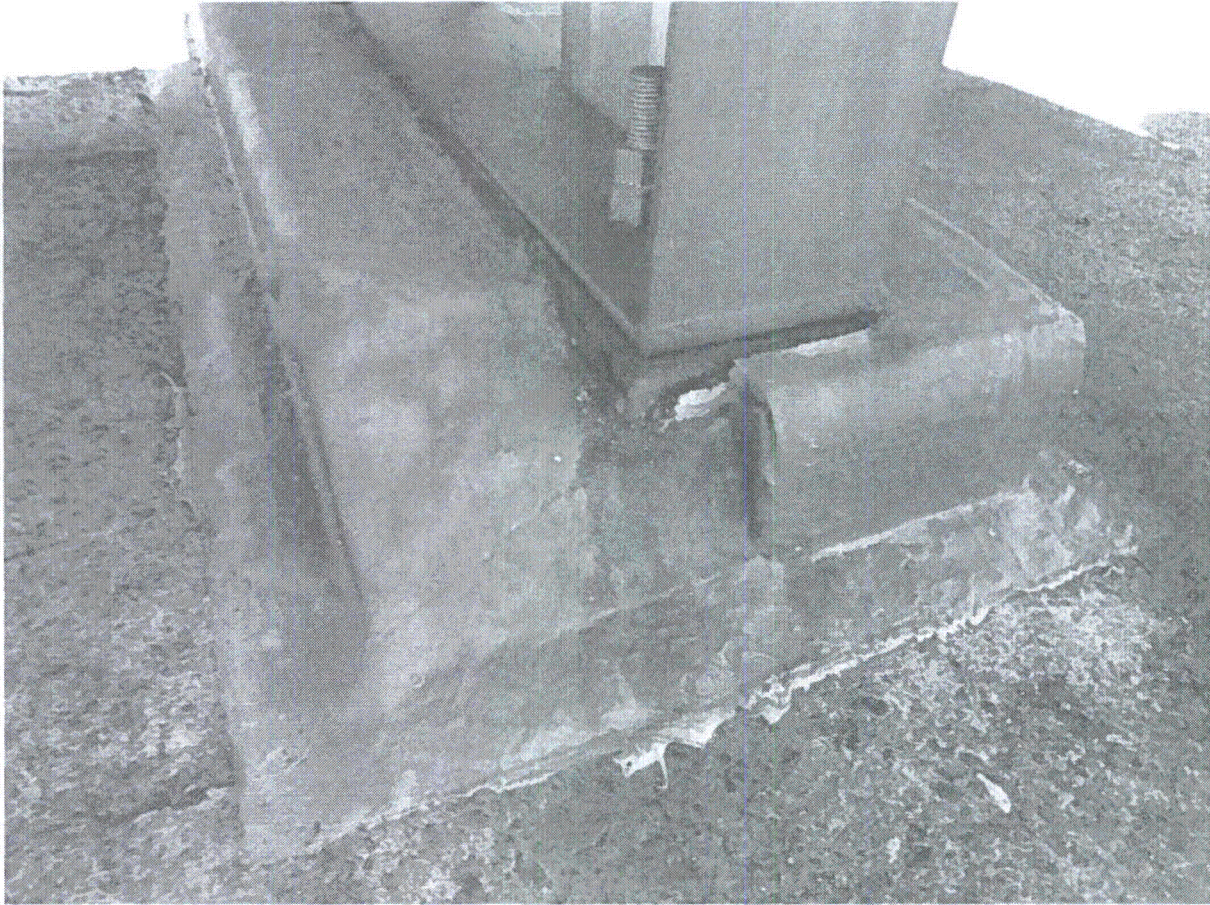
2. Does anchorage of equipment in the area appear to be free of significant degraded conditions? Y N U N/A
Concrete bearing pad of storage tank located 2nd from the north end of the roof exhibits spalled corners (see photograph 1). This is typical on all four ends of the pads. Grout pads are not structural. The bearing plate is well supported and the bolts fully extend into the concrete below the grout. The grout is not considered in the bolt capacity. Therefore, the concrete pads are judged to be seismically adequate.

1: Spalled Concrete Bearing Pad for Storage Tank (Diesel Building Roof – North End)

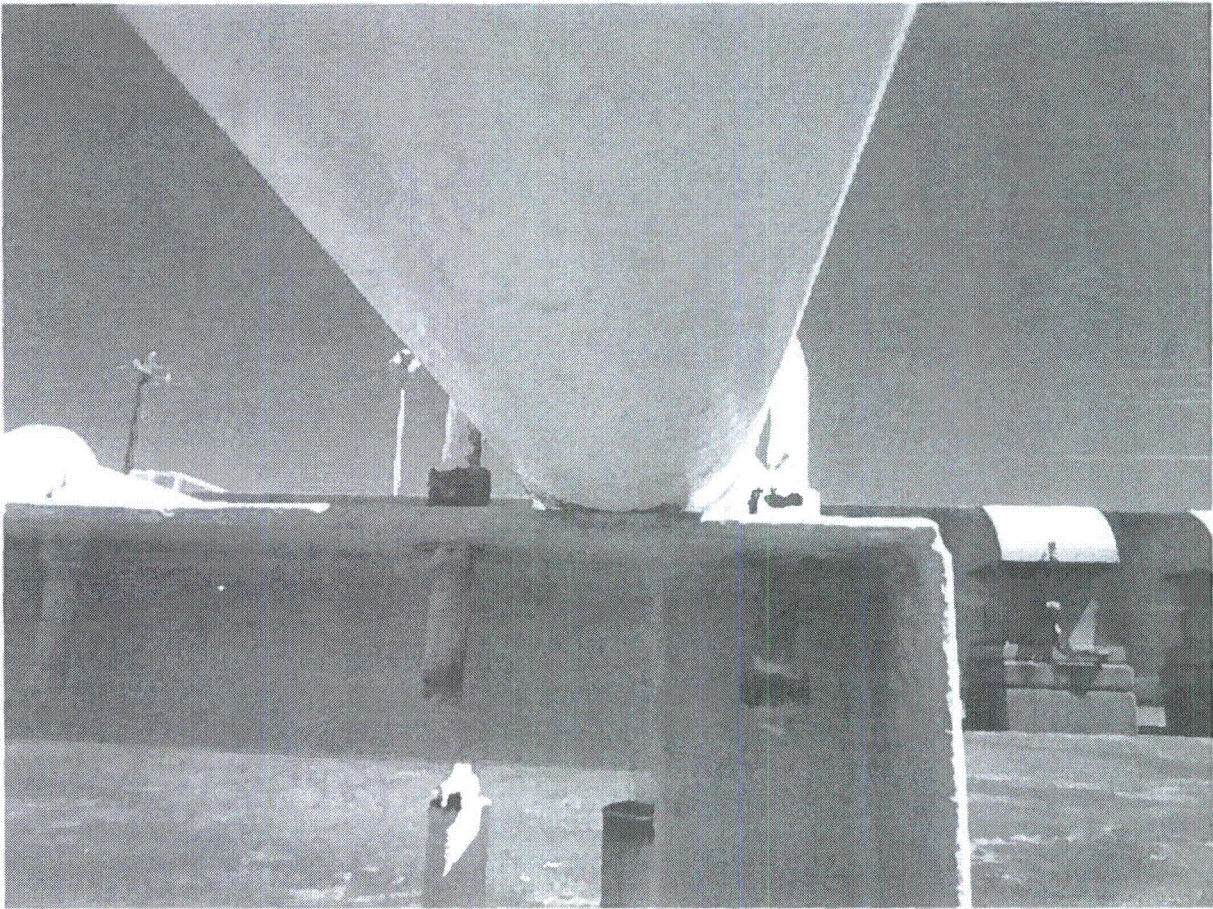
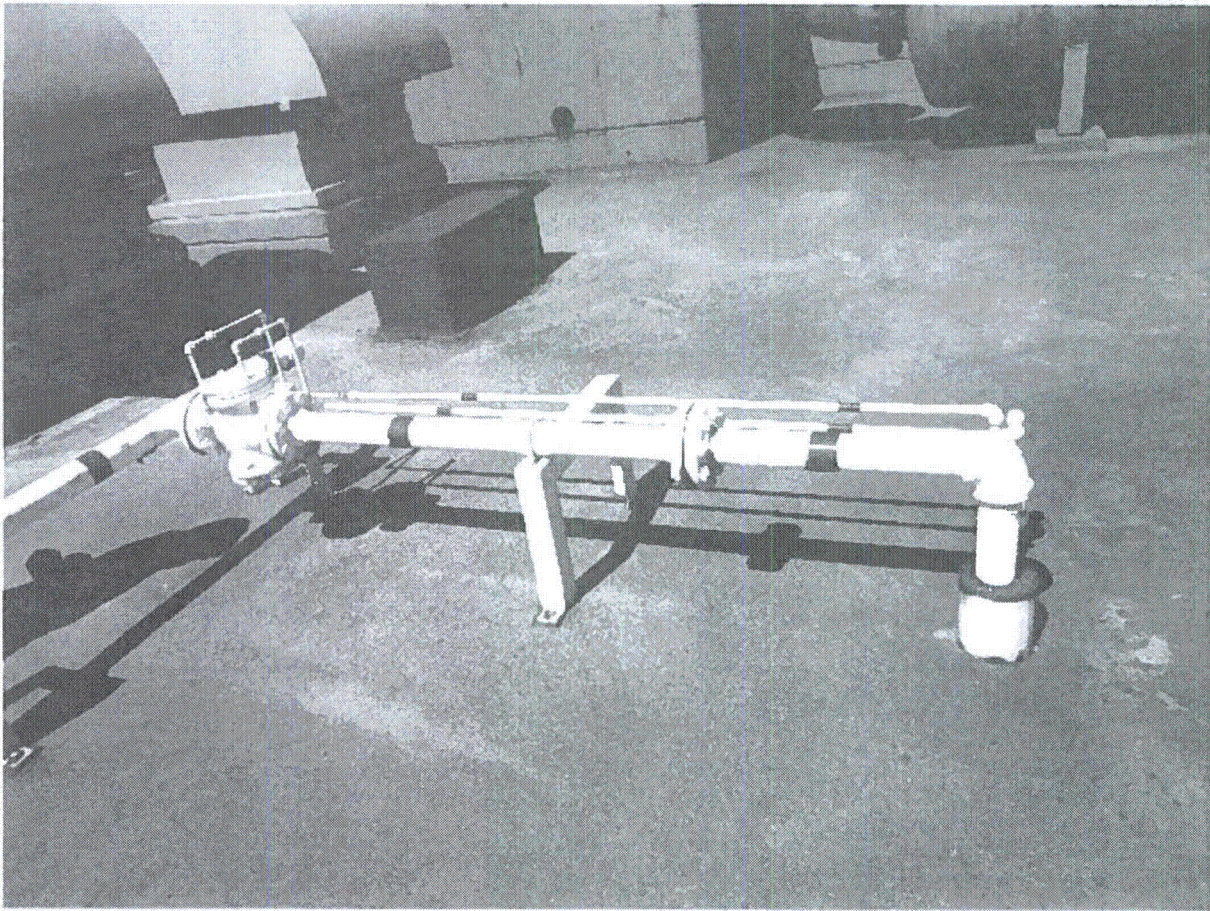
8. Have you looked for and found no other seismic conditions that could adversely affect the safety functions of the equipment in the area? Y N U
There is a U bolt support for a fire protection pipe (see photographs 2 and 3) which is not securely fastened to the angle support. A nut is missing and another is not tightened. The pipe is supported vertically but the angle support and the U bolt in place to prevent the pipe from moving off the support laterally. Vertical seismic accelerations are not great enough for the bolt to be lifted out of place. It is judged to be seismically adequate. CR 523486 has been written to replace the missing/unsecured nuts.

2: U Bolt Not Securely Fastened to Angle Support (Diesel Building Roof – North End)

3: Pipe Elevation With U Bolt Support Deficiency (Diesel Building Roof – North End)

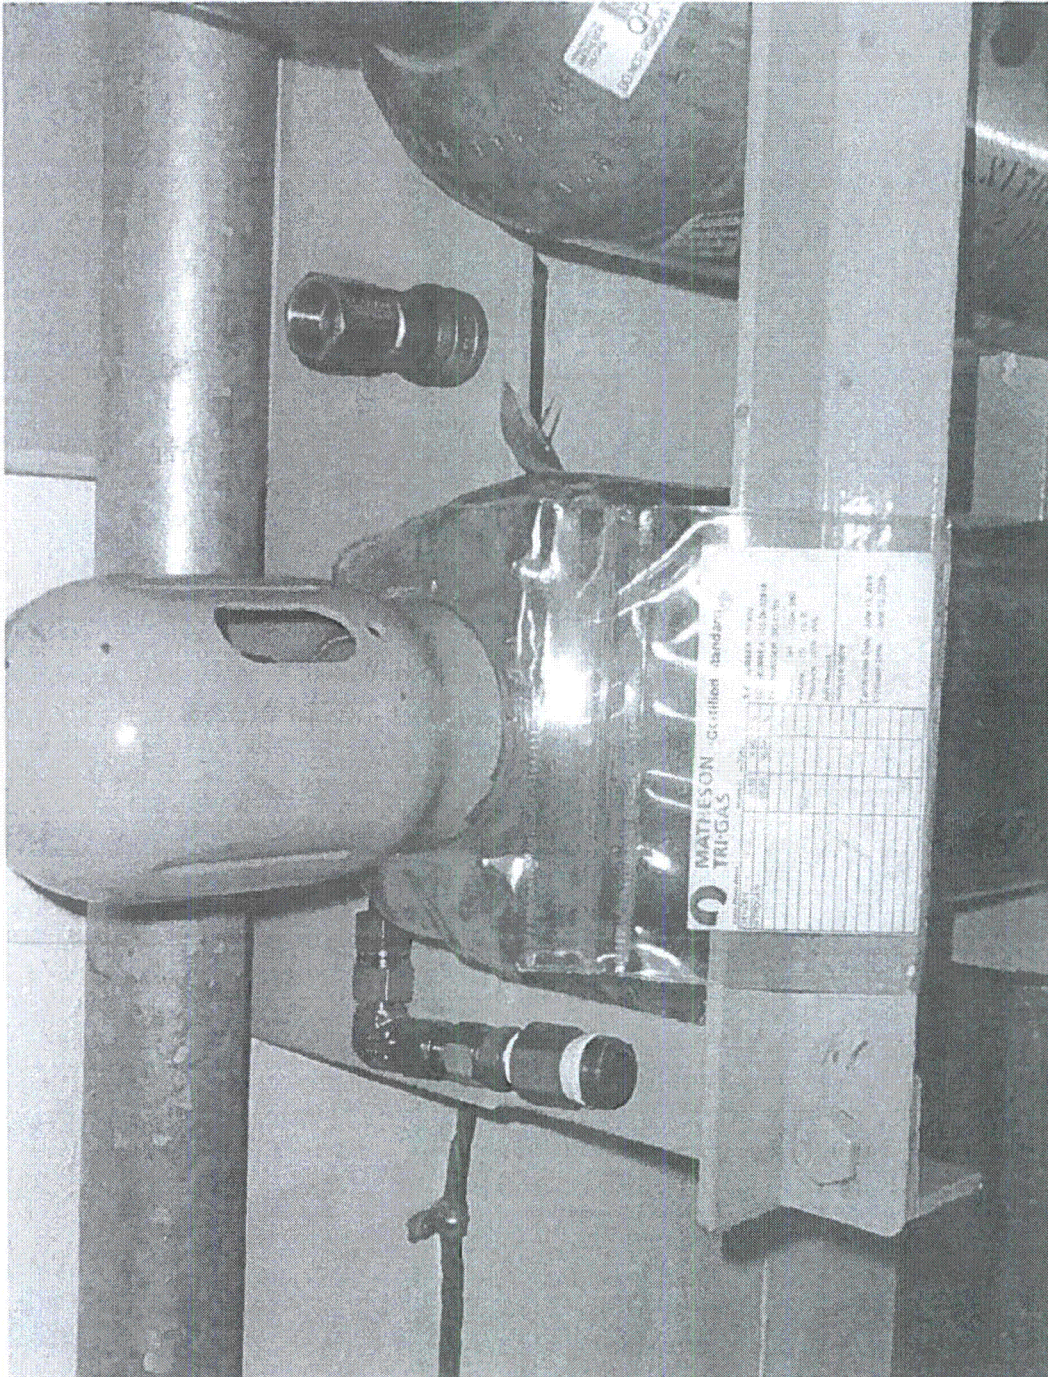
There are two brass nozzles sitting loose on top of the Gas Cylinder Location 2P33-P066 and two brass nozzles sitting on the frame for panel 2H21-P405B, which is a high potential to cause a plant transient (CR 515750). The nozzles are small and relatively light, so they are unlikely to cause any structural damage during a seismic event. However, due to their location on the support for a high trip hazard panel, there is a concern that the nozzles could potentially cause a plant transient.

Figure 1 – Loose Nozzles near Bottles (Near Equipment Hatch Unit 2)

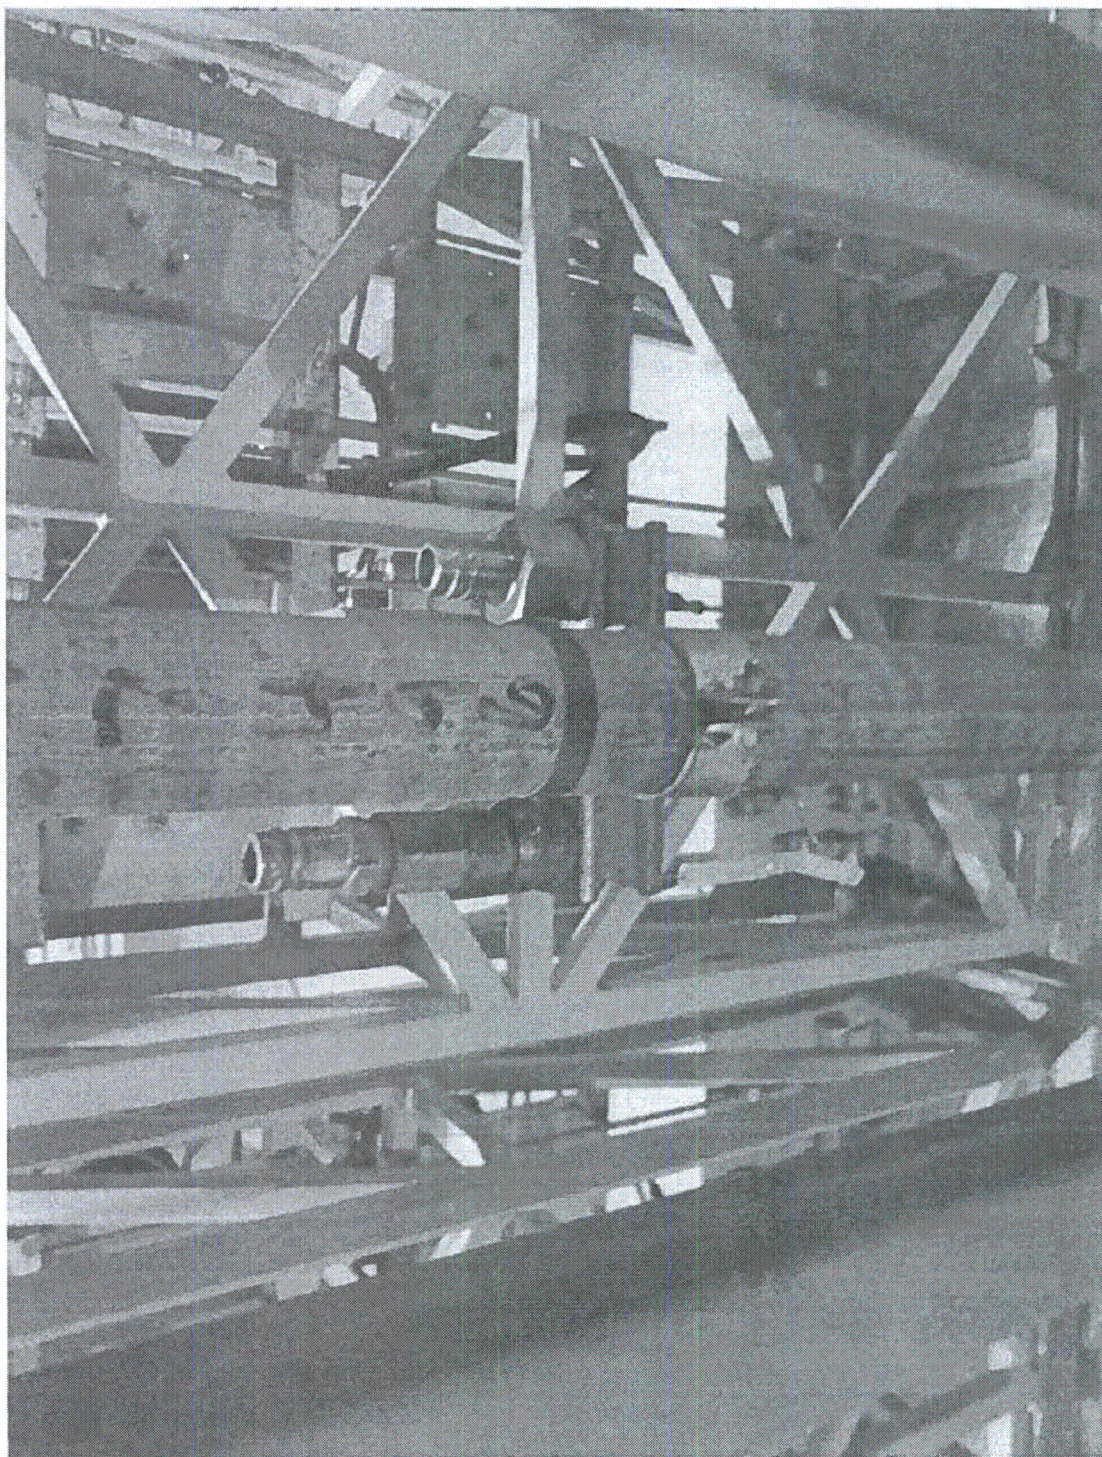
Figure 2 – Loose Nozzles behind Panel (Near Equipment Hatch Unit 2)

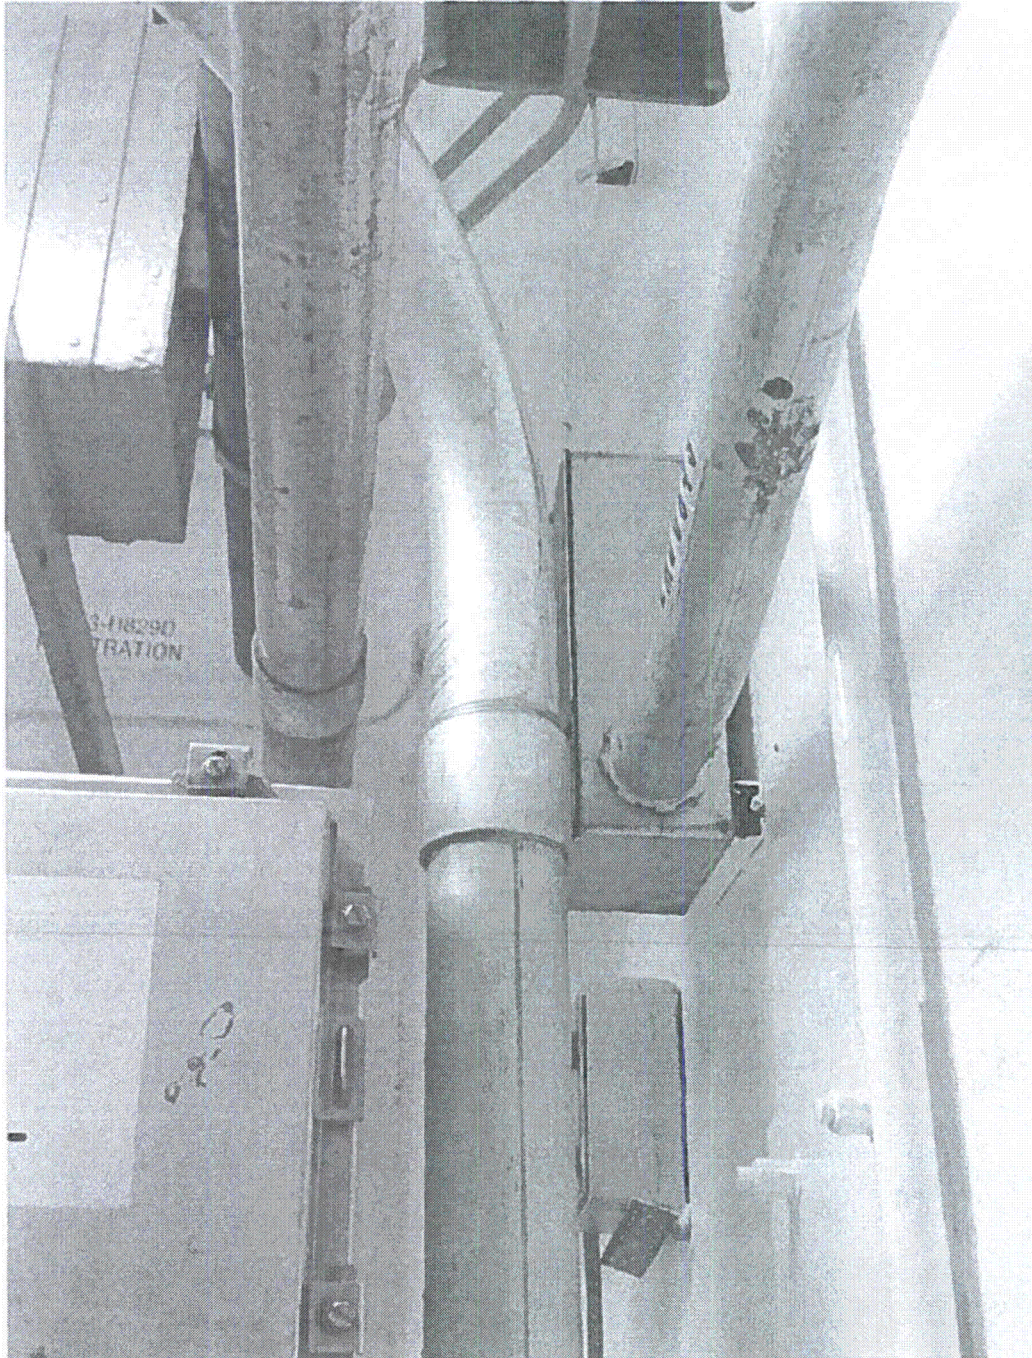
Figure 1 – Conduit and Electrical Box (Room C140)

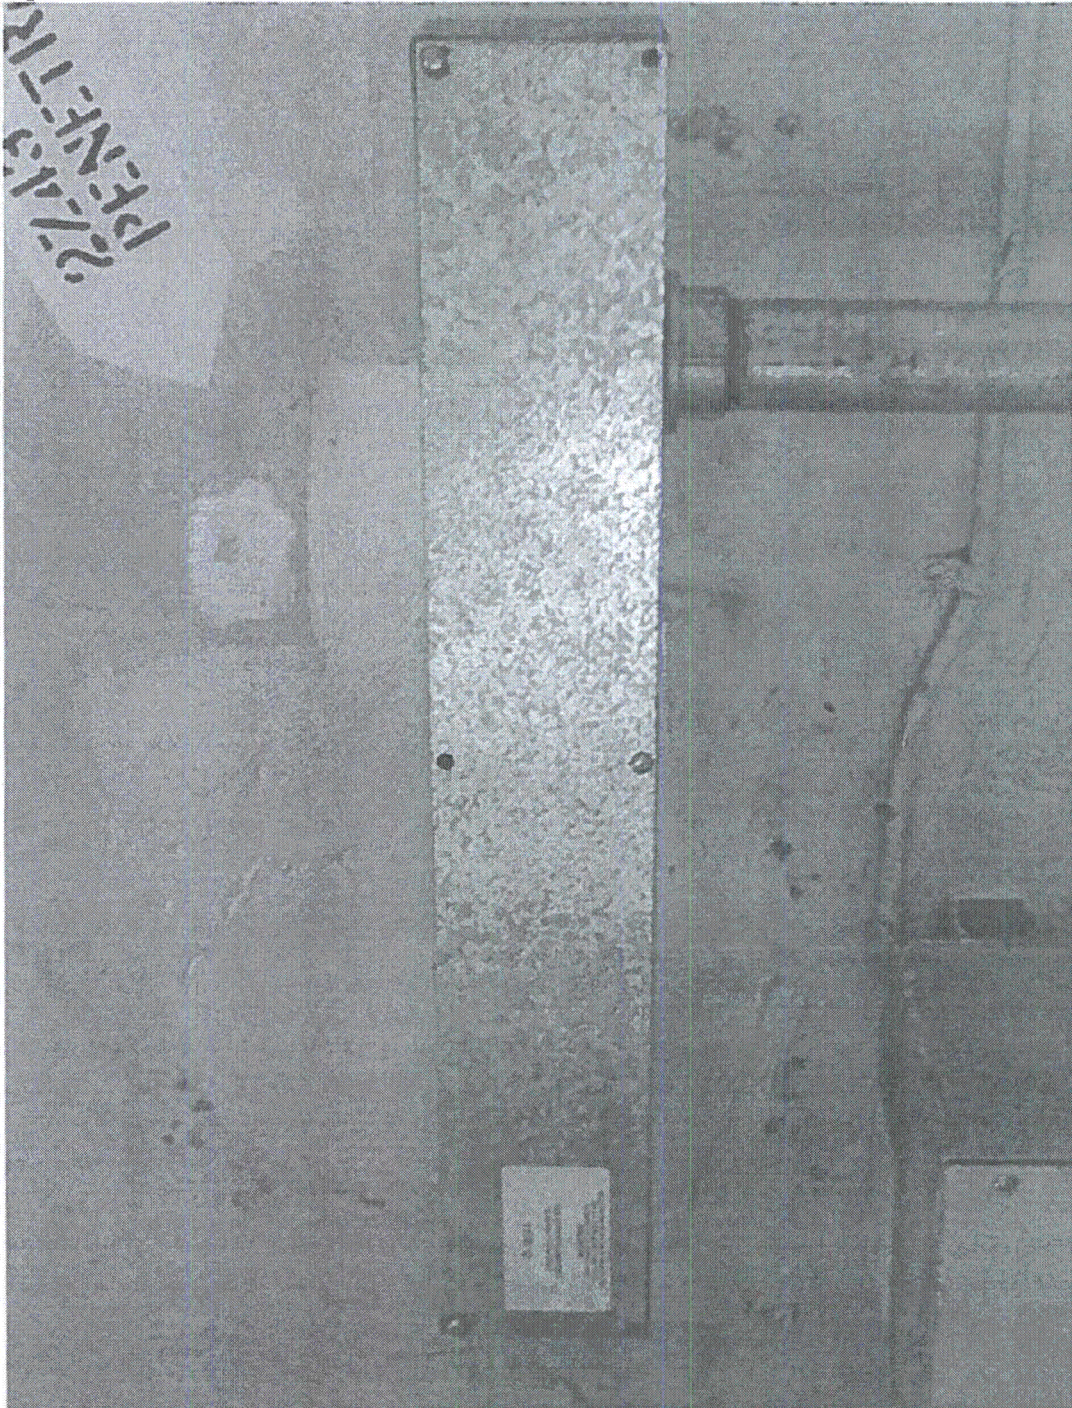
Figure 1 – Three Missing Cover Plate Screws (Unit 2 Station Battery Room 2A)

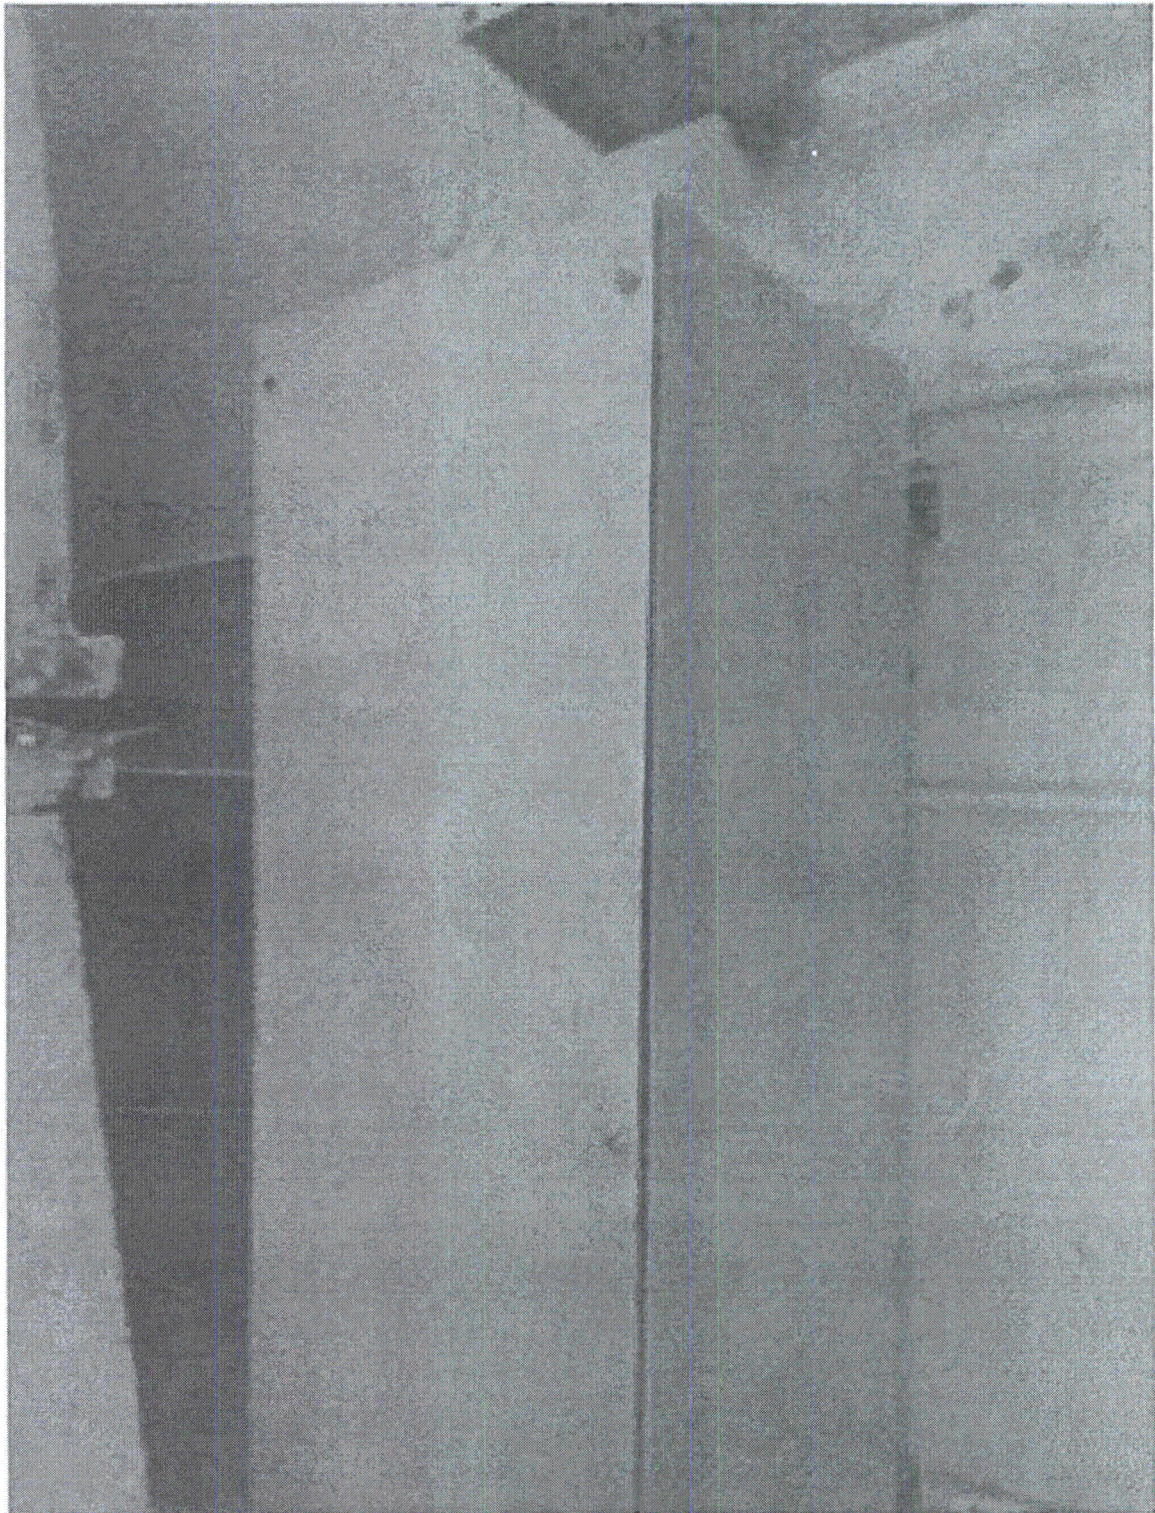
Figure 2 -- One Missing Cover Plate Screws (Unit 2 Station Battery Room 2A)
