Status: Y N U **Area Walk-By Checklist (AWC)**Location: Bldg. DIESEL Floor El. 130 Room, Area¹ SWITCHGEAR ROOM 2F**Instructions for Completing Checklist**

Area Walk-By Checklist (AWC)

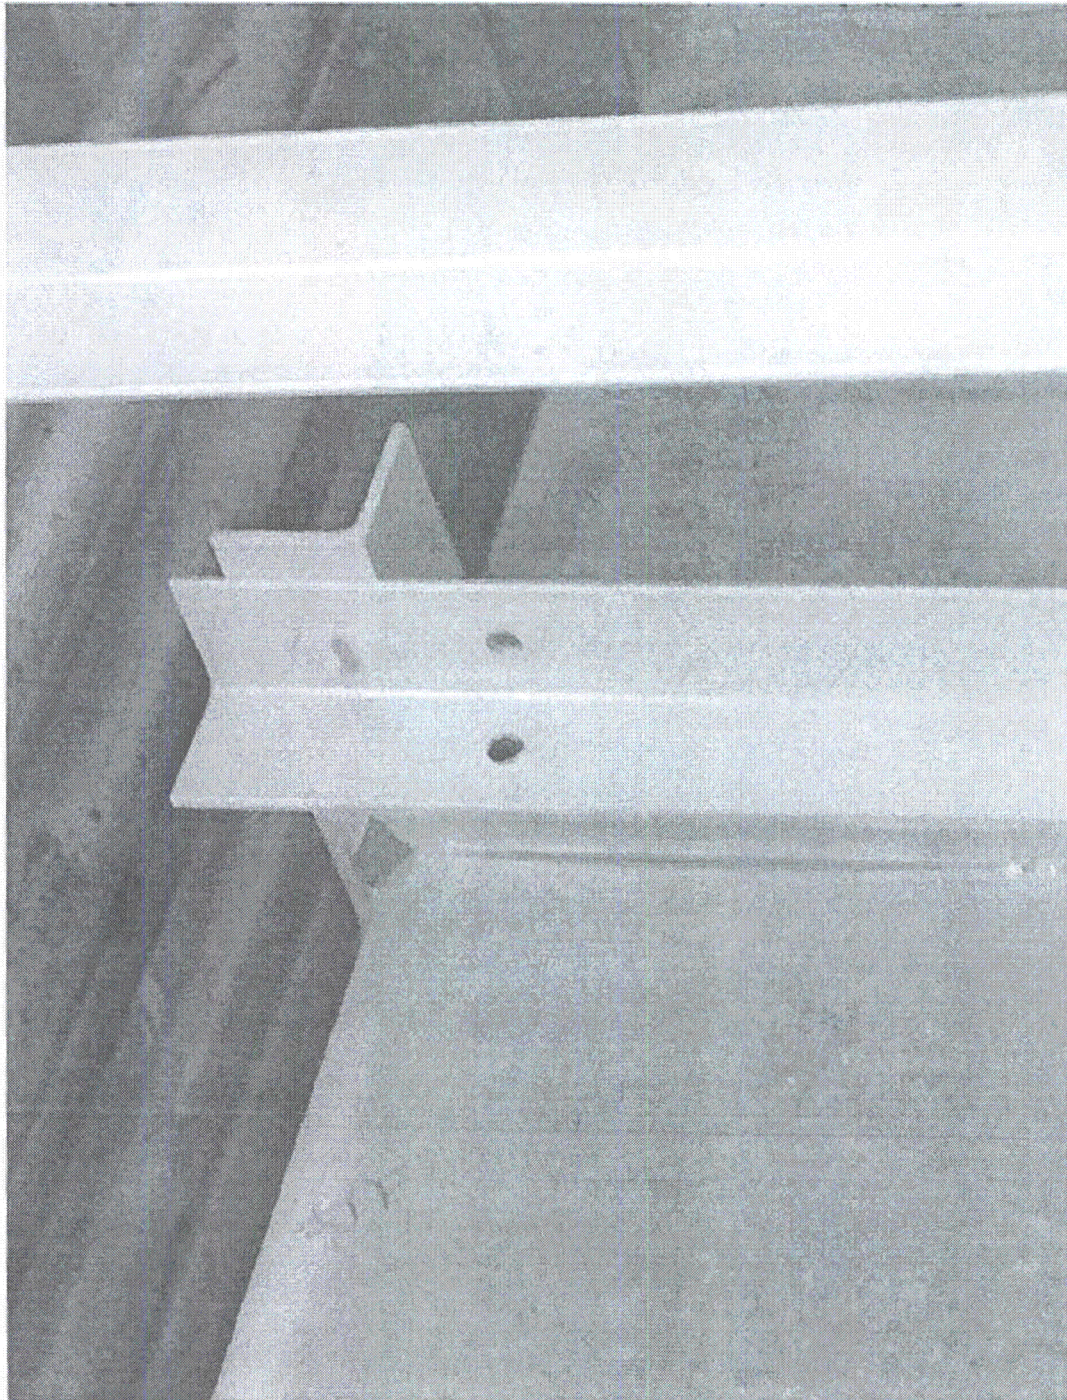
Figure 3 – Empty HVAC Bolt Hole (Unit 2 Station Battery Room 2A)
