Area Walk-By Checklists (AWCs)

Table D-1. Summary of Area Walk-By Checklists

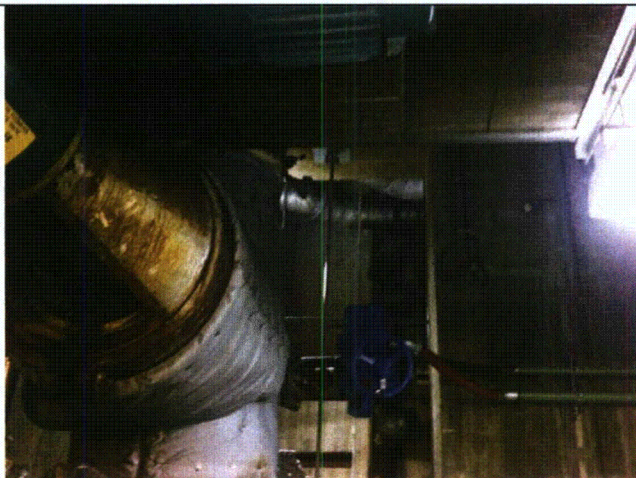
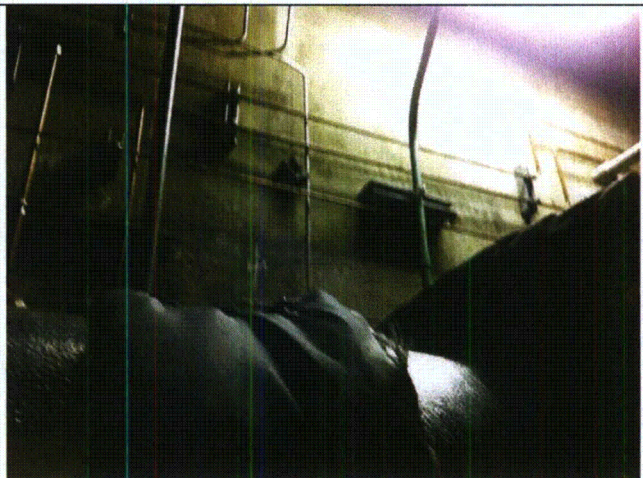
Instrument line FW-V-1073 second clamp not attached. Middle clamp misaligned. IR 1400290 - LOOSE/MISALIGNED MOUNTING CLAMP ON FW INSTRUMENT LINE addressed this. The Valve is a failed closed valve, therefore not a seismic concern.

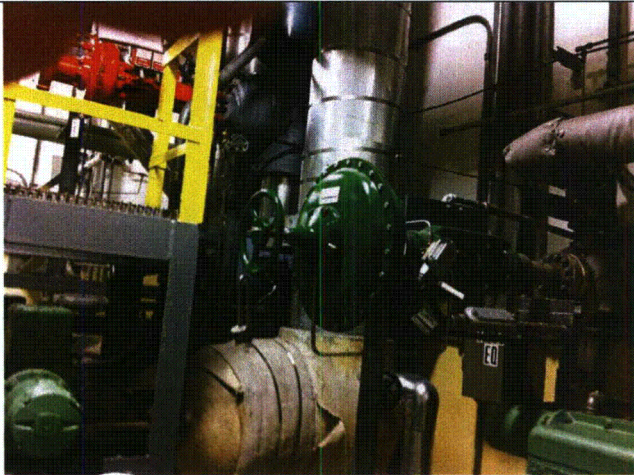
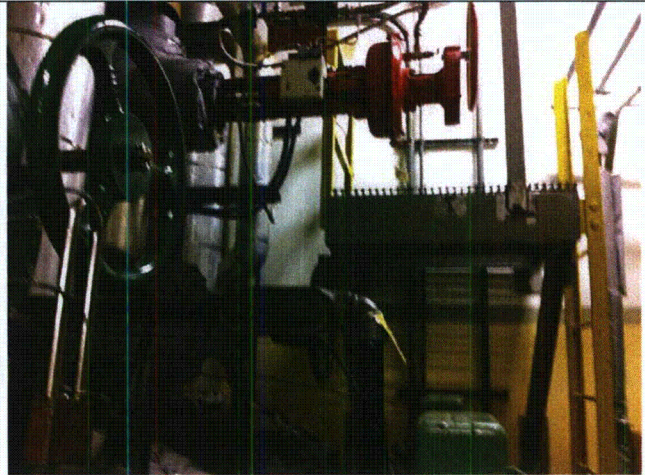
Vertical linear indications (Cracking) on wall, adjacent to 620 EQ, judged not to be a potential seismic concern.

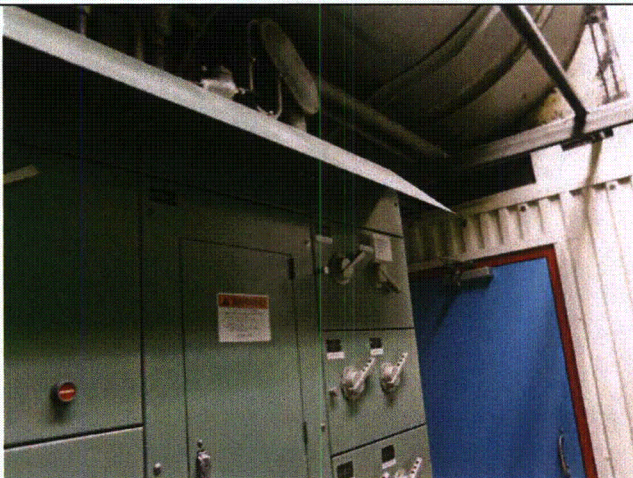
100_3765

Conduit elbow cover is purposely open and tagged. Not a seismic issue because no interactions exist above a non safety related panel IA Rad Waste Disposal. IR 1402066 is tracking this.

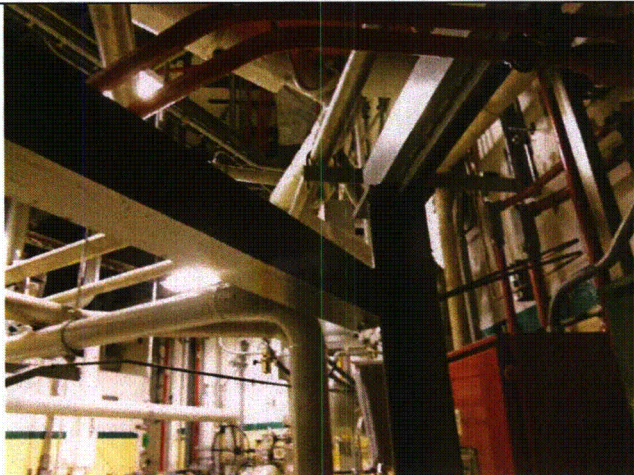
100_3821

Wall mounted Uni-strut support for instrument air IA-V-238 is skewed. Not Safety related. IR 1402062 – INSTRUMENT LINE SUPPORT CONFIGURATION is tracking this.

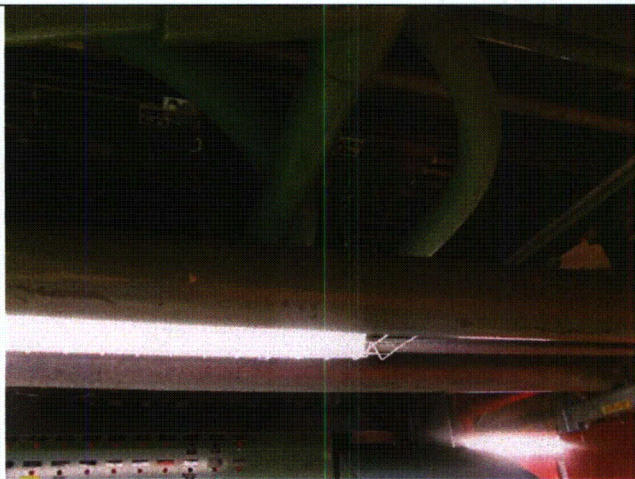
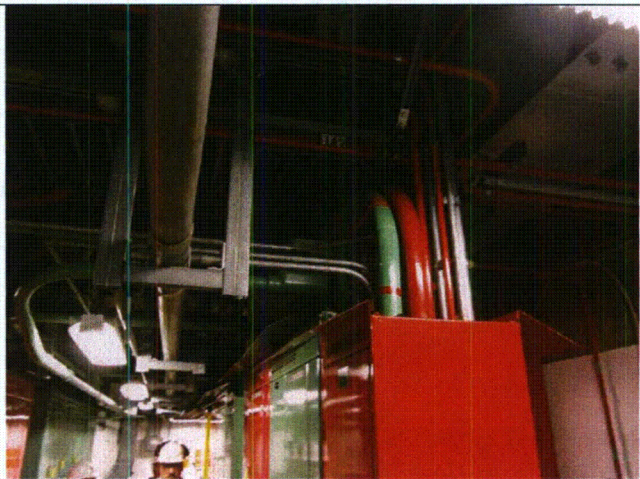
S-Hooks adjacent to junction box T855 needs to be crimped closed. This is not a seismic interaction issue because there is no equipment nearby the light that could potentially interact with.
S-Hooks in front of 2B needs to be crimped closed. This is not a seismic interaction issue because there is no equipment below the light.
This issue is generically addressed by IR 1401692.

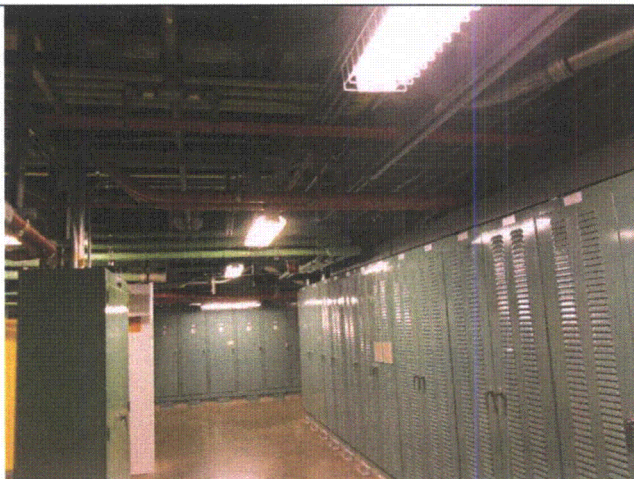
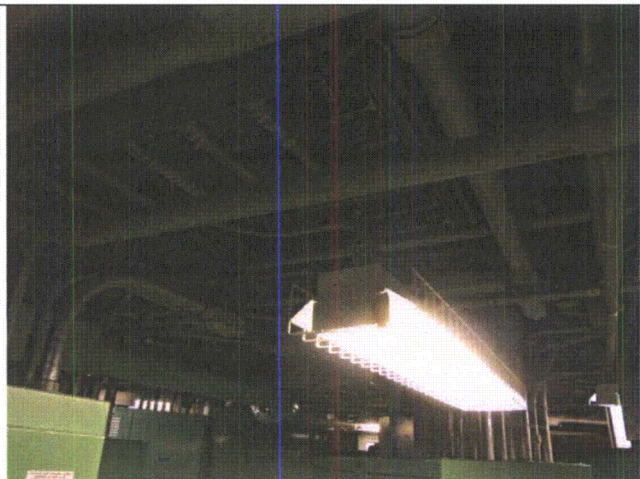
Overhead light in the vicinity of XCLA has S-Hooks that need to be crimped closed. This is not a seismic interaction issue because there is no equipment below the light. This issue is generically addressed by IR 1401692.

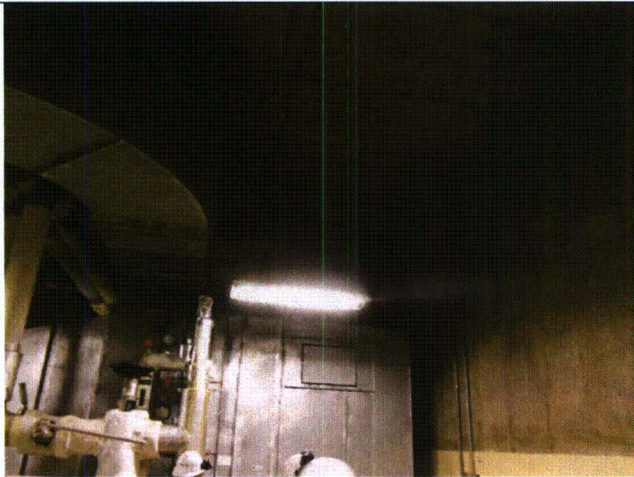
100_3377

AH-C-6B has surface oxidation near anchorage, judged not to be a potential seismic concern.

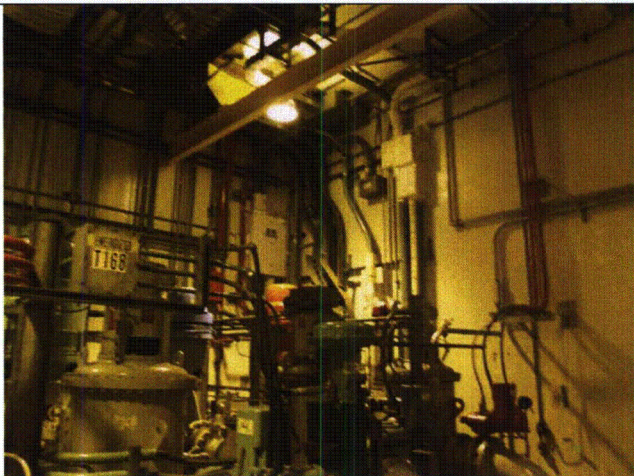
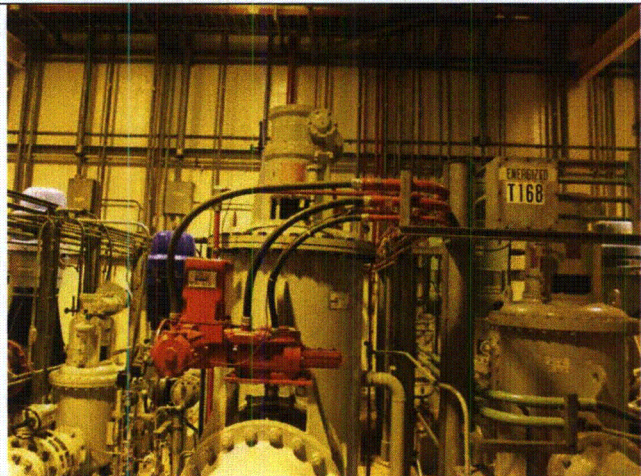
Support degraded for SW-PI-540B. This support is however for non safety related components.

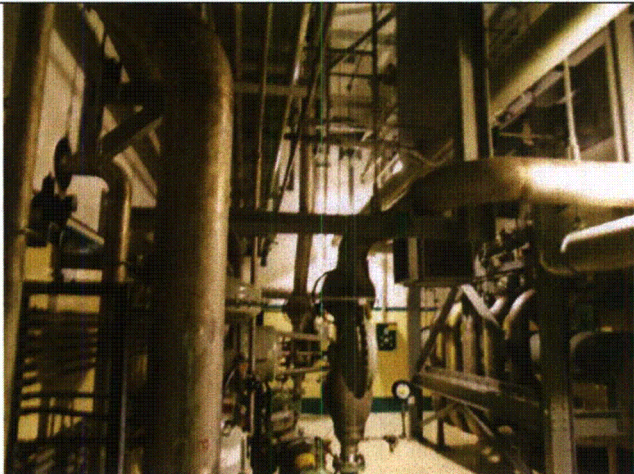
100_3261

Minor linear indications (Surface cracks) on floor, judged not to be a potential seismic concern.

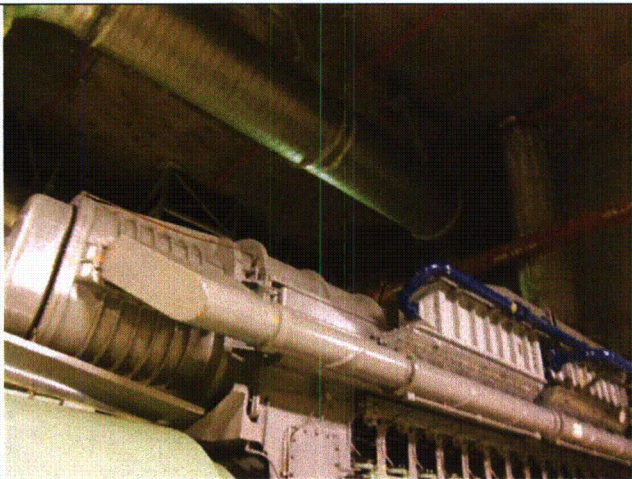
100_3118

Fire suppression piping on the east wall is not consistent with NFPA-13, however, there is no safety related equipment below. Therefore, there is no seismic interaction concern.

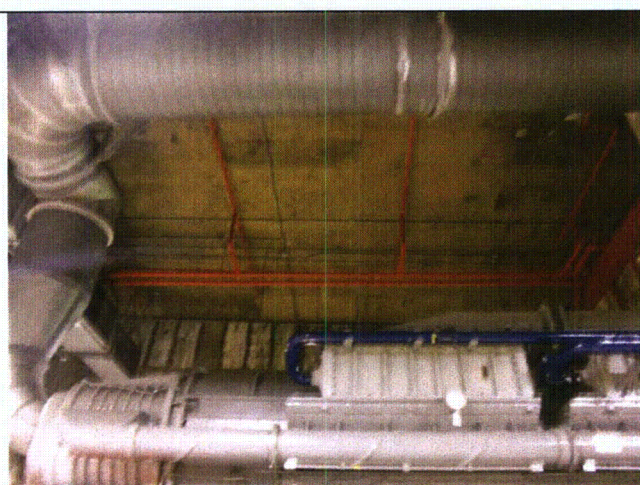
100_3132

Fire suppression piping on the east wall is not consistent with NFPA-13, however, there is no safety related equipment below. Therefore, there is no seismic interaction concern.
Fire suppression piping above diesel and associated safety equipment is consistent with NFPA-13

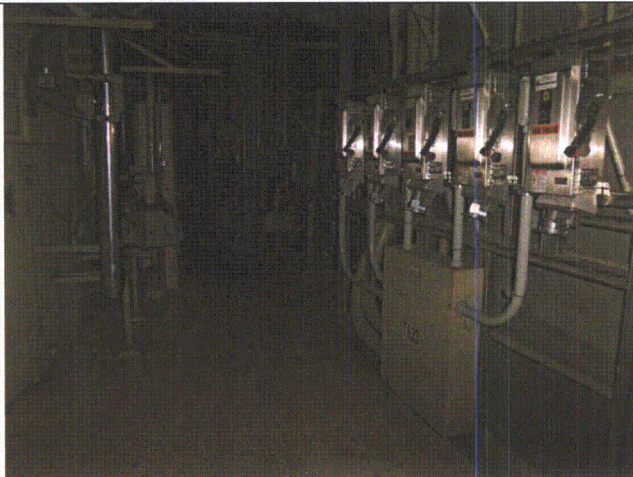
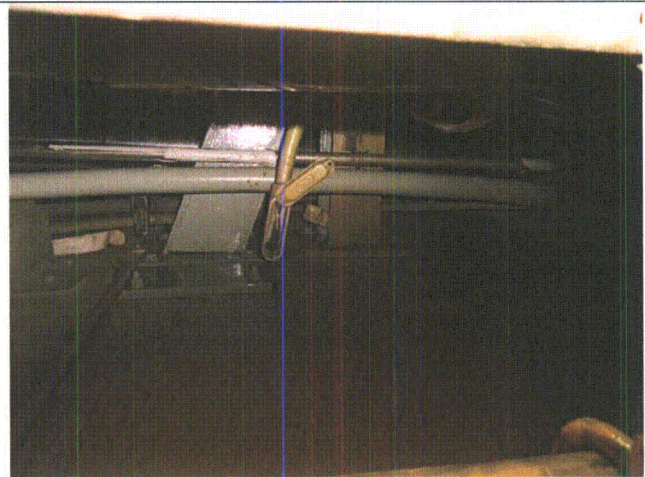
An electrical Conduit Cover near MS-PT-1184 was found to be open and held with one bolt out of two. Second bolt was missing. Addressed by IR 1404814
