**ATTACHMENT 9.6****SEISMIC WALKDOWN CHECKLIST FORM**

Status: Y  N  U **Seismic Walkdown Checklist (SWC) SWEL2- 004**Equipment ID No. PS-19-80A Equip. Class<sup>1</sup> 18 - INSTRUMENTS ON RACKSEquipment Description PRESSURE SWITCH (RK-10AA)Location: Bldg. RB Floor El. 303 Room, Area \_\_\_\_\_

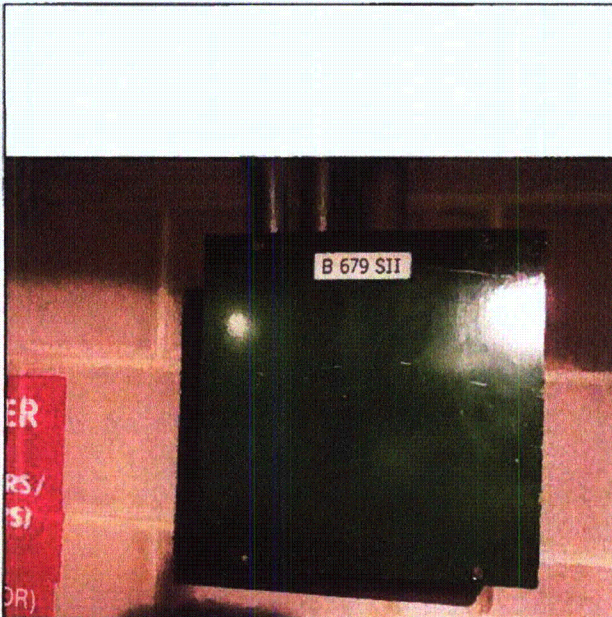
*Conduit # 44258 SII Junction box B679 SII, 2 screws missing on left side. Junction box is about 3' from the valve. Picture is attached.  
REF CR-VTY-2012-04870*

**Note:** Left side (top and bottom) screws are missing. Junction box is about 3' from the valve

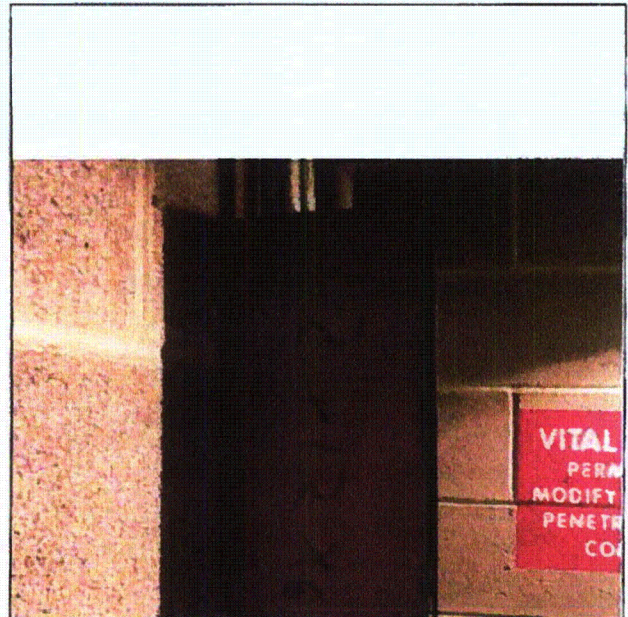
**Note:** Left side view of # B 679 SII showing gap resulting from missing screws.

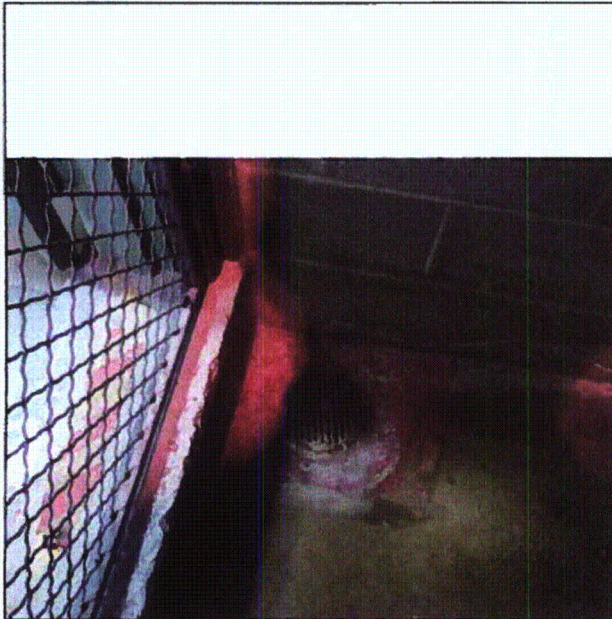
**Note:** Wall staining – possible drain backup. Not a seismic concern

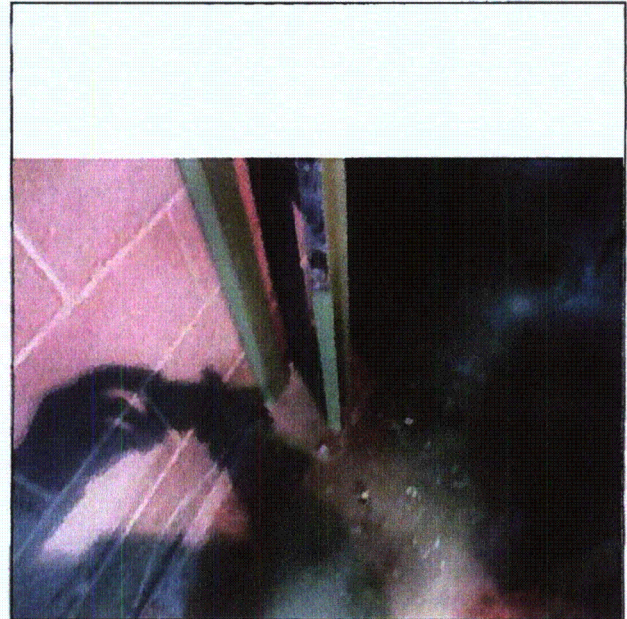
**Note:** Wall staining.

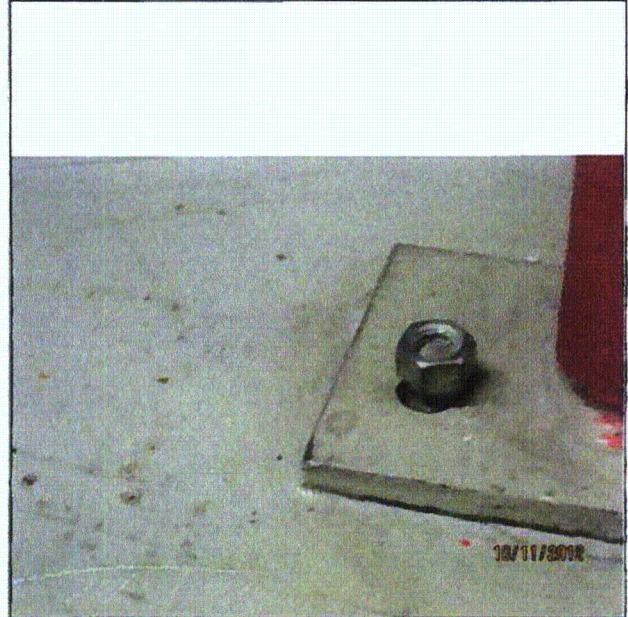
**Note:** Detail showing loose bolt on plate

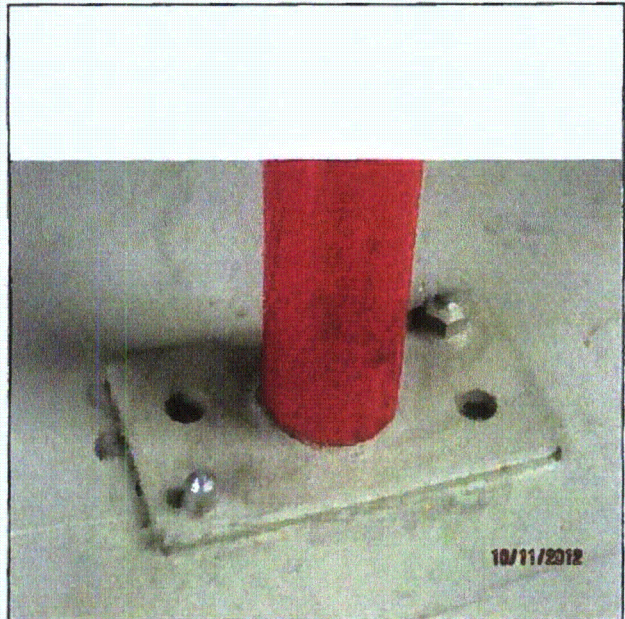
**Note:** Detail showing missing nut

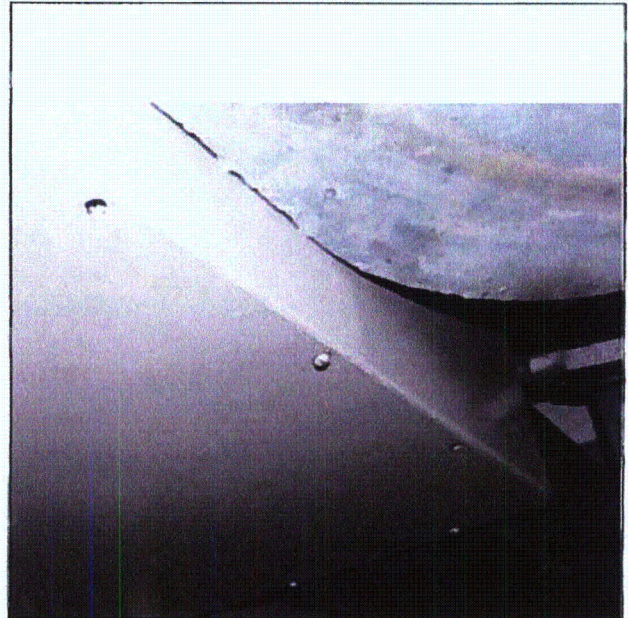
**Note:** Detail view showing 2 missing screws on access panel.

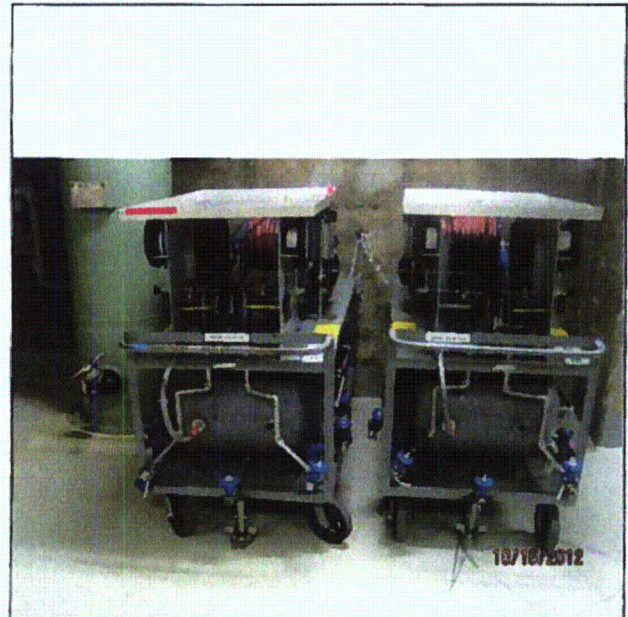
Note: Two wheeled leak test equipment secured.

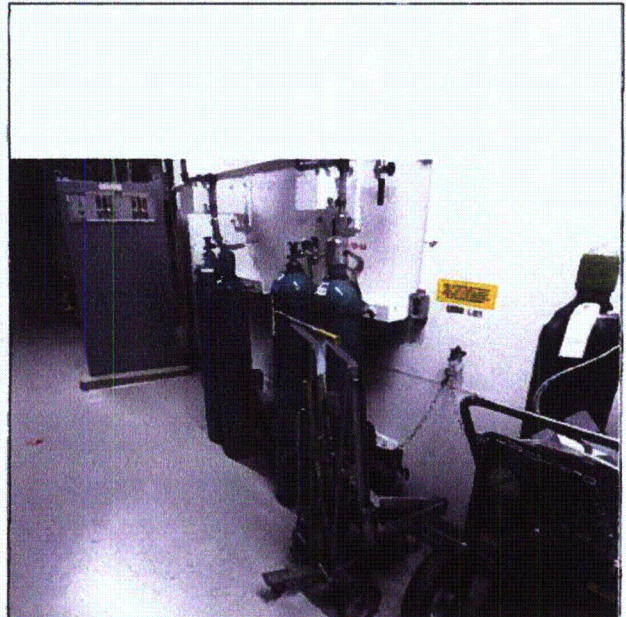
**Note: : CARTS ARE SECURED AND ARE LIGHT WEIGHT. NO SEISMIC IMPACT**

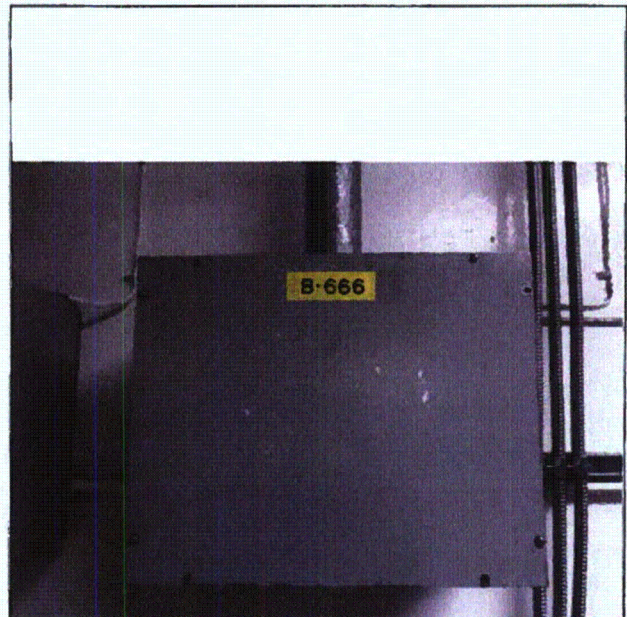
**Note:** MISSING SCREWS. THE BOX IS ABOUT 6' AWAY FROM THE CYLINDER REF CR-VTY-2012-05021

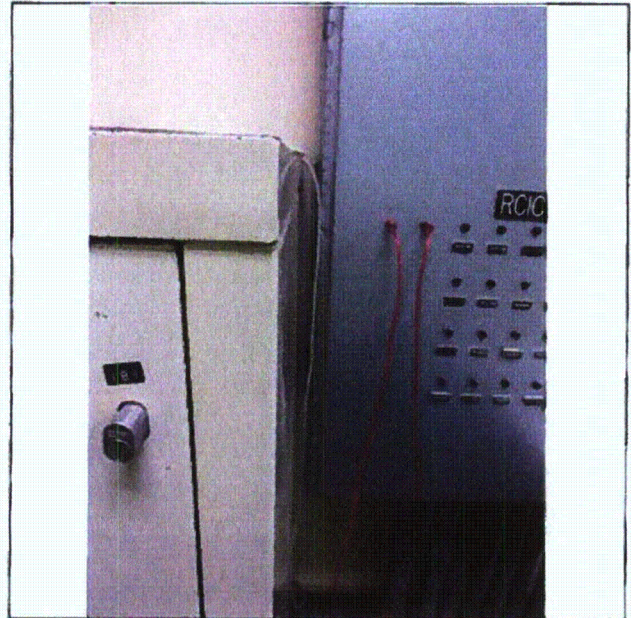
Note: Gap between filing cabinets and switch control panel.
