SUPPLEMENTAL SEISMIC WALKDOWN REPORT

SEISMIC WALKDOWN REPORT

This Supplemental Seismic Walkdown Report documents walkdowns performed at R.E. Ginna Nuclear Power Plant for components that were not accessible during the initial walkdowns and were not included in the Response to 10 CFR 50.54(f) Request for Information, Recommendation 2.3, Seismic [Ref. 3]. These seismic walkdowns did not identify any adverse seismic conditions that required licensing basis evaluations. Identified issues such as internal cabinet cleanliness and missing internal fasteners were entered into the station's corrective action program.

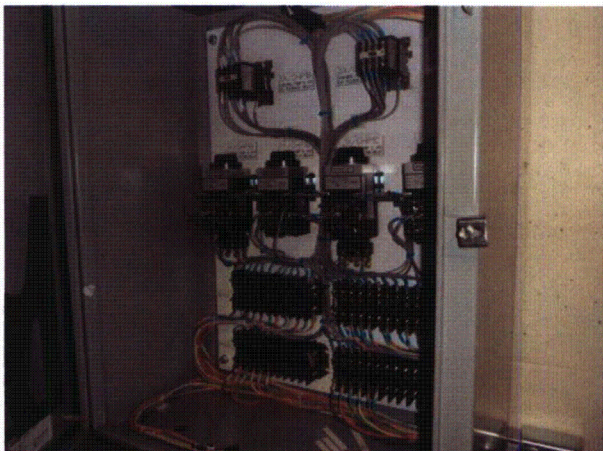
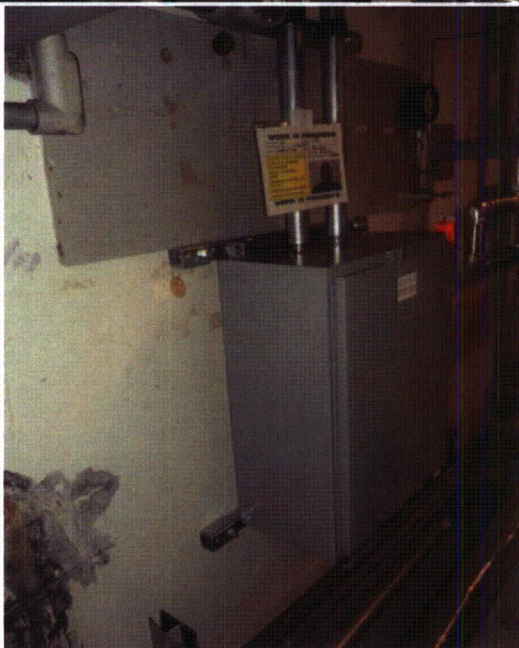
Equipment Description: CHARGING PUMP 1B / 1C MOTOR VFD RELAY CABINET

- **Adverse Conditions:** With the exception of one cabinet (ABCHP1B/1CRC), electrical cabinets were free of foreign material.

| Component ID | Potentially Adverse Seismic Condition | Action Taken to Address the Condition | Current Status |
|---|---|---|--|
| ABCHP1B/1CRC | Internal inspection of recently installed cabinet ABCHP1B/1CRC located several, spare, loose terminal deck labeling strips at the bottom of the cabinet. This condition is not consistent with electrical cabinet cleanliness and is considered foreign material. | CR-2012-008138 was issued. Electrical maintenance removed foreign material prior to closing cabinet | Current configuration acceptable. |

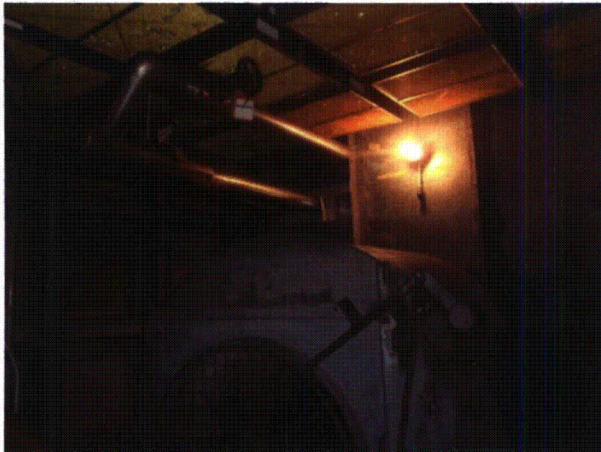
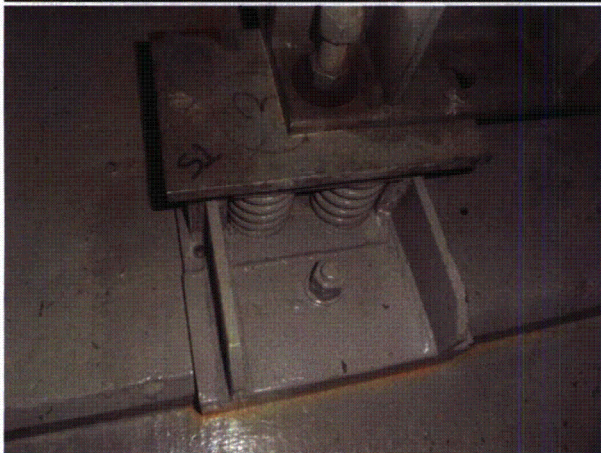
Equipment Description: CONTAINMENT RECIRCULATING FILTER AND COOLING UNIT C

Supplemental Anchorage Installed per MDCN-1740

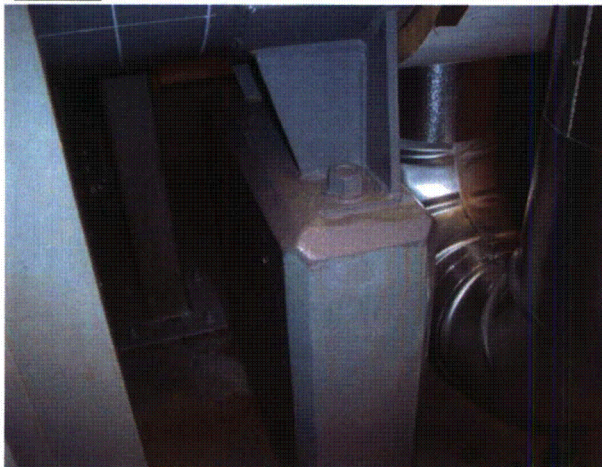
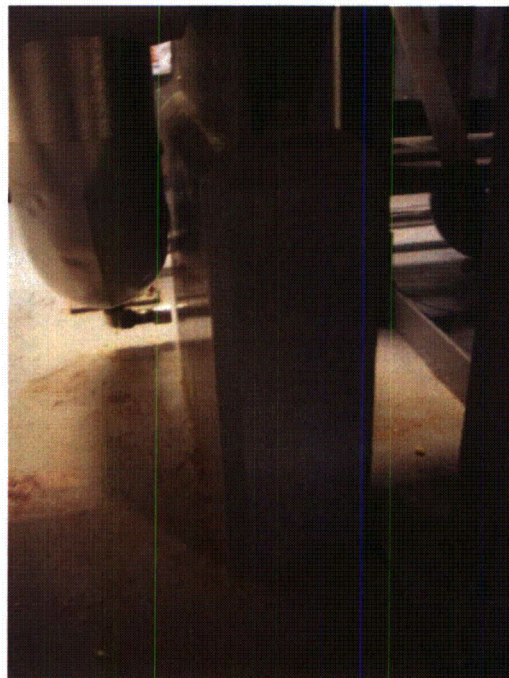
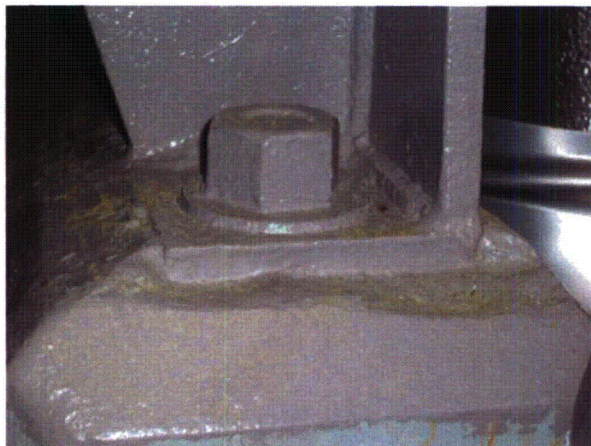
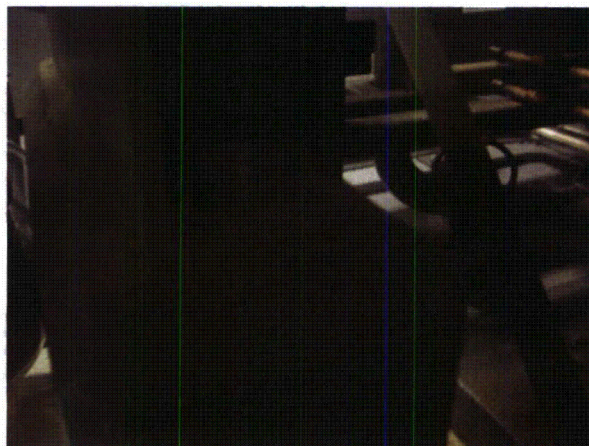
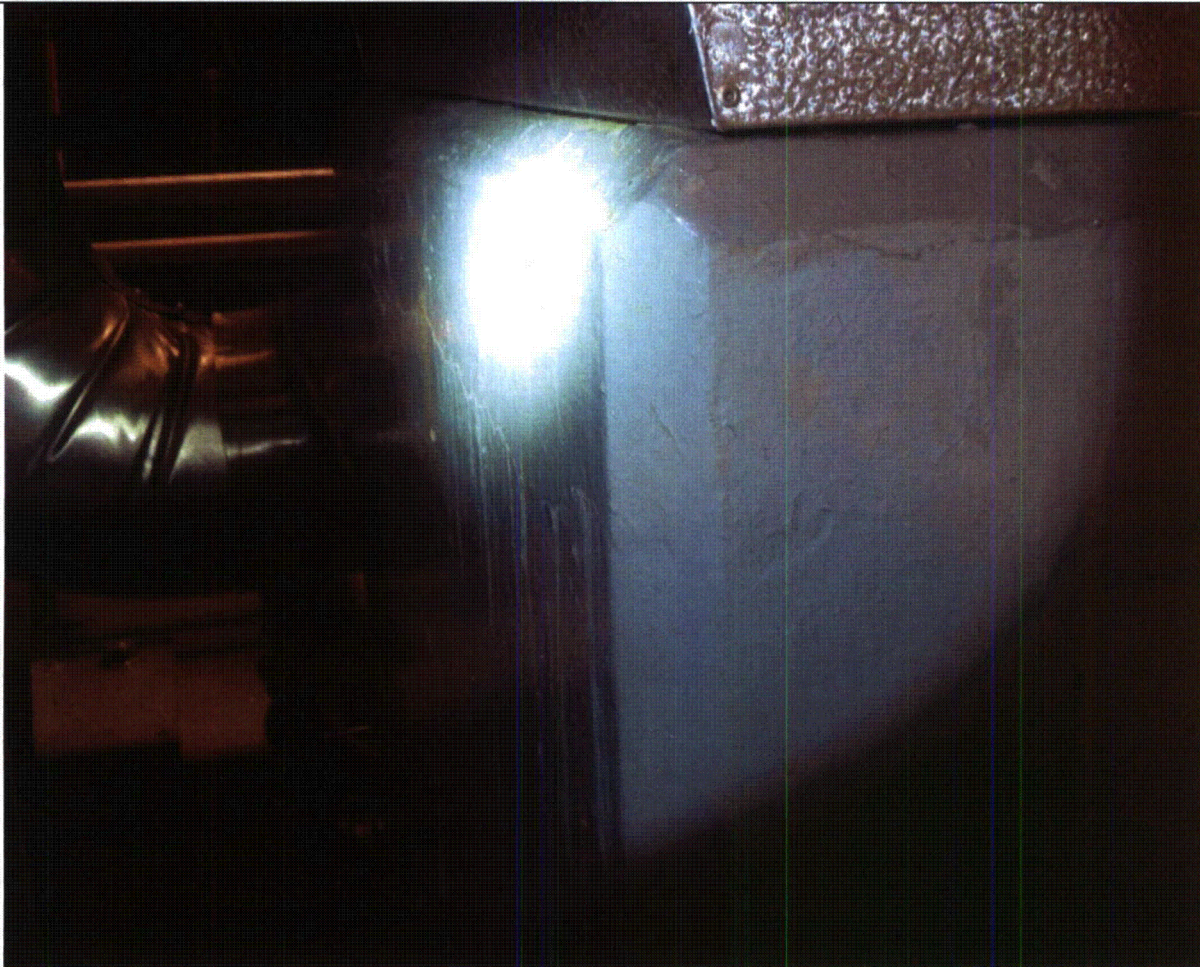
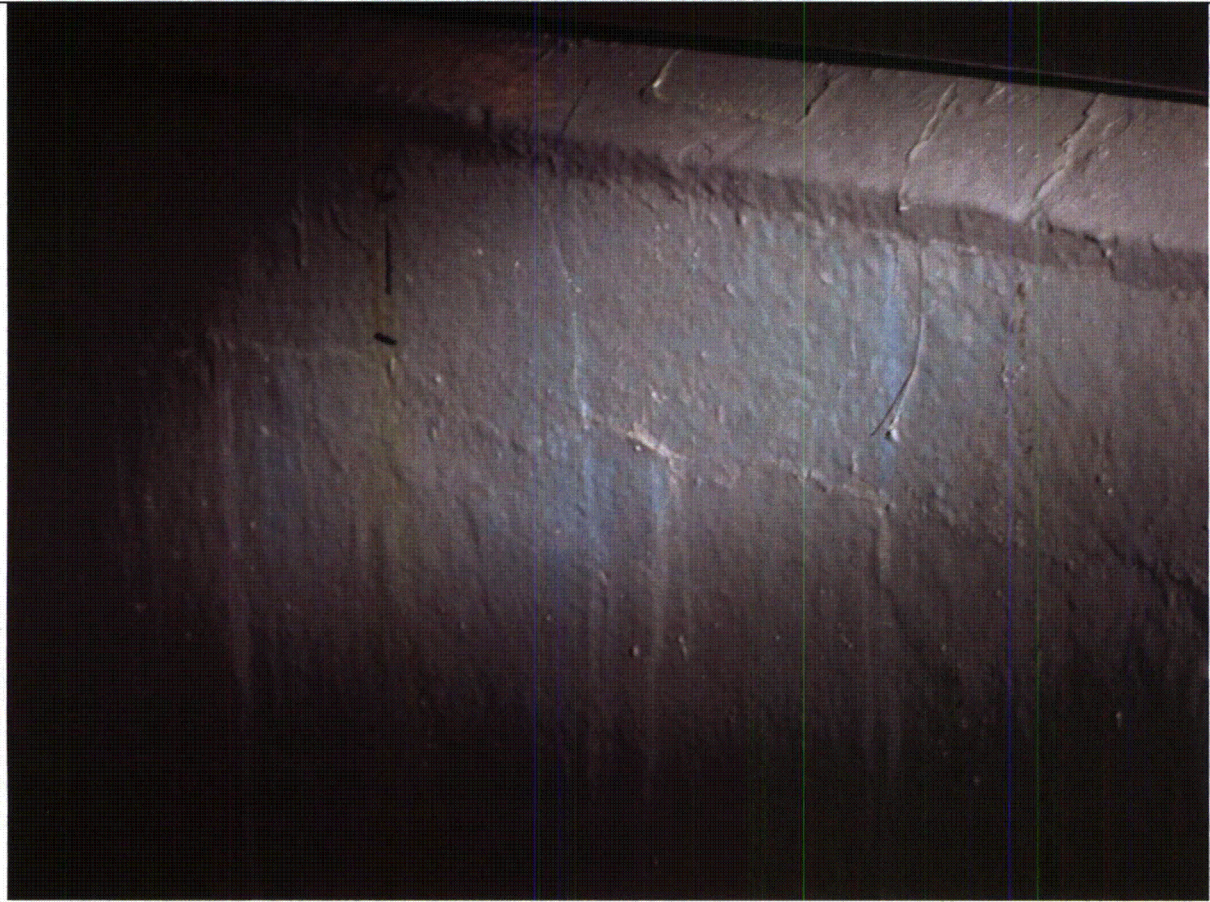
Equipment Description: SPENT FUEL POOL HEAT EXCHANGER A

| Component ID | Potentially Adverse Seismic Condition | Action Taken to Address the Condition | Current Status |
|---|---|---|---|
| EAC14 | Circumferential crack-like indication was identified on the East pedestal of the A SFP HX (EAC14). This crack is barely evident over applied paint. | CR-2012-008931 was initiated. Completed supplemental inspection of pedestal with senior civil engineer (Lead Peer Reviewer) | CR-2012-008931 documents evaluation of as-found condition considering crack is through entire pedestal. Based on anchor embedment depth the impact to the heat exchanger anchorage was determined to be negligible. |

| Item Tag No. | Equipment (GIP) Class | Walkdown Item | Location | Observations |
|---|---|---|---|--|
| EAC14 | 21 | SPENT FUEL POOL HEAT EXCHANGER A | AB-253 | Agree with identification of crack on pedestal. Completed supplemental walkdown with SWE.CR written, agree with disposition. |
