Seismic Walkdown Checklist (SWC)

Equipment ID No. ODG012 Equip. Class¹² (17) Engine Generators

Equipment Description E4 Standby Diesel Generator

Peach Bottom Atomic Power Station Unit 3
MPR-3812, Revision 3
Correspondence No. RS-12-173

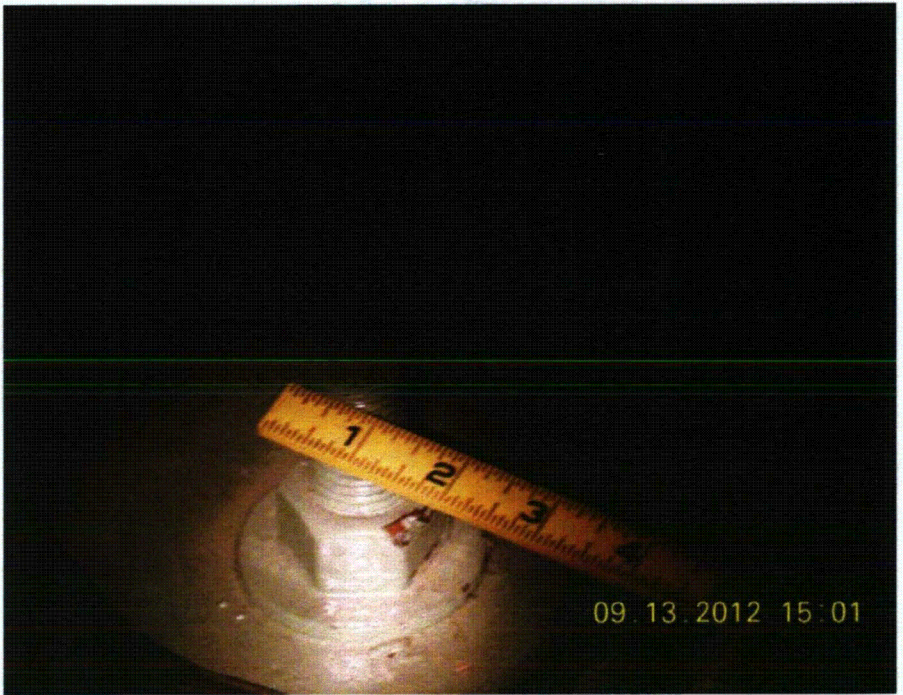
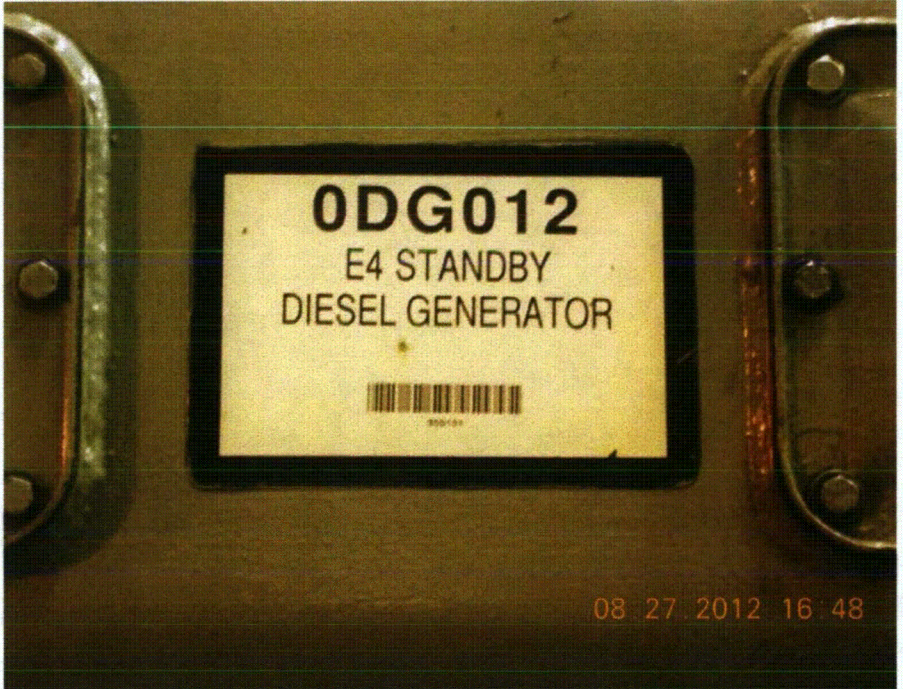
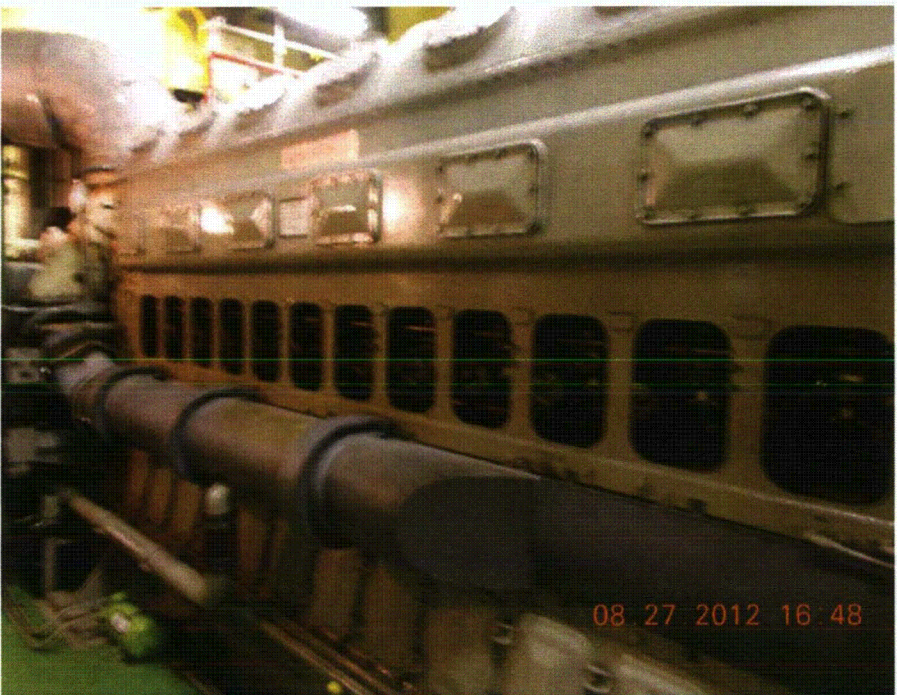
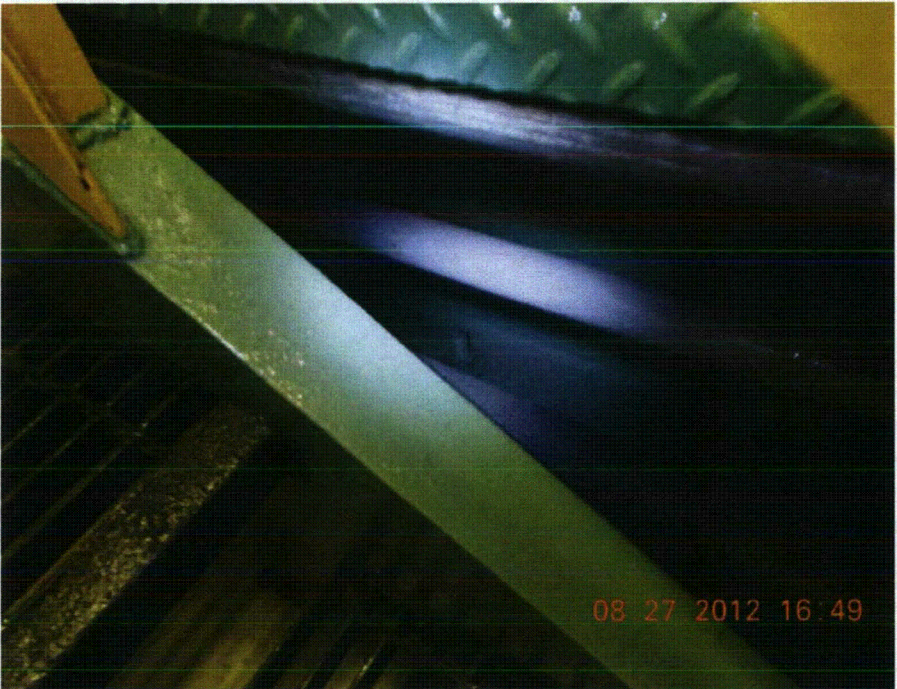
Equipment ID: ODG012

Does not match configuration evaluated in Calculation No. 6280-ES-155-1 (Rev. 1); as-built configuration has 1" anchor bolts securing skid to foundation instead of evaluated 1 1/4" anchor bolts. Judged acceptable for anticipated seismic loads per attached evaluation.

ANCHOR BOLT SIZE DISCREPANCY DOCUMENTED IN IR # 01438055 K6 11/9/12

7. Are soft targets free from impact by nearby equipment or structures? Y N U N/A
 TEMPERATURE GAUGE ON SCAVENGING AIR COOLER INLET COULD CONTACT ADJACENT LINE AND HOUSING COULD CRACK. WILL NOT AFFECT SAFETY FUNCTION
8. Are overhead equipment, distribution systems, ceiling tiles and lighting, and masonry block walls not likely to collapse onto the equipment? Y N U N/A
 FLUORESCENT LIGHT TUBES FALLING JUDGED CREDIBLE, BUT NOT SIGNIFICANT
9. Do attached lines have adequate flexibility to avoid damage? Y N U N/A
10. Based on the above seismic interaction evaluations, is equipment free of potentially adverse seismic interaction effects? Y N U

AS FOUND 1 " \varnothing BOLTS

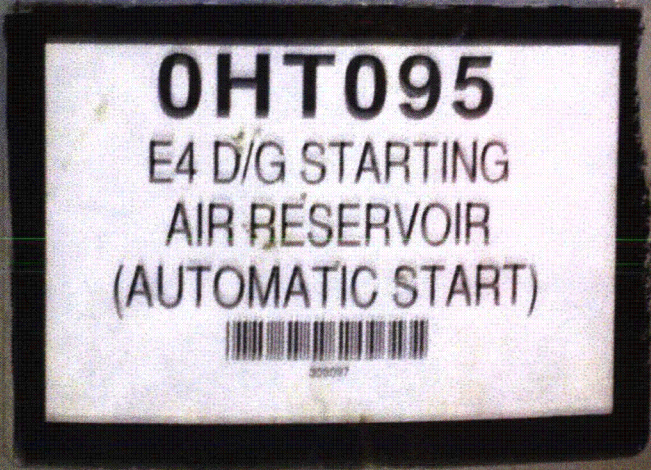
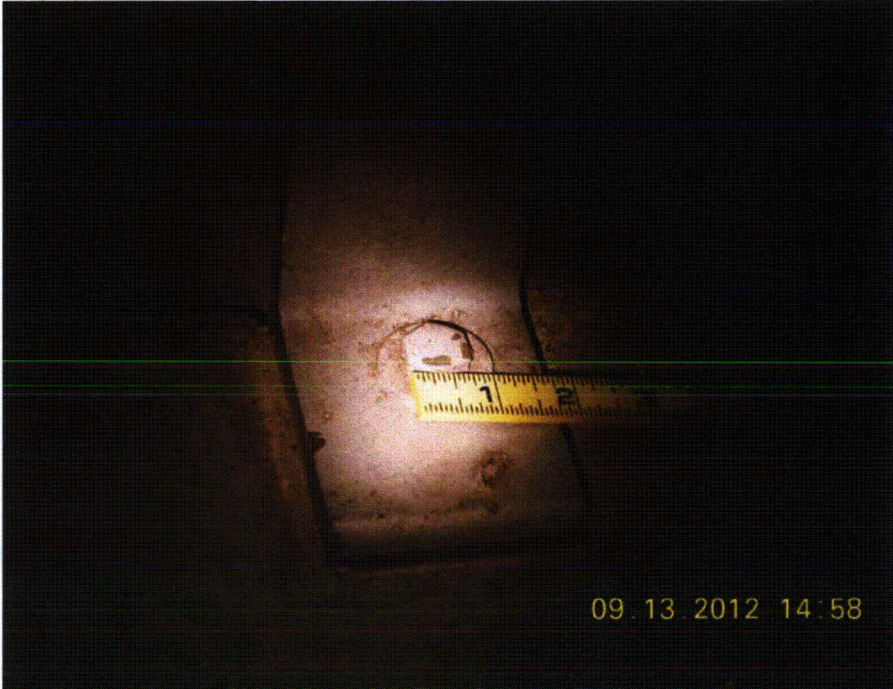
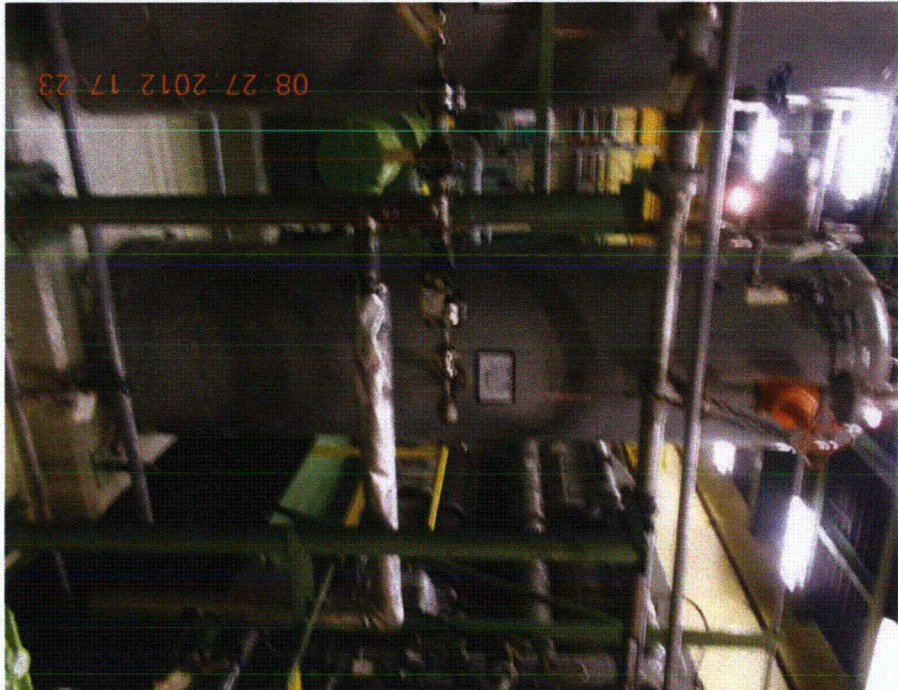
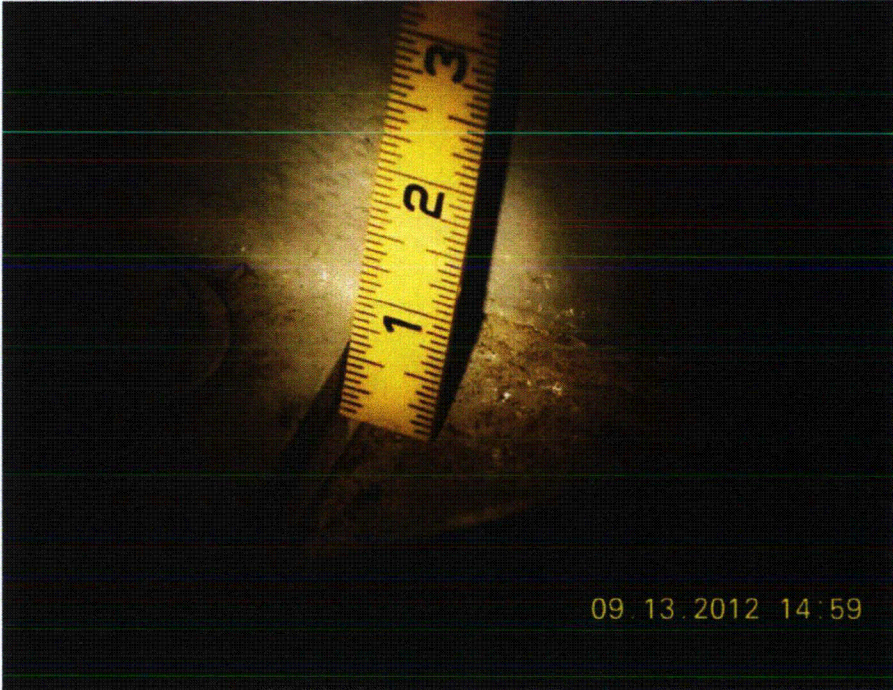
Equipment ID: OHT095

DISCREPANCY WAS EVALUATED PER NCR P900140 AND FOUND TO BE ACCEPTABLE. KE 11/5/12

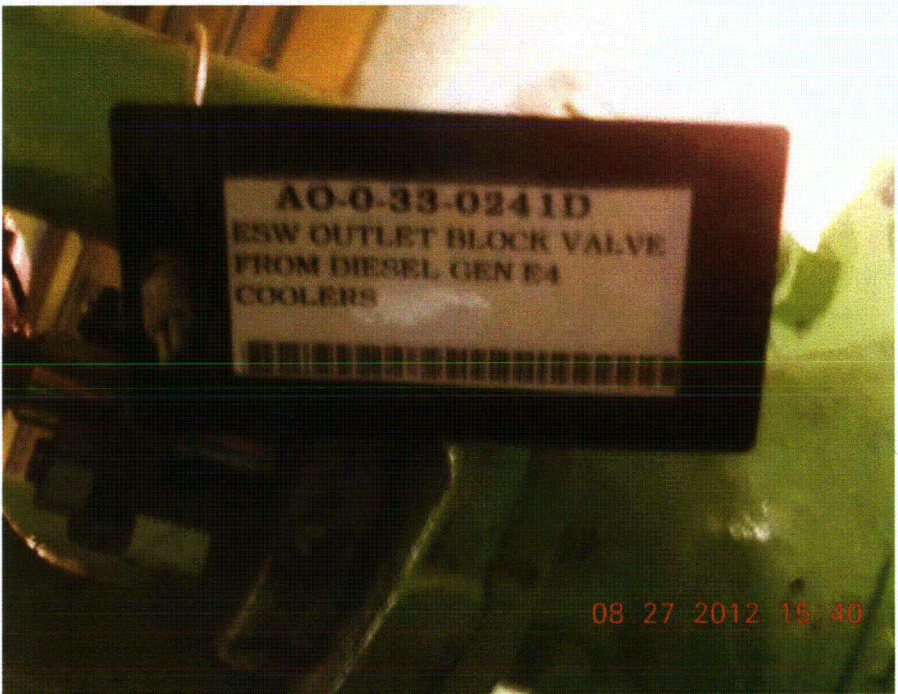
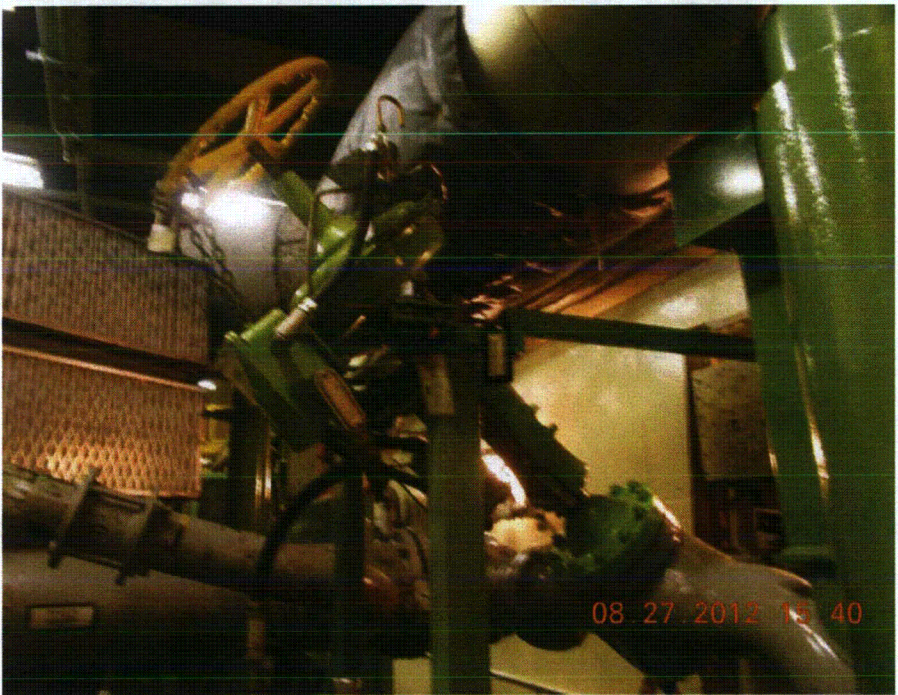
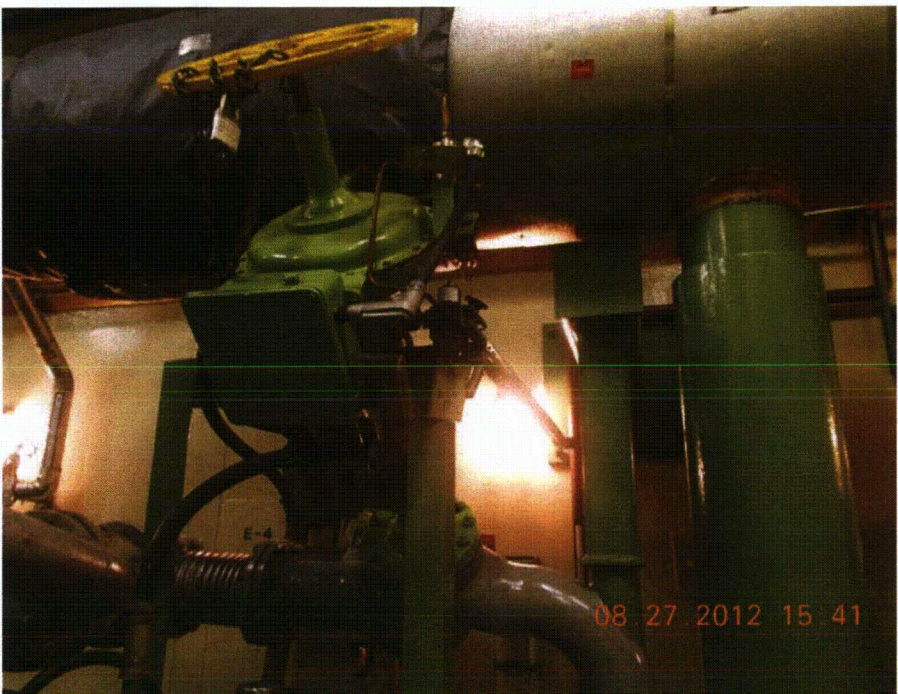
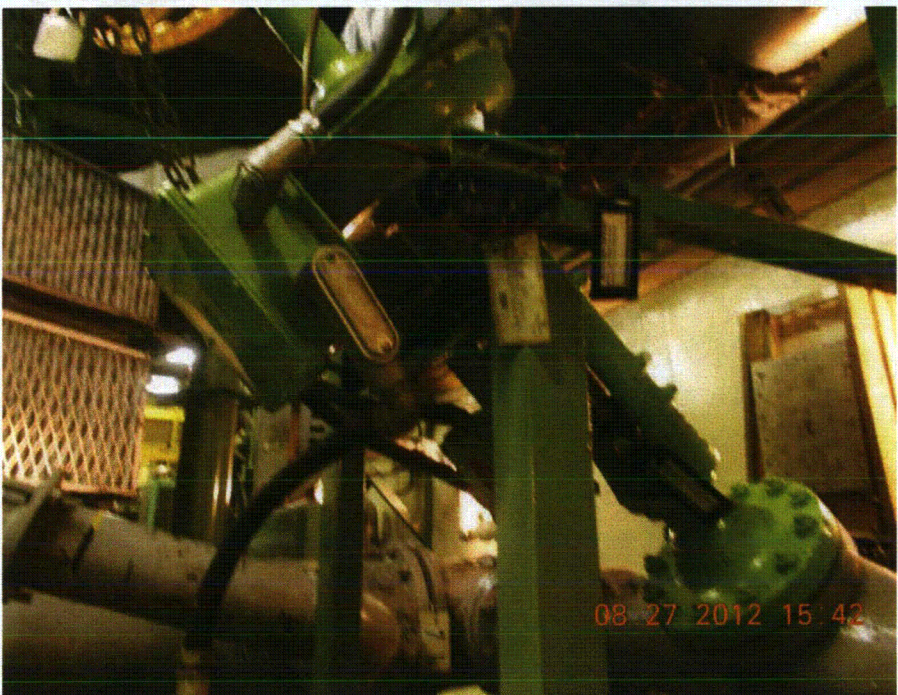
Equipment ID: AO-0-33-0241D

The lateral stiffnesses of the vertical support (two structural angles) attached to the operator of Air-Operated Valve AO-0-33-0241D and the pipe support (square structural tubing) attached downstream of the valve at the pipe elbow are calculated. The lateral stiffnesses of the supports are compared to help judge whether the valve being supported at two different locations (the diesel room wall and the top of the diesel engine base frame) could potentially cause damage to the valve during a seismic event.

The lateral stiffness of the pipe support is an order of magnitude stiffer than the support at the valve operator. Thus, if there is any differential motion between the wall of the diesel room and the diesel engine base frame during a seismic event, the support at the valve operator will easily displace without imparting significant load to the valve operator. Additionally, a structural joint was not observed between the floor of the diesel room and the wall of the diesel room so any differential displacement between these two locations will be very small. The diesel engine baseframe is securely attached to the floor, and the base frame is very stiff, so the top of the base frame (where the operator support is anchored) should displace with the floor.
