Seismic Walkdown Checklist (SWC)

Peach Bottom Atomic Power Station Unit 2
MPR-3815, Revision 3
Correspondence No. RS-12-173

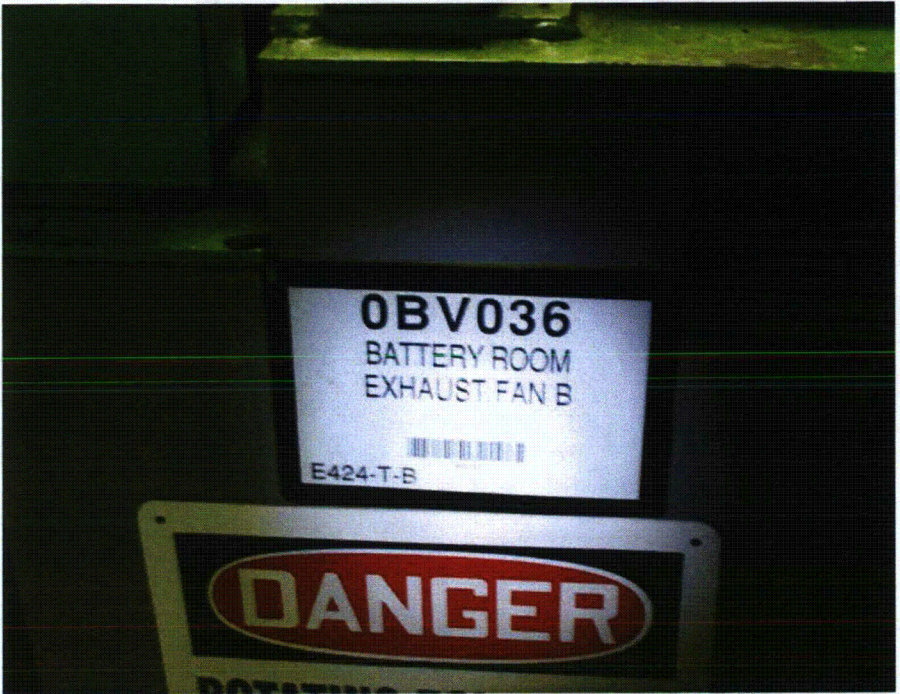
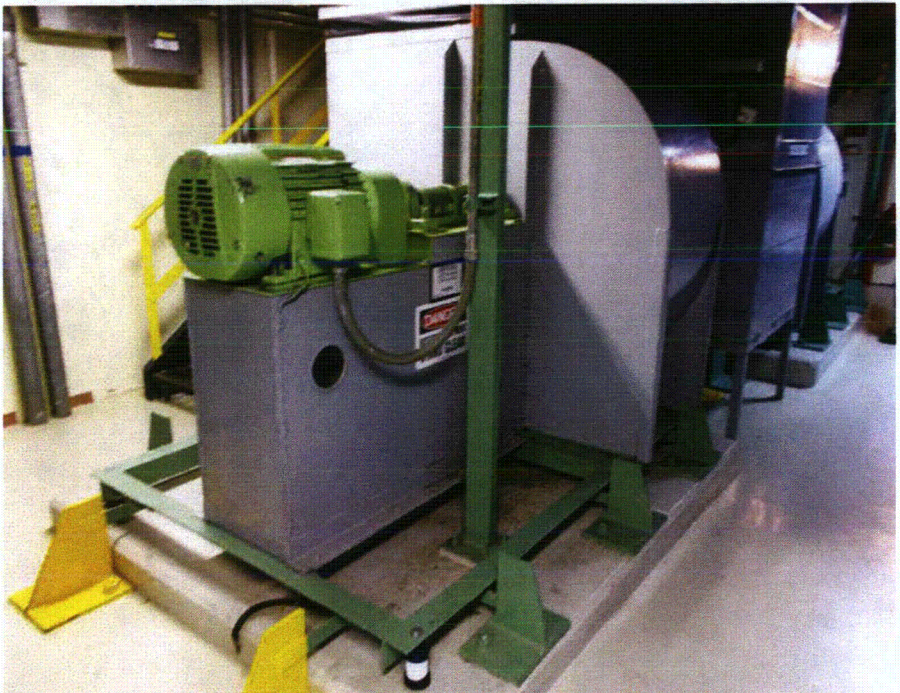
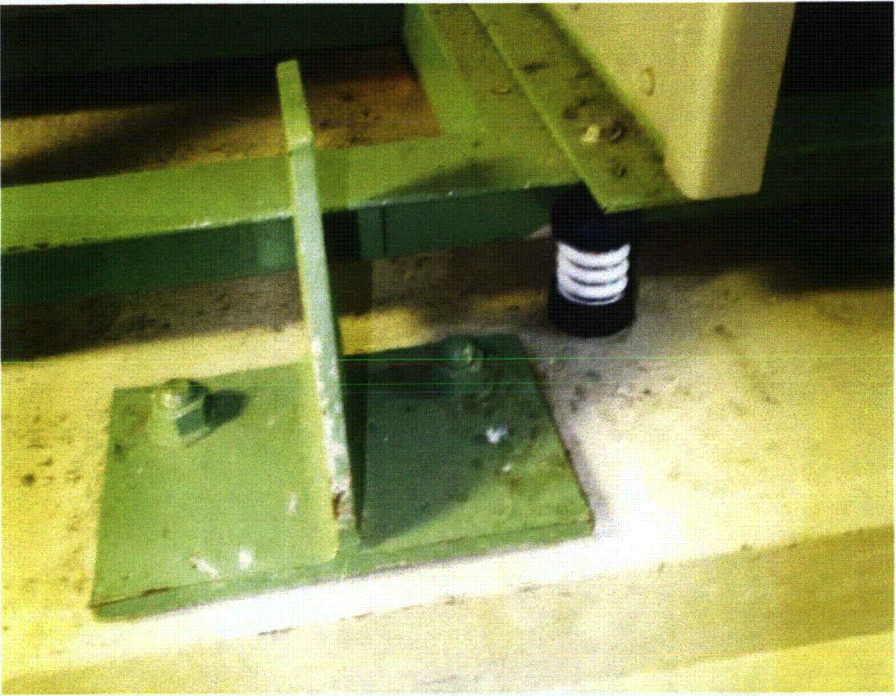
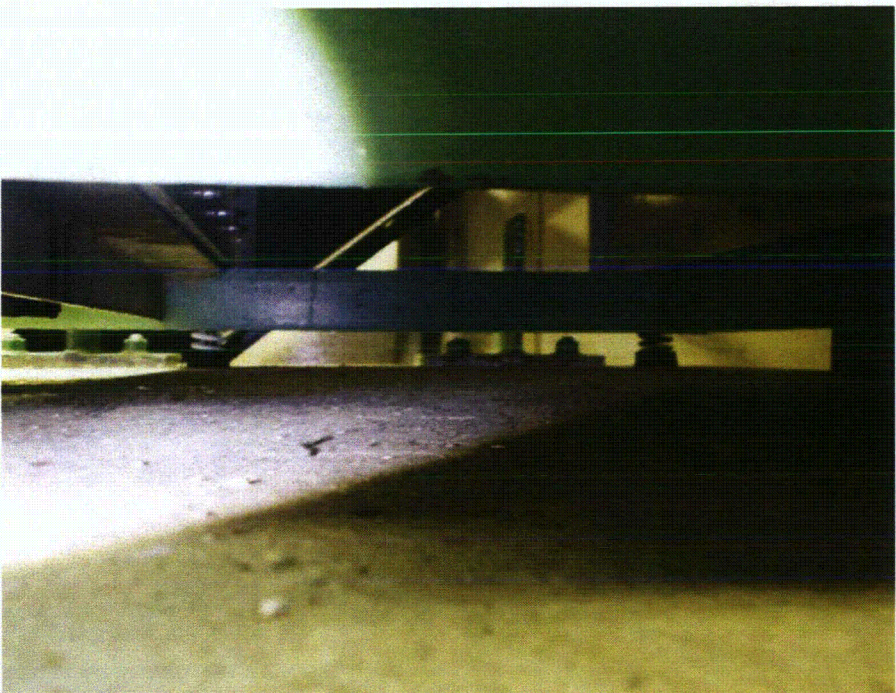
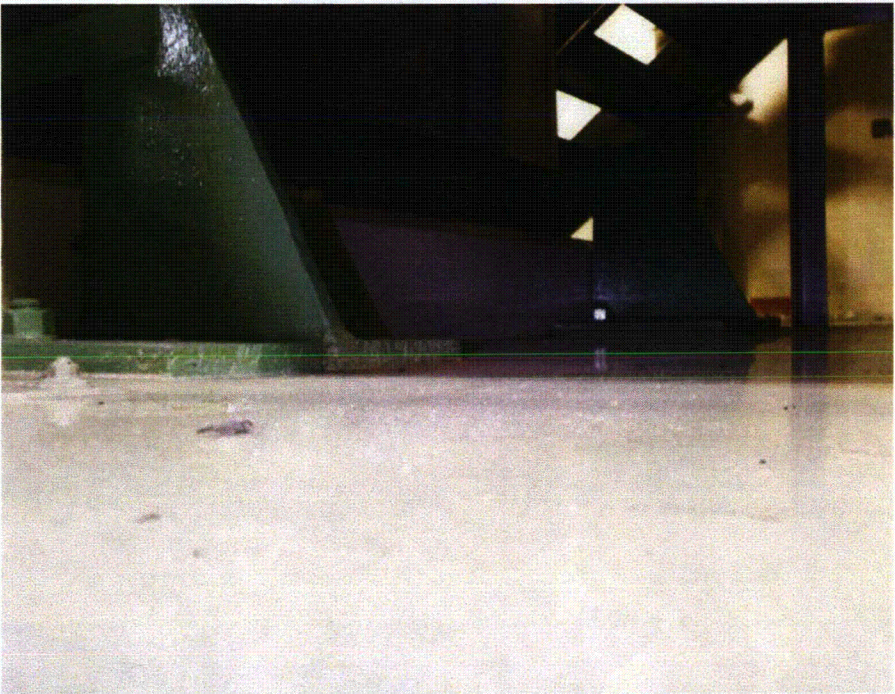
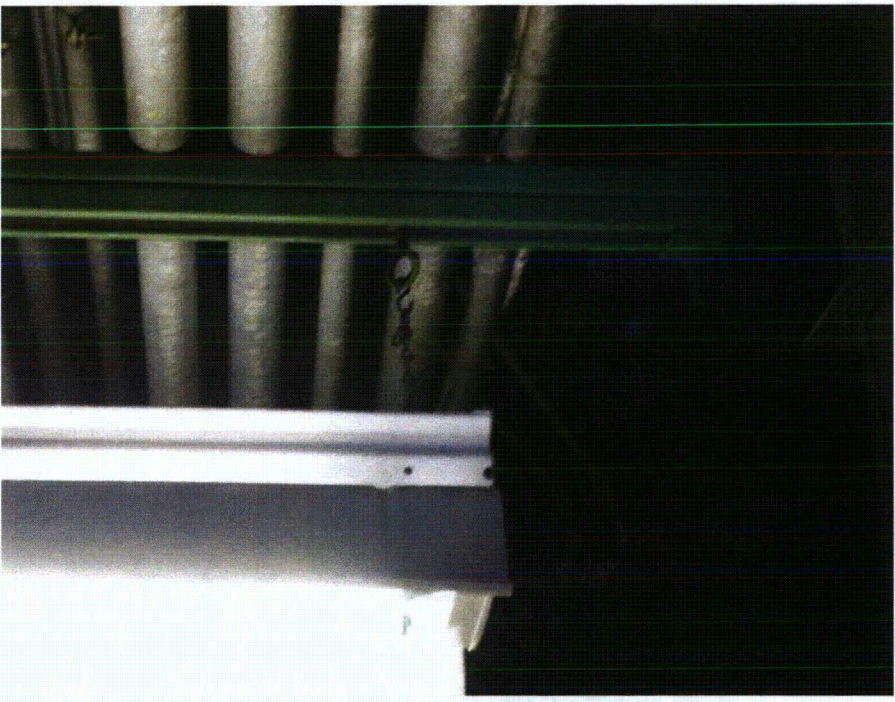
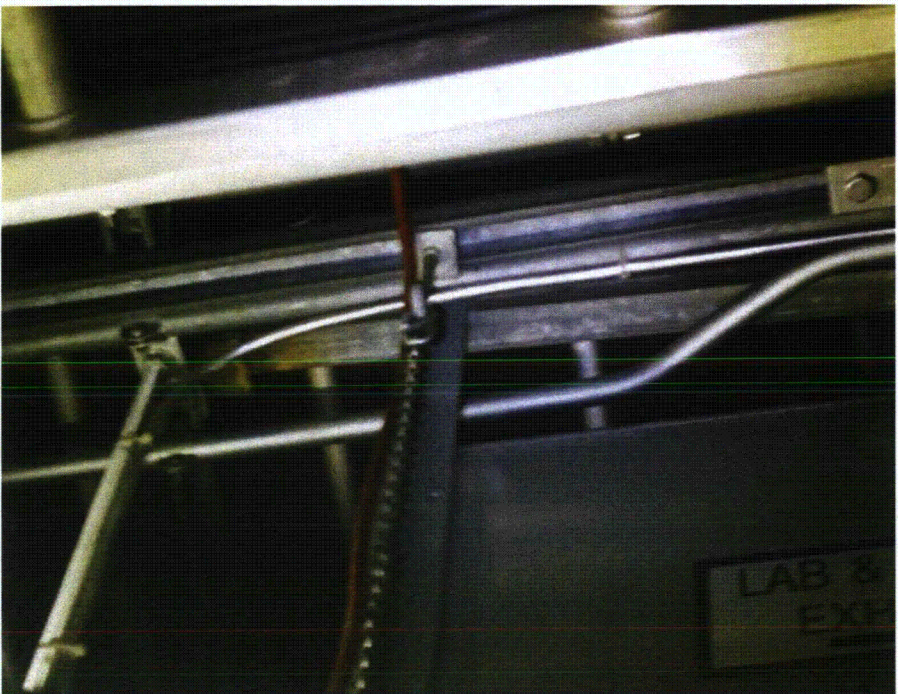
Equipment ID: OBV036

*Overhead fluorescent light fixture has open S hooks.
No soft targets in vicinity, so no issue.*

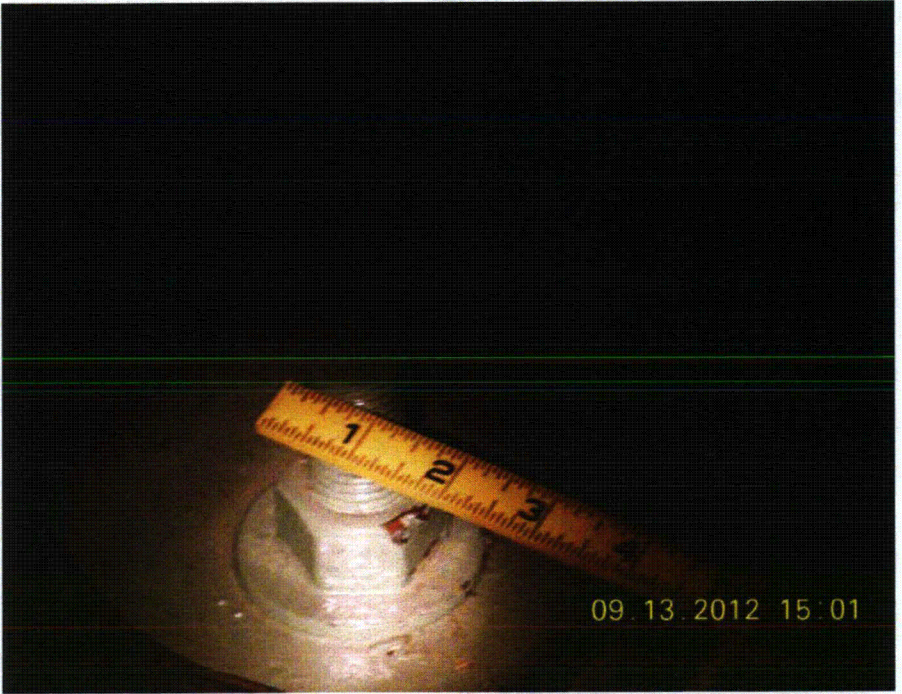
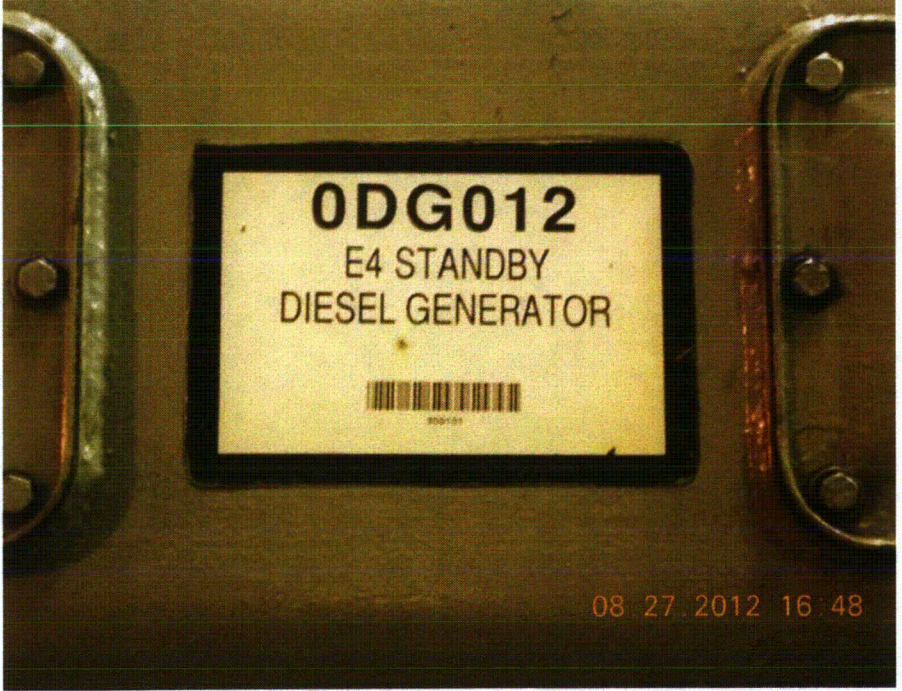
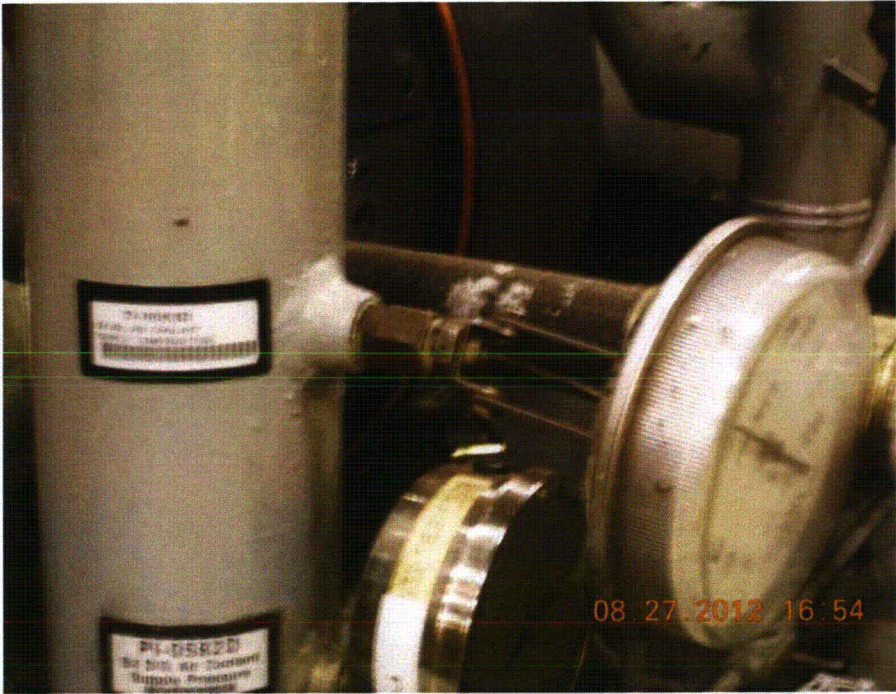
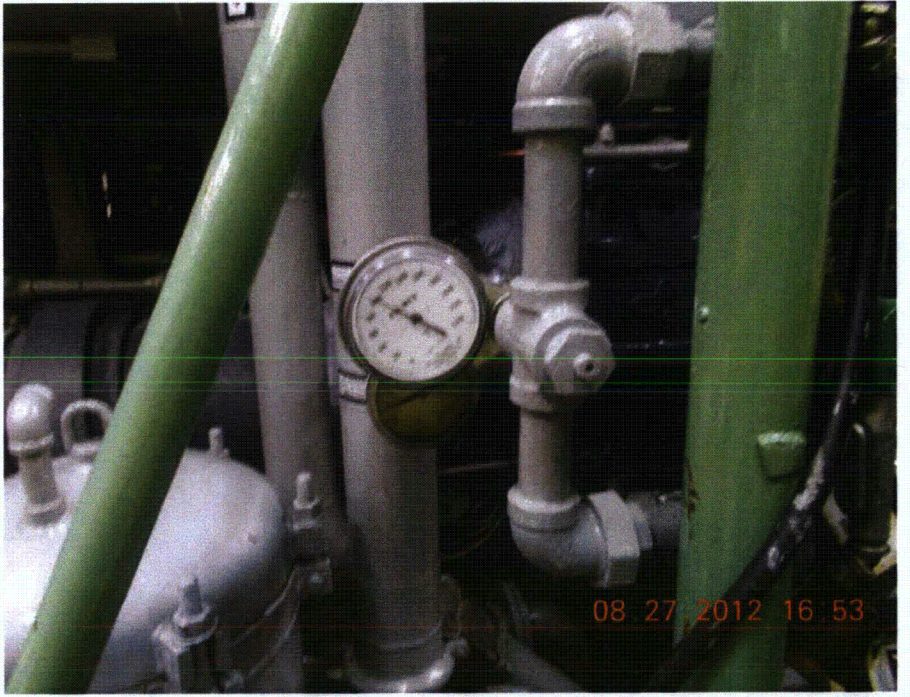
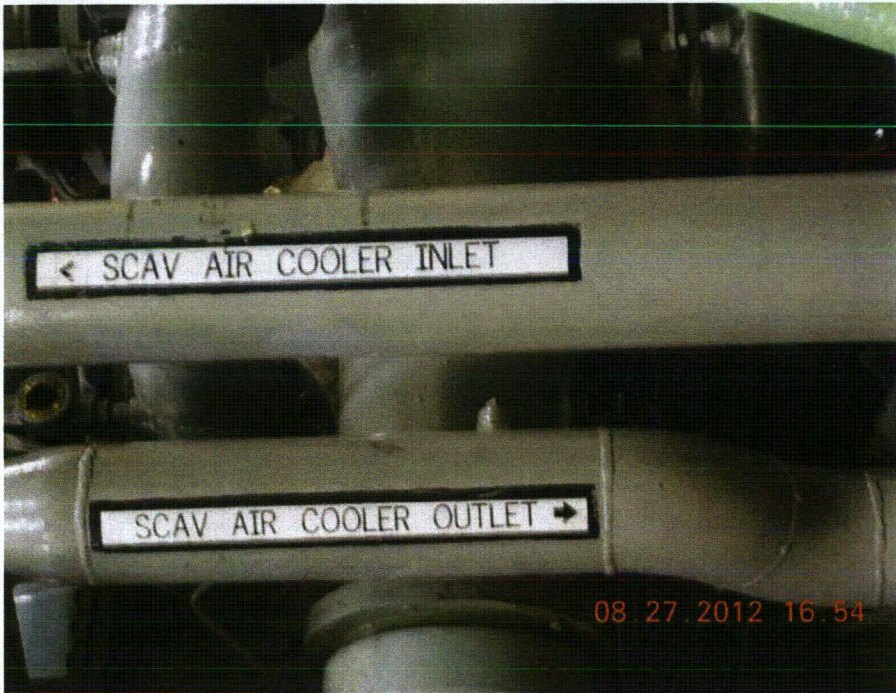
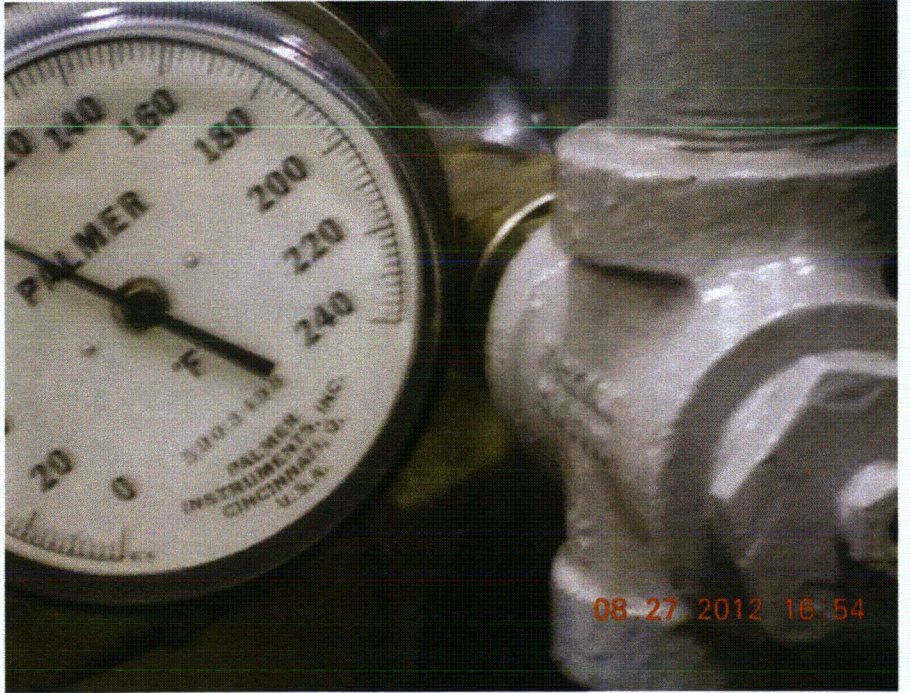
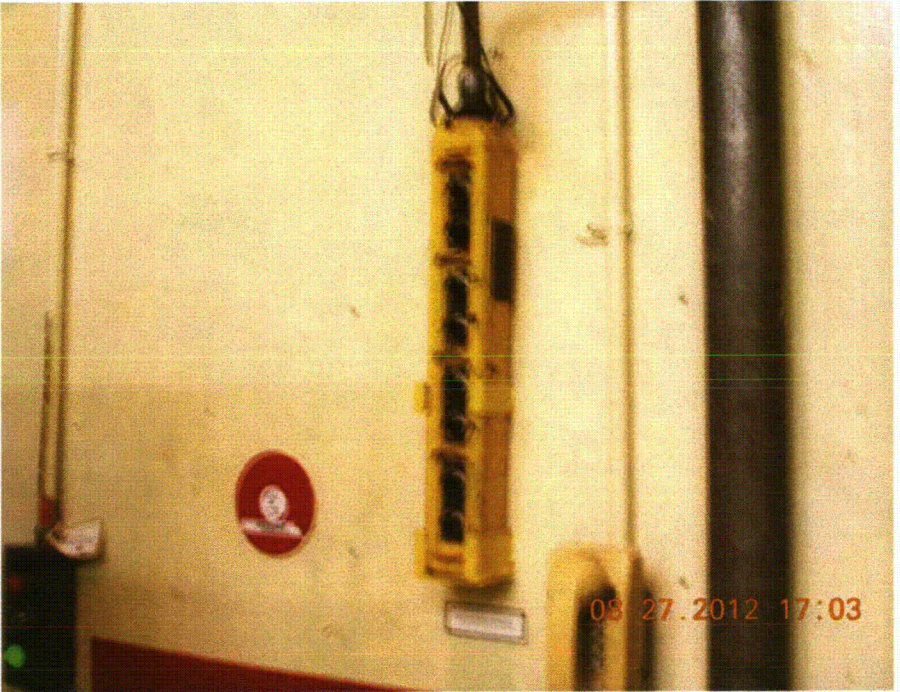
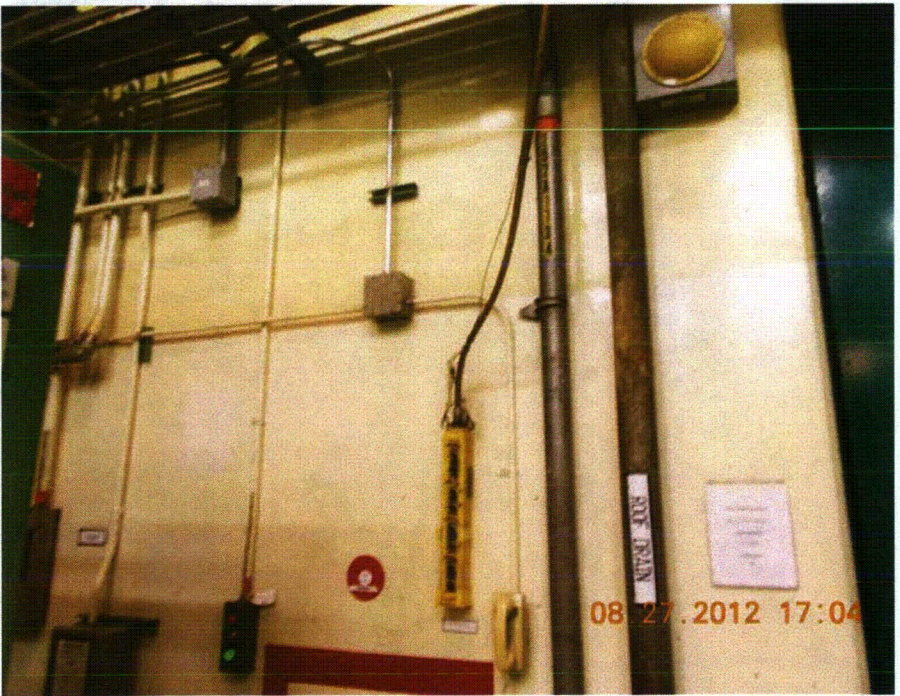
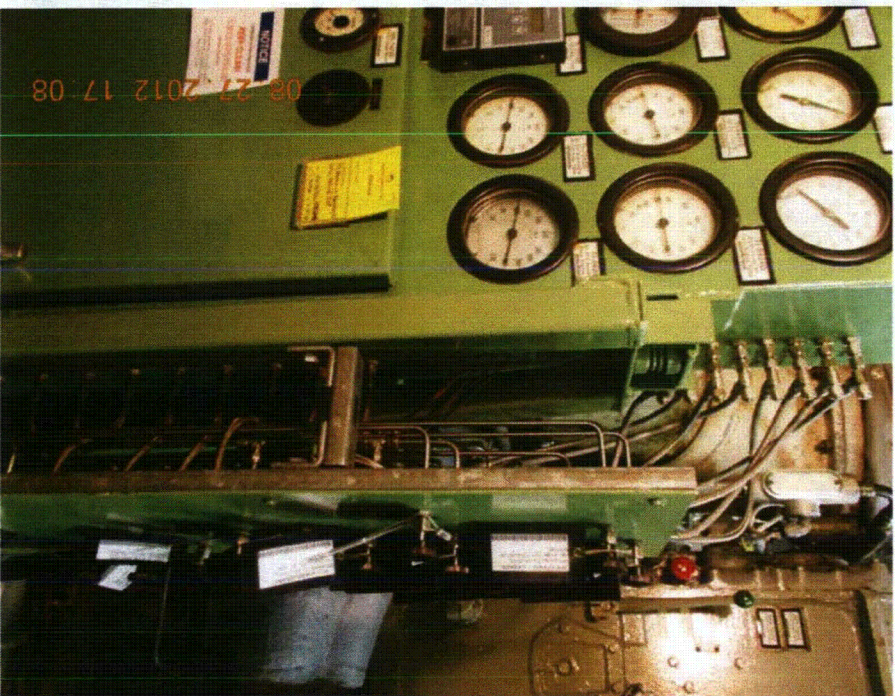
Equipment ID: ODG012

Does not match configuration evaluated in Calculation No. 6280-E5-155-1 (Rev. 1); as-built configuration has 1" anchor bolts securing skid to foundation instead of evaluated 1 1/4" anchor bolts. Judged acceptable for anticipated seismic loads per attached evaluation.

7. Are soft targets free from impact by nearby equipment or structures? YES NO U N/A
 TEMPERATURE GAUGE ON SCAVENGING AIR COOLER INLET COULD CONTACT
 ADJACENT LINE AND HOUSING COULD CRACK. WILL NOT AFFECT SAFETY FUNCTION
8. Are overhead equipment, distribution systems, ceiling tiles and lighting, YES NO U N/A
 and masonry block walls not likely to collapse onto the equipment?
 FLUORESCENT LIGHT TUBES FALLING JUDGED CREDIBLE, BUT
 NOT SIGNIFICANT
9. Do attached lines have adequate flexibility to avoid damage? YES NO U N/A
10. Based on the above seismic interaction evaluations, is equipment free YES NO U
 of potentially adverse seismic interaction effects?

AS FOUND $1" \text{ } \emptyset$ BOLTS

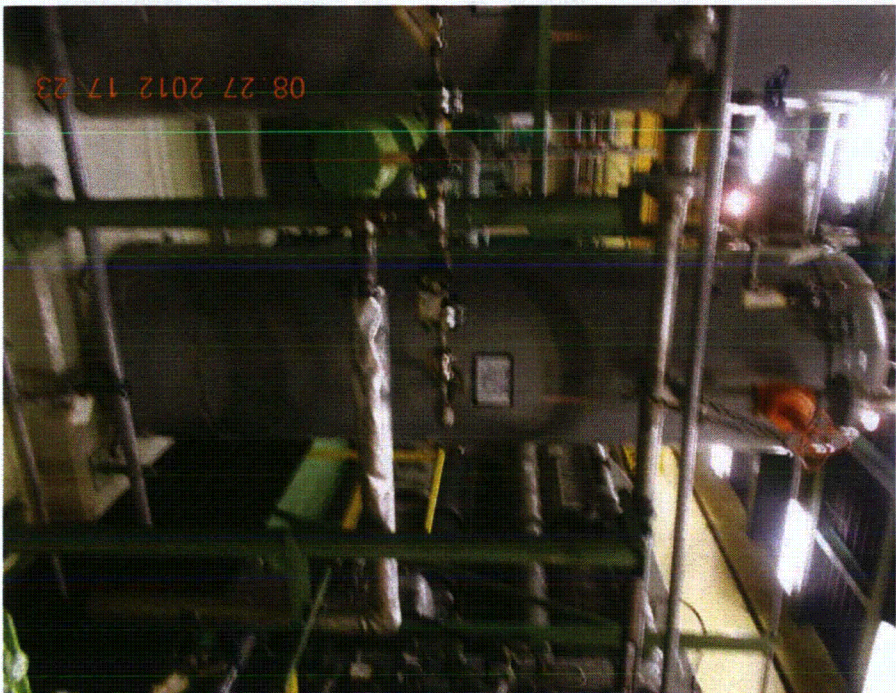
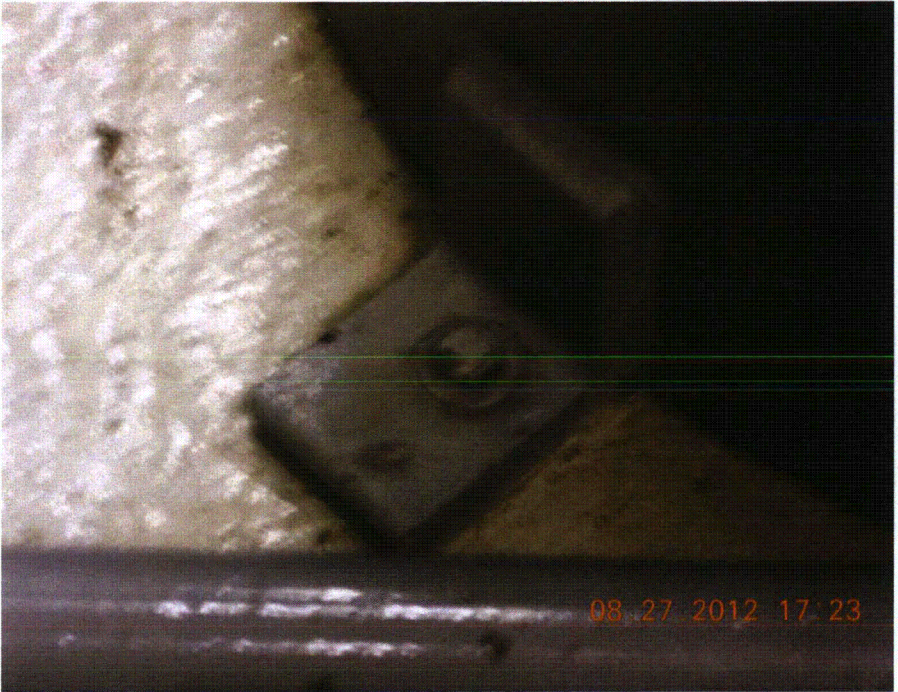
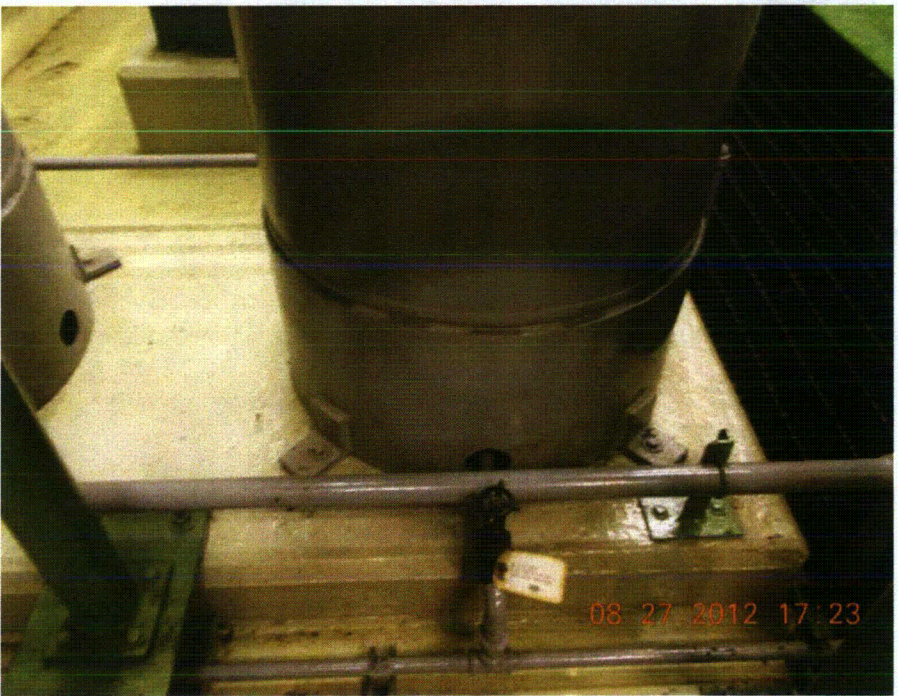
Equipment ID: OHT095

DISCREPANCY WAS EVALUATED PER NCR P900140 AND FOUND TO BE ACCEPTABLE. KC 11/5/12

AS FOUND $\frac{1}{2}$ " \varnothing BOLTS BASED ON $\frac{3}{4}$ " HEAD FLAT-TO-FLAT

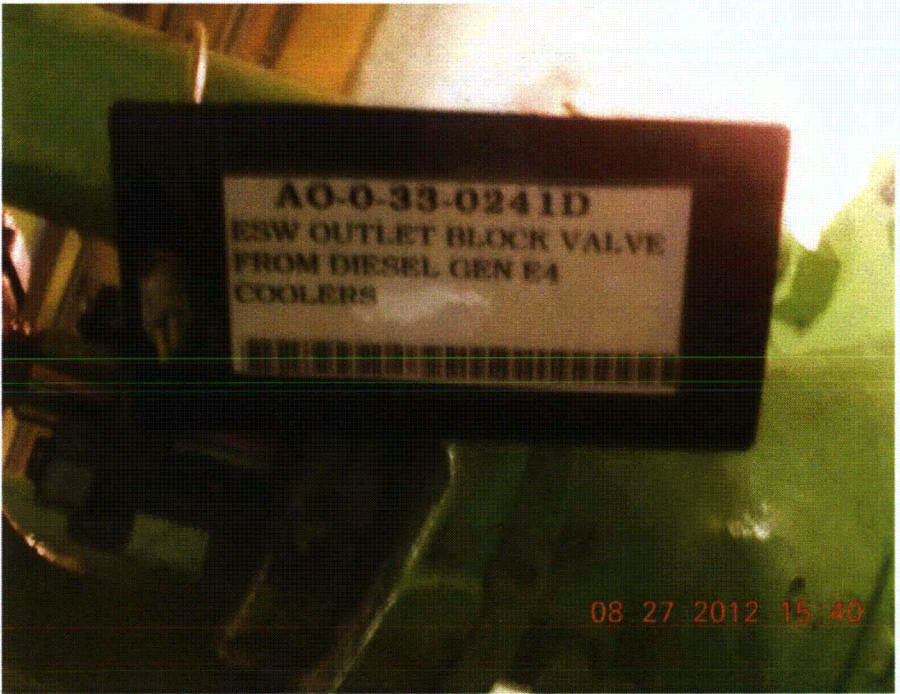
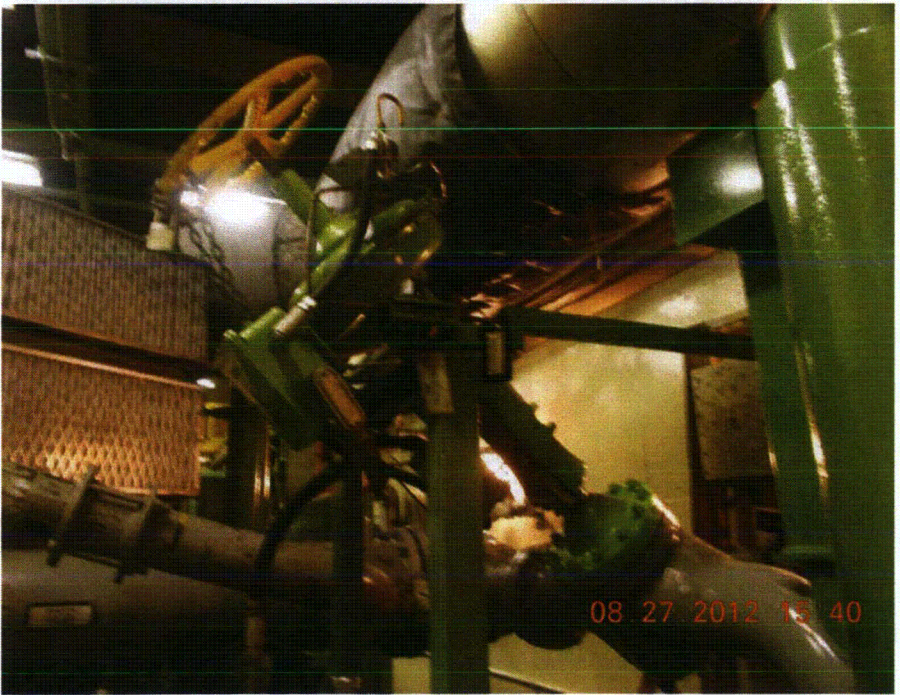
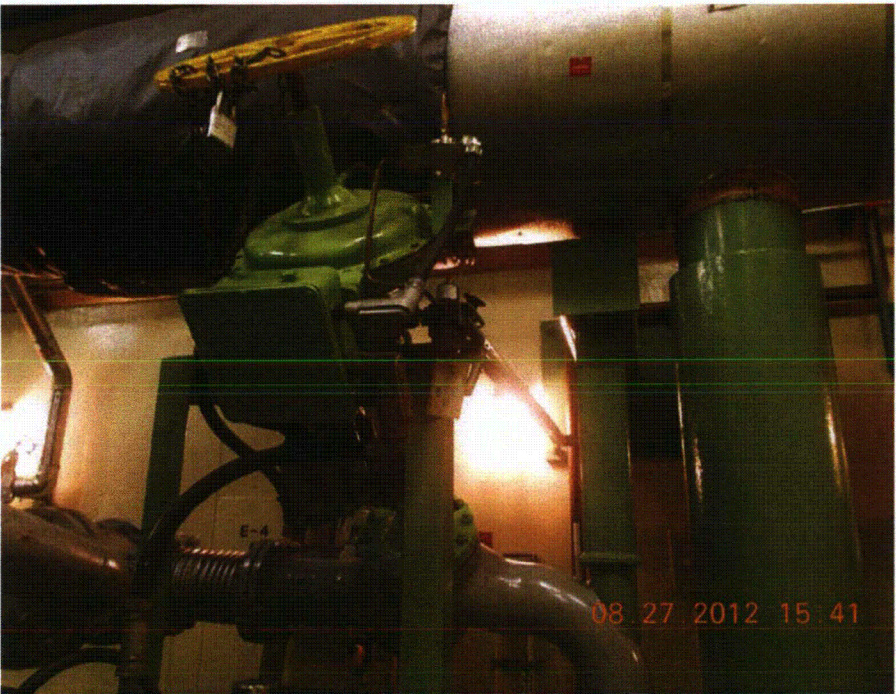
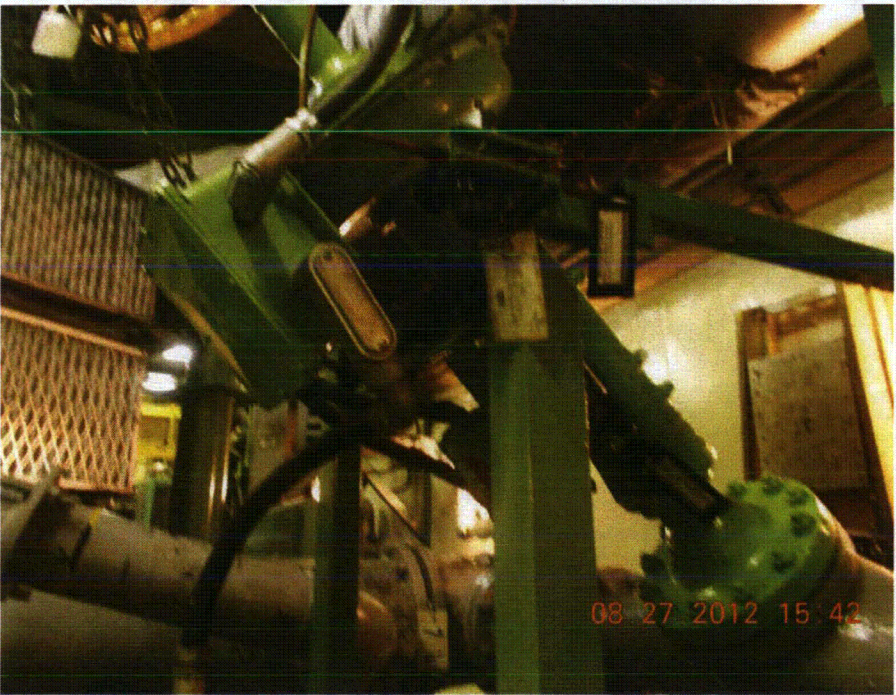
Equipment ID: AO-0-33-0241D

4. Is the anchorage free of visible cracks in the concrete near the anchors? Y N U N/A
ANCHORED TO STRUCTURAL STEEL WHICH IS ANCHORED TO CRACK-FREE CONCRETE

6. Based on the above anchorage evaluations, is the anchorage free of potentially adverse seismic conditions? Y N U
See attached evaluation for acceptance of independent anchorage for air operator

The lateral stiffnesses of the vertical support (two structural angles) attached to the operator of Air-Operated Valve AO-0-33-0241D and the pipe support (square structural tubing) attached downstream of the valve at the pipe elbow are calculated. The lateral stiffnesses of the supports are compared to help judge whether the valve being supported at two different locations (the diesel room wall and the top of the diesel engine base frame) could potentially cause damage to the valve during a seismic event.

The lateral stiffness of the pipe support is an order of magnitude stiffer than the support at the valve operator. Thus, if there is any differential motion between the wall of the diesel room and the diesel engine base frame during a seismic event, the support at the valve operator will easily displace without imparting significant load to the valve operator. Additionally, a structural joint was not observed between the floor of the diesel room and the wall of the diesel room so any differential displacement between these two locations will be very small. The diesel engine baseframe is securely attached to the floor, and the base frame is very stiff, so the top of the base frame (where the operator support is anchored) should displace with the floor.

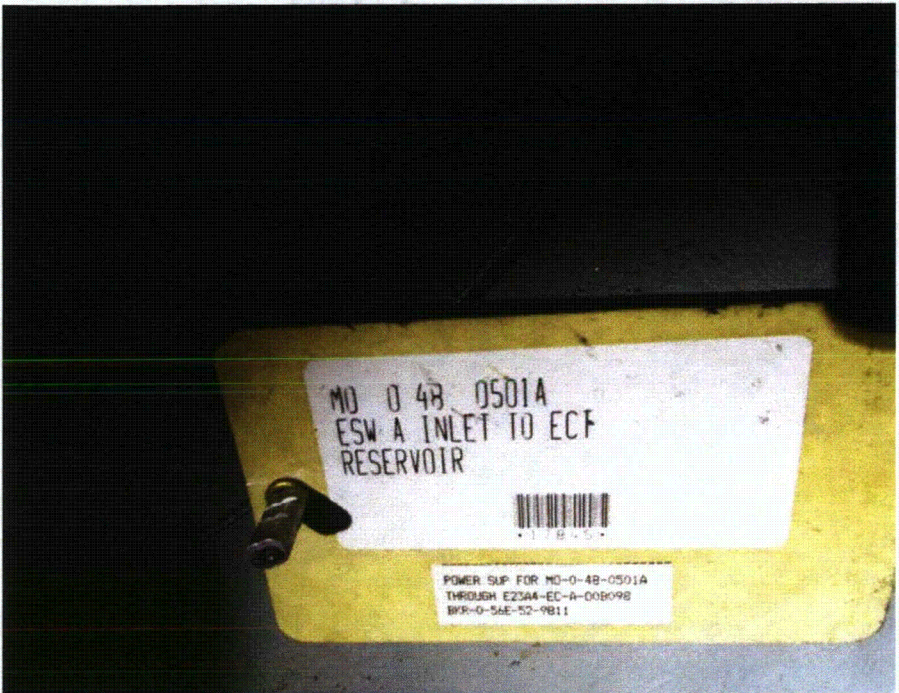
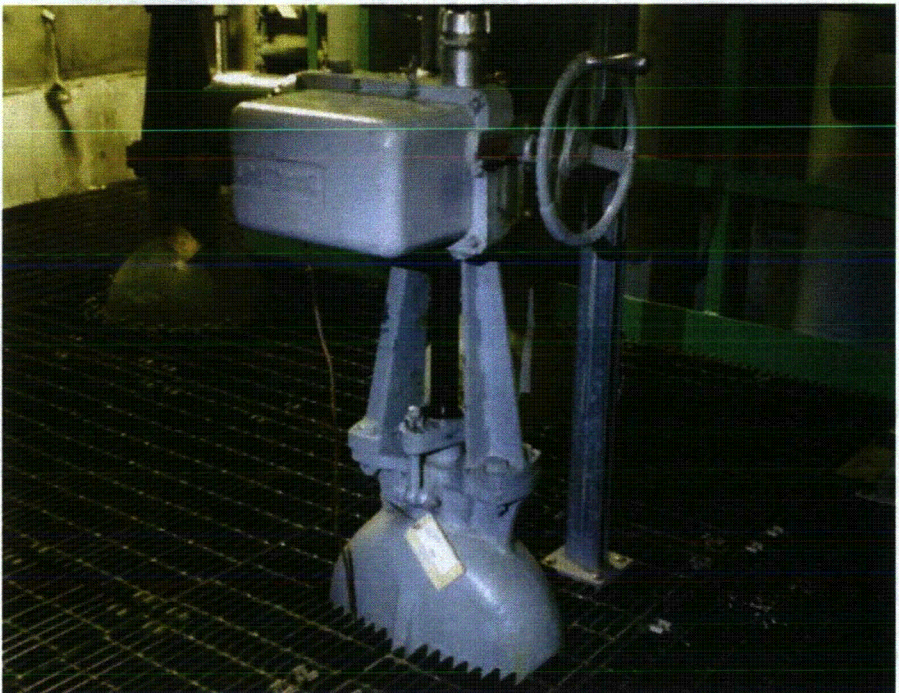
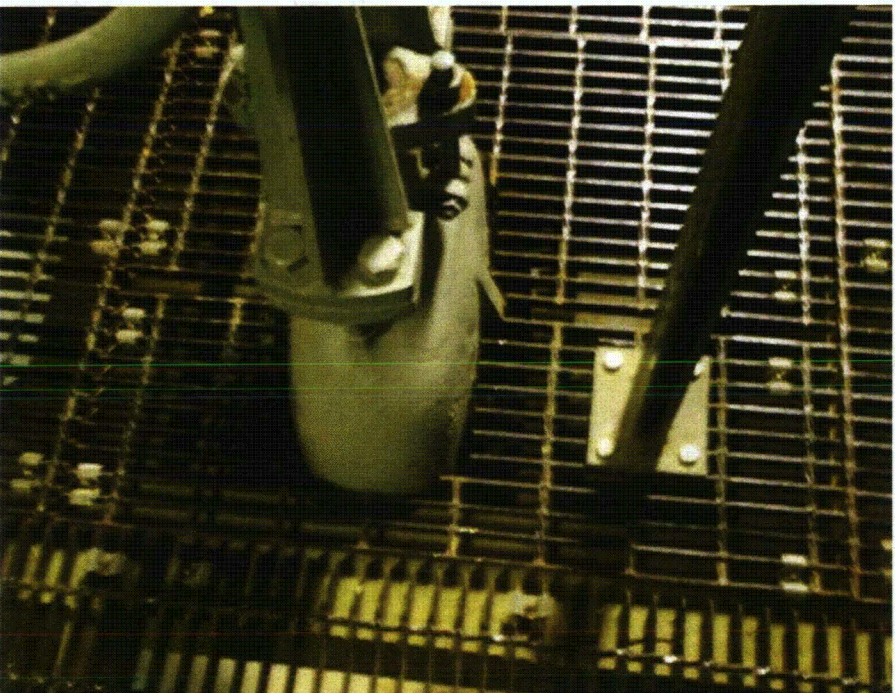
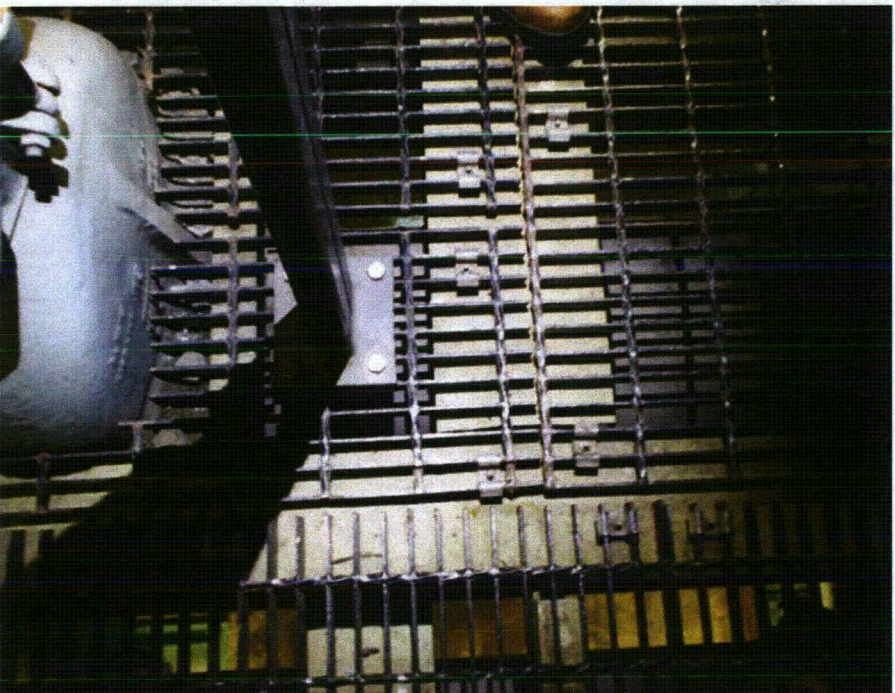
Equipment ID: MO-0-48-0501A

*Falling light bulbs not likely to cause damage to equipment.
Lighting properly secured with closed S-hooks.*

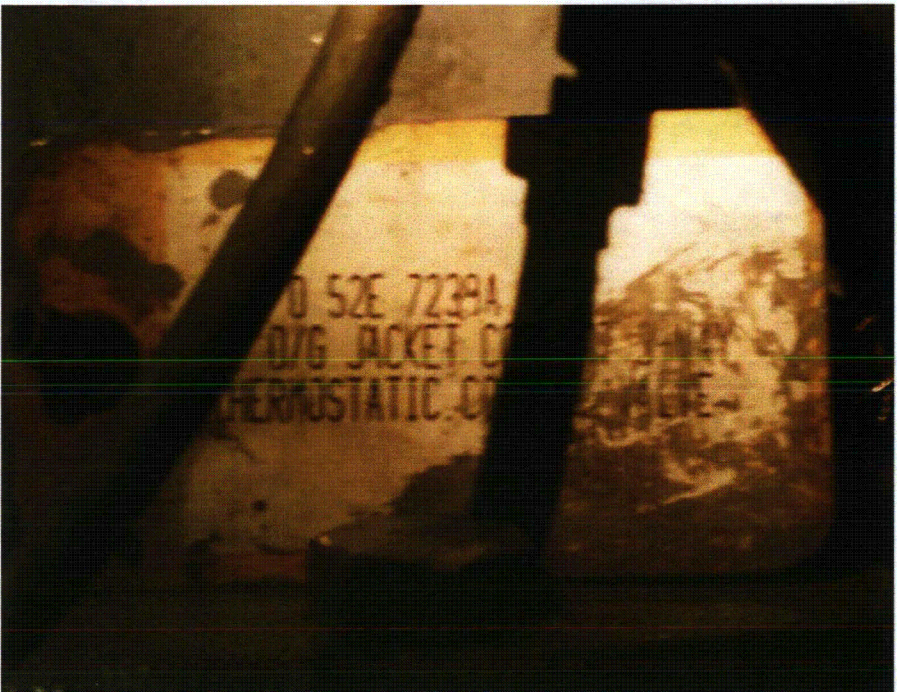
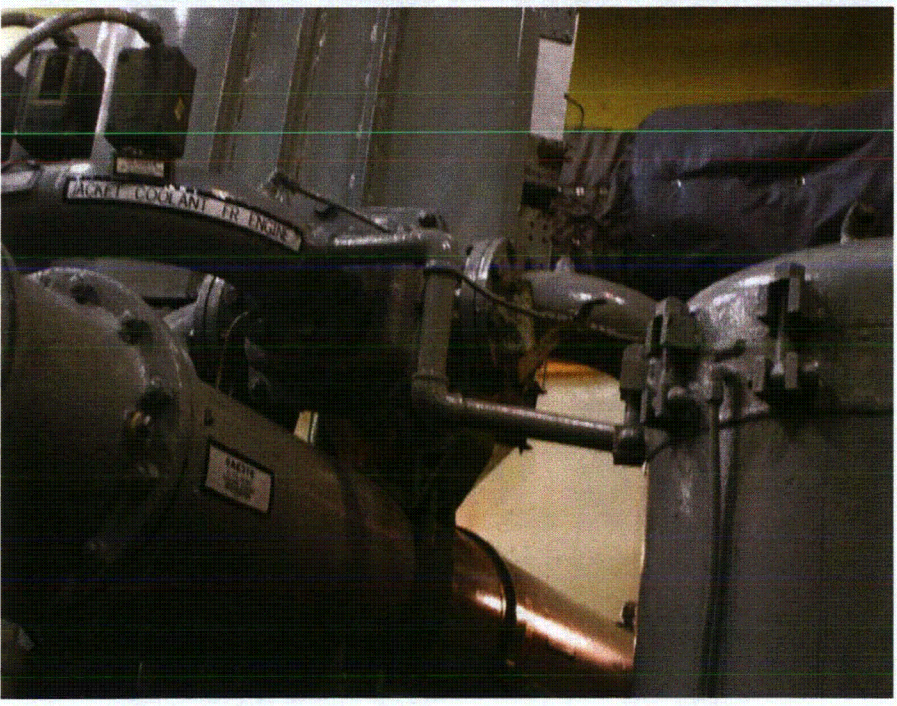
Equipment ID: TCV-0-52E-7239A

4. Is the anchorage free of visible cracks in the concrete near the anchors? Y N U N/A
 Anchored to OAE376 E1 D/G Jacket Coolant cooler underneath valve.

Falling light bulbs during seismic will not have credible damage.
