Area Walk-By Checklist (AWC)

Location: Bldg. NSC7 Floor El. 220' Room, Area¹³ R103

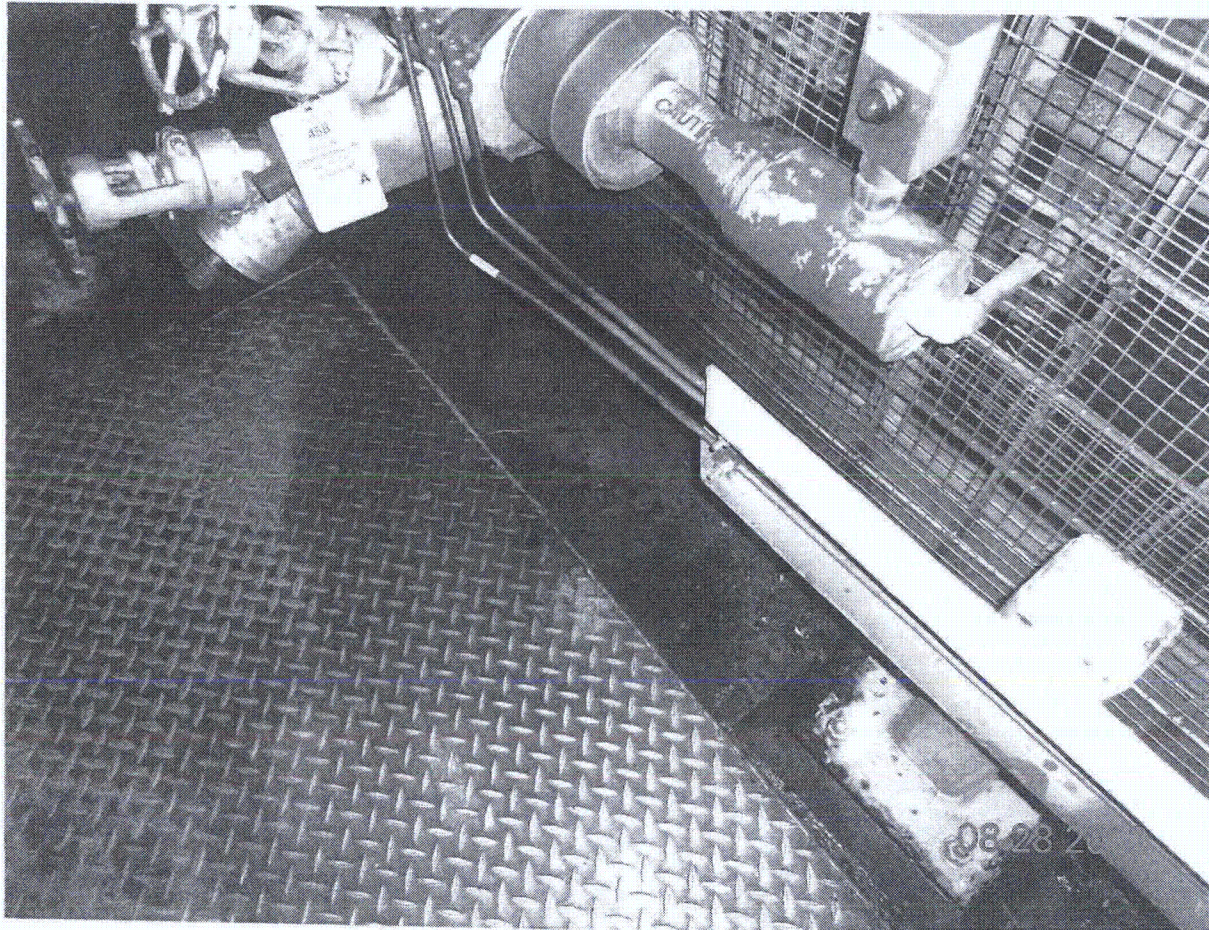
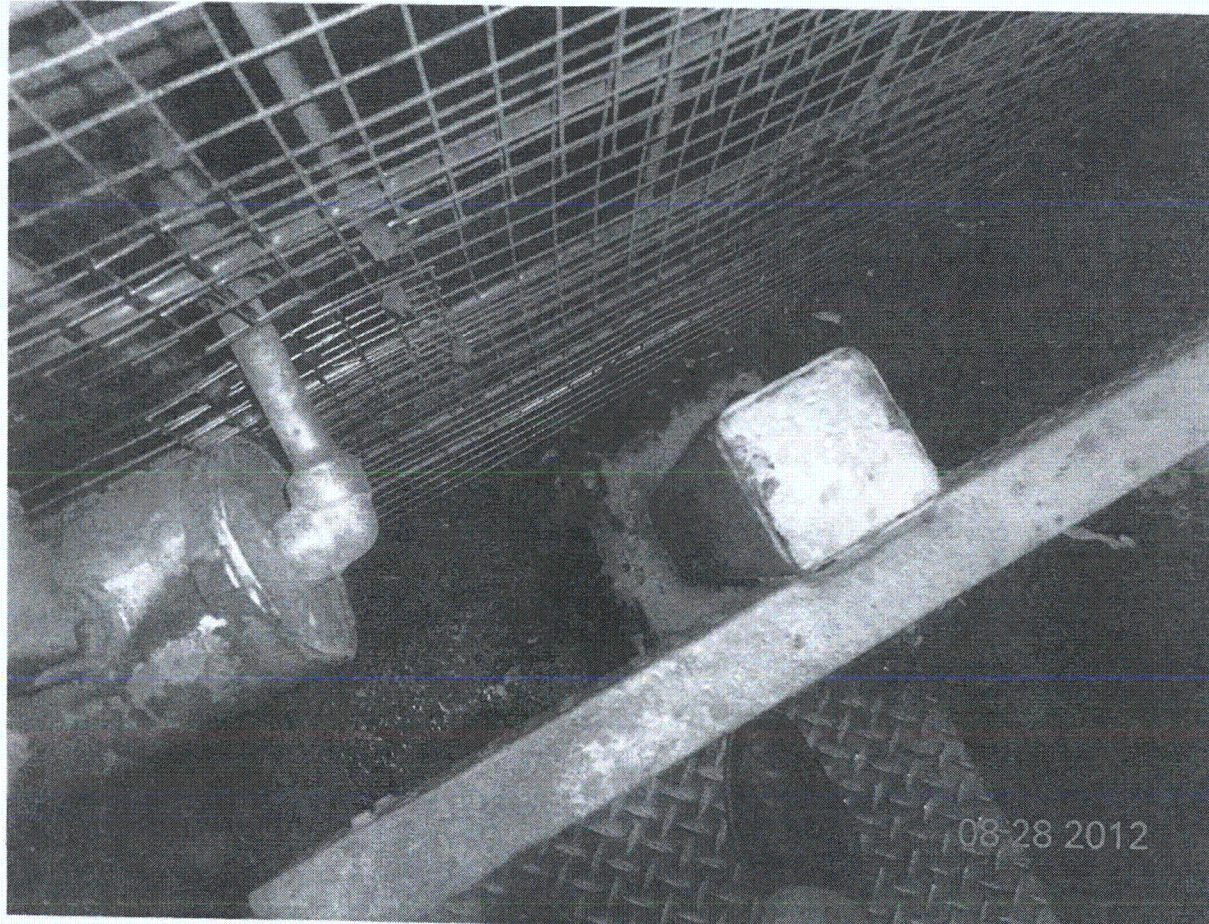
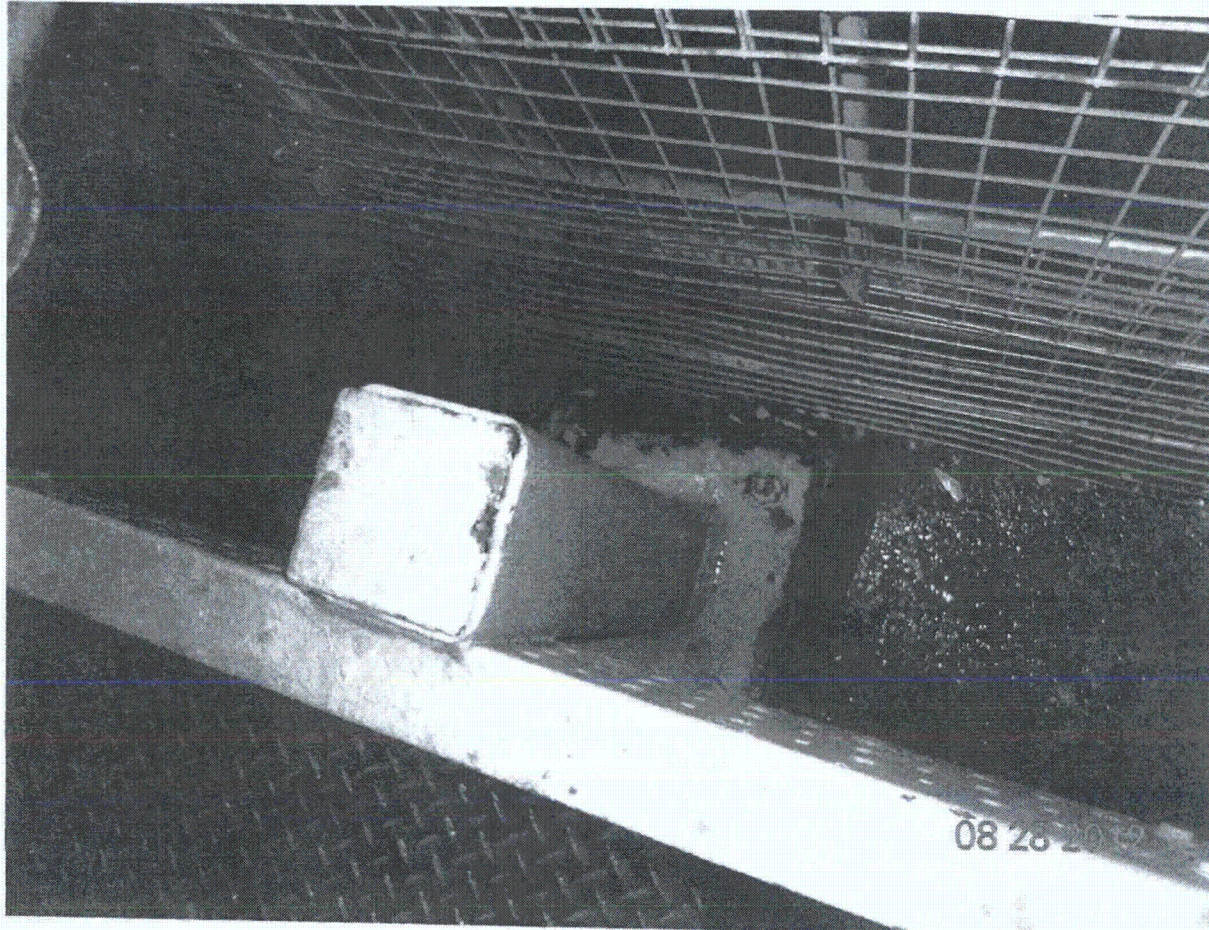
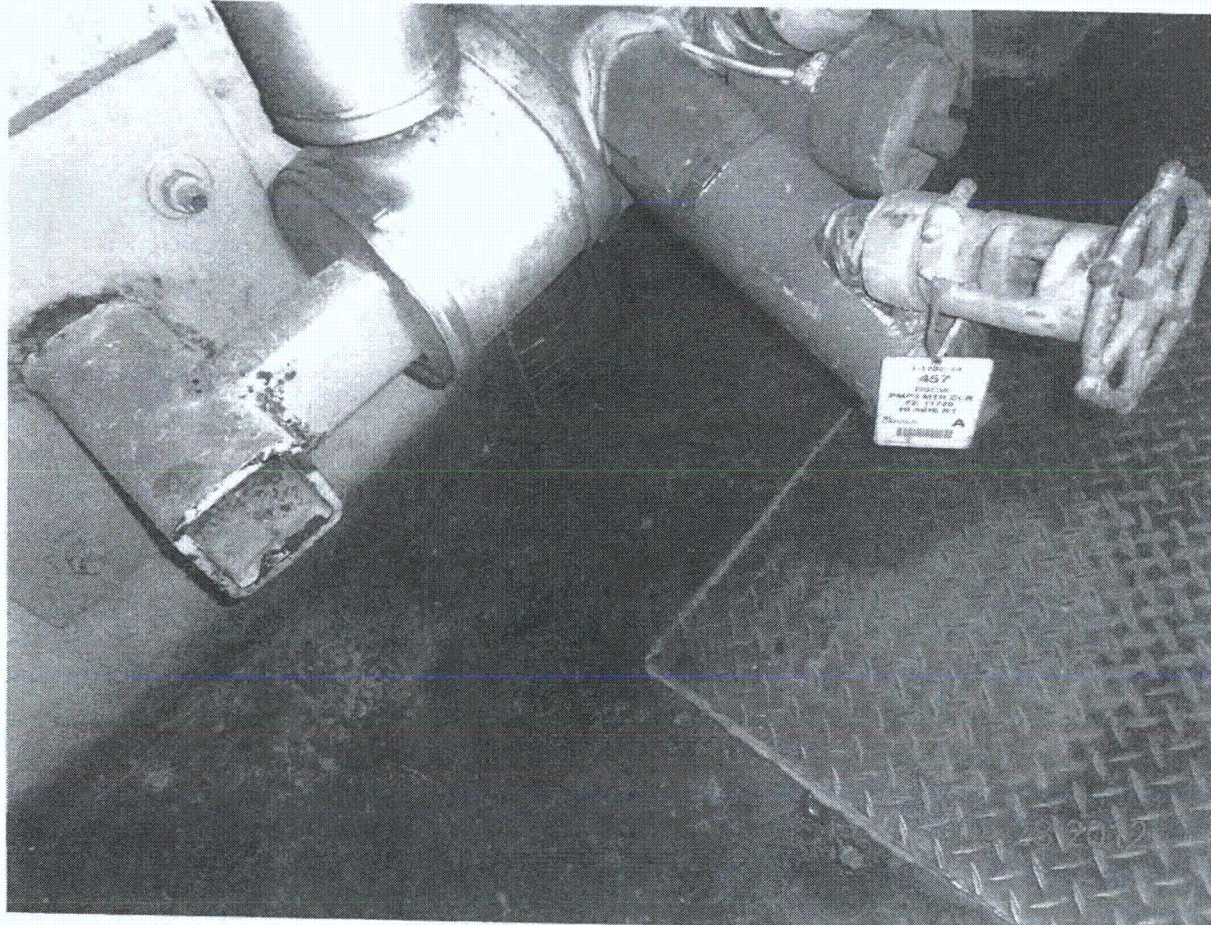
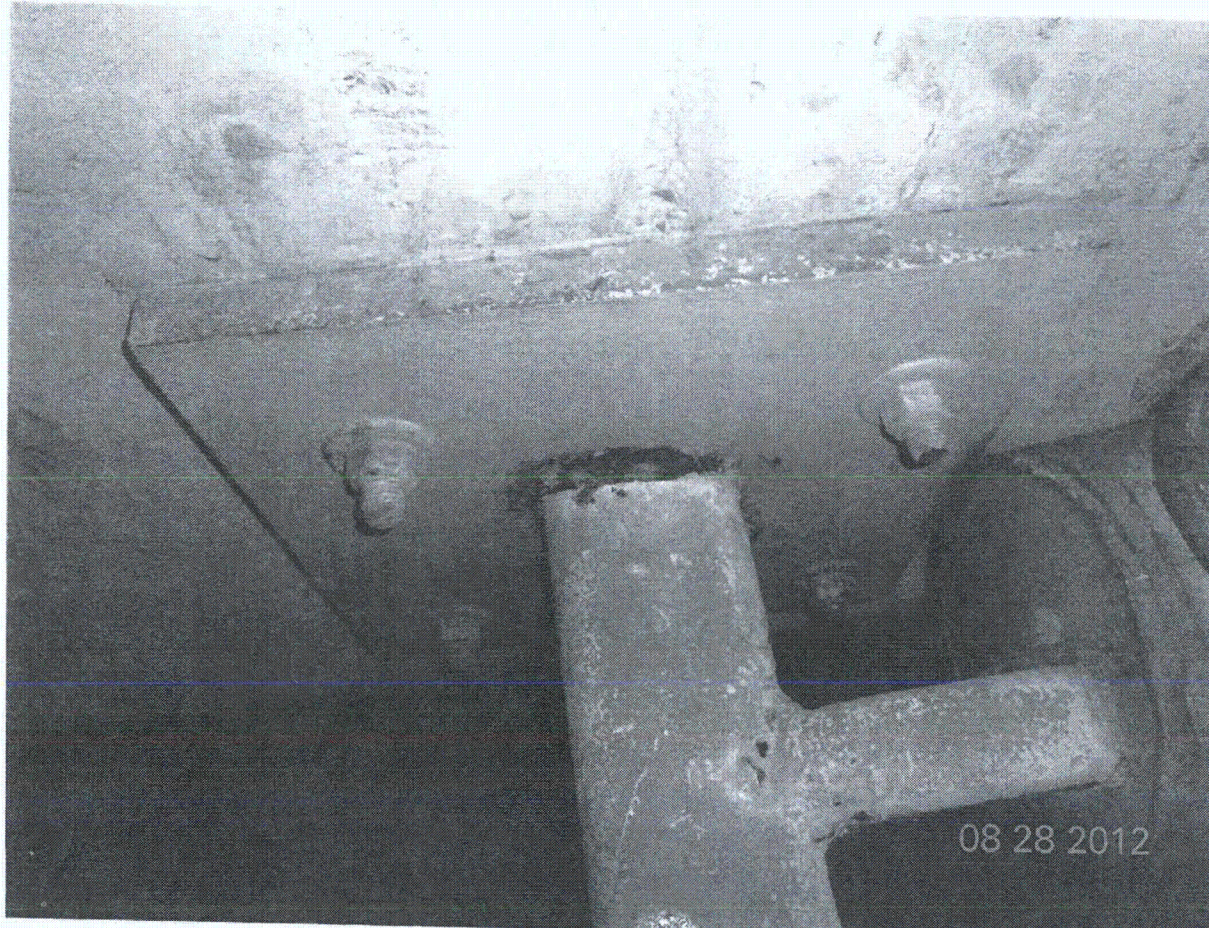
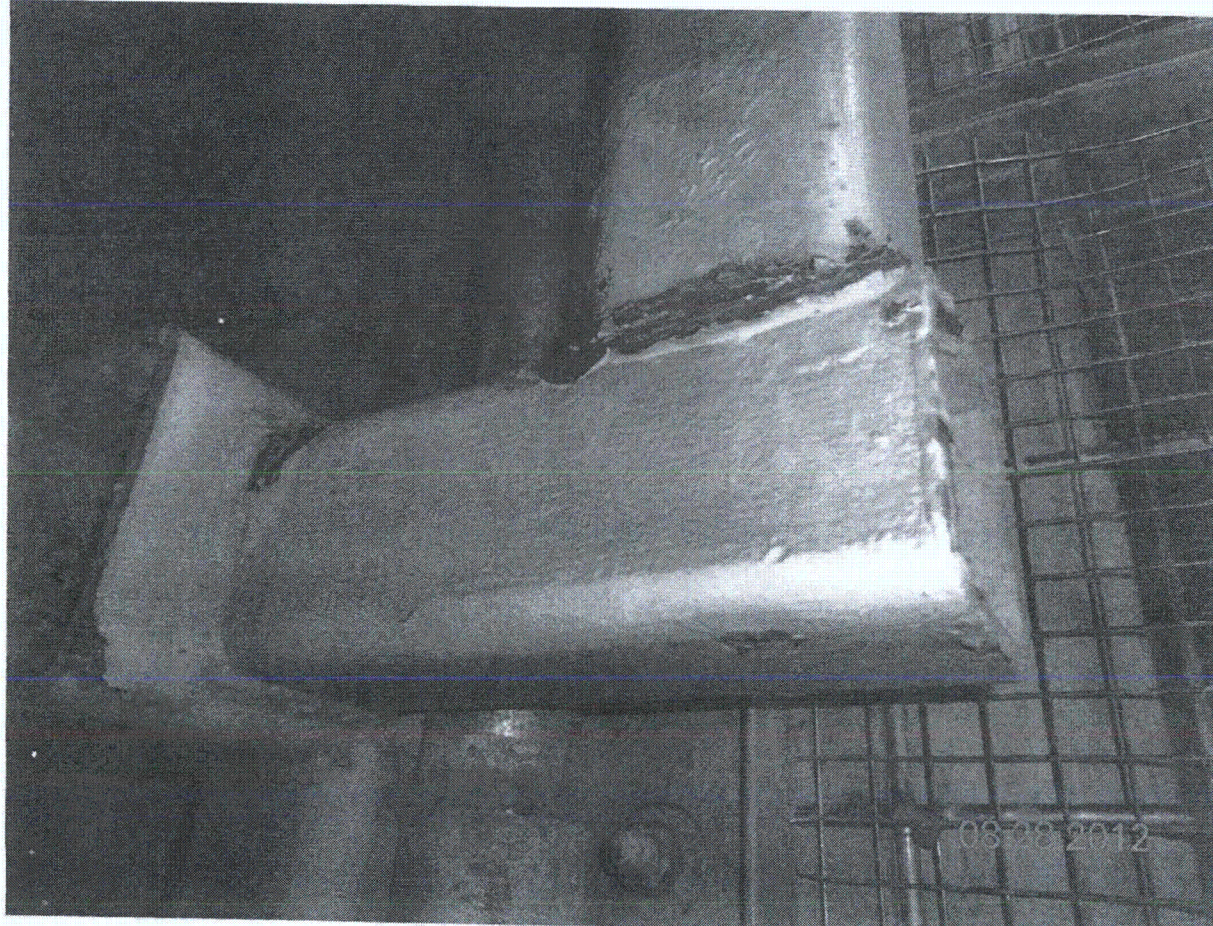
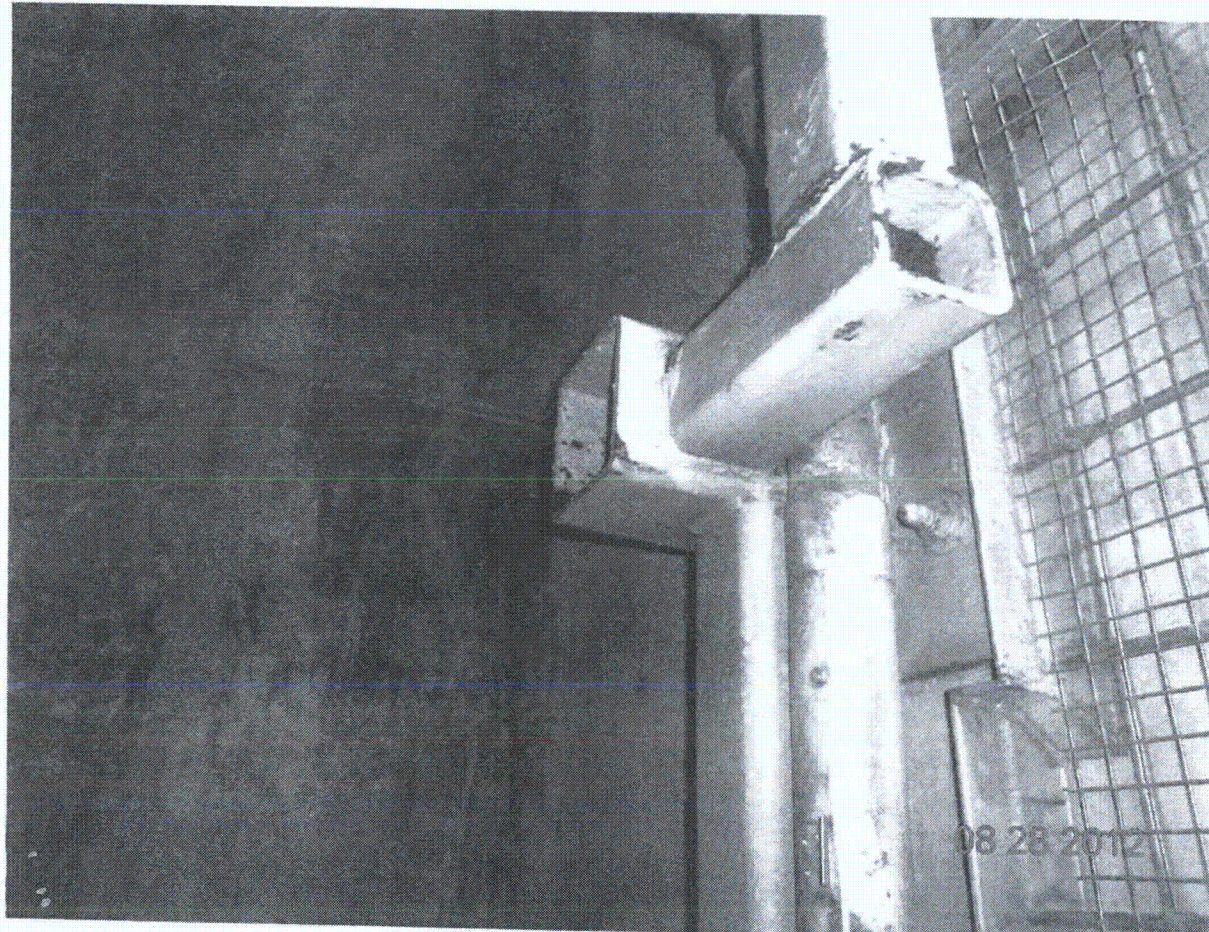
CONNECTION OF TUBE STEEL TO BASE PLATE HAS SIGNIFICANT OXIDATION ON A SURFACE OF WELD (PIPE SUPPORT FOR LINE ASSOCIATED W/VALVE 1-1202-X4-457). EDGES OF BASE PLATE FOR A SUPPORT FOR THREE INSTRUMENT LINES IS DEGRADED, ACCEPTABLE. REFER TO CR 509123

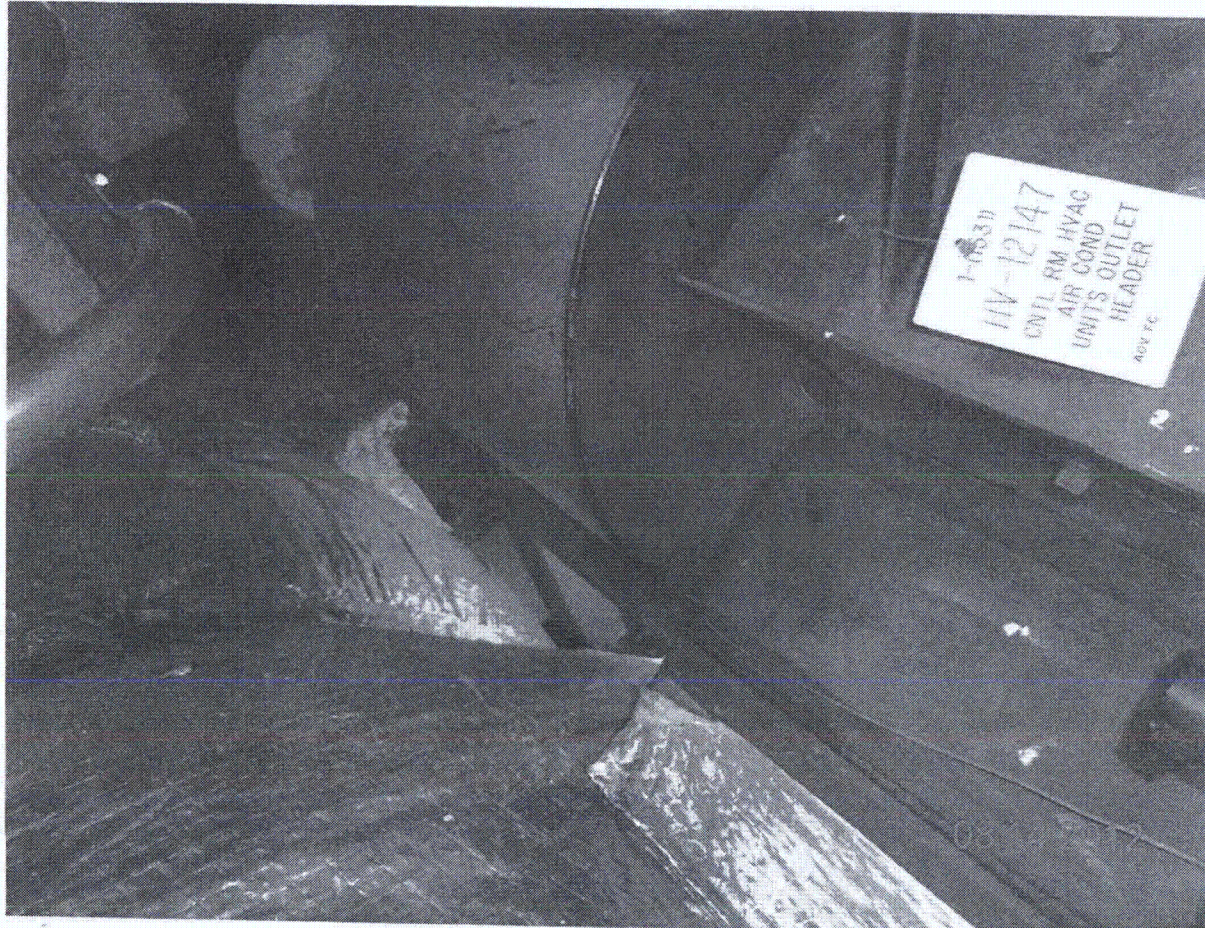
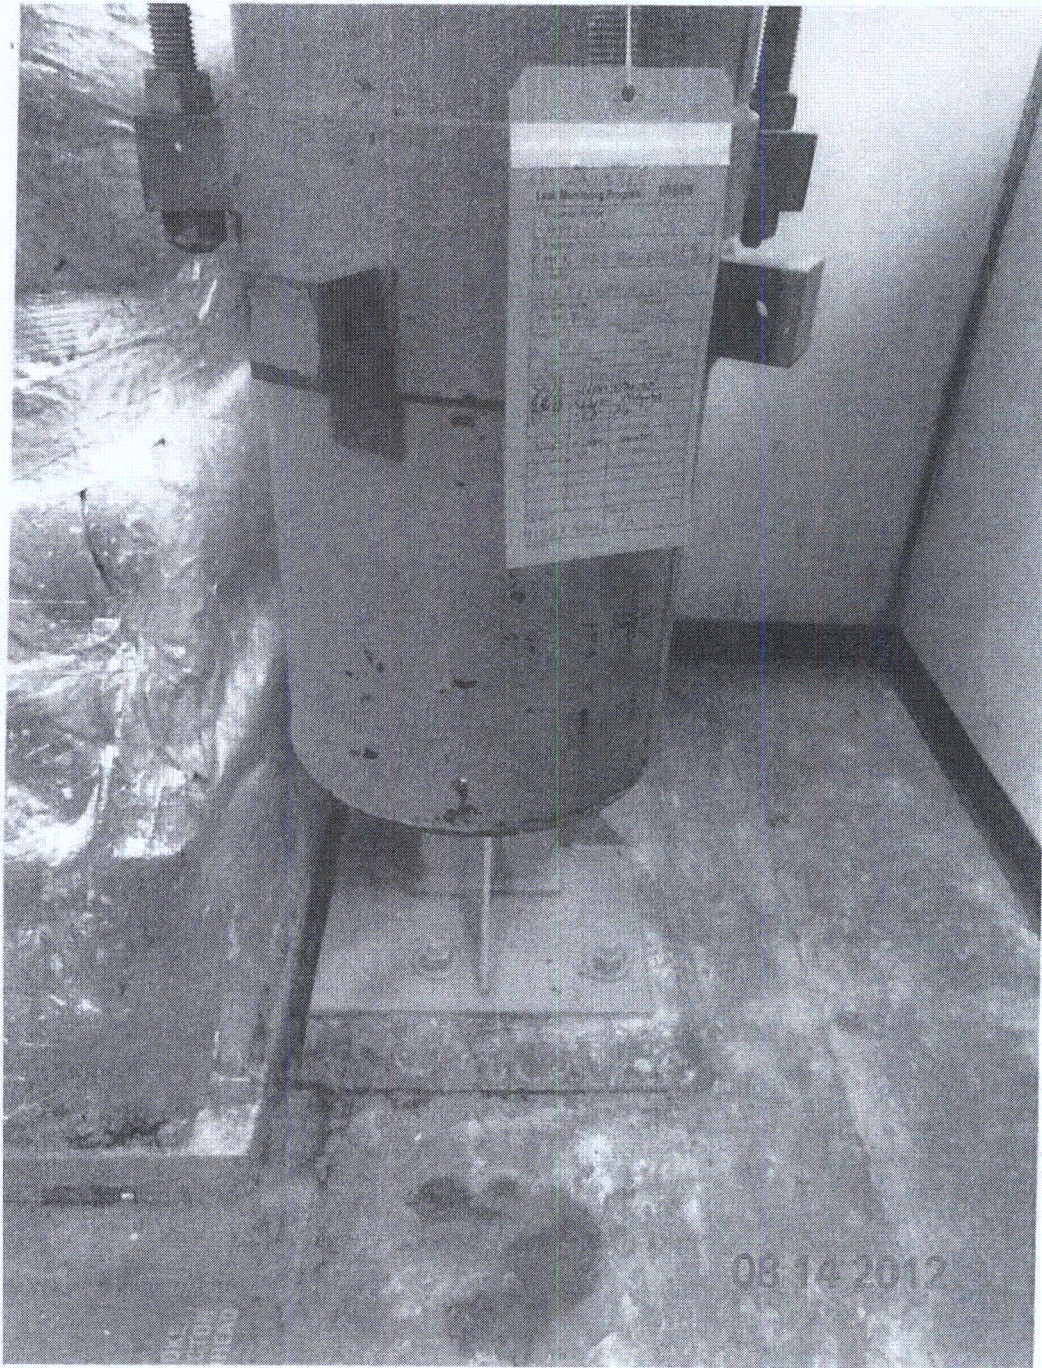
Bolts at connections corrode more than insignificant. No effect to the capacity at this time determined by walkdown team. There are some bolts are not visible due to insulation.

Adjacent equipment support grout has small hairline crack which is insignificant and is acceptable

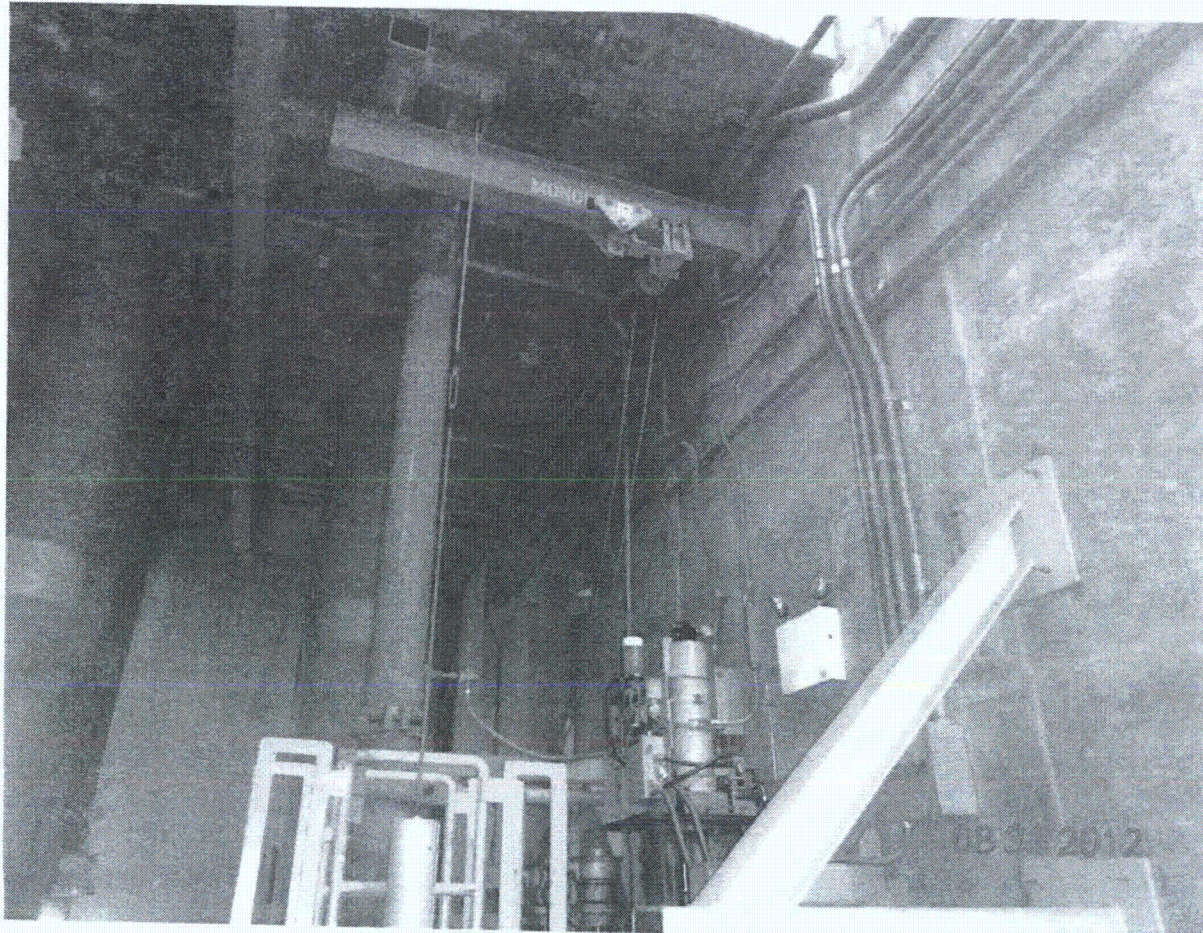
8. Have you looked for and found no other seismic conditions that could adversely affect the safety functions of the equipment in the area? Y N U
Monorail hoist chain is not secured properly and leans against area equipment. Refer to CR 502483.

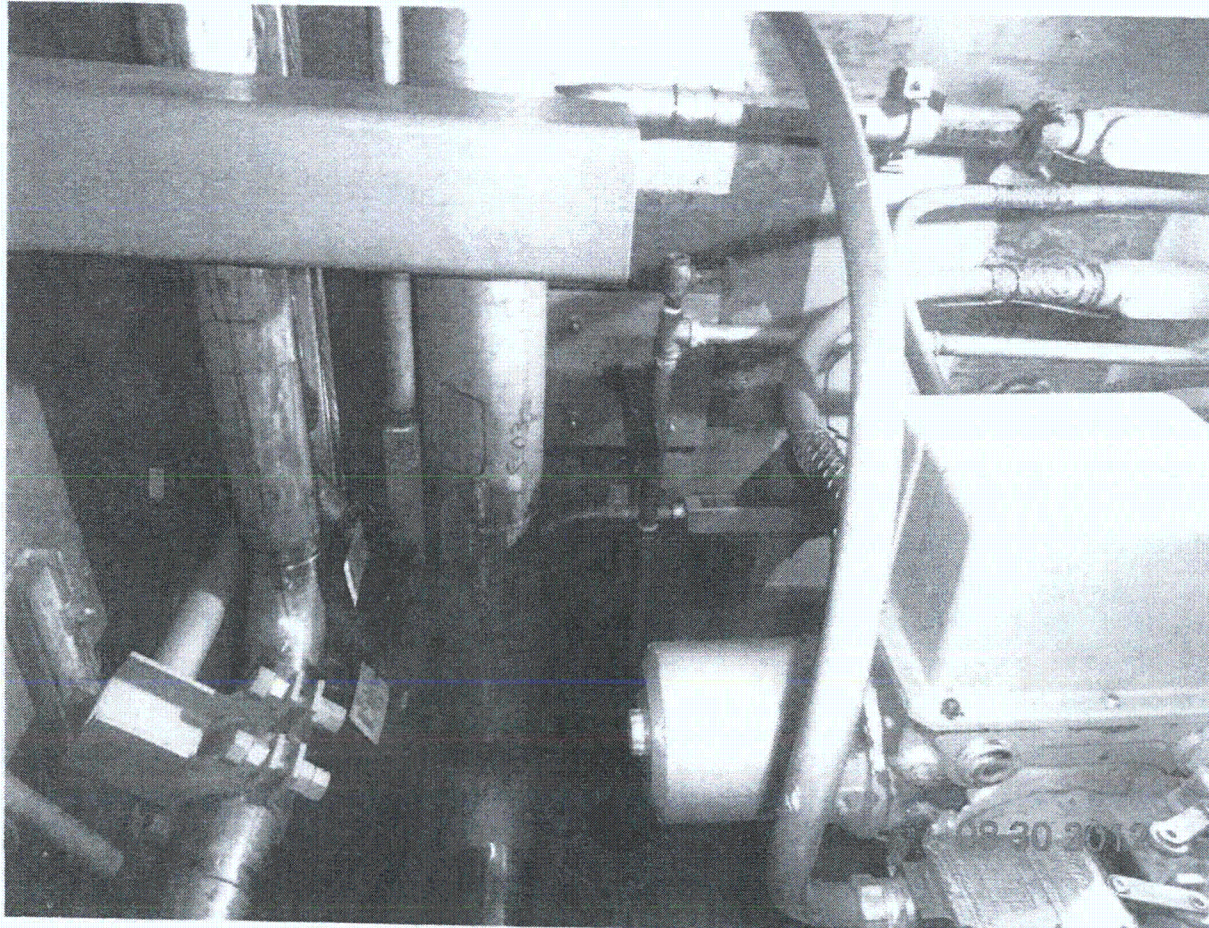
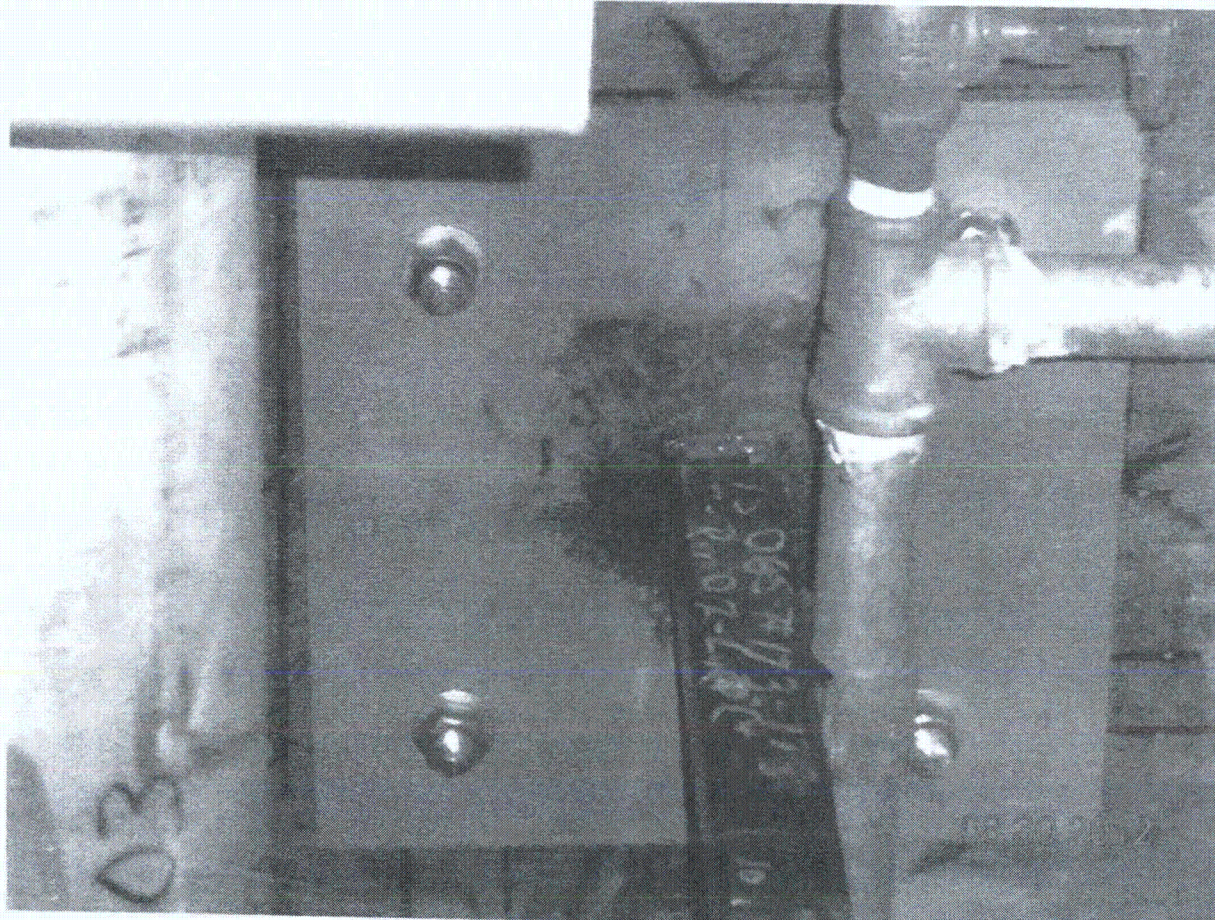
FIRE PROTECTION LINE SUPPORT HAS MILD CORROSION AT CONNECTION OF TUBE STEEL TO THE BASE PLATE (WELD & ADJACENT BASE PLATE SURFACES), ACCEPTABLE. REFERENCE CR310087

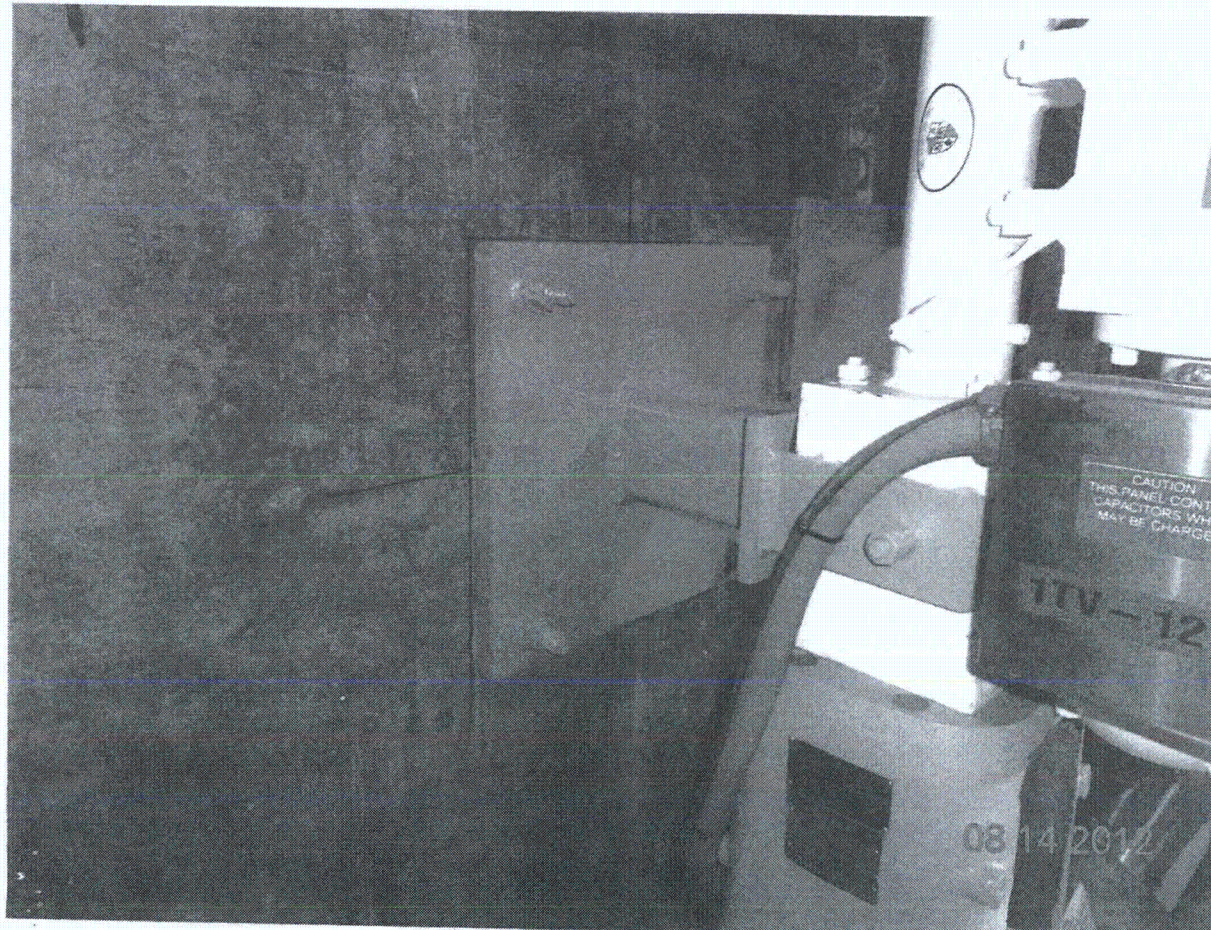
2. Does anchorage of equipment in the area appear to be free of significant degraded conditions? Y N U N/A
 SURFACE ROSS ON MOUNTING BOLTS AT BASE CONNECTION OF EQUIPMENT (1-1531-N7-002-000, NOT A SEISMIC STRUCTURAL CONNECTION)

MILD TO MODERATE RUST ON STRUCTURAL STEEL CONNECTION TO WALL (N. SOUTHWEST) CORNER OF ROOM 312. NOT CONSIDERED A SEISMIC CONCERN. ~~SEE COMMENTS FOR FURTHER INFORMATION.~~
J.D. 8-14-12
