**ATTACHMENT 5**

**UNIT 2 - IPEEE VULNERABILITIES INFORMATION**

**NO. SNCF164-RPT-02**

**Joseph M. Farley Nuclear Plant – Unit 2  
Seismic Recommendation 2.3 Walkdown Report Requested by NRC Letter,  
*Request for Information Pursuant to Title 10 of the Code of Federal  
Regulations 50.54(f) Regarding Recommendations 2.1, 2.3, and 9.3, of the  
Near-Term Task Force Review of Insights from the Fukushima Daiichi  
Accident, dated March 12, 2012***

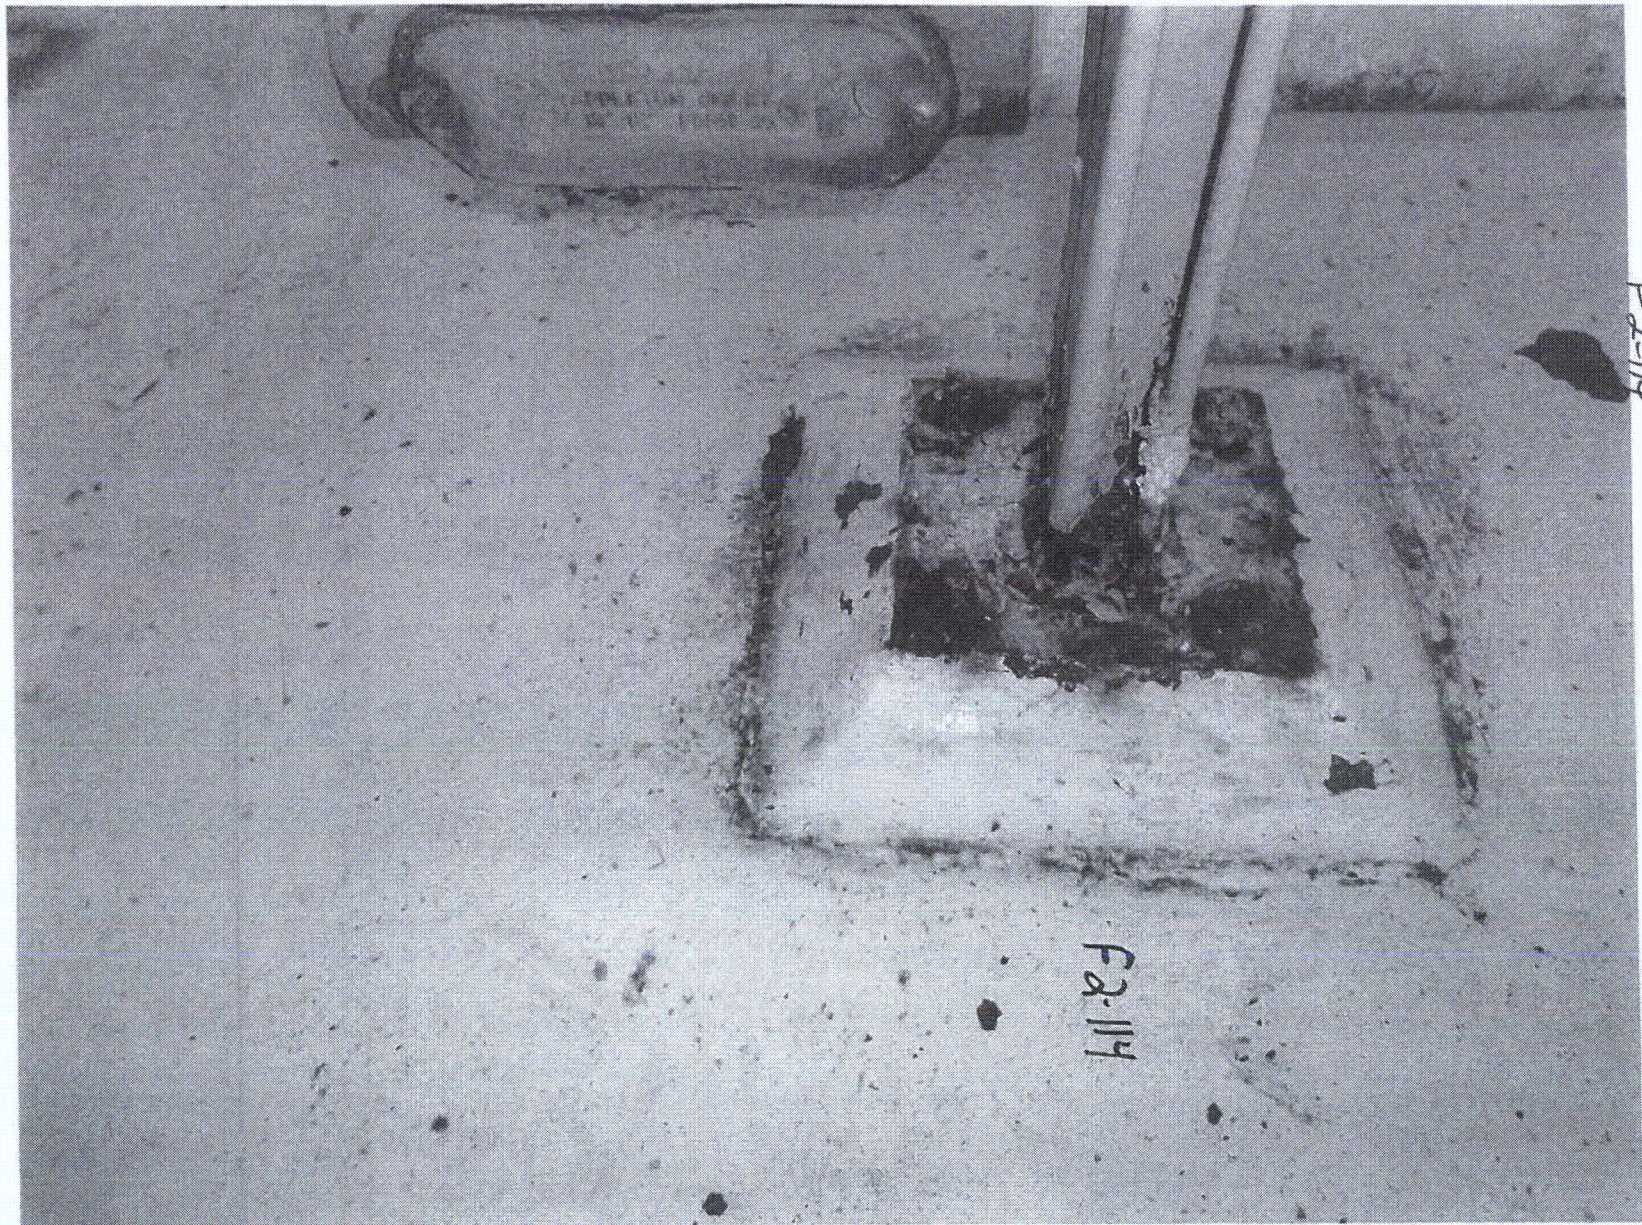
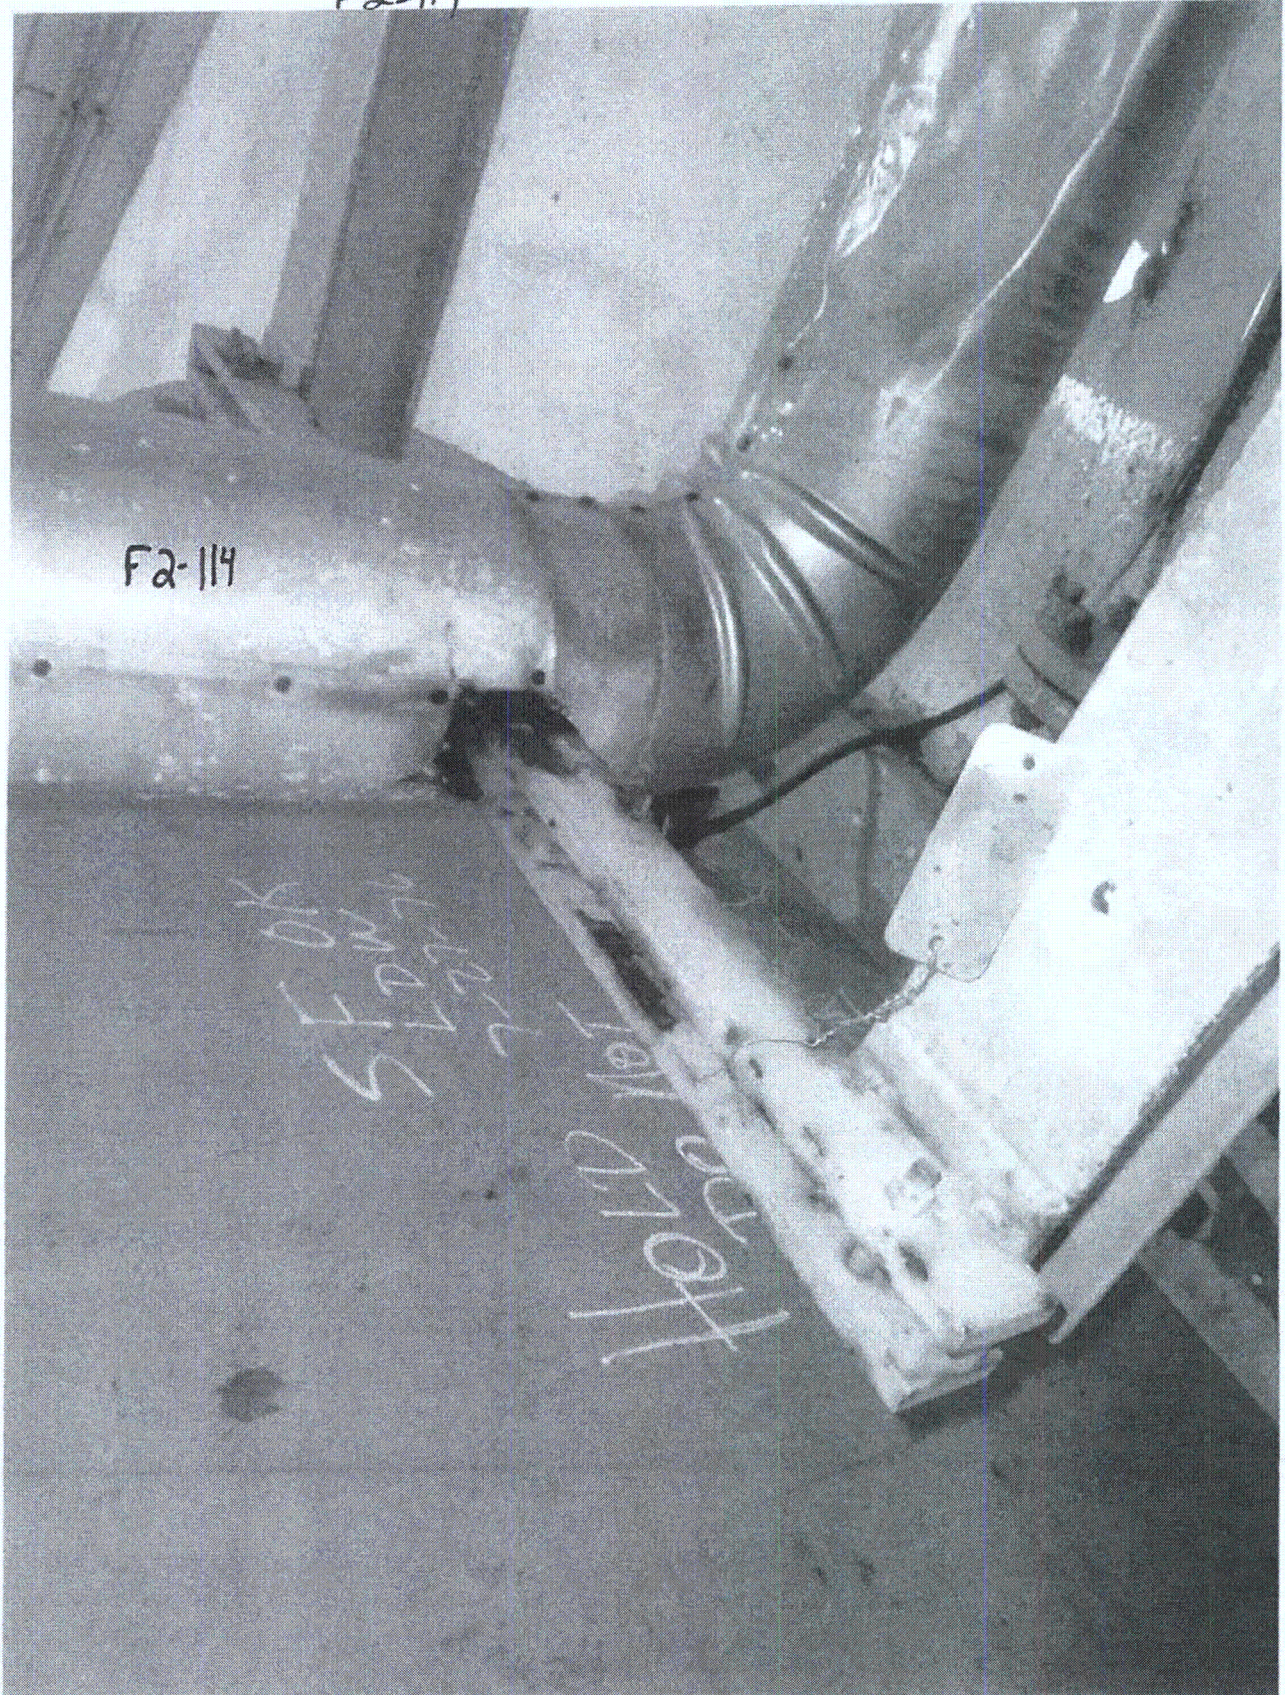
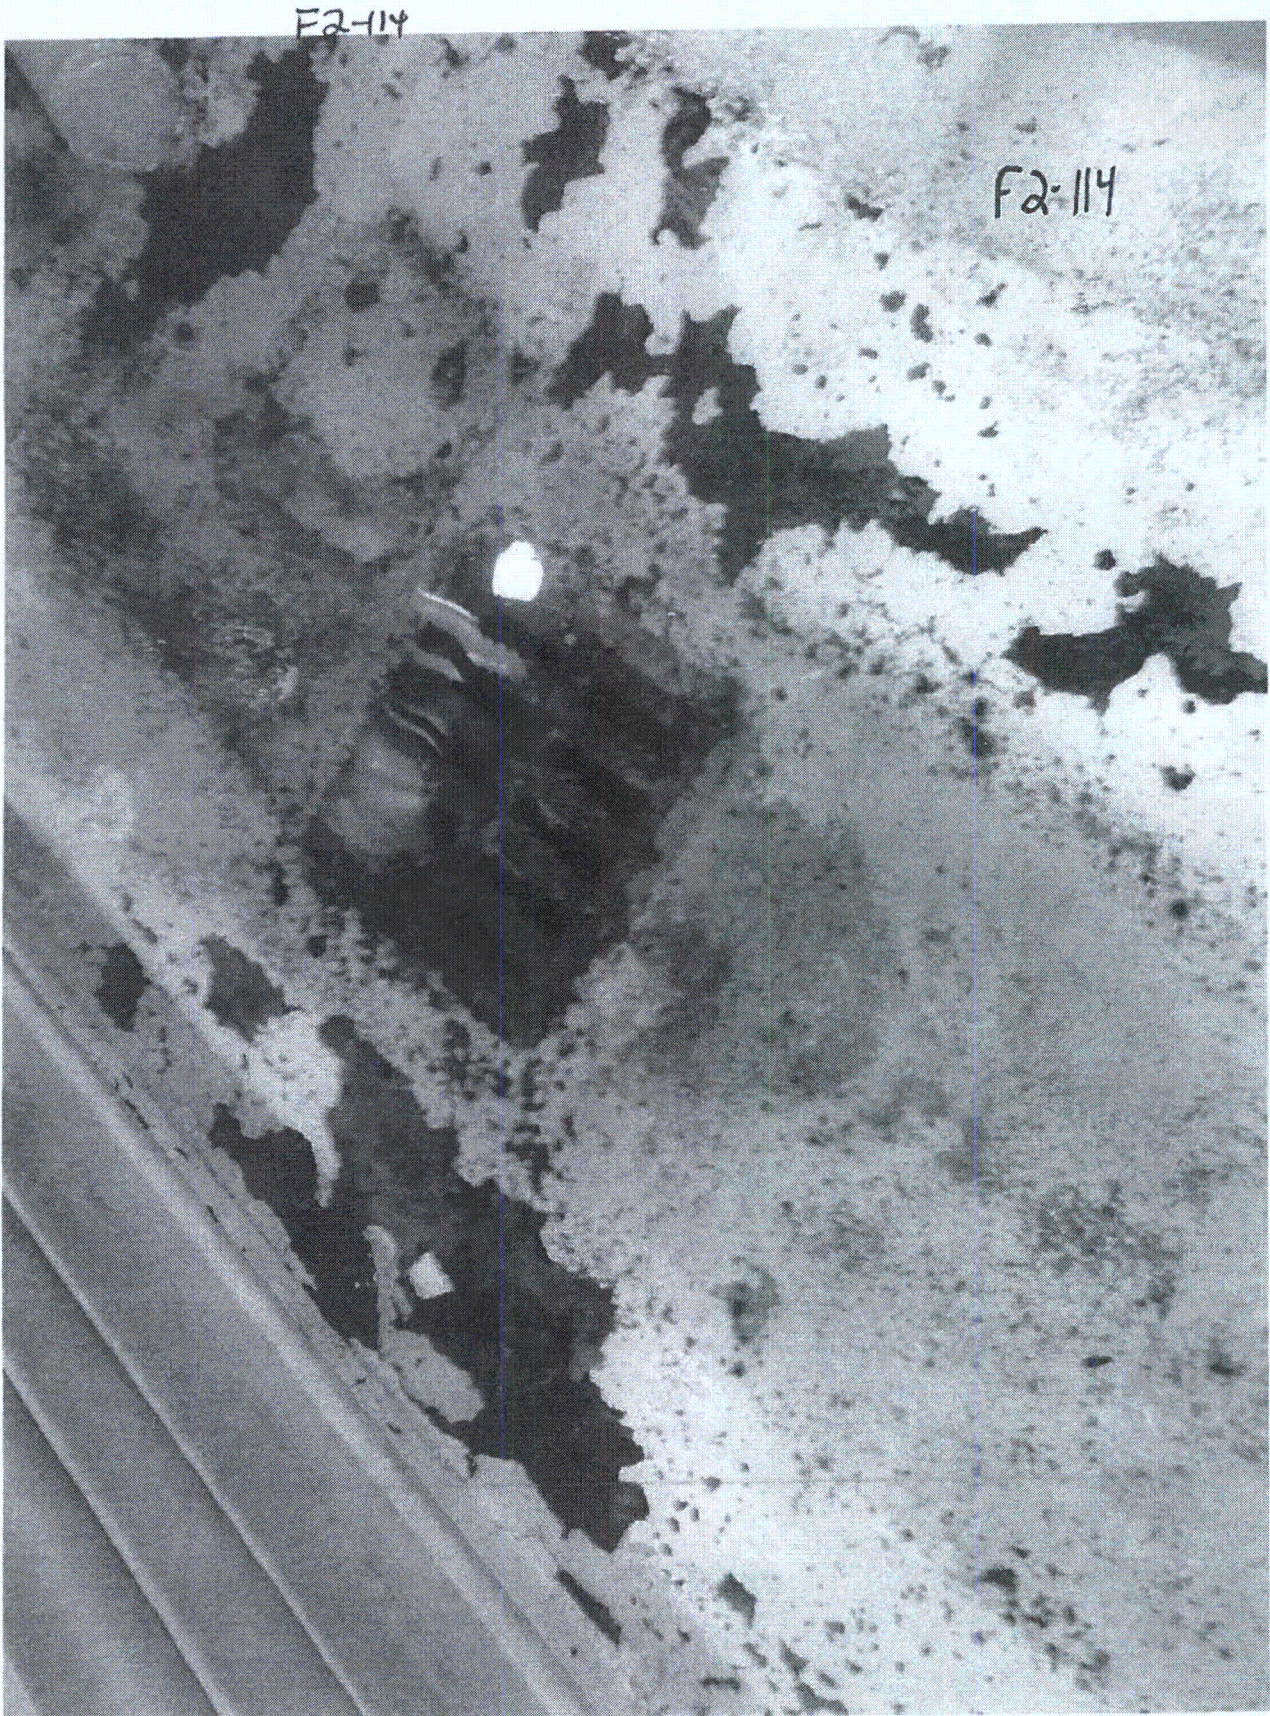
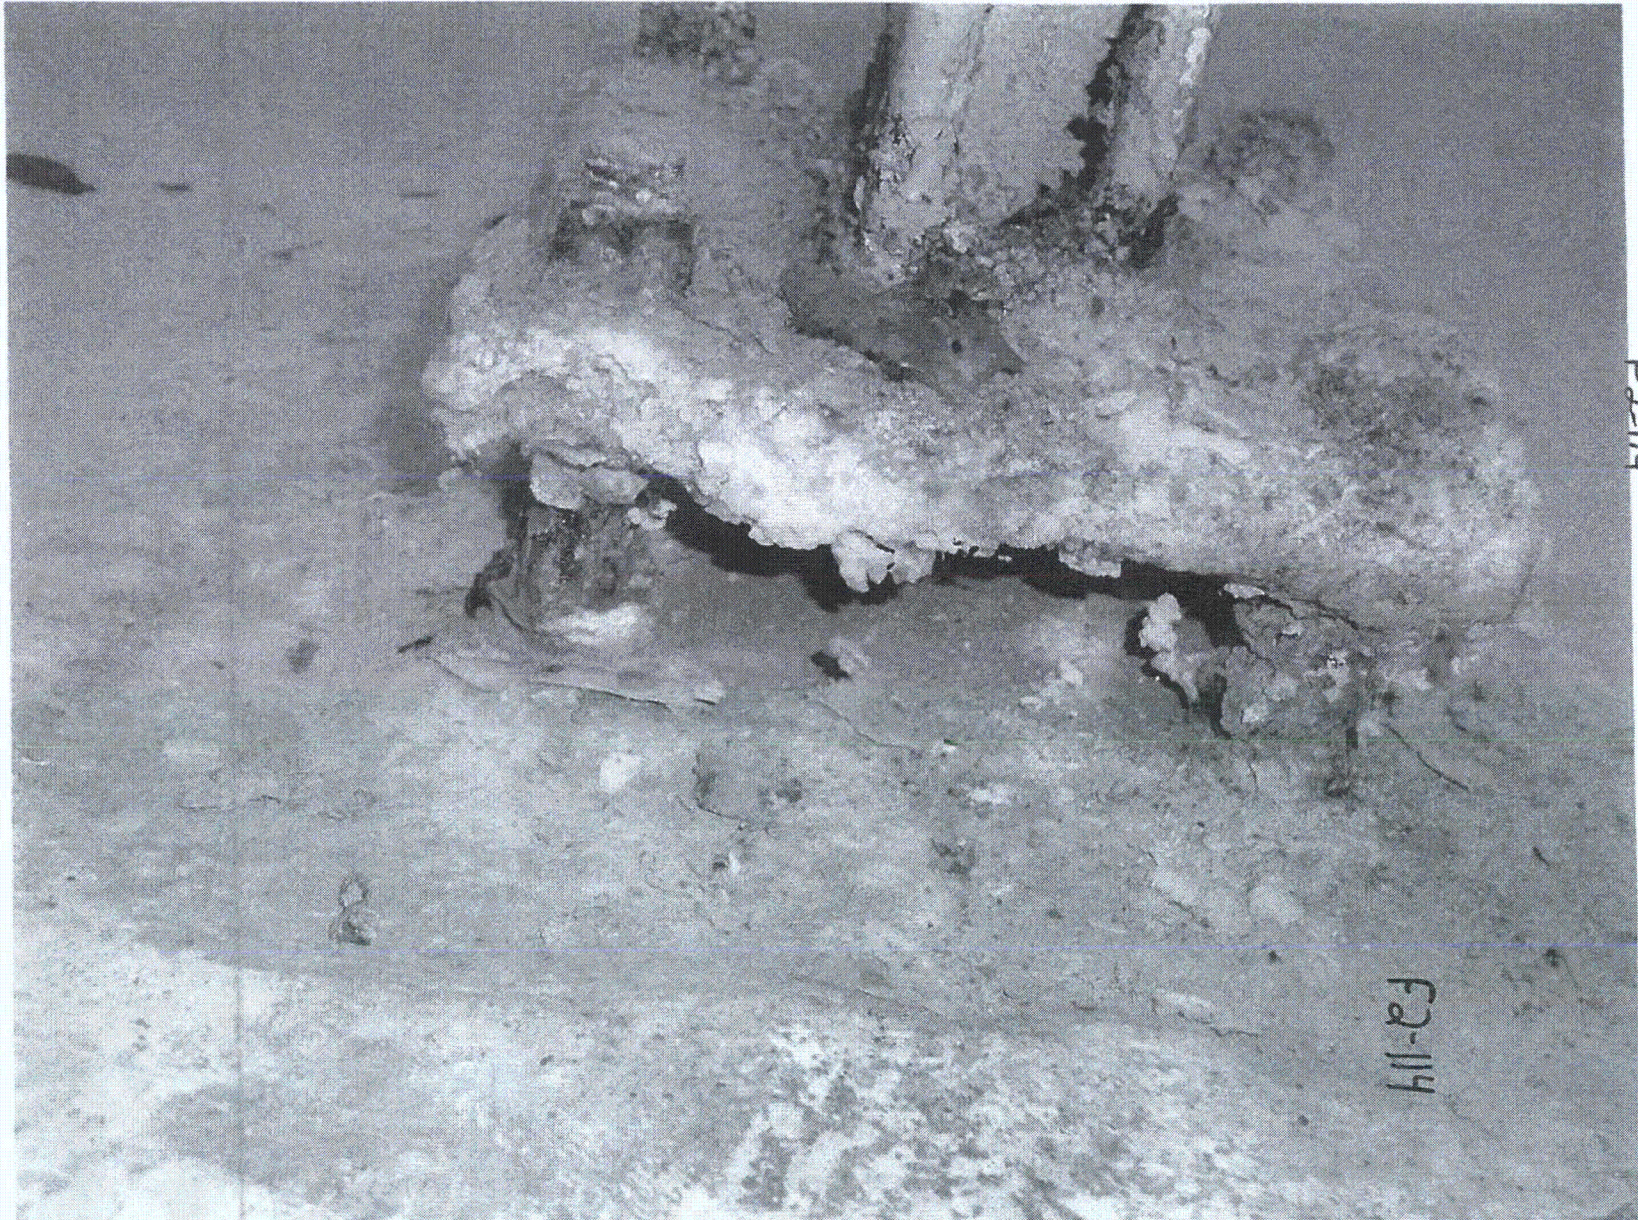
F2-114

*More than mild corrosion is on almost all supports mounted to the floor. Support T2-66C-1 has corrosion on the support arm. Existing CR 366965 (structural monitoring) has already addressed these issues and provided structural acceptability.*

*New CR 509889 was written since supports have not been cleaned and coated to have this done sooner.*

*New CR 509944 was written since floor drain is plugged adding to the moisture on supports problem.*

*New CR 509918 was written to clean and coat the RWST tank hold down bolts.*

*Based on reevaluation in CRs, area items are acceptable for seismic concerns.*

also see Quest. 2, floor drain stopped up, CR 509944 written to unstop. support adequacy addressed under Question 2
