APPENDIX C: AREA WALK-BY CHECKLISTS (AWCs)

PERRY NUCLEAR POWER PLANT

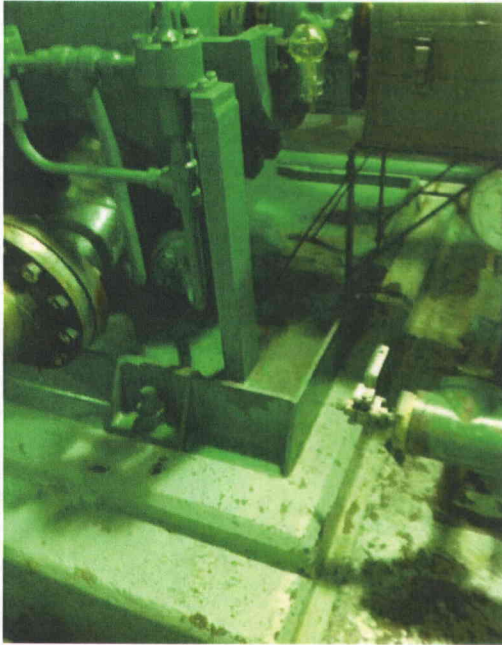
2. Does anchorage of equipment in the area appear to be free of significant degraded conditions?
Mild surface corrosion of skids judged to be acceptable.

File Name: 1-65-2-1-18.jpeg
Description: View of mild surface corrosion on anchorage

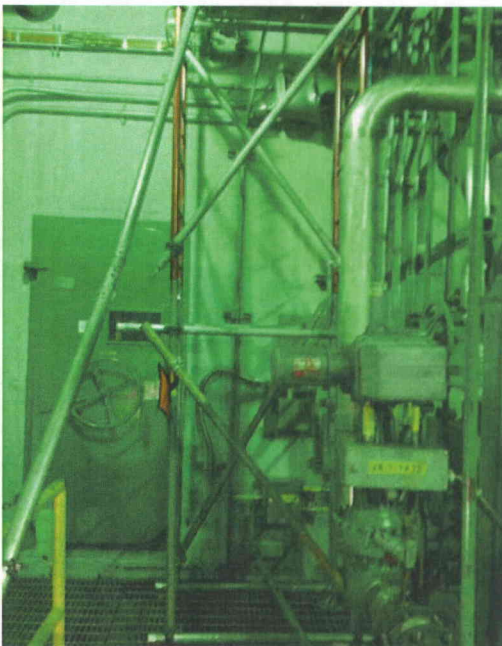
File Name: 1-66-2-1-18.jpeg
Description: View of scaffolding in the area

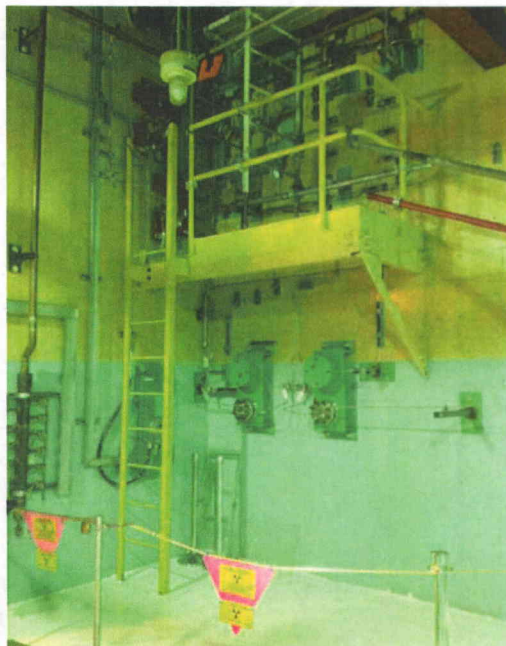
Anchorage of components in a high radiation contaminated area was examined visually from a distance of ~10 ft and no adverse conditions were identified.

File Name: 1-67-3-1-18.jpeg
Description: Inaccessible high radiation contaminated area where anchorage was checked from ~10 ft

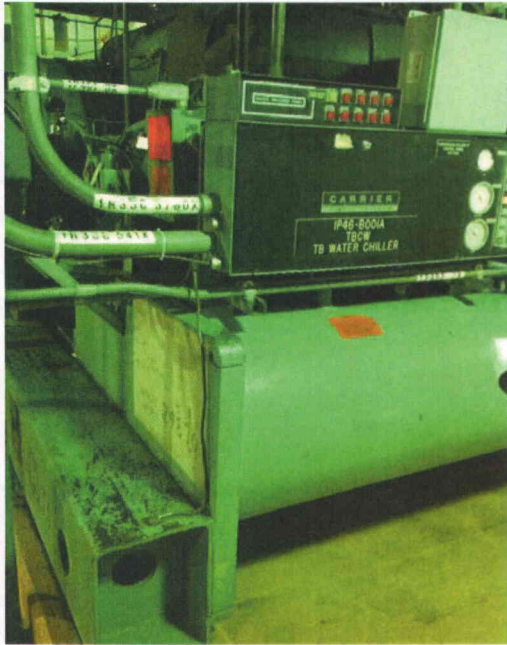
TB Chillers 1P46-B001A and 1P46-B001B are very large double stack chillers anchored with only four 3/4" anchor bolts on a ~16" wide x ~6" high pedestal. These chillers are not category I and anchorage may not be adequate for seismic loading. Judged acceptable because the chillers have a limited water supply and would not impact or flood any CAT-1 components if they should fail.

File Name: 1-67-3-1-20.jpeg
Description: View of 1P46B001A water chiller in the area

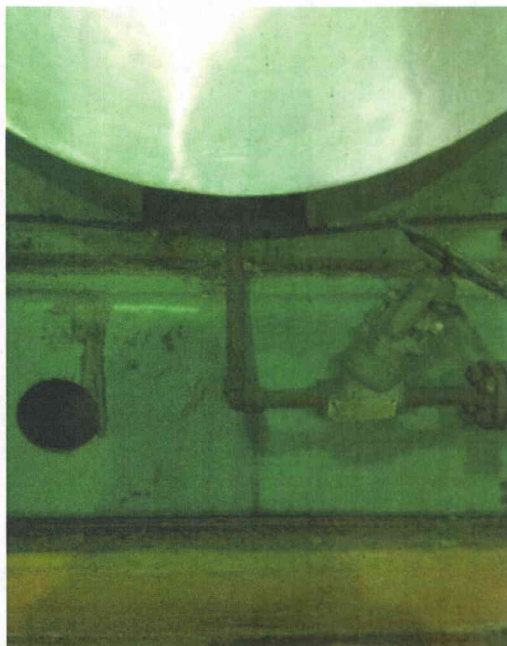
File Name: 1-70-3-1-20.jpeg
Description: View of corroded pipe in 1P46B001A

Anchorage for two CAT-2 chillers in area were identified with significant corrosion. This is judged to be acceptable because the chillers have a limited water supply and would not impact or flood any CAT-1 components if they should fail.

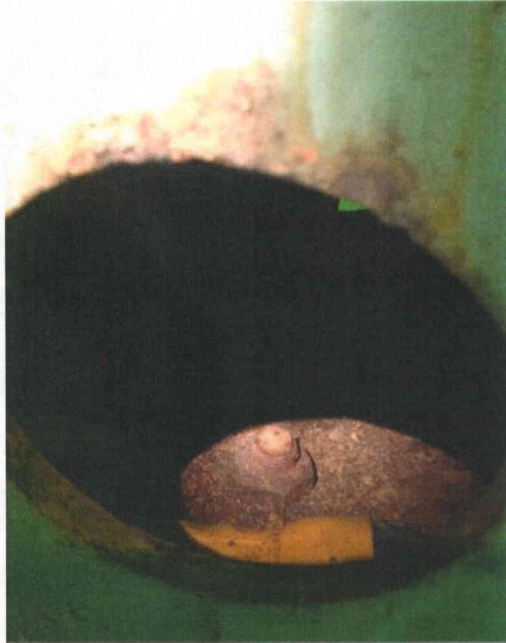
Anchorage for TB chillers identified with significant corrosion. This is judged to be acceptable, as described in comments for Question 1.

File Name: 1-71-3-1-20.jpeg
Description: View of corroded bolt located north east end of 1P46B001B

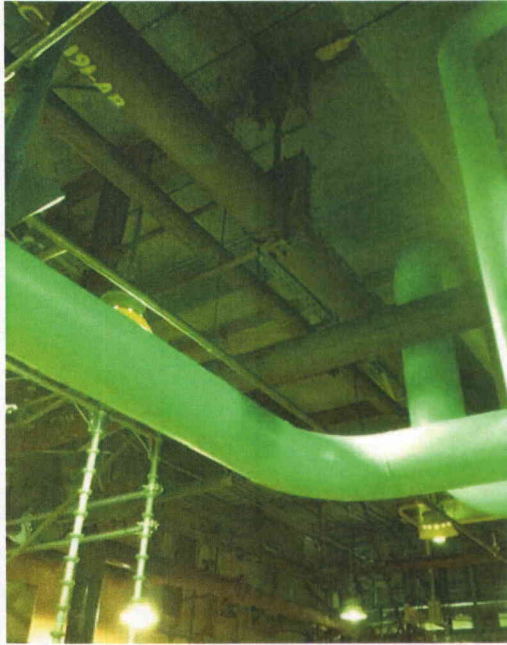
Overhead piping found to have adequate restraints.

File Name: 1-76-3-1-20.jpeg
Description: View of overhead piping restraints

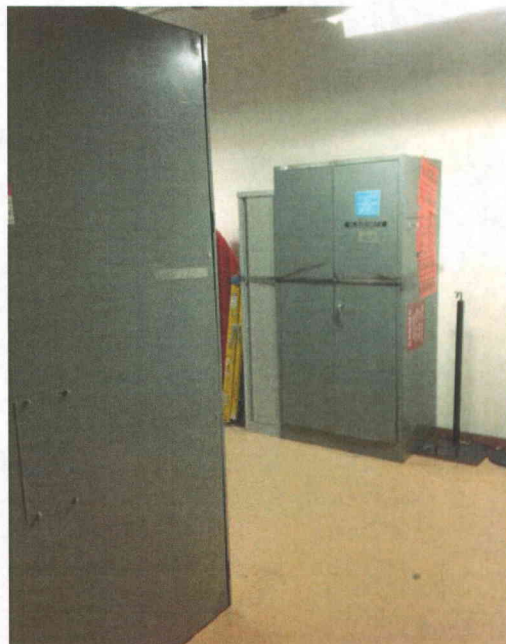
File Name: 1-69-1-1-06.jpeg
Description: Tool locker not restrained behind bus/breakers

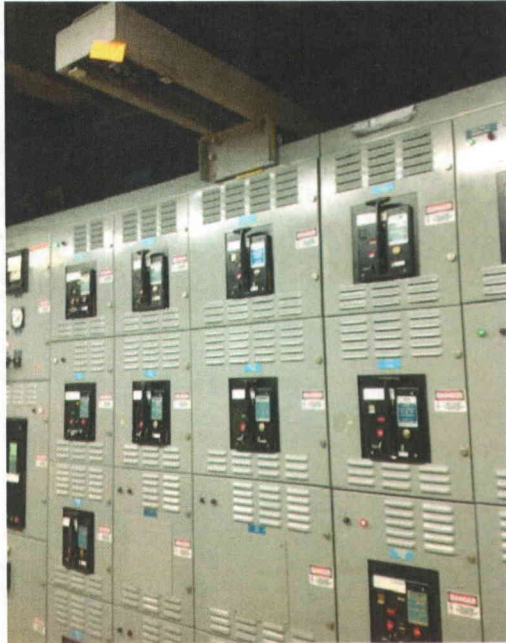
File Name: 1-71-1-1-06.jpeg
Description: View of trolley on top of Cabinet

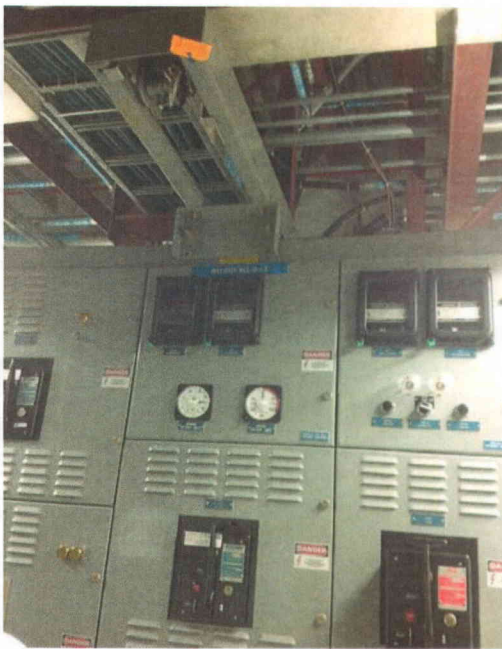
File Name: 1-66-1-1-02.jpeg
Description: View of trolley on top of Cabinet

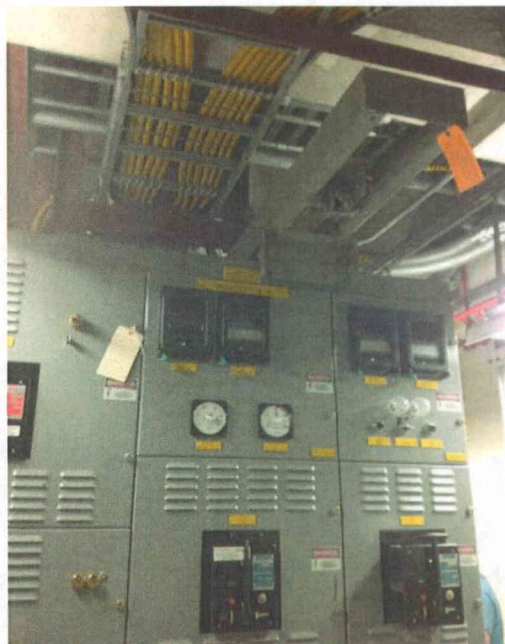
File Name: 1-60-3-1-02.jpeg
Description: View of trolley on top of Cabinet

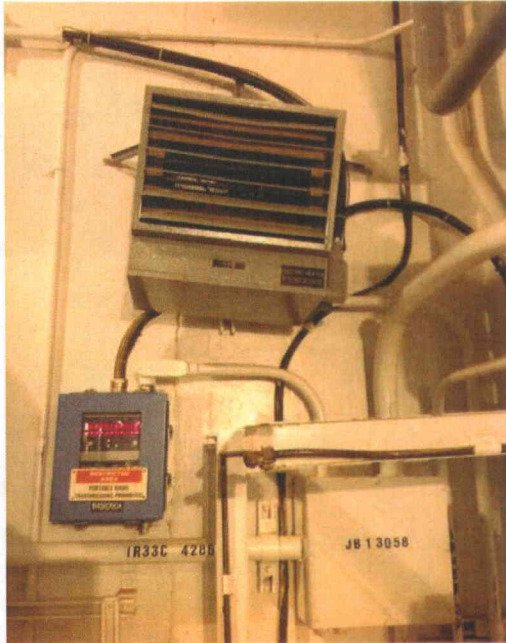
File Name: 1-65-1-1-08.jpeg
Description: View of crooked heater. Not a concern for operability.

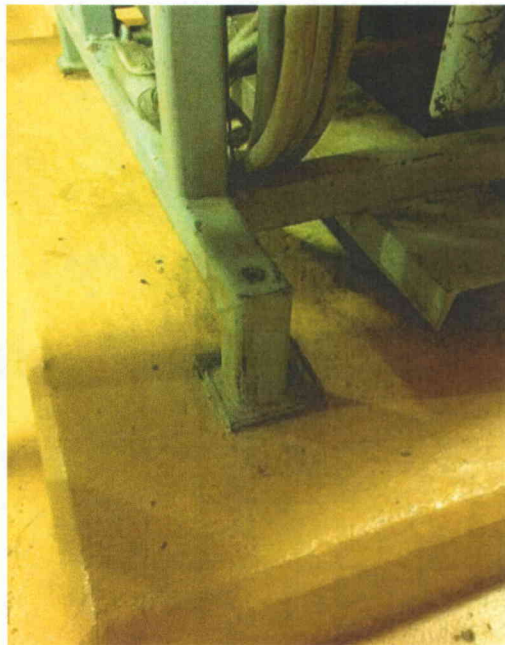
File Name: 1-74-1-1-01.jpeg
Description: Air dryer rack (1P52-D003B) missing anchorage (similar issue 1P52-D003A)

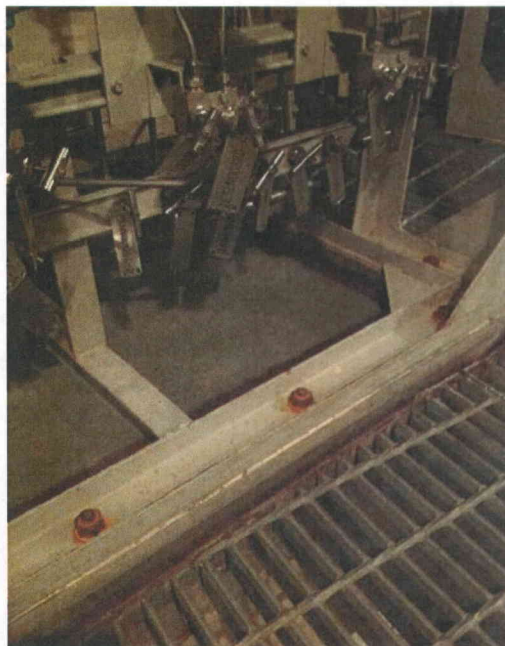
File Name: 1-65-1-1-13.jpeg
Description: Corrosion in instrument rack anchorage

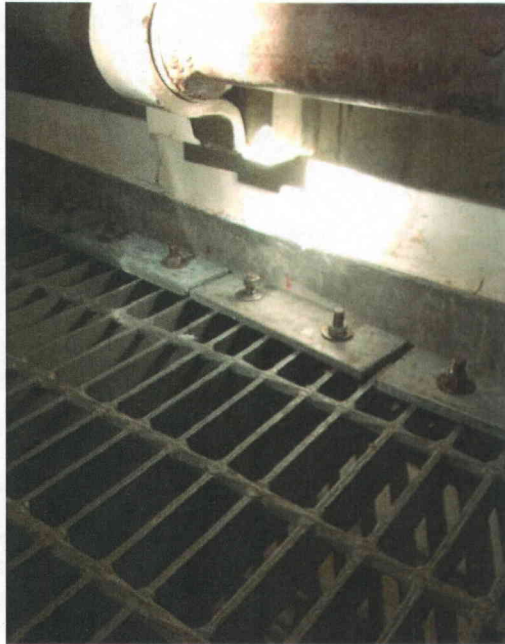
File Name: 1-66-1-1-13.jpeg
Description: Loose nut for securing grating.

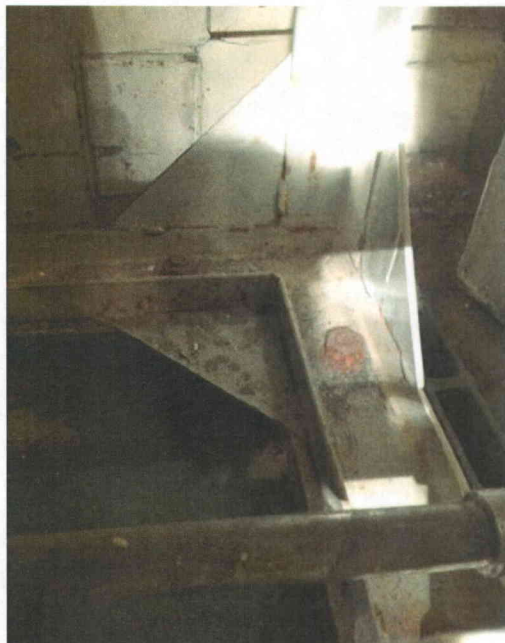
File Name: 1-71-1-1-13.jpeg
Description: Mild corrosion identified in anchorage

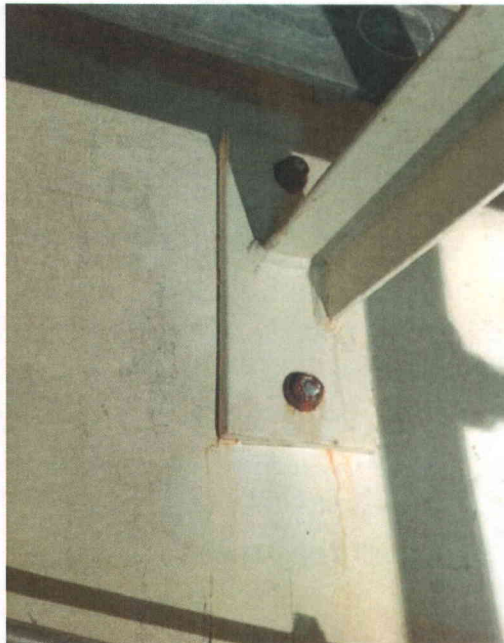
File Name: 1-60-1-1-12.jpeg
Description: Surface corrosion identified

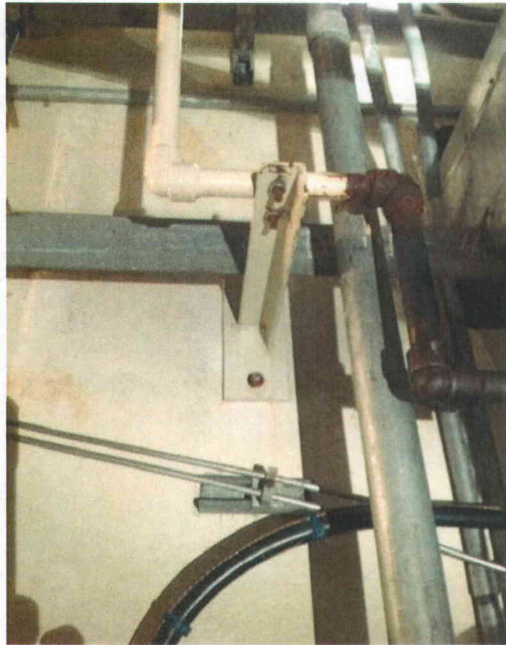
File Name: 1-65-1-1-12.jpeg
Description: Surface corrosion identified

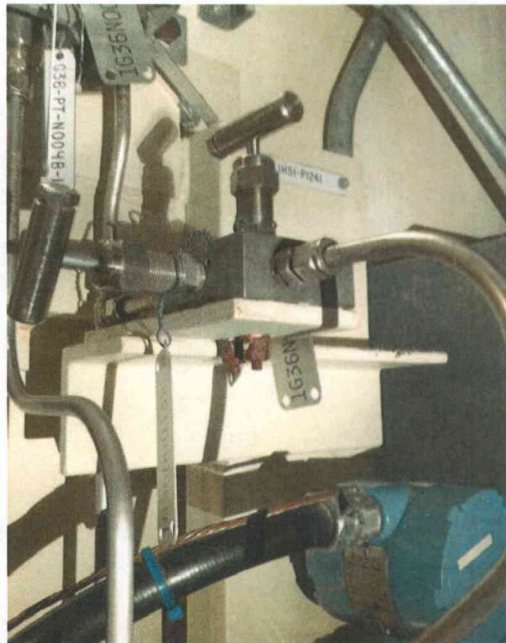
File Name: 1-67-1-1-12.jpeg
Description: Surface corrosion identified

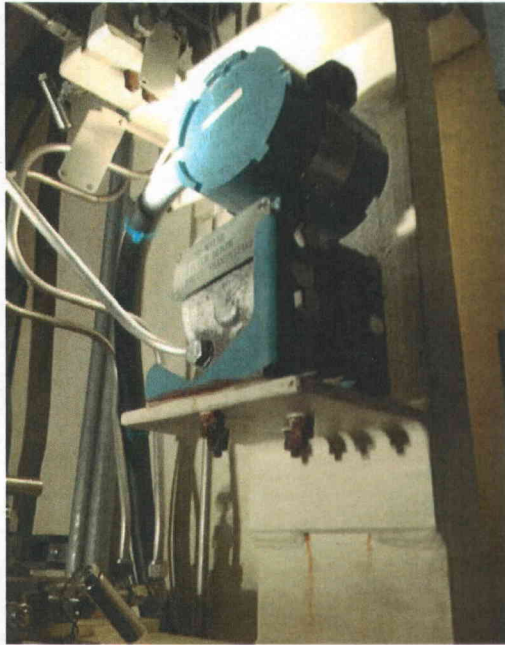
File Name: 1-68-1-1-12.jpeg
Description: Surface corrosion identified

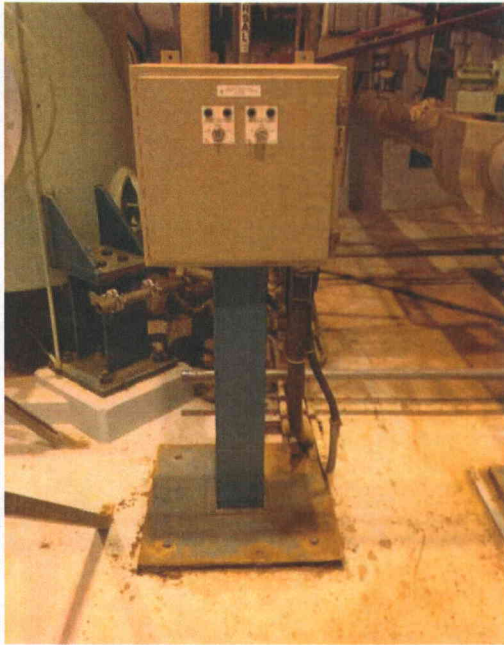
File Name: 1-65-1-1-05.jpeg
Description: View of 2H51-P753B anchorage condition

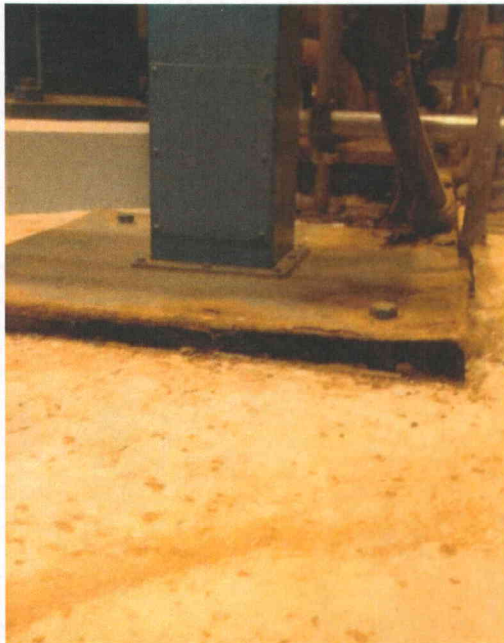
File Name: 1-66-1-1-05.jpeg
Description: Close up of anchorage condition

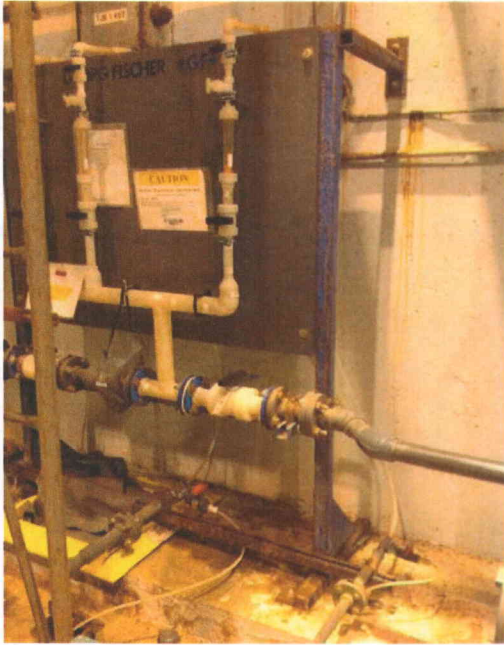
File Name: 1-70-1-1-05.jpeg
Description: Surface corrosion identified

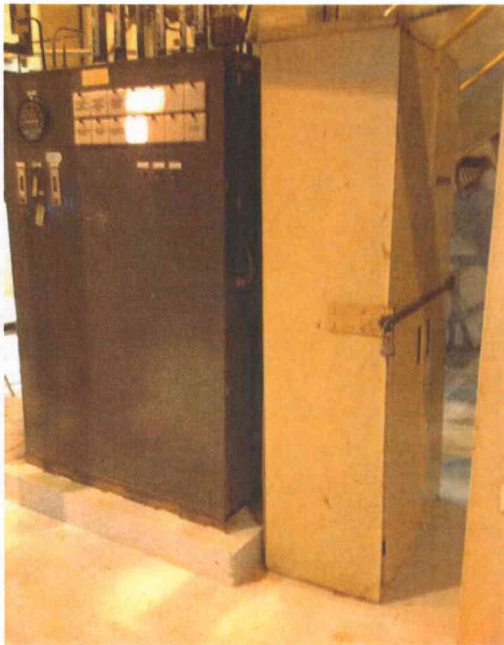
File Name: 1-71-1-1-05.jpeg
Description: Storage container identified next to H51-P010A

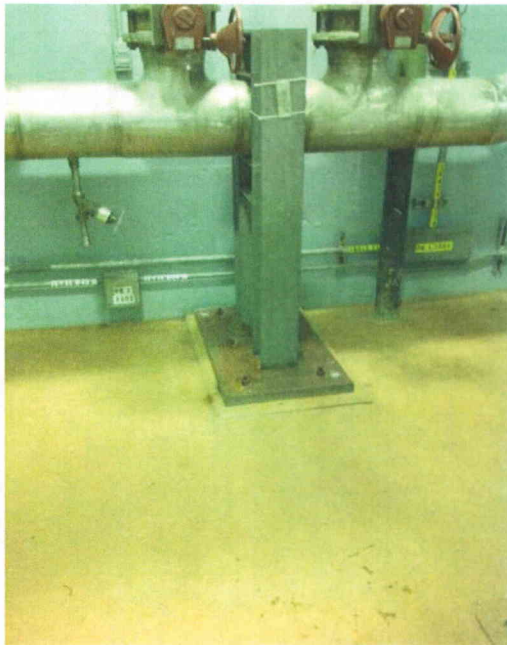
File Name: 1-60-2-1-22.jpeg
Description: Mild surface corrosion identified

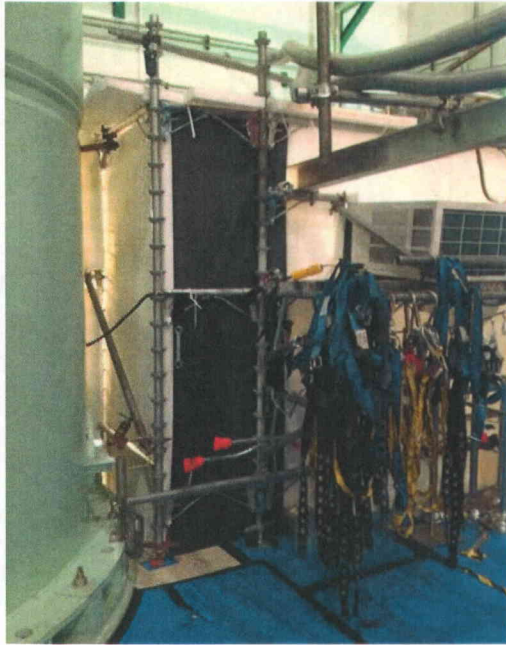
File Name: 1-67-2-1-17.jpeg
Description: Scaffolding clamped to tank
