Seismic Walkdown Checklist (SWC)

Equipment ID No. MCC-1-E7 Equip. Class 1. Motor Control Center

Equipment Description 480V Motor Control Center FED From 480V Substation 1-8Bus 1N(8N14)

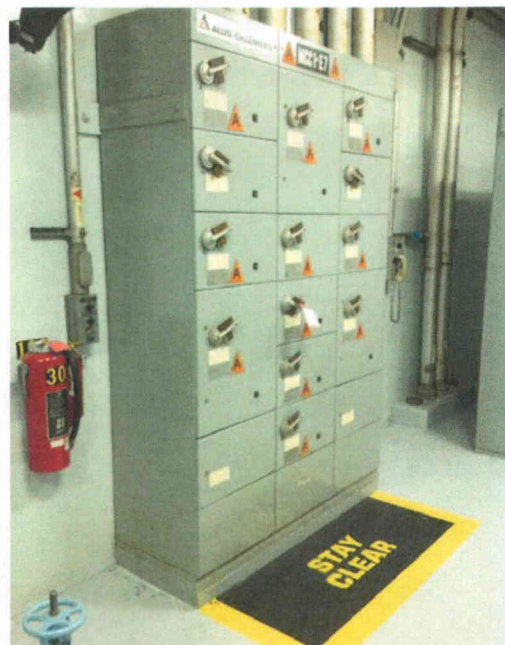
1. Is the anchorage configuration verification required (i.e., is the item one of the 50% of SWEL items requiring such verification)?
MCC composed of 3 sections. Component is close to wall but it is top braced by top entry conduit as well as separate top bracing mechanism.

5. Is the anchorage configuration consistent with plant documentation?
(Note: This question only applies if the item is one of the 50% for which an anchorage configuration verification is required.)
Base weld detail in MCC-1-E7 verified per Calculation 52233-C-001 Anchorage Calc

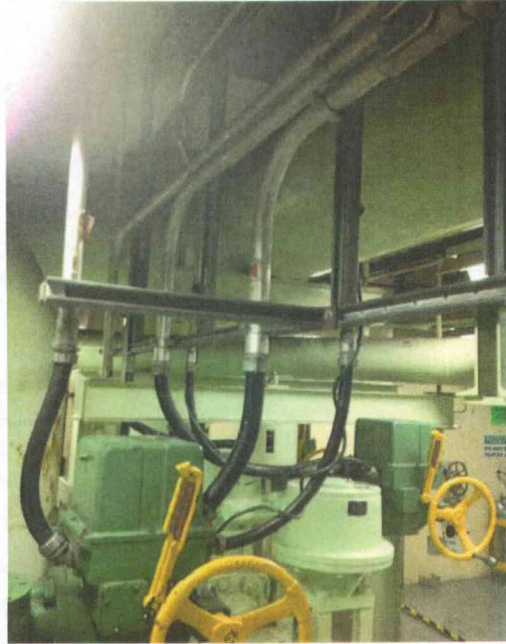
File Name: 2-63-3-1-43.jpeg
Description: View of flexible attached lines

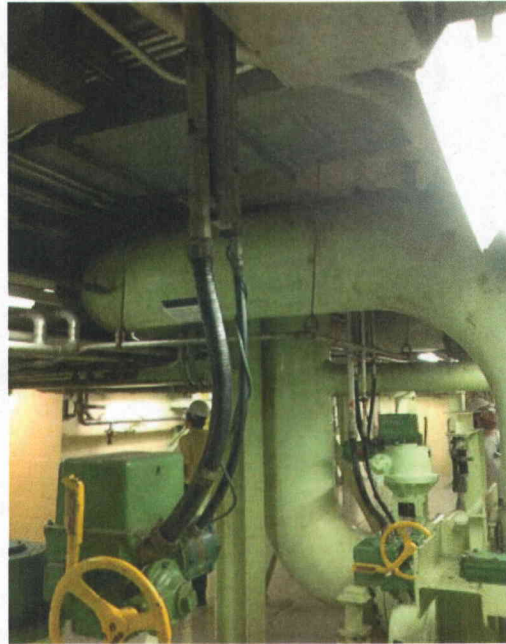
File Name: 2-63-2-1-43.jpeg
Description: View of flexible attached lines

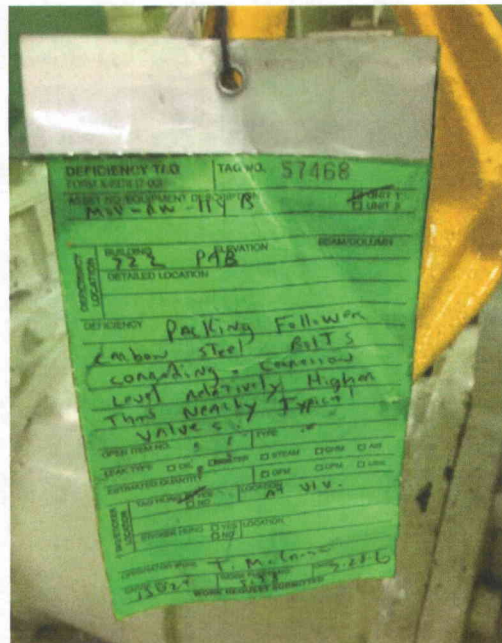
3. Is the anchorage free of corrosion that is more than mild surface oxidation?
Slight corrosion visible at packing. Tag No. 57468 identifies the rust issue.

File Name: 2-64-4-1-43.jpeg
Description: View of deficiency tag identifying moderate corrosion stage

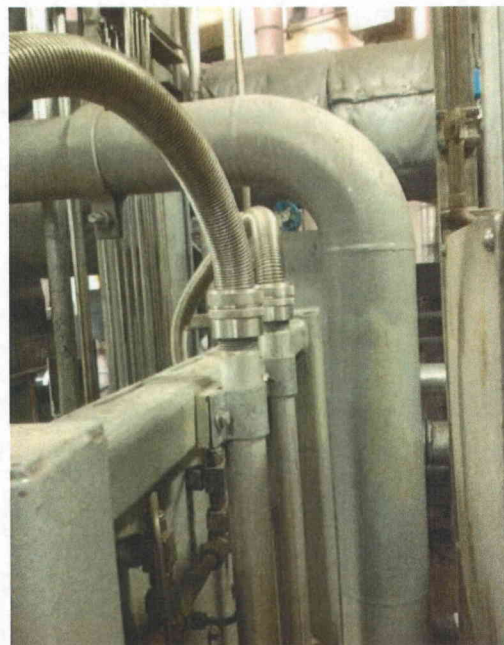
File Name: 2-64-7-1-32.jpeg
Description: View of flexible attached lines

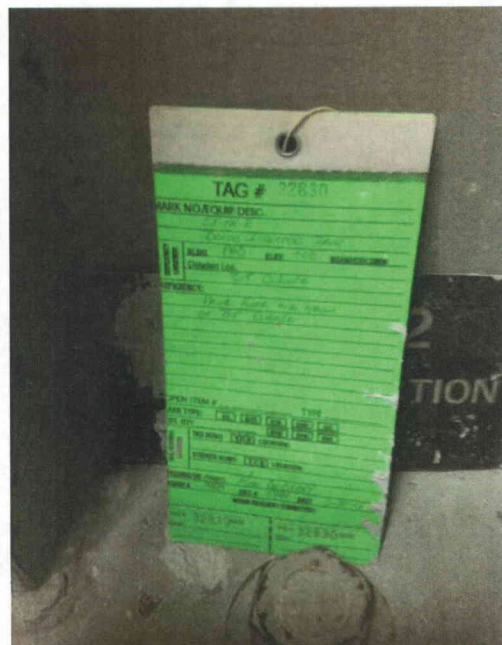
File Name: 2-64-1-1-42.jpeg
Description: Deficiency tag addressing paint of cubicle floor and walls

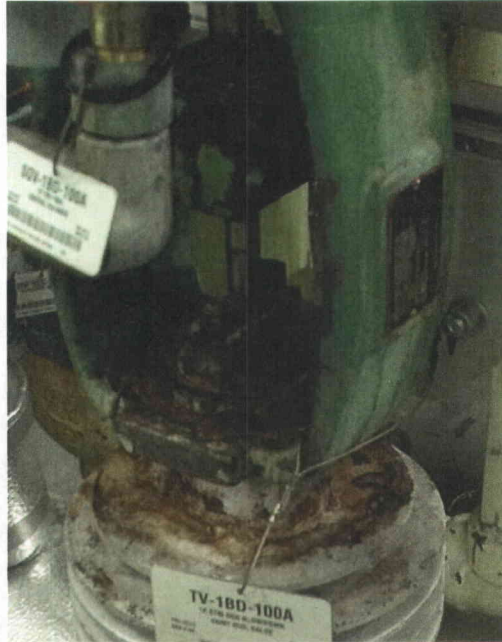
File Name: 2-63-1-1-38.jpeg
Description: Slight corrosion identified on valve

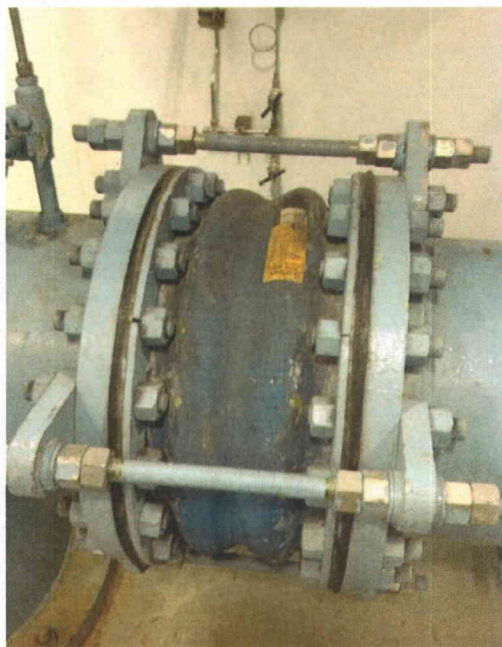
File Name: 2-73-2-1-28.jpeg
Description: View of expansion joint located in pump main line
