## APPENDIX C AREA WALK-BY CHECKLISTS (AWCs)

**Area Walk-By Checklist (AWC)**

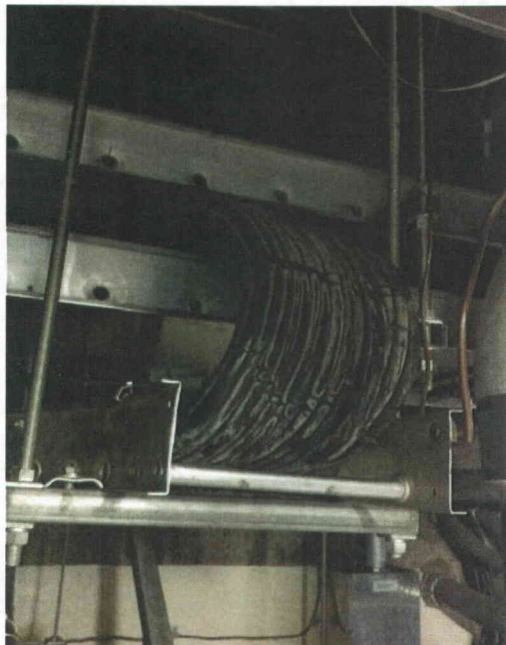
File Name: 1-66-1-4-06.jpeg  
Description: Cable trays in area full, but not overflowing

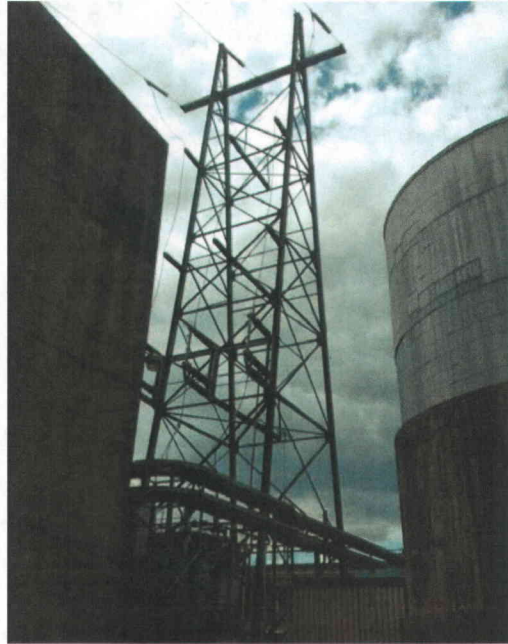
File Name: 1-65-1-4-09.jpeg  
Description: Tower near by is judged rugged, interaction is not credible.

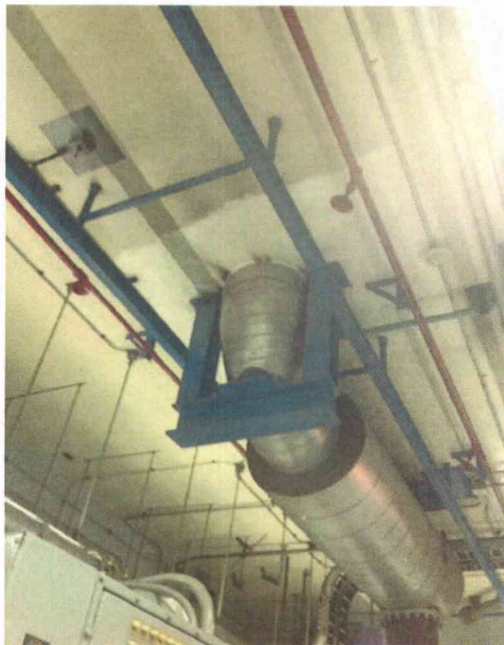
File Name: 1-68-1-4-20.jpeg  
Description: Soot on ceiling indicates possible exhaust leak inside building

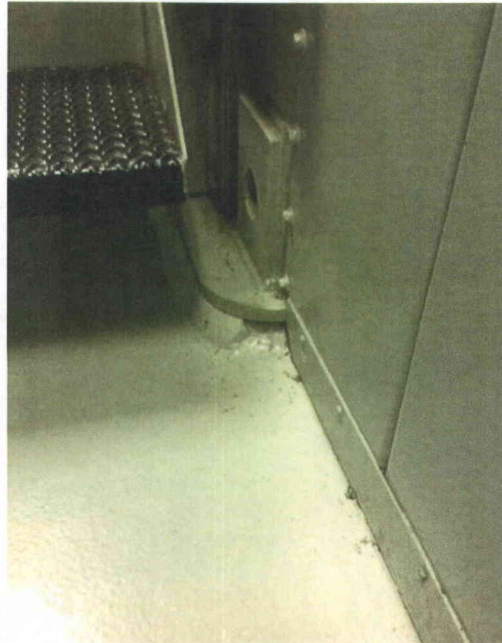
File Name: 1-69-1-4-22.jpeg  
Description: Minor spalling underneath diesel generator

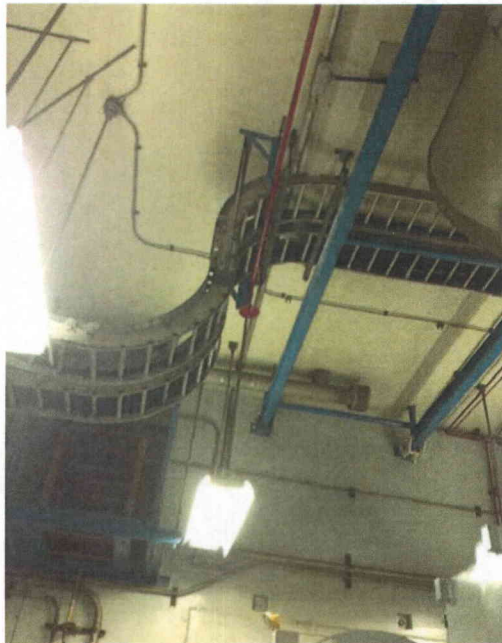
File Name: 1-70-1-4-22.jpeg  
Description: Fire pipe in proximity of cable tray, is a co2 line

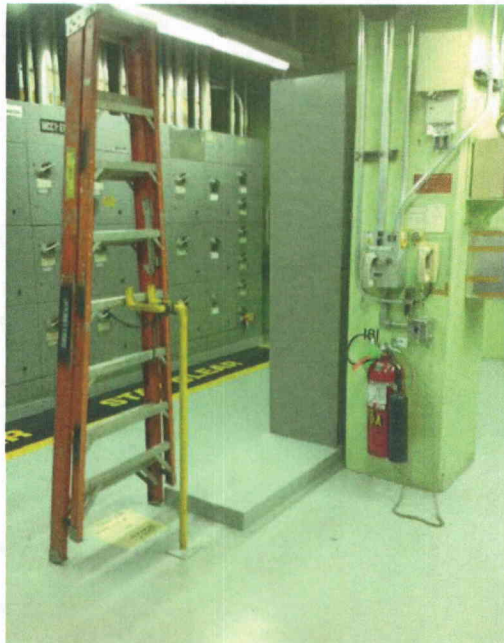
File Name: 1-67-1-4-23.jpeg  
Description: Fire extinguisher and loose ladder in area

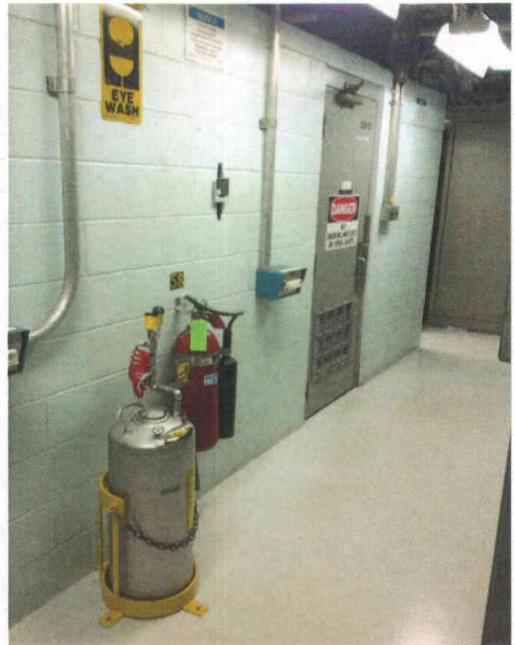
File Name: 1-65-1-4-25.jpeg  
Description: Block wall and unrestrained fire extinguisher in area.

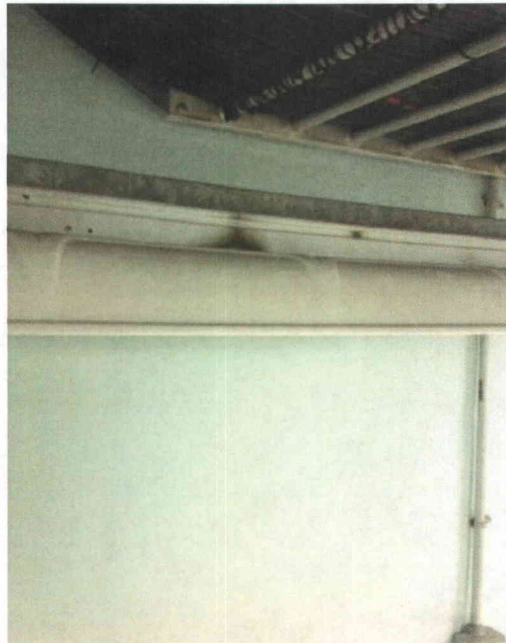
File Name: 1-68-1-4-25.jpeg  
Description: Light has burn marks on it, appears disused.  
Considered a non issue.

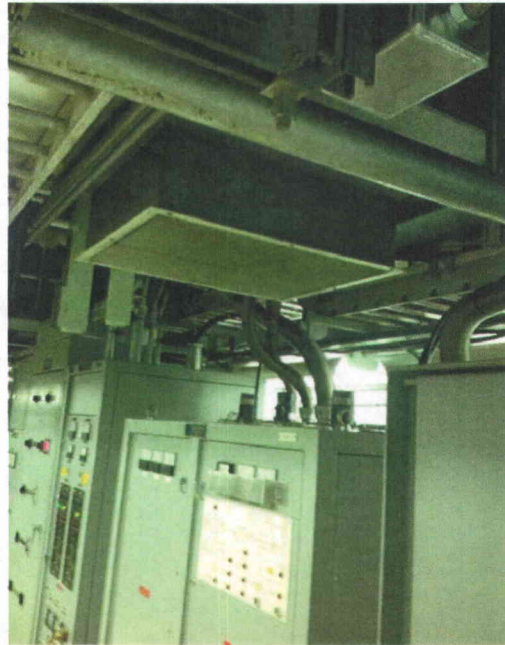
File Name: 1-71-1-4-25.jpeg  
Description: HVAC grill over INV-VITBUS1-3 judged adequately restrained.

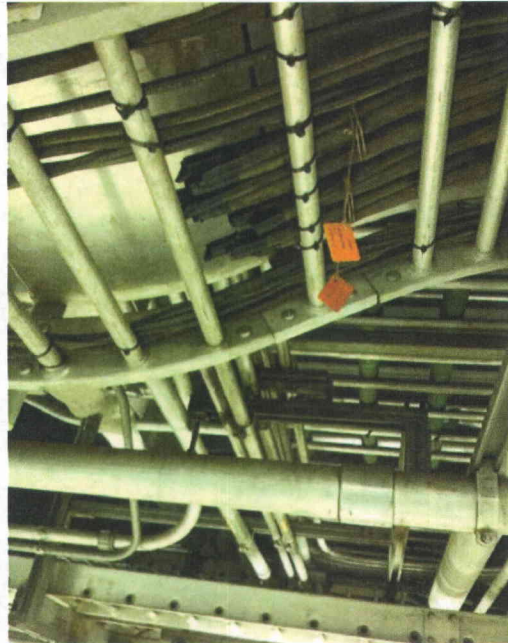
File Name: 1-75-1-4-25.jpeg  
Description: View of unused cables in cable tray.

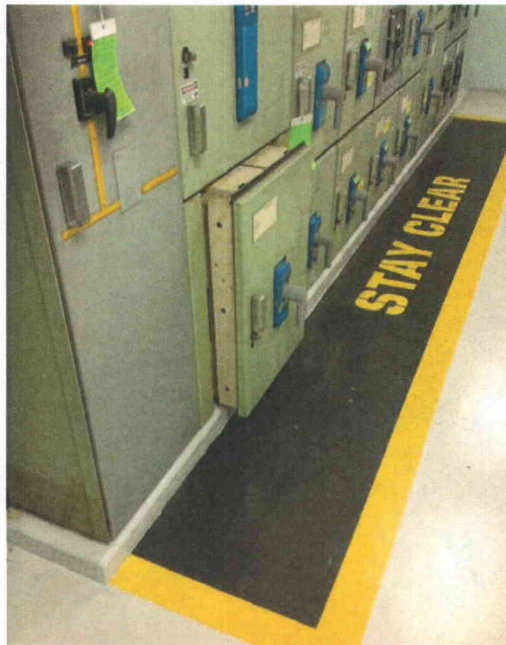
File Name: 1-66-1-4-26.jpeg  
Description: SUB STA 1-9 BUS 1P, with un-racked breaker

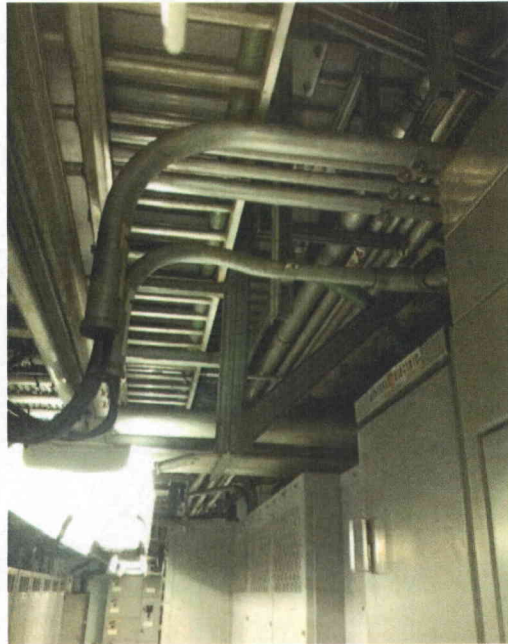
File Name: 1-72-1-4-26.jpeg  
Description: Cable tray has long rod support,  
but is laterally braced and judged a non issue

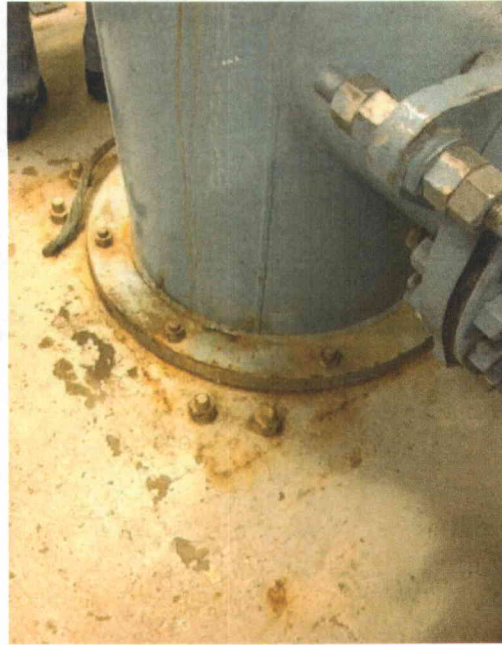
File Name: 1-65-1-4-28.jpeg  
Description: Surface rust on pump 1WR P 1B not an issue

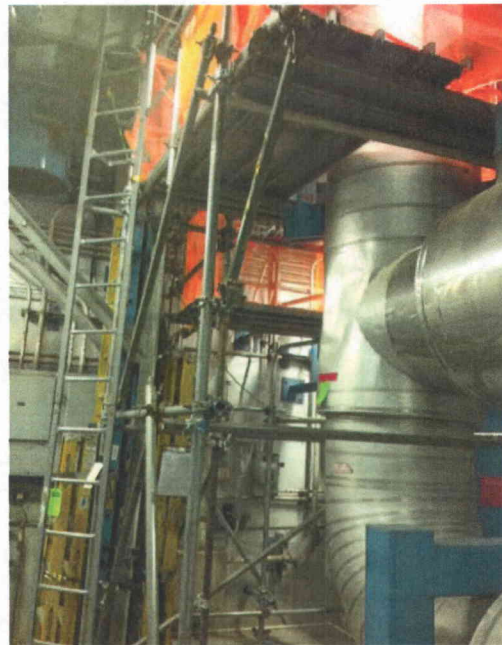
File Name: 1-66-1-4-28.jpeg  
Description: Temporary scaffold not an issue

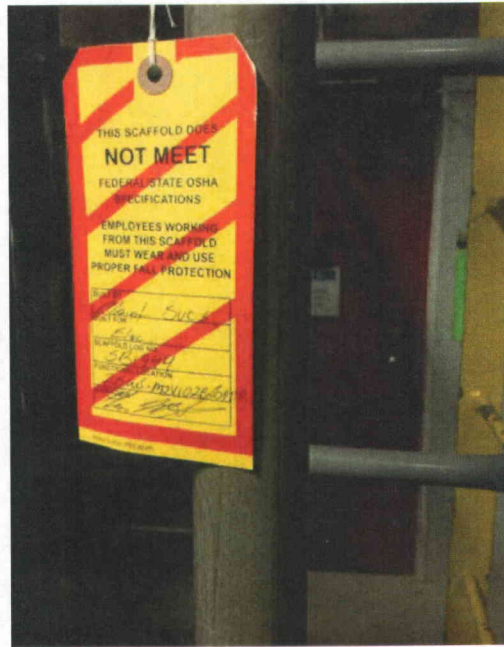
File Name: 1-67-1-4-29.jpeg  
Description: Scaffold deficient tag

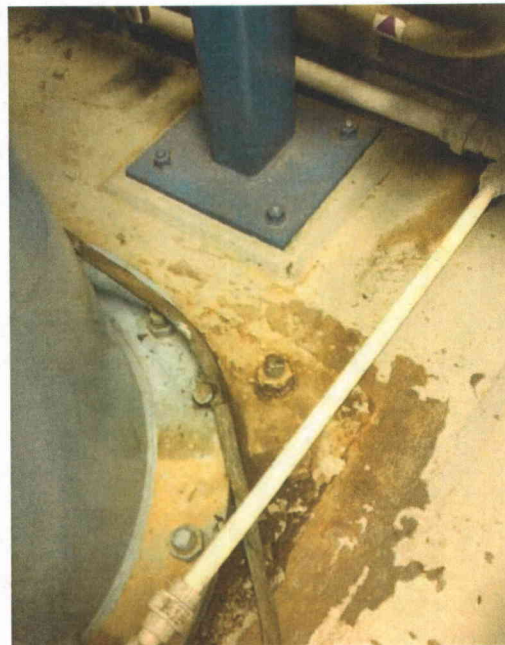
File Name: 1-68-1-4-29.jpeg  
Description: Corroded bolt near pump. Bolt hold nothing

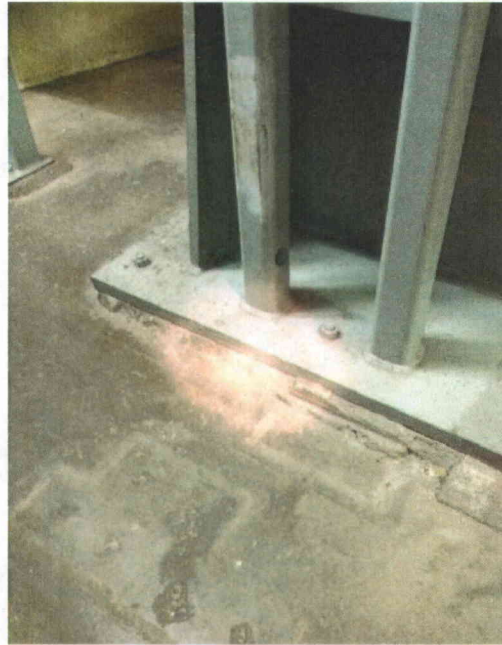
File Name: 1-69-1-4-32.jpeg  
Description: Spalled grout on main steam support, not significant

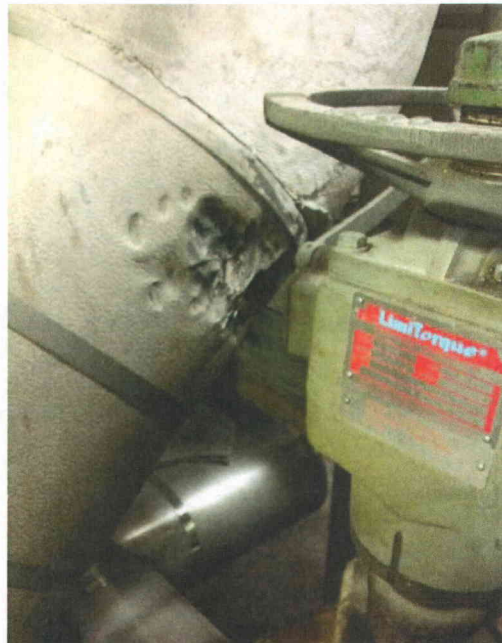
File Name: 1-70-1-4-32.jpeg  
Description: Insulation damage believed to be due to valve servicing MOV 1 MS 105

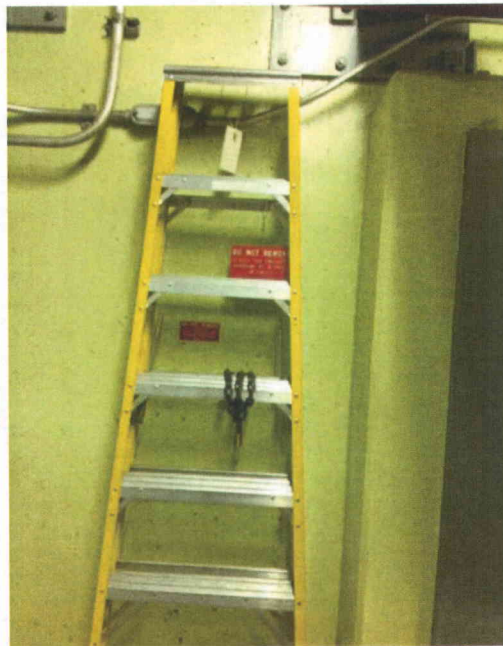
File Name: 1-72-1-4-32.jpeg  
Description: Ladder, loosely secured.

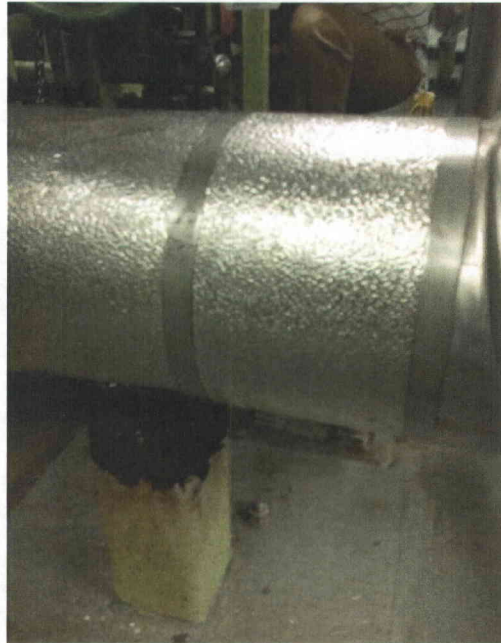
File Name: 1-65-1-4-38.jpeg  
Description: Noted minor corrosion in area

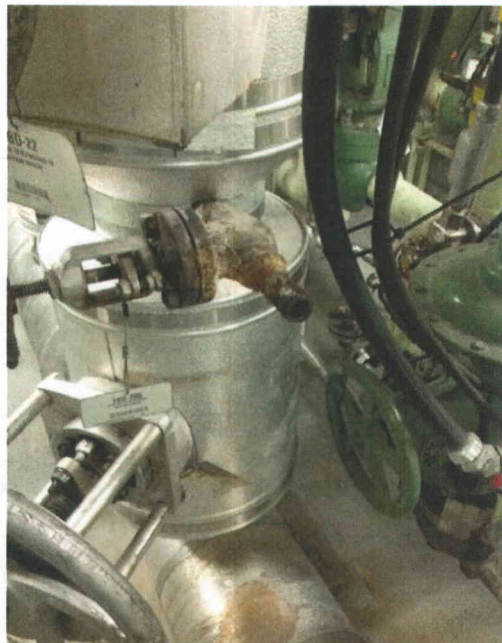
File Name: 1-66-1-4-38.jpeg  
Description: Noted minor corrosion in area

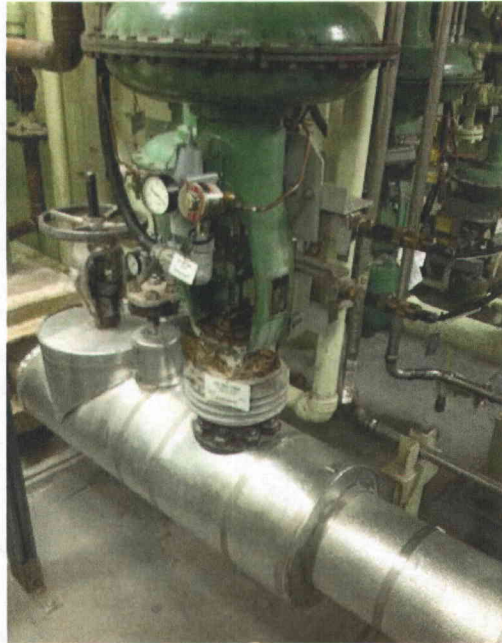
File Name: 1-67-1-4-38.jpeg  
Description: Noted minor corrosion in area

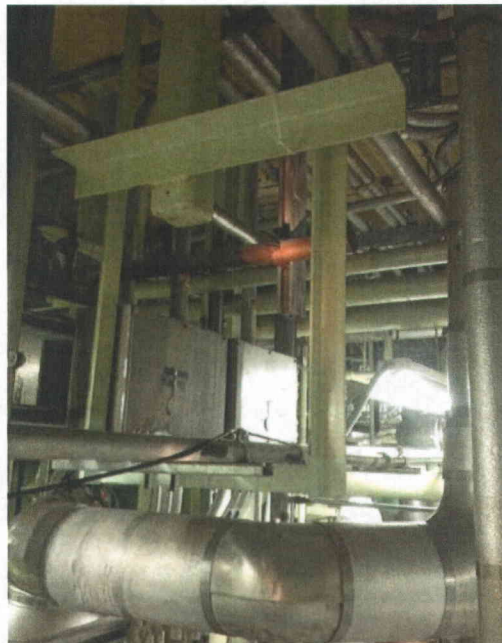
File Name: 1-68-1-4-38.jpeg  
Description: Noted minor corrosion in area

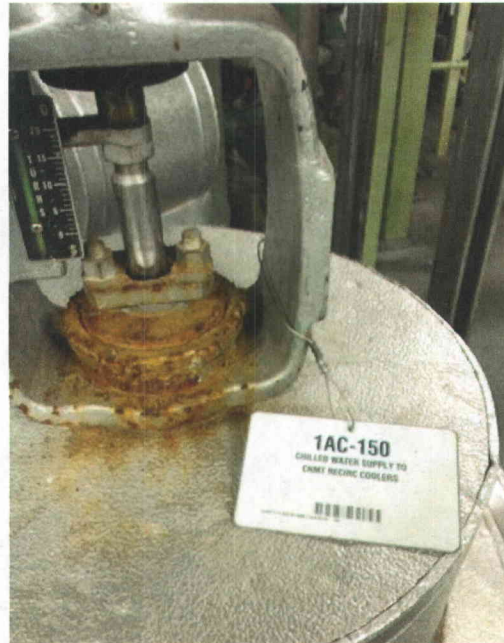
File Name: 1-69-1-4-38.jpeg  
Description: Noted corrosion in area, CR-2012-13971 initiated

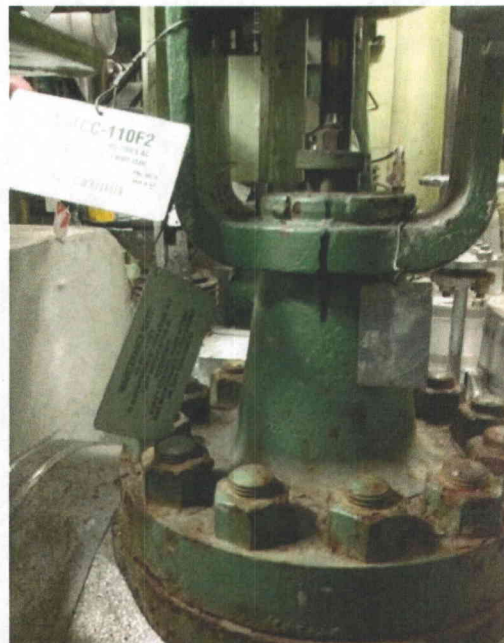
File Name: 1-70-1-4-38.jpeg  
Description: Noted corrosion in area, CR-2012-13970 initiated

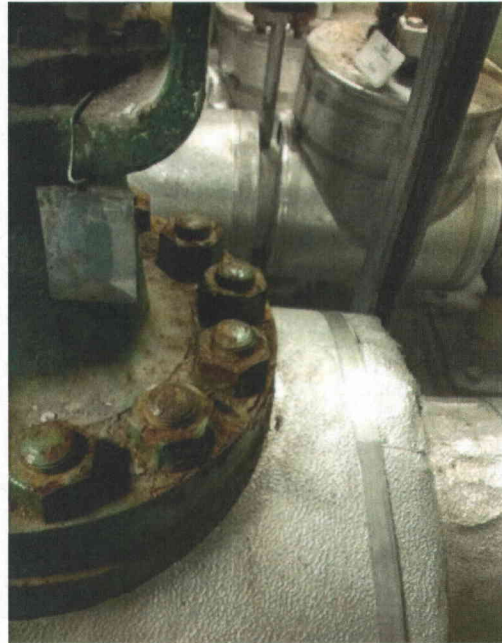
File Name: 1-71-1-4-38.jpeg  
Description: Noted corrosion in area, CR-2012-13970 initiated

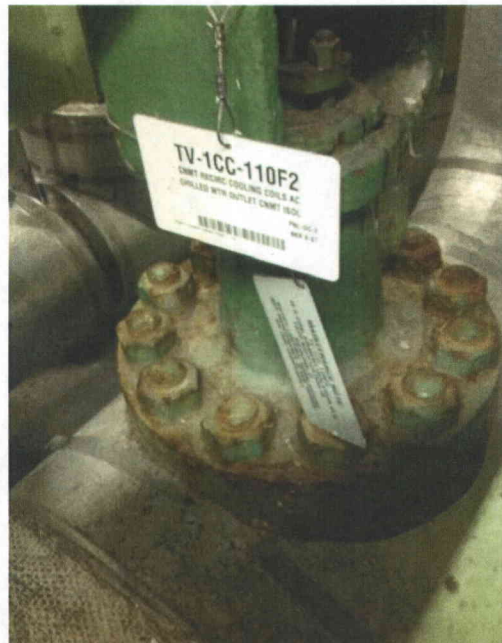
File Name: 1-72-1-4-38.jpeg  
Description: Noted corrosion in area, CR-2012-13970 initiated

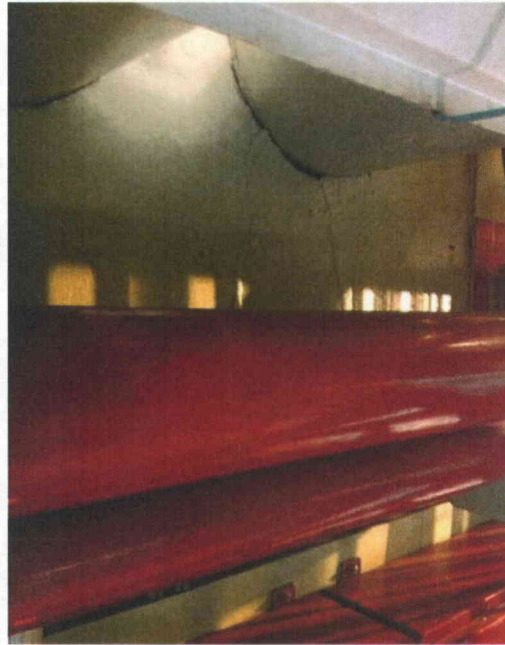
File Name: 1-75-1-4-38.jpeg  
Description: Wall with potential cracking, east wall, judged not significant

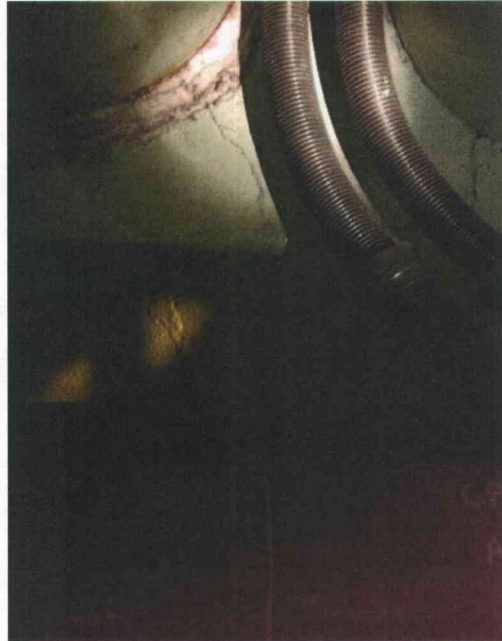
File Name: 1-76-1-4-38.jpeg  
Description: Wall with potential cracking, east wall, judged not significant

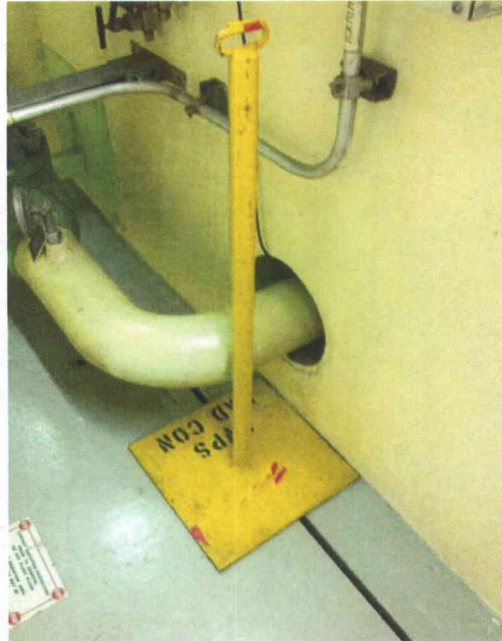
File Name: 1-65-1-4-41.jpeg  
Description: Loose pole could impact

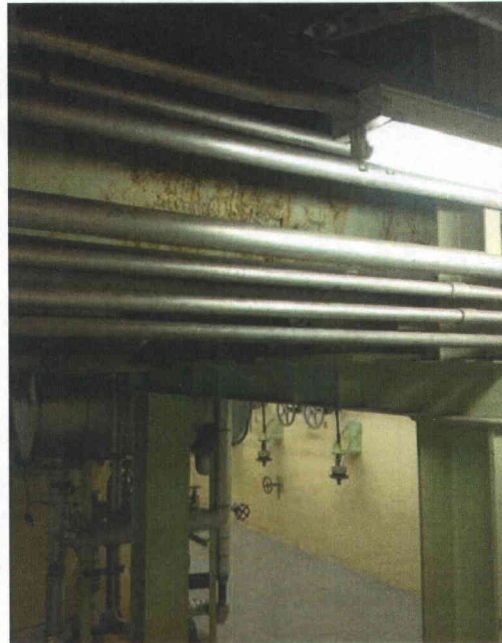
File Name: 1-71-1-4-43.jpeg  
Description: Surface corrosion identified on large pipes. Judged not a concern.

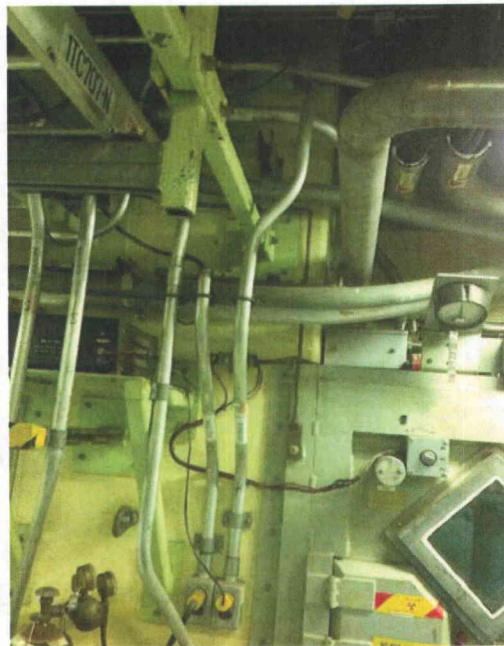
File Name: 1-66-1-4-46.jpeg  
Description: HSS hung cable tray is axially braced and judged a non issue.

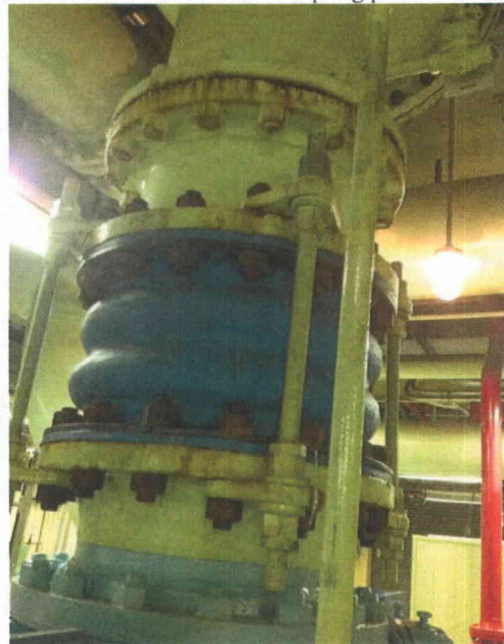
File Name: 1-68-1-4-46.jpeg  
Description: Surface corrosion, judged a non issue

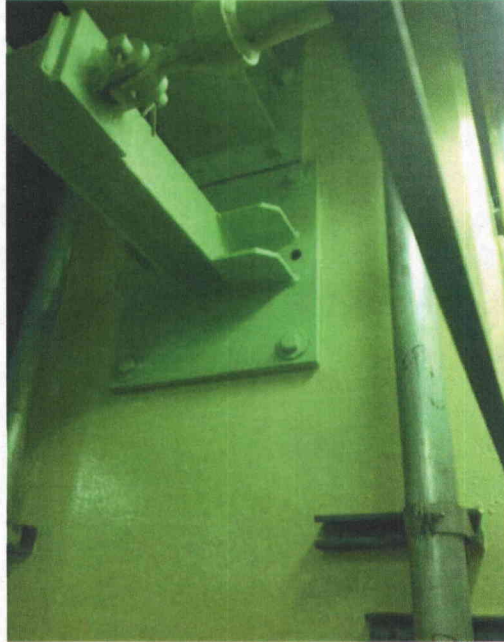
File Name: 1-69-1-4-46.jpeg

Description: Support for CC Water Pump outlet is missing 1 bolt. Mounted on column near MOV RW 187. CR 2012-14047 was generated

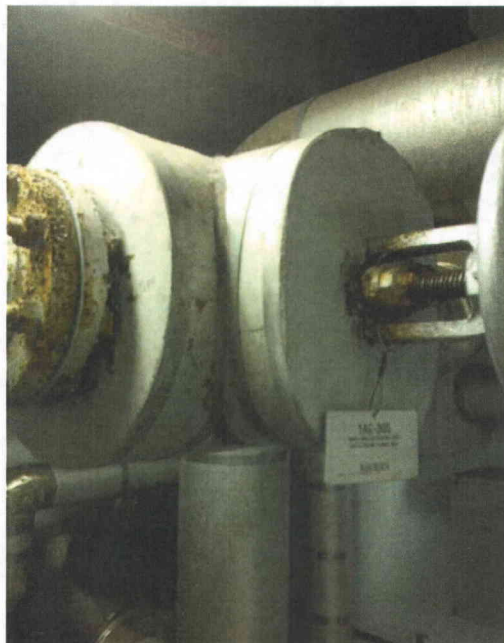
File Name: 1-66-1-4-50.jpeg  
Description: Corroded valve identified. CR-2012-13972 issued to address this condition.

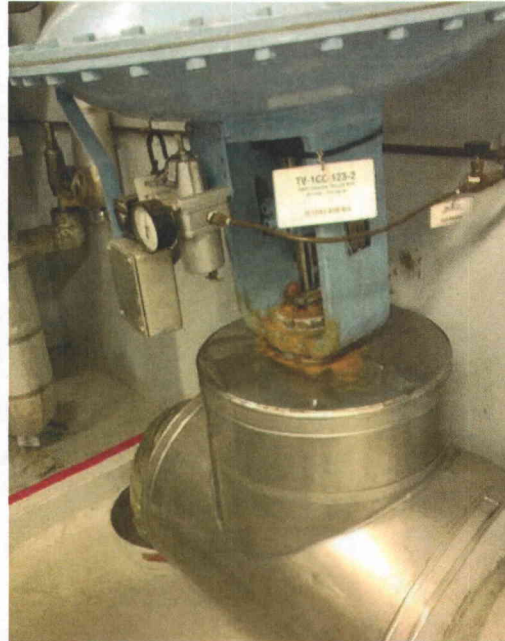
File Name: 1-67-1-4-50.jpeg  
Description: Corroded valve identified. CR-2012-13972 issued to address this condition.

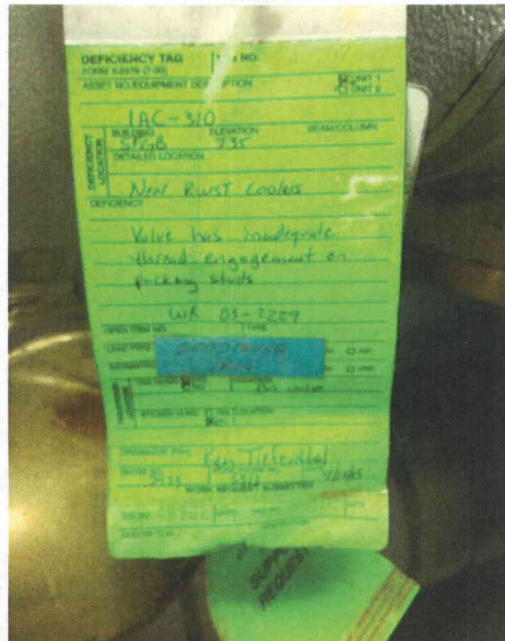
File Name: 1-68-1-4-50.jpeg  
Description: Example of very old deficiency tag.

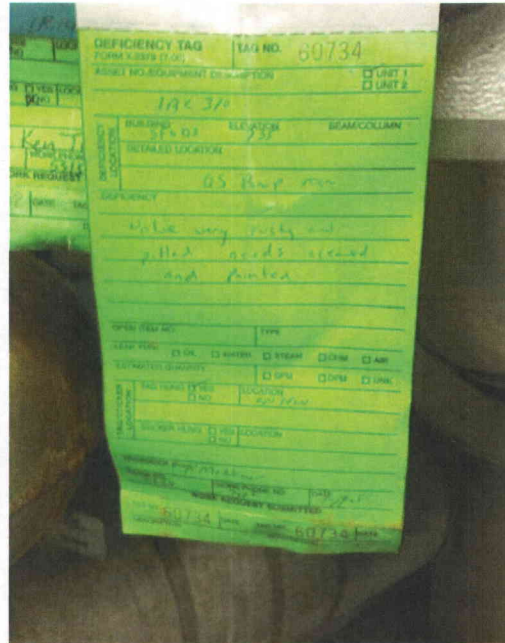
File Name: 1-69-1-4-50.jpeg  
Description: Very old deficiency tag

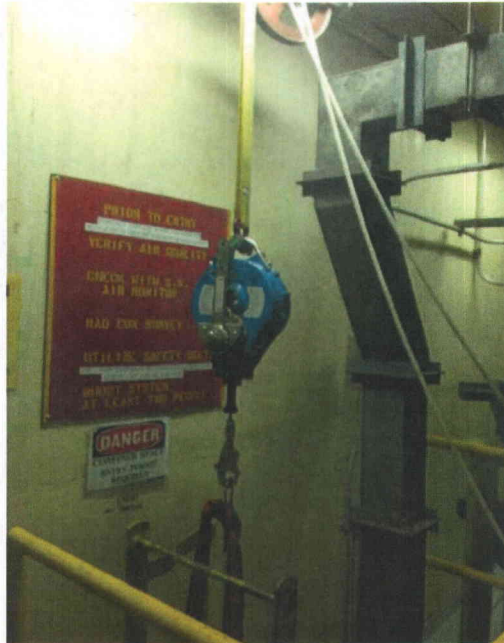
File Name: 1-65-1-4-58.jpeg  
Description: Lifting hook unsecured. Judged not to cause interaction concerns.

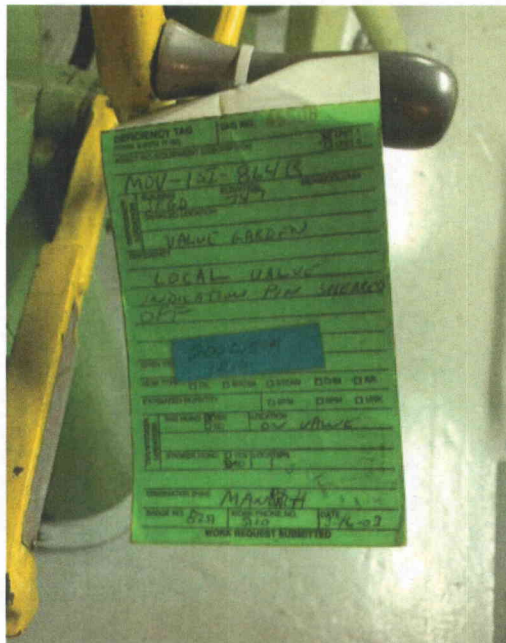
File Name: 1-69-1-4-58.jpeg  
Description: Deficient tag out of date.

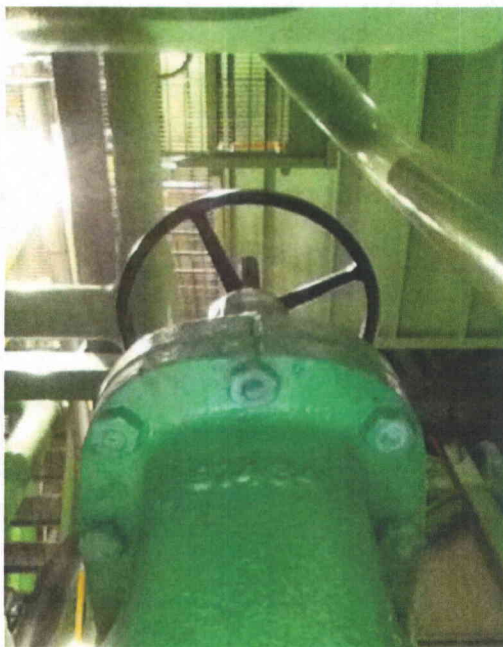
File Name: 1-66-3-4-60.jpeg  
Description: Underside of not engaged nut. Judged acceptable.

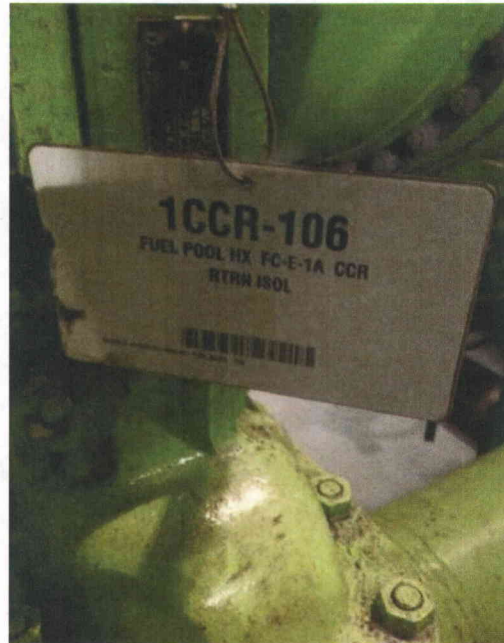
File Name: 1-67-3-4-60.jpeg  
Description: One nut with one-half thread engagement missing, judged acceptable.

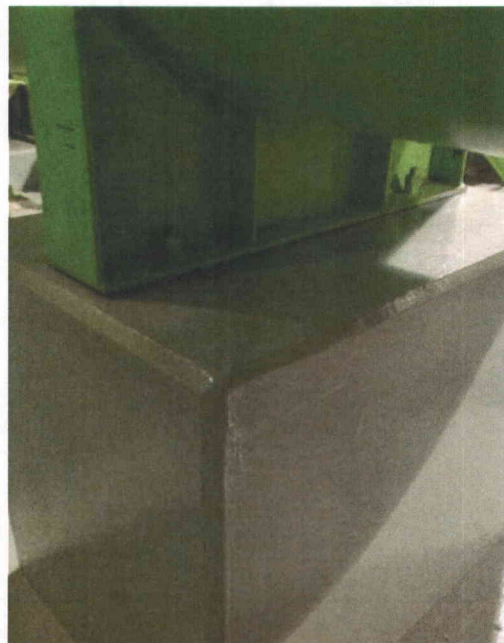
File Name: 1-68-3-4-60.jpeg  
Description: Small gap under base of FC-E-1B judged not a concern.

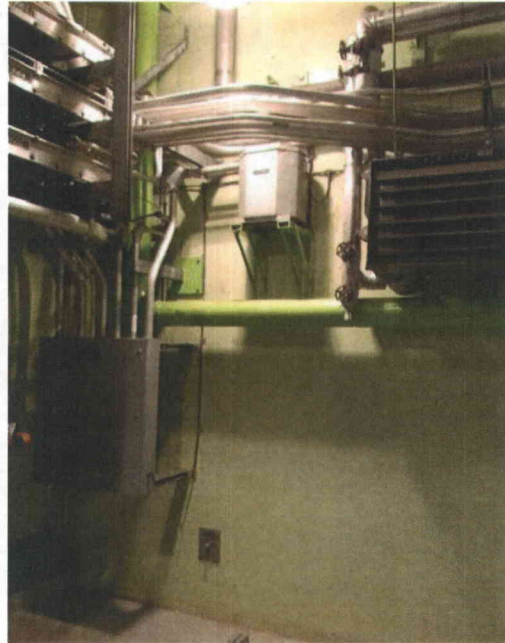
File Name: 1-78-3-4-60.jpeg

Description: Lighting transformer and lighting panel are judged to be outside of potential spray hazard zone of the space heater

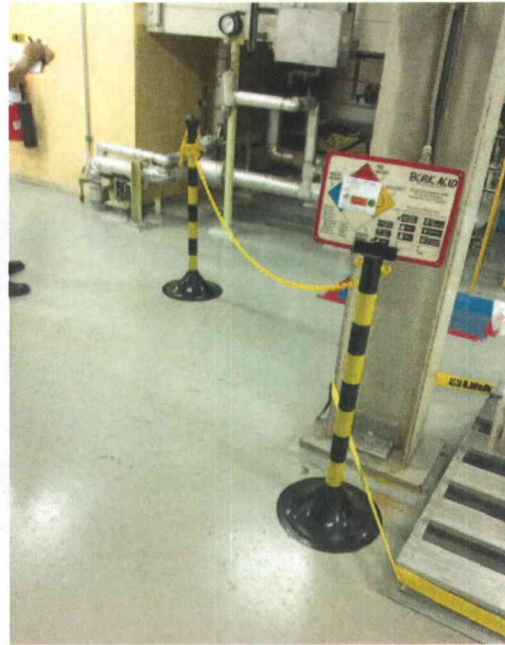
File Name: 1-65-4-4-60.jpeg  
Description: Unsecured poles, not heavy significant

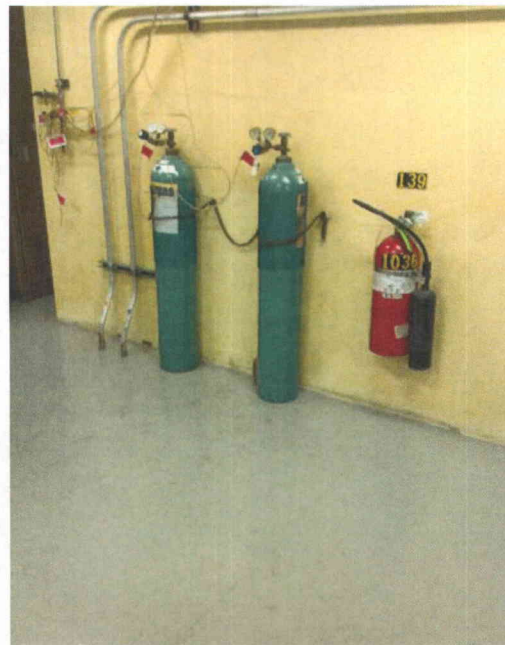
File Name: 1-66-4-4-60.jpeg  
Description: Fire extinguisher in area and chained gas bottle judged not to be interaction concerns
