APPENDIX B: SEISMIC WALKDOWN CHECKLISTS (SWCs)

Seismic Walkdown Checklist (SWC)

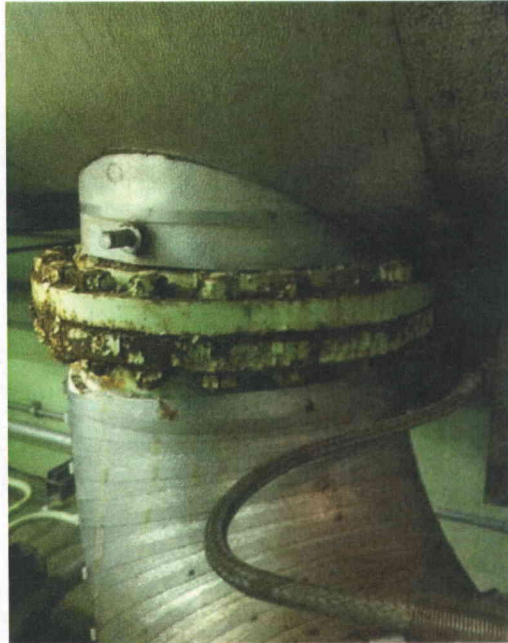
Surface corrosion observed on flanges judged not to be a concern.

File Name: 2-98-4-2-01.jpeg
Description: View of Corrosion on Flange

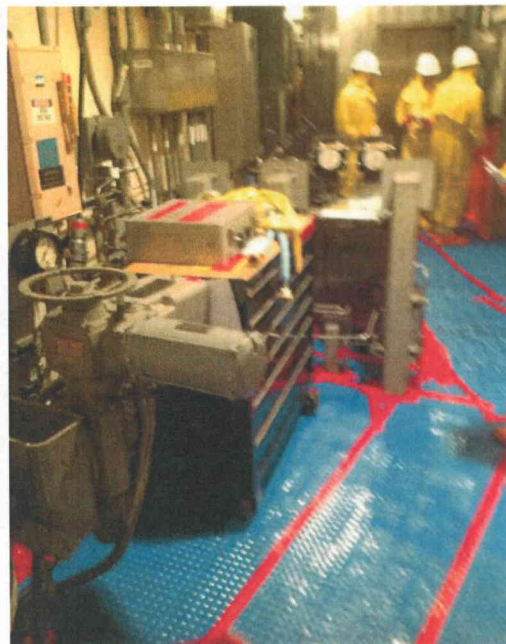
File Name: 2-64-3-2-19.jpeg
Description: View of Restrained Temporary Equipment in Area

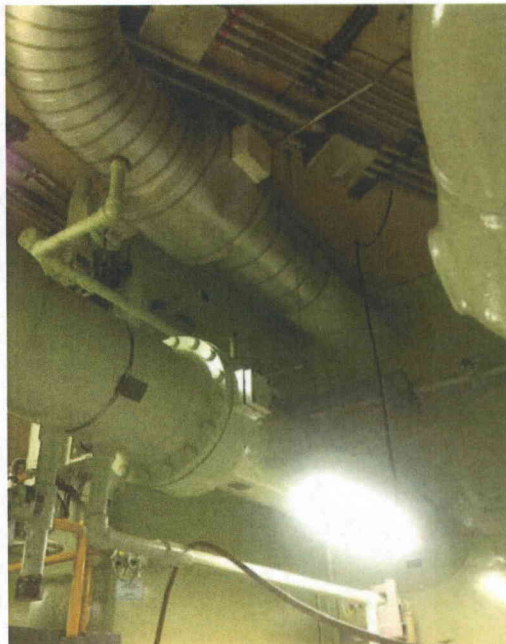
File Name: 2-94-1-2-12.jpeg
Description: View of Penetration Support and Branch Line with Adequate Flexibility

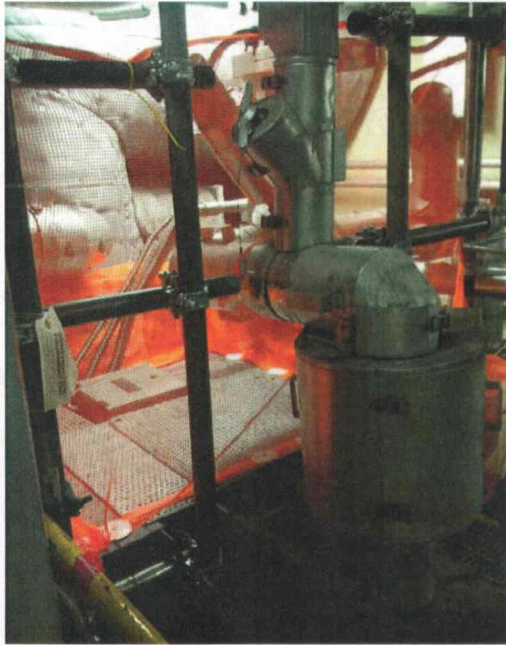
Description: Scaffold tag log no 16-672

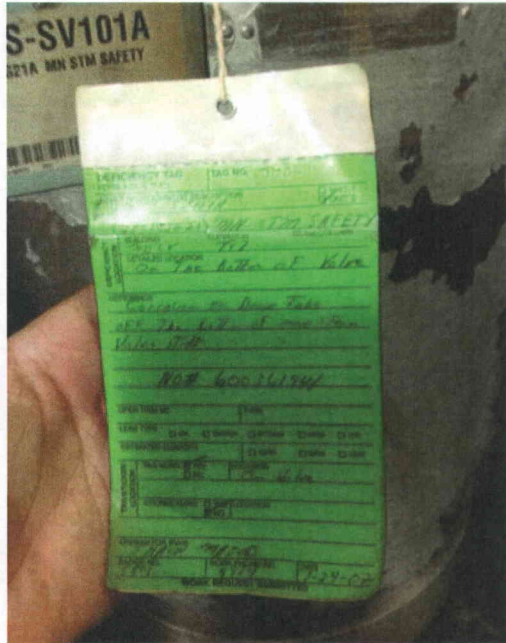
File Name: 2-63-6-2-16.jpeg
Description: Deficiency Tag on Component

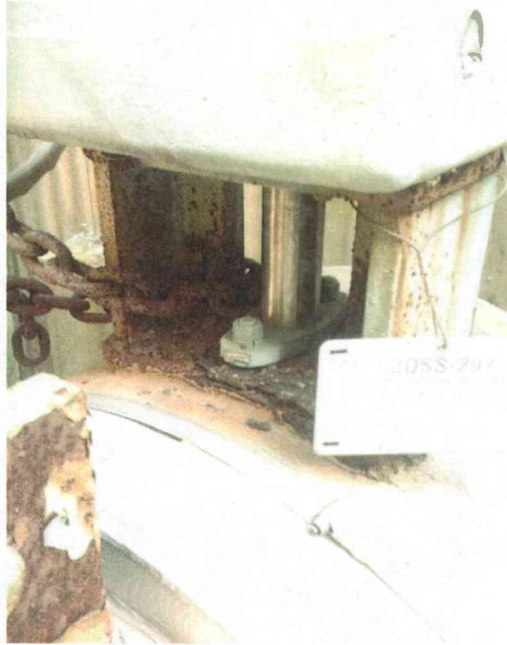
File Name: 2-63-9-2-29.jpeg
Description: Corrosion at Valve Base

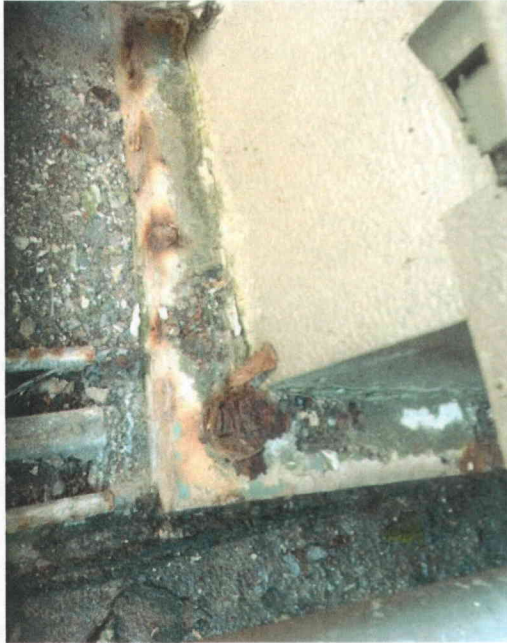
File Name: 2-73-10-2-29.jpeg
Description: Corrosion Observed on Anchorage
