Seismic Walkdown Checklist (SWC)

Equipment ID No. 2SIS-MOV867A Equip. Class 8A. Motor Operated Valve

Equipment Description HHSI Isol to Cold Leg Injection

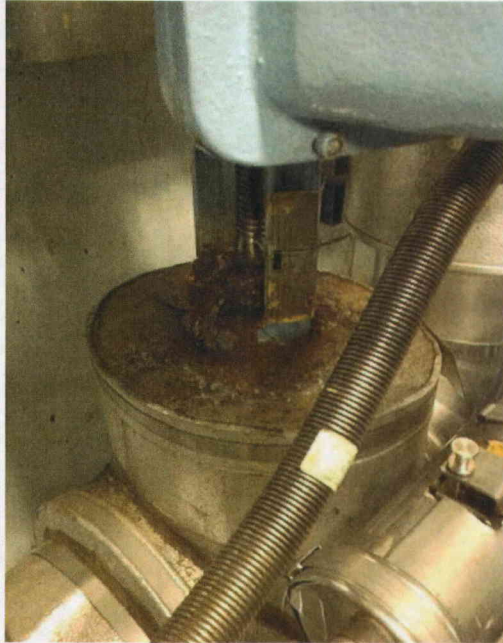
File Name: 2SWS-MOV113A(3).jpg
Description: View of Corroded Packer Nuts

Both packing nuts observed to have moderate corrosion. CR-2012-14409 written to document this condition.

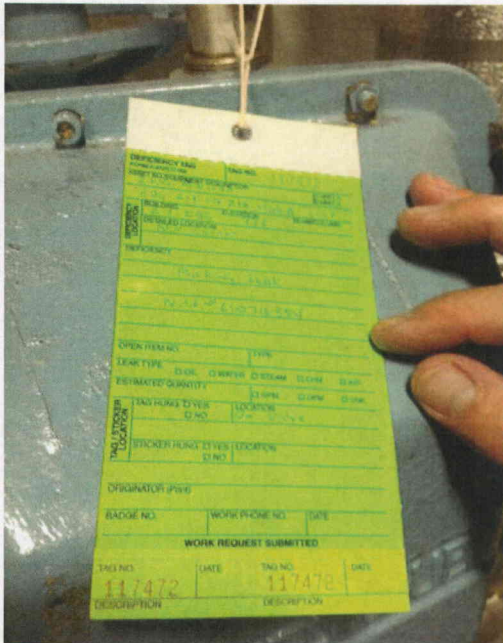
File Name: 2SWS-MOV113A(4).jpg
Description: Deficiency Tag on Component

11. Have you looked for and found no other seismic conditions that could adversely affect the safety functions of the equipment?
Deficiency tagged as "packing leak" (Notification no. 600716354).

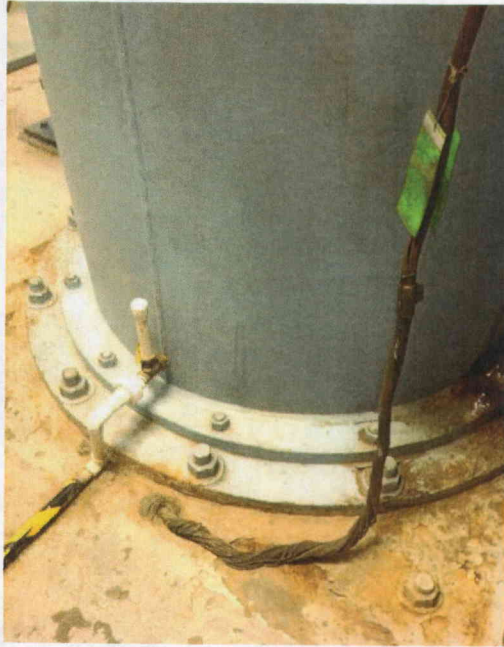
File Name: 2SWS-P21A(3).jpg
Description: View of Anchor Bolts

Pump is leaking oil. Most anchor bolts have minor corrosion, 2 machine bolts have moderate corrosion with material degradation. CR-2012-14408 generated to document this issue.
