APPENDIX C: AREA WALK-BY CHECKLISTS (AWCs)

Area Walk-By Checklist (AWC)

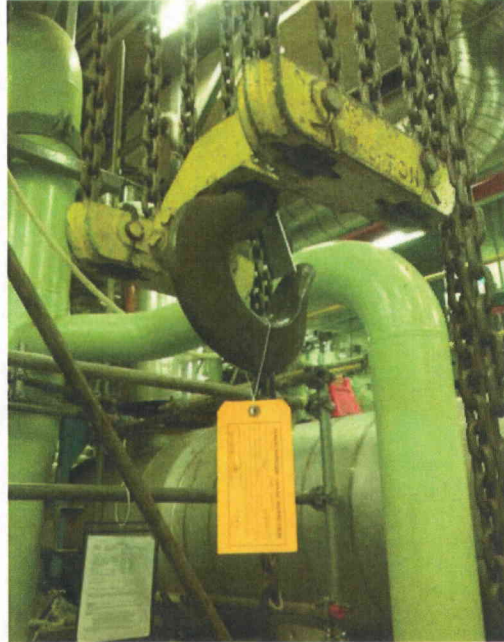
File Name: 1-65-4-3-01.jpeg
Description: Pulley in the area noted to be properly restrained

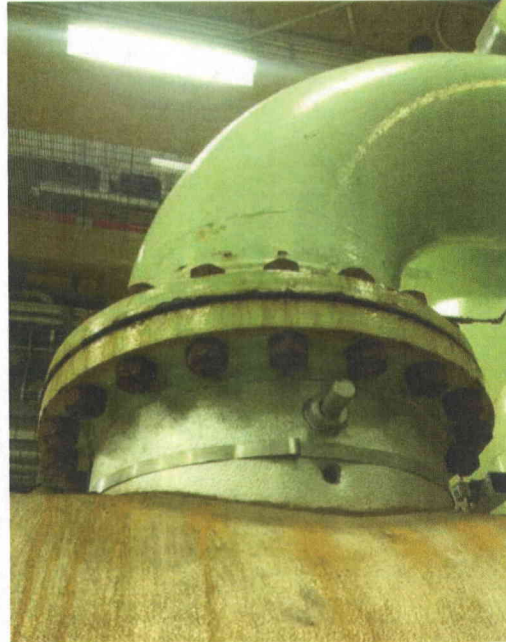
Most of 20-1" diam flange nuts at outlet nozzle for HX2CCP-E21C were identified with surface corrosion. CR-2012-14459 was issued to address this finding.

File Name: 1-67-4-3-01.jpeg
Description: Mild corrosion identified on nuts of 2CCP-E21C outlet nozzle

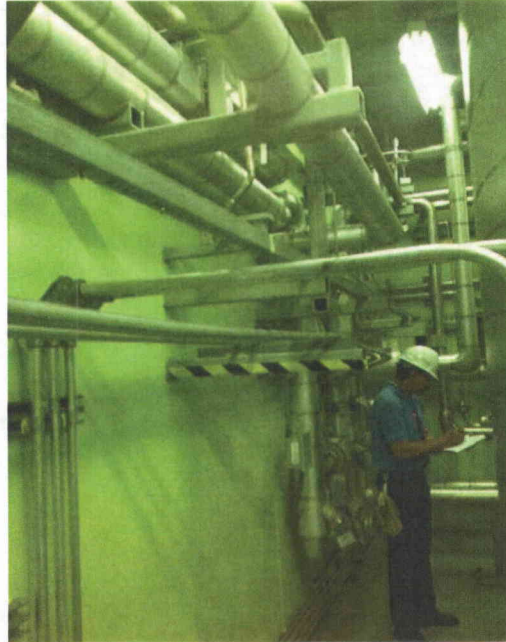
File Name: 1-65-4-3-04.jpeg
Description: Piping in the area identified to be rigidly supported.

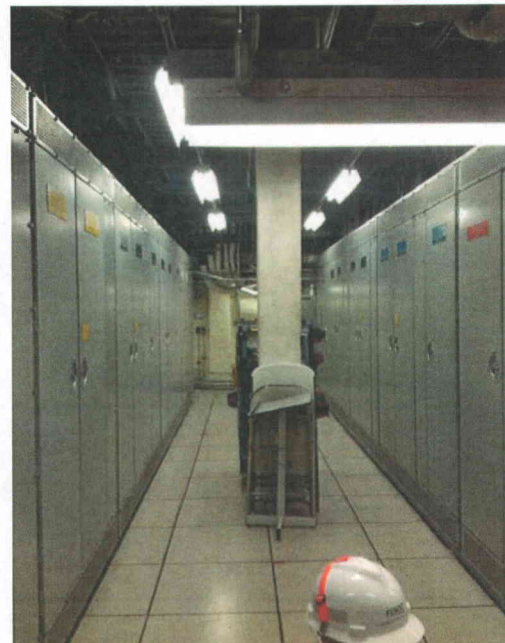
File Name: 1-60-4-3-06.jpeg
Description: View of maintenance equipment properly tight to center column

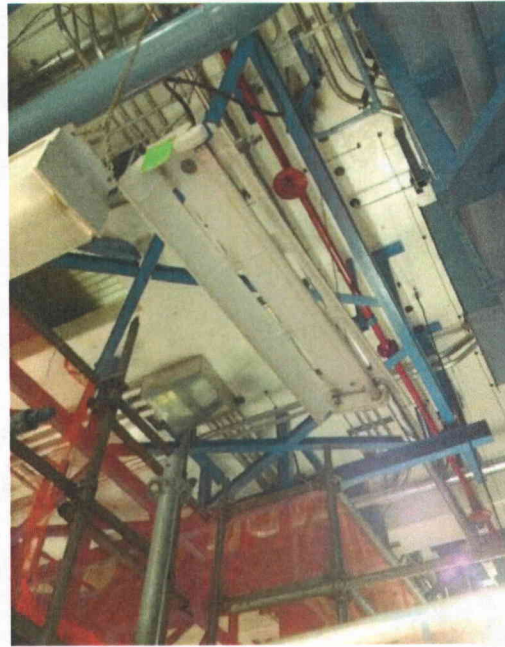
File Name: EDG2-1(9).jpg
Description: View of lighting fixture with missing fluorescent tube.

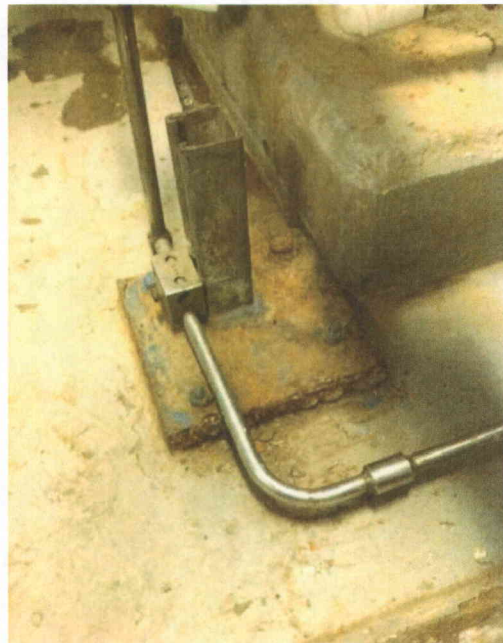
File Name: INTK_CUB_C(4).jpg
Description: Surface rust identified on small pipe support.

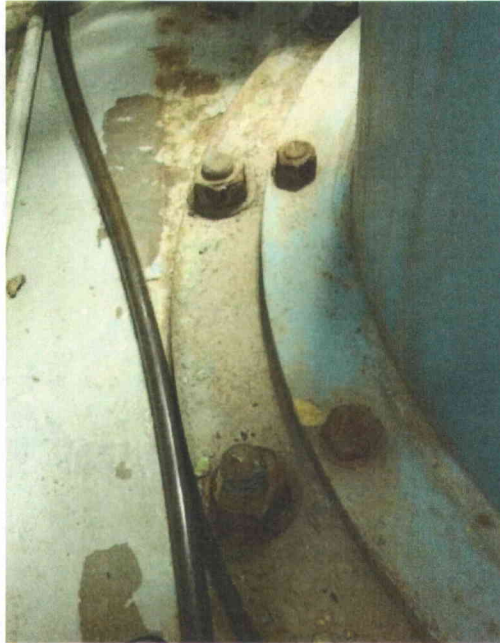
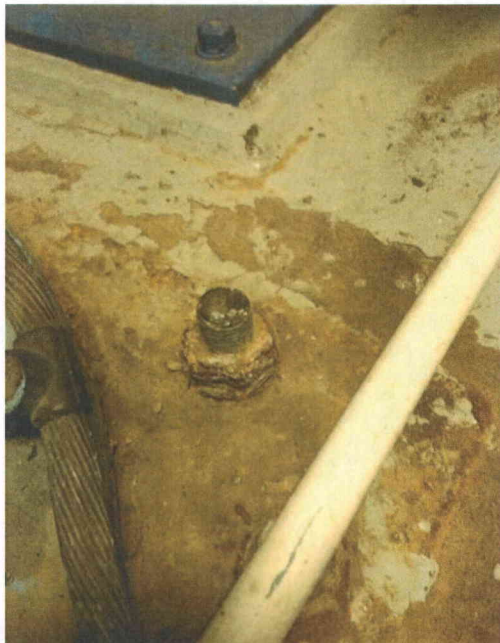
File Name: INTK_CUB_C(5).jpg
Description: Surface rust identified on bolts for Pump 2SWS-P21B.

File Name: INTK_CUB_C(6).jpg
Description: Surface rust identified on bolts for Pump 2SWS-P21B.

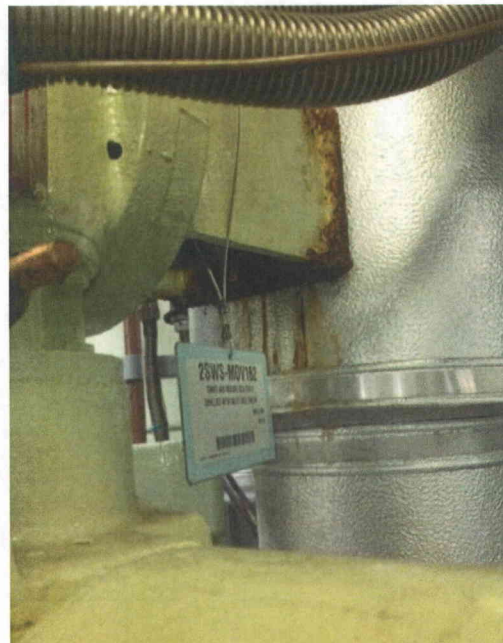
File Name: 1-68-2-3-12.jpeg
Description: Surface rust identified for valve 2SWS-MOV162.
CR-2012-14450 issued for this finding.

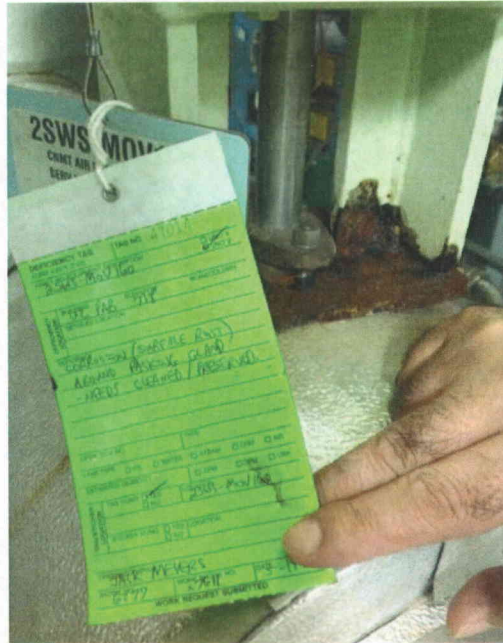
File Name: 1-69-2-3-12.jpeg
Description: Deficiency tag identified for 2SWS-MOV160.
CR-2012-14449 issued for this situation.

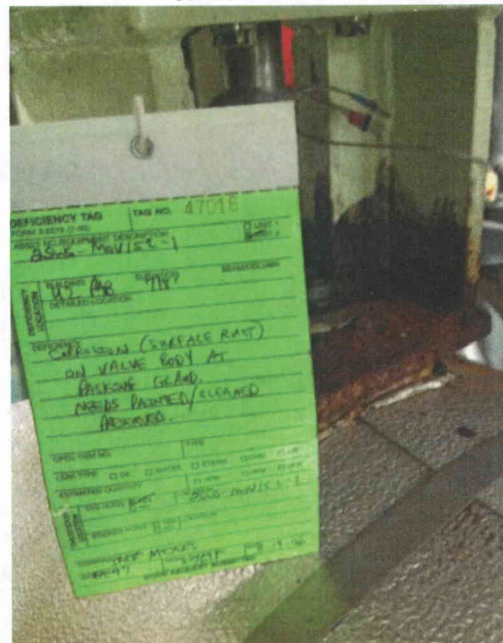
File Name: 1-70-2-3-12.jpeg
Description: Deficiency tag identified for 2SWS-MOV152-1.
CR-2012-14452 issued for this situation.

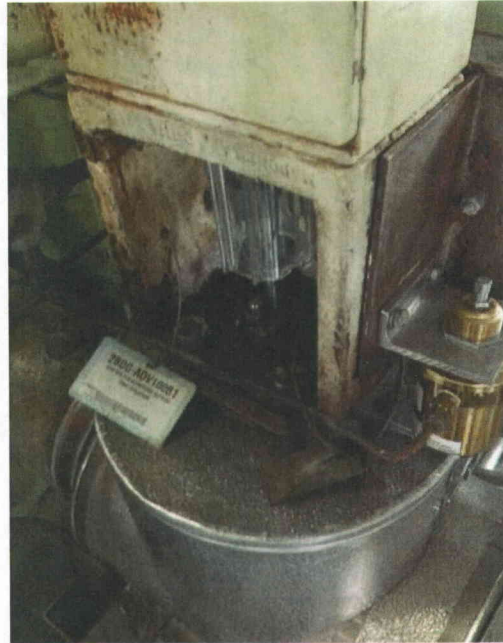
File Name: 1-71-2-3-12.jpeg

Description: Corrosion identified on base of 2BDG-AOV100B1.
Judged not a seismic concern.

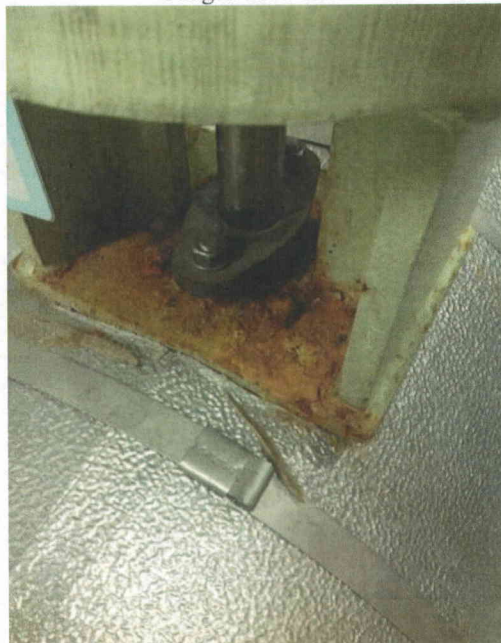
File Name: 1-72-2-3-12.jpeg

Description: Corrosion identified on base of 2SWS-MOV161. Bolts appeared to be undersized. CR-2012-14455 was issued to address this situation.

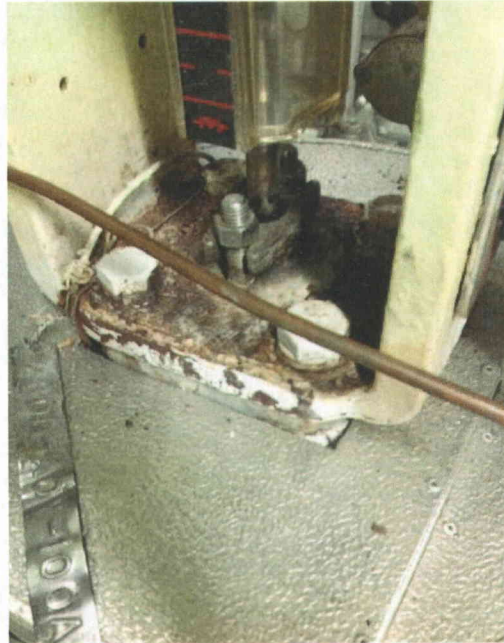
File Name: 1-74-2-3-12.jpeg

Description: 2BDG-AOV-100A identified with mild surface corrosion.
Judged not a seismic concern.

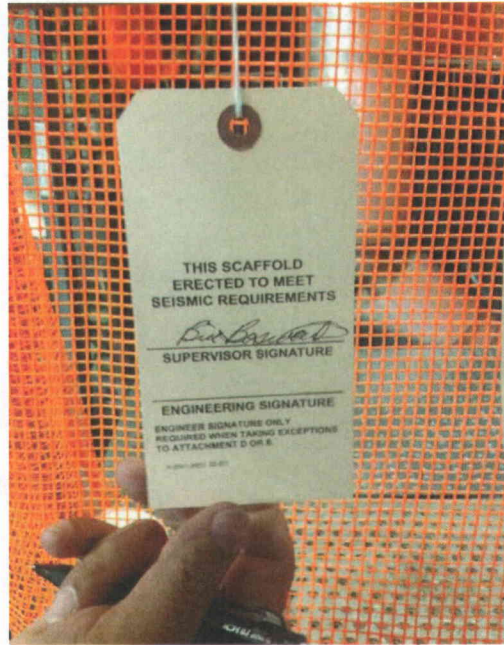
File Name: 1-76-2-3-12.jpeg

Description: Tag and signature for scaffold meeting seismic requirements.

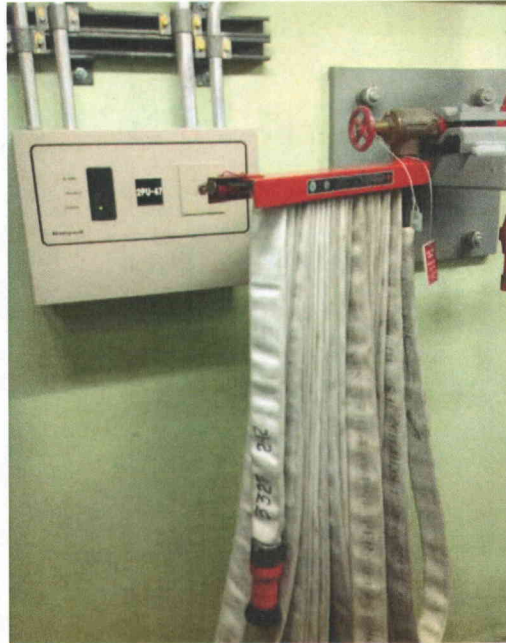
File Name: 1-65-2-3-14.jpeg

Description: Fire hose station located near panel 2PU-47. Judged not a seismic concern

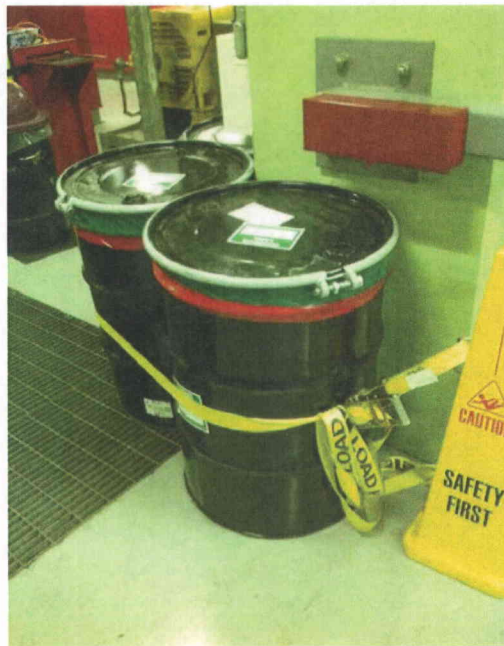
File Name: 1-68-5-3-03.jpeg
Description: Restrained drums located in the area

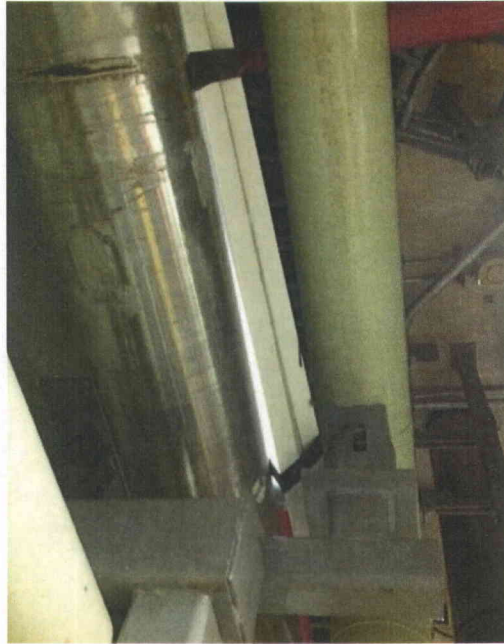
File Name: 1-65-5-3-23.jpeg
Description: Hanging light bearing on top of pipe.

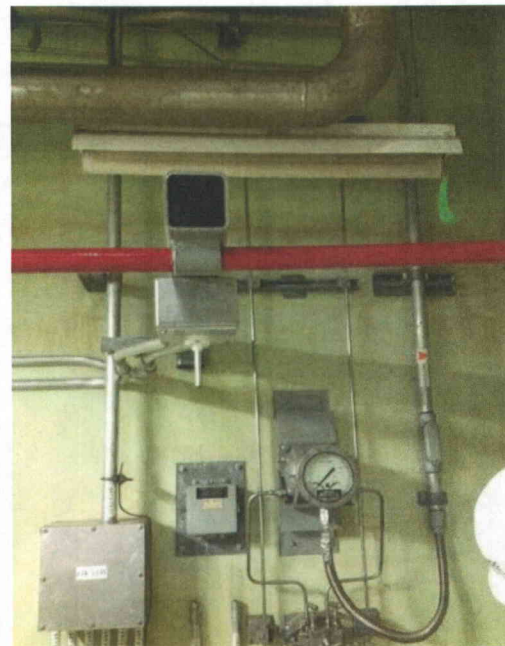
File Name: 1-70-5-3-23.jpeg
Description: Potential falling of light bulb could impact instrument below.
Judged not a significant interaction.

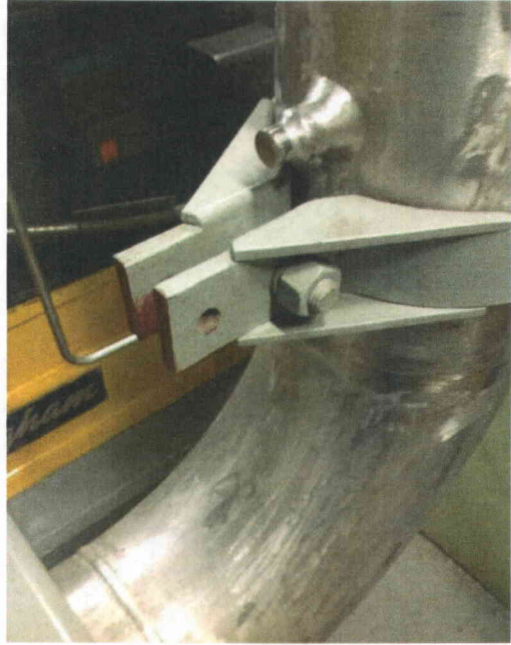
File Name: 1-68-5-4-23.jpeg
Description: View of deleted support rod for 2QSS-P21A discharge nozzle.

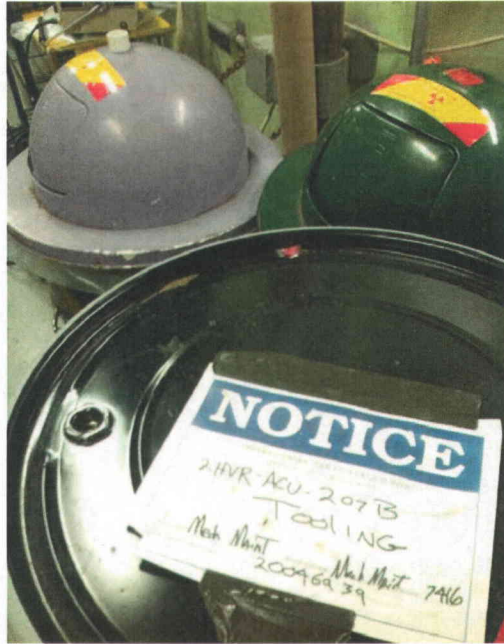
File Name: 1-65-2-3-24.jpeg
Description: Notice label on top of unrestrained drum near MCC.

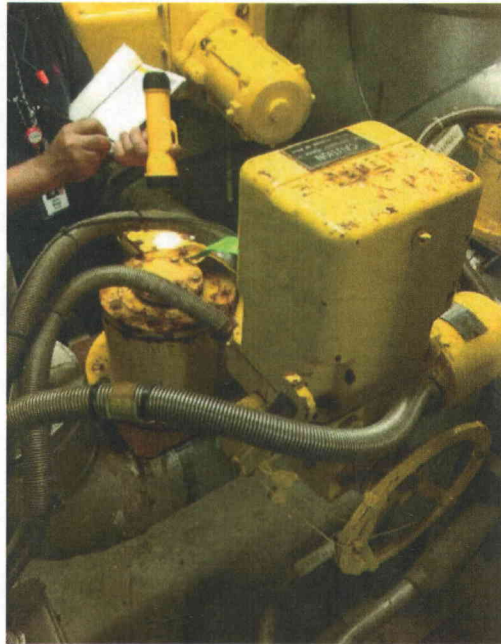
File Name: VLV_PT_A(3).jpg
Description: Surface rust identified on several MOVs in the area.

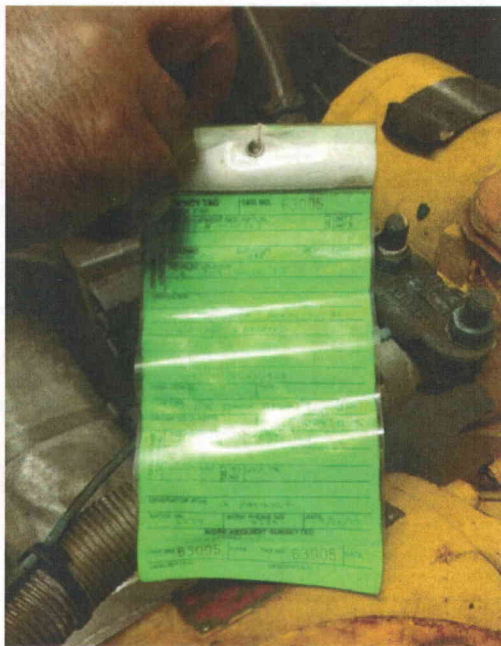
File Name: VLV_PT_A(4).jpg
Description: Deficiency tag requesting cleanup and painting.
CR-2012-14412 issued to address this finding.

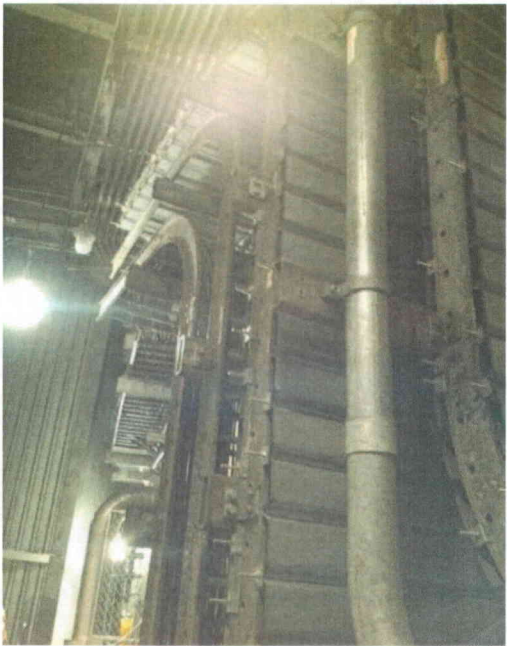
File Name: 1-66-2-3-19.jpeg
Description: View of vertical cable trays properly supported

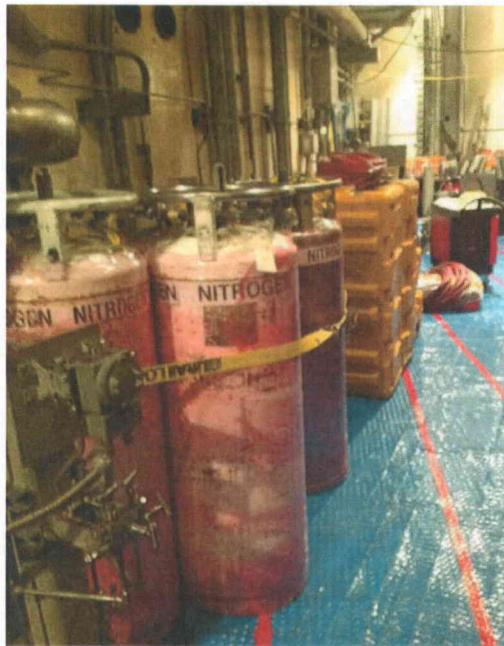
File Name: 1-60-5-3-19.jpeg
Description: View of nitrogen bottles and storage boxes properly secured in the area
