**APPENDIX C**  
**AREA WALK-BY CHECKLISTS (AWCs)**

**Area Walk-By Checklist (AWC)**

Room 105 Floor El. 545 Bldg. AUXB

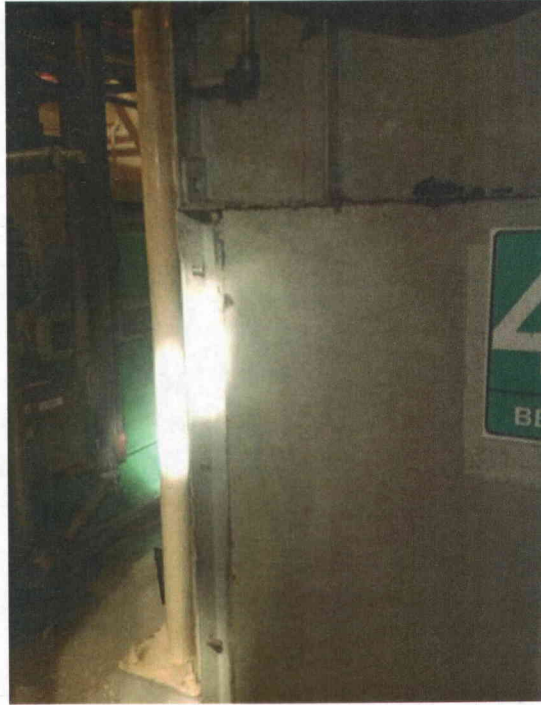
*Anchorage for cover plate of E31-4 does not have nuts, see Photo 2. Concern has been judged not to represent an adverse condition regarding the component's seismic performance.*

**Photo 2**  
**Missing Nuts on Cover of E31-4**

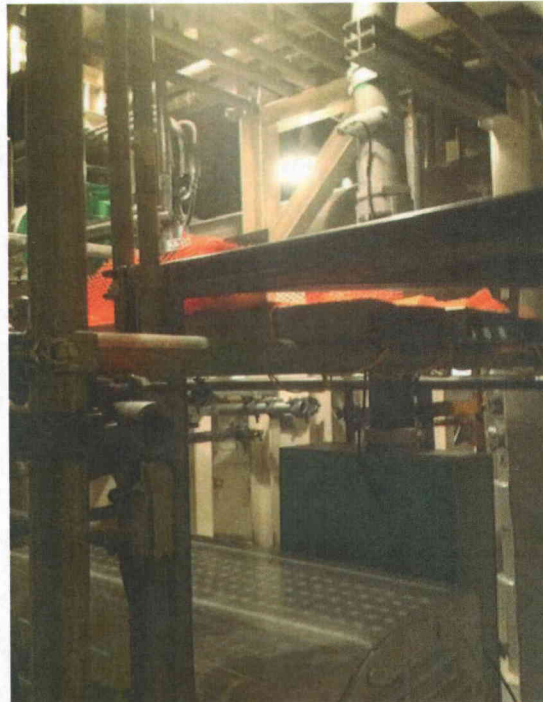
**Photo 3**  
**Temporary Scaffolding Restrained**

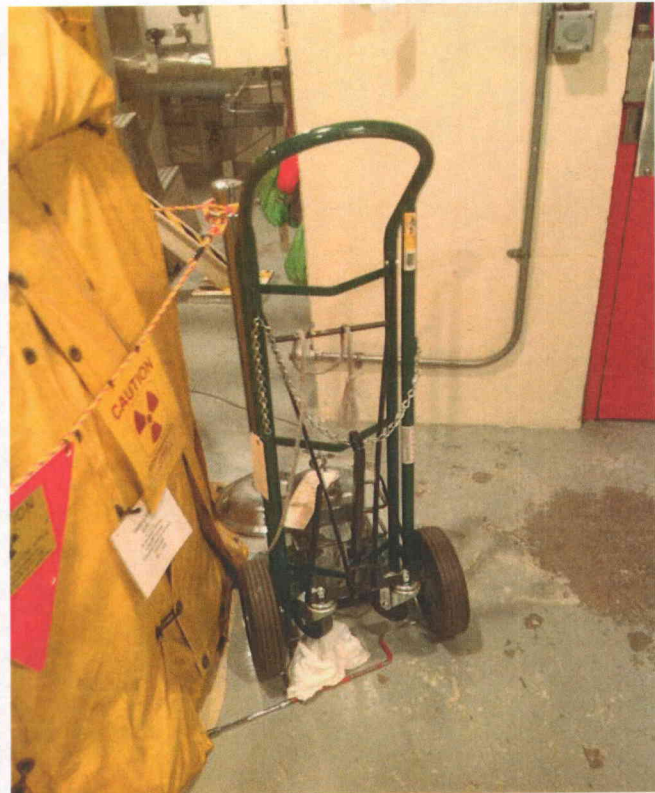
*A dolly was found unrestrained in the area. Since the dolly had restraining chains on it, it was judged that it is temporarily located at the position found in the room and will be returned to its storage location and tied when work is done. Also, no sensitive equipment found in the vicinity of this dolly.*

**Photo 2**  
**Unrestrained Dolly in Area**

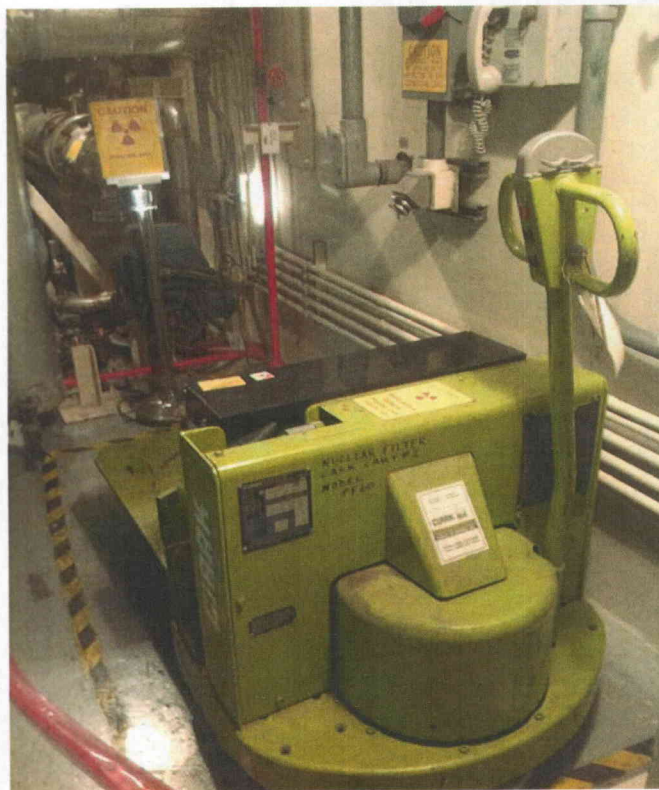
*Nuclear filter cask cart unrestrained adjacent to components. There are no sensitive equipment in the zone of influence of this cart and it is judged OK. It is also noted that this cart appear to be temporarily in the area.*

**Photo 2**  
**Nuclear Filter Cask Cart Not Restrained**

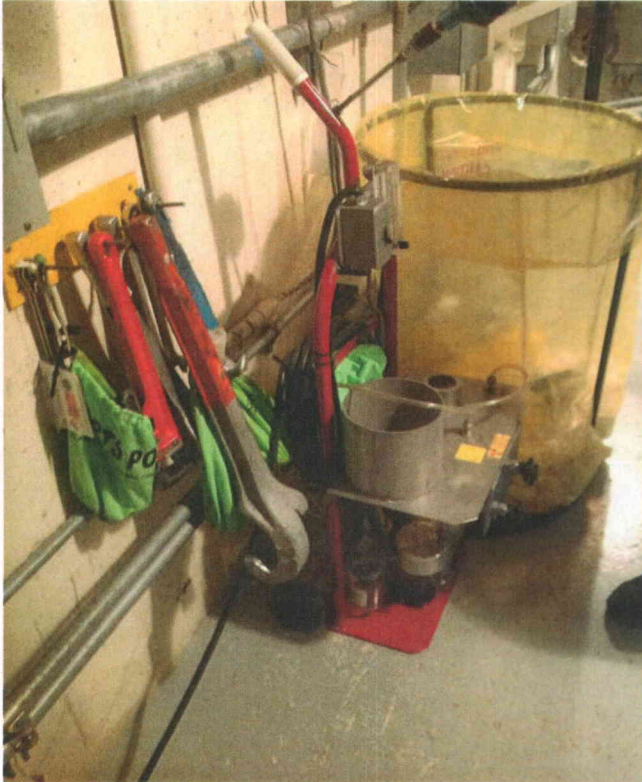
*RP cart and dolly not restrained.  
In a subsequent visit to his area on the next day, it was observed that this cart was properly restrained.*

**Photo 1**  
**Dolly Not Restrained**

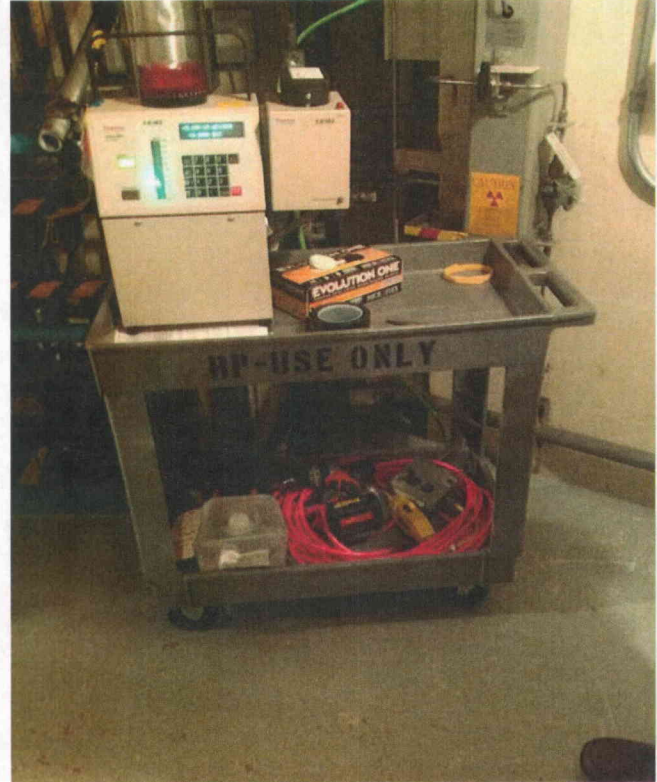
**Photo 2**  
**RP Cart Not Restrained**

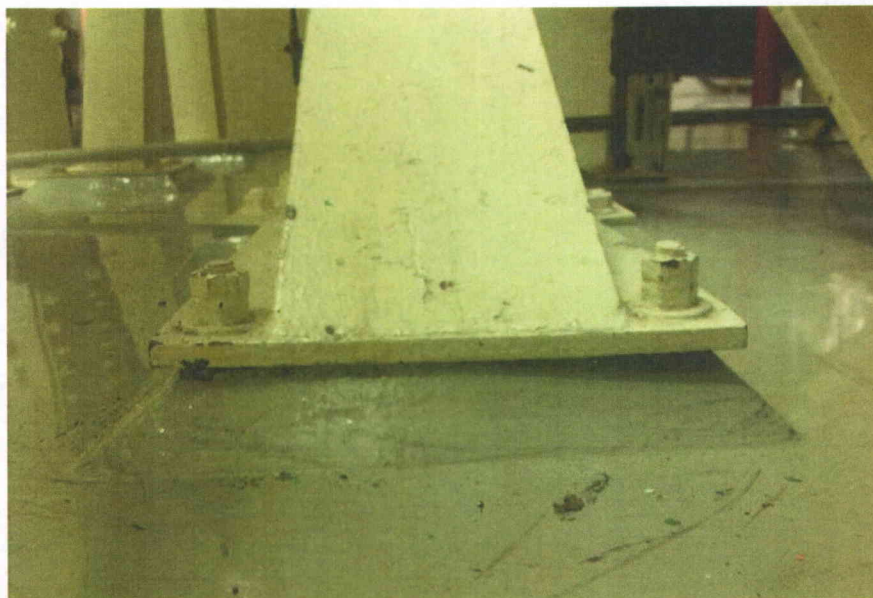
**Photo 2**  
**Gap Between Grout and Anchor Plate**

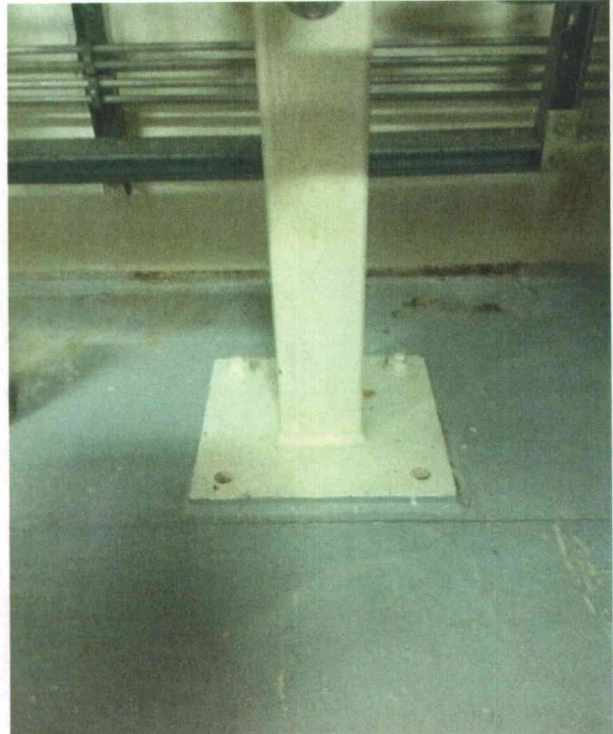
**Photo 2**  
**Missing Anchor Bolts**

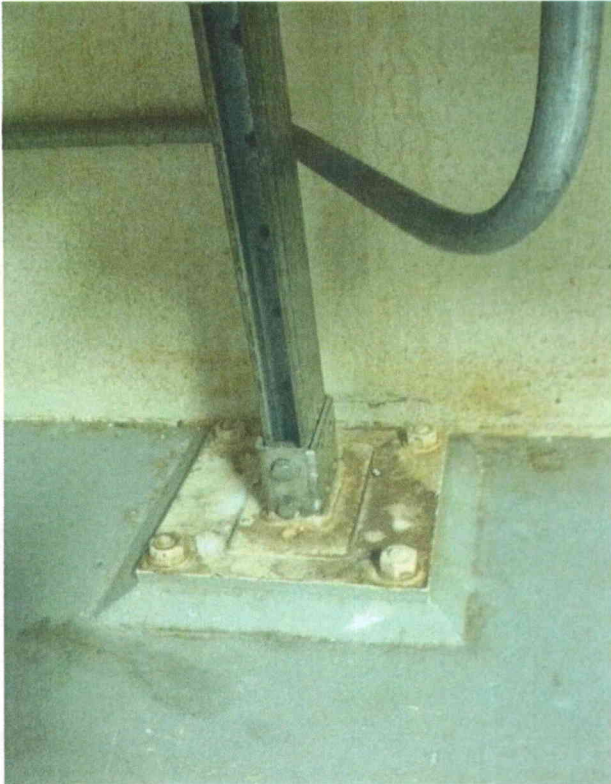
**Photo 3**  
**Minor Corrosion on**  
**Anchor Plate**

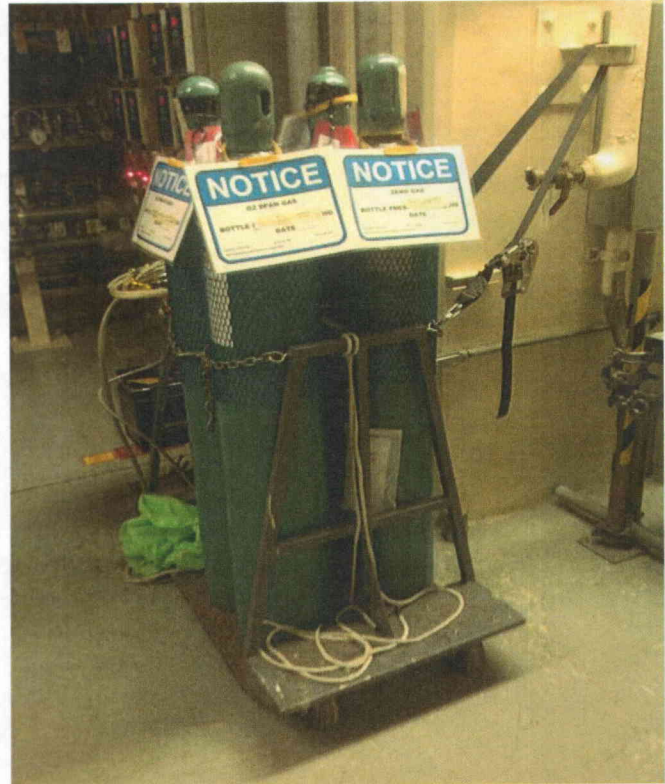
**Photo 4**  
**Cart Containing Gas Canisters**  
**Loosely Restrained**

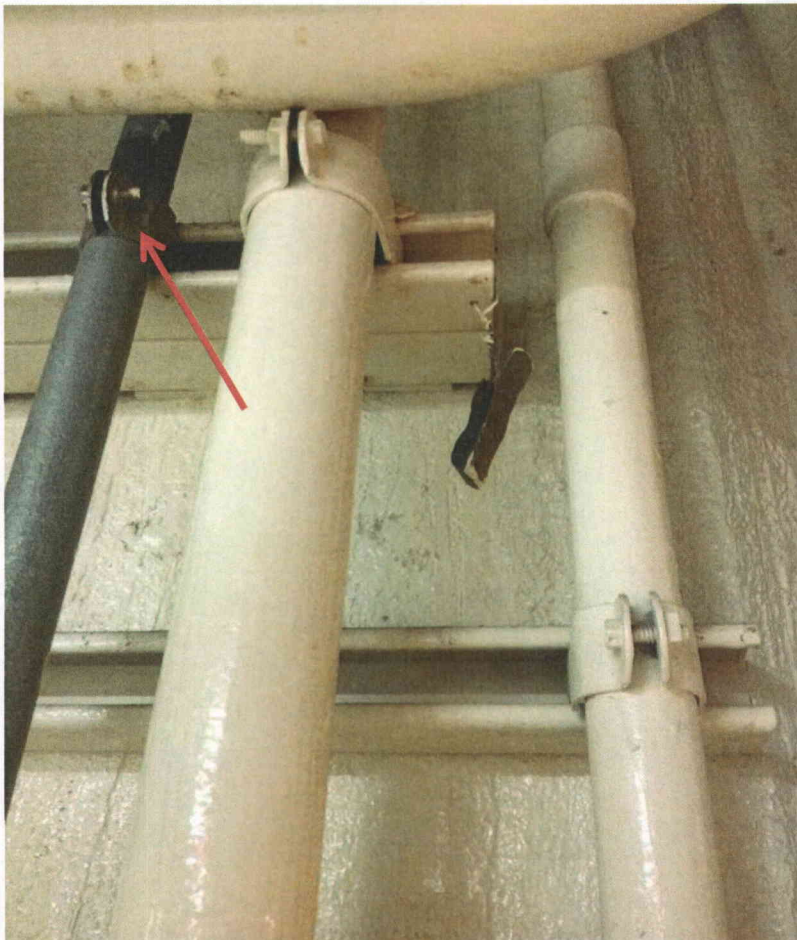
**Photo 1**  
**Nut Missing on Conduit**

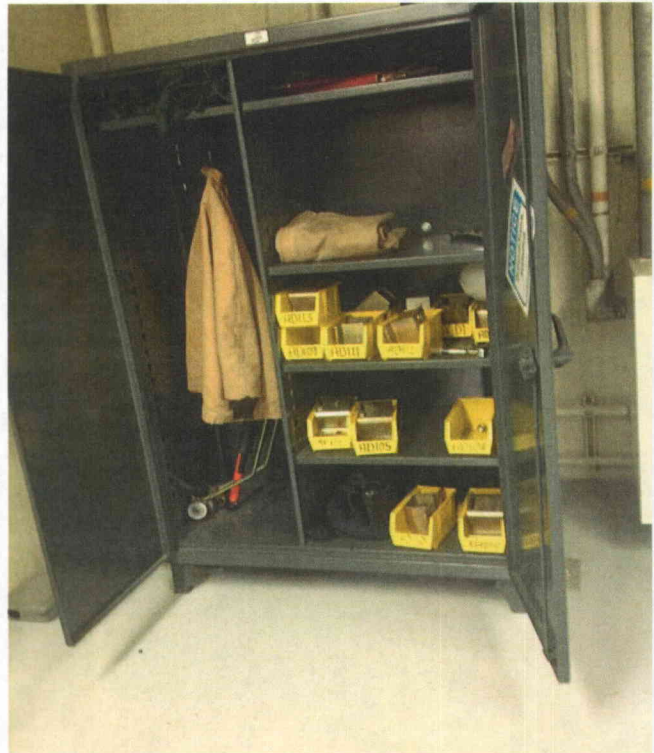
**Photo 2**  
**Supply Cabinet Left Open**

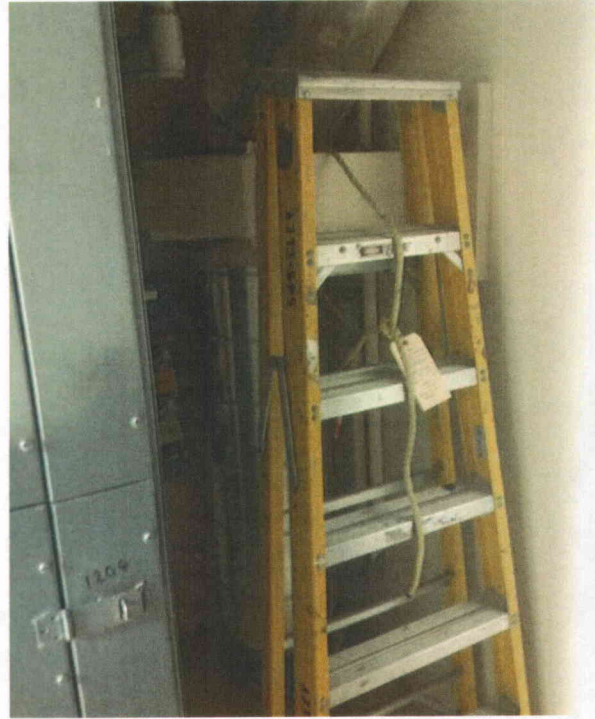
**Photo 2**  
**Ladder Loosely Tied Adjacent to MCC F11A**

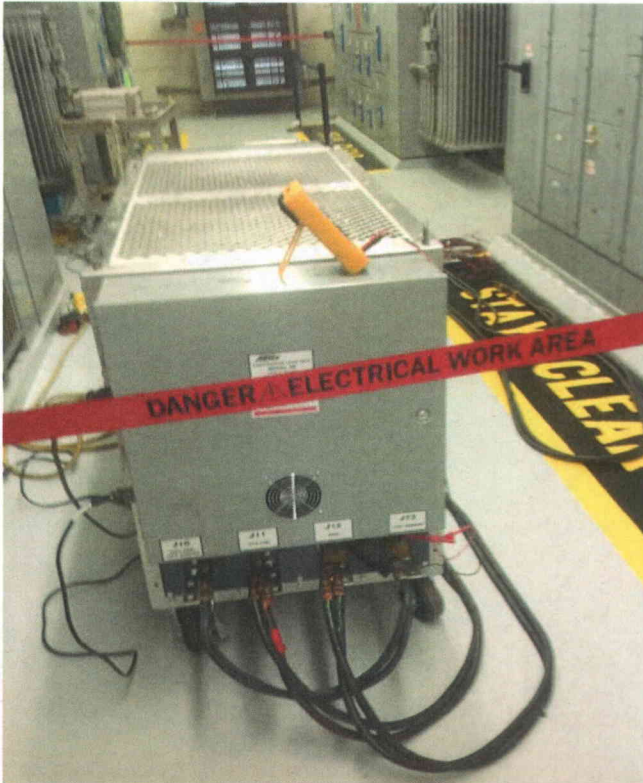
**Photo 3**  
**Unrestrained Work Cart**

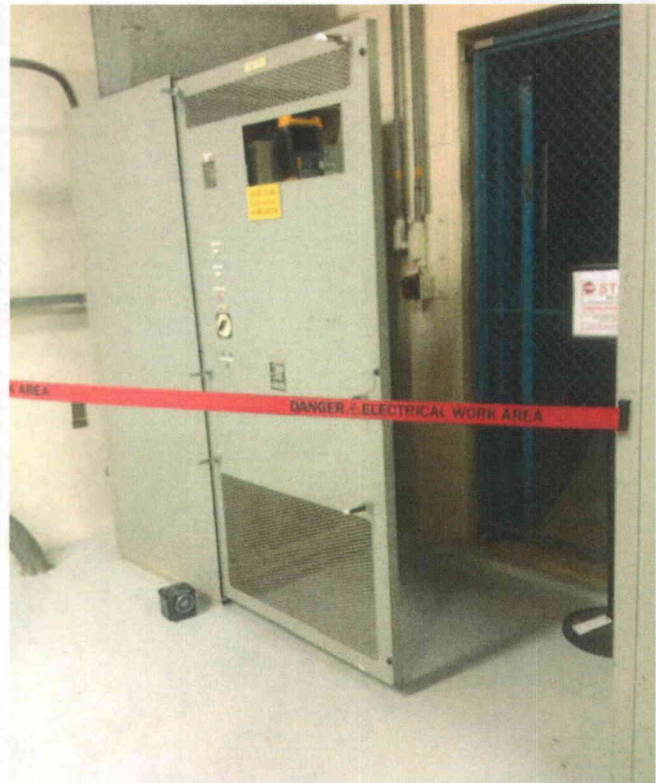
**Photo 4**  
**Cabinet DCB-2P Door Left Open**

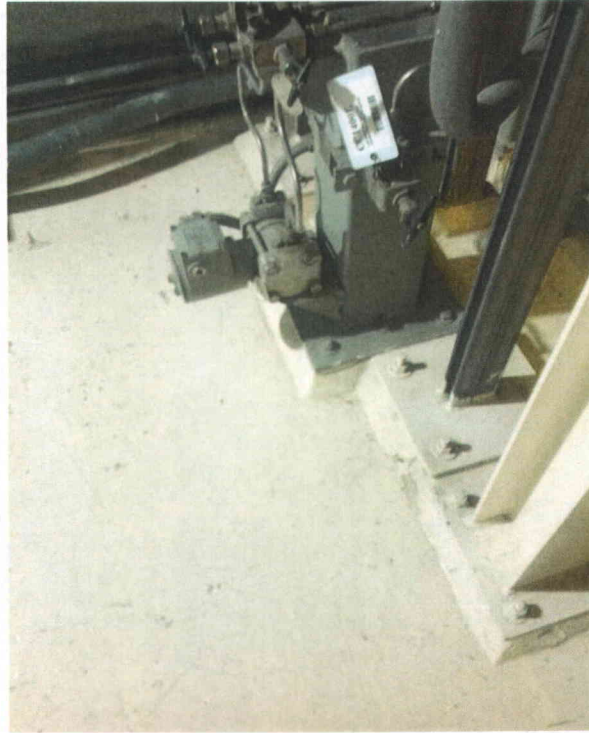
**Photo 1**  
**Damaged Grout**

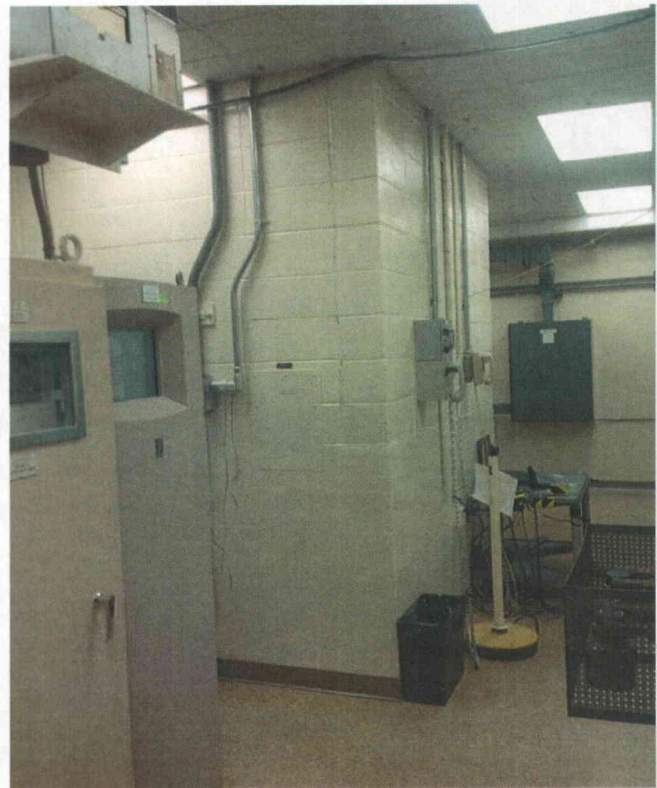
**Photo 2**  
**Crack in Masonry Wall**

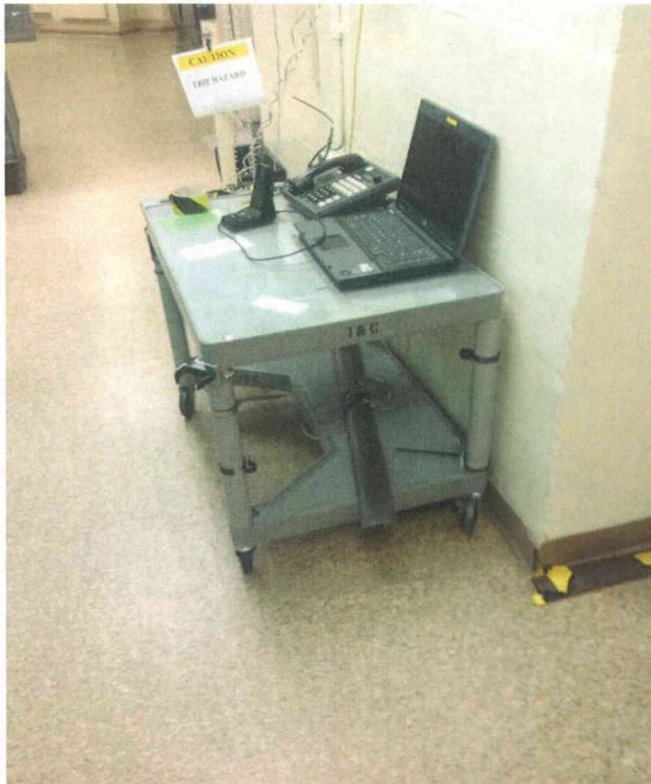
**Photo 3**  
**Unrestrained I&C Cart**

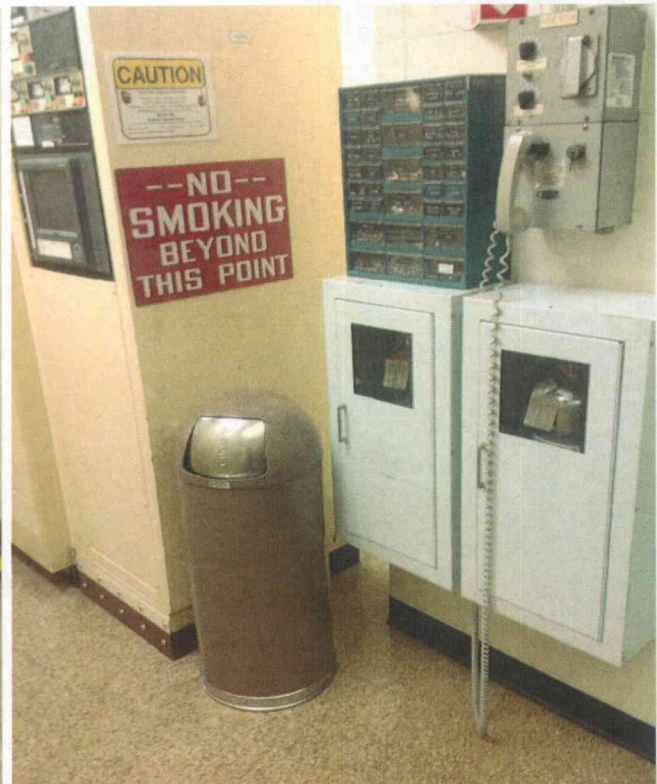
**Photo 4**  
**Unrestrained Trash Can  
and Light Bulb Storage**

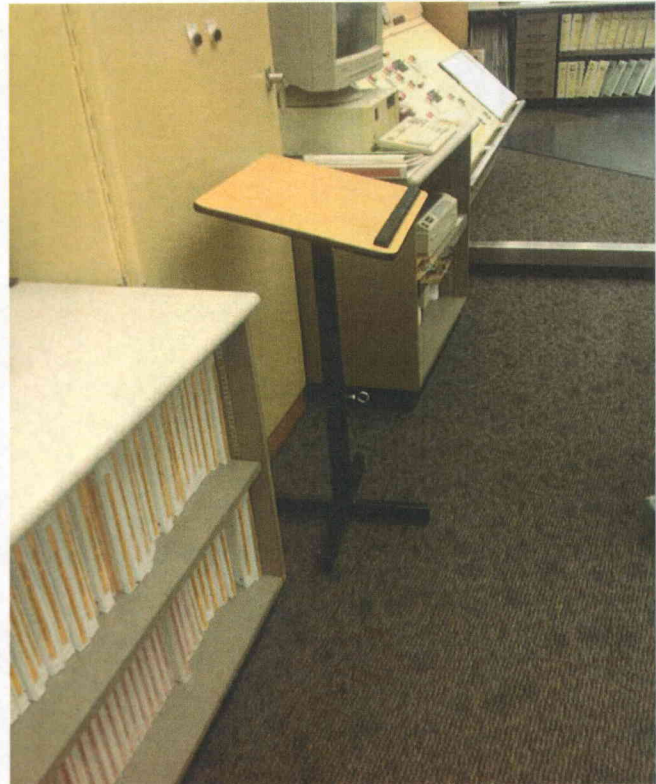
**Photo 2**  
**Small Podium Not Anchored**

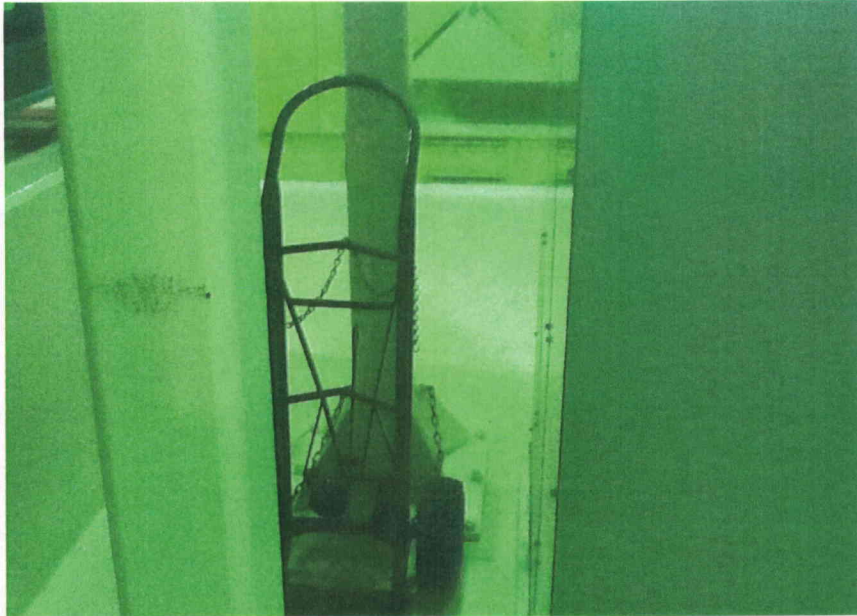
**Loosely Tied Dolly in Room 515**

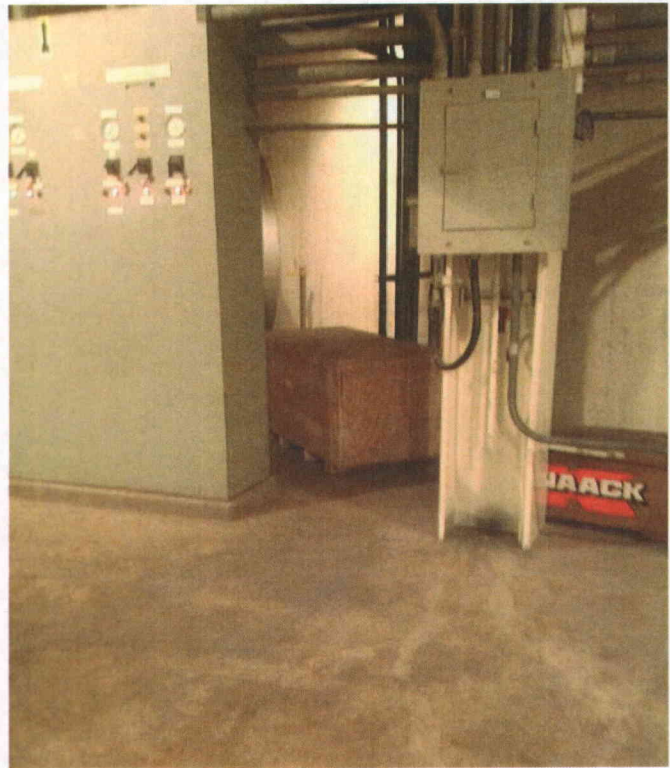
**Photo 2**  
**Unrestrained Storage Containers**

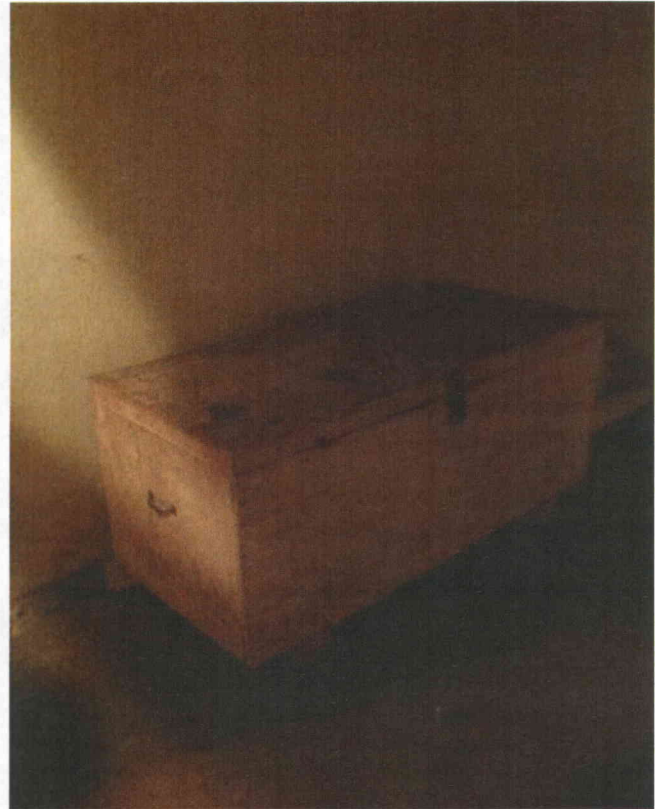
**Photo 2**  
**Unrestrained Storage Container**

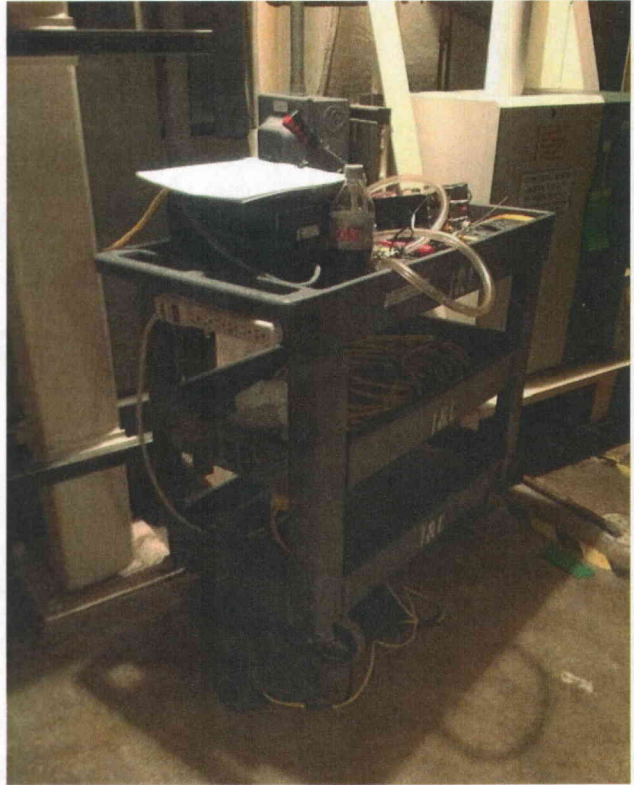
**Photo 2**  
**Cart Not Restrained**

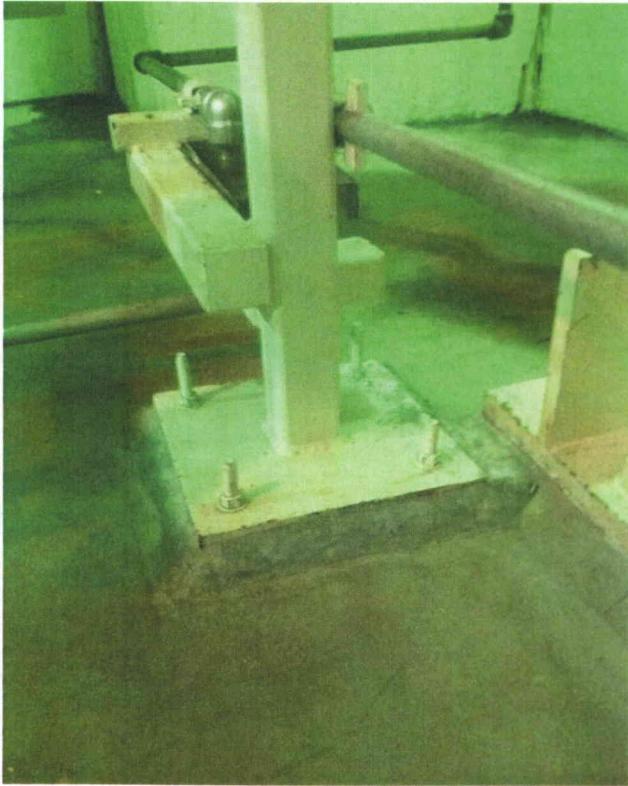
**Photo 1**  
**Anchor Threading**  
**Substantially Past Nut**

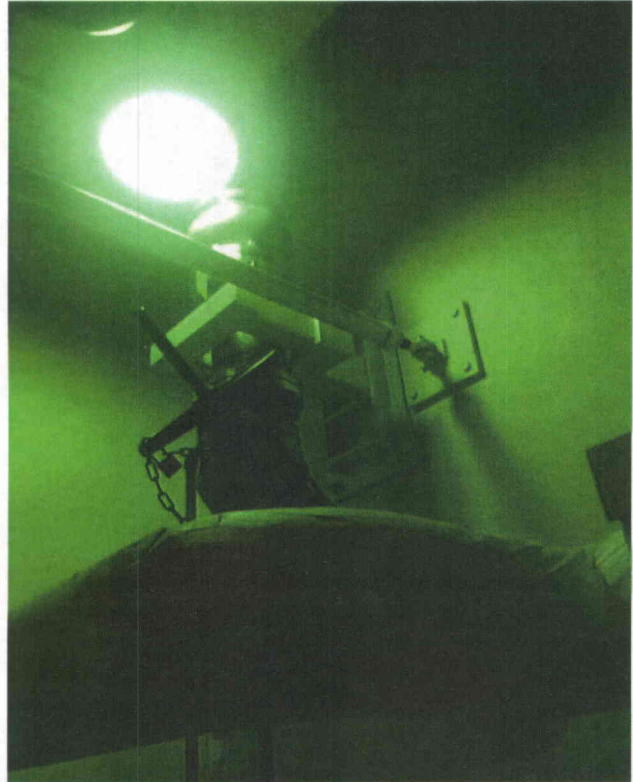
**Photo 2**  
**Hanging Light**  
**Touching Component**

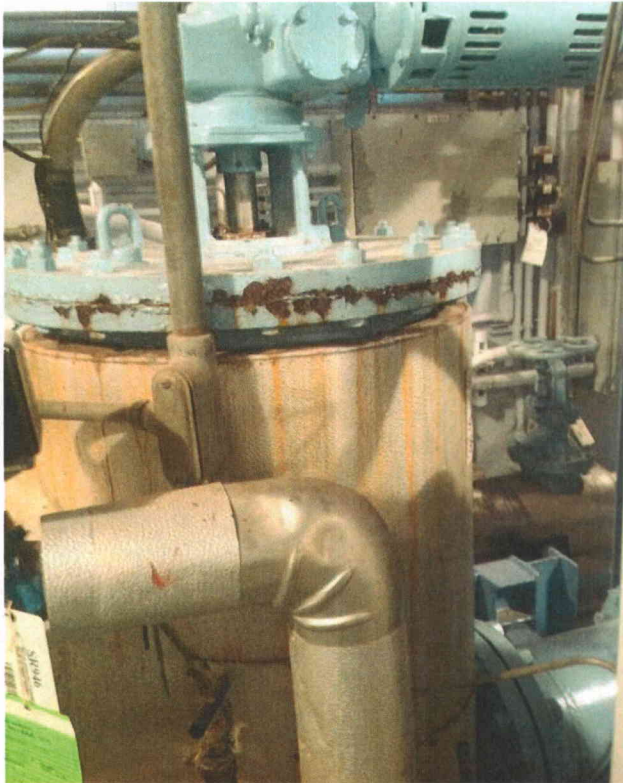
**Photo 1**  
**Minor Corrosion**

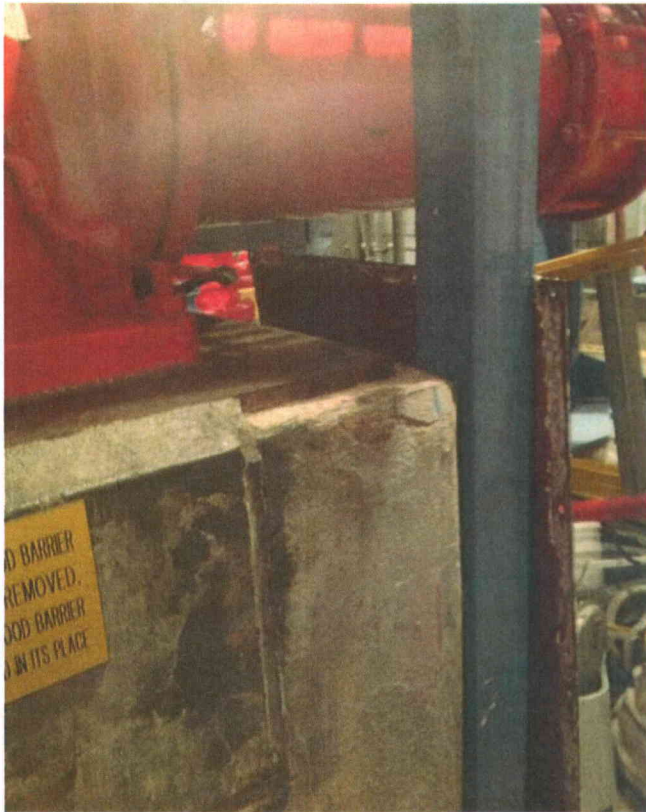
**Photo 1**  
**Damaged Grout**

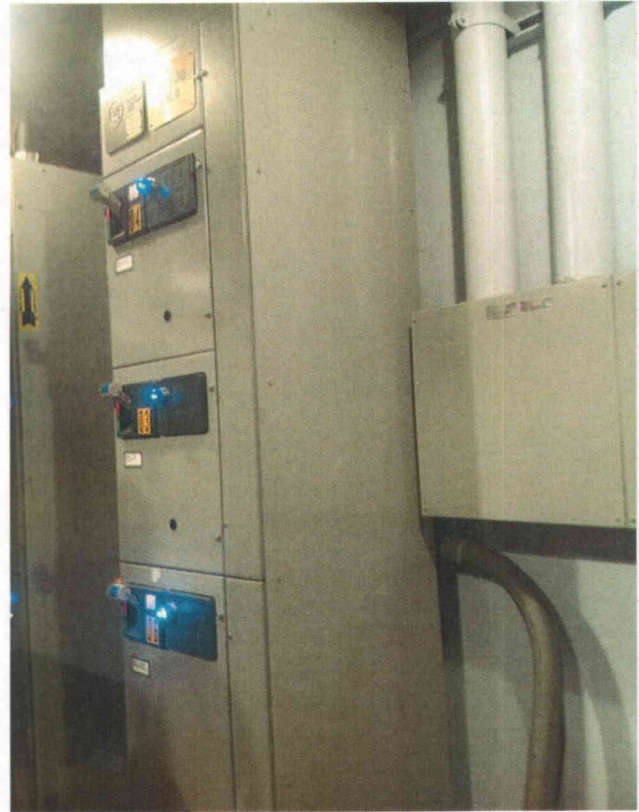
**Photo 2**  
**Movement of MCC Restrained  
by Adjacent Component**

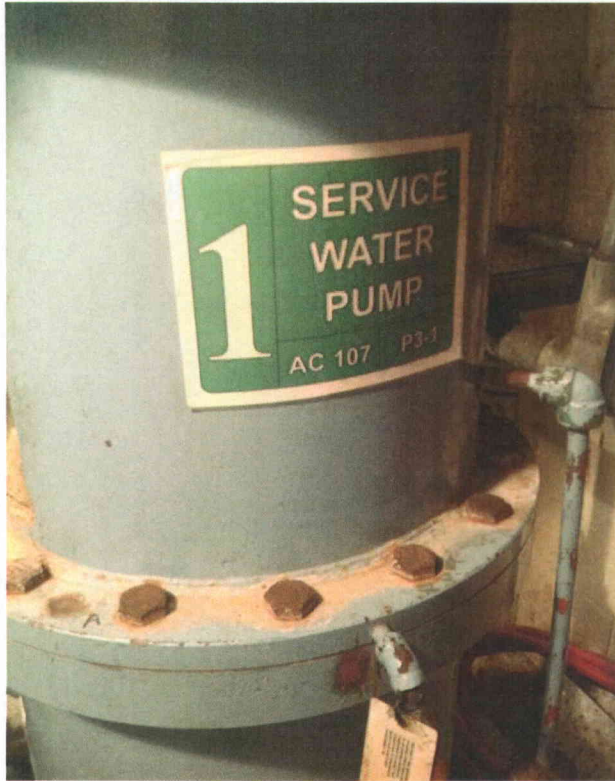
**Photo 1**  
**Minor Corrosion of Pump P3-1**

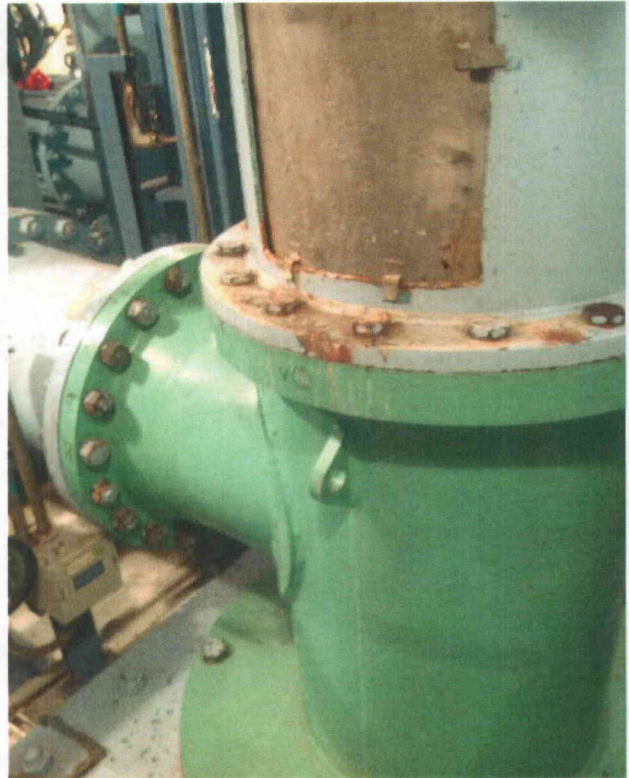
**Photo 2**  
**Minor Corrosion of Pump P3-3**

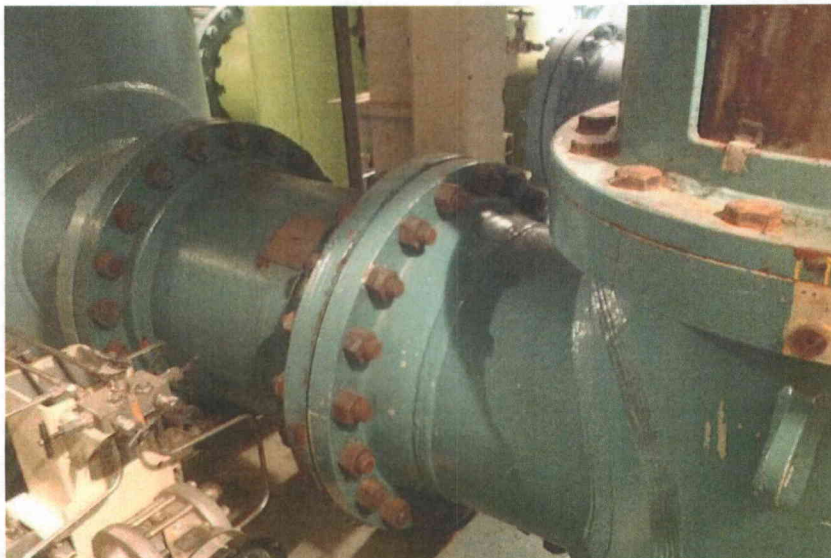
**Photo 3**  
**Minor Corrosion of Pump P3-2**

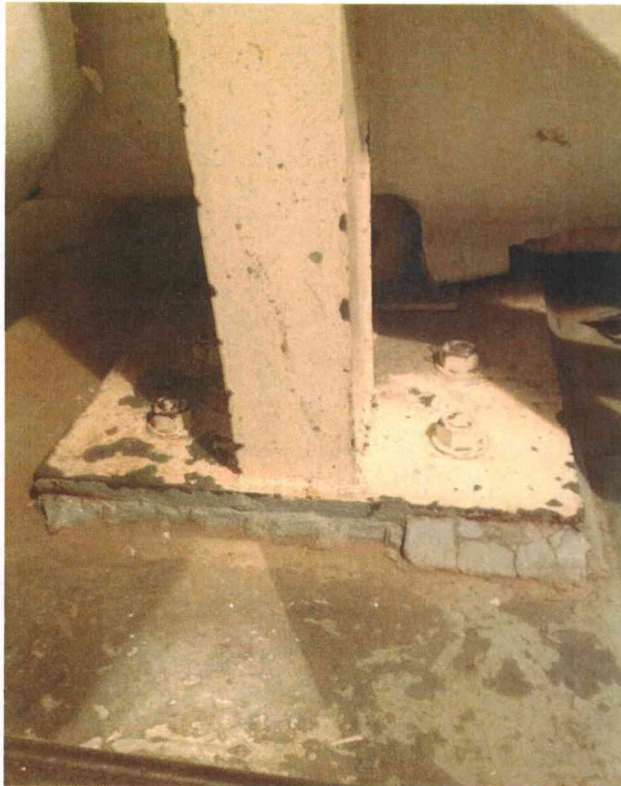
**Photo 1**  
**Damaged Grout**

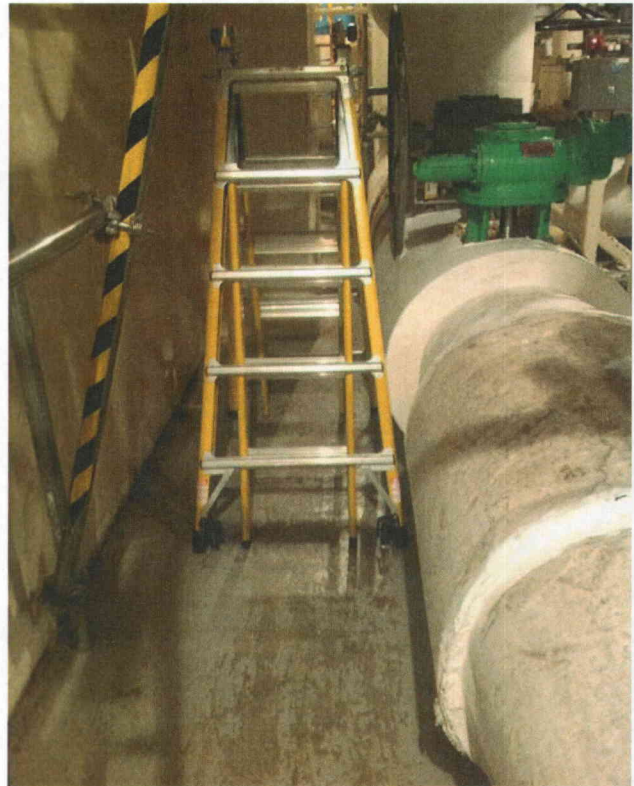
**Photo 2**  
**Ladder Not Restrained**
