APPENDIX B: SEISMIC WALK-DOWN CHECKLISTS (SWCs)

Seismic Walkdown Checklist (SWC)

Equipment ID No. 0G41A0002A Equip. Class 21. Tanks and Heat Exchangers

Equipment Description FPCC Surge Tank

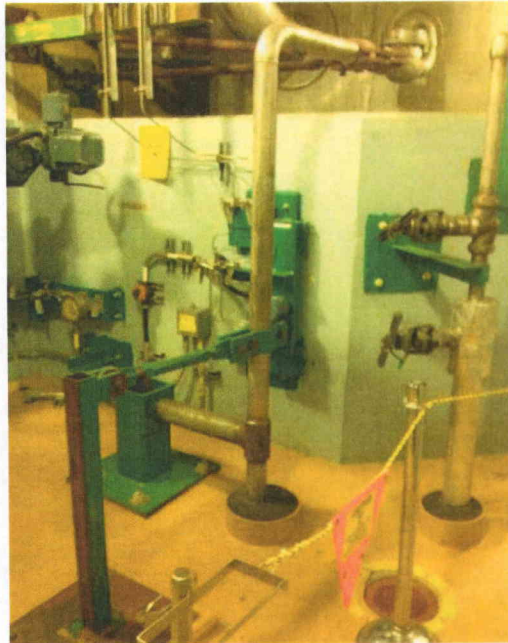
File Name: 2-63-1-4-22.jpeg
Description: View of attached lines to component

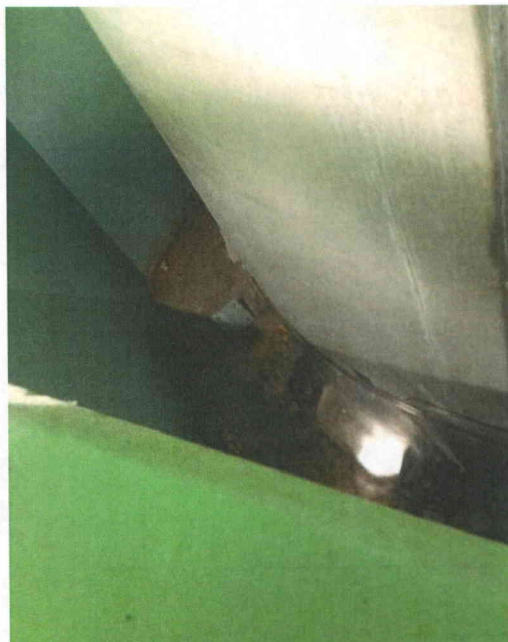
File Name: 2-64-1-4-22.jpeg
Description: View of component anchorage detail

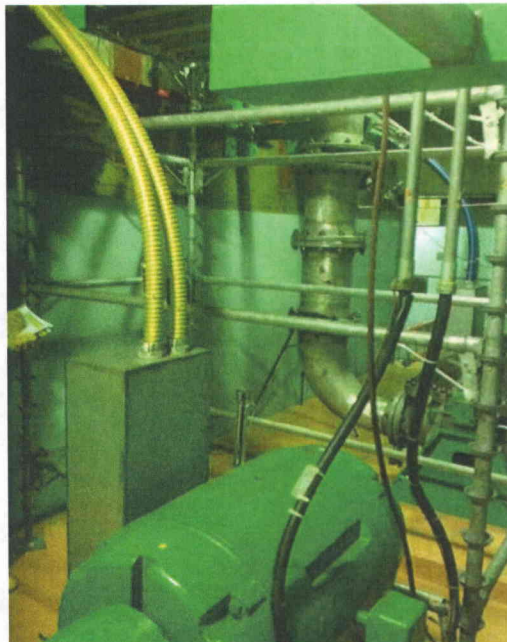
File Name: 2-62-2-4-21.jpeg
Description: View of attached lines

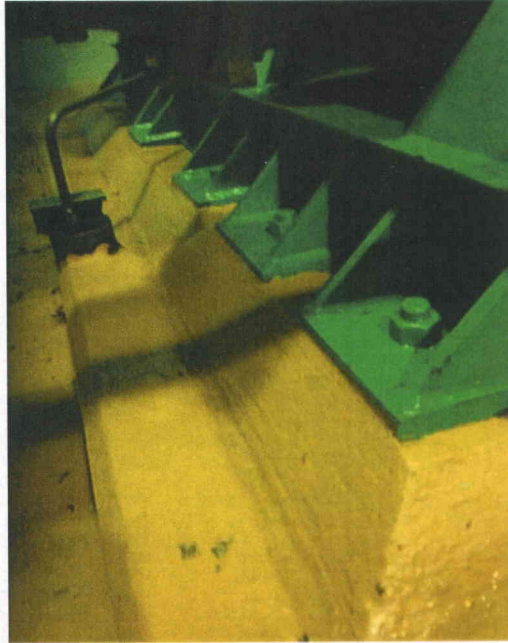
File Name: 2-63-1-4-21.jpeg
Description: View of component anchorage configuration

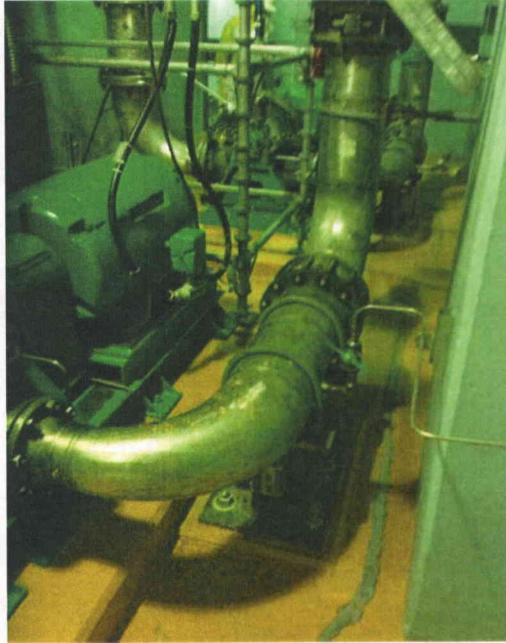
File Name: 2-63-3-4-21.jpeg
Description: View of main pipe line connected to component

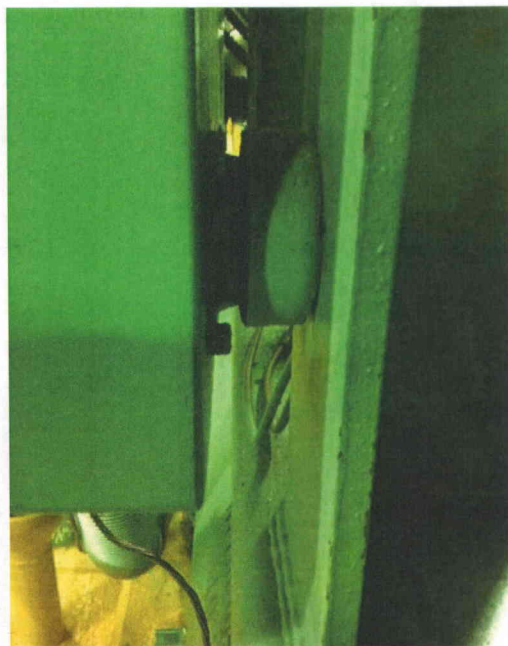
File Name: 2-63-1-1-01.jpeg
Description: Isolator close up

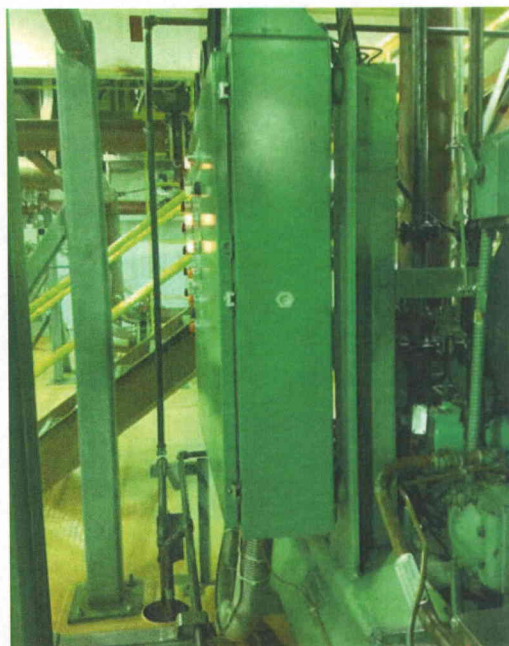
File Name: 2-64-1-1-01.jpeg
Description: Isolators, plate welded to chiller

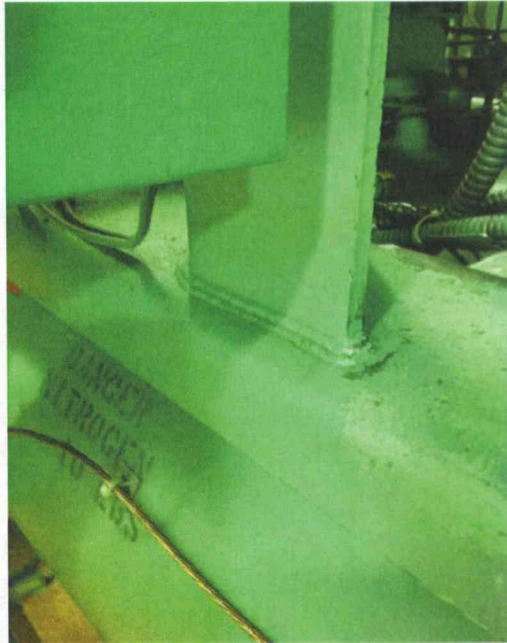
File Name: 2-73-1-1-01.jpeg
Description: Control panel base weld detail

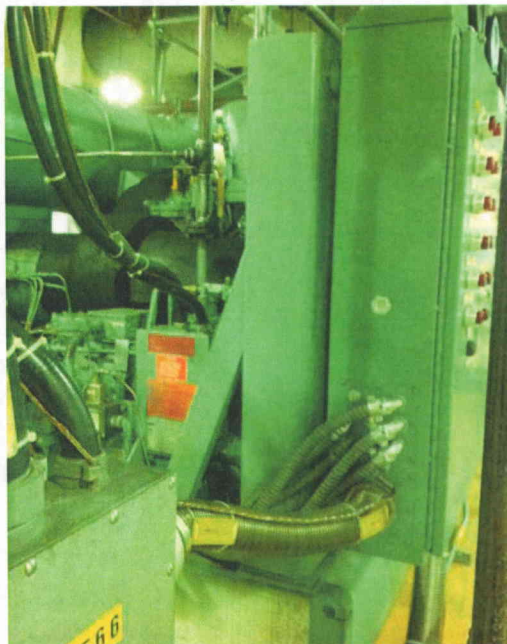
File Name: 2-94-1-1-01.jpeg
Description: Left side isolators attached to L

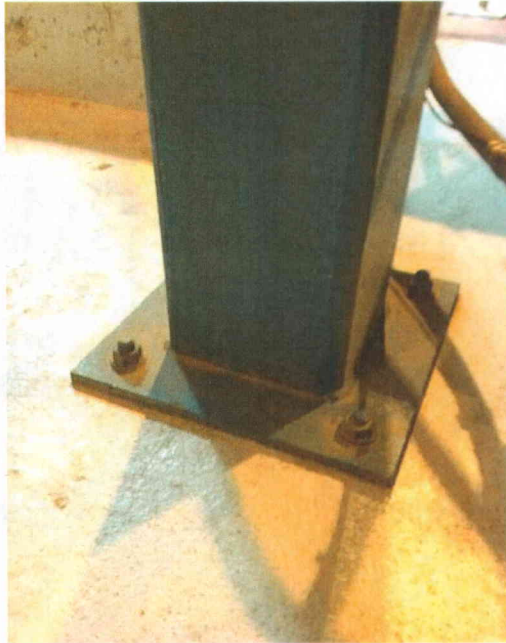
File Name: 2-63-3-1-05.jpeg
Description: Anchorage view of component

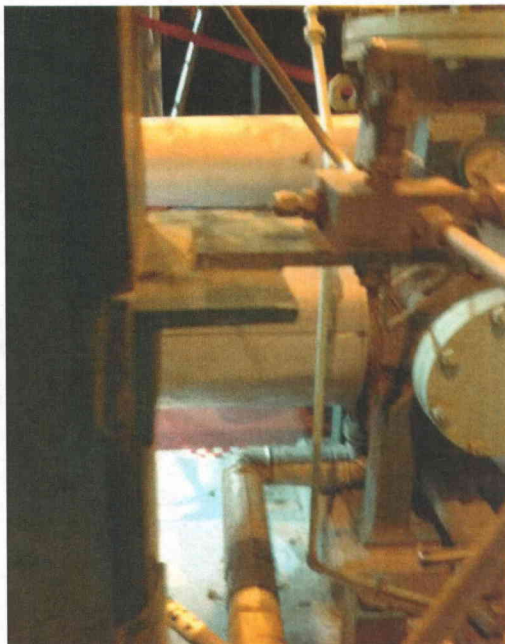
File Name: 2-64-3-1-05.jpeg
Description: Close up view of angle support

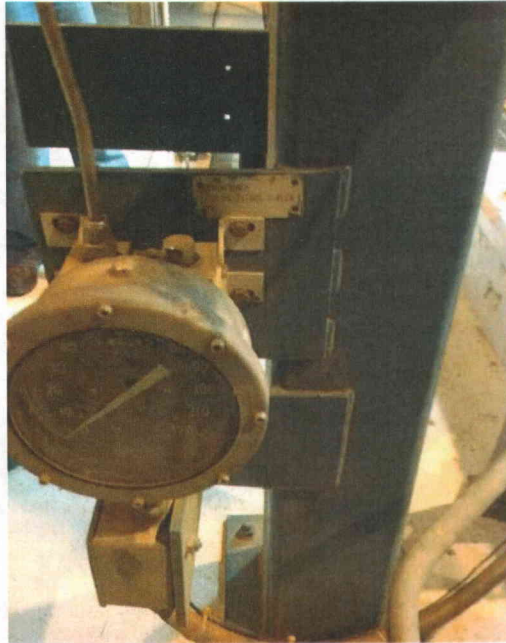
File Name: 2-73-3-1-05.jpeg
Description: Instrumentation support detail

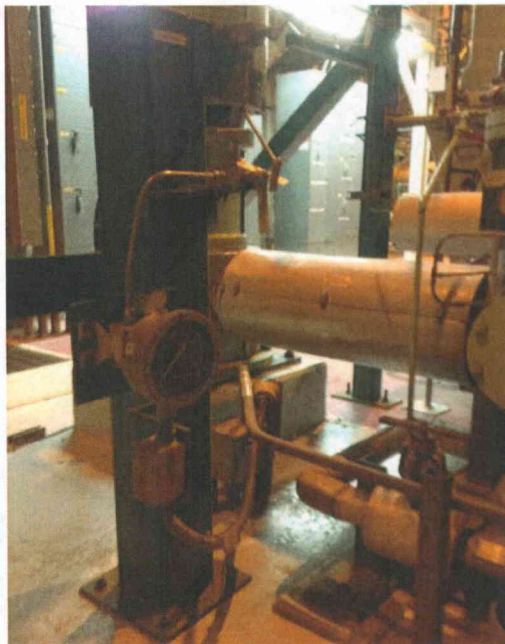
File Name: 2-94-3-1-05.jpeg
Description: Differential not expected

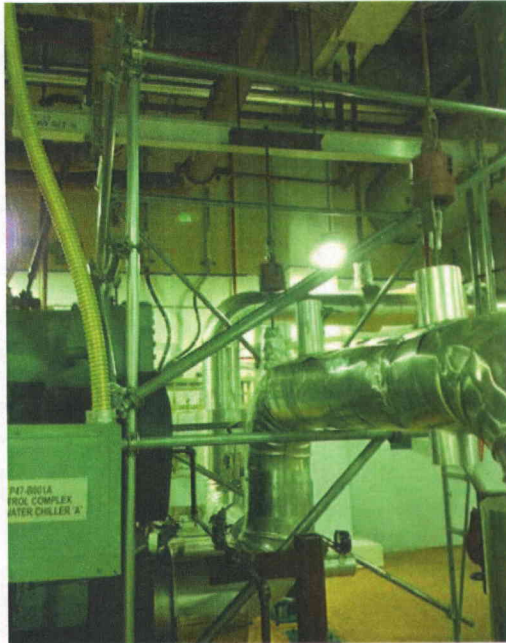
File Name: 2-63-8-4-01.jpeg
Description: Scaffolding located in the area

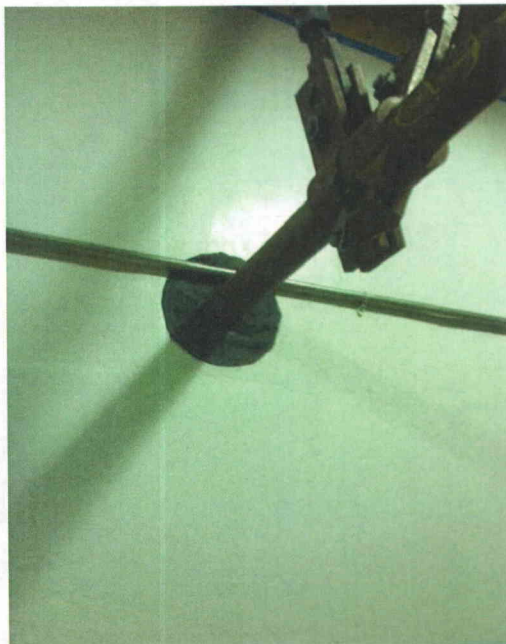
File Name: 2-64-8-4-01.jpeg
Description: View of insulation material in concrete wall

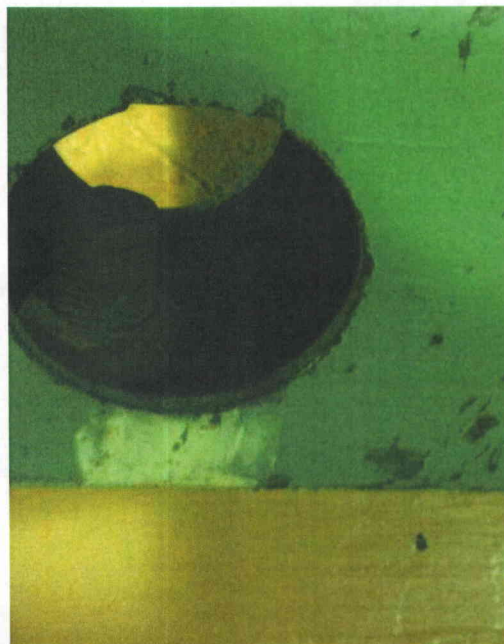
File Name: 2-94-8-4-01.jpeg
Description: View of anchorage condition

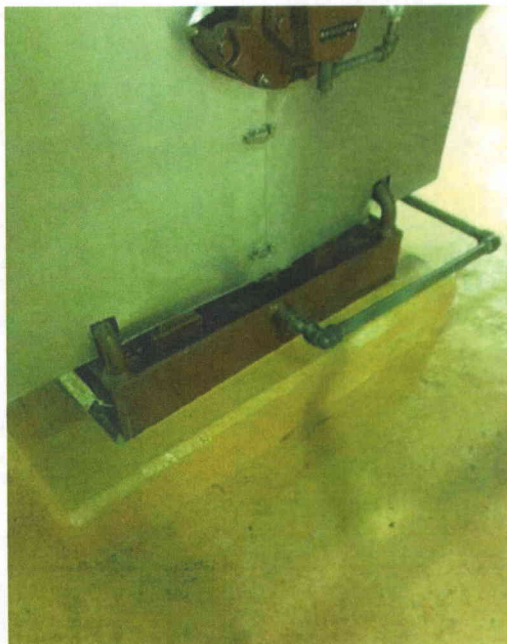
File Name: 2-64-5-4-01.jpeg
Description: View of attached lines at component base

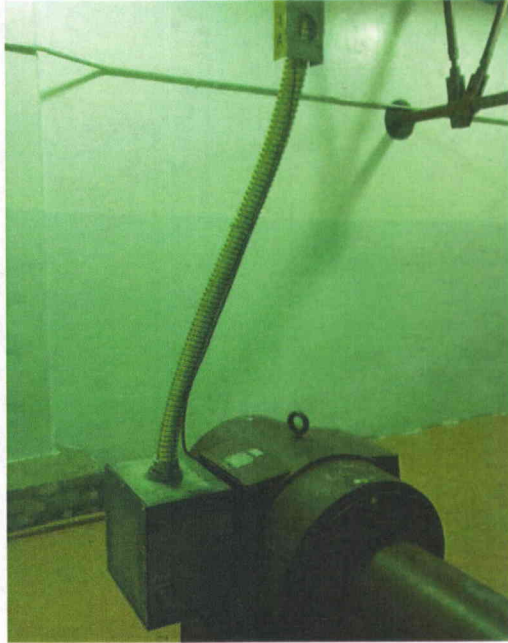
File Name: 2-73-5-4-01.jpeg
Description: View of flexible attached lines

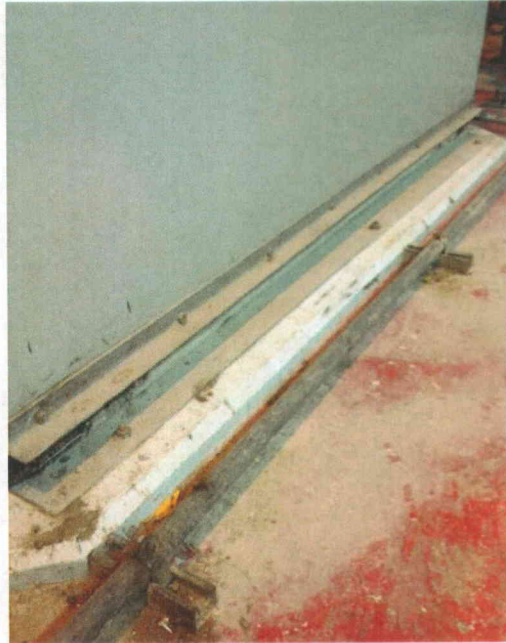
File Name: 2-73-2-4-05.jpeg
Description: View of anchorage detail

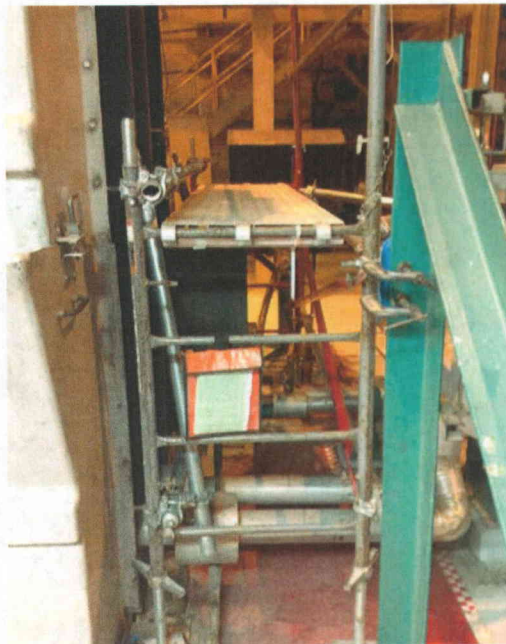
File Name: 2-94-2-4-05.jpeg
Description: Scaffold located near component

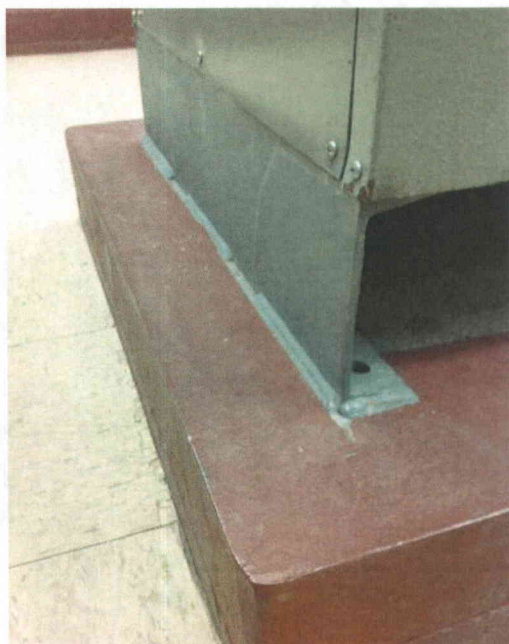
File Name: 2-64-6-1-06.jpeg
Description: View of base anchorage detail

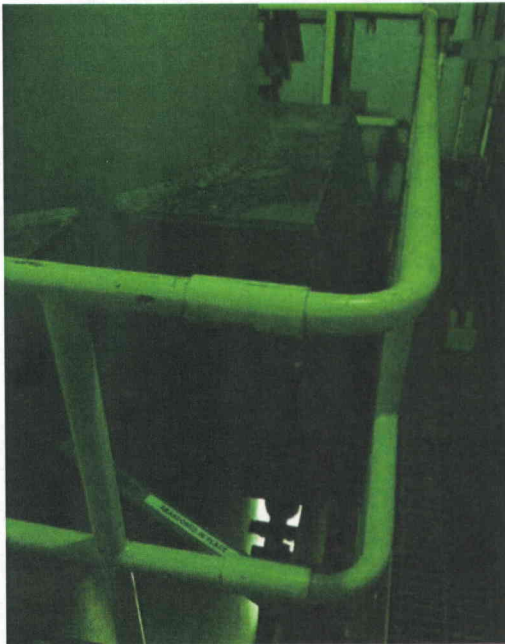
File Name: 2-62-1-4-20.jpeg
Description: View of anchorage detail of component

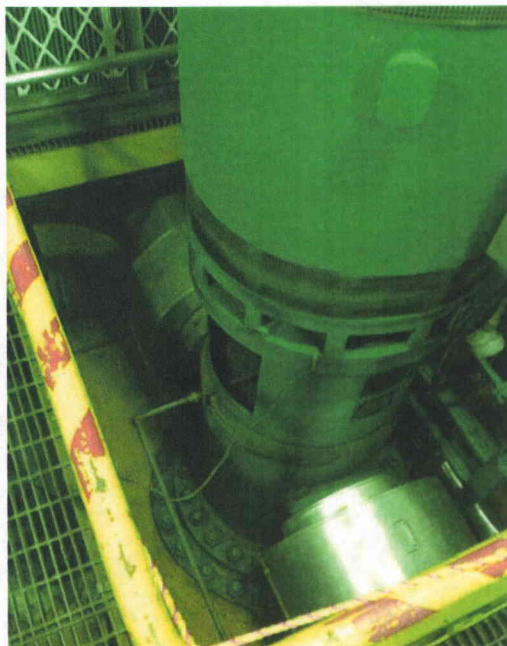
File Name: 2-63-2-4-19.jpeg

Description: View of anchorage configuration

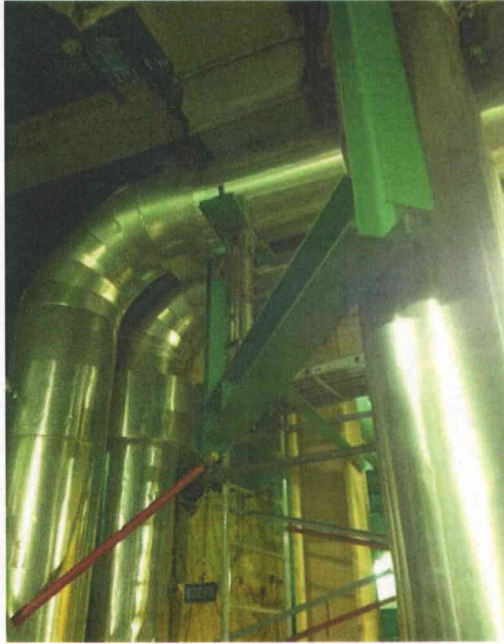
File Name: 2-63-3-4-20.jpeg

Description: View of support condition for pipe line

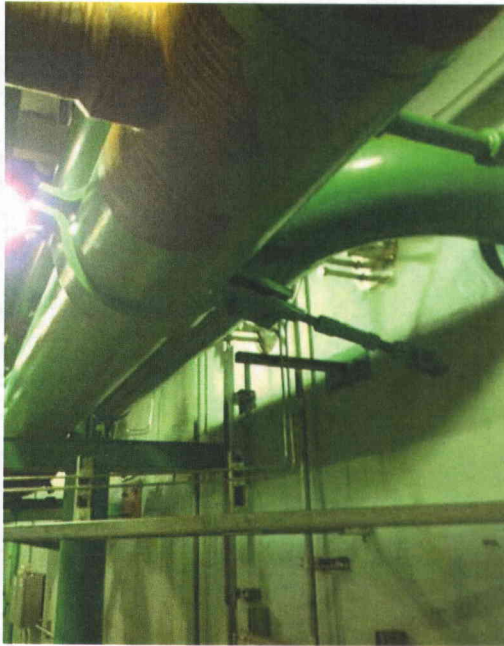
File Name: 2-63-13-4-18.jpeg
Description: View of pipe line lateral supports

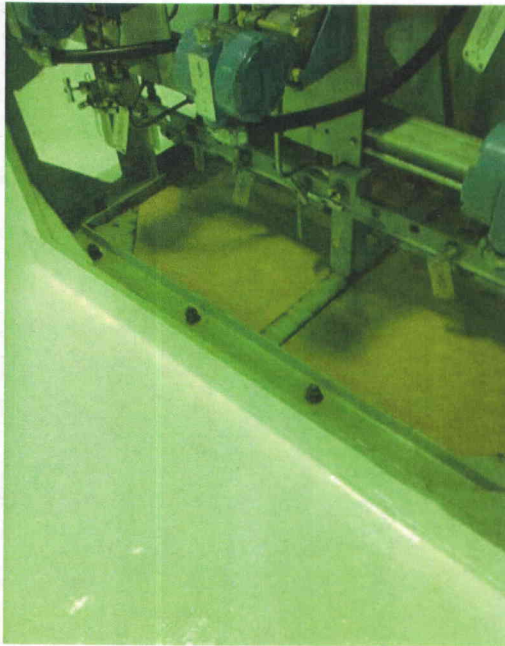
File Name: 2-63-5-4-18.jpeg
Description: View of component anchorage configuration

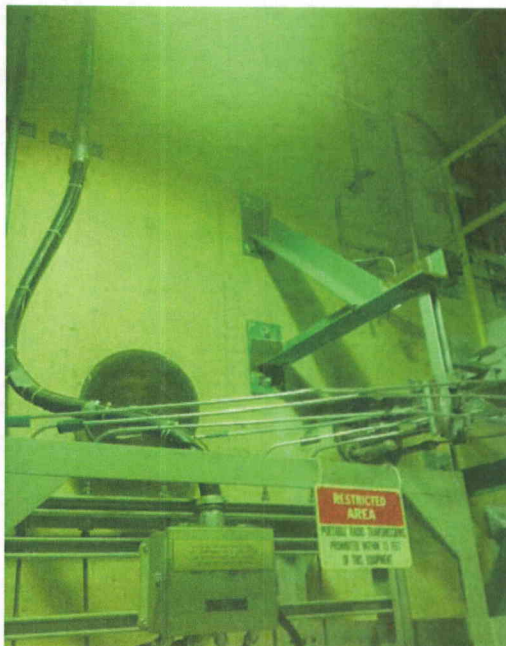
File Name: 2-64-5-4-18.jpeg
Description: View of attached small lines

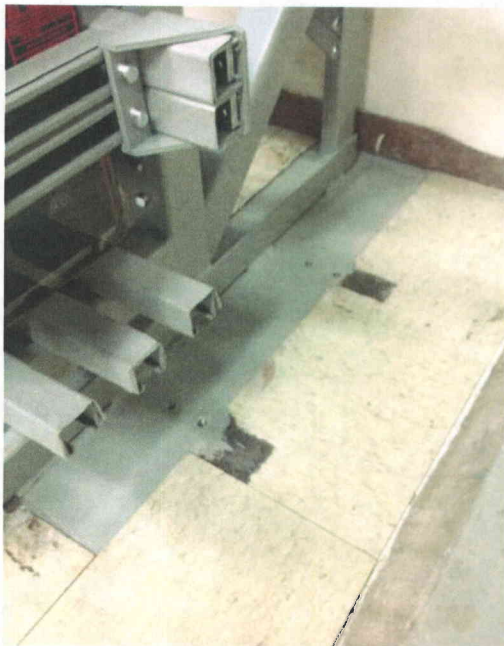
File Name: 2-64-5-4-06.jpeg
Description: View of component base detail
