# Operating Experience Note

No. 19

January 2018

## End of Cycle Operating Experience Update, 2018

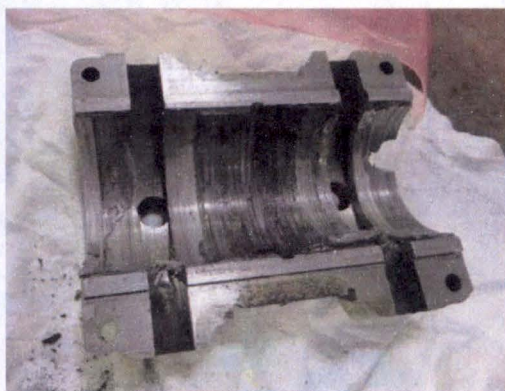
On September 13, 2017, during an auxiliary feedwater pump (AFW) quarterly surveillance run, the licensee at Davis Besse noted high temperatures on the AFW turbine inboard bearing. Operators tripped the pump, and investigation revealed bearing damage, which was attributed to a lack of lubrication caused by insufficient level in the oil reservoir. The staff issued an Operating Experience [OpE Communication](#) (COMM) describing the event at Davis Besse. The COMM includes discussions of other similar events where oil levels in various components were inaccurately indicated on sight glasses for a variety of different reasons.

Figure 1: Davis Besse Failed Inboard Bearing

(b) The minimum level mark on the sight glass was lower than what was described in the vendor manual. Operators had recently drained 10-11 ounces from the oil reservoir for a sample. Since level was still above the low level mark on the sight glass, they did not replenish the oil. This caused oil level to remain below that required for the turbine's slinger rings to effectively lubricate the inboard bearing, and resulted in excessive bearing damage (see figure 1).

A review of the vendor guidance for the AFW pump and turbine revealed specific instructions for setting the oil sight glass minimum and maximum levels. The band described in the guidance required oil level to read higher on the sight glass, and required oil level to be maintained within a tighter band

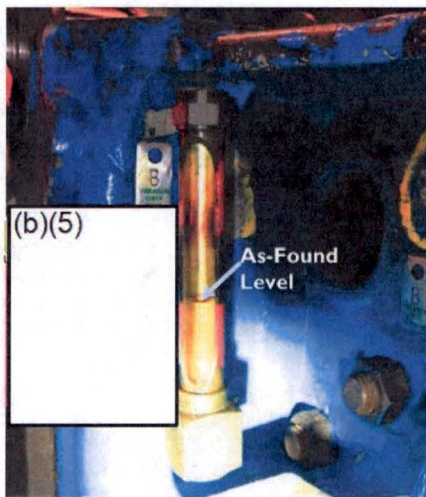
Figure 2: Davis Besse As-Found Oil Level

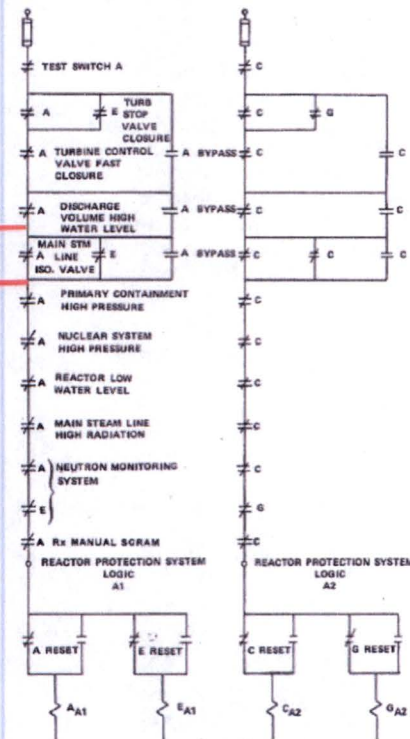
When used in MSIV and TSV RPS logic surveillances, the RPS Test Box is installed across contacts that are arranged in parallel (see Figure 3). Doing so removes multiple contacts from the circuit, and impacts the ability to meet the TS requirement for both trip systems to have each channel associated with the MSIVs in 3 main steam lines either operable or in trip, or for both trip systems associated with the TSVs to have 3 channels either operable or in trip. With the RPS Test Box installed across multiple contacts, 2 of 4 main steam lines become inoperable, rendering the MSIV closure function (and similarly for the TSV closure function) not maintained. This requires the licensee to enter a TS Condition requiring

action to restore trip capability within one hour. In the case of Fermi, the test box was installed for less than an hour, but the licensee did not enter the TS Condition. At Oyster Creek, the licensee had the RPS Test Box installed for greater than the one hour allowed by TS.

Figure 3: Fermi-2 RPS Trip System Logic Showing Location of RPT Test Box for MSIV Surveillance Testing

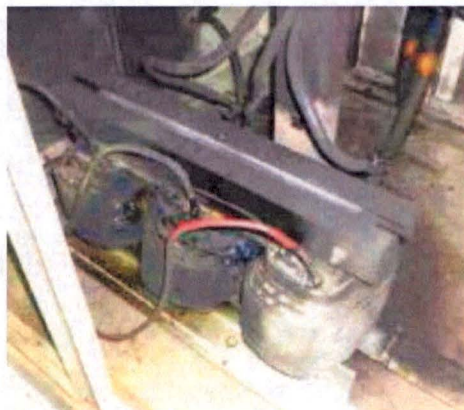
In October 2014, during a 24-hour surveillance test, Wolf Creek's 'B' EDG tripped due to a fire in the electrical excitation control cabinet. The source of the fire was the power potential transformer (PPT). The PPT became overloaded because of two failed diodes in the EDG's current transformer (CT). When these diodes failed, the current boost to the EDG excitation field was reduced, and the voltage regulator compensated by increasing the output of the PPT. This exceeded the load capability of the PPT, and over time it eventually failed. The CT diodes had likely failed during a previous surveillance run in June 2014. Operators had noticed smoke coming from the PPT during interim monthly runs, but it wasn't until the 24-hour endurance run that conditions worsened to the point of PPT overheating and failure. The licensee had planned to replace the PPT in August 2014, but the replacement was delayed until February 2015.

Figure 5: Failed PPT at Wolf Creek
